Rapid Response to Emergencies:

**ASDSO – Seattle Washington
Tuesday September 21, 2010
General Session 8:30 – 10:00 AM**

Rapid Response to Dam Emergencies Introduction; The Ah-Ha Moment

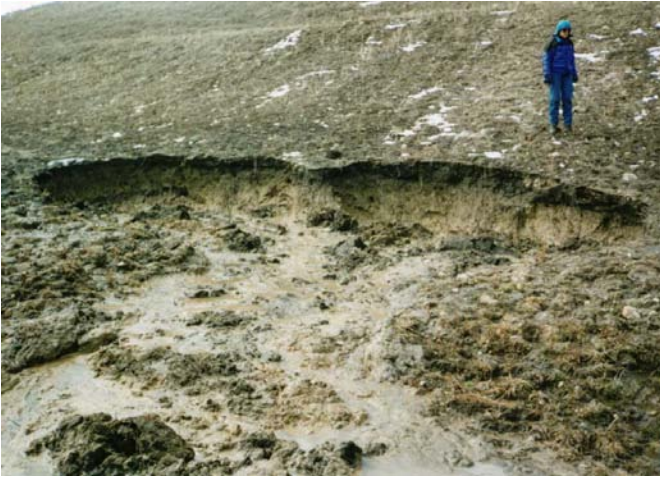
In June, 1995, the Montana Dam Safety Program received a call from the State Prison Ranch. Approximately 100 GPM of seepage was flowing from a large hole at the toe of one of the large ranch dams. The hole was increasing in size rapidly....flow was increasing as well. Unquestionably, this would lead to catastrophic failure of the dam in short order.

Blow out at toe of Powell dam

The blow out hole was located on the left edge of a recently constructed seepage control berm. It is suspected that construction of the seepage berm may have concentrated seepage towards the edges of the berm. Another contributing factor could have been the storage of top soil during construction. When the top soil was removed, the area may have been left with an uplift safety factor near 1. What is perplexing is the failure did not occur until the second filling after construction.

A toe drain was added to the dam, intercepting and draining the gravel layer believed to be the source of the high pressures to the area. No further problems have been encountered.

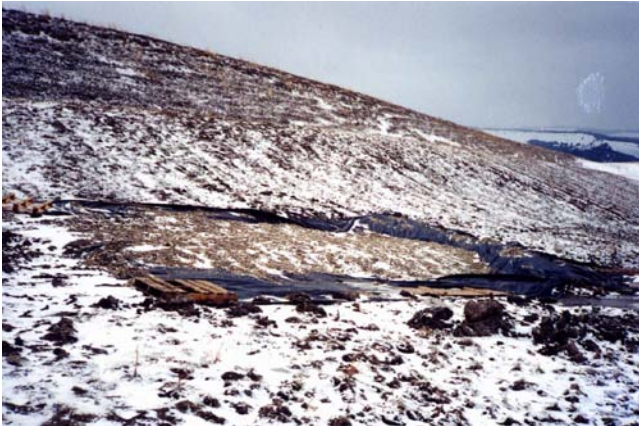
Repaired blow out

The ranch had several rolls of a woven geotextile on hand (for silt fence construction). They placed the geofabric directly over the rapidly developing hole, and weighted the fabric down with drain rock that was stockpiled nearby. This successfully stopped the seepage erosion from progressing.

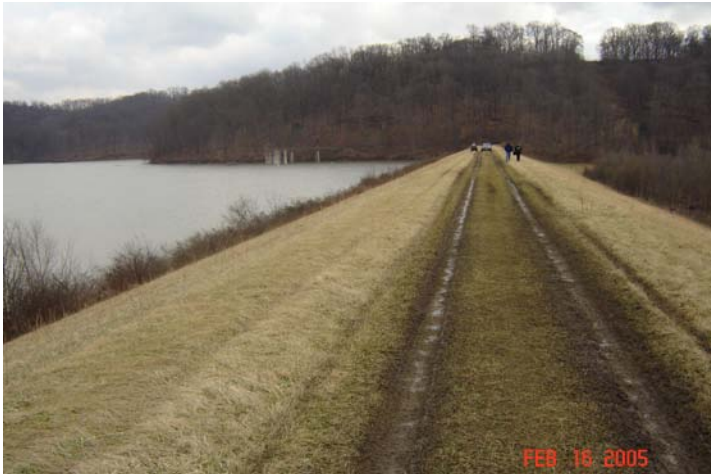
Record high pool levels preceded incident

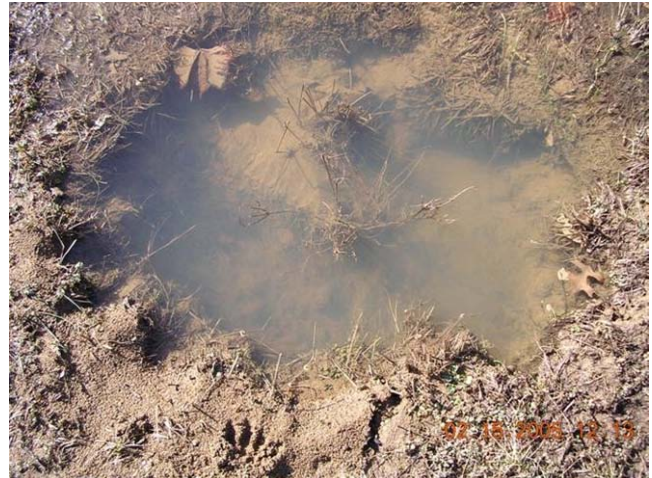
In February, 2005, the Ohio Dam Safety Program received a call from the Salt Fork State Park. A large seepage boil had appeared at the toe of the 61 foot high dam, following record high pool levels. Staff had noted water at the toe of the dam, but the alarm was not sounded until the dam safety trained maintenance manager observed the boil. The boil was 4 feet in diameter, cloudy, with soil particles moving at the bottom.

Four foot diameter boil at toe of dam

The boil was caused by a malfunctioning toe drain and surcharging of the toe drain by flows from the right abutment. The toe drain material consisted of a concrete sand filter material and a larger drainage material of gravel up to 8 inches in diameter that was clogged with sediment. The drain pipe also had a tear in it, and the pipe was full of sediment.

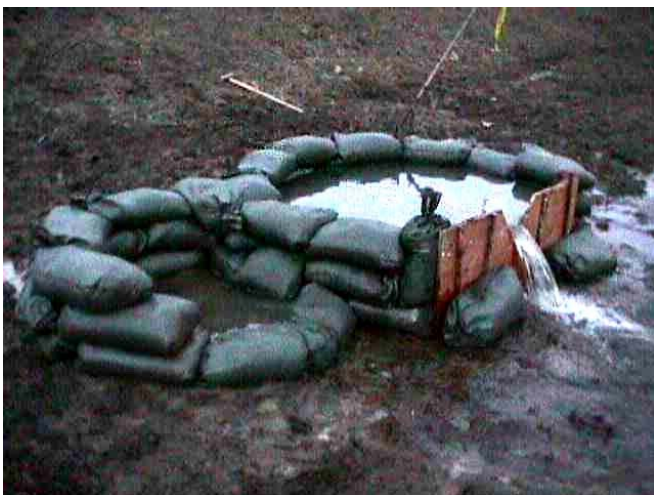
Sand bag ring

A sandbag ring was constructed around the boil and a V notch weir installed to monitor flow. The amount of flow coming into the lake made it impossible to quickly lower the lake level. The use of large pumps to assist with the drawdown was not an option, due to high cost and availability. Excavating through an abutment to drain the lake was considered, but since both abutments are bedrock this idea was abandoned. It was decided to construct a weighted filter berm over the boil consisting of pea gravel over the boil overlain by concrete sand. Seepage flow increased from 50 GPM to 130 GPM during a short period of time

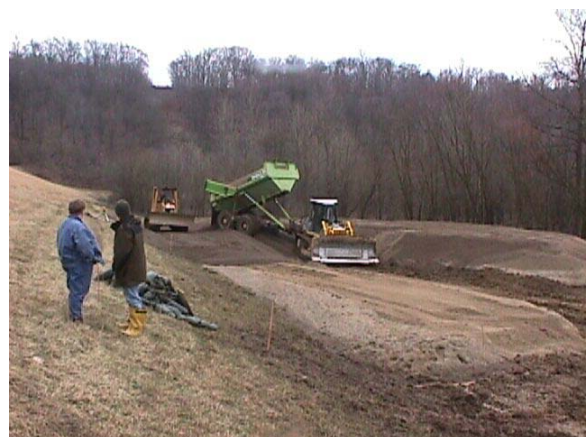
Construction of Weighted Filter Berm

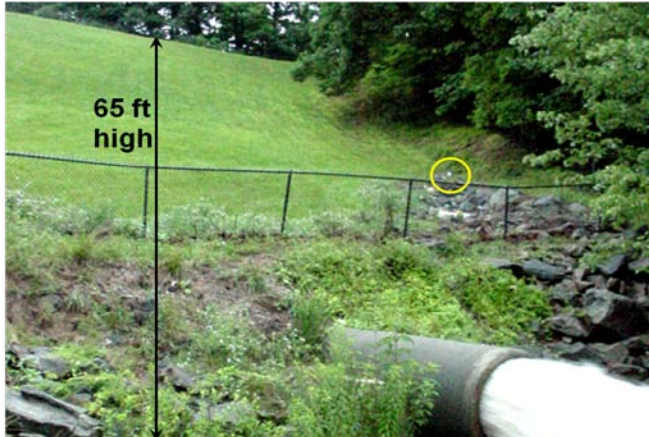
In June, 2006 heavy rains caused a 23 foot rise in Lake Needwood, located in suburban Washington, D.C. Uncontrolled cloudy seepage through the dam and foundation occurred and the dam was on the verge of failure. The Dam had been judged to be in excellent condition prior to the event. No serious problems occurred when the lake rose to a similar high level in 1972. Annual inspections of the dam starting in about 1995 noted some wet areas, and by 1999 nine observation wells were installed into the dam embankments and foundation

Seep on left abutment viewed from downstream slope

There were insufficient funds to grout the entire foundation during construction and only the right side was grouted. The leak occurred in the ungrouted left abutment. Some finger drains of gravel were included on the left side to control foundation seepage, but the leakage rate during the flood exceeded the flow capacity of the gravel drains and flow started exiting the embankment when the head increased.

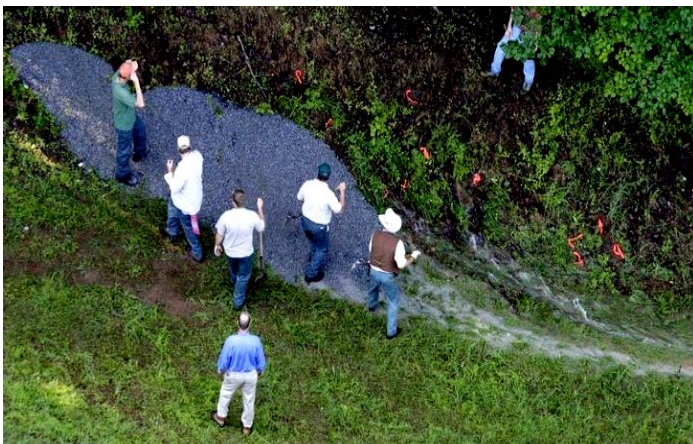
Spreading gravel over the leak in preparation for filter

First, gravel was spread over the entire leak area. The gravel is used to collect seepage. Next filter fabric was placed over the entire seepage area and held down with gravel and sandbags. The filter fabric was intended to minimize the loss of soils due to internal erosion. The filter fabric was then held down with sand bags and gravel. Evacuation of 2400 people also took place. A simple plywood monitoring weir was constructed to monitor the change in seepage.

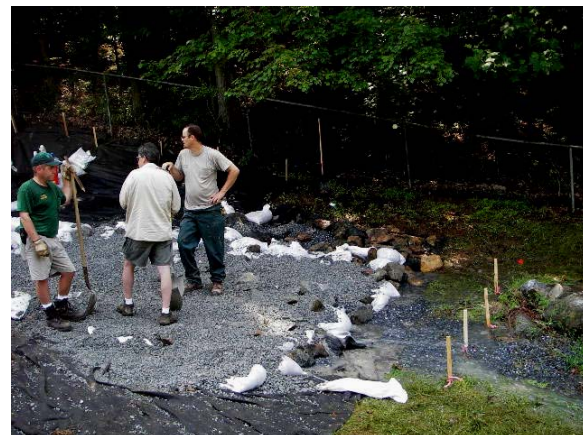
Filter Fabric with sandbags and gravel for weight

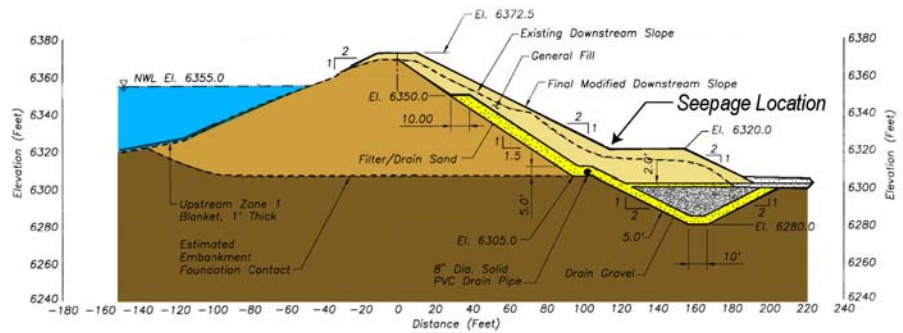
A. Cross Section of Original Modification

Washakie Dam had undergone a major modification project to address historic seepage problems, principally through the glacial foundation soils. The modification included a single-stage chimney drain and a two-stage, deep, toe drain (Figure A). In June 2000, during first filling after the modification, a damp area was observed at the junction of the downstream slope and a toe berm. While test pits were being excavated to investigate the wet area, seepage and piping occurred suddenly in one of the pits.

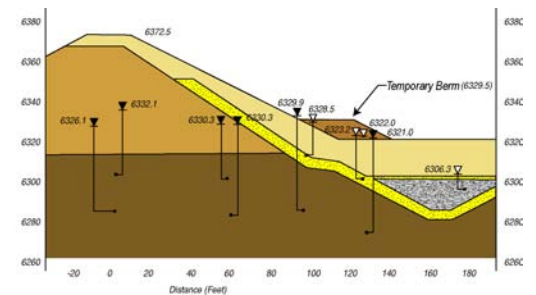
C. Piezometer Readings

Investigations, including detailed evaluations of piezometers (Figure C) indicated that the incident was caused by large quantities of concentrated seepage flowing through highly permeable zones in the glacial foundations. This seepage was so concentrated and so large that it overwhelmed the single-stage sand chimney drain. The chimney drain could not convey the seepage to the large capacity toe drain below. The seepage bled off of the drain, raising the piezometric pressures in the downstream section of the embankment, causing the wet area and a blowout in the test pit.

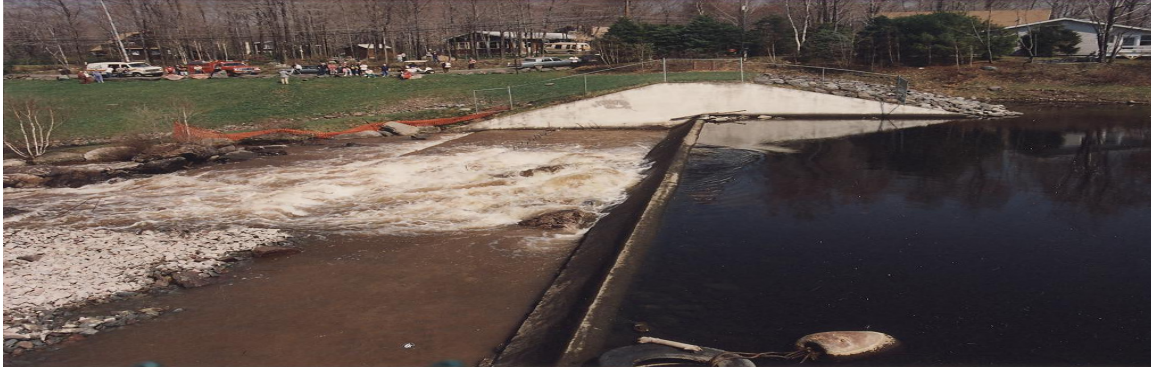
In December 1993, due to severe weather the emergency spillway apron repair work was put on hold until spring. In April 1994, prior to the contractor returning to the project, a maintenance man observed a large muddy boil approximately 20 feet in diameter just below the weir with a whirlpool in the reservoir directly upstream of the weir.

Whirlpool above weir with boil flowing downstream of weir.

The emergency action plan was activated immediately. A local stone quarry provided equipment and materials to plug the boil. A cofferdam was constructed upstream of the weir to dewater the area so an inspection of the weir could be conducted.

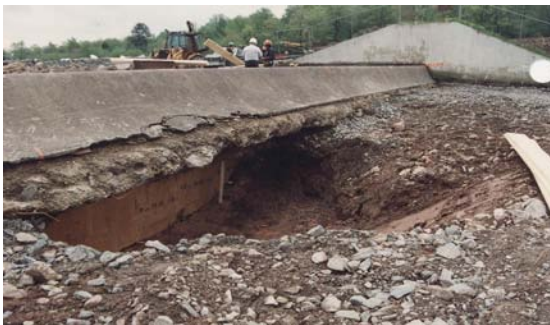
Void upstream of the weir.

A trapezoidal shaped void 20-feet long, 4-feet deep had developed under the weir. The concrete cutoff wall consisted of logs and sticks surrounded by bags of concrete.

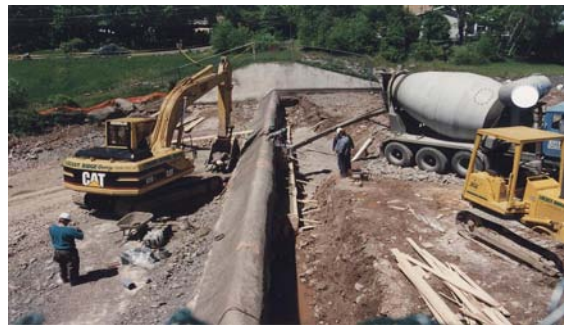
Repairing the void upstream of the weir.

The upstream void was repaired with concrete. A new concrete spillway apron with an under drain system was constructed. A concrete cutoff wall was placed downstream of the new apron. All repairs were completed by July 1994.

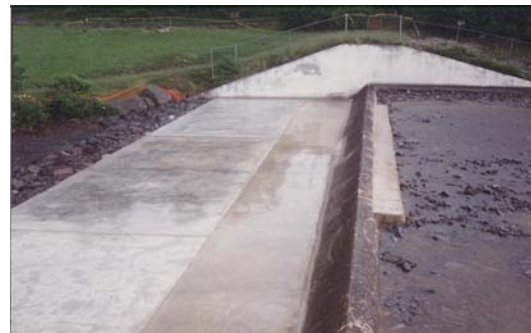
Repaired spillway.

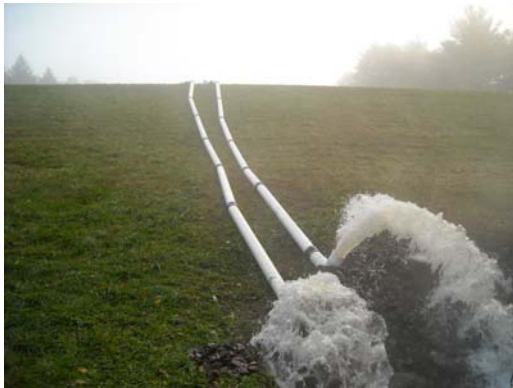
Two siphons on the downstream face.

In 2009, PA-DEP began preparing a removal plan. As the design progressed, it was realized that a complete removal would take longer than expected. It was decided that the hazard must be reduced as much as possible until the removal of the dam could take place. Four siphons were constructed to lower the water surface elevation to a point where the primary spillway structure could be cut where it meets the upstream embankment.

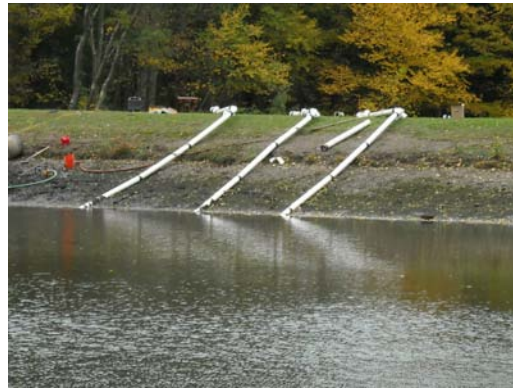
Water surface drawn down six feet below normal pool.

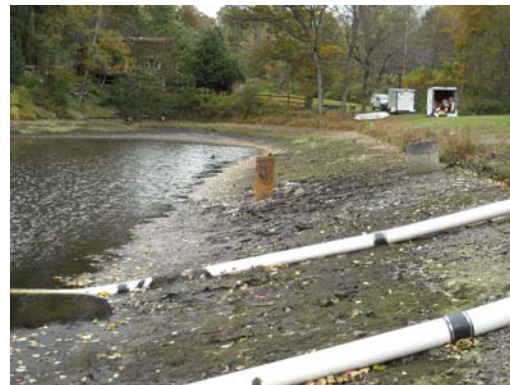
Water level drawn down below primary spillway.

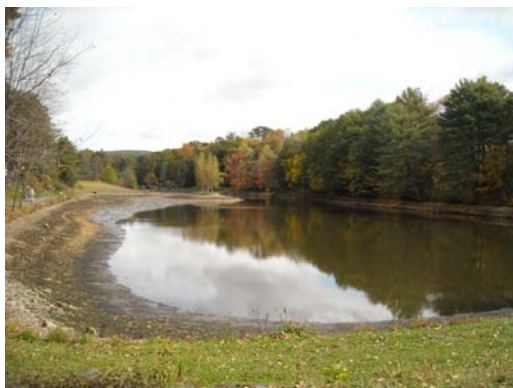
Current conditions at the dam.

The removal of the dam is planned for the fall of 2010. Funding has been obtained to create an educational wetland system within the impoundment which will be maintained by a local environmental group.

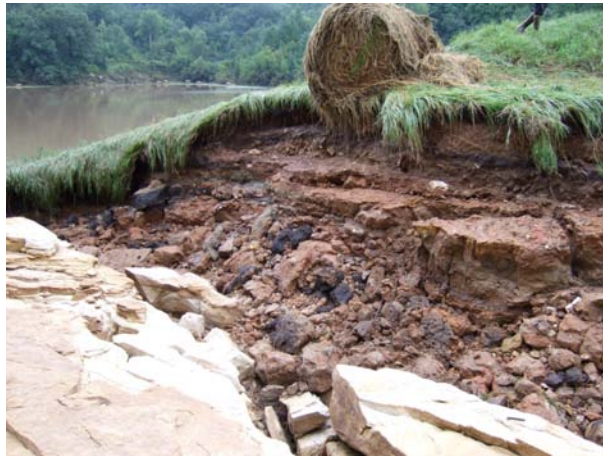
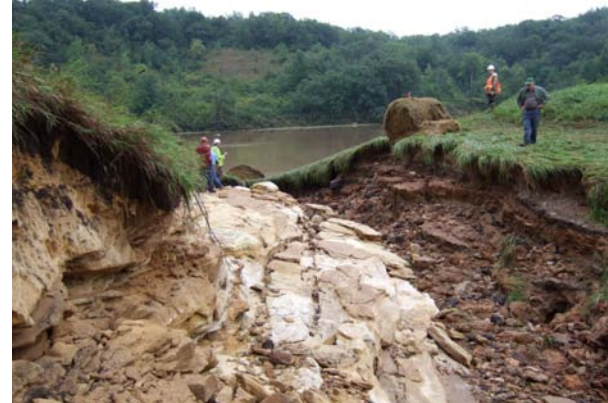
In August of 2007 large rainfall events occurred over west central Wisconsin. This area of the state is home to the largest concentration of PL566 flood control dams in WI. Up to 12 inches of rain in 24 hours fell on very steep, saturated soils causing rapid runoff. The Kickapoo Valley took the blunt of the rain and reports came in quickly of the flood control dams filling and discharging through their auxiliary spillways. One remote high hazard structure, Hidden Valley Dam, was located downstream of a farm where hay was recently cut and baled into large round bails. Those bails became floating nightmares to dam operations. The weather forecast for additional heavy rains caused concern with plugging of the principal outlet 80 bails remained in the reservoir and flowing of the already partially failed auxiliary spillway.

Aux. spillway crest with hay bail

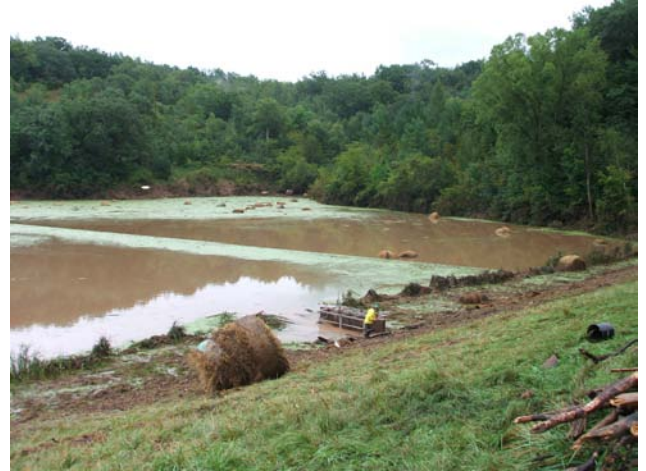
Hay bails contained by seines

We called in the Wisconsin Department of Natural Resources operations crew with a backhoe, small dozer and 6 people. Some of the six were fisheries staff and when brainstorming as to how to control the hay bails it was mentioned that they had access to two large seine nets. We devised a method to anchor the large nets to the shore using steel pipe and strung the nets across the entire impoundment upstream of the outlet structure making sure to allow for an increase in water levels. The forecasted rains came and nets held the bails from getting to the dam. Over the next two days the fisheries crews rounded up the bails using small boat, dragged them to shore and the backhoe lifted them safely out of harms way. A crew of prisoners from a low security prison was brought into to assist in the removal of woody debris that had washed down the valley to the dam.

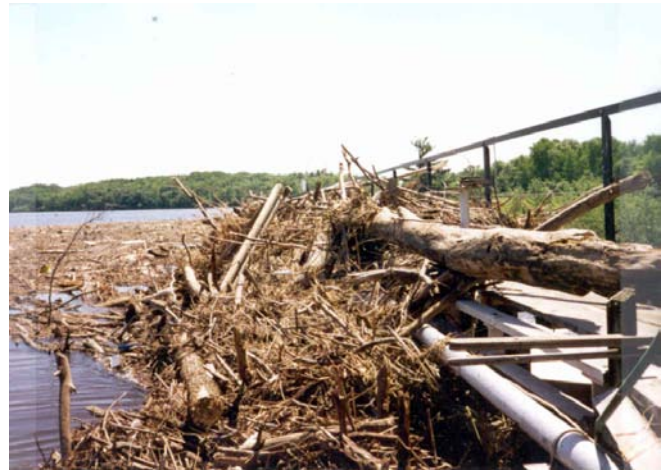
Debris clogging trip gates

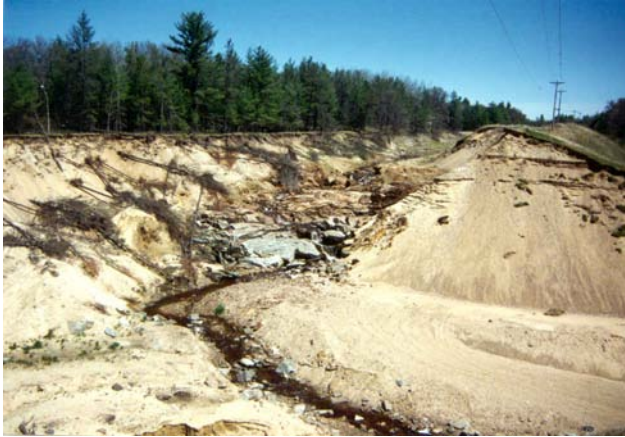
Canal breach

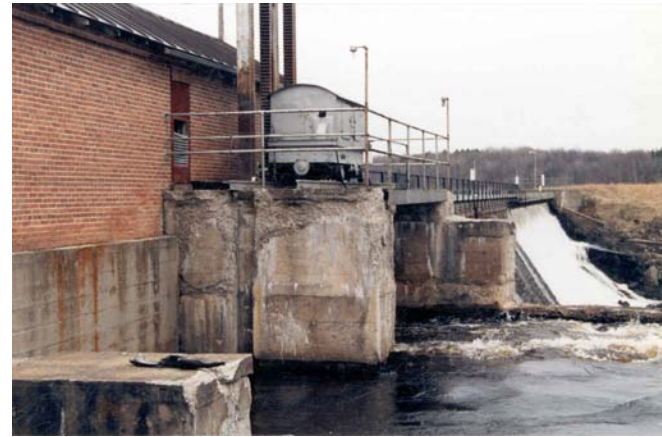
Dam safety staff were sent to the scene to assist local law enforcement and the dam owner. Once the headgates were shut the concern became whether or not the gates were actually designed to hold the expected head once the race was drained. Emergency response had been focused on the flooding downstream of the failed structure but there could be a very dangerous situation still unfolding. A call was made back the dam safety office and calculations were made to determine if the gates would be sufficient. The onsite engineer was justified in his concern since the factor of safety for the gate structure was under 1.0 under full head.

Headgates

The solution was to create another dam just downstream of the headgates to back pressure the gates and reduce the pressure. An earthen embankment was constructed using tight clay soils while the gates were temporarily closed. Construction was completed within a day and the gates were cracked open to fill the area between the gates and the new earthen plug. An engineer was on site during the “filling” to inspect the structure. There is a concrete overflow spillway between the gates and the plug that regulated the water levels during high flow. That section of spillway was intended to control the water levels in the canal.

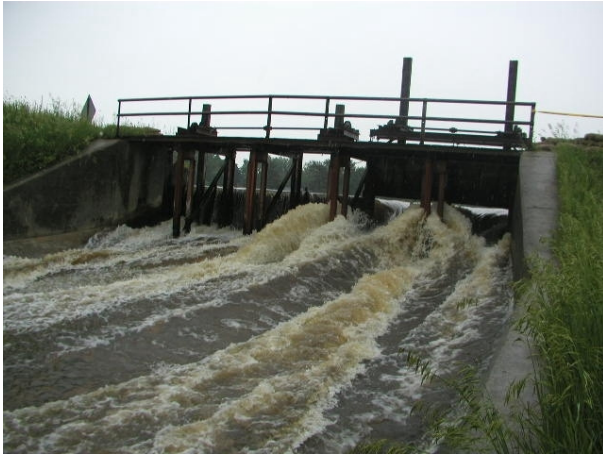
Main gates (just after flood)

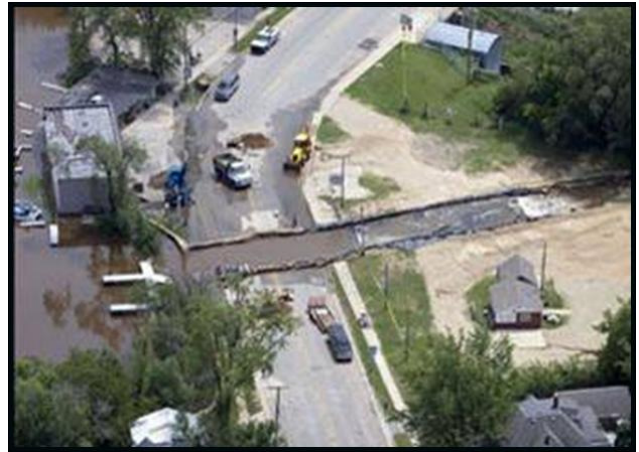
Emergency spillway from the air

The upstream portion of the roadway was sandbagged to prevent overtopping while the idea was formulated to construct a temporary emergency spillway across the crest of the road using plastic sheets and sandbags. The plastic sheets were placed and sandbags were used on upstream end and along both sides to channel the water downstream. Additional sandbags were placed in the flow way to prevent the plastic from “floating” and to assist in energy dissipation on the downstream slope. Water was allowed to enter the channel by removing a sandbag at a time from the upstream end of the channel and monitoring the conditions before removing more bags. The channel was extended 50 feet past the edge of the road to a rocky area in hopes that the water levels would recede faster than the embankment would wash out.

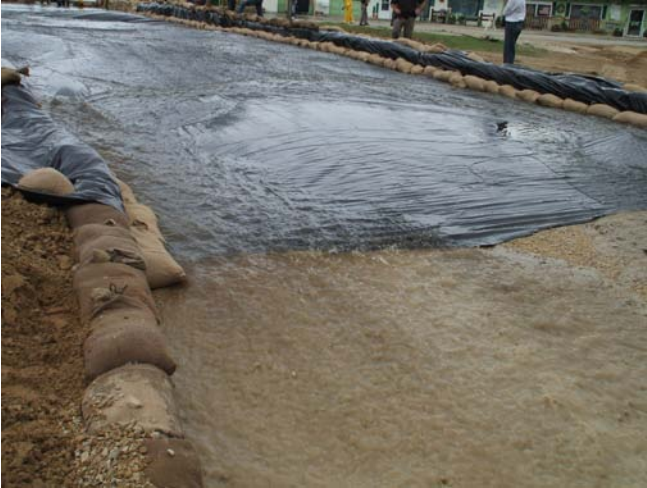
Downstream end of emergency spillway

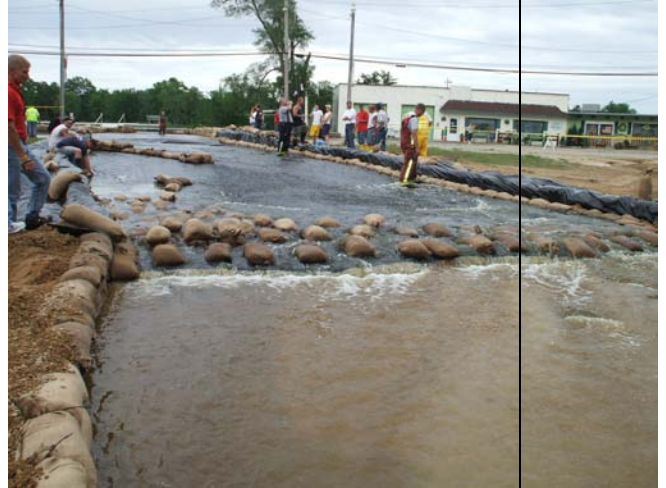
Downstream end with energy dissipation
