Heliyon 2 (2016) e00120

Dam-Breach hydrology of the Johnstown flood of 1889—challenging the findings of the 1891 investigation report

Neil M. Coleman^{a,*}, Uldis Kaktins^a, Stephanie Wojno^b

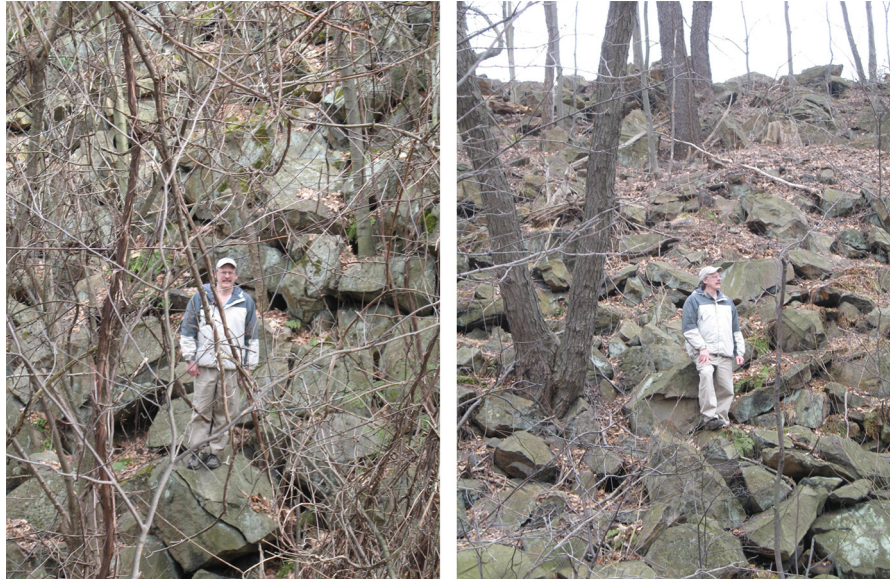
Fig. 3. Large sandstone riprap on the western (left) and eastern (right) remnants of the dam. These represent the downstream side of the dam and illustrate the excellent riprap used in the original construction, obtained mostly from excavation of the main spillway (photos by U. Kaktins). Large riprap like this was *not* used in reconstruction efforts by the SFFHC (see Fig. 4). The person shown stands 1.8 m high.

One of the key changes was that the large riprap originally used to cover the downstream slope of the dam (see Fig. 3) was *not used* to cover the repaired section. Smaller riprap was used, and this is evident in plate LIIIA of Francis et al. (1891) (also see Fig. 4). Despite this photographic evidence to the contrary in their own report, Francis et al. (1891, p. 446) state that “heavy” riprap was used to cover both sides of the repaired embankment. Also the original dam, instead of a heart wall, relied on “puddled” clay layers to ensure a low permeability integrity of the embankment. But the puddled layers were not replaced during the repairs.

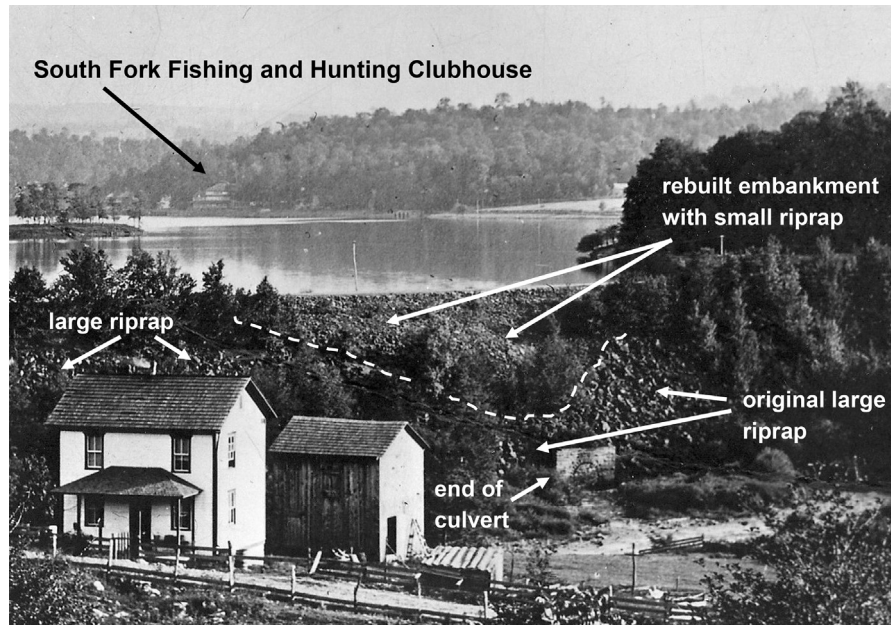
Another major change was the lowering of the dam crest, reportedly to widen the carriage road on top (Francis et al., 1891, p. 446), but the lowering of the crest was also an obvious expedient to quickly get material to begin repair of the partial breach of 1862 (Kaktins et al., 2013). We believe that was the primary reason for

Fig. 4. Undated photo taken after the 1862 partial dam failure but before the 1889 flood. View is toward due south. After the repairs, large riprap is missing from the downstream center of the dam but is clearly seen on the eastern (left) and western (right) sides of the original embankments (see Fig. 3). Note the lesser amount of vegetation on the repaired section (zone above dashed white line). The house site at lower left now lies beneath a bridge foundation on Interstate 219. Base image modified from Plate LIIIA of Francis et al. (1891) and also available from the Johnstown Heritage Association at: http://jaha.org/edu/flood/why/img/dam_gallery/pages/southfork_dam.html. [Accessed 3/2/2016].

lowering the crest. The lowering of the dam crest is nicely shown even today by the fact that large riprap boulders on the intact eastern embankment stand higher than the present-day crest (Fig. 5). Only a few large riprap remain near the crest on the western dam remnant. That area was accessible by road in later years, and we believe most of the boulders along that crest were long ago removed for other purposes. Unfortunately for the SFFHC, the initial material stripped from the dam crest and used to fill the 1862 breach was washed out by heavy rains in December 1879. Additional changes included the construction of a bridge over the mouth of the spillway and the installation of a boom and fish screens at the bridge. These features would have had the effect of somewhat reducing the main spillway discharge capacity.

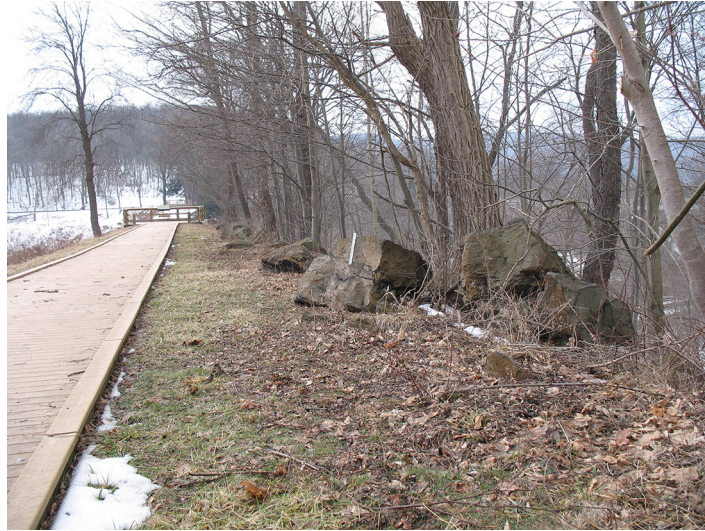
Fig. 5. View along crest of the eastern dam remnant, looking westward toward the observation platform. This part of embankment represents original construction. Large riprap from the original construction is *still in place*, standing more than 0.6 m higher than present crest, as a result of the embankment crest being lowered as much as 0.9 m by the SFFHC. White ruler on rock is 0.33 m long (photo by N. Coleman).

[Fig. 5](#) and [Fig. 6](#) provide direct evidence that the dam was lowered more than 0.6 m to as much as 0.9 m by the SFFHC. [Francis et al. \(1891, p. 446\)](#) claim that the dam was lowered 2 ft and report a mean height of 7.96 ft (2.43 m) above the spillway floor for eight points on the crest of the dam remnants. We sought to recreate their mean height and got a value of 7.90 ft using elevation stations 2, 2 + 50, 3, 3 + 50, 9, 9 + 50, 10, and 10 + 50 (see [Francis et al., 1891](#), Plates L and LIII). However, station 10 + 50 should not have been included because it is part of the natural surface of the abutment and not the embankment. It had a height 9.94 ft above the spillway floor, near the height of the original dam crest. Excluding this station yields a mean height above the spillway of 7.6 ft. More importantly, station 9 is 38 m east of the breach margin and stood just 7.07 ft above the spillway floor. It indicates a lowering of the dam of 0.9 m, and this part of the embankment was laterally distant from the dam center where sag due to inadequate compaction of the repaired section may have further lowered the crest. Evidence of sag is discussed in comments and diagrams by P. Brendlinger (in [Francis et al., 1891, p. 465](#)) who estimated that the lowest part of the embankment may only have been 6 ft (1.8 m) above the spillway floor. [Davis \(1889\)](#) estimated a sag of at least 0.6 m, while others proposed even greater sag. The lowering of the crest, along with the sag, substantially reduced the originally designed spillway capacity because the relation between spillway and weir depth and discharge is nonlinear. For example,

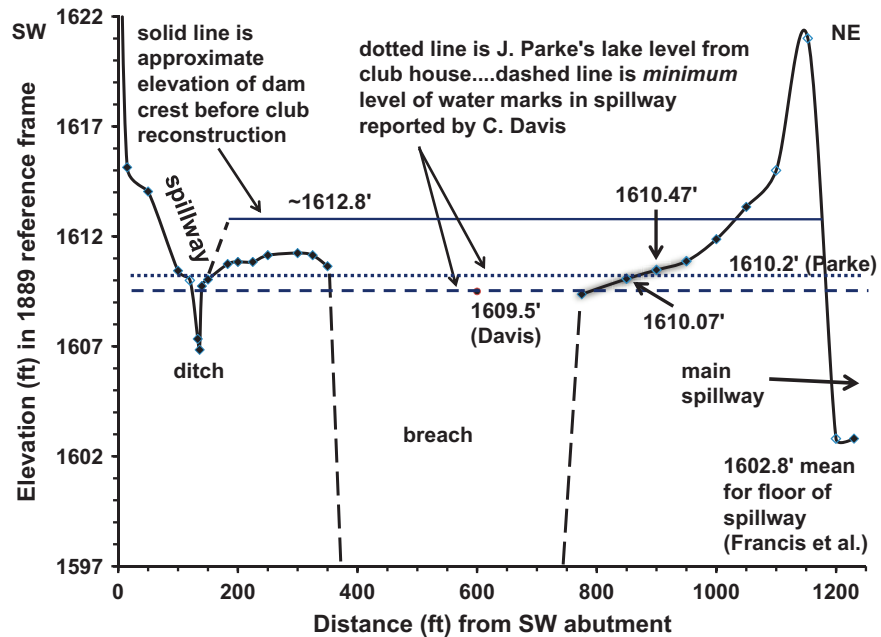
Fig. 6. Profile of the dam remnants and abutments from the post-flood survey in 1889 (Francis et al., 1891). Data are in English units with respect to the 1889 elevation datum. The mean elevation of the main spillway floor is ~ 1602.8 ft (1889 survey, Francis et al., 1891). The shadowed line from distance 775 ft to 950 ft included a 50 m length of plowed furrow that was preserved after the flood on the NE crest (Unrau, 1980, p. 117; Wellington and Burt, 1889). Overtopping depths would have been greatest at the sagging center. We estimate a lake level of ~ 1610.1 ft (1889 elevation) at time of dam breach. Data point at the 775 ft distance at the edge of the breach is on a slumped remnant and would not represent the elevation of the rebuilt crest. The bases for water levels by Parke, Davis, and Francis et al. are given in the text. Figure has large vertical exaggeration to show subtle differences in elevations.

mound near the break and extending for about 46 m on the eastern dam remnant (Fig. 6). The preservation of this soft mound of material, which would have rapidly been swept away by overtopping flows, provides evidence that the lake level was no higher than 1610.1 ft (1889 survey), and may have been somewhat less. Correcting for the difference between 1889 and modern elevations, the maximum lake level was ~ 1616.3 ft (NAVD 88), or ~ 492.6 m. Our best estimate of the lake surface elevation at the time of dam failure is in the range from 492.5 to 492.6 m.

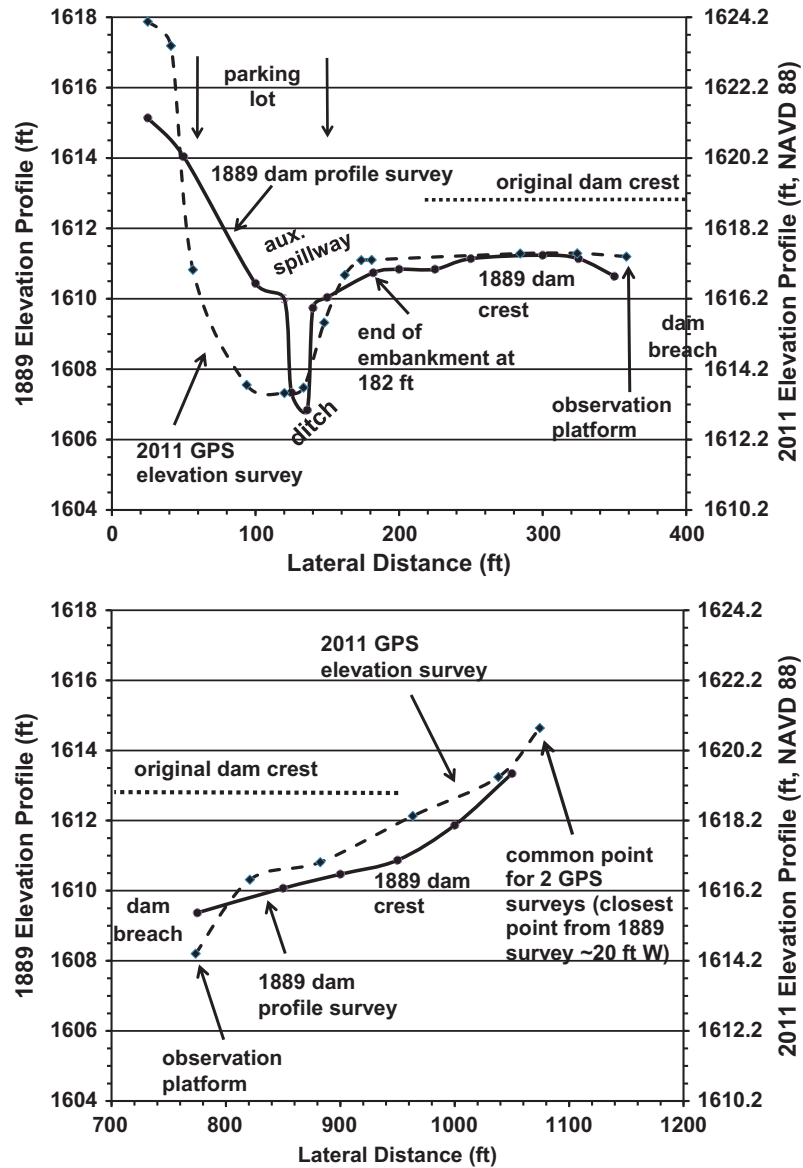
The profile of the dam remnants has significantly changed since the time of the flood. The two biggest changes were (1) the excavation of the northeastern breach remnant to construct a double line railroad embankment, and (2) the construction of a parking lot at the western abutment. Fig. 7 shows the topographic profiles of the dam remnants, comparing the 1889 topographic data with present-day GPS (global positioning system) profiles. The top frame in Fig. 7 shows the superimposed profiles for the western dam remnant, along with a line that represents the approximate original dam crest. Shown in this way, it is obvious that an auxiliary spillway existed on the western abutment since even after lowering of the crest the abutment is noticeably lower than the embankment. That this area of the abutment was the original location of an auxiliary spillway is further substantiated by observers noting that the initial overflow was in this area (Kaktins et al., 2013), which is why the emergency ditch was dug here. This spillway was shallower than the main spillway, but nonetheless was an important addition to the

Fig. 7. Topographic profiles of present-day western (top) and eastern (bottom) dam remnants and abutments compared to 1889 survey. There is a difference of ~6.2 ft (1.9 m) between the 1889 and modern elevation (NAVD 88) reference frames; the 1889 data are systematically lower (see Section 2.3.2). Dotted line in each frame shows approximate position of original dam crest.

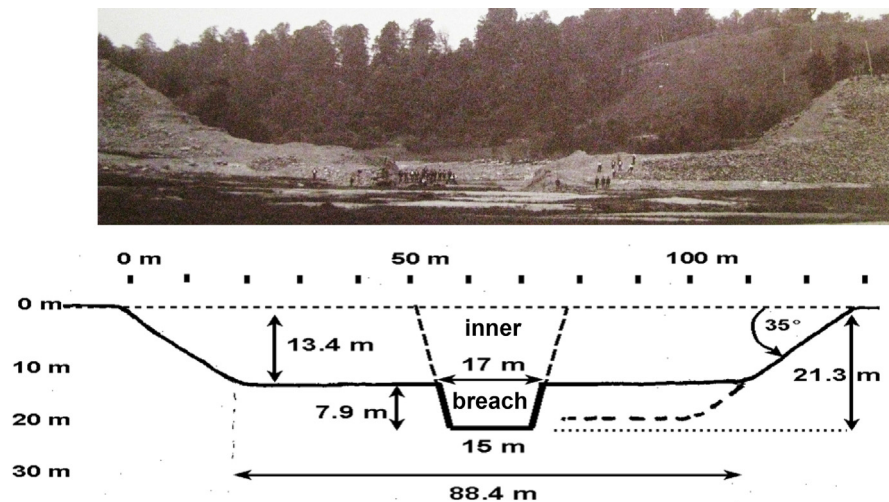
Fig. 14. Geometry of the breach in the South Fork dam. There is no vertical exaggeration. Dimensions based on post-flood dam survey data (Francis et al., 1891) and 1889 photographs. Dashed line at lower right shows where dam remnant was later removed to build a double rail line through the old breach. Note numerous people standing on the dam remnants in post-flood image at top.

17 m wide center) as separate calculations. As surveyed in 1889, the top, or maximum, total width of the breach was 129.6 m. The upper part of the breach had an average depth of ~ 13.4 m and a bottom width of ~ 88.4 m. Subtracting the mean width of the inner breach gives a width of $88.4 - 19$ m = 69.4 m ($r = 5.18$ and $\theta = 35^\circ$). The inner breach was cut to the base of the dam and was ~ 15 m wide at the base and more than 21 m high ($r = 0.70$ and $\theta = 73^\circ$). The combined dam breach discharge of ~ 8870 $\text{m}^3 \cdot \text{s}^{-1}$ approximates the maximum possible discharge that could have occurred through the breach. At the moment of general dam failure, flow was also occurring through the main spillway and ditch, plus flow over the central portions of the crest. There is no explicit addition of overtopping flow because that is incorporated in the breach flood discharge. The spillway transmitted ~ 86 $\text{m}^3 \cdot \text{s}^{-1}$, and the ditch about 10 $\text{m}^3 \cdot \text{s}^{-1}$, resulting in a combined flood discharge of ~ 8970 $\text{m}^3 \cdot \text{s}^{-1}$. We consider it reasonable to include a 15% increase in breach discharge rates to incorporate uncertainty (see Section 4.7). The result is a maximum peak discharge of $10,200$ $\text{m}^3 \cdot \text{s}^{-1}$ through the breach, plus ~ 100 $\text{m}^3 \cdot \text{s}^{-1}$ flow through the spillway and ditch.

There is little doubt that the upper part of the dam breach formed very rapidly (Kaktins et al., 2013). This may not have been the case for the bottom 7.9 m of the inner breach as its erosion through the original puddle layers at the base of the dam may have been more gradual. A more realistic value for the instantaneous peak produced by the initial flood wave would incorporate rapid failure of the upper 13.4 m of the breach (7100 $\text{m}^3 \cdot \text{s}^{-1}$) and flows through the main spillway (86 $\text{m}^3 \cdot \text{s}^{-1}$) and ditch. The result is an estimated peak discharge (Q_p) of ~ 7200 $\text{m}^3 \cdot \text{s}^{-1}$ for the instantaneous discharge rate during catastrophic formation of the upper breach. The estimate of peak discharge given by multiple authors (8500 $\text{m}^3 \cdot \text{s}^{-1}$) is probably too high, although it is less than our estimate of the highest plausible discharge of $\sim 10,300$ $\text{m}^3 \cdot \text{s}^{-1}$.
