United States Committee on Large Dams

**Observed Performance  
of Dams  
During Earthquakes  
Volume I**

July 1992

Prepared by the USCOLD Committee on Earthquakes

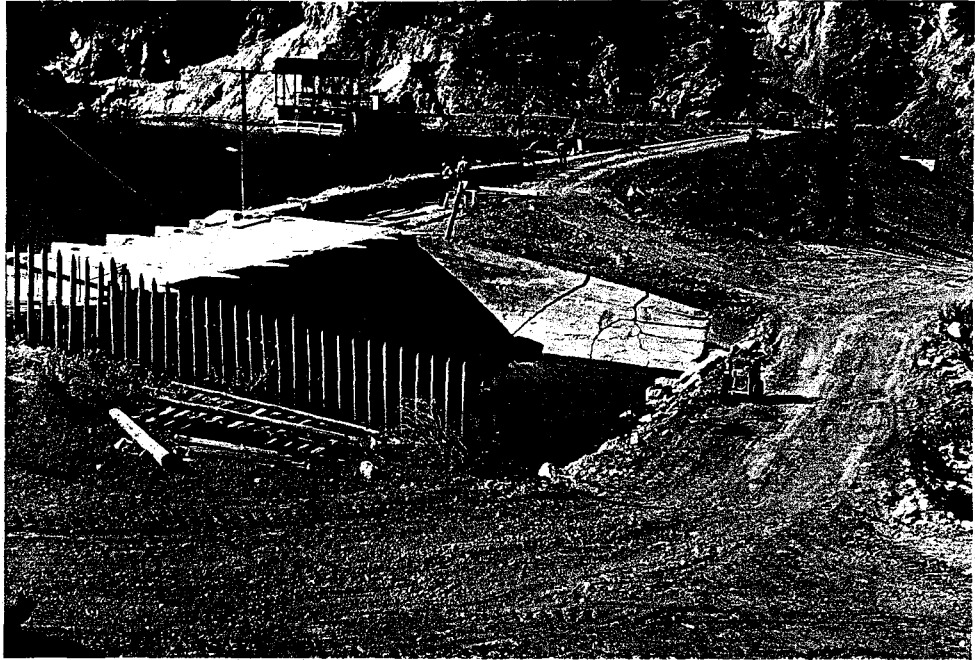
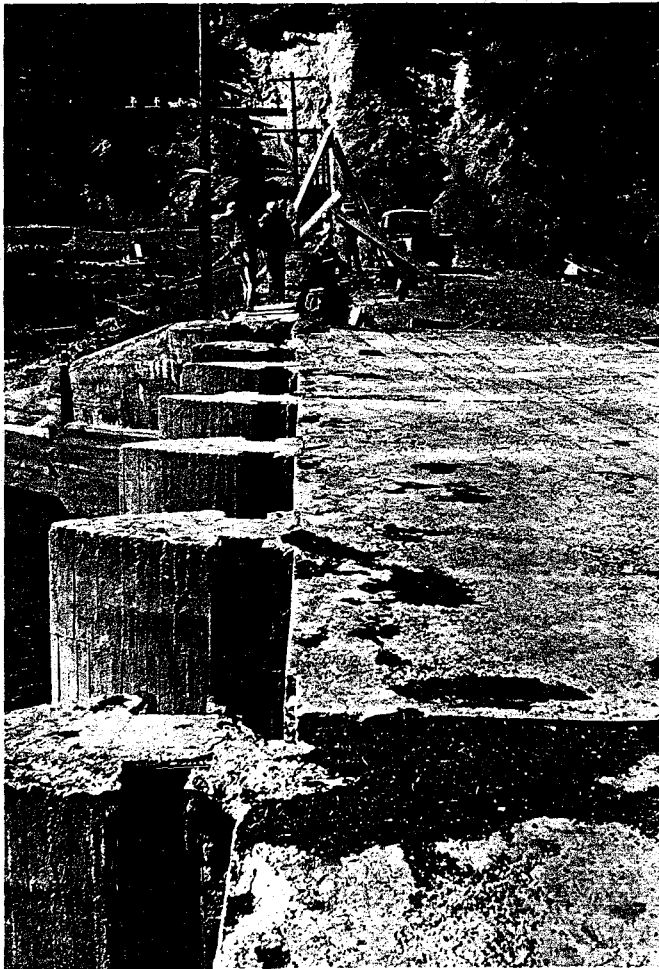
**EARTHQUAKE DAMAGE, AUGUST 1959**  
Hebgen Dam  
Figure 3

Although Hebgen Dam did not fail, the structure was severely damaged (Figure 3). From the right abutment of the dam to a point about 400 feet toward the center, the top of the concrete core wall was deflected downstream a maximum distance of 0.8 feet in approximately the shape of an arch. From that point to the edge of the spillway, about 220 feet, the arch continued on with a maximum deviation upstream of 2.8 feet from the original center line. The right end of the core wall sloped down a maximum of 0.17 foot in a distance of about 86 feet. Three major cracks, from 2 to 4 inches wide, opened in the top of the core wall, as well as numerous hairline cracks. The cracks in the core wall elongated the wall about 7 inches.

The main damage to the dam embankment was from settlement relative to the concrete core wall (and relative to the bedrock). The earthfill settled on both sides of the core wall. The high magnitude earthquake consolidated the relatively uncompacted material of the dam and the glacio-fluvial soils near and under the spillway. The upstream fill, which was saturated and more clayey than the downstream fill, suffered the most compaction. However, cross sections taken every 25 feet across the dam after the earthquake indicated little or no evidence of rotational failure of the slopes as a whole.

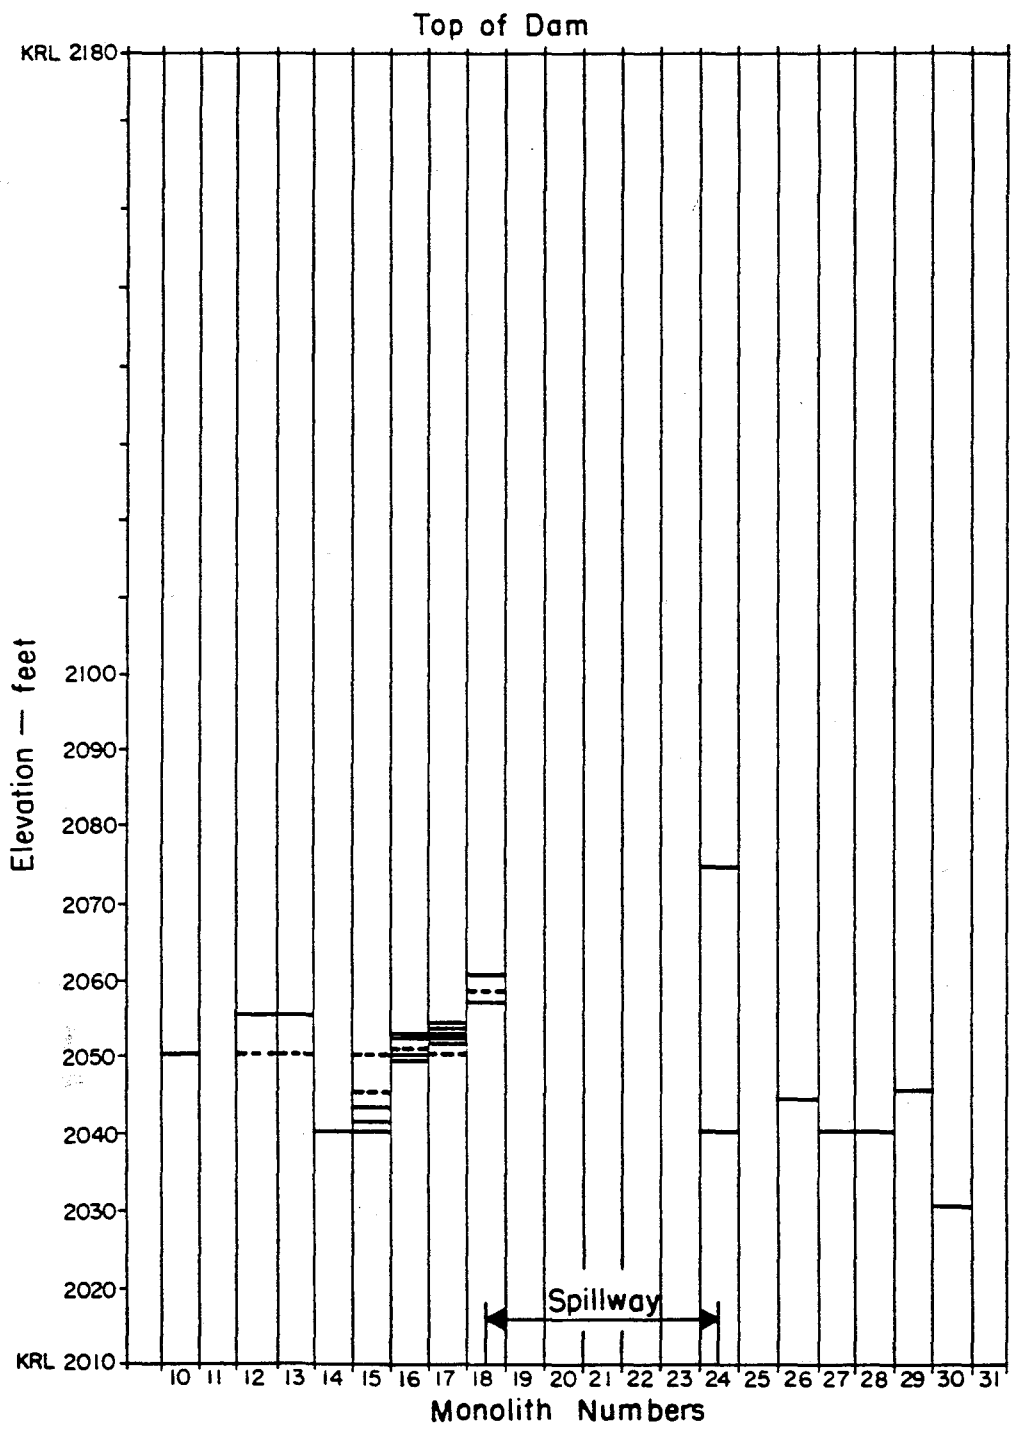
**CRACKS INDUCED BY THE  
 DECEMBER 11, 1967 EARTHQUAKE**  
 Koyna Dam  
 Figure 4

— Cracks on u/s face  
 --- Cracks on d/s face

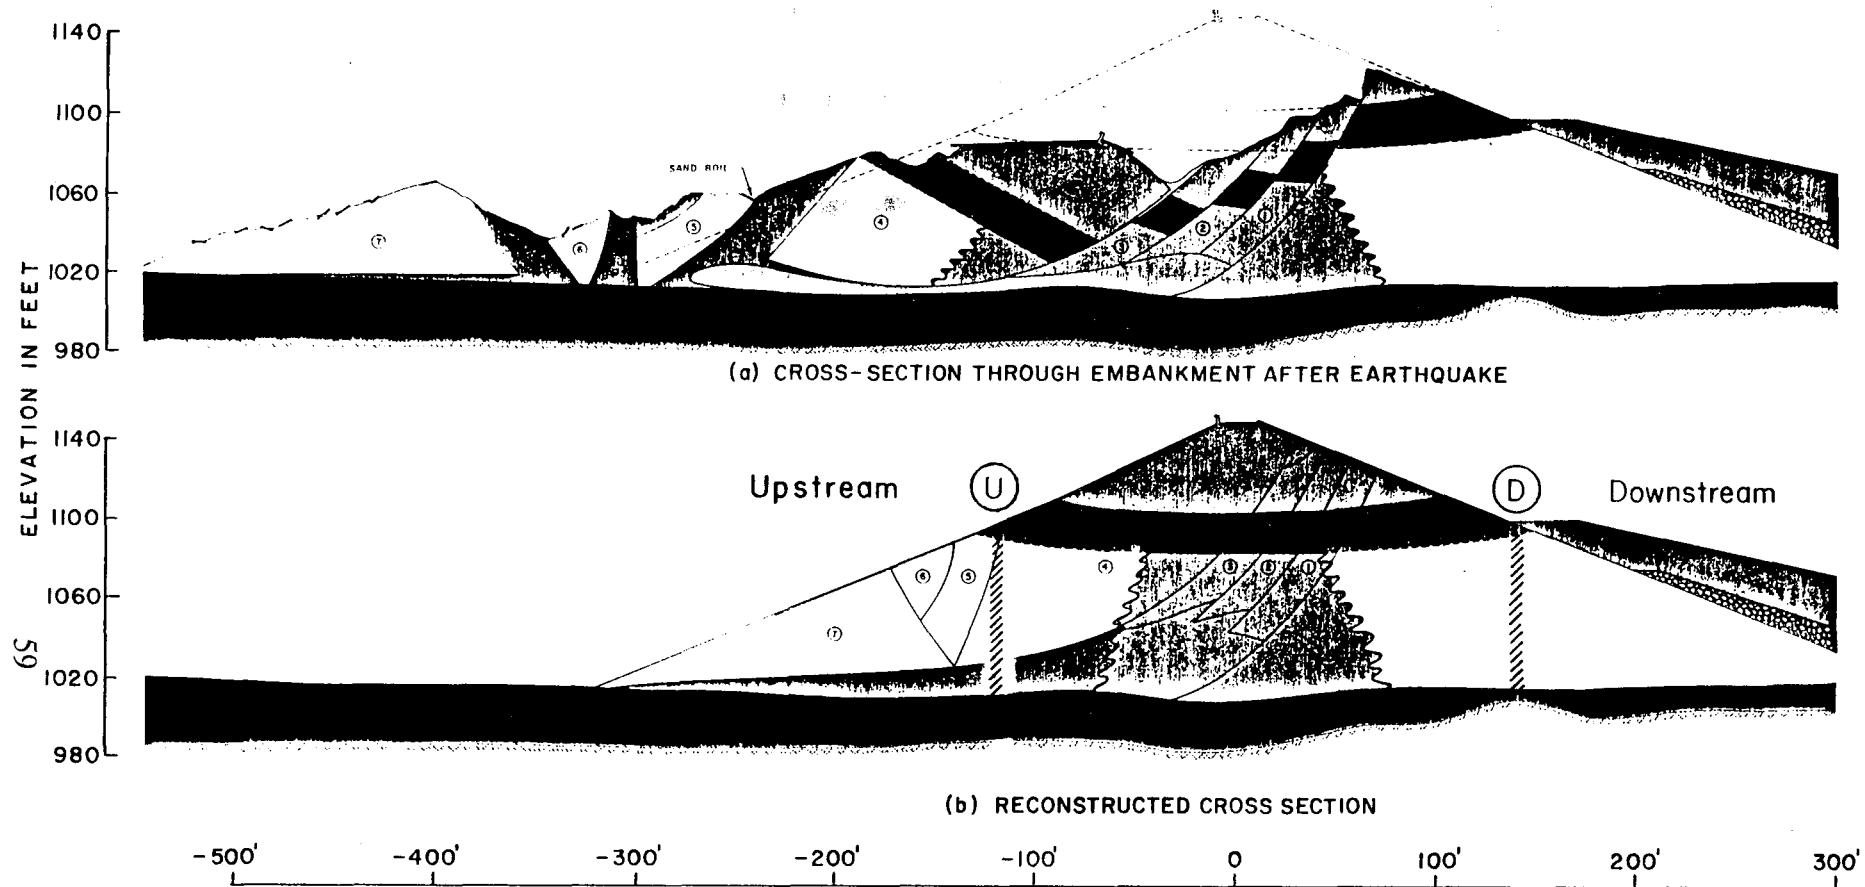
**FAILURE AND RECONSTRUCTED SECTIONS**  
 Lower Van Norman Dam  
 Figure 3

Existing hydraulic fill at Location (D) represents a mirror image of failed section at Location (U)

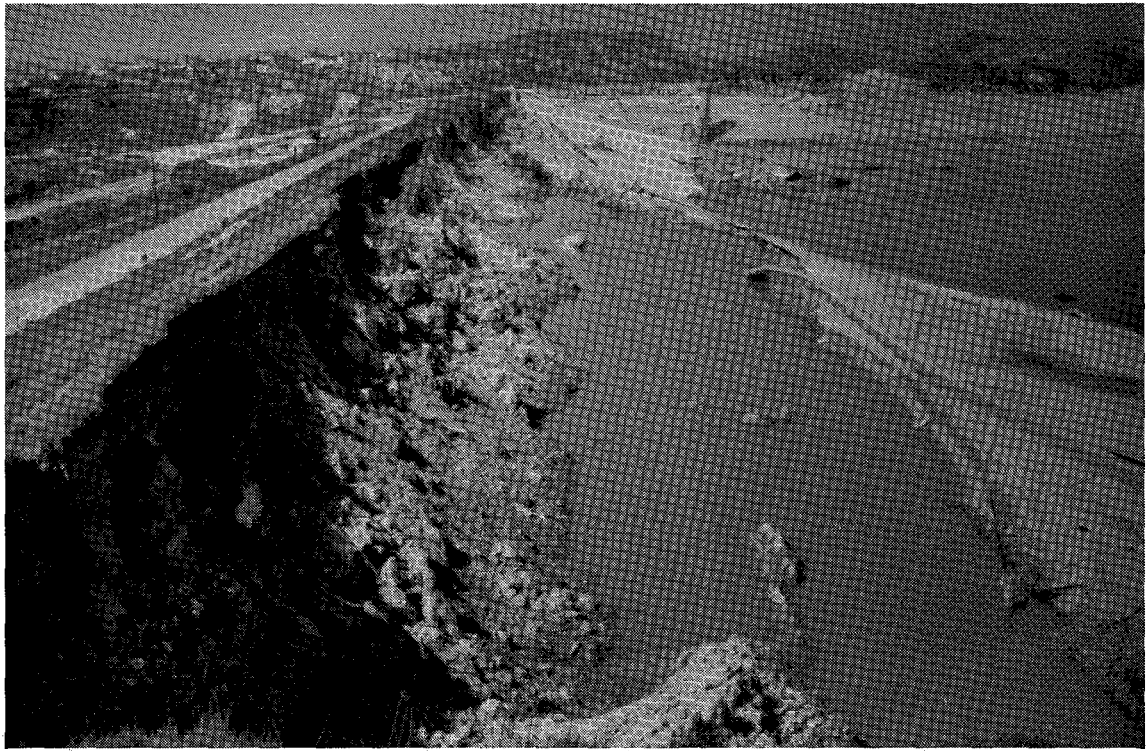
**FEBRUARY 9, 1971, FAILURE  
LOOKING WEST  
Lower Van Norman Dam  
Figure 4**

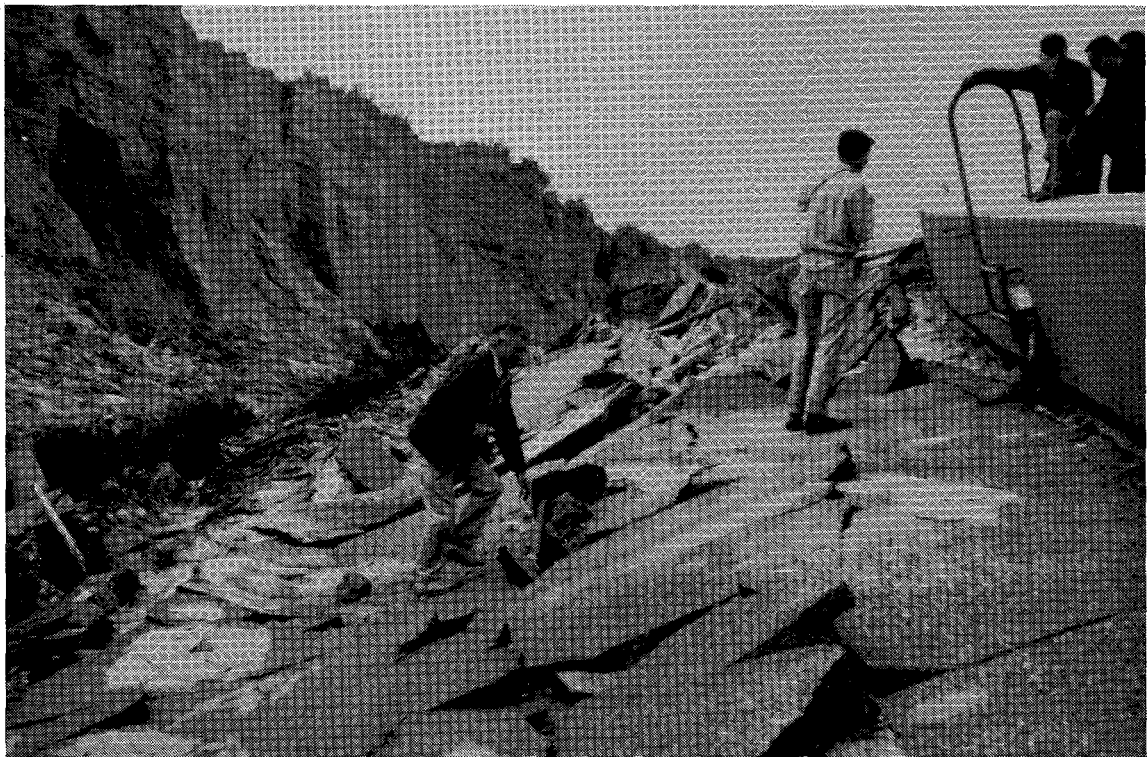
**FEBRUARY 9, 1971, FAILURE  
COLLAPSED CREST OF DAM  
Lower Van Norman Dam  
Figure 5**

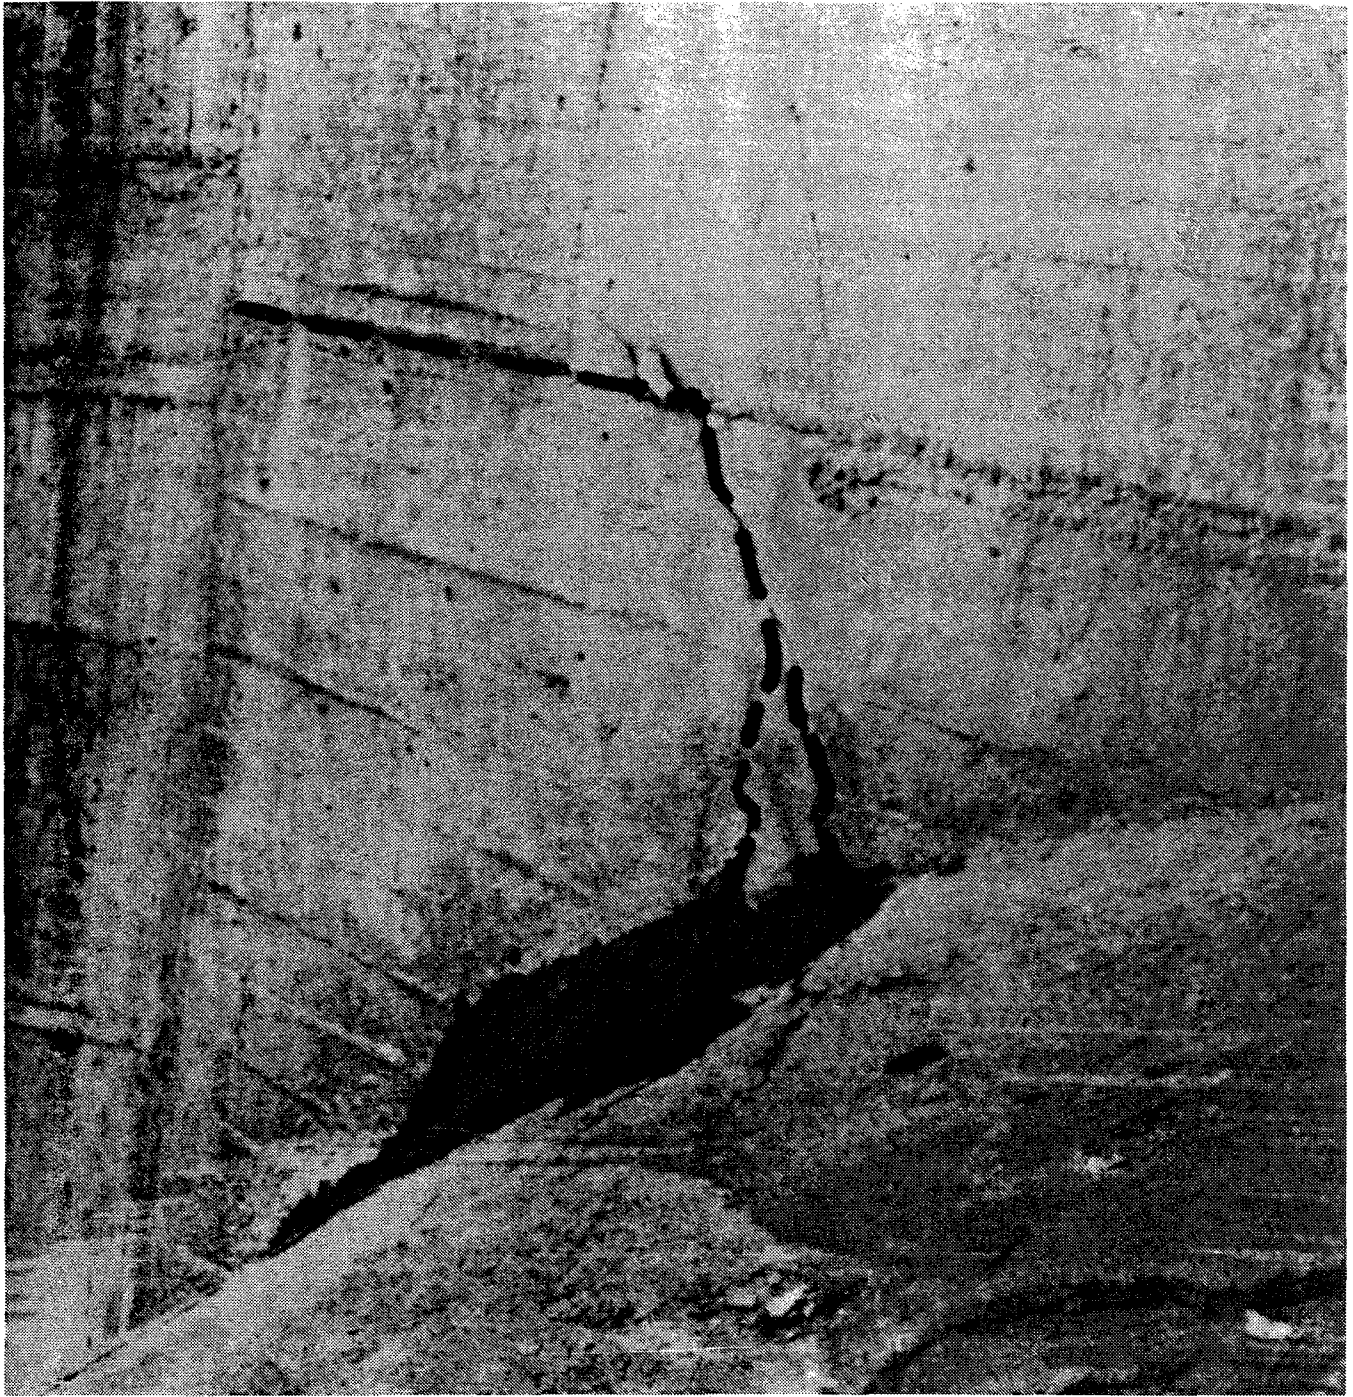
**CRACK AT LEFT THRUST BLOCK**  
Pacoima Dam  
Figure 3

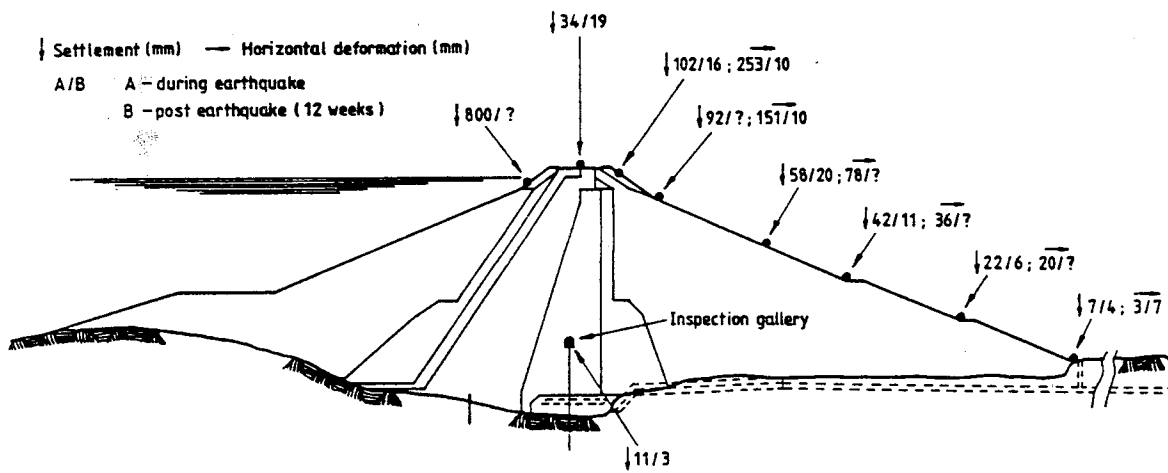
**MEASURED SETTLEMENTS**  
**(SECTION)**  
**Matahina Dam**  
**Figure 4**

The extensive network of surface monuments of the dam had been resurveyed about three weeks prior to the earthquake. Post-earthquake surveys indicated that the dam settled significantly as a result of shaking. Most of the settlement occurred immediately, but it continued for several weeks. The crest settled a maximum of 4.02 inches and moved

Deformations at centre of dam

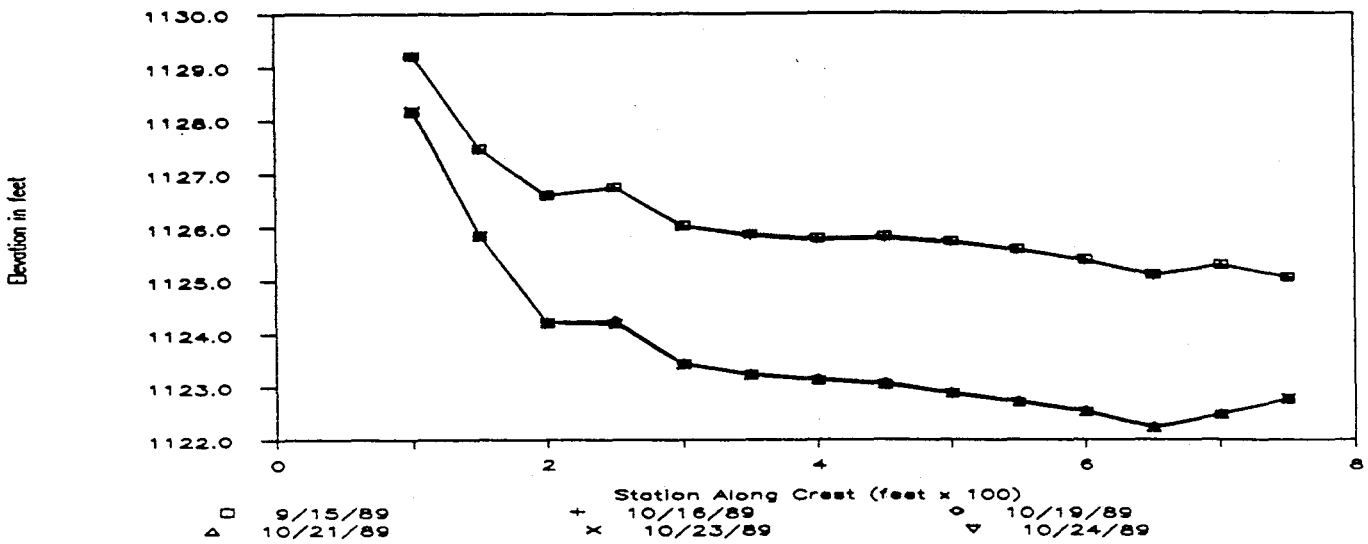
**CREST SETTLEMENT,  
LOMA PRIETA EARTHQUAKE  
Austrian Dam  
Figure 4**
