Reassessment of the Castlewood Dam Failure

Chris Leibli, P.G.
Gregg Scott, P.E.
Pete Schaffner, P.G.
Risk Management Center, Denver

US Army Corps of Engineers
BUILDING STRONG®

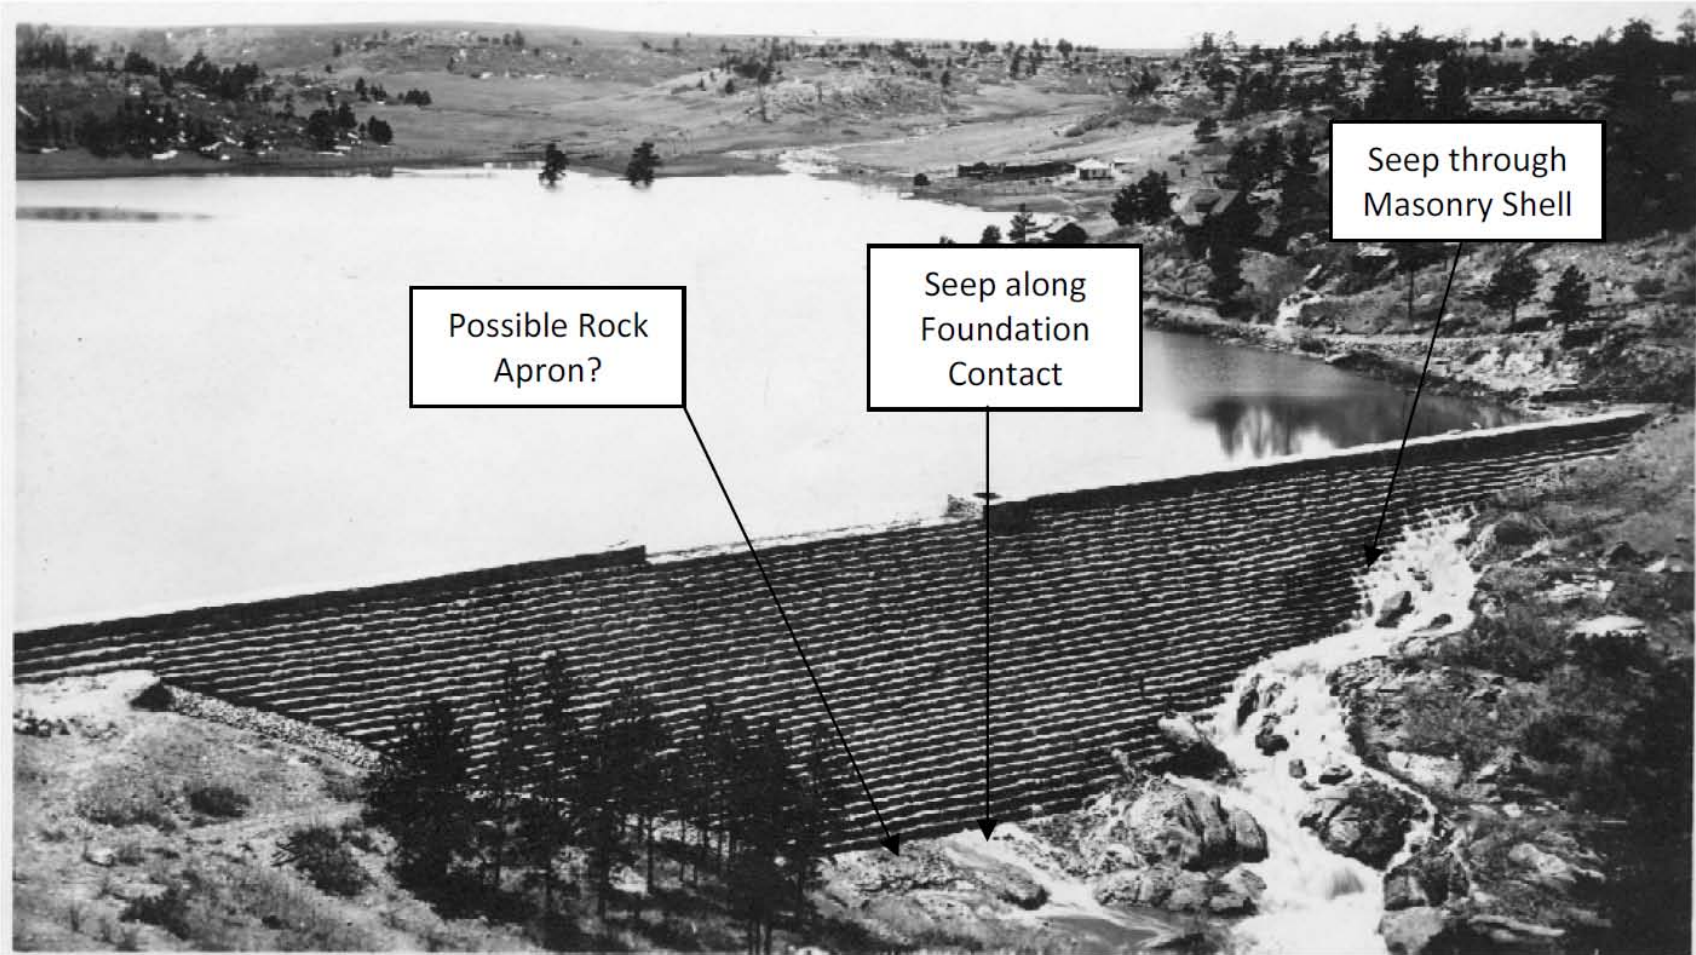
Photo Showing Leakage in May, 1900

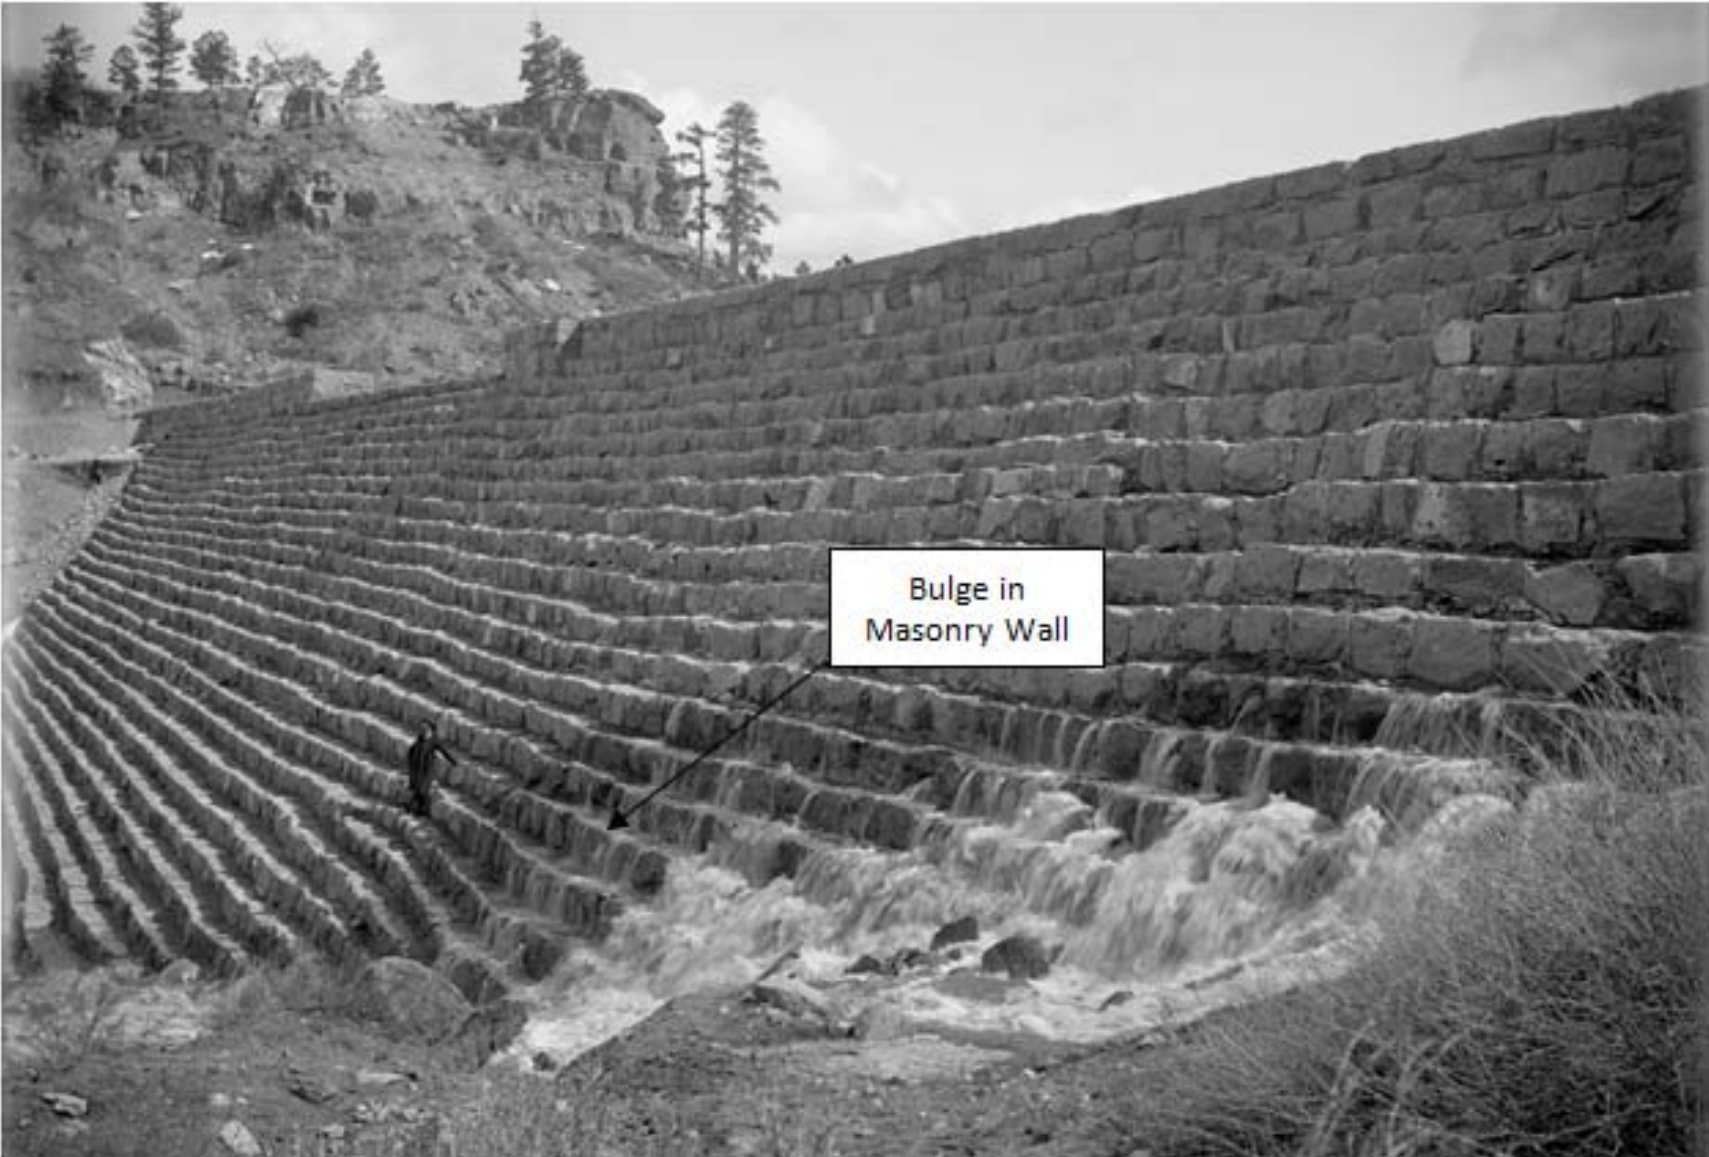
Photo Showing Leakage in May, 1900

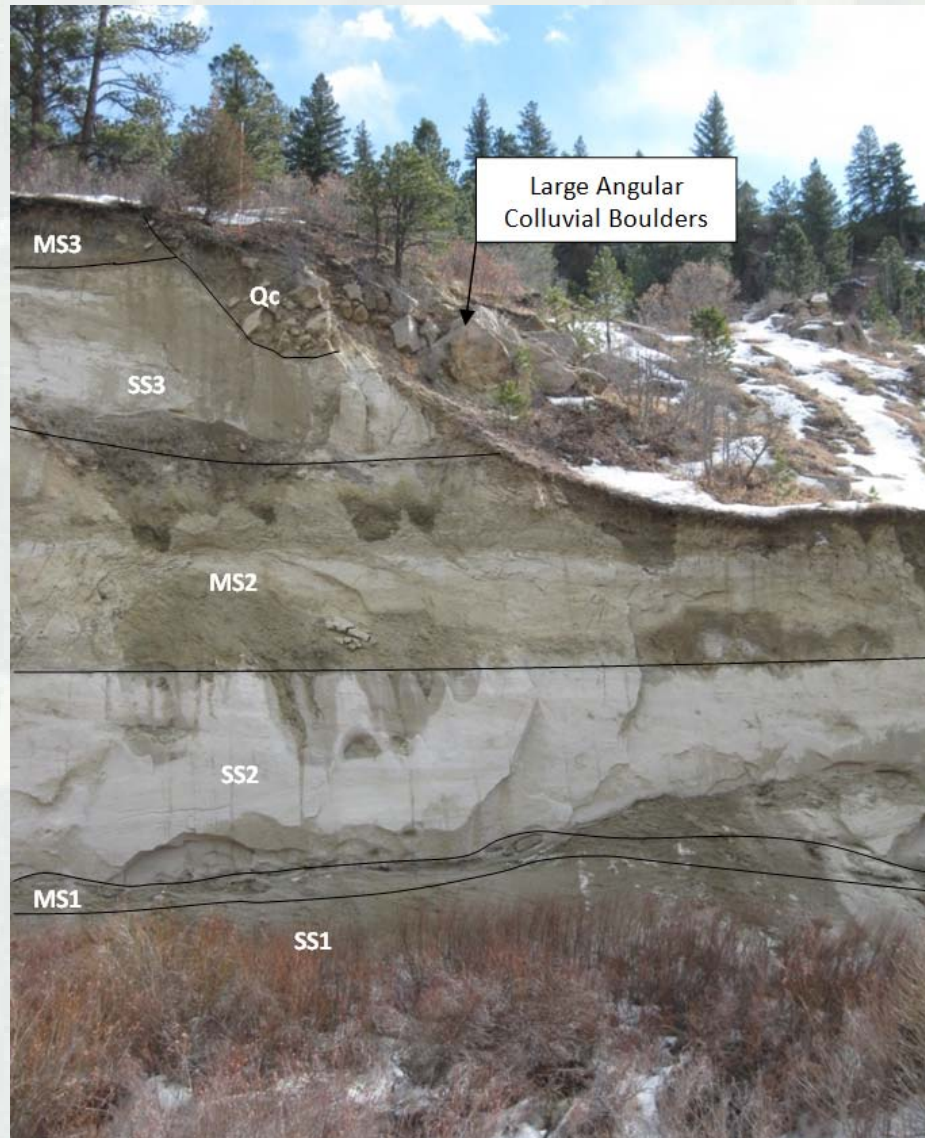
Erosional Cut on Right Side of Cherry Creek

Exposed face stands nearly vertical indicating some strength.

Base of dam founded on MS2, significant stream erosion subsequent to failure.

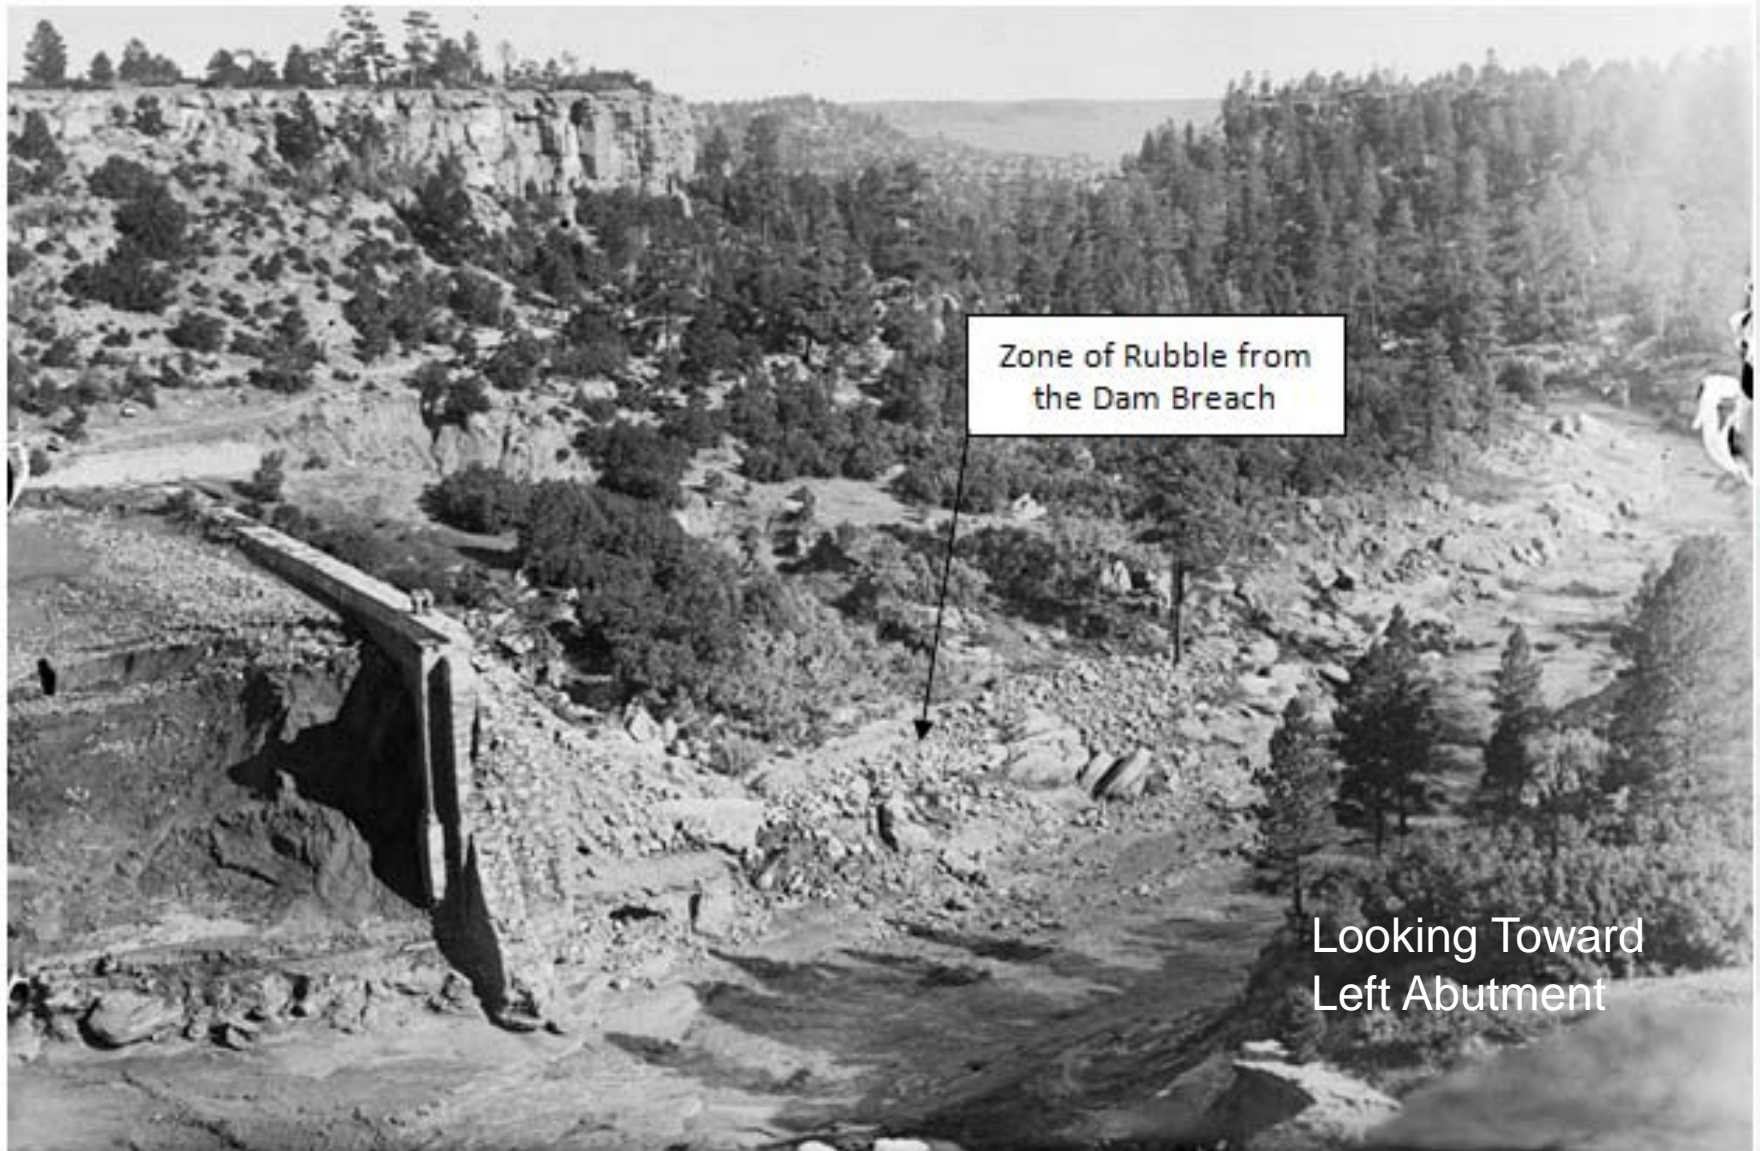
Photo Shortly after Dam Breach

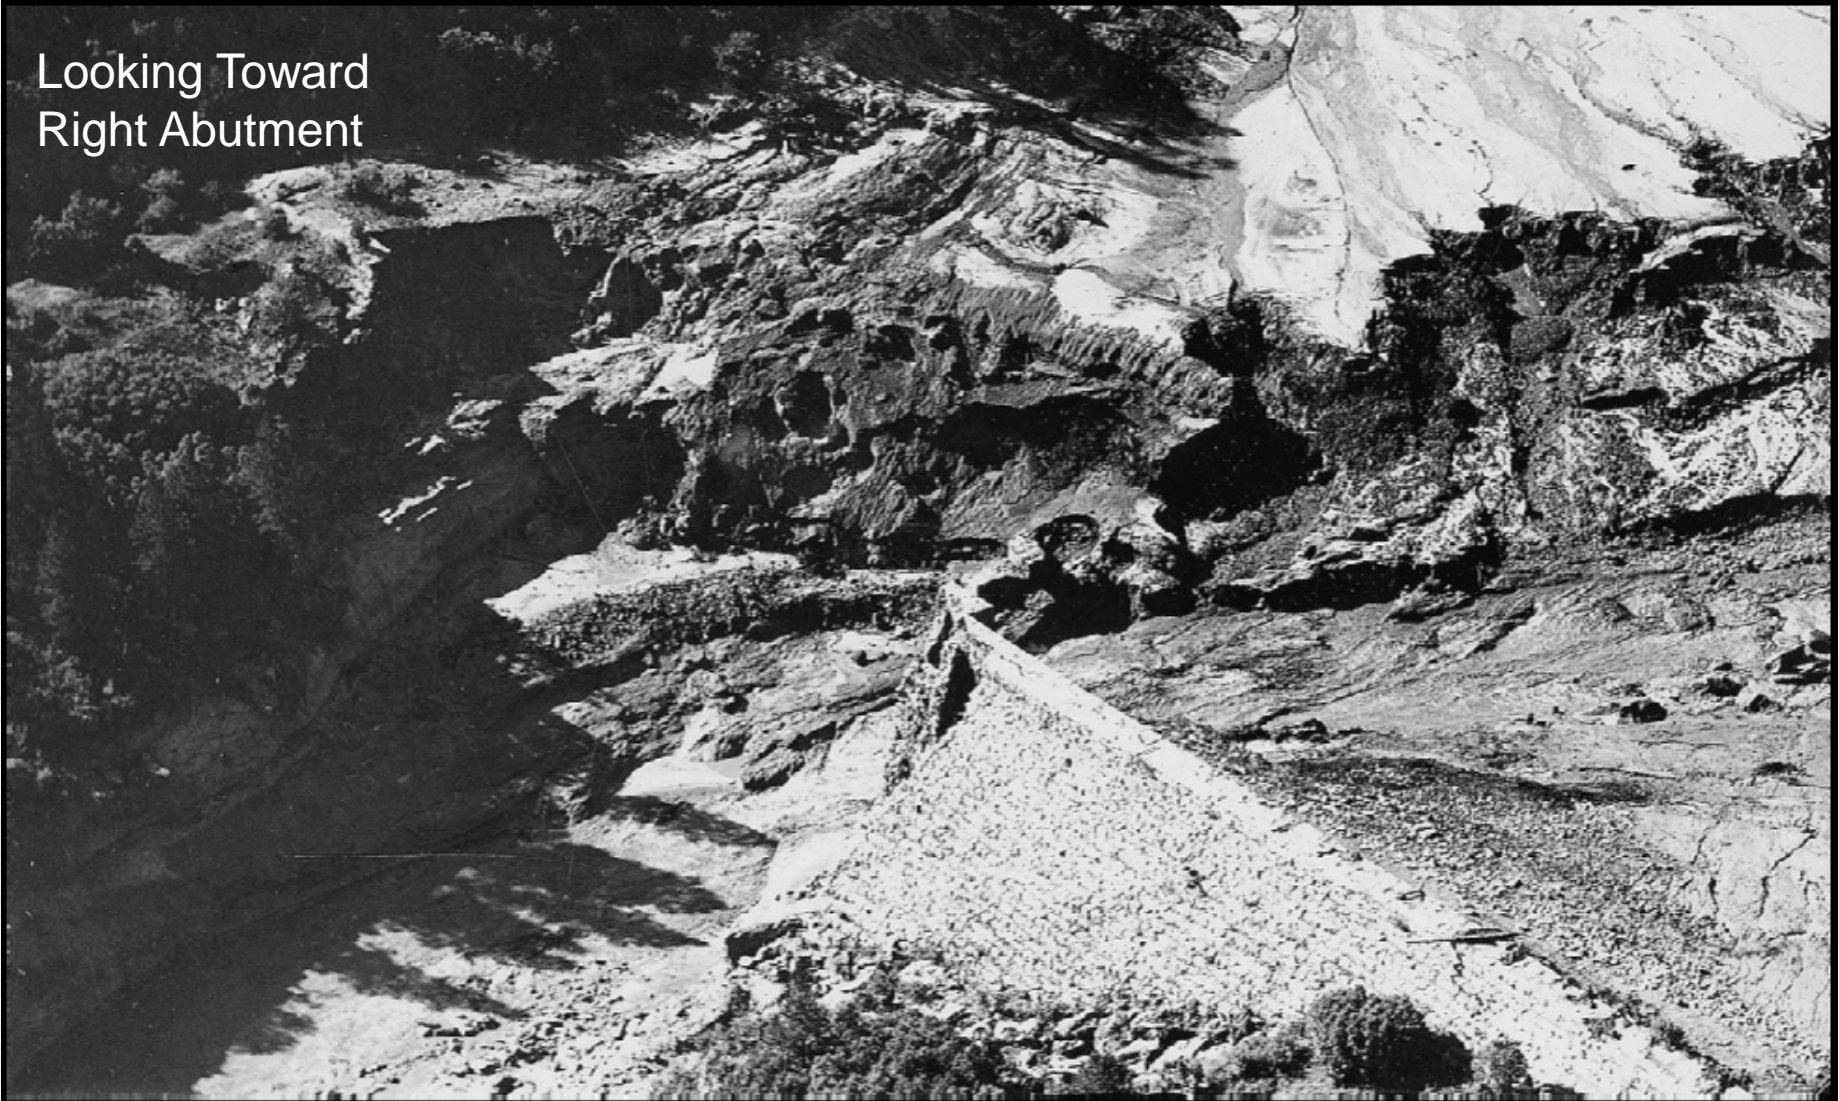
Photo Shortly after Dam Breach

Looking Toward
Right Abutment

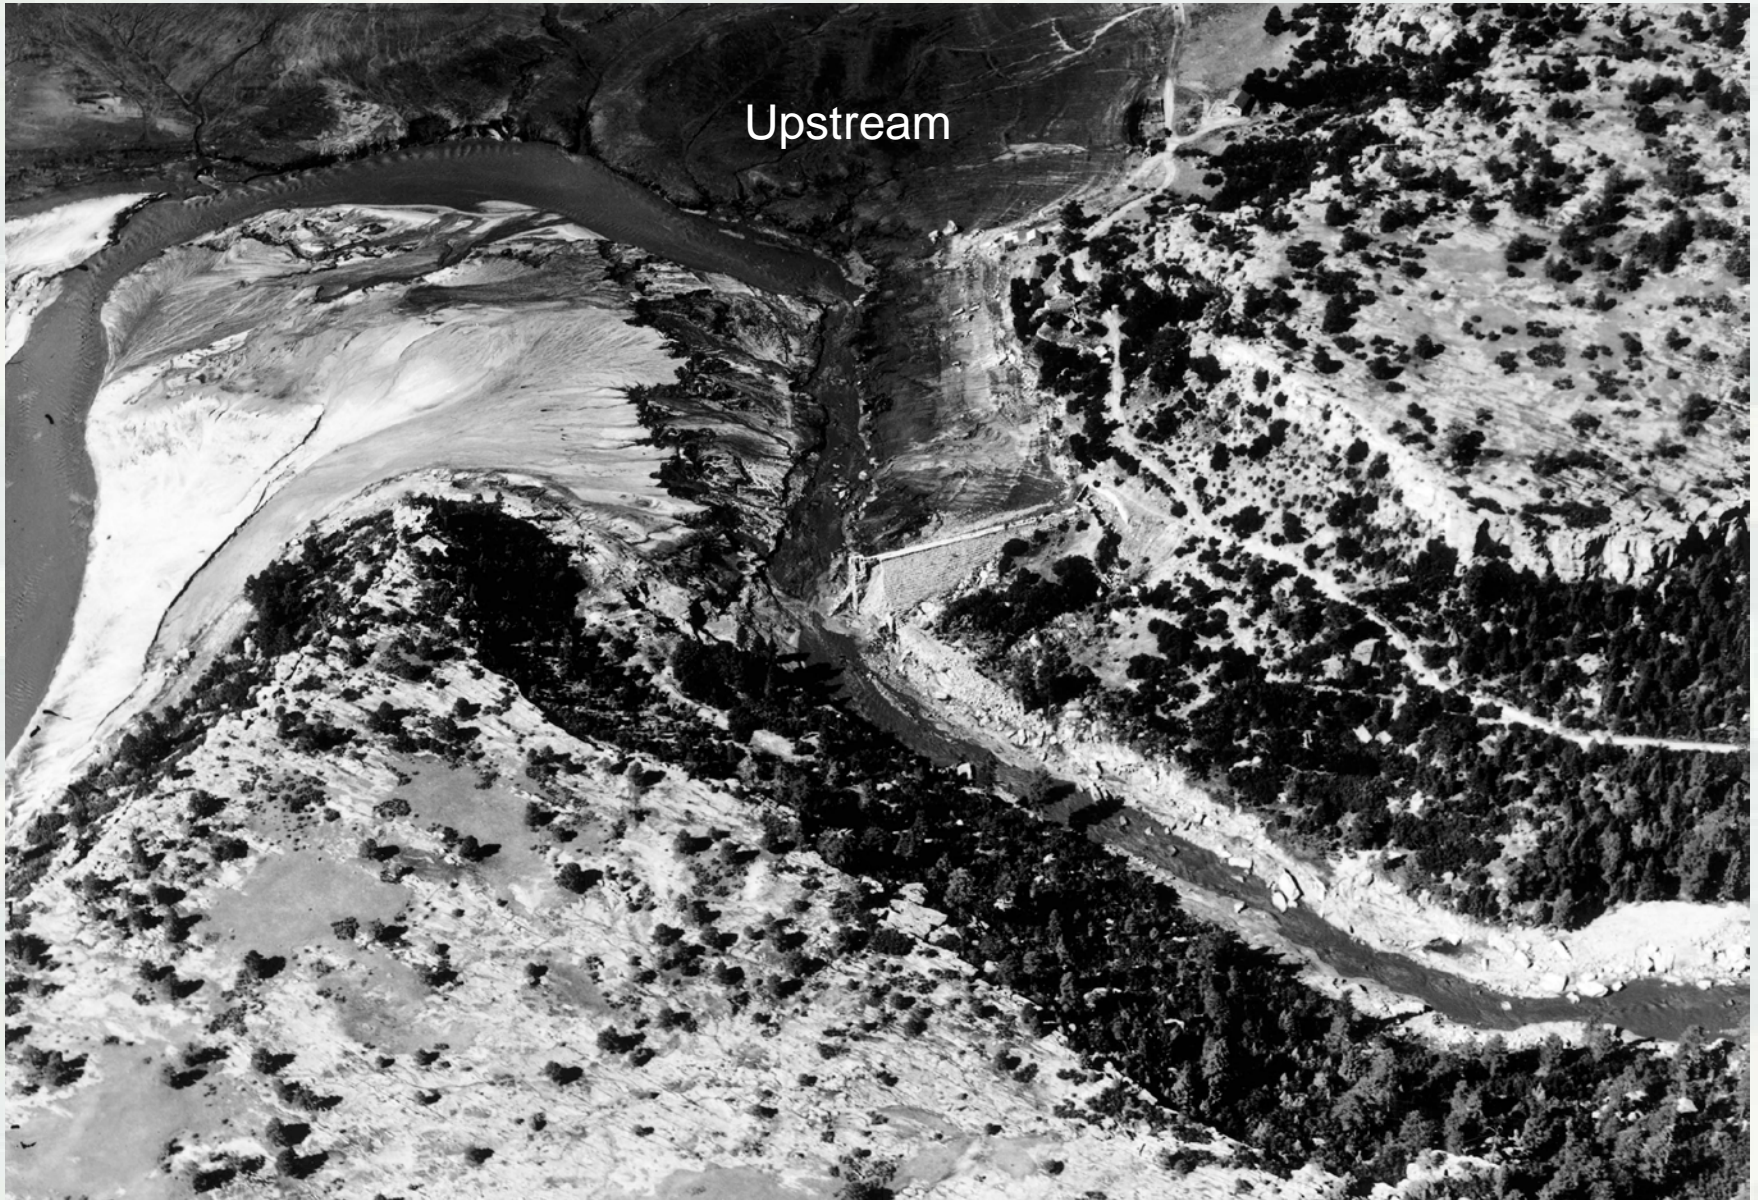
Photo Shortly after Dam Breach

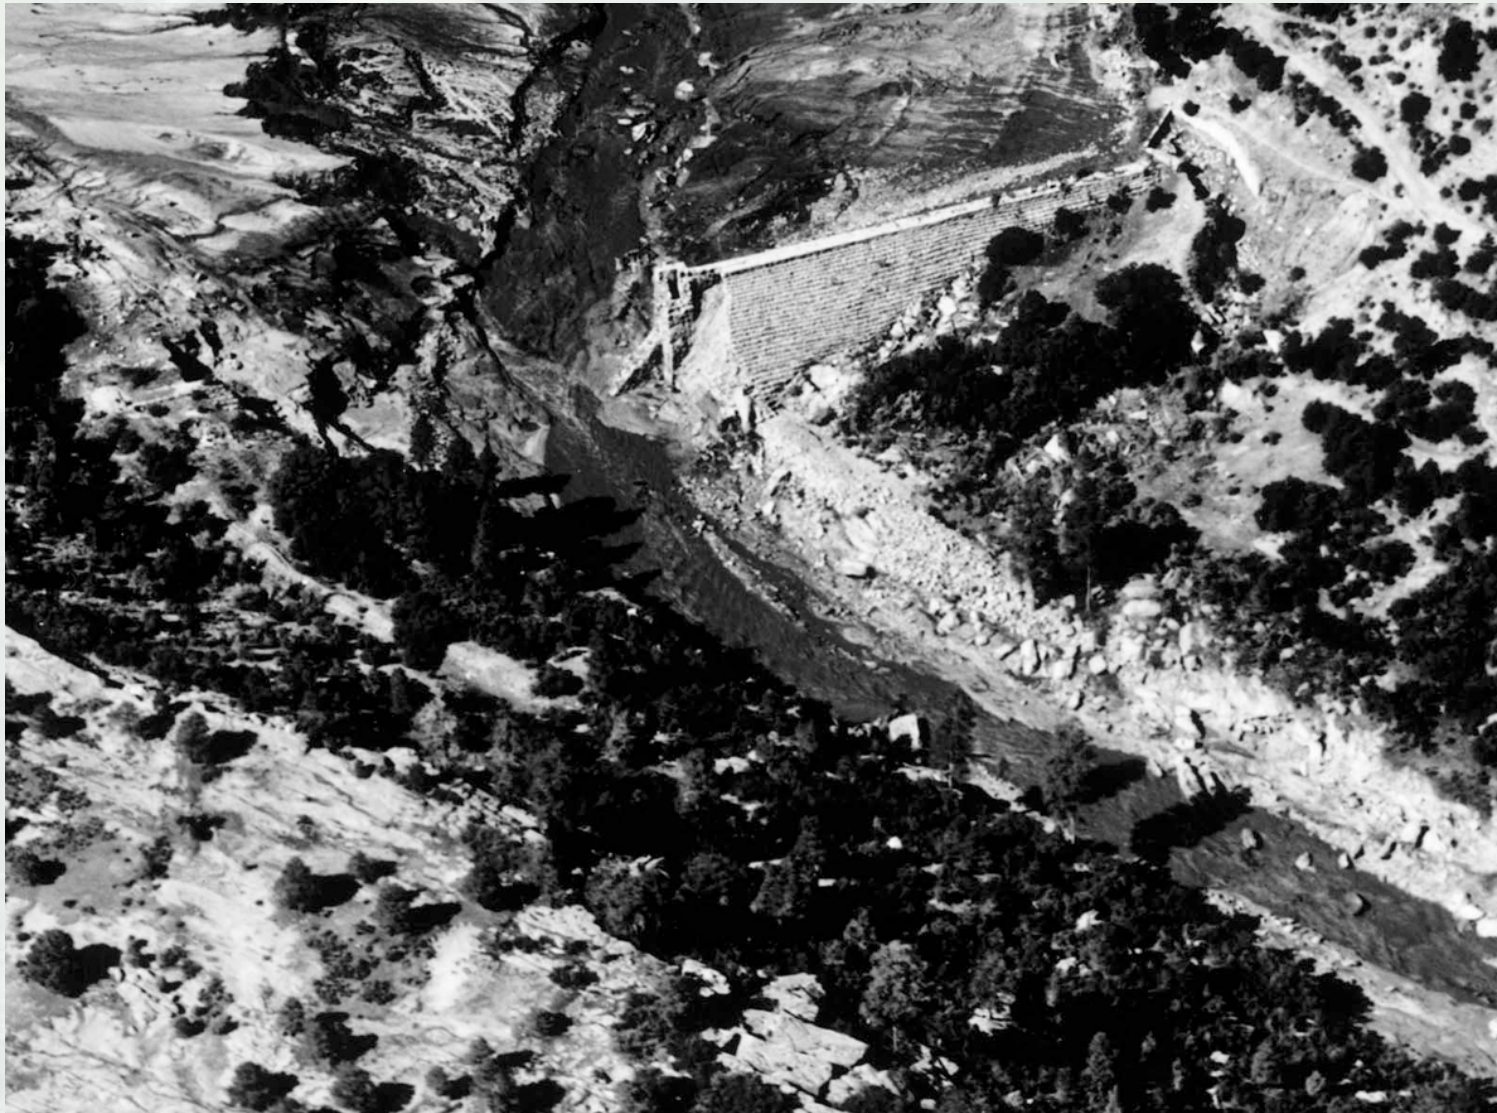
Close-up of Last Photo

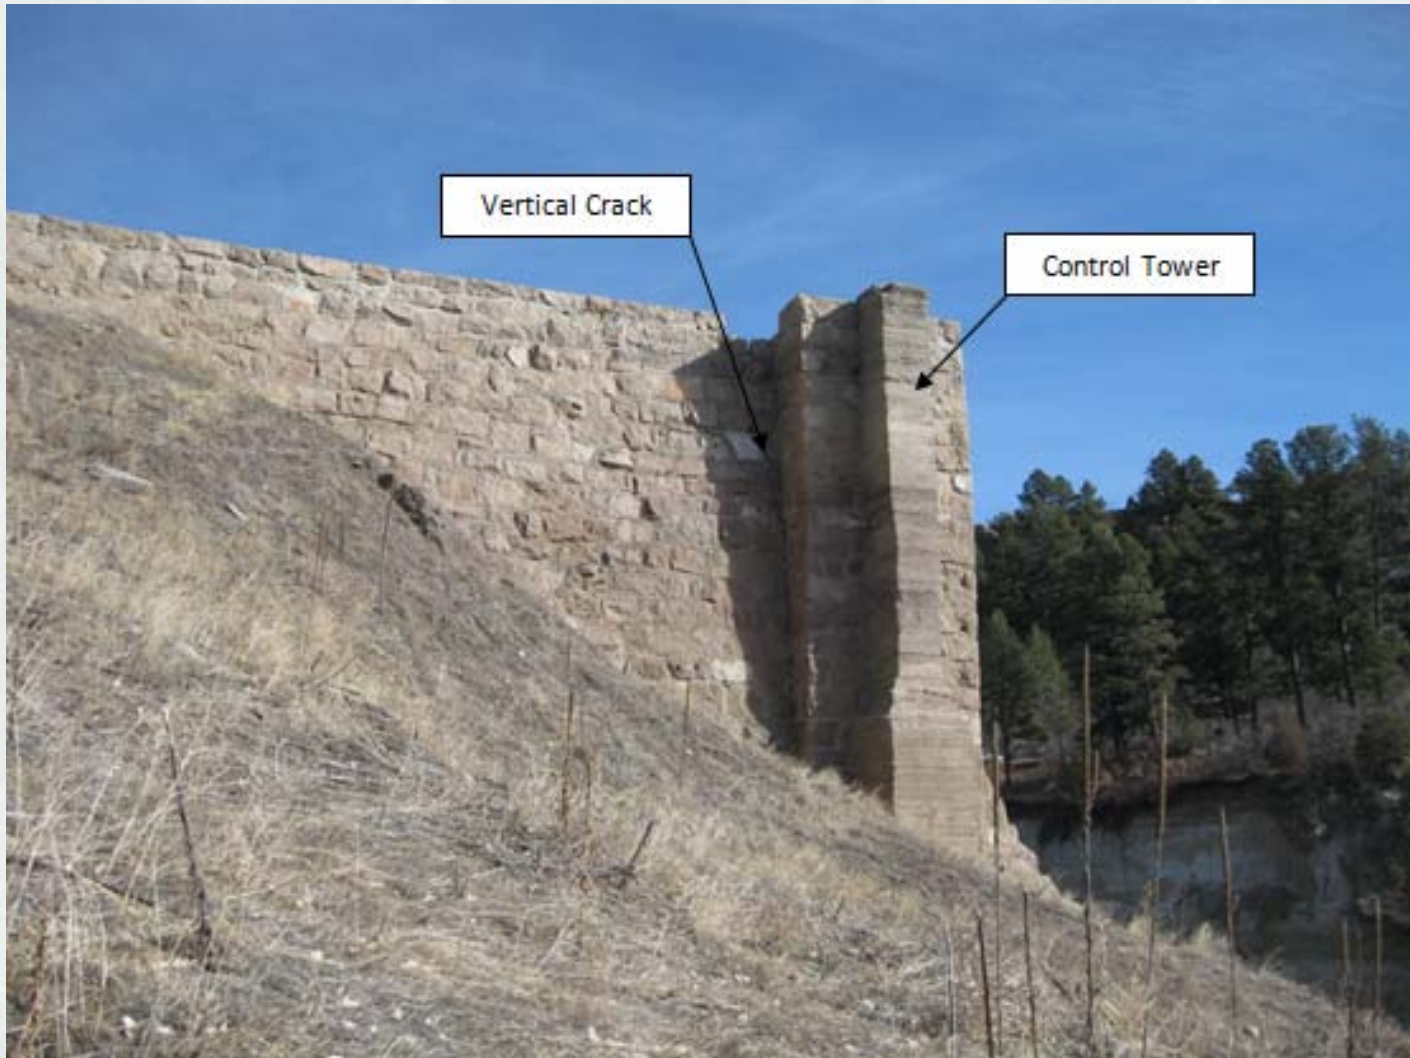
Upstream Side of Left Portion of Remains

Vertical Crack

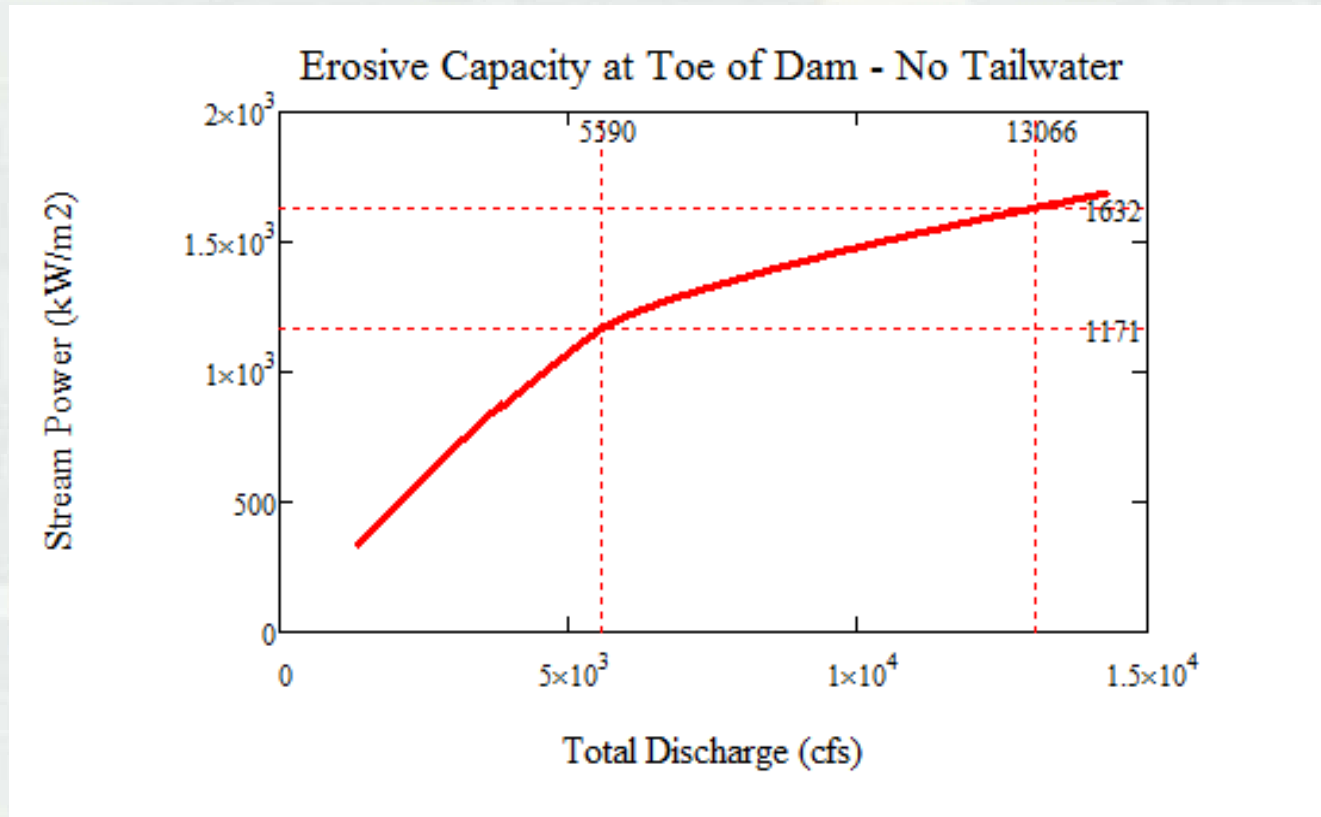
Erosive Capacity of Water at Toe of Dam Assuming no Tailwater

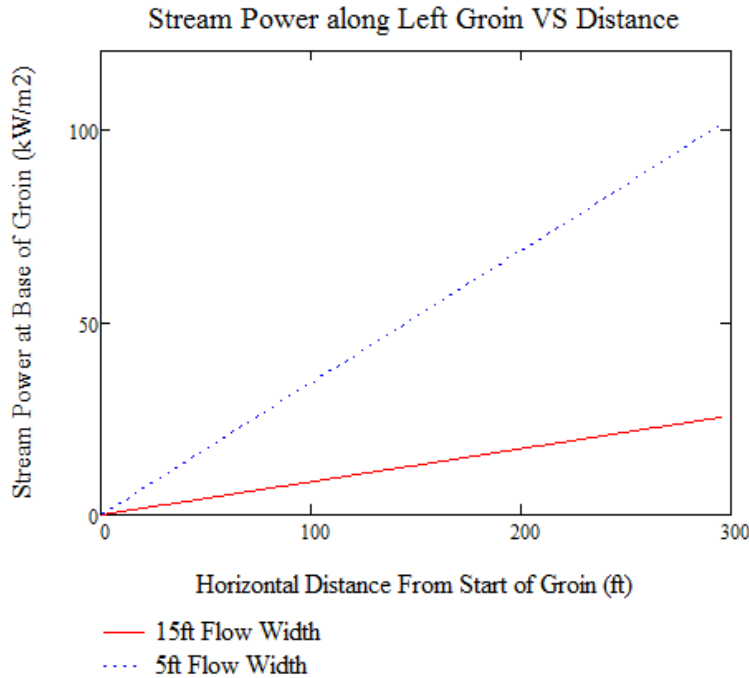
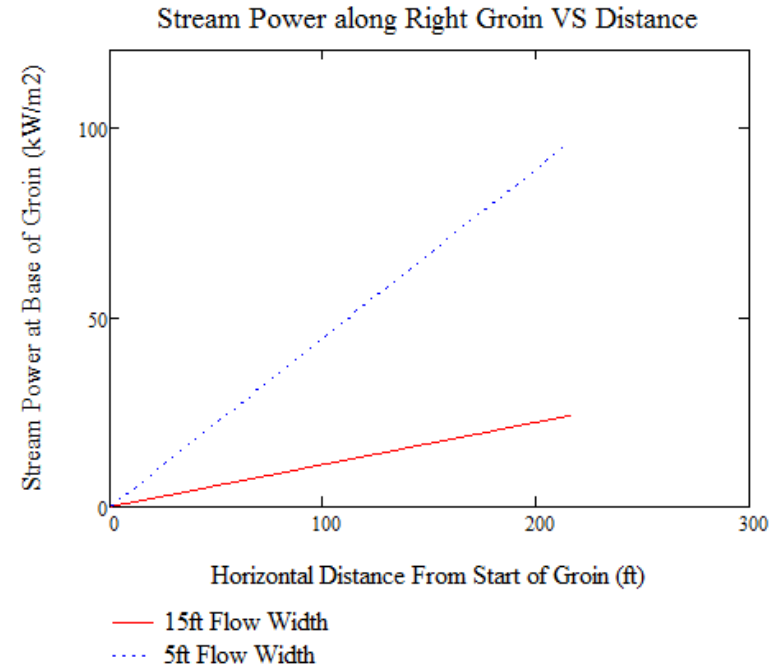
Erosive Capacity of Water Along Groins at 5.34 ft of Overtopping Assuming no Tailwater

Varies greatly with width of flow
Added to stream power at toe of center spillway

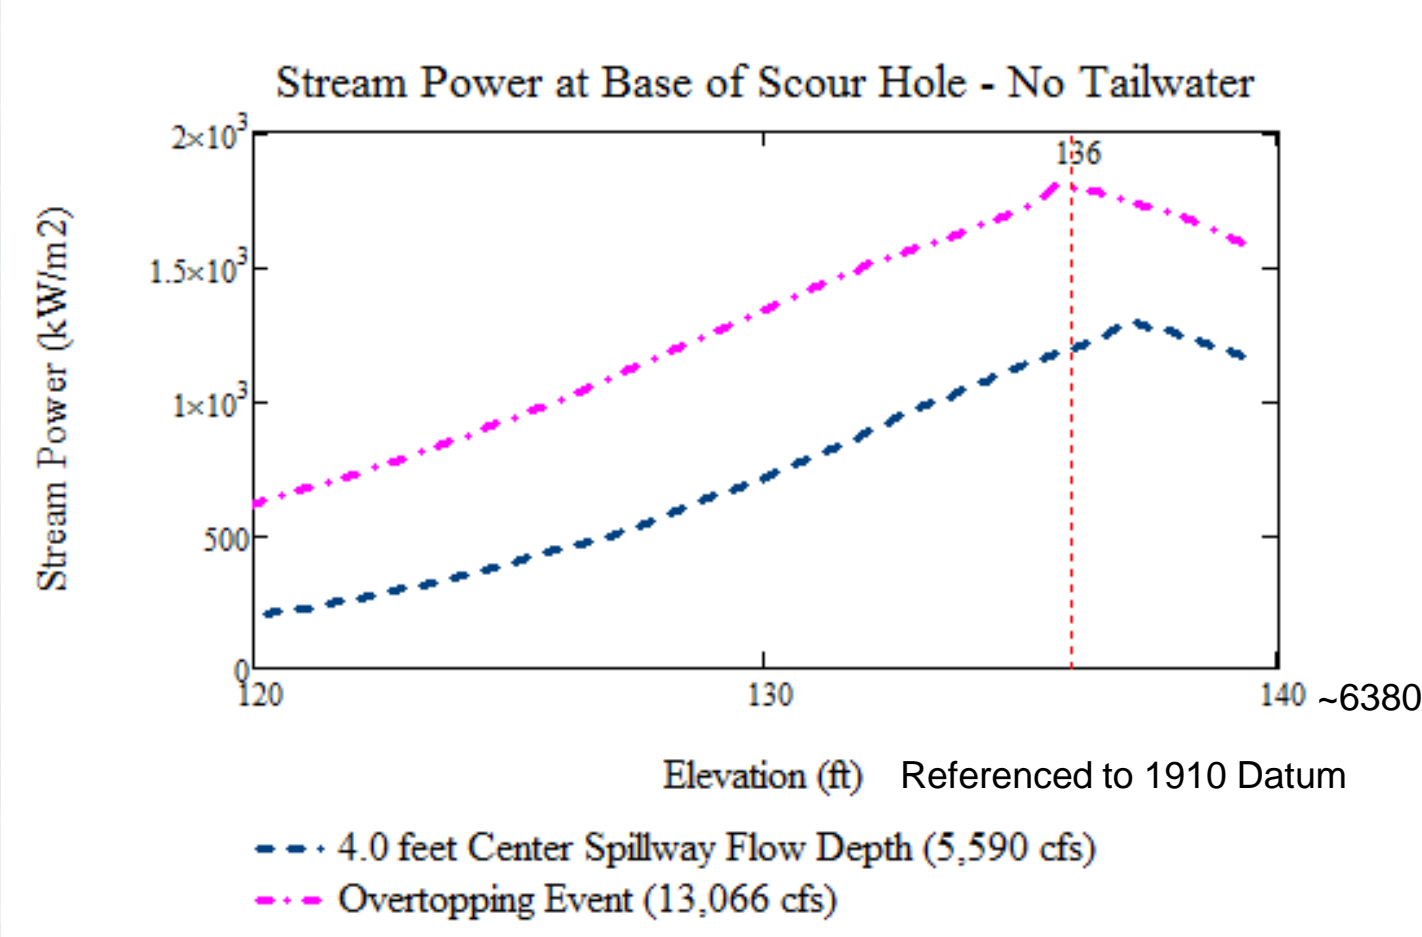
Stream Power vs. Base of Scour Hole Elevation assuming no Tailwater

~6380 ft MSL @ toe

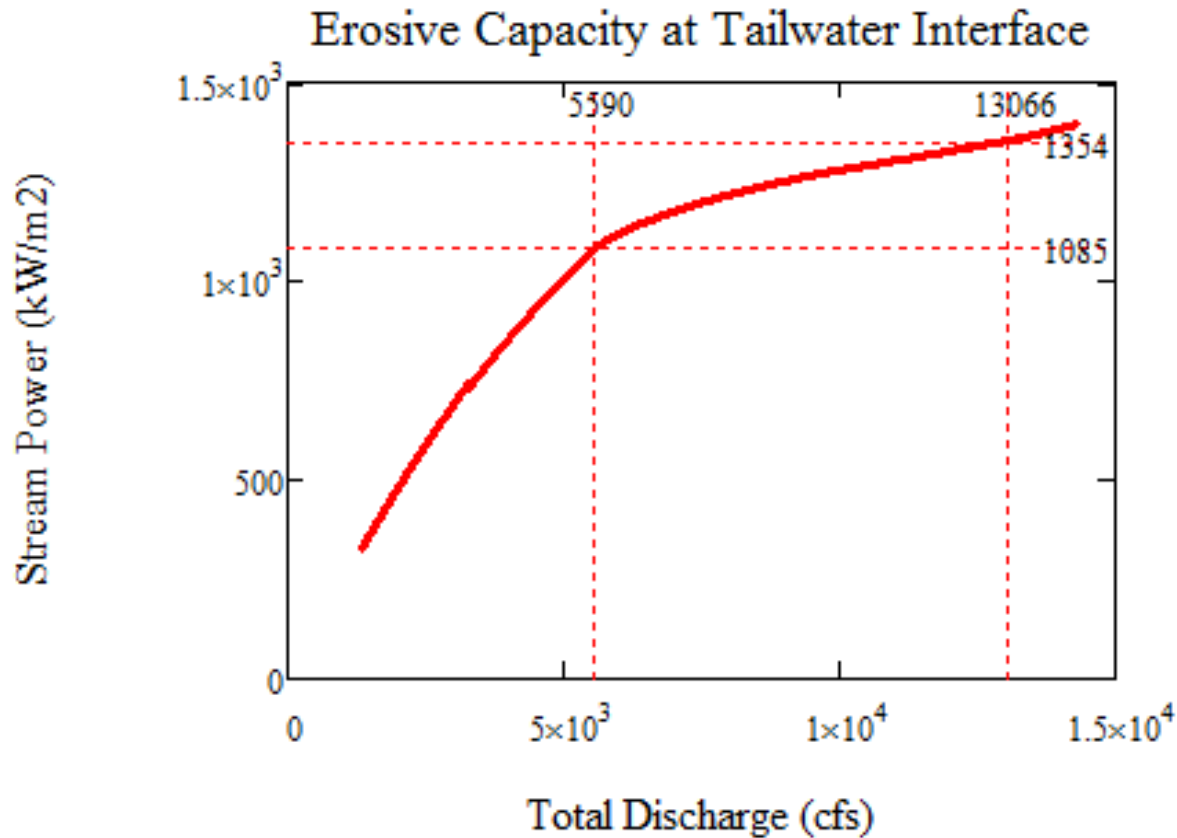
Erosive Capacity of Water at Toe of Dam Assuming Steady State Tailwater Conditions

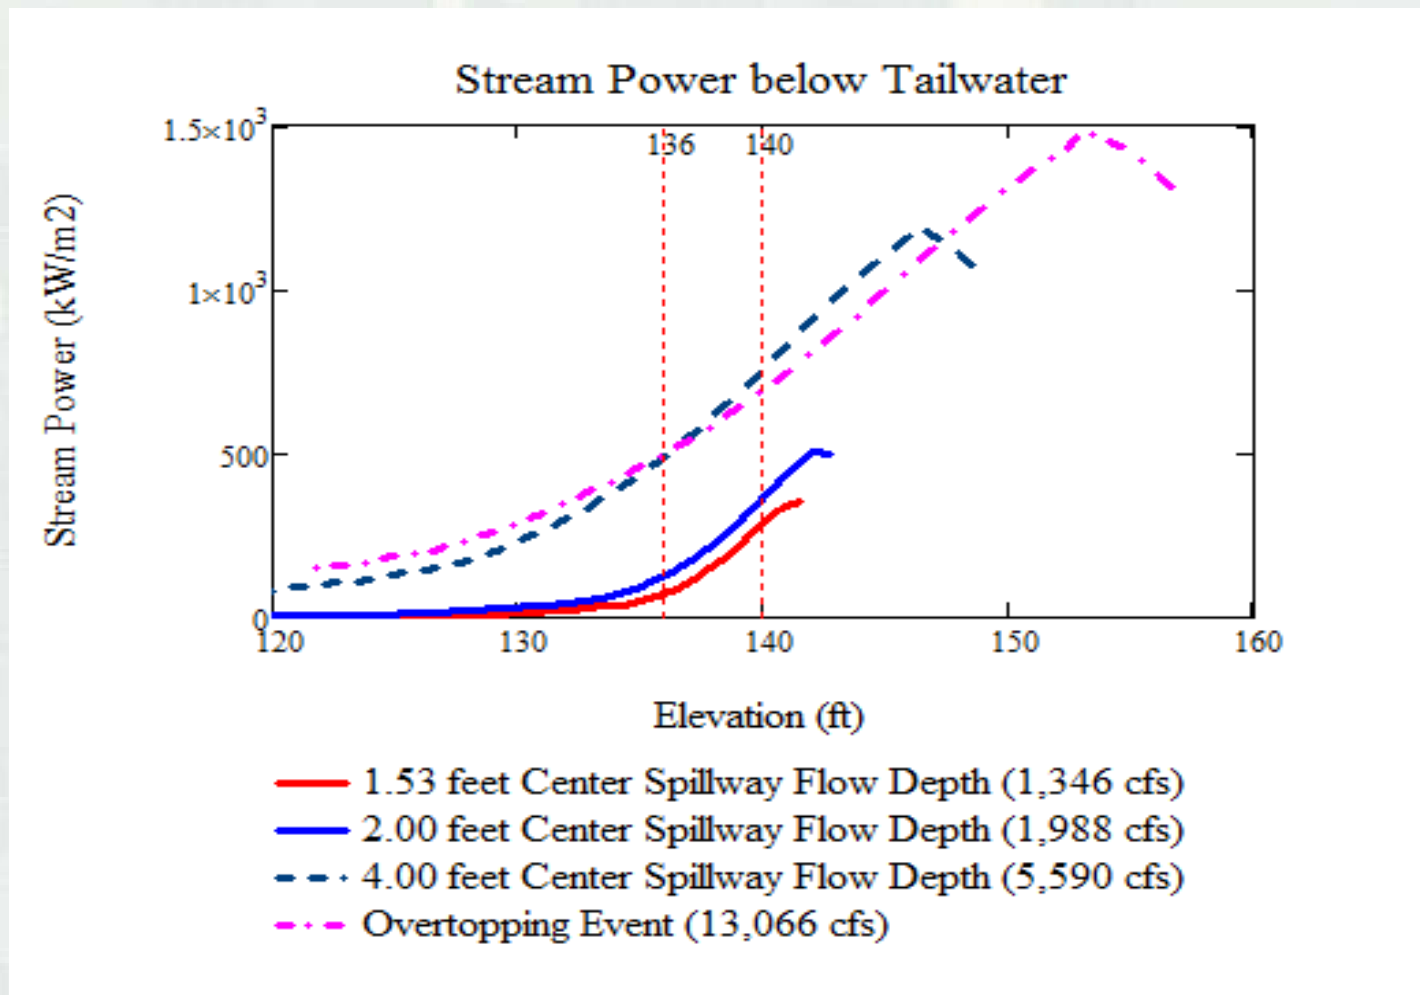
Stream Power Below Tailwater Interface vs. Elevation
