Defiance of Statute and Engineering Law Wrecked Mammoth Dam

Original Plans and Specifications Approved by State Engineer Not Followed—Too High Water Level Under Makeshift Conditions of Construction and Operation

By H. S. KLEINSCHMIDT
Consulting Engineer, Salt Lake, Utah

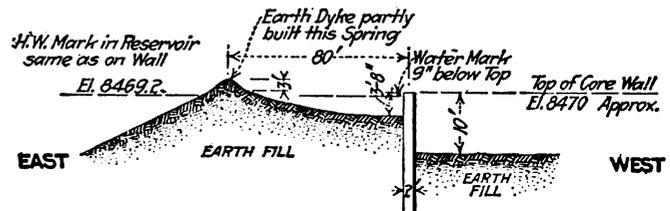
Cross-Section, East-West Near South End of Dam
FIG. 2

Relative levels of water in reservoir, heart wall, earth embankment above and below heart wall at time of break are shown in section and location of flume and initial break in plan

It is the writer's opinion that this assumption is not correct. It is impossible that less than 4 ft. of water could have caused the breaking off of the wall at a depth of 5 ft. The break must have occurred near the level of the top of the earth-fill on the downstream side of the wall.

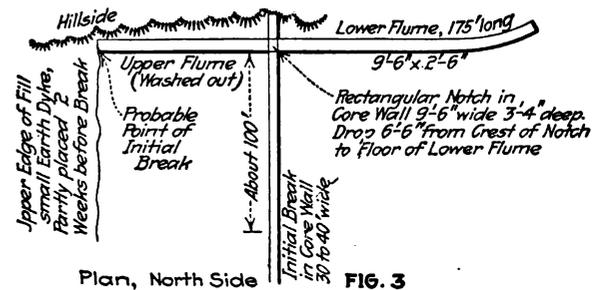
Plan, North Side
FIG. 3

Evidence and testimony point to the break having occurred in one way only, as follows: Water found its way around or under the upper end of the flume, which had not been properly bedded and protected in the earth dike at the upper end of the fill. This water filled the depression between the dike and the heart wall. Water marks on the upstream face of the heart wall show 9 in. below the top on the south end and 7 in. below the top at the north end. This mark corresponds to the high-water mark of the reservoir on the slopes above the dam. This water saturated the earth-fill sufficiently to overturn or push out by sliding a portion of the heart wall. Scour marks on the earth-fill under the lower flume just below the heart wall show that water pouring through the notch had deeply scoured the fill. This may have been a contributing cause to the failure of the heart wall.

have happened. A spillway 20 ft. wide, 4 ft. deep, with floor 10 ft. below the crest of the fill, should have been provided.

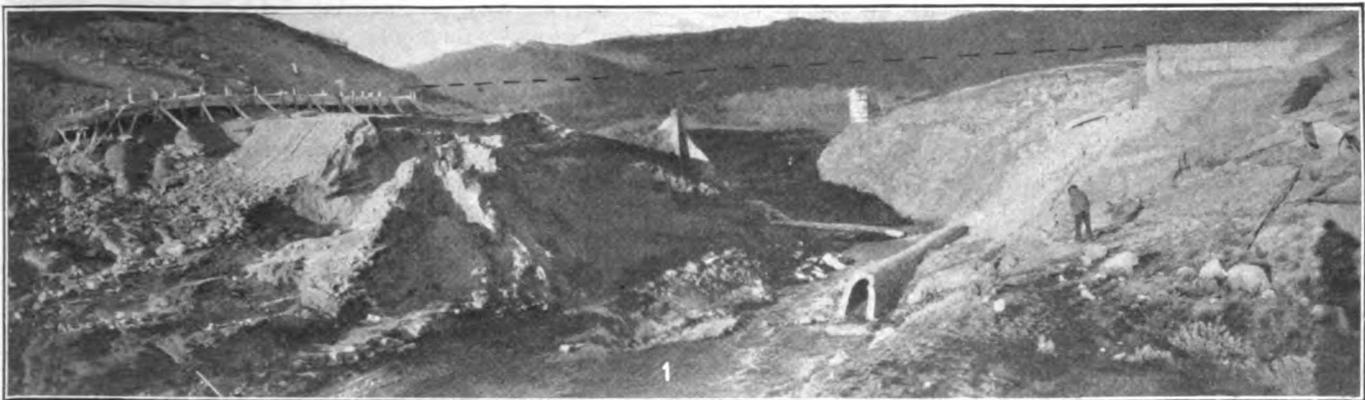
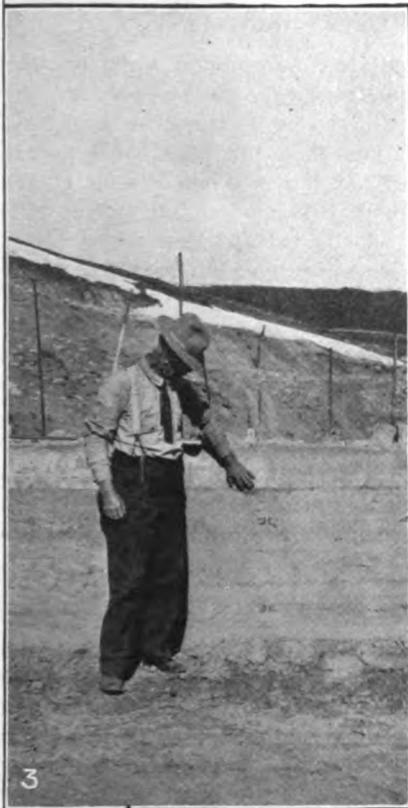
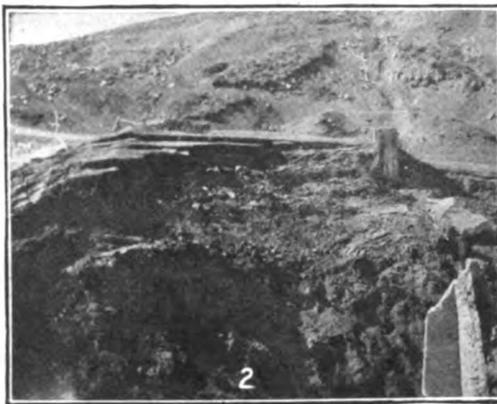
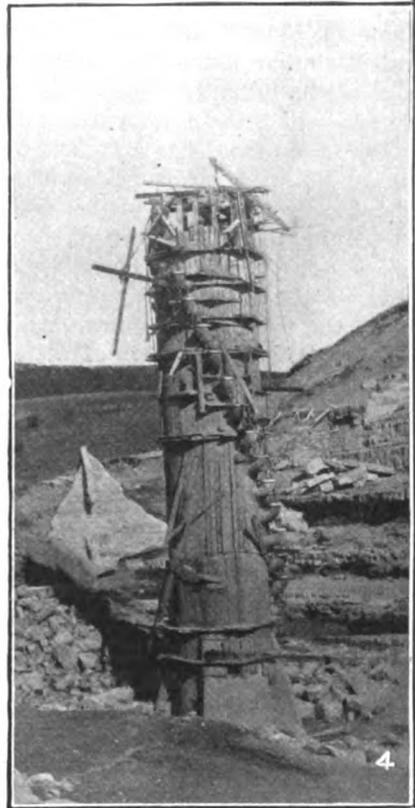
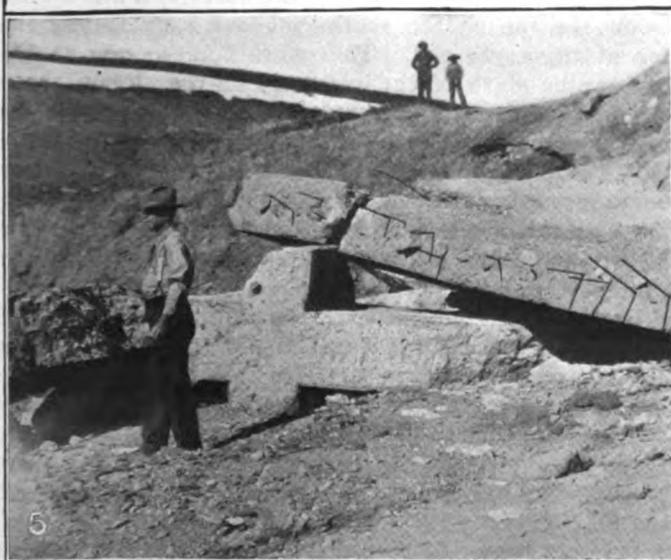
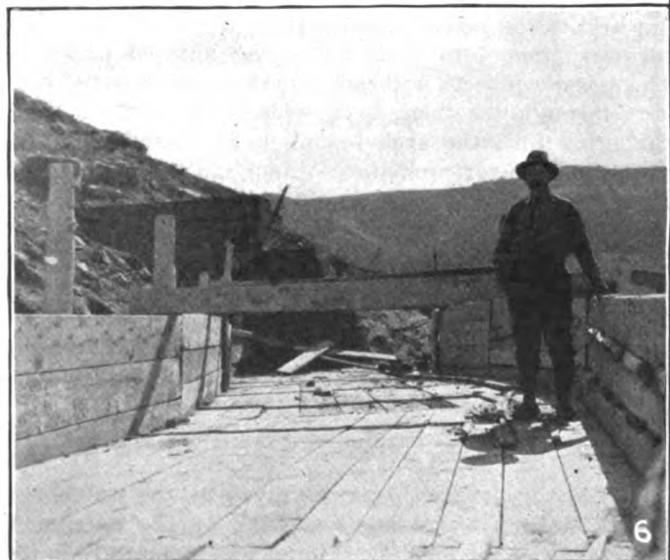
1. LOOKING AT RUINED DAM FROM BELOW
2. LOOKING SOUTH ALONG DAM AND HEART-WALL
3. TIPS OF MAN'S FINGERS ARE AT WATER MARK ON HEART-WALL
4. UNFINISHED OUTLET TOWER STANDS UNHARMED
5. REINFORCEMENT SHOWN IN SECTION OF HEART-WALL ADDED IN 1916
6. LOOKING EAST THROUGH LOWER PORTION OF FLUME

STORY OF THE FAILURE OF THE MAMMOTH RESERVOIR DAM IN UTAH, AS TOLD BY THE CAMERA

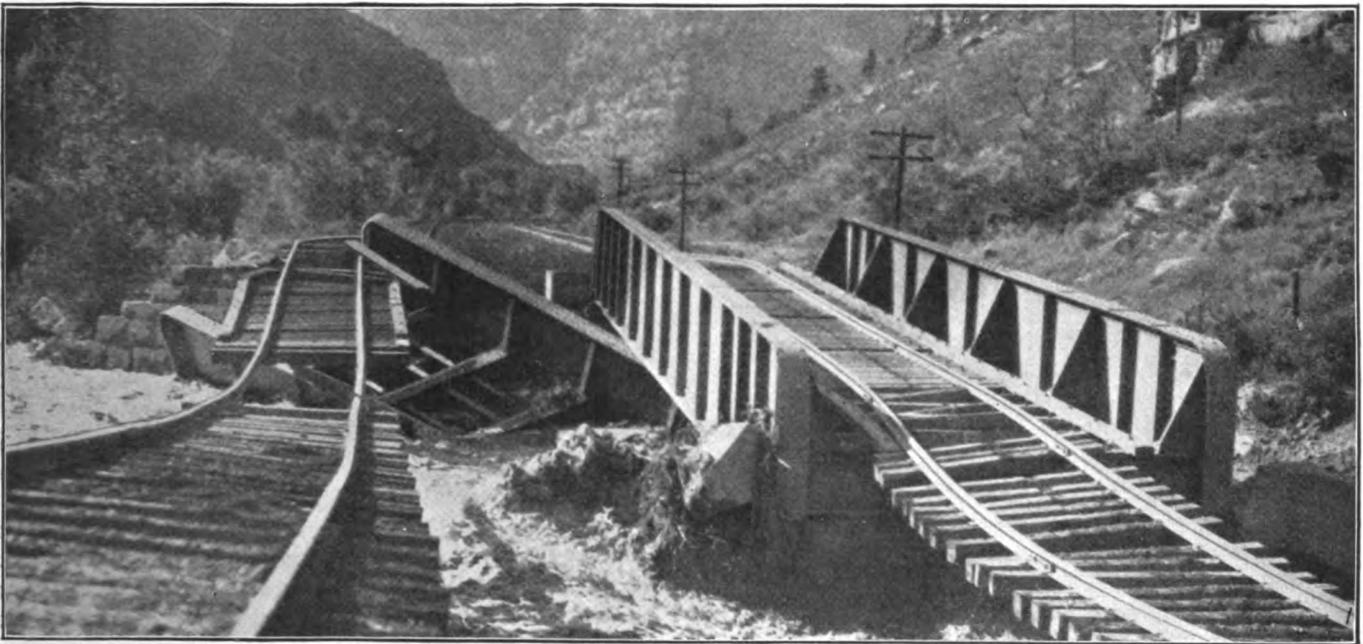
TWO OF THE DENVER & RIO GRANDE RAILROAD BRIDGES HIT BY THE FLOOD WATERS FROM MAMMOTH DAM FAILURE

These were 85-ft. bridges. The east pier of one was washed out and of the other cracked and twisted from foundations when flood cut a new river channel
