INTRODUCTION

WHY WASN'T CASTLEWOOD WORTH A DAM?

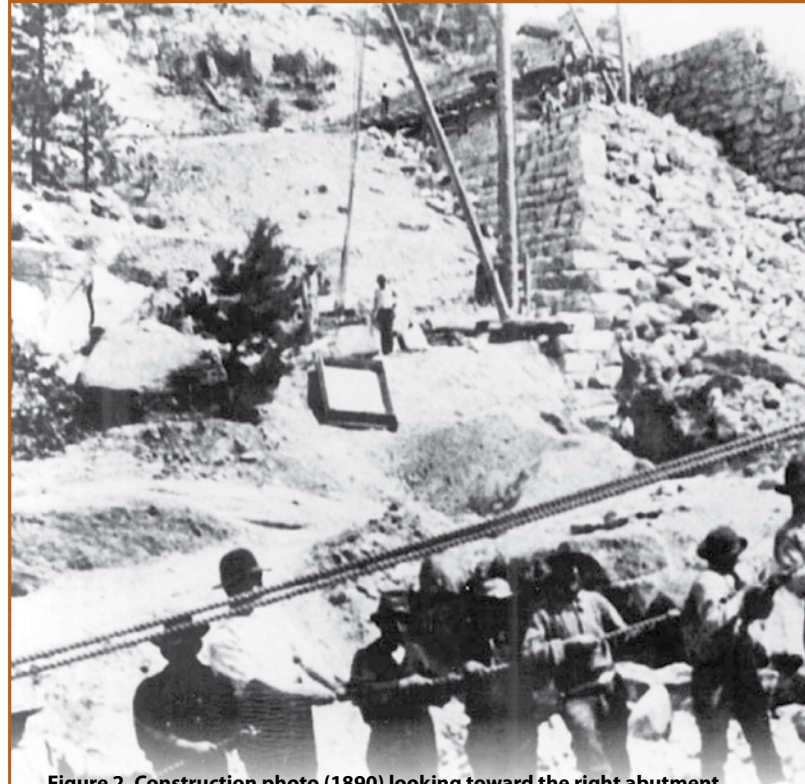
Figure 2. Construction photo (1890) looking toward the right abutment (Photo Courtesy of the Denver Public Library, Western History Collection)

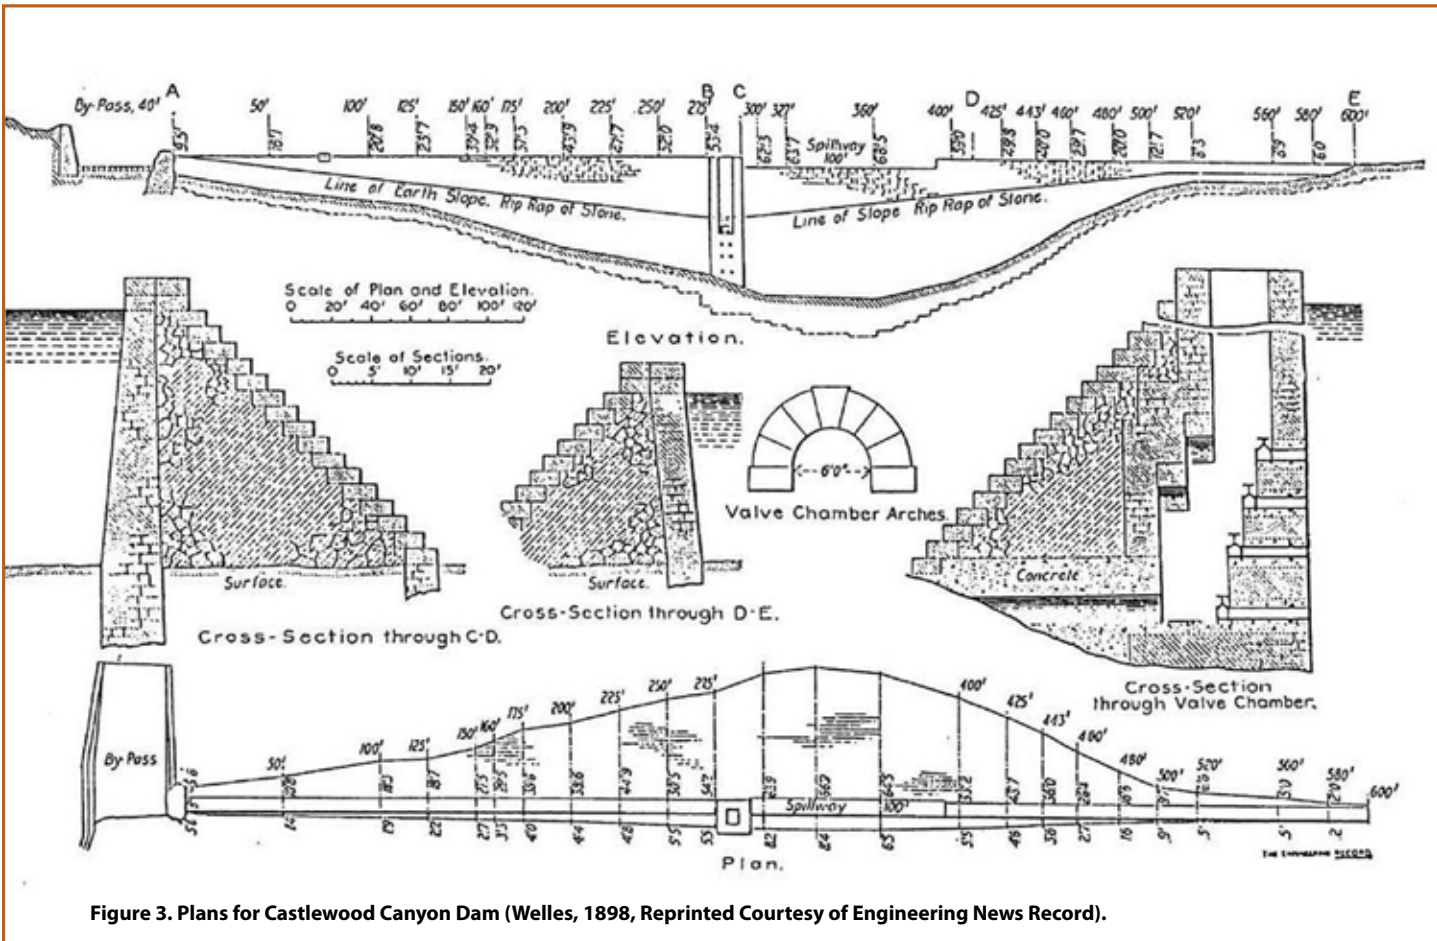
As constructed, the Castlewood Dam was reported to be approximately 600 ft long, 70 ft high from the lowest point of the reservoir floor, 92 ft high above the lowest point of the foundation on the upstream masonry wall, 50 ft wide at the base near the center, and 8 ft wide at the top. The main center spillway was 100 ft long and 4 ft deep. A 40-ft wide masonry lined bypass spillway capable of passing 4,000 cfs was also constructed near the left abutment. The upstream masonry wall was constructed at a 1:10 (H:V) slope from conglomerate blocks set in mortar. The wall had a thickness of 11 ft at the base and 4 ft at the crest along the center spillway, and a consistent thickness of 4 ft from base to the crest along the rest of the dam. The upstream masonry wall was reported to be founded 6 to 22

Figure 3. Plans for Castlewood Canyon Dam (Welles, 1898, Reprinted Courtesy of Engineering News Record).

ft below ground surface on “hard sandy clay.” The “hard sandy clay” referred to in the report is likely a mudstone unit within the Dawson Formation. The downstream masonry wall was constructed at a 1:1 (H:V) slope from 2 ft thick conglomerate blocks set in mortar. Construction of the downstream masonry wall was completed by layering the 2 ft thick conglomerate blocks on one another in rows. Each row stepped in approximately 2 ft resulting in a stepped surface with 2 ft by 2 ft steps. The foundation of the downstream masonry wall was reported to be founded 10 ft below the ground surface. No information on the foundation of the downstream masonry wall was reported. The rubble fill between the masonry walls was placed directly on the ground surface and consisted of loose dumped rock of various sizes. An outlet control structure consisting of eight 12 inch pipes with a total combined capacity of approximately 250 cfs was constructed near the center of the dam. These pipes fed into a square control tower, which connected to a 36 inch outlet pipe discharging near the downstream toe of the dam (Bartlett, 2003; U.S. Geological Survey, 1899). During initial construction, a small soil berm was placed along the upstream masonry wall.

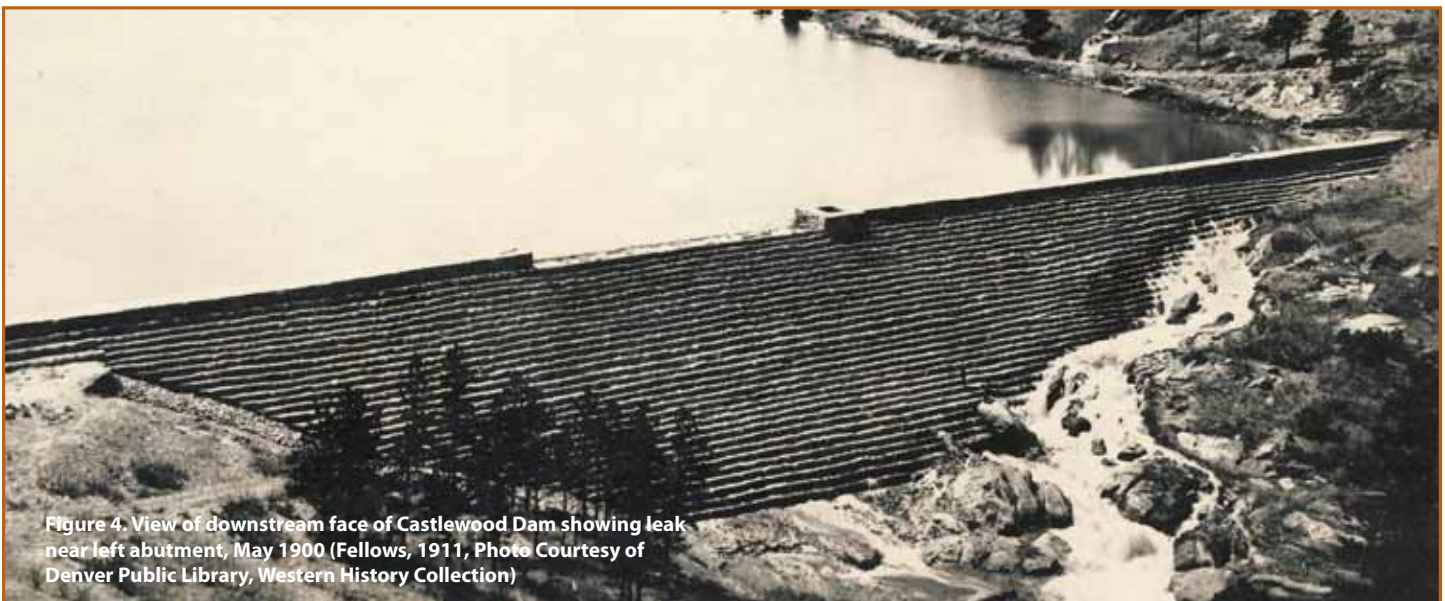
Figure 4. View of downstream face of Castlewood Dam showing leak near left abutment, May 1900 (Fellows, 1911, Photo Courtesy of Denver Public Library, Western History Collection)

In mid to late April of 1900, high rainfall filled the reservoir to capacity. Newspaper reports indicate that at this time, large amounts of water were flowing through the dam, near a bulge in the lower left side of the downstream face. As evident in Figure 4, there also appears to be a substantial amount of water flowing along the dam/foundation contact near the middle of the center spillway. The highest reservoir level during this time period was reached on April 30, 1900. Exact reservoir levels for this event could not be found but it was reported that 500 cfs was flowing through the main spillway and bypass spillway for approximately 30 hours, causing substantial erosion of the bypass spillway on the left abutment (Engineering Record, 1900). This spillway erosion is still visible today.

After this event, the state engineer ordered that the reservoir be emptied until repairs had been made (Engineering Record, 1900). Following its purchase of the dam in approximately 1902, the Denver

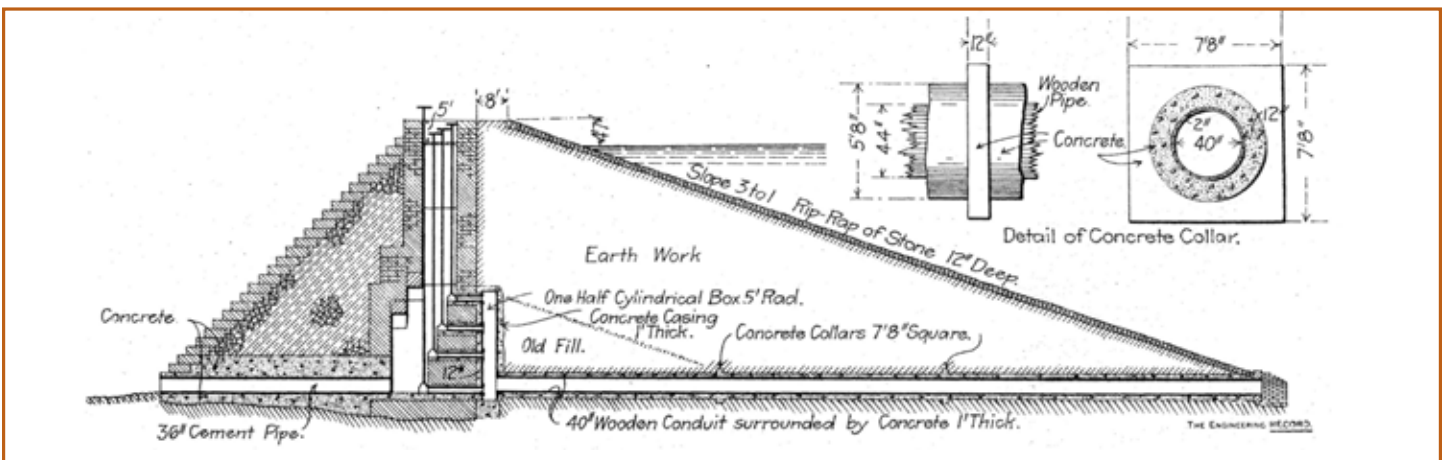
Figure 5. Plans for 1902 reconstruction of the Castlewood Dam (Engineering Record, 1902, Reprinted Courtesy of Engineering News Record)

Sugar, Land and Irrigation Company, made repairs, which consisted of placing an upstream earthen embankment up to the base of the spillway at a 3:1 (H:V) slope protected by riprap, building a small masonry wall across the left abutment bypass spillway inlet so it would only flow when water was 1 ft above the crest of the dam or higher, building a new 12-ft wide unlined by-pass spillway near the right abutment, and reconstructing the inlet to the valve chamber. Figure 5 shows plans for the reconstruction approved by the state engineer.

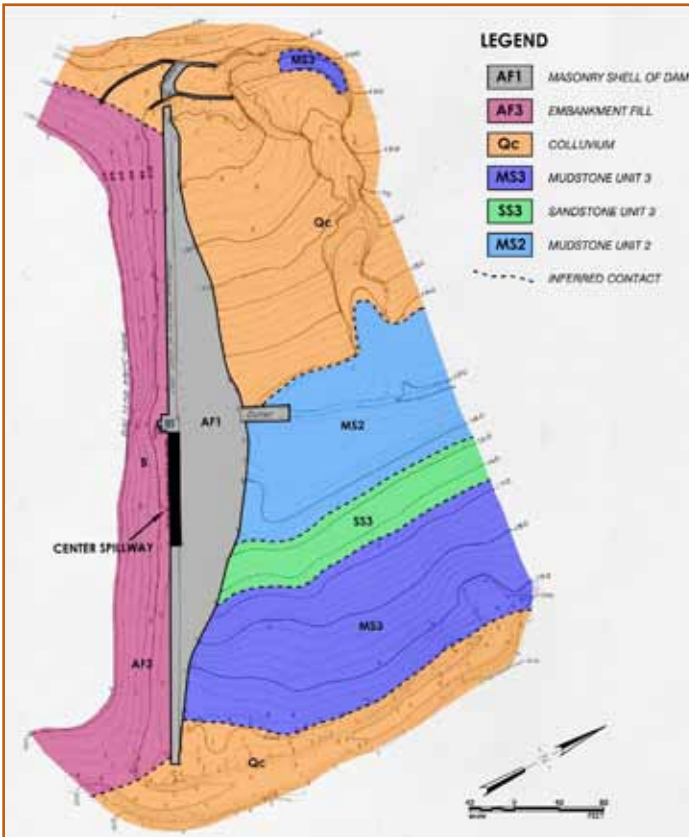
The first step in the analysis was to perform geological and geotechnical characterizations of the foundation rock and the masonry. Figure 7 shows a geologic map developed from the available information, and Figure 8 shows the sandstone and mudstone rock units exposed in the erosional cut on the right side of the canyon. The dam was founded on the MS3 mudstone, the SS3 sandstone, and the MS2 mudstone (although the left abutment of the dam appears to be founded on large colluvial boulders derived from the conglomerate cap rock). Therefore, the canyon has eroded more than 20 feet below the original base of the dam since its failure.

Figure 7. Geologic plan map showing recently mapped contacts

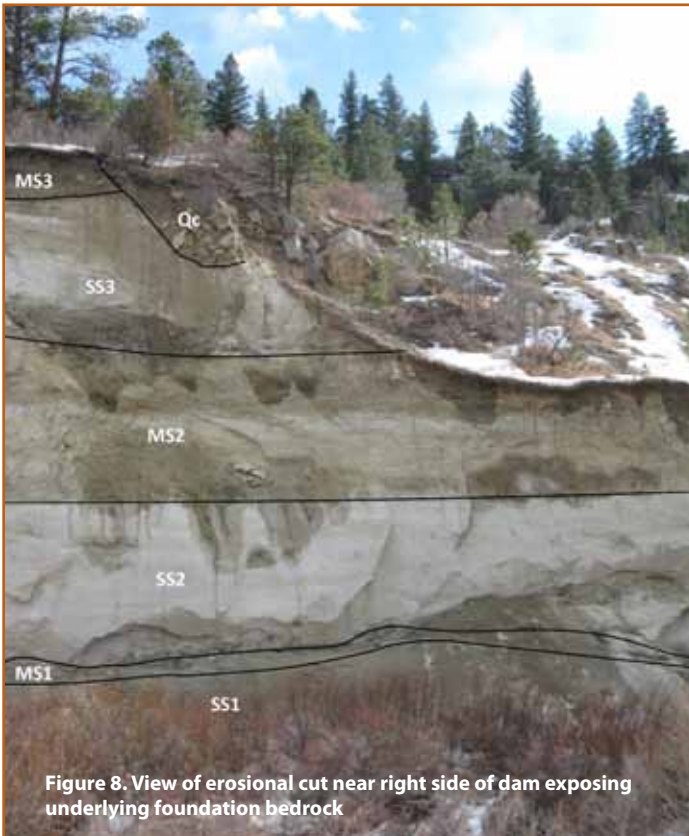
Figure 8. View of erosional cut near right side of dam exposing underlying foundation bedrock

The most significant piece of evidence supporting an overtopping erosion failure mode discovered during the site investigation was the existence of weak, highly erodible sandstones and mudstones underlying the remains of the dam. It is readily apparent based on visual inspection alone that this bedrock would easily scour. The more than 20 ft of scour erosion that has occurred in this canyon since the dam's failure also suggests that the mudstone and sandstone bedrock is highly erodible.

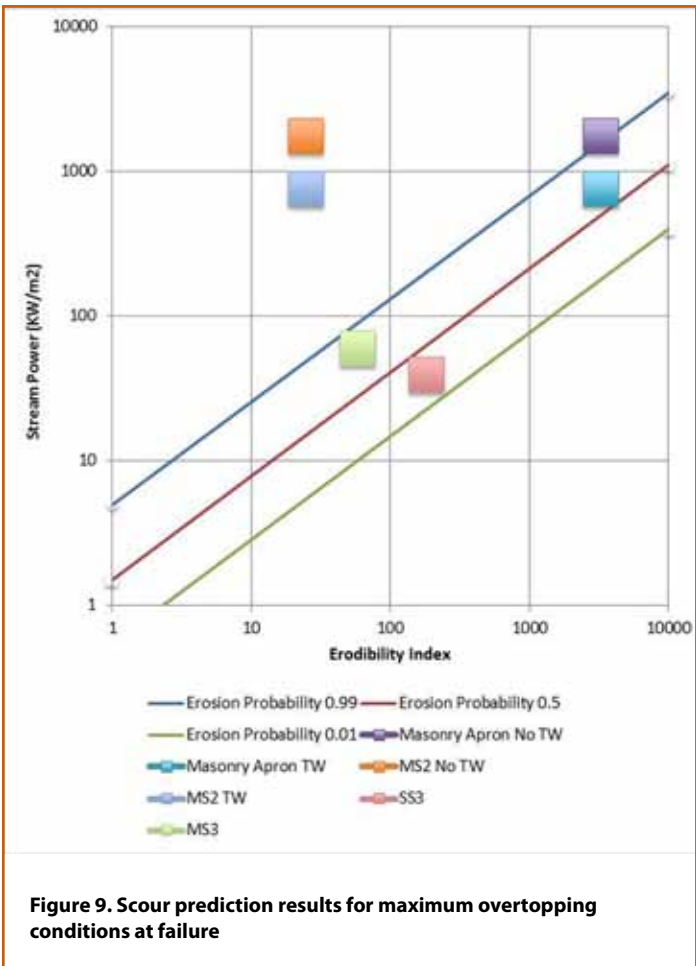
The results of this evaluation at the toe of the dam are summarized in Table 3 and Figure 9. Only the masonry and MS2 units would be impacted at the toe of the dam.

Figure 9. Scour prediction results for maximum overtopping conditions at failure

Even though direct photographic evidence of the masonry apron could not be found, the results are consistent with the reported behavior given a masonry apron in place. For flows over the central spillway less than 2 ft in depth, the analysis predicts erosion would be unlikely, especially if some tailwater was to build up (probability of erosion 0.18 to 0.42). Erosion of the masonry apron would be likely with 4 ft of flow over the central spillway, consistent with the erosion hole that formed. At the maximum overtopping depth, prior to failure, erosion is virtually certain, especially before tailwater had a chance to build. If the masonry apron is lost, erosion of the underlying MS2 is predicted to occur rapidly. An evaluation of stream power at elevations below the toe of the dam indicates that scour depths of over 20 ft would be probable for the overtopping event.

At maximum overtopping, flow down the groins would potentially erode the MS3 and SS3 units on the abutments. Table 4 shows an evaluation of the average potential for erosion at the point of maximum discharge along the groin. It can be seen that the upper more erodible MS3 has a higher likelihood of erosion than the lower SS3 unit even though the Stream Power at overtopping is less along the upper groin. In both cases, it appears that the likelihood of erosion along the groins is less than that at the toe of the dam, even with the masonry apron in place. This can be seen in Figure 9 where the MS3 point is closer to the 0.99 probability line than the SS3 point.
