DOMINANT FACTORS IN VEGETATED EARTH SPILLWAY FAILURES ^{1/}

by
Darrel M. Temple ^{2/}

ABSTRACT

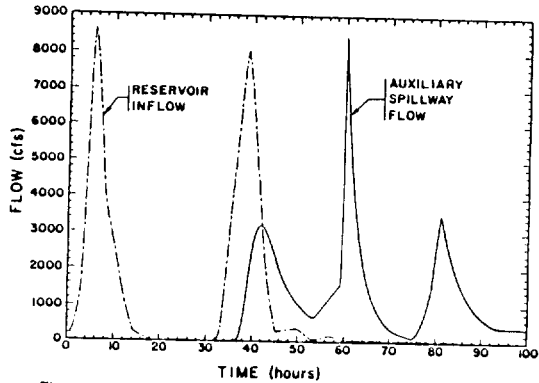
The reservoir inflow hydrograph shown in Fig. 1 was generated by a 9 inch rainfall over a 19 square mile watershed which had experienced a 5 inch rainfall earlier in the week. The outflow hydrograph shown in Fig. 1 includes the spillway breach flow and was generated by the analysis given by Temple (1989). Maximum elevation of the water surface above the original spillway crest was computed to be 5.1 ft. The time from beginning of spillway flow to complete spillway breach was approximately 60 hours.

Figure 1. Reservoir inflow and auxiliary spillway hydrographs for Black Creek Site 53, May 1983 flood.

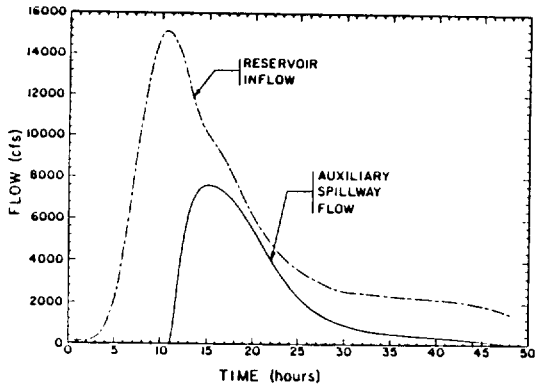
The flood described by Fig. 3 was a result of up to 9 inches of rainfall in approximately 9 hours. Analysis required routing of the flood through two upstream flood control reservoirs in addition to Site 4 (SCS, 1987). Maximum reservoir water surface elevation was approximately 3.8 feet above the spillway crest, and the spillway flowed for about 38 hours.

Figure 3. Reservoir inflow and auxiliary spillway hydrographs for Misteguay Site 4, September 1985 flood.

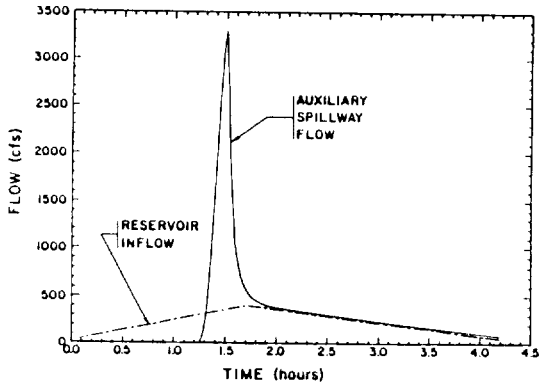
The flows indicated in Fig. 5 were the result of approximately 12 inches of rain over a 173 acre watershed in about a 12 hour period. The maximum reservoir water surface elevation as a result of these flows was approximately 1.5 ft above the original auxiliary spillway crest. The auxiliary spillway hydrograph shown in Fig. 5 includes breach outflow and was generated using the National Weather Service dam break model. Although it is recognized that this model is not entirely consistent with the overfall mode of failure observed in spillways, there were insufficient observations and data available for this site to justify more detailed analysis.

Figure 5. Reservoir inflow and auxiliary spillway hydrographs for Buck and Doe Run Site 33, September 1986 flood.

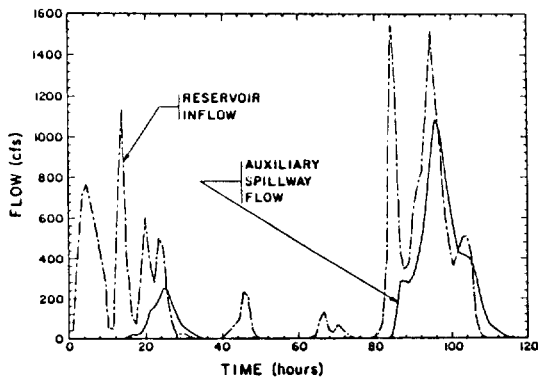
The flows indicated in Fig. 7 were the result of approximately 23 inches of rain on the 2.7 square mile watershed during a 5 day period (Smith, 1987). The SCS DAMS2 flood routing suggested 2 periods of auxiliary spillway flow during this time with a cumulative duration of 51 hours. Maximum reservoir water surface elevation, based on a survey of reservoir high water marks following the flood, was 4.2 ft above the crest of the auxiliary spillway.

Figure 7. Reservoir inflow and auxiliary spillway hydrographs for Middle Caney Site 17-3, October 1986 flood.
