Geotechnical Extreme Events Reconnaissance (GEER)

## **Preliminary Observations of the Fujinuma Dam Failure Following the March 11, 2011 Tohoku Offshore Earthquake, Japan**

June 6, 2011

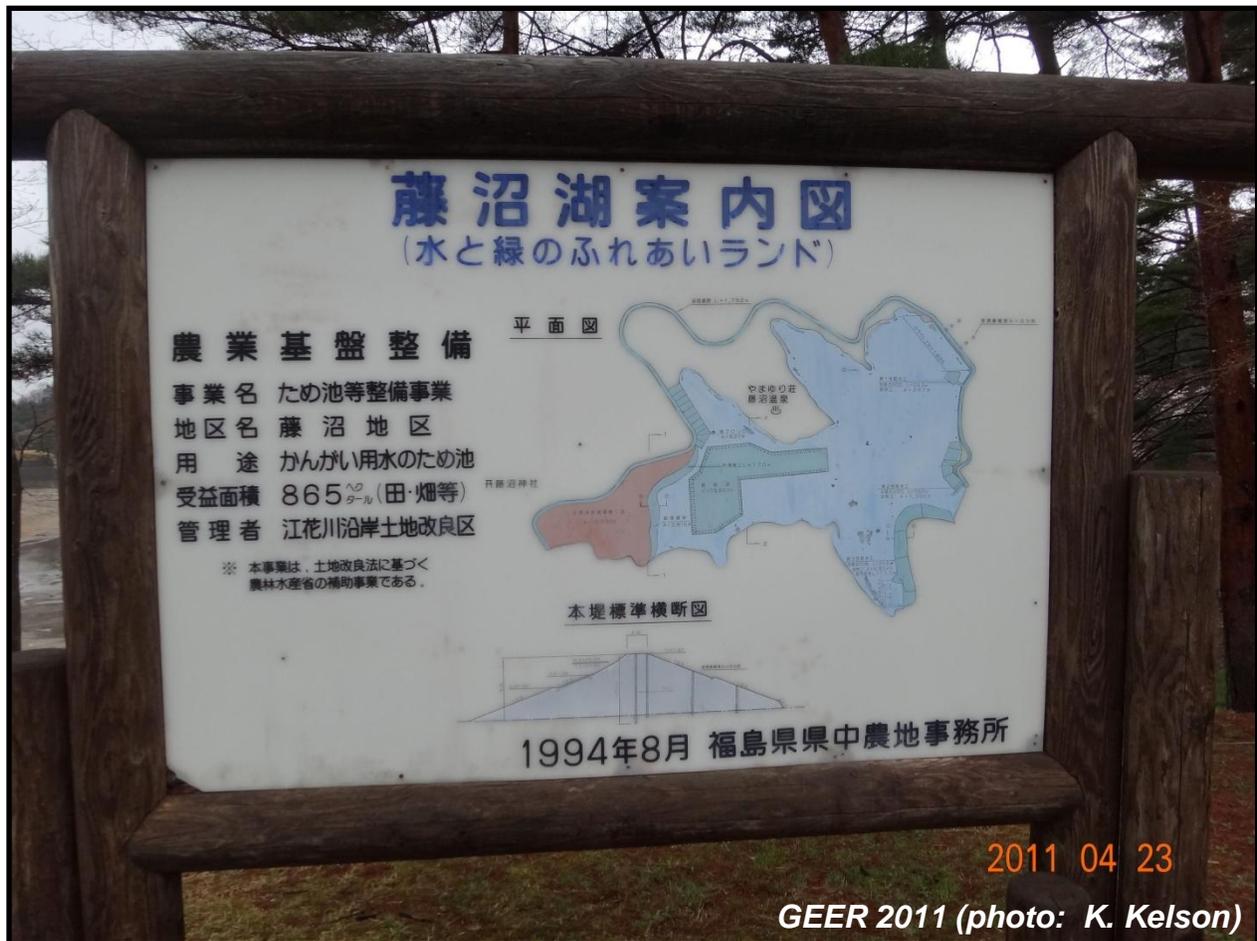
The performance history of Fujinuma Dam is not available at the time of this writing. However, a diagram posted on the left abutment of the main dam (see Figure 5) indicates that the main dam has had a seepage problem in either the upper foundation or lower embankment materials. As shown in Figure 6, the diagram suggests that a series of grout holes was

Figure 5: Photograph of a Diagram Posted on Left Abutment of Fujinuma Dam  
(N37.3025°, E140.1943°, April 23, 2011)

- The diagram found on the left abutment of the main dam suggests that the dam has had a seepage problem within the upper foundation in the relatively recent past (1994).

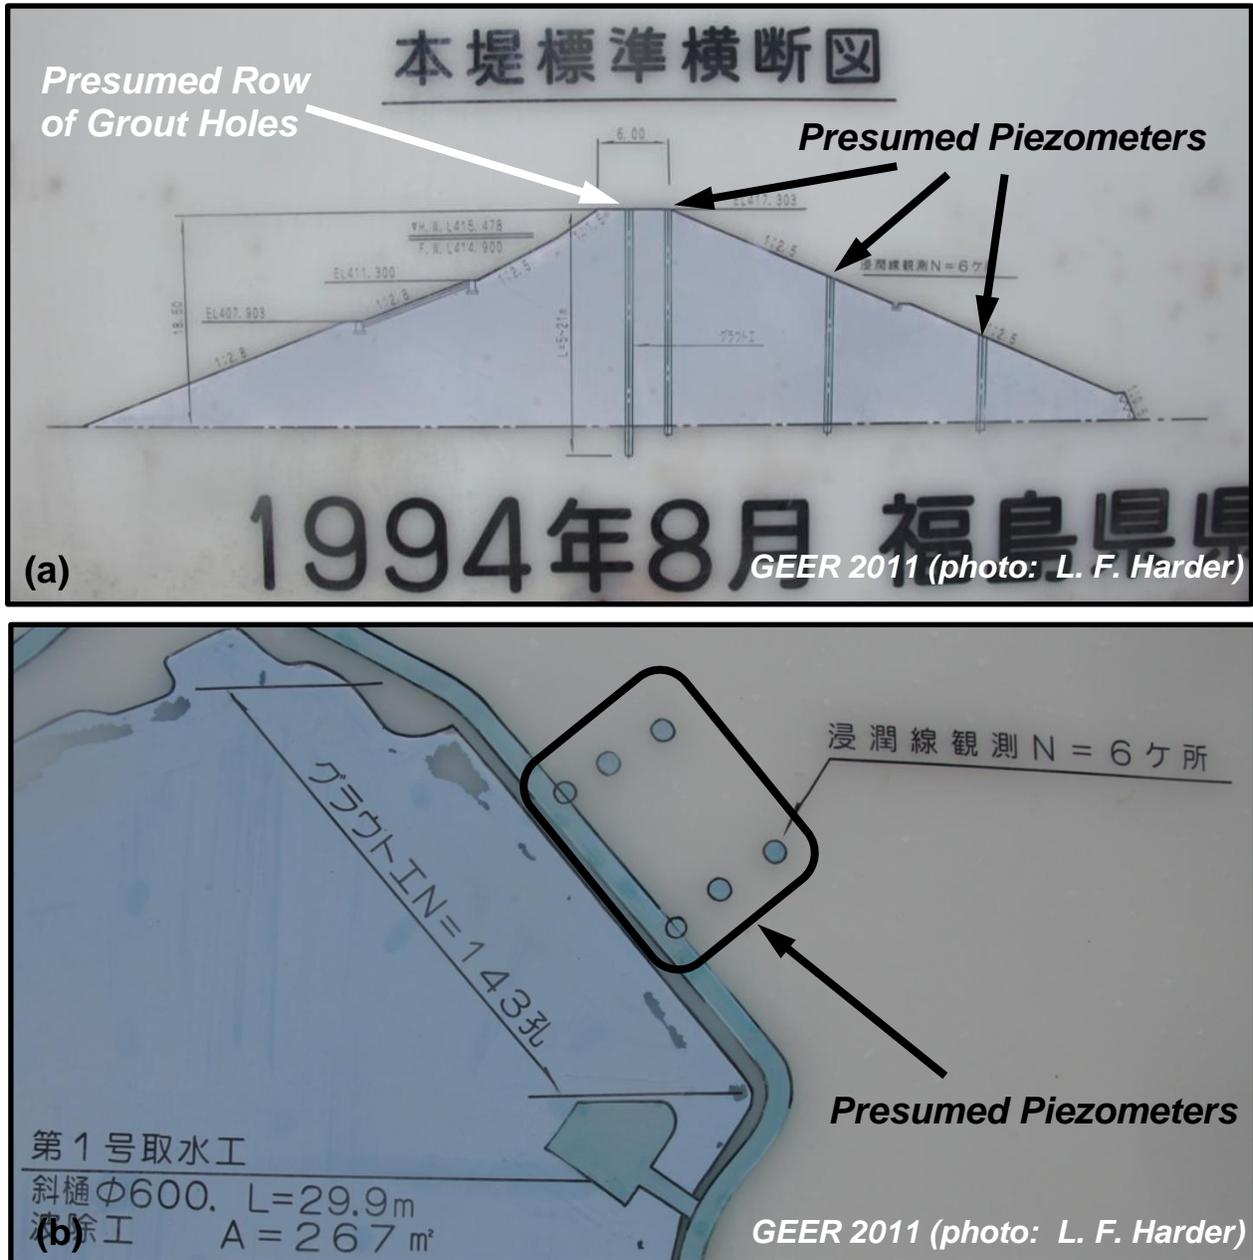
Figure 6: Photographs of (a) Cross Section and (b) Plan View of Fujinuma Main Dam Taken from a Diagram Posted on Left Abutment of Fujinuma Dam Suggesting a 1994 Foundation Treatment and Monitoring Program (N37.3025°, E140.1943°, April 23, 2011)

7. There was no sign in the breach area that a cutoff trench through the black residual soil and into the tuff bedrock had been constructed. This observation matches the drawings and the diagram found on the left abutment (see Figures 3 and 6).

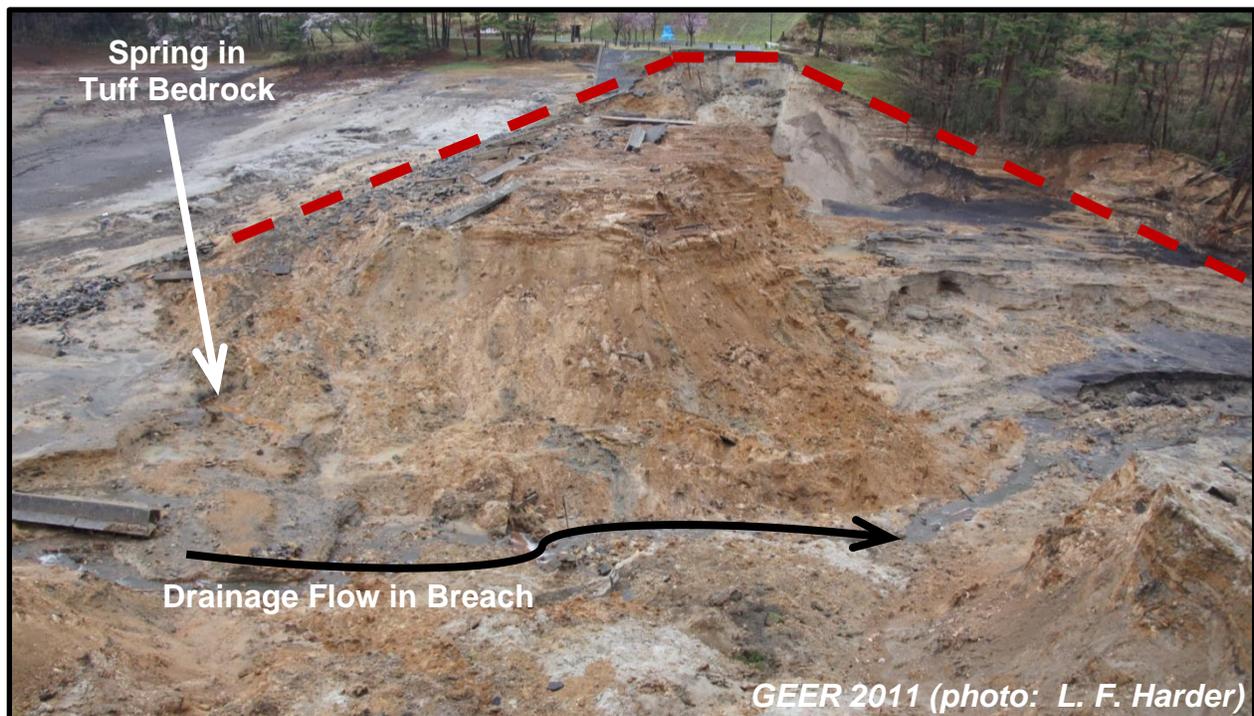
1. The breach of the main dam appeared to be in the maximum section near the right abutment.
2. There was a dark brown embankment fill remaining for most of main dam (see Figures 8 through 13). Breach flows had cut through this material in the area of the breach, but had also overtopped this material for most of the dam's length. Where it had been overtopped, the upper, residual surface of this dark brown embankment fill was left almost uniformly flat at a level approximately 6 meters below the pre-earthquake crest of the dam. The uniform, regular nature of the upper portion of the remaining section of this dark brown embankment fill where it had been overtopped, together with the regular nature of the downstream slope of this material, suggested that this was either a man-made core section, or perhaps a zone that had been placed during an early phase of the dam construction.

Figure 8: View of Breach in Fujinuma Main Dam from Right Abutment  
(N37.3014°, E140.1957°, April 23, 2011)

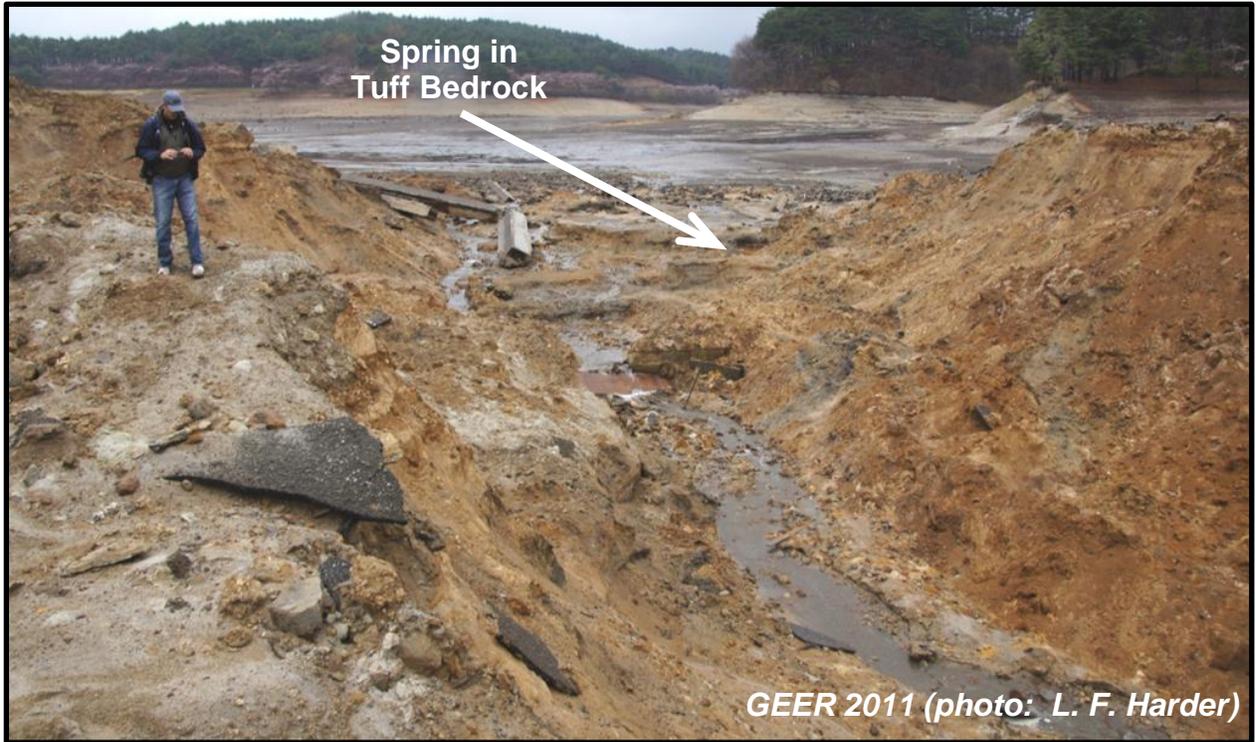
9. Within the breach area, a small spring was found in the volcanic tuff exposed directly beneath the black residual soil near the upstream toe (see Figures 8, 9, 21, and 22).

Figure 9: View of Breach in Fujinuma Main Dam Looking Upstream towards Empty Reservoir (N37.3021°, E140.1958°, April 23, 2011)

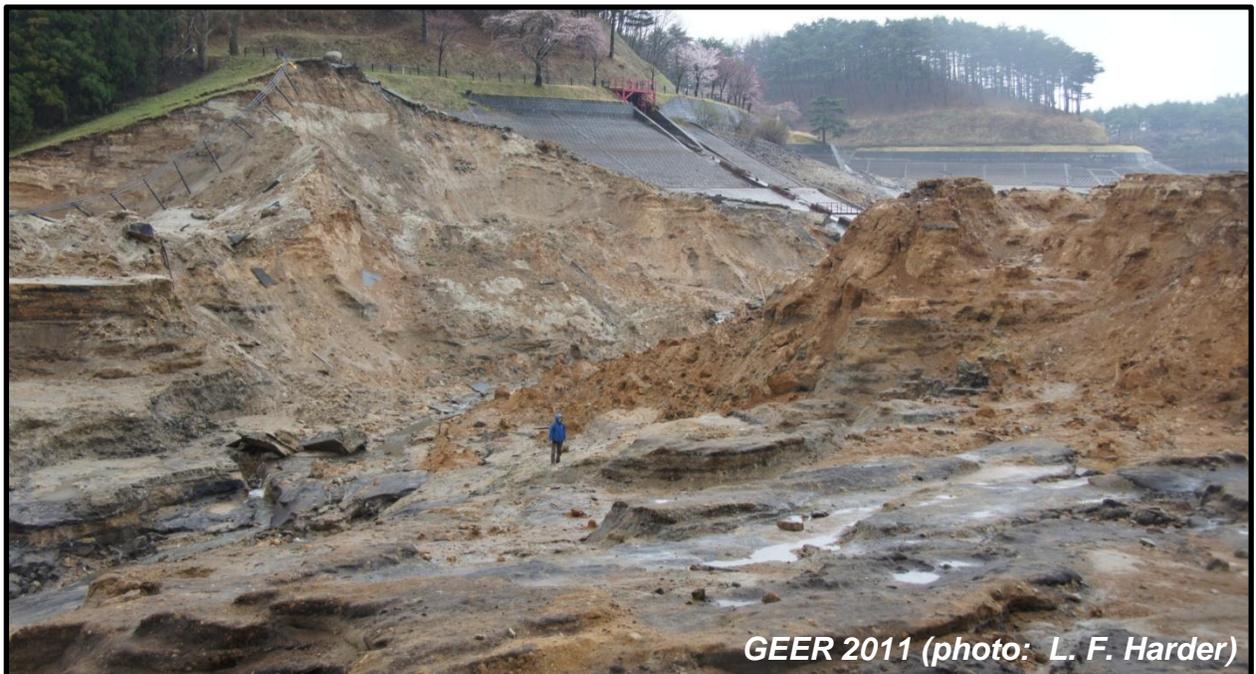
Figure 10: View of Breach in Fujinuma Main Dam from Left Abutment Looking Upstream (N37.3021°, E140.1952°, April 23, 2011)

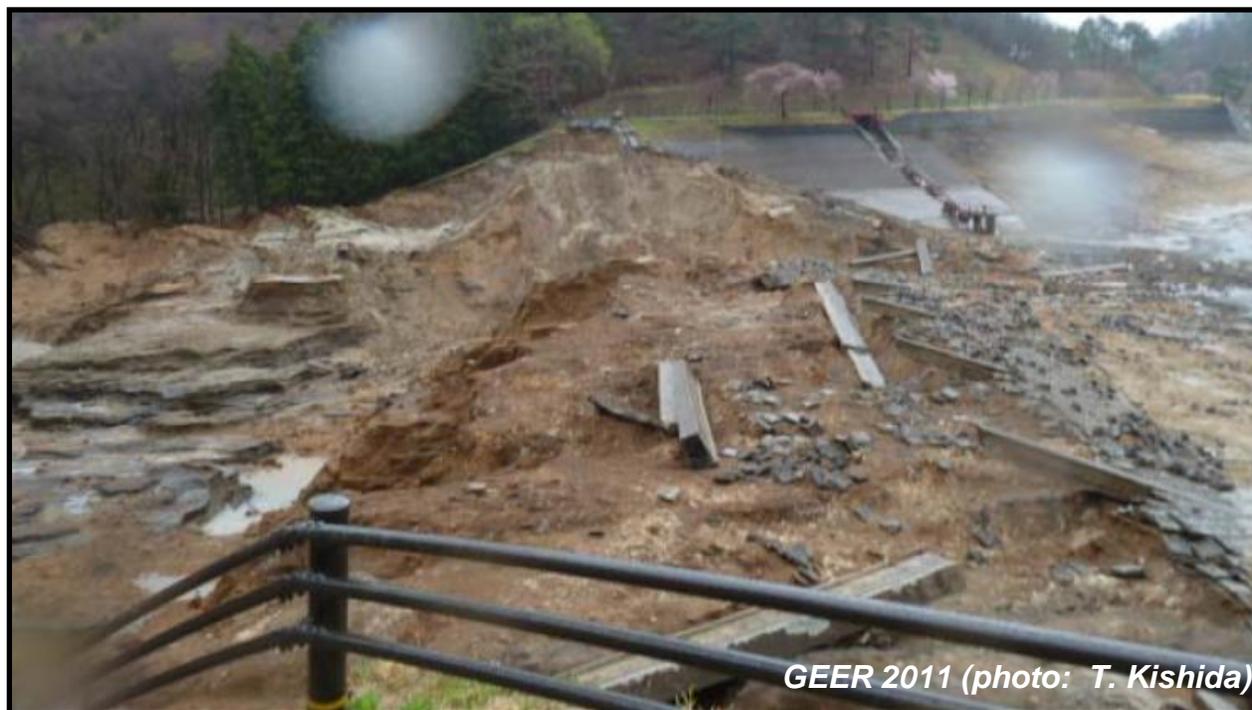
Figure 11: View of Breach in Fujinuma Main Dam from Left Abutment  
(N37.3024°, E140.1946°, April 23, 2011)

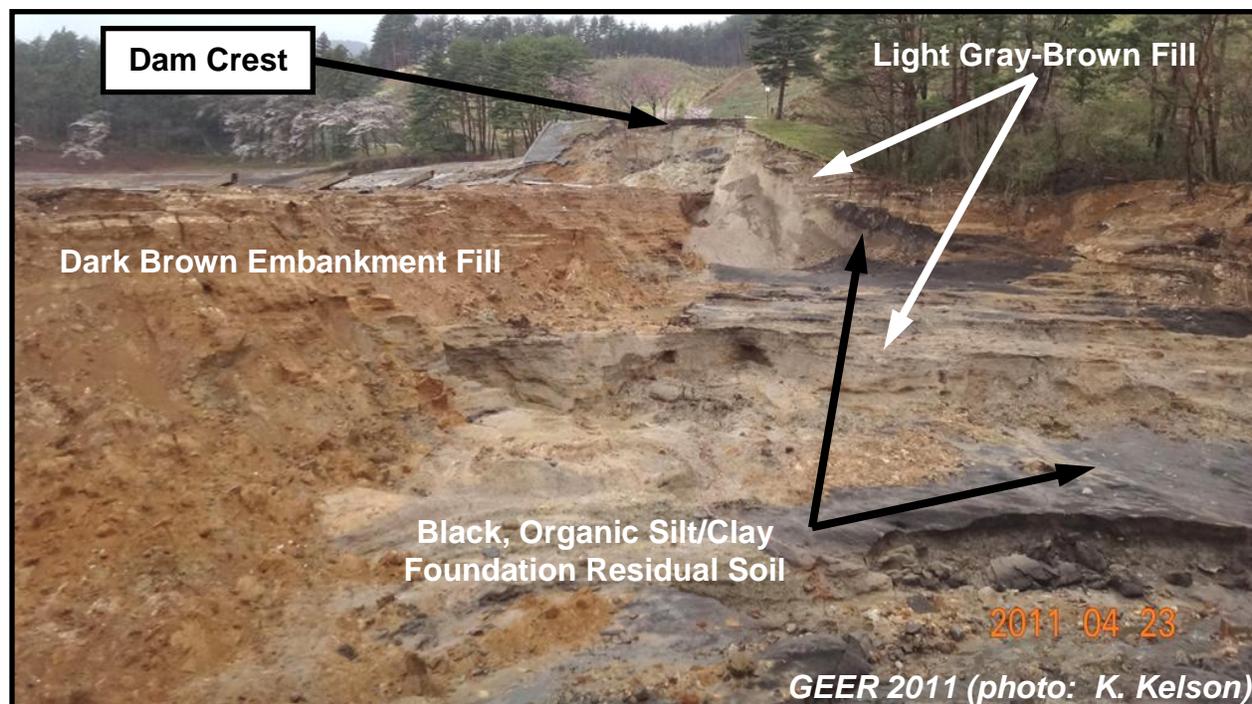
3. On top of and downstream of the dark brown fill appeared to be another embankment fill material with a lighter gray-brown color (see Figures 12 and 13).

Figure 12: View of Eroded Downstream Slope of Fujinuma Main Dam from Right Abutment –  
Note Uniform Top Surface of Dark Brown Embankment Fill Zone Below Dam Crest  
(N37.3020°, E140.1959°, April 23, 2011)

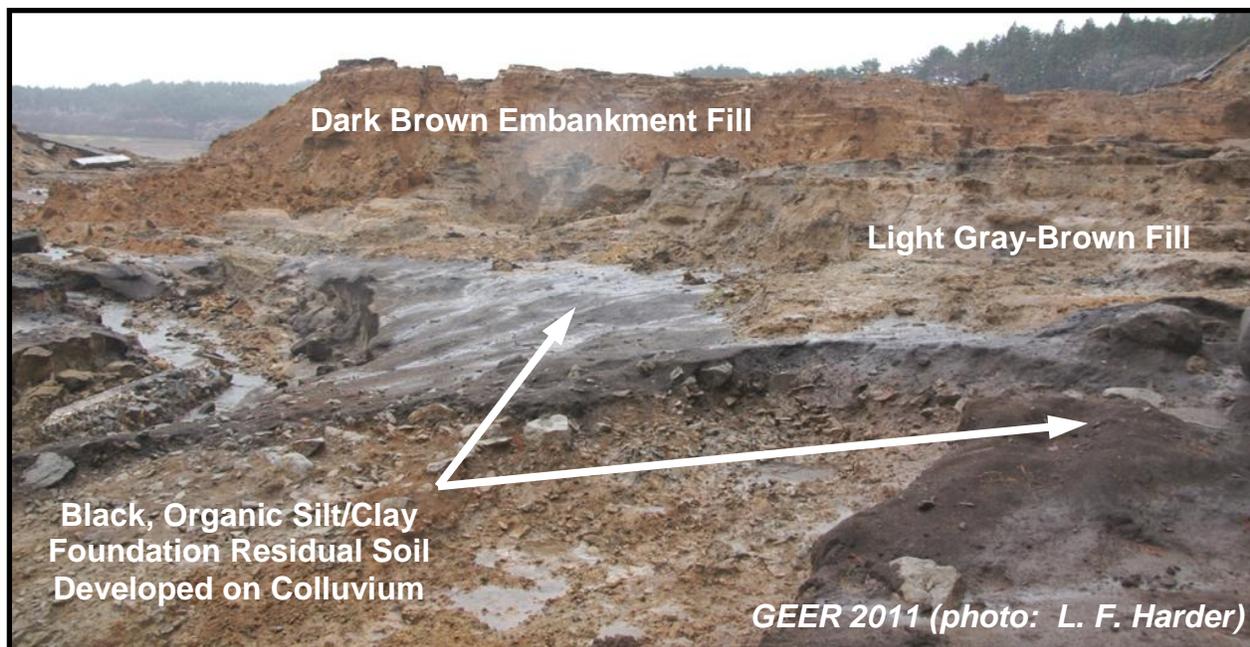
Figure 13: View of Eroded Downstream Slope of Fujinuma Main Dam from Downstream Toe – Note Uniform Top Surface of Dark Brown Embankment Fill Zone below Dam Crest and Lighter Gray-Brown Embankment Fill Overlying Black Organic Foundation Residual Soil (N37.3023°, E140.1955°, April 23, 2011)

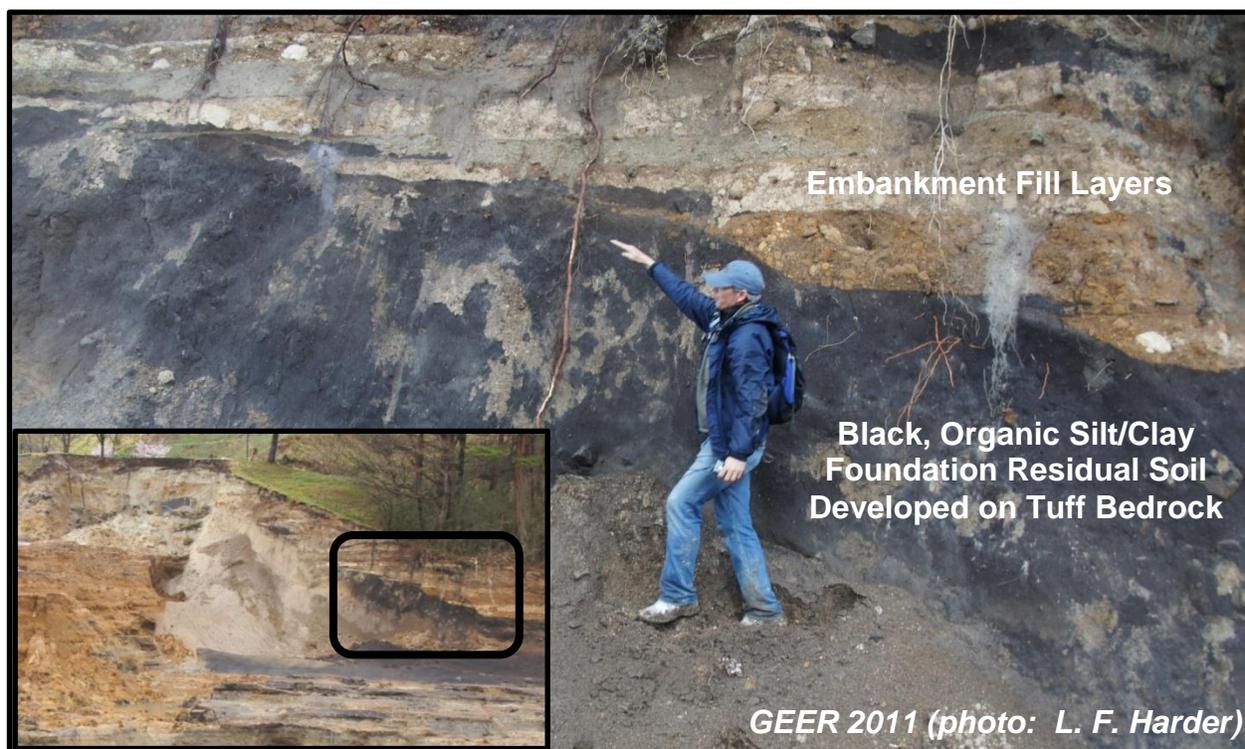
4. Embankment fill materials appeared to be generally cohesive and placed in lift thicknesses ranging between 20 and 45 centimeters (see Figures 14 and 19).

Figure 14: View of Fujinuma Dam Embankment Fill Layers On Top of Black Organic Foundation Residual Soil Exposed within Downstream Slope at Left Abutment (N37.3024°, E140.1951°, April 23, 2011)

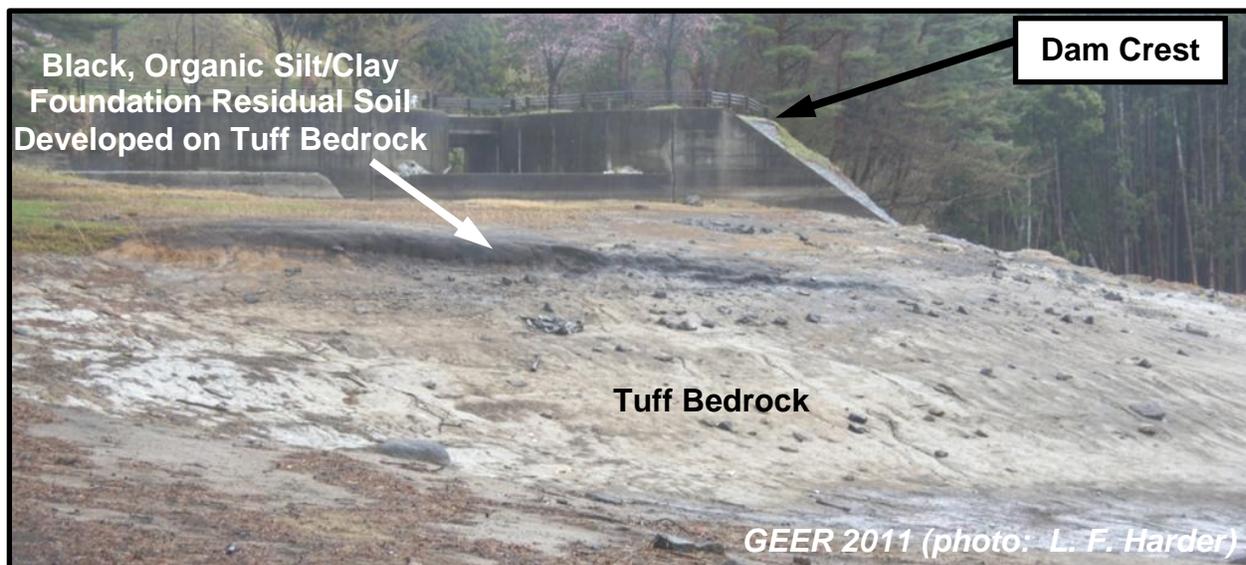
Figure 15: View of Black Organic Foundation Residual Soil and Underlying Tuff Bedrock Exposed Upstream of Concrete Spillway on Fujinuma Main Dam Left Abutment (N37.3022°, E140.1942°, April 23, 2011)

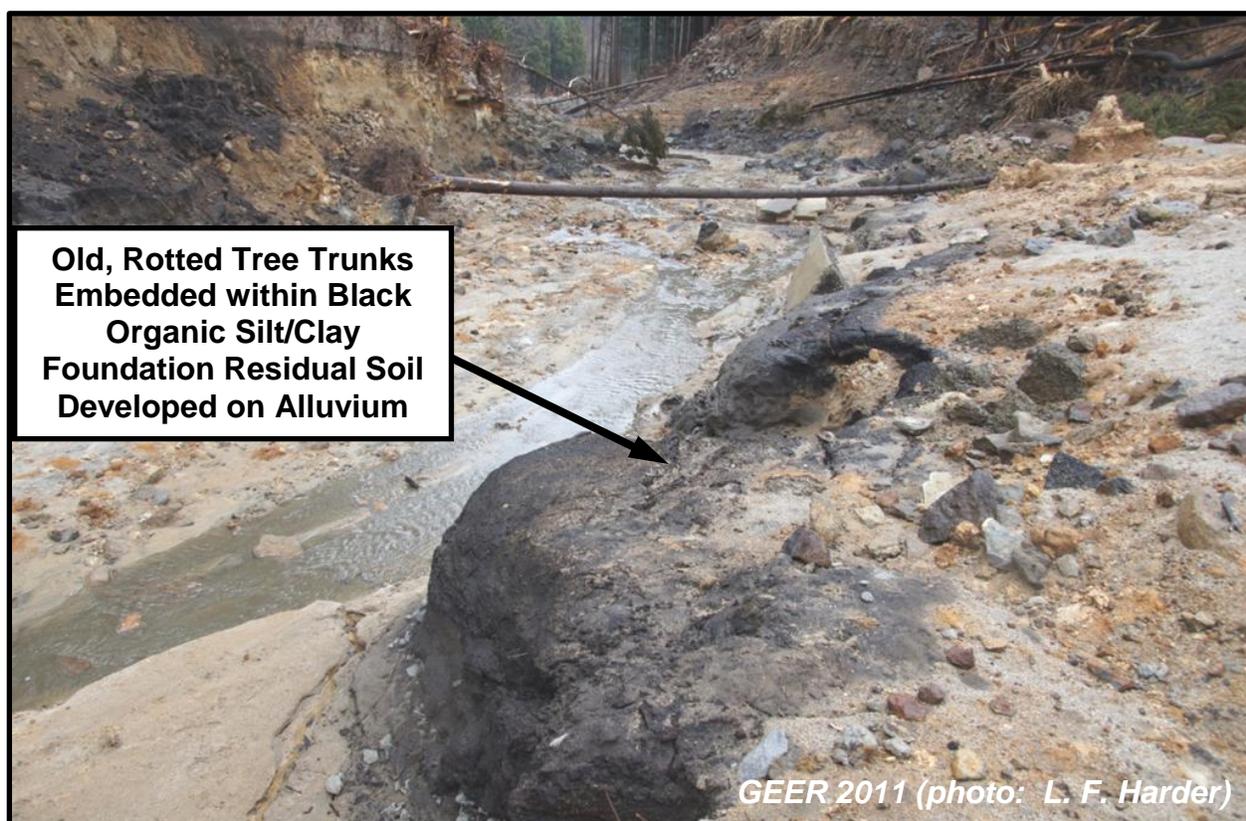
Figure 16: View of Black Organic Foundation Residual Soil Exposed in Eroded Channel Downstream of Breach in Fujinuma Main Dam (N37.3022°, E140.1959°, April 23, 2011)

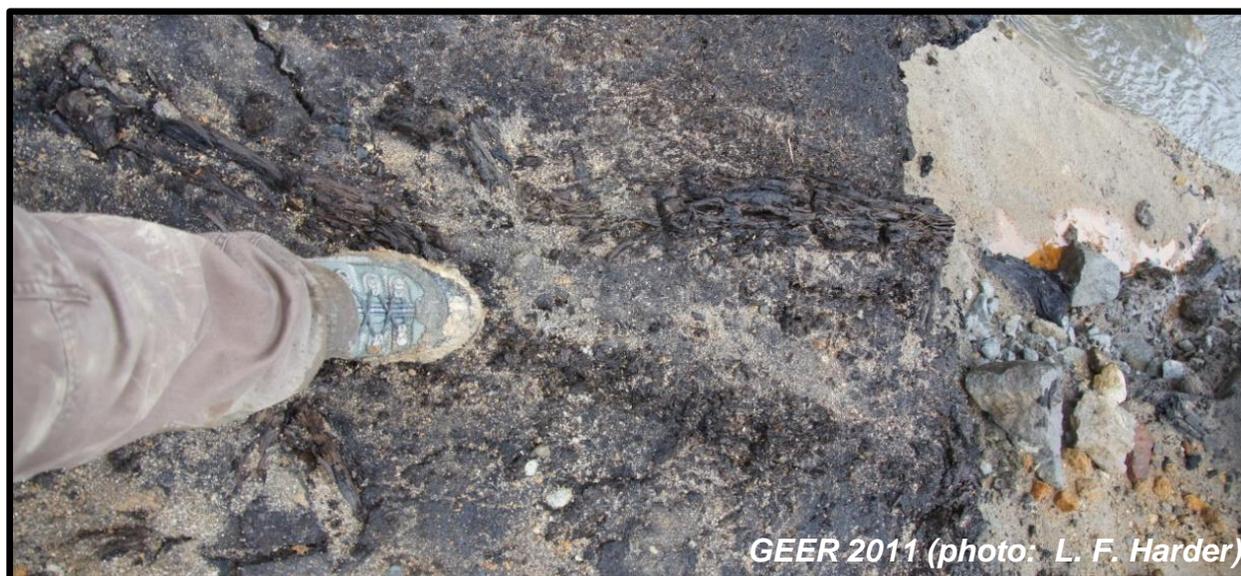
Figure 17: View of Old, Rotted Small Tree Trunks Embedded within Black Organic Foundation Residual Soil Exposed in Eroded Channel Downstream of Breach in Fujinuma Main Dam (N37.3022°, E140.1959°, April 23, 2011)

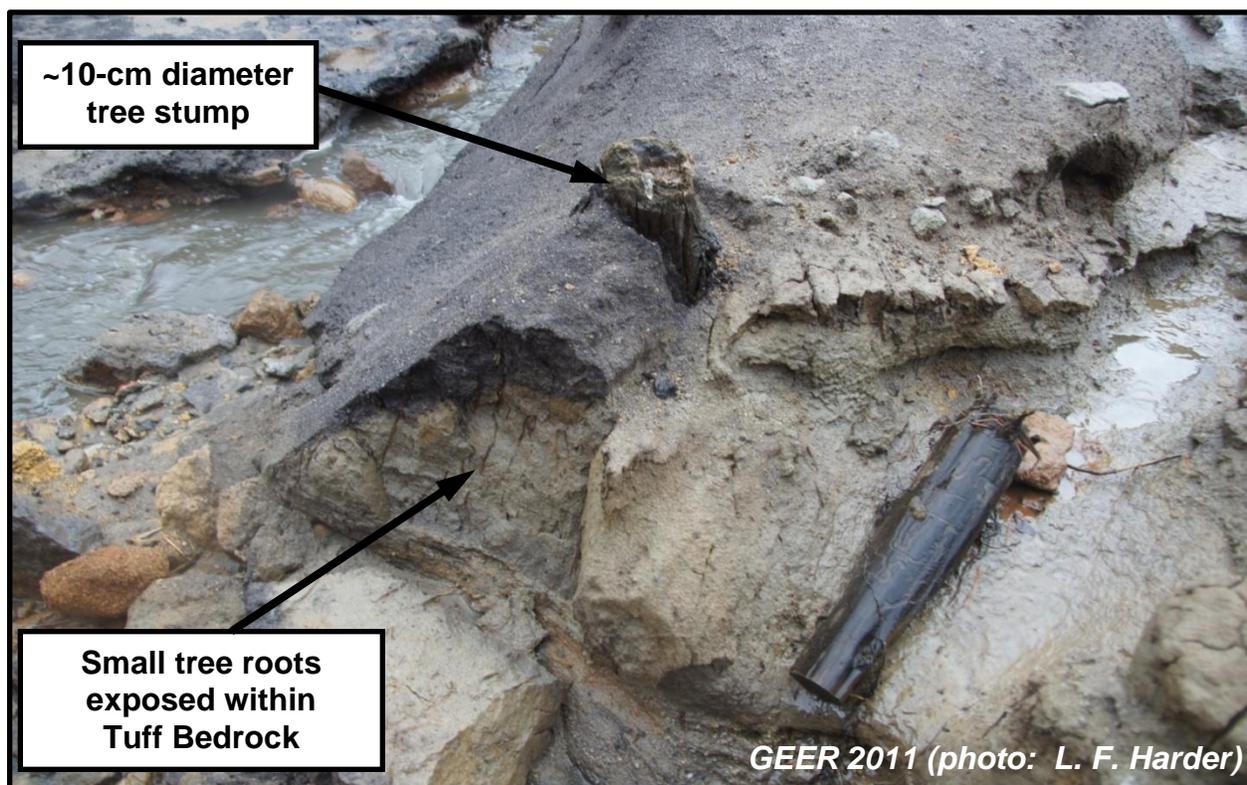
8. The presence of the residual soil developed on alluvium in areas formerly overlain by embankment fill indicates that dam construction did not include complete removal of unconsolidated foundation materials. There also appeared to have been an incomplete effort, or perhaps no effort, made at clearing and grubbing the foundation as a small, intact tree stump was found in the top of the black residual soil within the breach area. Small paleo-rootlets from this stump were present in the residual soil and underlying tuff bedrock (see Figure 18).

Figure 18: View of Small Tree Stump in Black Organic Foundation Residual Soil Overlying Tuff Bedrock within Breach in Fujinuma Main Dam (N37.3019°, E140.1954°, April 23, 2011)

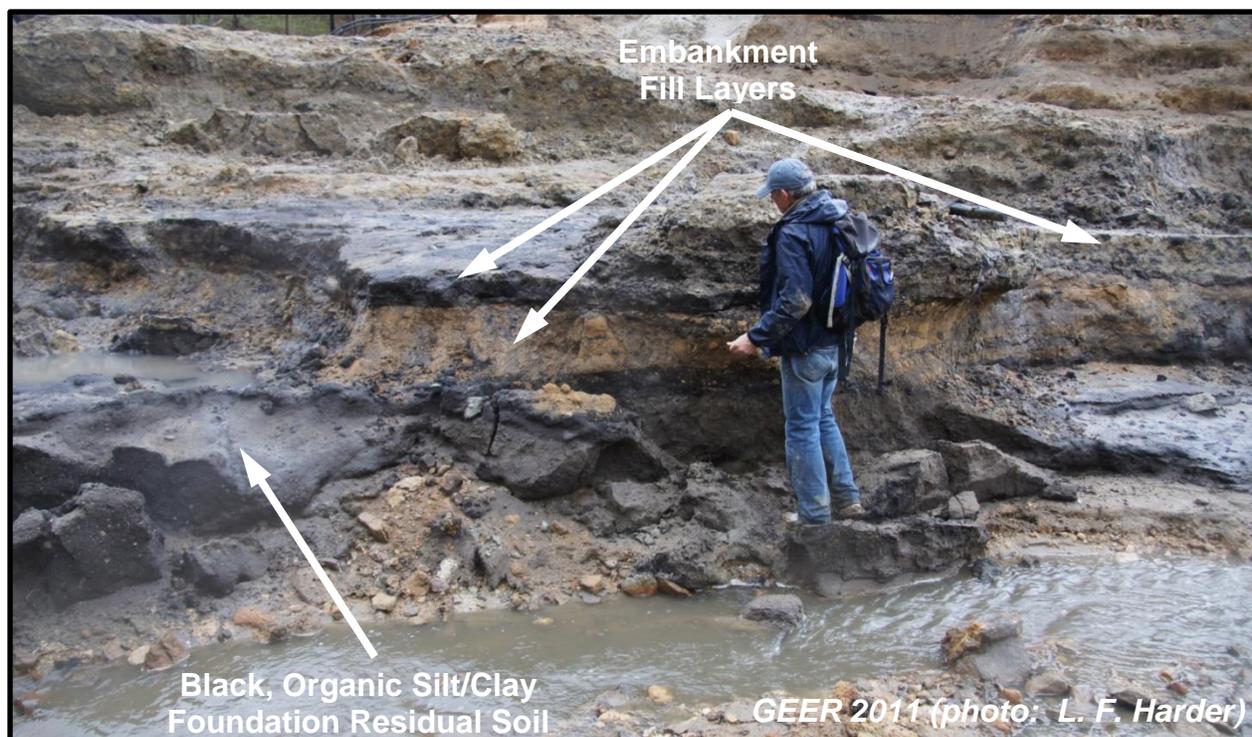
5. Beneath the embankment, fill material appears to have been placed directly on top of a black, organic silt/clay residual foundation soil. This organic residual soil appeared to have general thicknesses of approximately 1 to 2 meters across the dam footprint. Within the residual soil, small, decomposed tree trunks and branches were found. The black residual soil was observed throughout the damsite and in the reservoir basin. In some areas, it also appeared that this organic soil was used in the embankment fill as well (see Figure 19).

Figure 19: View of Embankment Layers Placed on top of Black Organic Foundation Residual Soil Exposed within Breach in Fujinuma Main Dam – Note Use of Black Residual Soil as Fill  
(N37.3019°, E140.1954°, April 23, 2011)

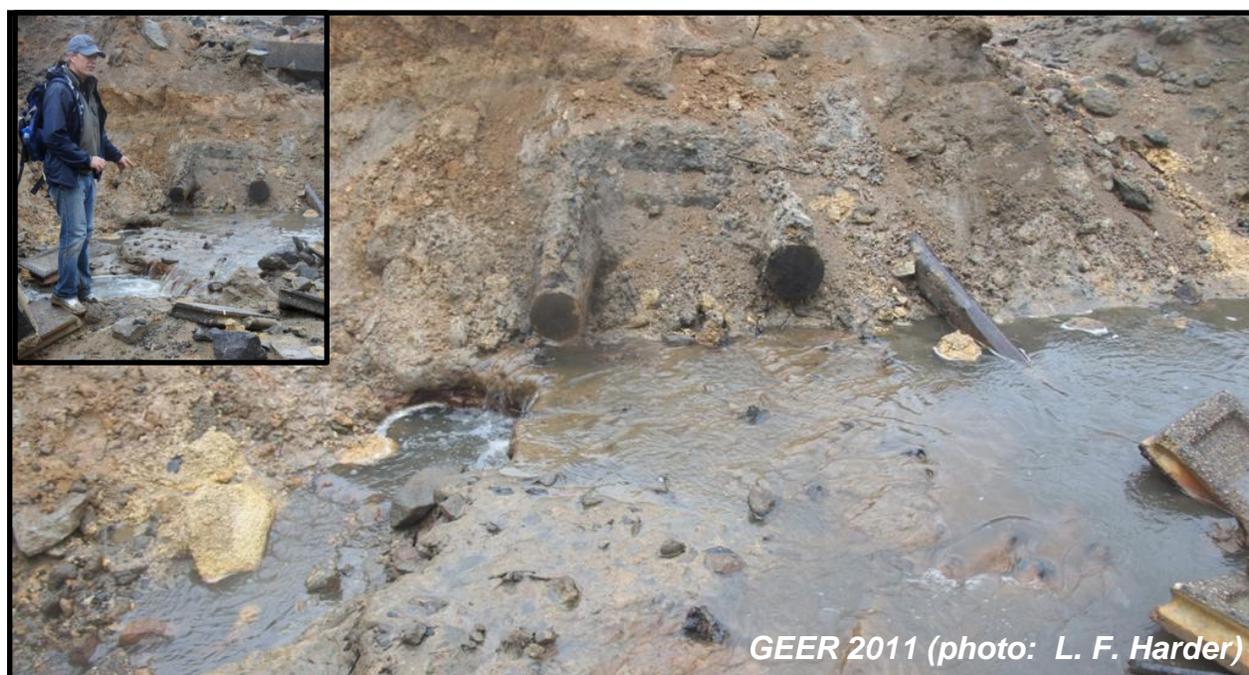
Figure 20: View of Timber Exposed in Embankment Debris Overlying Tuff Bedrock within Breach in Fujinuma Main Dam  
(N37.3019°, E140.1954°, April 23, 2011)

- Because of intermittent dam construction, it is possible that an area of the embankment fill or foundation was left open for drainage for several years. If such a drainage feature actually existed and was not properly removed and the adjacent fill adequately treated, this may have left a defect in the lower portion of the dam and a path for preferred seepage and piping (see old timber found within breach area in Figure 20).

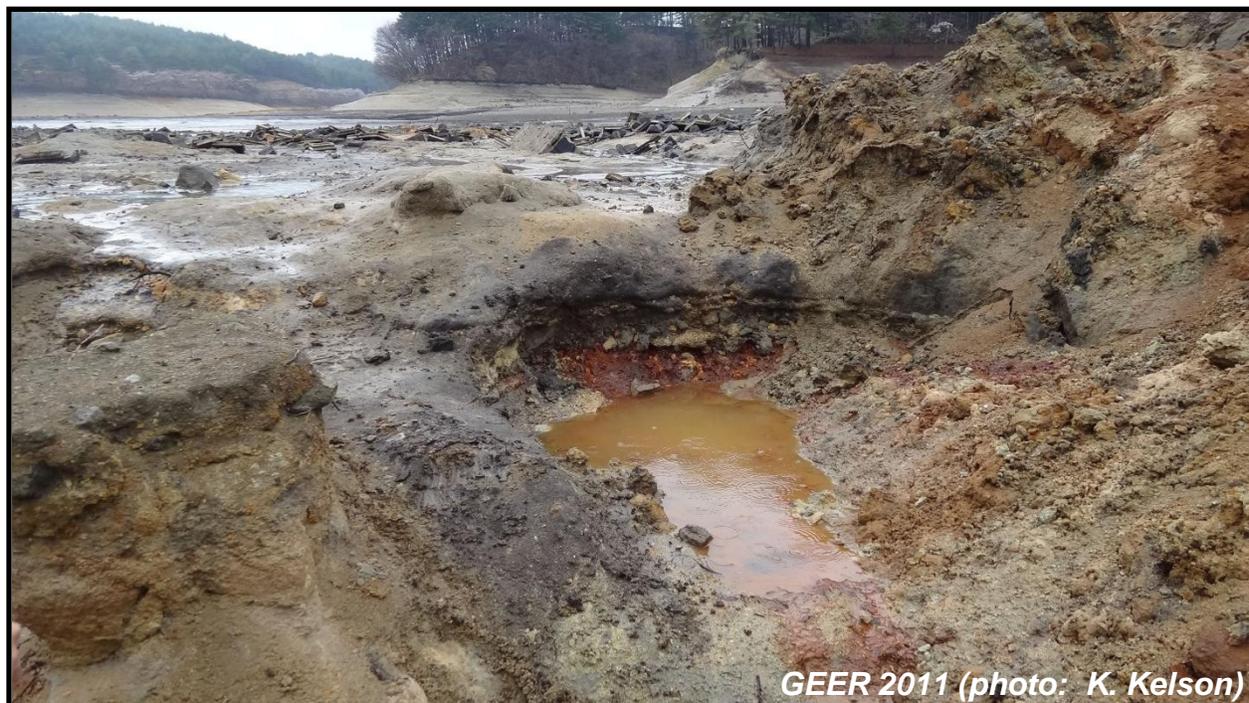
Figure 21: View of Spring within Tuff Bedrock Immediately Below Black Organic Foundation  
Residual Soil Exposed within Breach of Fujinuma Main Dam  
(N37.3017°, E140.1953°, April 23, 2011)

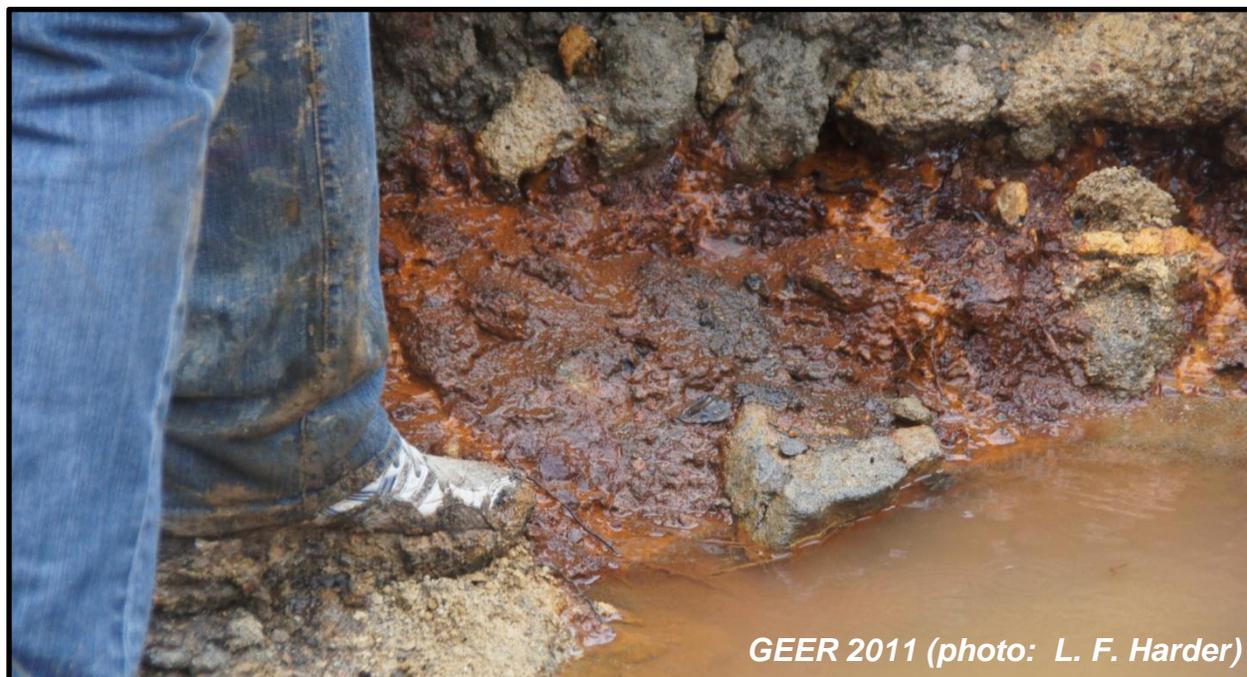
Figure 22: View of Spring within Tuff Bedrock Immediately Below Black Organic Foundation  
Residual Soil Exposed within Breach in Fujinuma Main Dam  
(N37.3017°, E140.1953°, April 23, 2011)

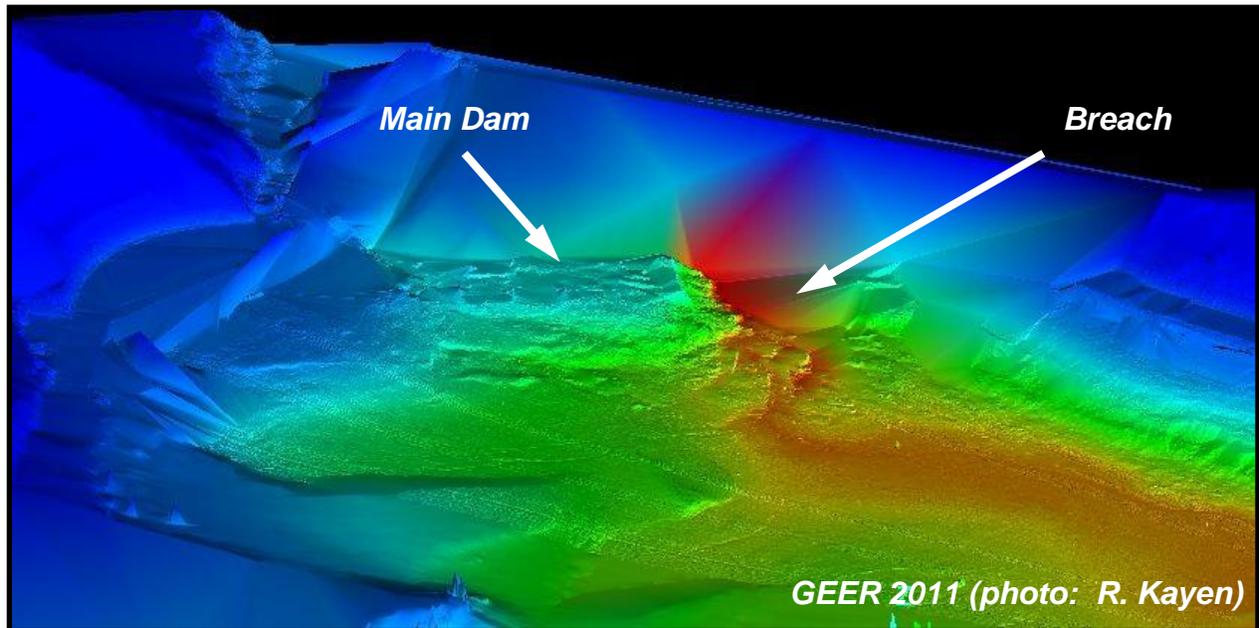
Figure 23 presents an image developed by a LiDAR scan of the main dam. The scan was taken from the reservoir area upstream of the dam and looking across the reservoir area at the breach. The image clearly shows the uniform top surface of the overtopped dark brown embankment remaining across the dam site to the left of the breach, together with details of the breach geometry. The LiDAR data can be used to develop detailed cross sections of the remaining dam and of the breach at various locations and directions.

Figure 23: LiDAR Image of Fujinuma Main Dam and Breach Surveyed from Reservoir Area Upstream of the Dam Site (April 2011)

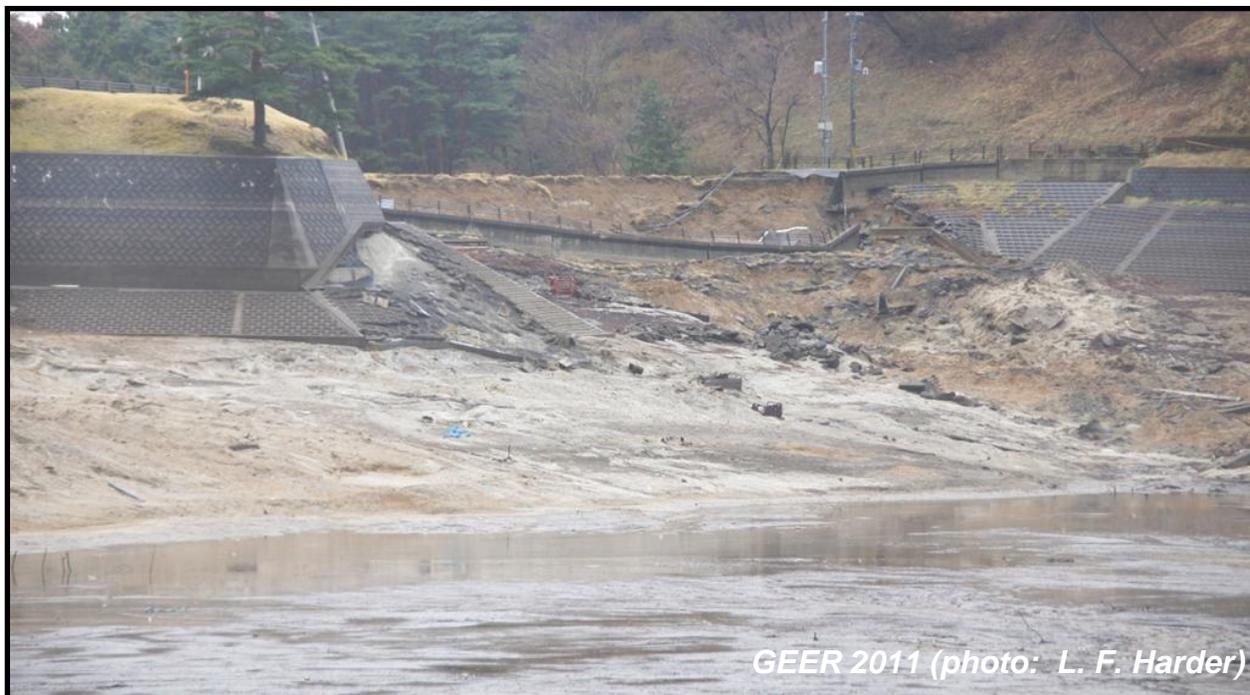
1. The auxiliary dam appeared to have been approximately 6 meters high and about 60 meters long prior to the earthquake.
2. There was a large upstream slide within the auxiliary dam which removed almost the entire upstream half of the embankment. The slide had the appearance of a flow slide (see Figures 24 through 28).
3. There was no obvious distress to the landside slope of the auxiliary dam (see Figure 27).

Figure 24: View of Upstream Slide in Fujinuma Auxiliary Dam from Empty Reservoir Area  
(N37.3011°, E140.1933°, April 23, 2011)

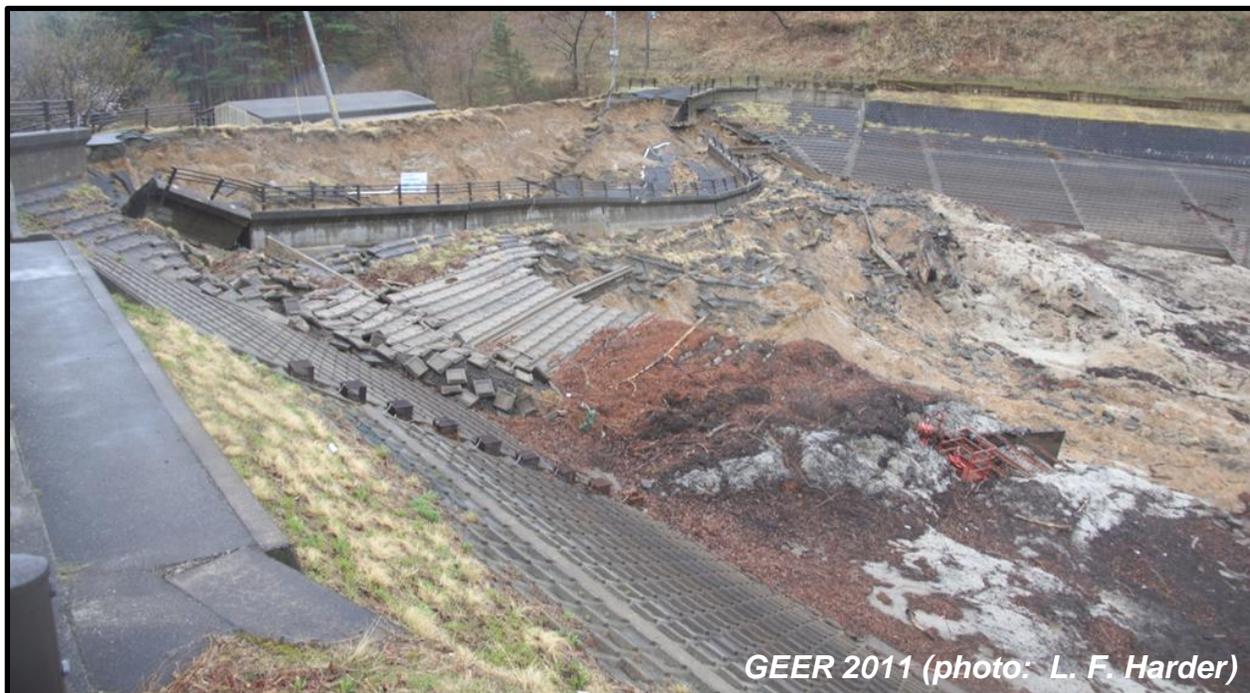
Figure 25: View of Upstream Slide in Fujinuma Auxiliary Dam  
from Location Upstream of Auxiliary Dam Left Abutment  
(N37.3011°, E140.1933°, April 23, 2011)

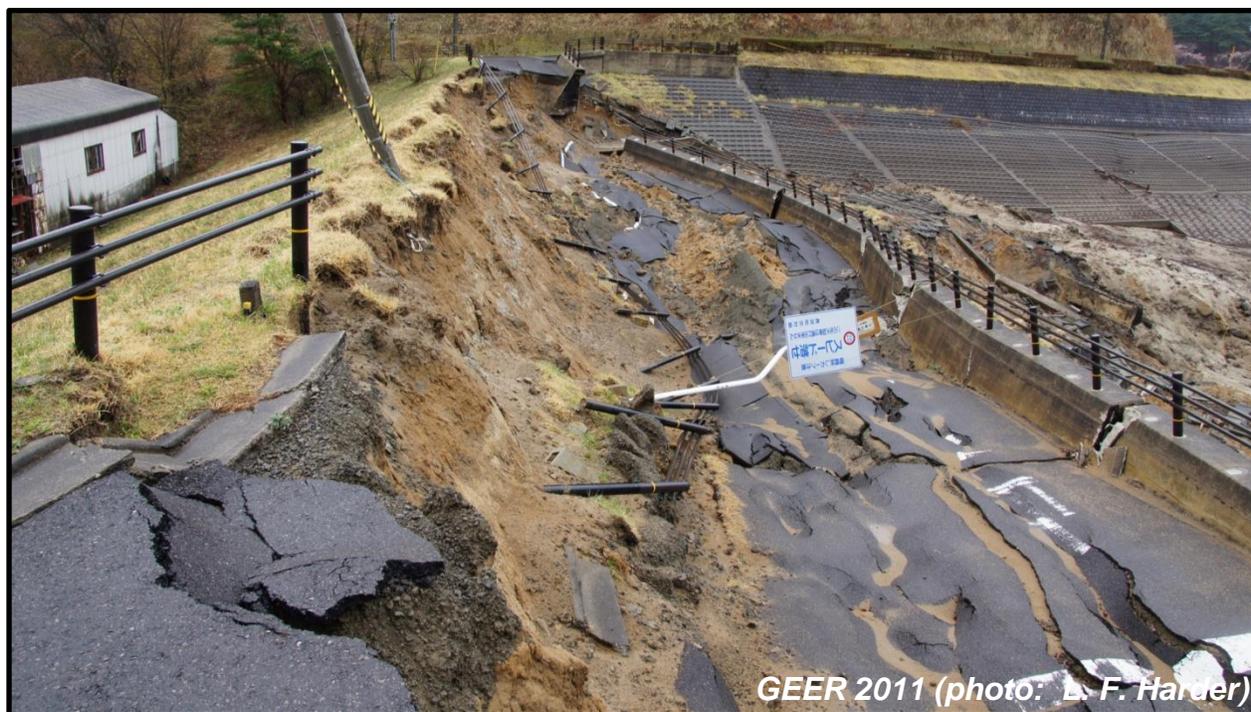
Figure 26: View of Upstream Slide in Fujinuma Auxiliary Dam from Left Abutment  
(N37.2995°, E140.1956°, April 23, 2011)

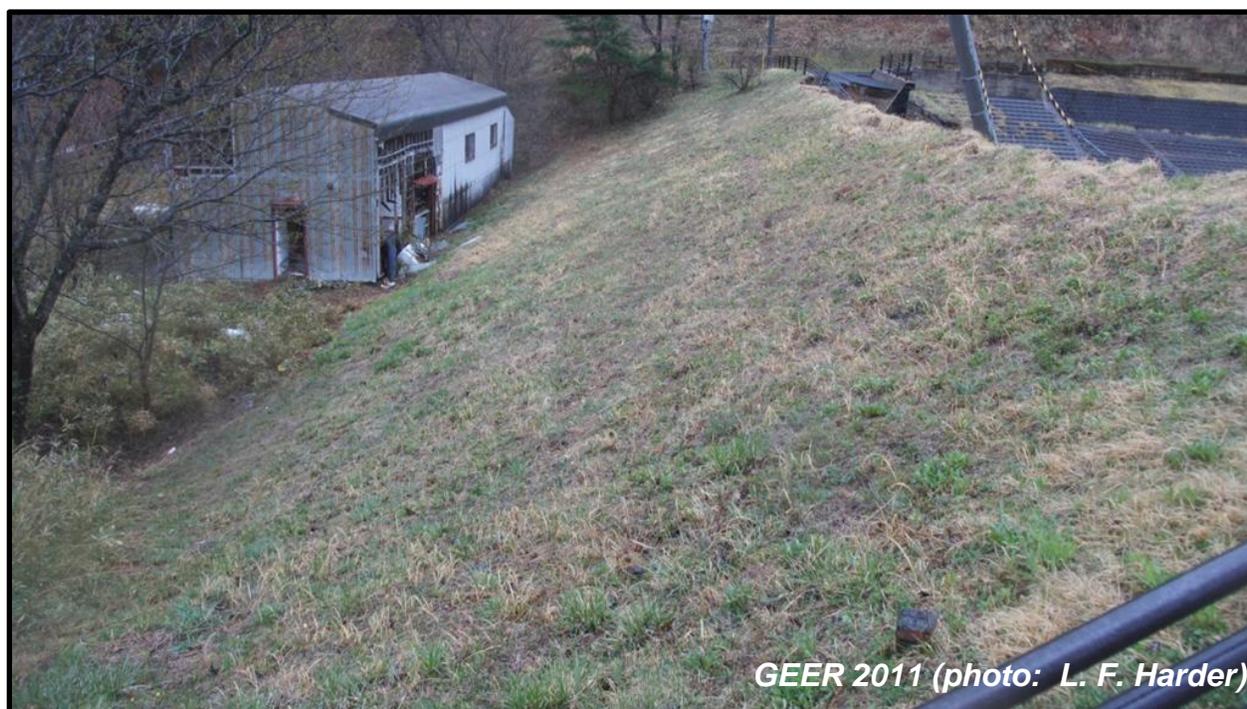
Figure 27: View of Downstream Slope of Fujinuma Auxiliary Dam from Left Abutment  
(N37.2995°, E140.1956°, April 23, 2011)
