Geotechnical Extreme Events Reconnaissance (GEER)

## **Preliminary Observations of the Fujinuma Dam Failure Following the March 11, 2011 Tohoku Offshore Earthquake, Japan**

June 6, 2011

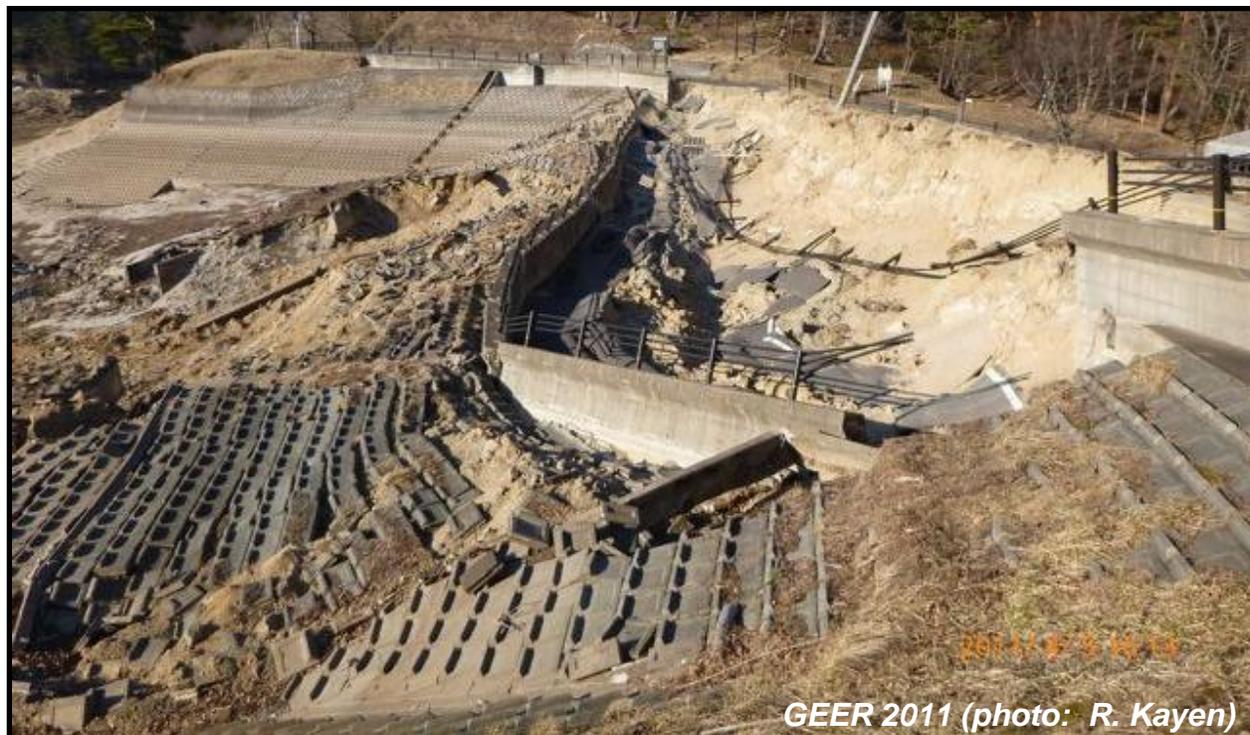
Figure 28: View of Upstream Slide in Fujinuma Auxiliary Dam  
from Auxiliary Dam Right Abutment  
(N37.2990°, E140.1952°, April 5, 2011)

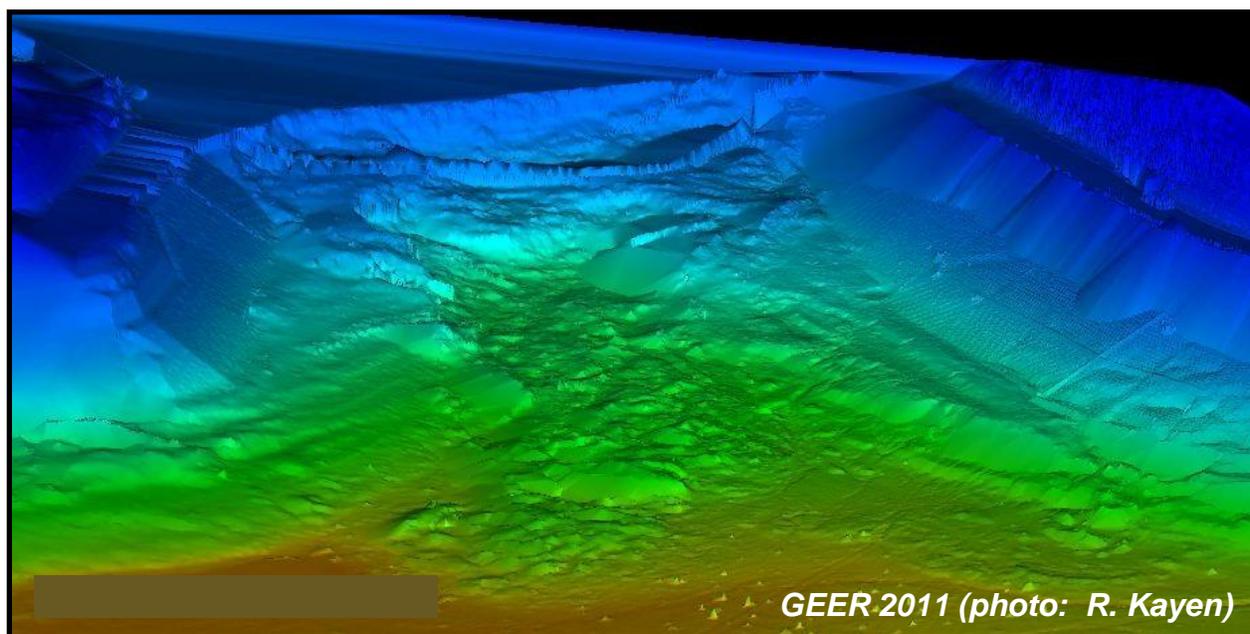
Figure 29 presents an image developed by a LiDAR scan of the upstream slide in the auxiliary dam. The scan was taken from the reservoir area across from the auxiliary dam and looking downstream at the surface of the upstream slide. As with the images of the main dam, the LiDAR data can be used to develop detailed cross sections of the auxiliary dam and slide.

Figure 29: LiDAR Image of Upstream Slide in Fujinuma Auxiliary Dam Surveyed  
from Reservoir Area Across from Auxiliary Dam (April 2011)

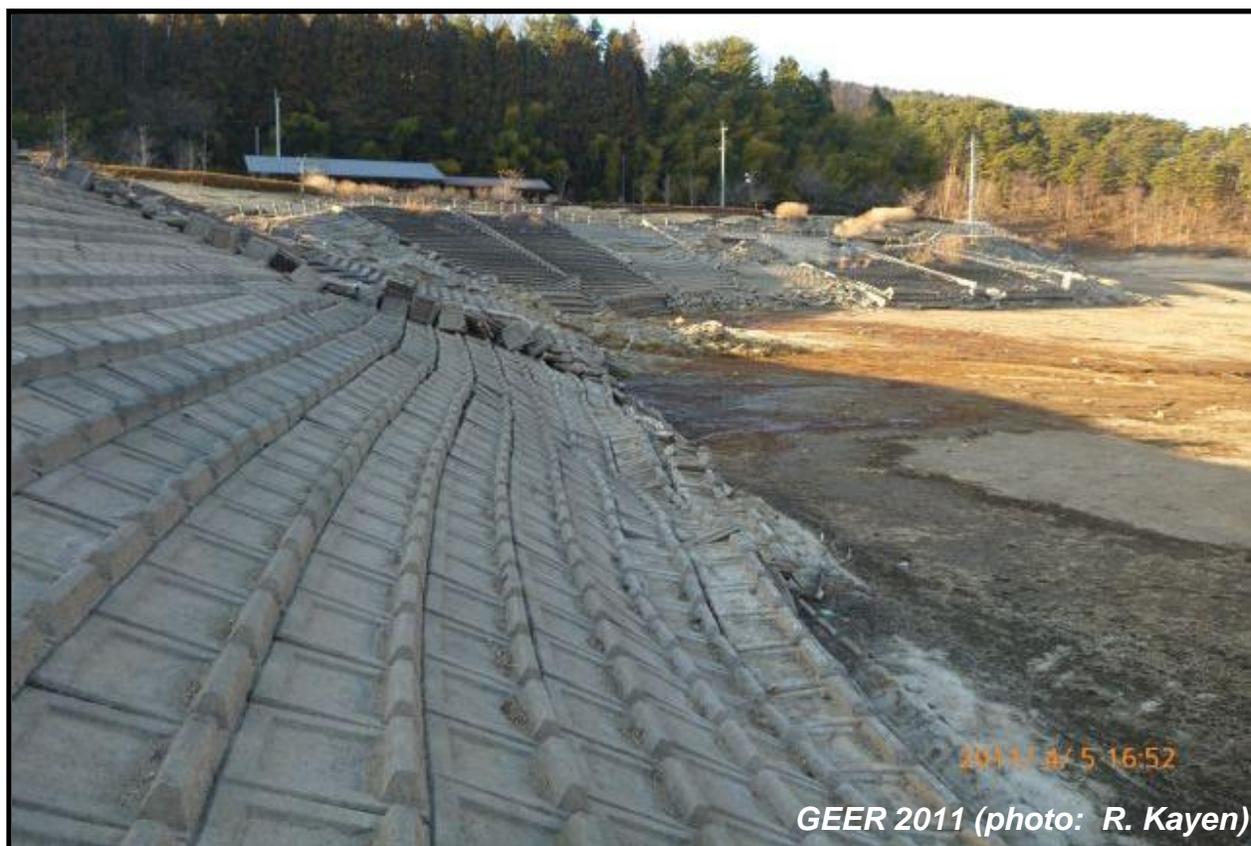
There were areas along the reservoir rim where minor to moderate slope distress, together with intermittent slope failures occurred. Some of these areas were covered with concrete revetments such as the areas near the auxiliary dam and across the reservoir from the auxiliary dam. However, other areas had just bare soil or rock exposed. The slope distress in these areas appeared to have generally occurred within the natural soils and rock around the reservoir rim. However, in some cases, the slope distress also involved manmade fill that had been placed over natural soils. Figures 30 and 31 present photographs of two of the revetted slopes along the reservoir rim that experienced distress. As with the upstream slide in the auxiliary dam, it couldn't be determined whether it was earthquake shaking or the rapid reservoir drawdown that caused the slope distress and sliding along the reservoir rim. Figure 32 presents an image developed by a LiDAR scan of one of the slides in the reservoir rim.

Figure 30: View of Slope Distress in Revetted Reservoir Rim Slope  
Across from Fujinuma Auxiliary Dam  
(April 5, 2011)

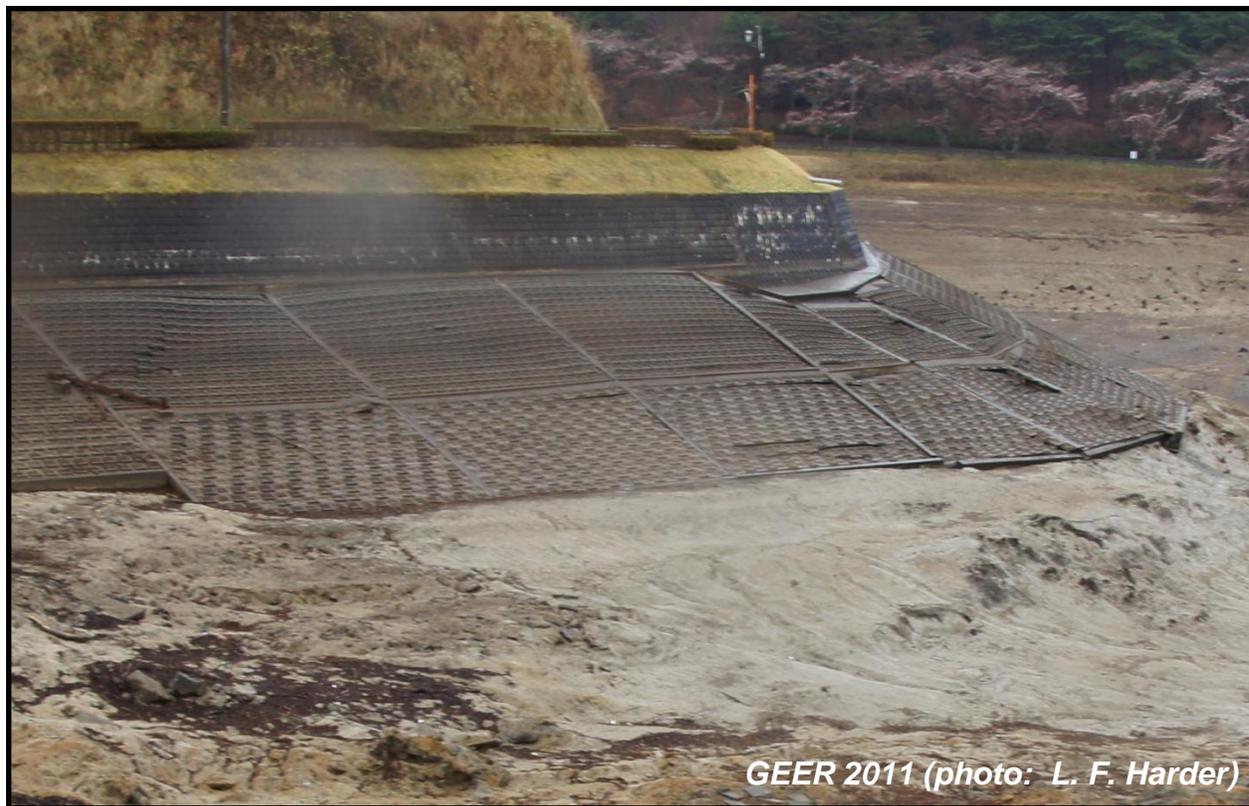
Figure 31: View of Slope Distress in Revetted Reservoir Rim Slope Upstream of Fujinuma Auxiliary Dam Right Abutment (N37.2990°, E140.1945°, April 23, 2011)

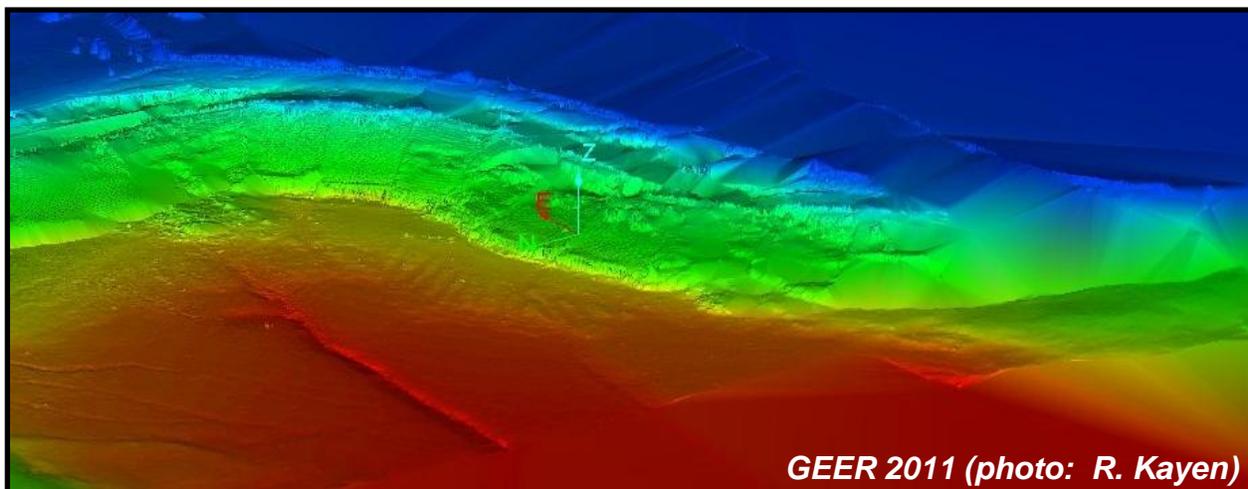
Figure 32: LiDAR Image of Slope Distress in Revetted Reservoir Rim Slope Across from Fujinuma Auxiliary Dam (April 2011)

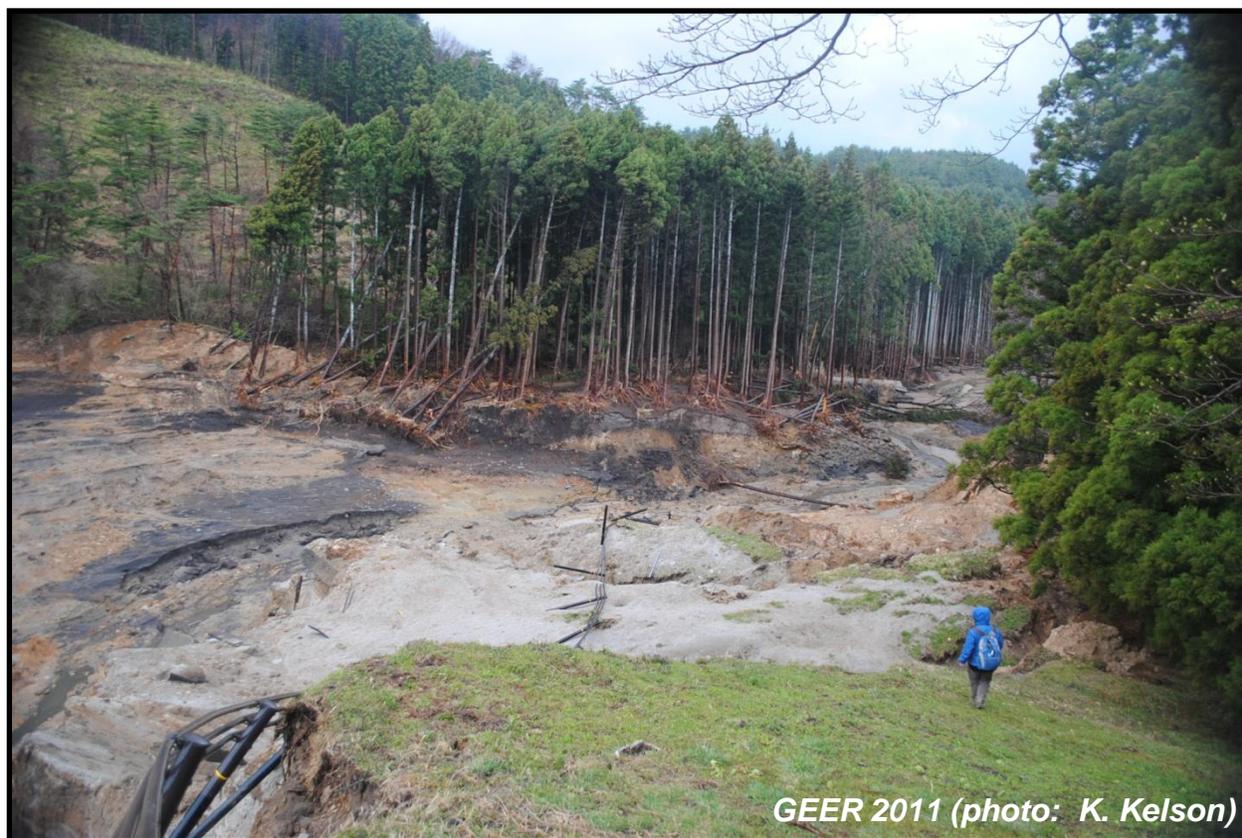
Directly below the breach in the main dam, the small natural drainage had been catastrophically eroded and there was significant debris present (see Figures 33 and 34). Flood flows resulting from the breach traveled downstream in a northeasterly direction within this small drainage channel for almost a kilometer until they met a river channel and then turned 90 degrees to the southeast along the river channel (see Figures 4 and 35). Portions of the channel had been lined with concrete revetments. The breach flows exceeded the capacity of the revetted river channel and resulted in damage to farmland, homes, buildings, a bridge, and to the channel revetments themselves (see Figures 36 and 37). Eight people lost their lives due to these breach flows that resulted when the Fujinuma Main Dam failed.

Figure 33: View of Breach Flow Path within Natural Drainage Channel  
Below Breach in Fujinuma Main Dam  
(N37.3025°, E140.1961°, April 23, 2011)

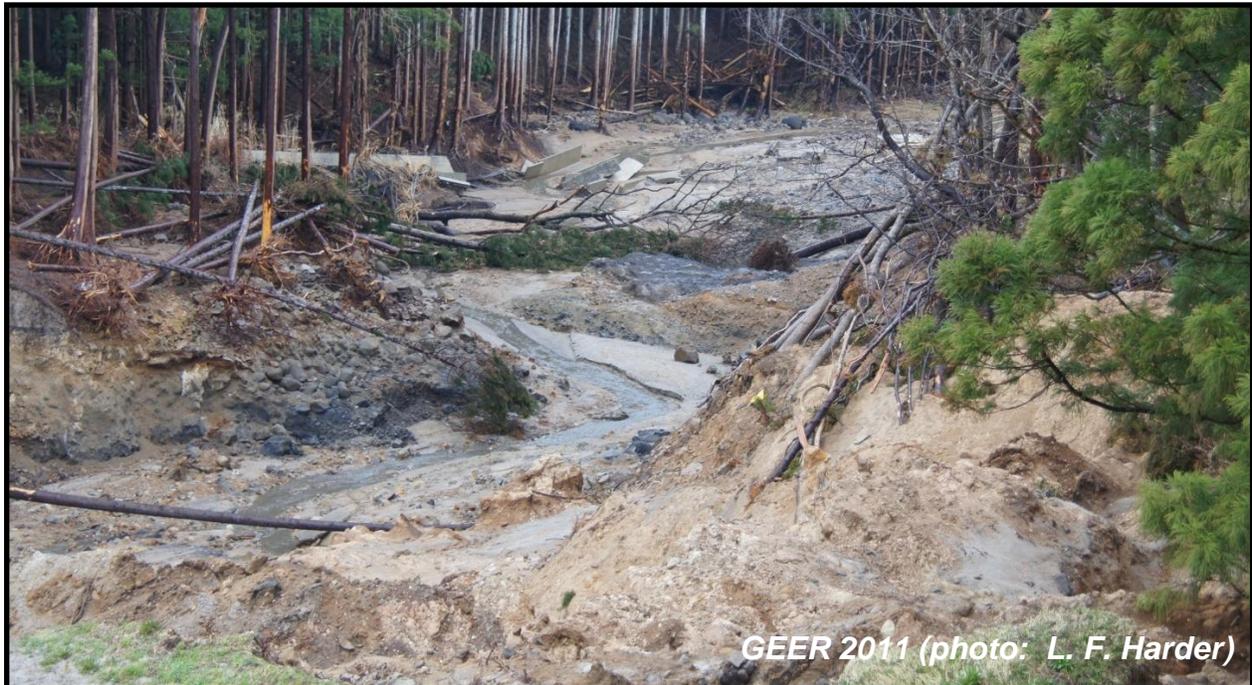
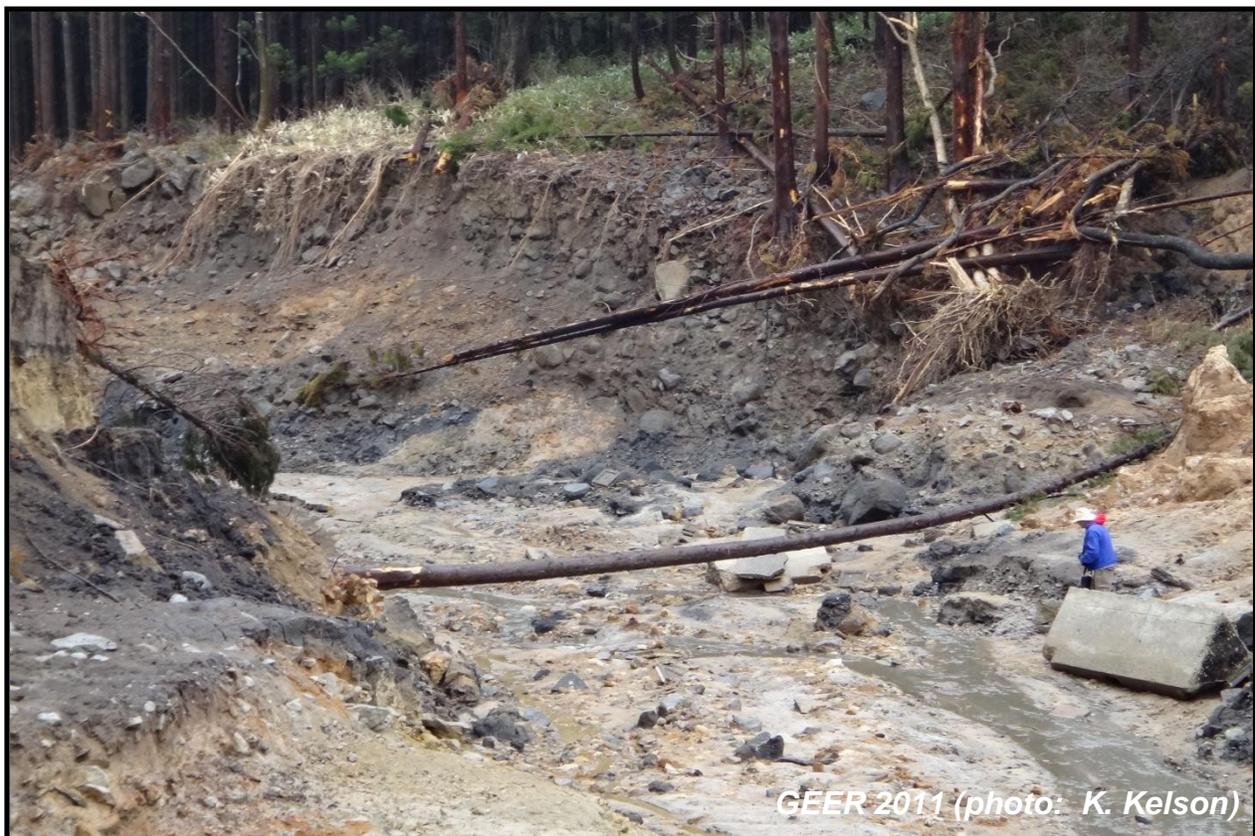
Figure 34: Views of Downstream Erosion within Natural Drainage Channel  
Below Breach in Fujinuma Main Dam  
(N37.3025°, E140.1961°, April 23, 2011)

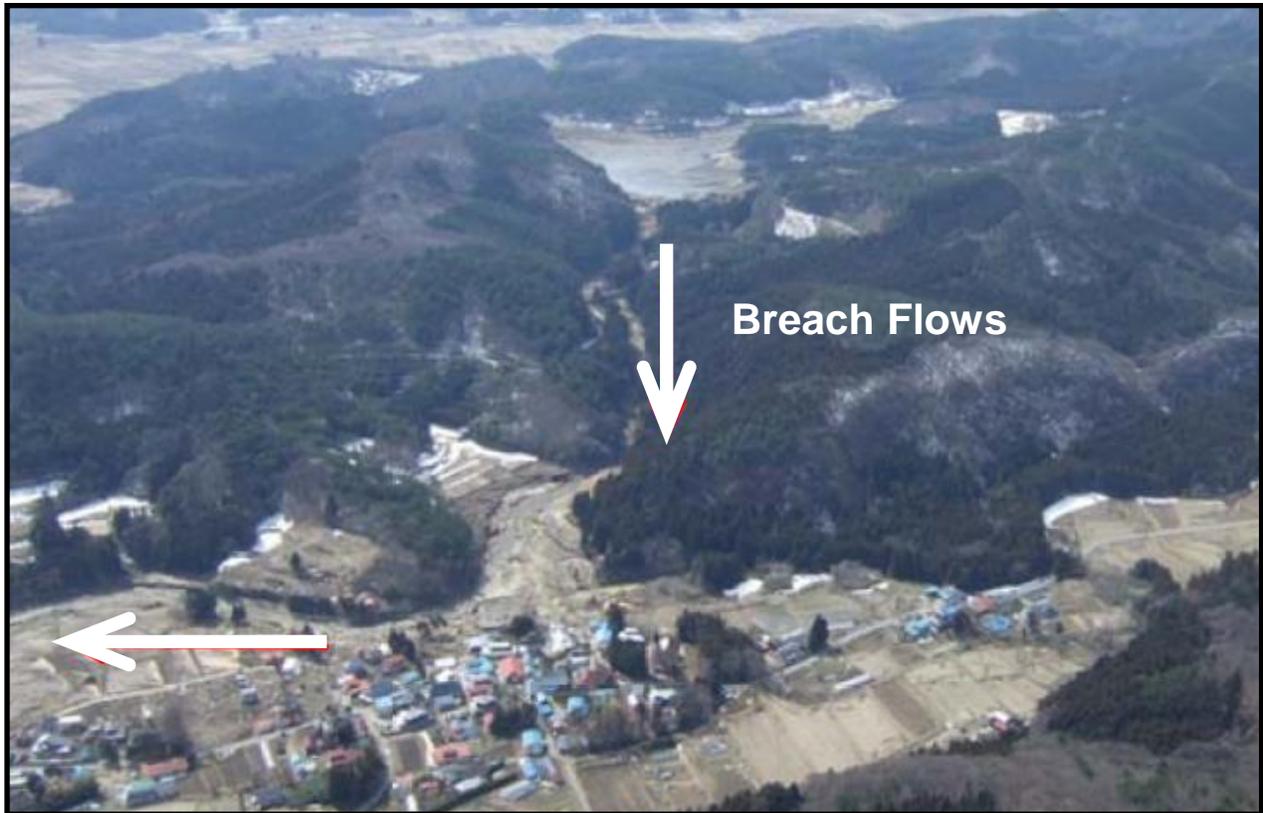
Figure 35: Aerial View of Breach Flow Path below Fujinuma Main Dam towards Naganuma (adapted from Japanese National Institute for Land and Infrastructure Management, 2011)

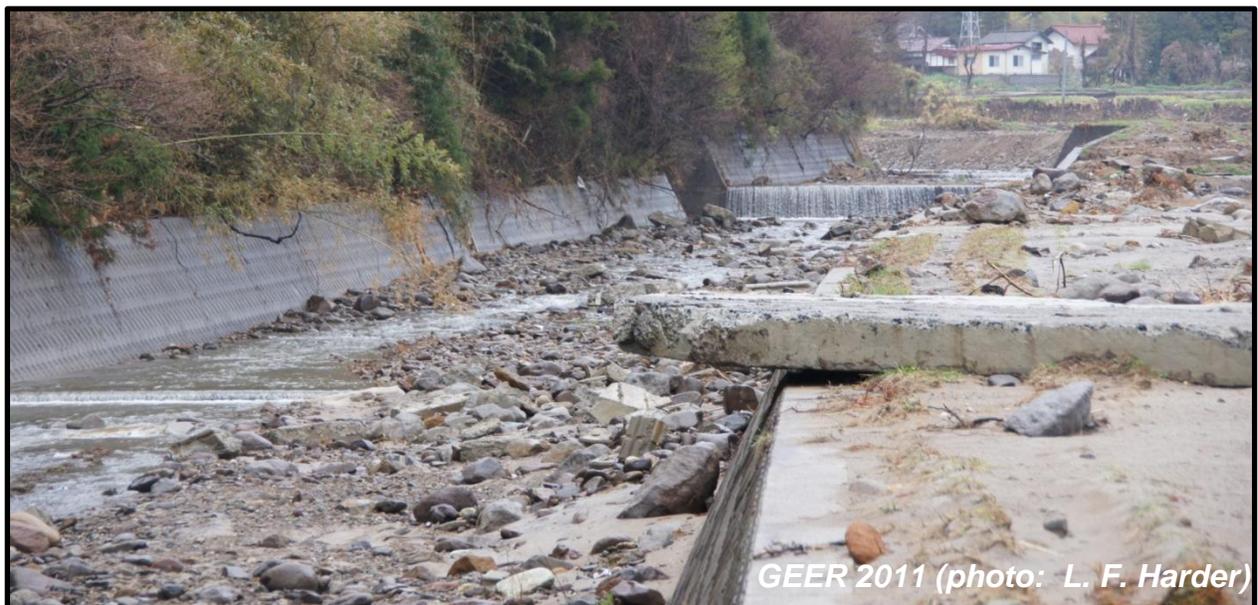
Figure 36: Views of Erosion and Damage within River Channel in Naganuma Below Breach in Fujinuma Main Dam (N37.3062°, E140.2064°, April 23, 2011)

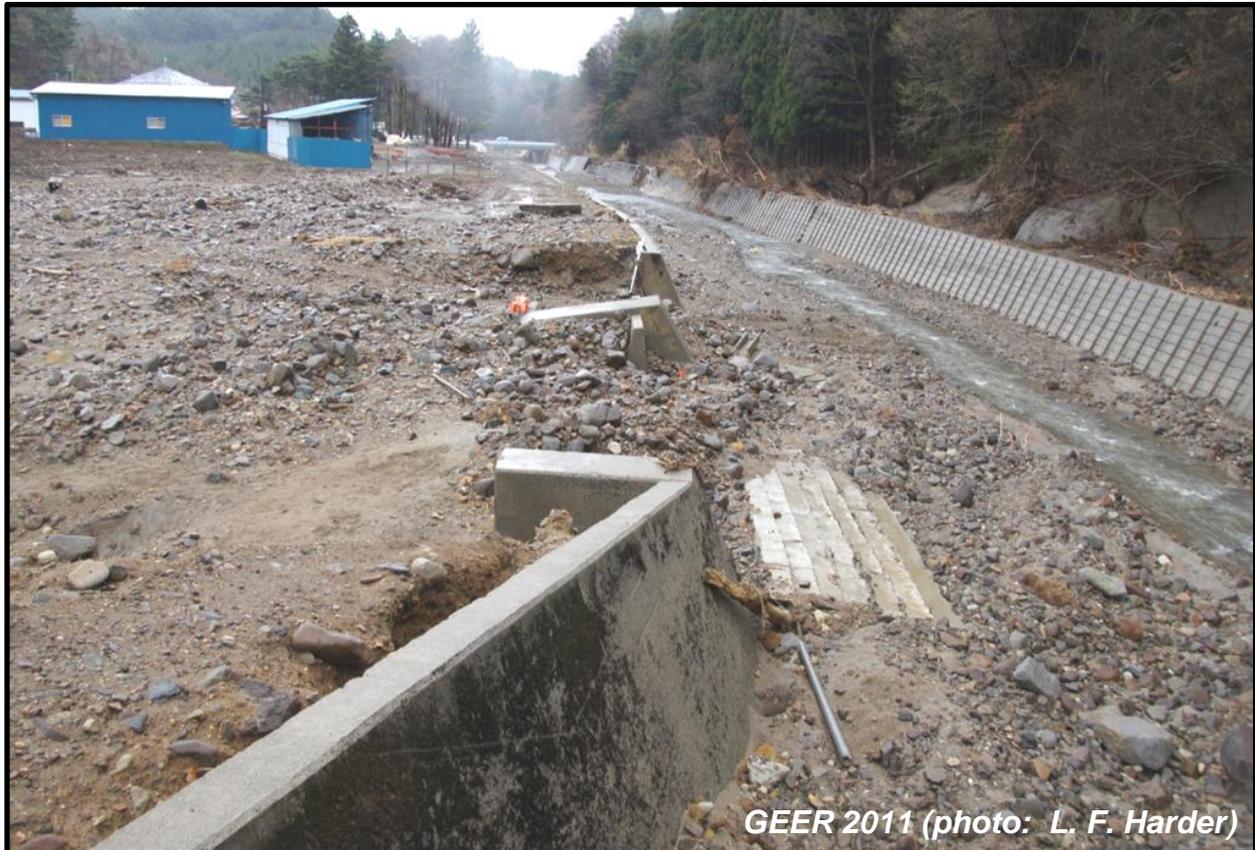
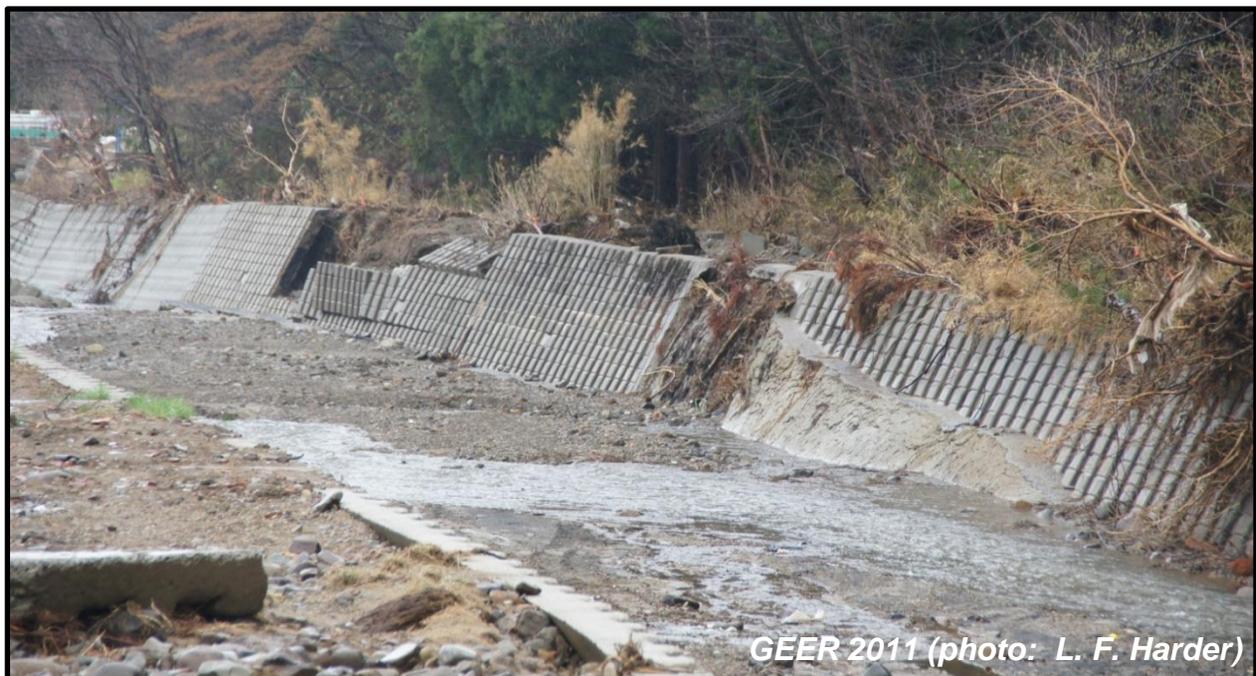
Figure 37: Views Looking Downstream of Debris, Erosion, and Damage within River Channel in Naganuma below Breach in Fujinuma Main Dam (N37.3044°, E140.2076°, April 23, 2011)
