## The 50-Year Anniversary of the Kingsley Dam Wave Erosion Incident

Tim Gokie, P.E., Chief Engineer, Dam Safety Section,  
Nebraska Department of Natural Resources; and  
Michael A. Drain, P.E., Natural Resources and Compliance Manager,  
The Central Nebraska Public Power and Irrigation District

**Abstract--** On May 1st and May 2nd, 1972, a 30-hour windstorm battered and eroded the upstream face of the Kingsley Dam in western Nebraska. The erosion removed a significant amount of the upstream shell and led to the collapse of more than 400 feet (120 m) of the parapet wall running along the crest of the dam. The downstream town of Keystone was evacuated, and crews were summoned to lower the reservoir and begin emergency repairs. The failure of Kingsley Dam would have been the largest dam failure in U.S history, releasing 1.8 million acre-feet (2.2 km<sup>3</sup>) of water. The winds eventually subsided, and thankfully, the dam did not fail. Repairs were made and investigations were conducted. The incident was soon overshadowed by the failure of Canyon Lake Dam in South Dakota one month later. Fifty years after the incident, it is important to revisit the lessons that were learned,

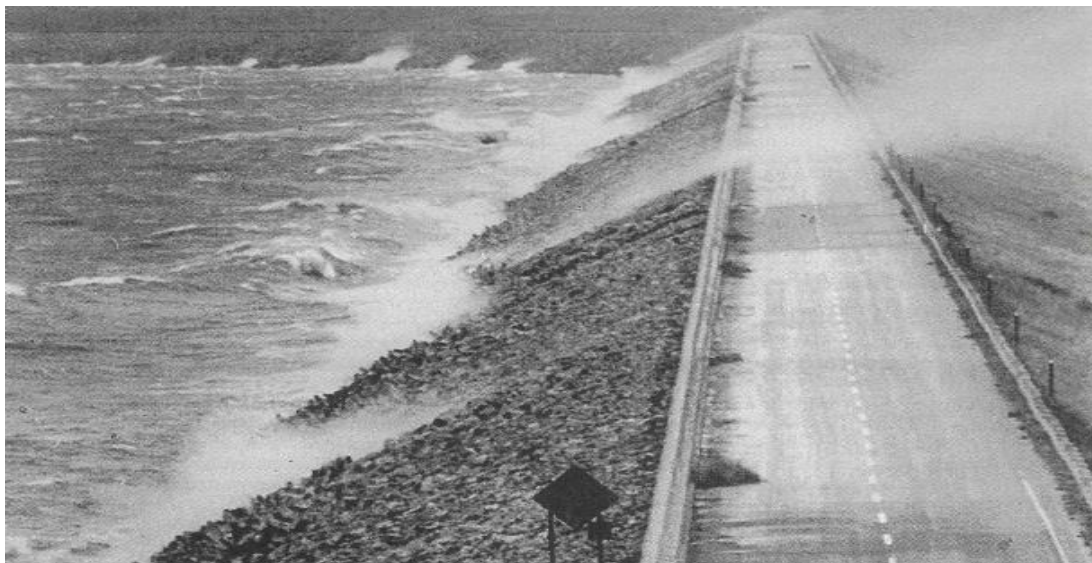
Starting just after midnight, winds picked up across the lake, and by about five o'clock in the morning of May 1, there were sustained winds of 30 mph (50 km/hr) blowing from the west down the 22-mile (35 km) fetch of the reservoir. The winds remained at 30 mph (50 km/hr) through the rest of the morning, and then around noon the sustained winds increased to 40 mph (60 km/hr), with gusts to 65 mph (100 km/hr), creating waves up to 8 feet (2.4 m) high [2] [4]. While Lake McConaughy and Kingsley Dam had experienced winds of similar or higher magnitude in the past, this storm was unique due to the simultaneous combination of the wind direction, the sustained duration, and the relatively high reservoir level.

Figure 2. Wind-Driven Waves at Kingsley Dam, May 1, 1972 [7].

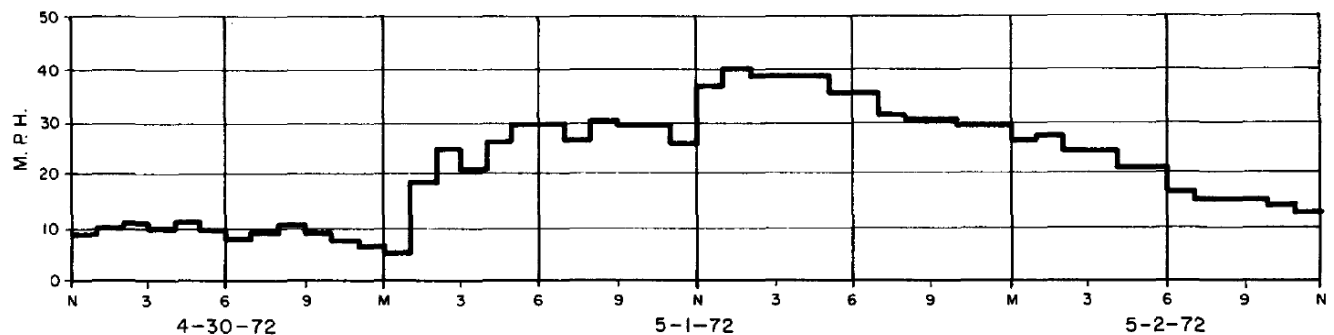
Figure 3. Hourly Wind Velocities at Kingsley Dam during the 1972 Windstorm [4].

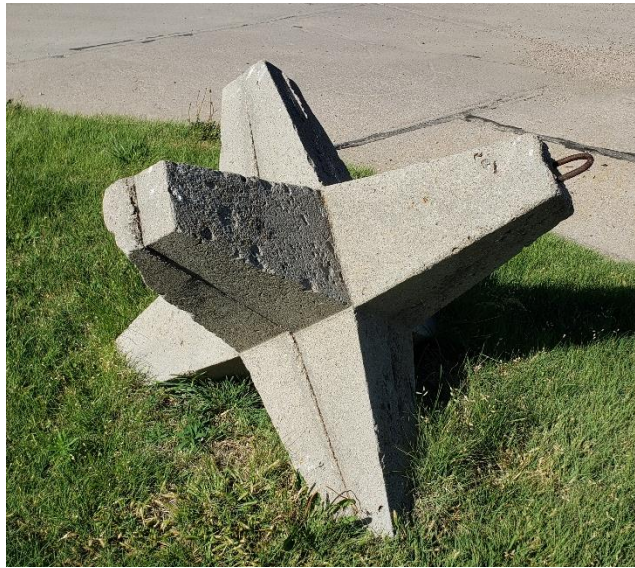
Figure 4. A Hexapod like the Kind Used for Emergency Repairs at Kingsley Dam During the 1972 Windstorm [photograph by author Michael Drain].

- Smaller events continued to damage the dam through the 1950s, so in 1959, a new slope protection method was introduced. The new protection consisted of 800-pound (360 kg), precast concrete “hexapods” (also referred, mistakenly, as “tetrahedrons”, or simply “jacks”) tied together with steel cables. Between 1959 and 1963, 41,000 hexapods were placed on the dam. Nevertheless, a strong, 62-hour-long windstorm in April of 1964 caused severe damage along the entire length of the embankment. It is believed that subsequent repairs between 1964 and 1972 were made with more hexapods. [4]

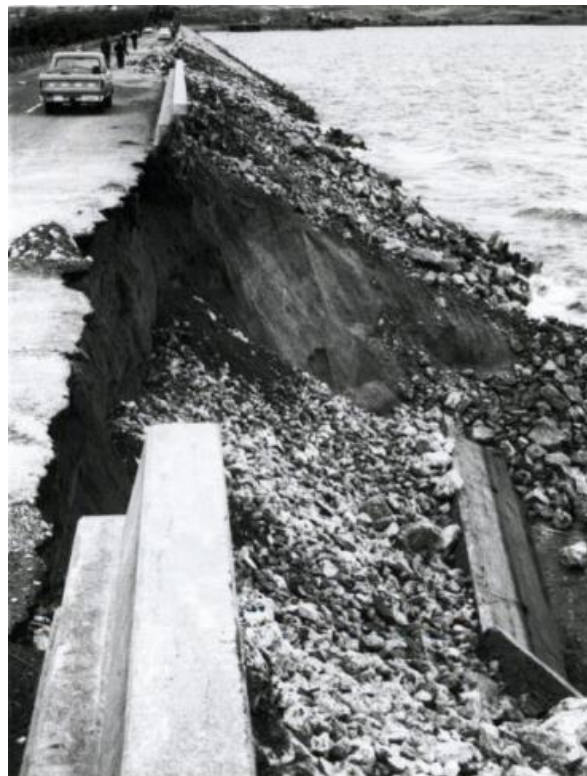
At around five o'clock in the afternoon, it was noticed that rock riprap slope protection was beginning to slough [3]. Wind speeds started to diminish slowly going into the evening, but were still about 30 to 40 mph (50 to 60 km/hr), and the large waves and riprap sloughing continued. Several large holes began to develop where the slope protection had failed, and erosion now began to progress into the upstream, sandy shell of the dam. At three locations, the erosion and subsequent sloughing progressed back so far as to undercut the parapet wall running along the upstream edge of the crest of the dam [4].

The wind-driven waves resulted in damage at multiple locations along almost the entire length of dam. The most severe damage extended along a 3/4-mile stretch of the dam where there were twenty eroded pockets ranging in width from 20 feet (6 m) to 700 feet (200 m). In three locations, the sloughing reached into the crest of the dam [4] [8]. Over 400 feet (120 m) of the concrete parapet wall fell into the eroded pockets and up to 6 feet (1.8 m) of the 28-foot-wide (8.5 m) asphalt highway surfacing was either lost or undermined [1] [2]. The total volume of material eroded during the 1972 storm is unknown, but 50,500 yd<sup>3</sup> (38,600 m<sup>3</sup>) of rock riprap, spalls, gravel and sand along with 10,000 concrete hexapods were placed in the eroded holes created by the storm [4].

Figure 5. 1972 Windstorm Damage to Kingsley Dam [5]. Note the collapse of the concrete parapet wall.

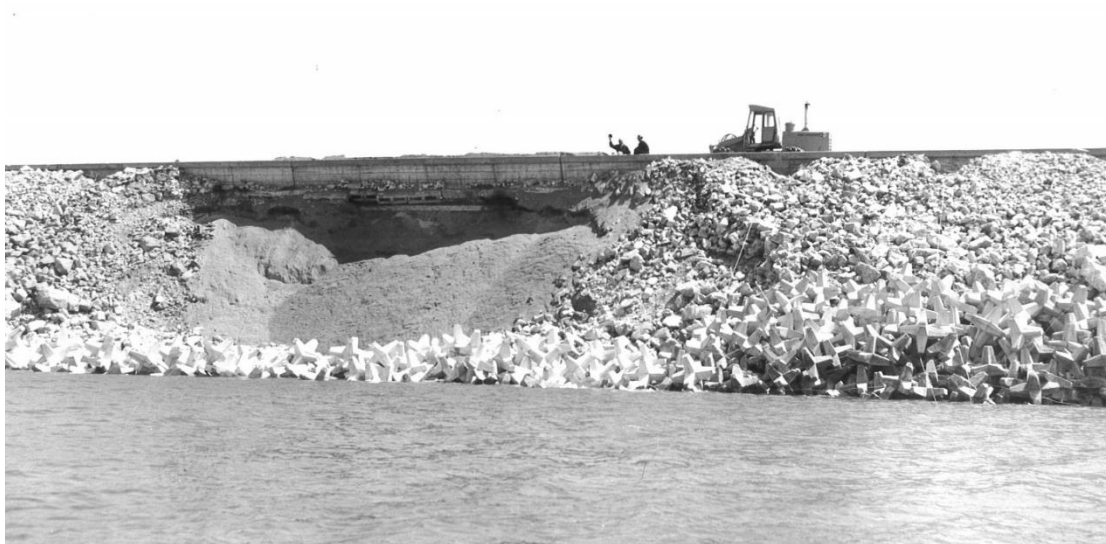
Figure 6. 1972 Windstorm Damage to Kingsley Dam [10]. Note the emergency placement of hexapods at the waterline.

Meanwhile, as soon as the riprap damage started to occur, Central began to assemble equipment and personnel to conduct emergency repairs in an effort to prevent a possible breach. In addition to using their own resources, Central asked for assistance from various state and local agencies, as well as from private contractors with heavy equipment nearby. Soon, there was a continuous caravan of 28 dump trucks transporting materials from emergency stockpiles that Central had located near the dam [8]. Concrete "hexapods" were assembled to form barriers across the larger breaks in the upstream slope protection, and rock and gravel were dumped behind these barriers to further shore up the dam. Outflow from the dam was increased from 500 cfs (14 m<sup>3</sup>/s) to 1,500 cfs (42 m<sup>3</sup>/s) to begin lowering the reservoir. Although much greater rates of release were possible, outflows were

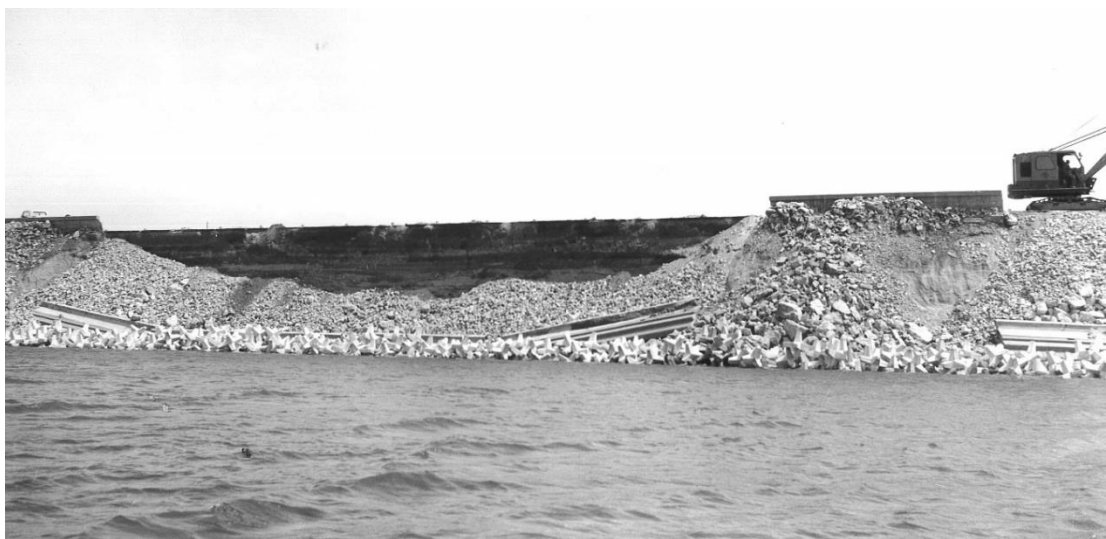
Figure 7. 1972 Windstorm Damage to Kingsley Dam [10]. Note collapsed parapet wall and emergency placement of hexapods at waterline.

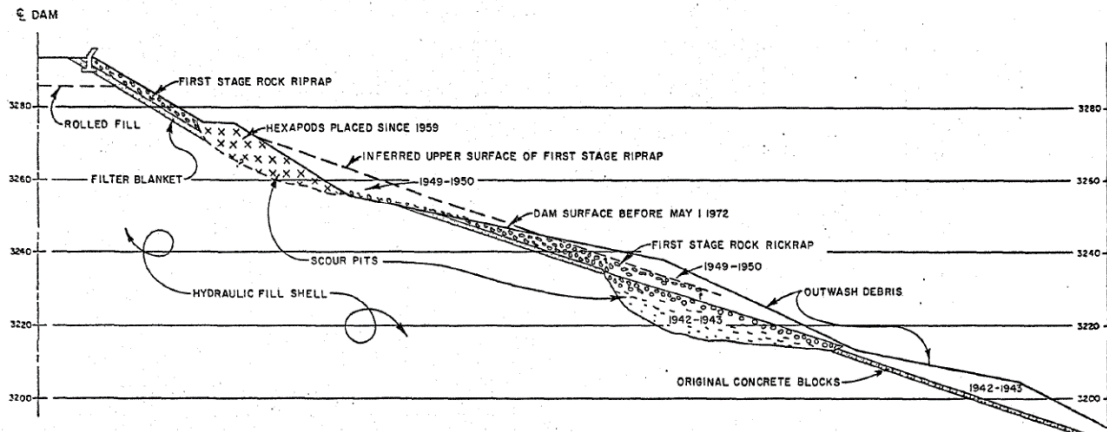
After reviewing all the records and several visits to the dam, the board of consultants issued their report in May of 1973. Ultimately, the board concluded, “the May 1, 1972 damage to the slope protection of Kingsley Dam was initiated with the removal of the cohesionless fine sand of the embankment shell and/or filter blanket from beneath the rock riprap, by wave action. Depressions developed in the protective surface and ultimately all slope protection was removed by the waves...” [4]. The board found that the filter blanket was too thin and inadequate in protecting the underlying fine sand in the dam embankment from erosion. The board also concluded that the previous slope failures over the previous 30 years could also be primarily attributed to the movement of the gravel bedding and embankment sand materials through the voids in the overlying concrete blocks, rock riprap, and hexapods. [4]

Figure 8. Estimated Condition of Kingsley Dam Slope Protection Prior to 1972 Windstorm [4].

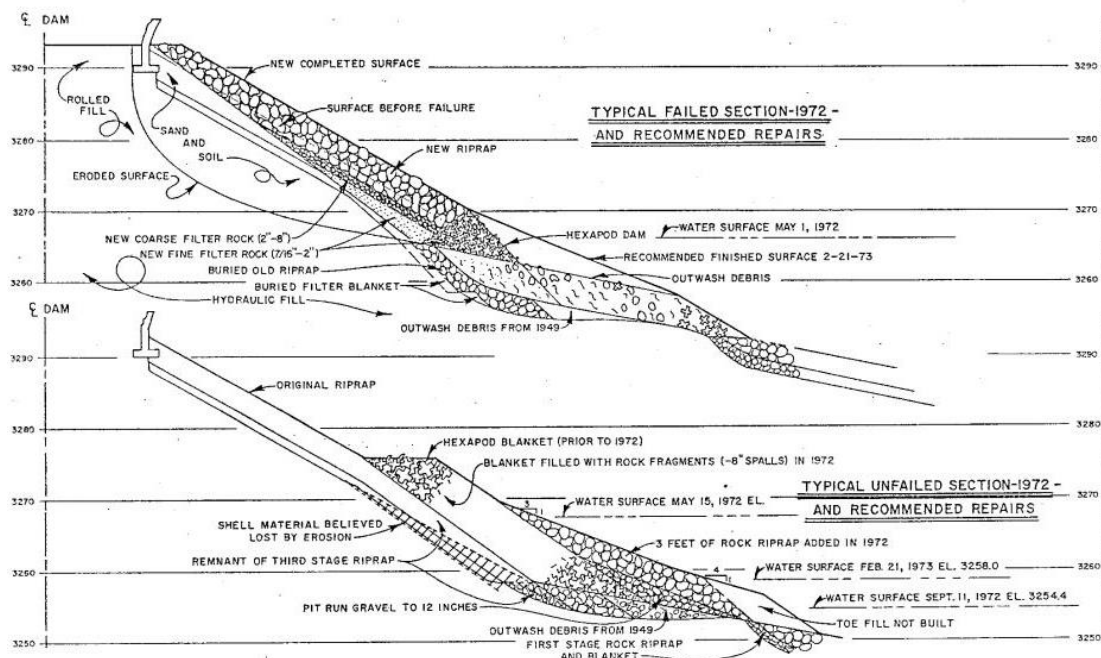
Figure 9. Design for Kingsley Dam Slope Protection Repairs Following the 1972 Windstorm [4].

Lake McConaughy was lowered, and emergency repairs were made to provide interim protection until permanent repairs could be made. The board of consultants developed a design for permanent repairs intended to minimize shell and filter particle erosion from beneath the riprap face. First, any eroded shell materials were filled with sand and soil, and a filter layer of fine graded stone was then placed over the embankment shell. Graded rock from 7/16 to 3-inch (1 to 8 cm) in size was used to fill voids around in-place hexapods. The face was then covered in rock fragments up to 12 inches (30 cm) in size to provide additional filtering and frictional resistance to movement, and over that was placed three feet of heavy rock riprap [4].

These repairs were made to both failed and un-failed areas along the length of the dam. In placing these materials, the slope of much of the upper elevations of the upstream face was reduced from 2H:1V to 3H:1V, continuing the new slope down to the point where it intersected with a lower bench that was formed by deposition of the material that had been washed out from above. The board of consultants concluded that the corrective work would result in the erosion protection being stronger than was before the windstorm, and would reduce future wave-induced damage and maintenance costs [4].

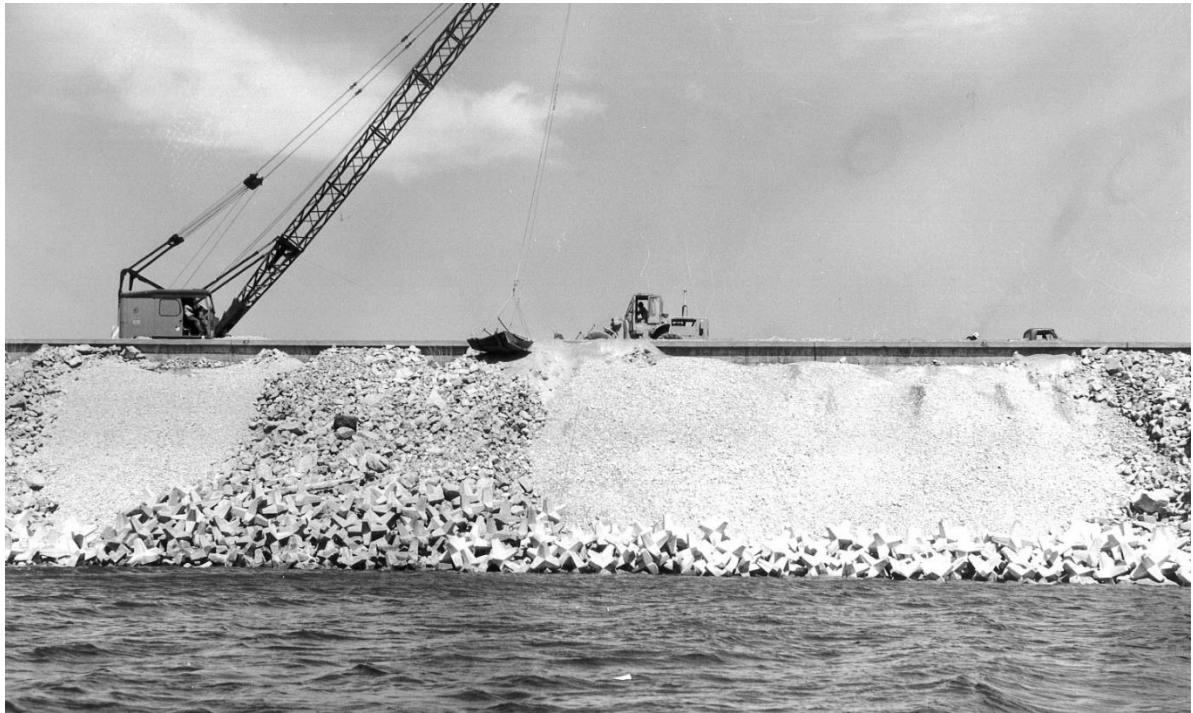
Figure 10. Making Permanent Repairs to Kingsley Dam Following the 1972 Windstorm [10].

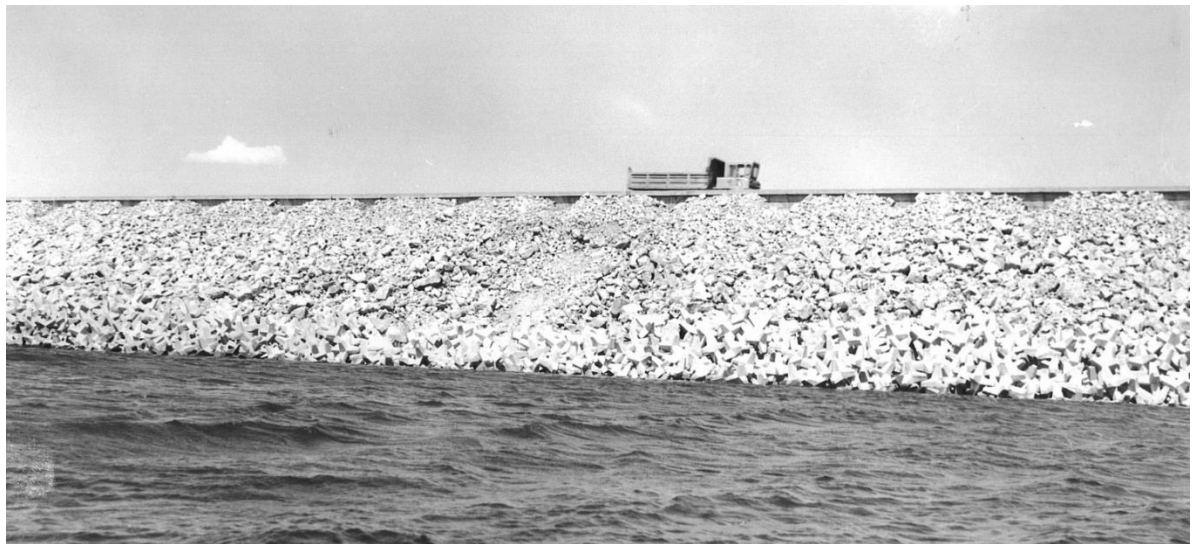
Figure 11. Newly Installed Kingsley Dam Erosion Protection Following 1972 Windstorm Repairs [10].

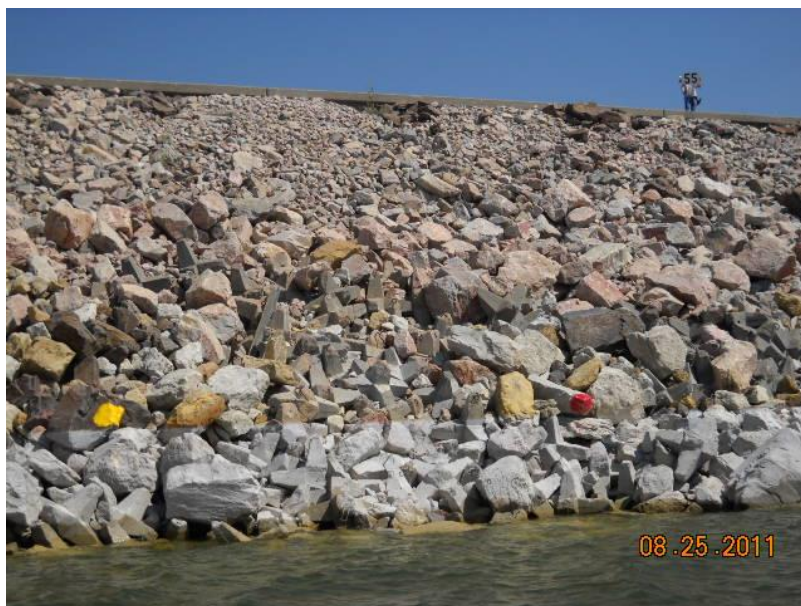
Figure 12. Paint Marks on Kingsley Dam Riprap for Monitoring Movement [12].

- Central maintains a continuously operating and recording wind gage at Kingsley Dam and checks the condition of the dam from the crest following every large wind event. Central also inspects the face of the dam from the lake side every spring to look for any damage or other change that might have occurred but gone unnoticed from the crest. Central additionally takes photographs of the riprap along the entire length of the dam every five years to maintain a historic record of the condition and facilitate looking for long-term changes. Finally, Central has a series of painted marks on the riprap at a constant elevation along the length of the dam to facilitate these efforts of identifying movement. [13]
