# ***The Fontenelle Dam Incident: The Investigation, Likely Causes, and Lessons (Eventually) Learned***

Presented to: Association of State Dam Safety Officials, Annual Conference, Washington DC, September 2011. Authored and presented by: Mark E. Baker, PE, National Park Service, [Mark\\_E\\_Baker@nps.gov](mailto:Mark_E_Baker@nps.gov), phone: 303-969-2921

## **Summary**

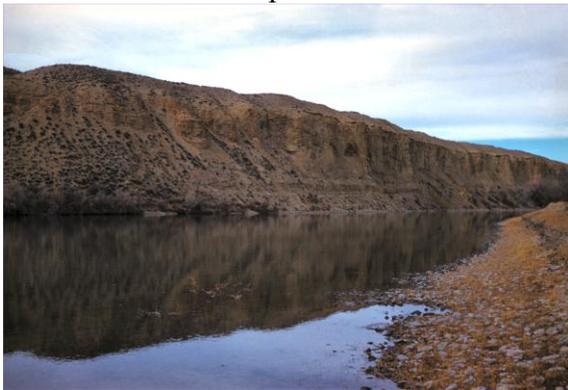
*Figure 1: Cliffs at location of right abutment*

Site reconnaissance began in the 1950's. The site selected is located within a wide-bottom, 5,000-foot-wide Green River valley with steep cliffs on the right (east) abutment (the location of the main erosion incident) (see figure 1) and a gently sloping left or east abutment. The foundation and abutment rock consists primarily of the Green River formation and has a grey-white or olive green appearance. The rock is exposed from the river up and beyond the future crest of the dam. At the dam alignment, the river is located at the foot of the right abutment cliffs. The Green River Formation rock at the site consists of shale, siltstone and sandstone. The rock is nearly horizontally bedded with a 1-degree dip to the downstream. In the steep right abutment, there are settlement cracks and relief joints (see figure 2).

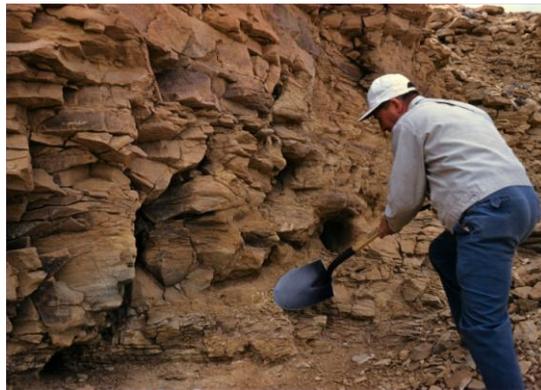
*Figure 2: Highly fractured sandstone at the right abutment.*

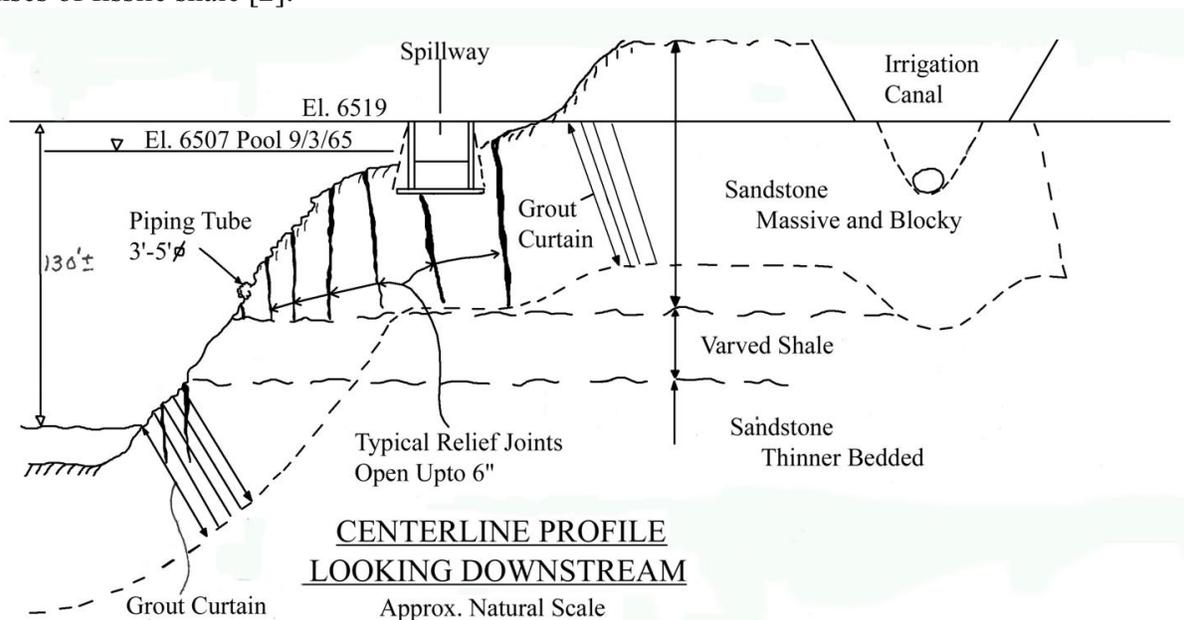
Figure 3: Section of the right abutment looking downstream

Relief joints, generally parallel to the valley, occur in the massive sandstone (see figure 3). These joints extend the full length and depth of the unit. They are formed due to removal of

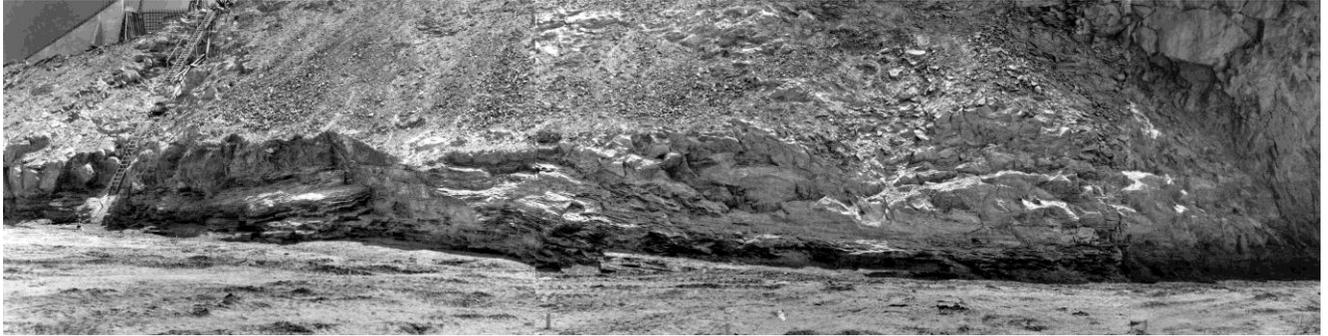
The cliffs on the right abutment required extensive stripping to bring the slope to  $\frac{1}{2}$  to 1 as called for by the design. This stripping was done by a dragline crane dragging its bucket up the slope. According to the project construction engineer, all joints were filled by puddling in a slurry of soil and water. The impervious material was hand-tamped for a width of 2 feet next to the abutment. Photos indicate rock overhangs and discontinuities were left in place during embankment placement (see figure 7).

*Figure 7: Panoramic image of right abutment with embankment placement at approximate elevation of 6438. Note overhangs and discontinuities.*

3. The rock abutment was not prepared with the designer's intent. Rock irregularities and even overhangs were left in place during embankment placement. These irregularities prevented adequate compaction and bonding of the Zone 1 against the abutment. Although design engineers were generally discouraged from visiting Reclamation dam construction sites [3], the designer visited the site in 1963 and recommended that Zone 1 be widened in the upstream direction (a positive factor in preventing failure).

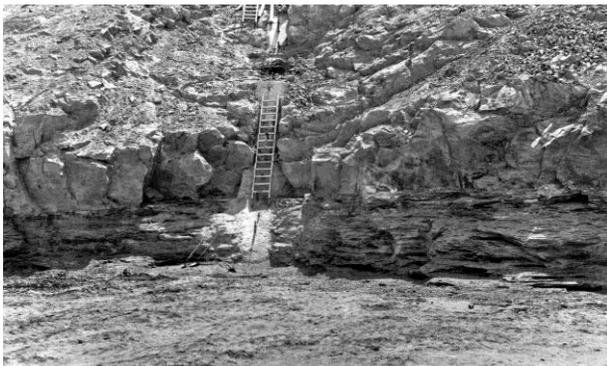
The grout curtain continued up the steep right abutment (see figures 8 and 9) where the rock was predominately massive, homogeneous, fine-grained silty sandstone and siltstone. The holes were spaced at 5- to 2-1/2- foot centers. Grout takes were heavy in the area of the spillway and right abutment. This massive character extends upstream with a more bedded character downstream. The grout cap was so steep in places that ladders were used for personnel to access the full length of the grout cap. A special challenge was grouting near the surface where excessive grout pressures would cause uplift of the upper-most rock. This was especially challenging in the steep right abutment. Sediment or other material in the cracks may have prevented adequate spread of grout.

*Figure 8: Right abutment with Zone 1 at elevation 6438. Note shale layers overlain by sandstone.*

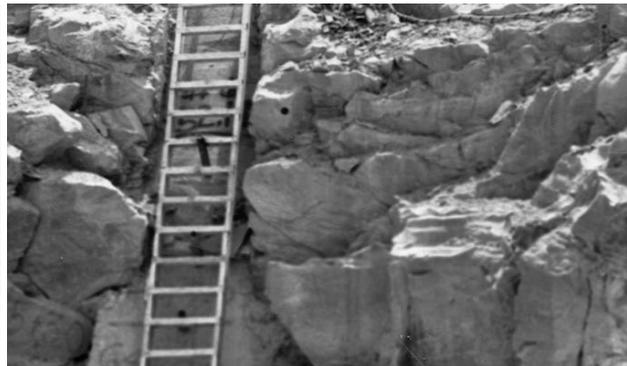
*Figure 9: Detail of Figure 8. Sandstone and grout cap at approximate elevation 6450.*

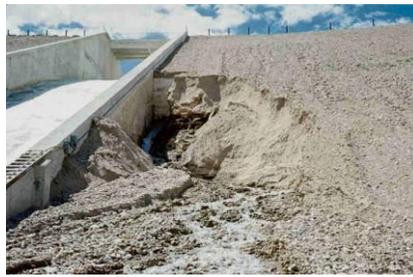
On July 8, the material slid for a 3<sup>rd</sup> time (figures 11 and 12). Seeping water was observed squirting from the rock formation in numerous places.

*Figure 11: The third embankment slide on July 27, 1965*

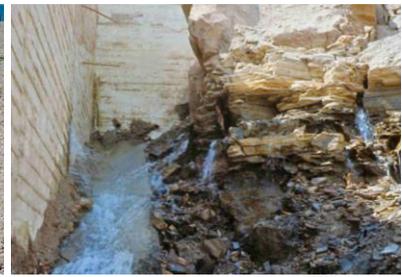
*Figure 12: Third embankment slide. Seeps issuing from vertical cracks in sandstone.*

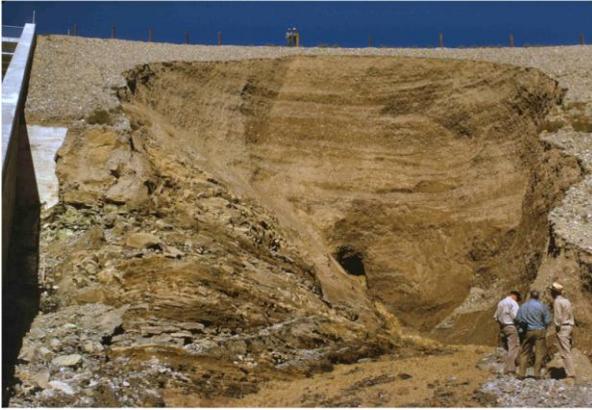
By morning the eroded hole was 80-feet-wide, 60-feet-deep and 200-feet-long (see figures 13 and 14). A leak flow of about 20 cfs was coming out of the embankment at the contact with the right abutment rock at elevation 6447. Importantly, the flow was very muddy in color indicating internal erosion was actively occurring (see figure 13).

*Figure 13: The erosion hole about noon on Saturday September 4. Note 4-foot-diameter leak exit tunnel adjacent to the right abutment rock.*

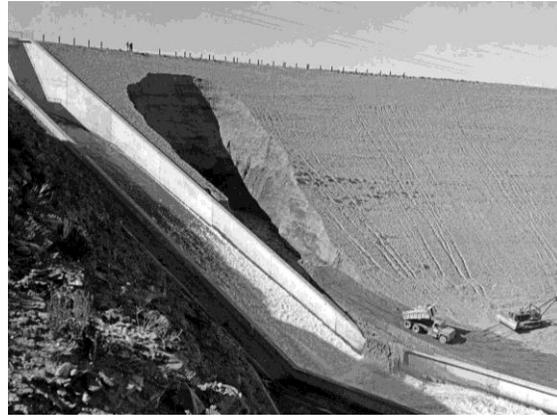
*Figure 14: Erosion hole about 4:00PM Saturday September 4. Dump truck is dumping rock to create a windrow at downstream end of erosion hole.*

To address failure mode 2, the CE directed that a windrow of rock be placed along the left side of the bottom of the erosion hole (see figure 14). This would crowd leak flows against the abutment rock. The windrow was constructed first at the downstream end of the eroded hole by dumping and dozing rock as far up the cavity as considered safe. Rock was also dumped over the upstream edge of the eroded hole from the dam crest. Consideration was given to constructing a weir at the mouth of the slough to raise the elevation of the leak exit with a corresponding reduction in the hydraulic head – however, this was never constructed.

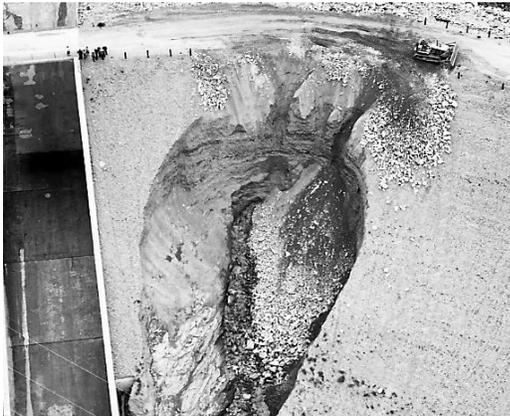
By Sunday morning, 1700 cubic yards of rock had been dumped in the hole (see figure 15). As the rock tumbled down the 60 feet of embankment height, it brought with it embankment material. This rendered the rockfill relatively impervious and effectively dammed the leak. As

the rock/soil berm enlarged, the leak exit point moved up and to the right along the contact with the abutment. This caused further sloughing of the upstream face of the erosion hole. The CE directed continued rock placement with perhaps complete filling of the erosion hole.

*Figure 15: By Sunday morning September 5<sup>th</sup> a large rock berm was created in the left side of the erosion hole. However, the berm was dirty and blocked the leak exit forcing the exit point higher and toward the spillway.*

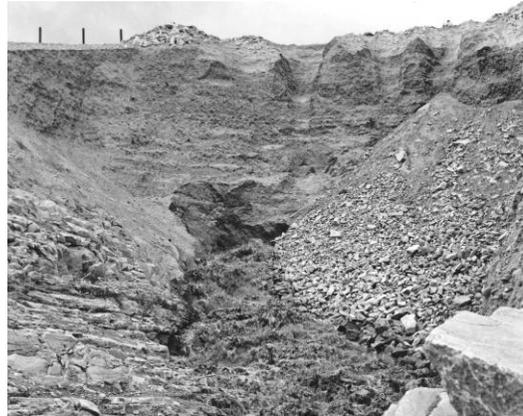
*Figure 16: At 3:00PM Sunday, there began a series of sudden surges of up to 35 cfs.*

At 3:00PM, a series of surges began (see figure 16). These surges were up to 35 cfs. After each surge, the leak flow dropped significantly. Water pressure built up and then broke free causing the surges. The PCE thought the dam might fail and contacted the down of Green River by radio and told the authorities to be on heightened alert for evacuation. After an hour, the surges subsided and by nightfall leak flows were again steady.

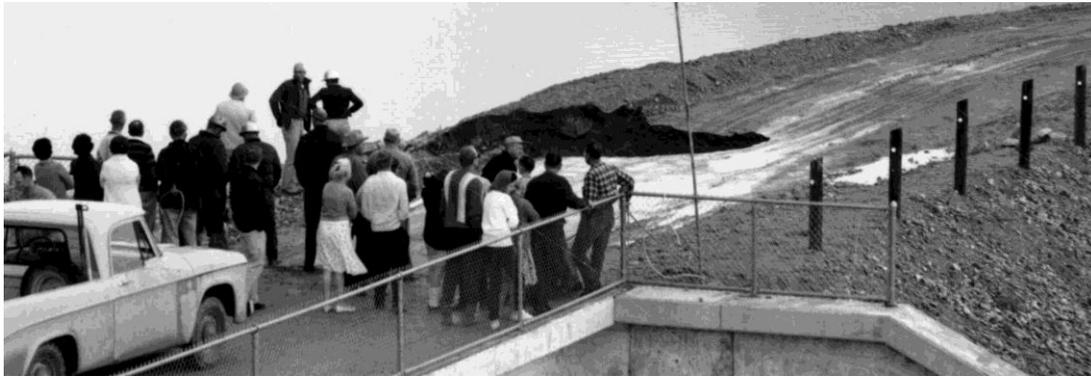
On Monday, reservoir releases continued. At 4:45PM a sudden and alarming event occurred. A 15-foot by 20-foot section of the crest road near the spillway suddenly and quickly collapsed (see figure 17). The sinkhole was in line with the downstream erosion hole. The PCE inspected the sinkhole by standing on the edge and peering down into the hole. He measured it and found it was 31 feet deep. Toward the bottom, it enlarged an additional 10 to 15 feet in the downstream and left direction - in the direction of the leak exit (see figures 18 and 19). He observed that water was exiting the abutment rock and percolating down through the bottom of the sinkhole.

Figure 17: At 4:45PM Monday a 15x20 foot sinkhole suddenly opened up in the crest of the dam.

The PCE decided to immediately fill the sinkhole with riprap bulldozed from the upstream face. This decision was later confirmed by the CE. By nightfall, the sinkhole was filled-in with rock and a layer of road base was added to allow for resumed travel along the crest road.

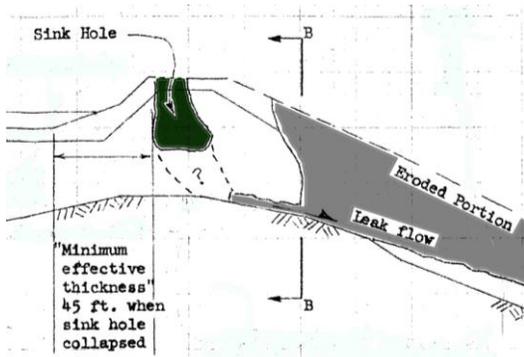
Figure 18: Section of the sinkhole looking left. The sinkhole was 31-feet-deep.

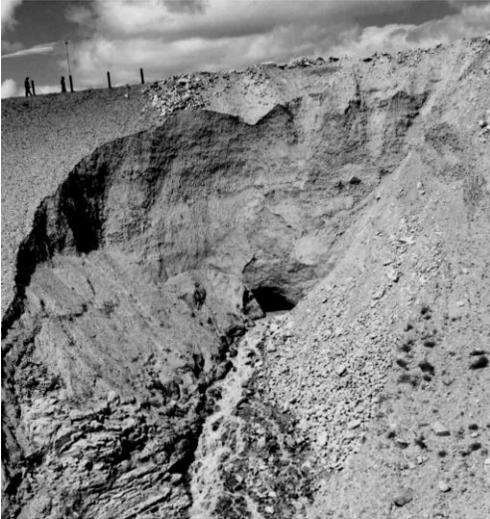
For the next six days, the reservoir lowered and leak flows diminished (see figure 20). A total of 3 feet of embankment width was gained for every one foot drop in the reservoir. On Wednesday, the reservoir lowered below the top of the wide Zone 1 berm adding 80 feet of embankment width between the reservoir and the leak exit. On Thursday, the rockfill in the sinkhole settled ceasing traffic across the crest road (see figure 21). The rock settled a total of 8 to 10 feet and additional rock was placed.

*Figure 20: Erosion hole on Thursday September 9. Note diminished leak flows.*

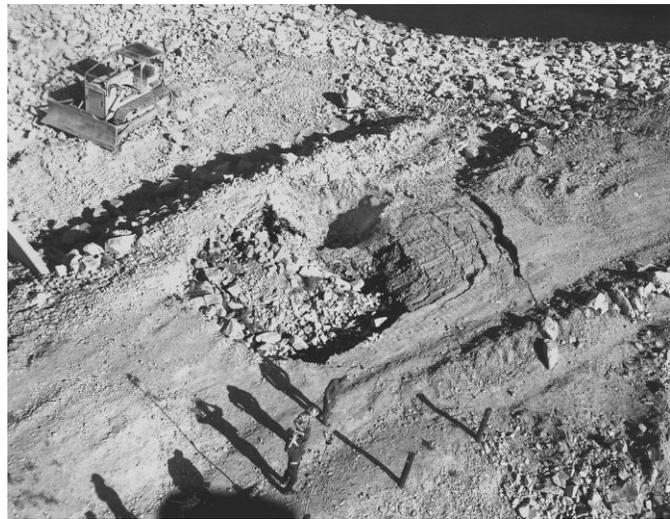
*Figure 21: Subsidence of the rock placed in the sinkhole on Thursday September 9.*

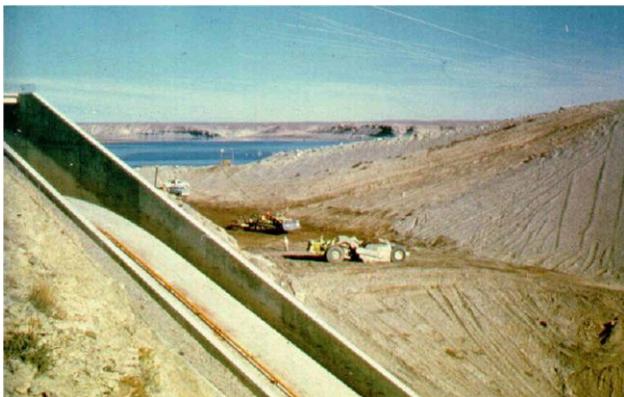
Reclamation moved quickly to hire a contractor to excavate the embankment down to the elevation of the leak exit. The right 350 feet of embankment were removed (see figure 23) to determine the cause of failure and to perform a significant grouting program. The depth of the excavation was 65 feet.

*Figure 23: Section of dam removed for investigation and repair*

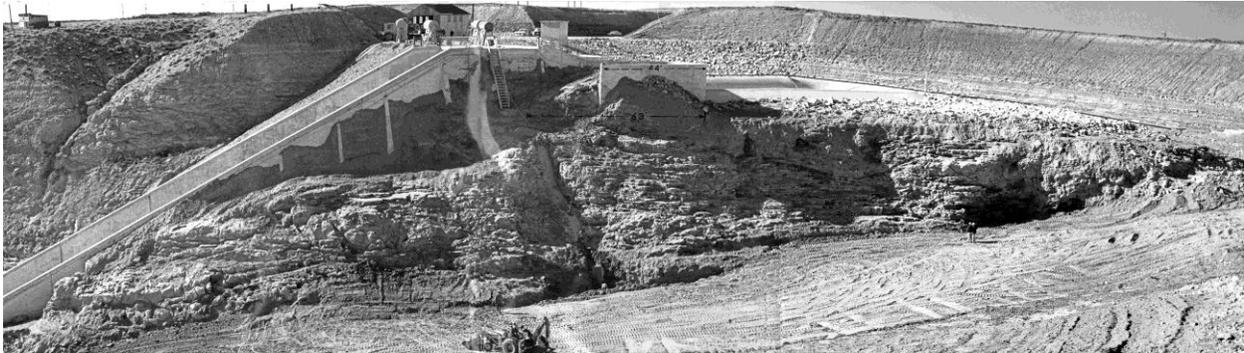
Figure 24: Panoramic photo of right abutment circa November 1965

A panoramic photo was made of the entire abutment (see figure 24) and more close-up photos were made of important relief cracks. A total of 29 “disturbing” relief cracks were mapped [10]. These cracks were mostly vertical, followed the contour lines and extended upstream and downstream. Crack widths varied up to 4-inches. One open relief joint (identified as location “B” in the reports and photos), was about 15 feet long and 85 feet upstream of the grout cap about 13 feet above the leak exit elevation (see figure 25). The crack was clean indicating possible transmission of seepage.

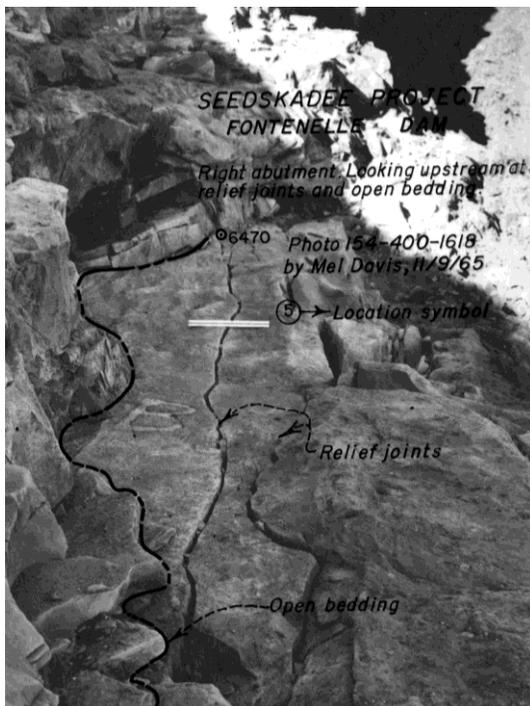
Figure 25: Relief crack in area “B” approximately 85 feet upstream of the grout cap at elevation 6471.4.

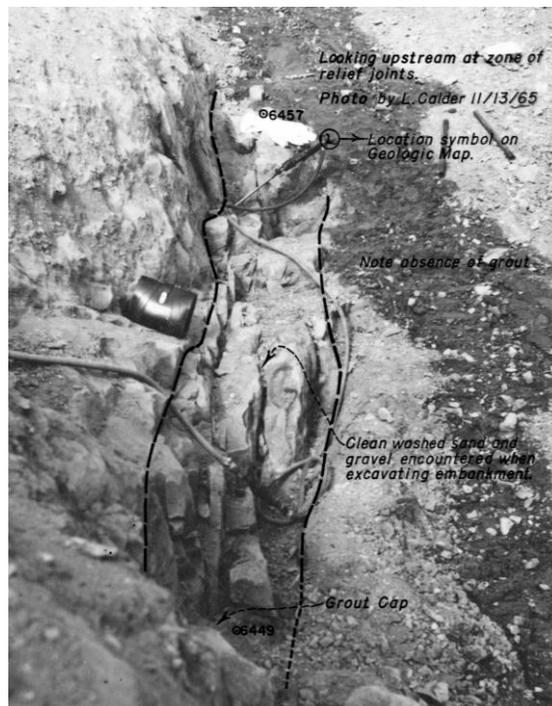
Figure 26: Relief cracks in area “G” just upstream of the grout cap at approximate elevation 6453.

Another crack system (location “G” – see figure 26) was located just upstream of the grout cap and the area was excavated down to elevation 6449. A clean sand and gravel deposit was located adjacent to one of these cracks. The embankment design engineer who visited the site stated, “This clean sand and gravel strongly indicated that flowing water had washed the fines away from the embankment material leaving only the coarser fraction” [10].

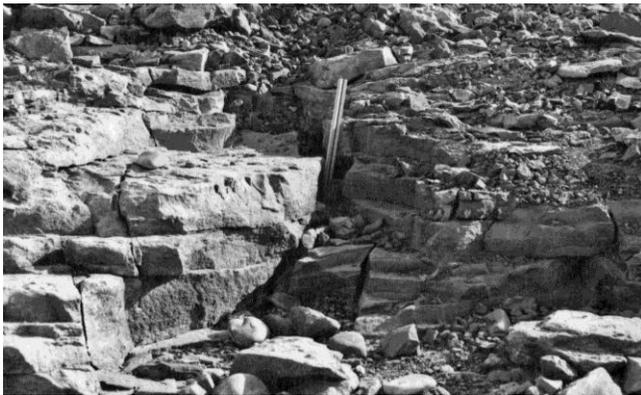
In addition, a geologist discovered a crack upstream of the embankment abutment contact in the canal inlet (at location “J” – see figure 27). This crack trended toward the leak area and “... surely appears to have transmitted water recently.” He stated that “...I feel quite sure that other cracks occur in the bedrock of this area.” [11]

*Figure 27: Location “J”, one of the probable locations of water leakage into the right abutment from upstream of the dam.*
