# Replacement of a Deteriorated Earthfill Dam with an RCC Gravity Dam

## The Penn Forest Dam Replacement Project

1999 USCOLD 19th Annual Meeting and Lecture

**Paul G. Schweiger**, Project Engineer, Gannett Fleming, Inc., Harrisburg Pennsylvania

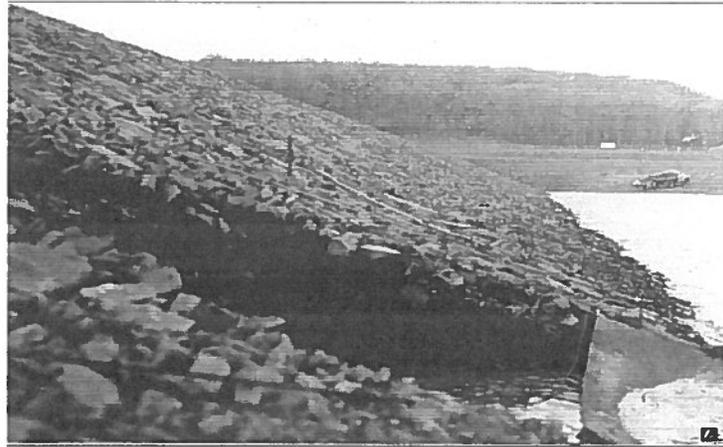
Problems plagued the earthfill dam from the beginning. In April 1960, during first impounding, approximately 350 gpm of turbid seepage emerged from a road cut immediately downstream of the dam and, a month later, a sinkhole developed on the upstream slope of the embankment near the right abutment. The sinkhole, which was reported to be on the order of 15 feet in diameter and more than 15 feet deep, raised the

*Sinkhole, May 1960*

Initial repairs consisted of grouting the underlying foundation rock in the vicinity of the sinkhole and pressure injecting surface-hydrated bentonite lumps and cellophane strips in the embankment to fill the voids. During drilling for grouting, voids were encountered in the embankment up to 18 inches in diameter. The foundation rock was grouted with cement grout mixed in a ratio of 1:1 by volume. The grouting program did not significantly reduce the measurable seepage emerging from the embankment.

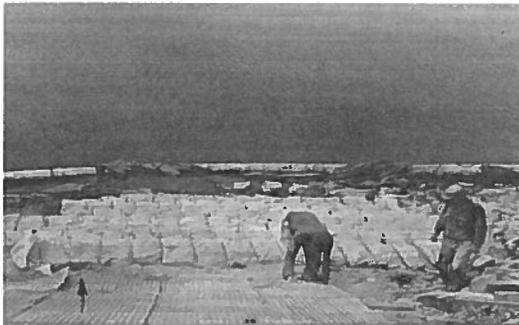
*Initial Repairs, May/June 1960*

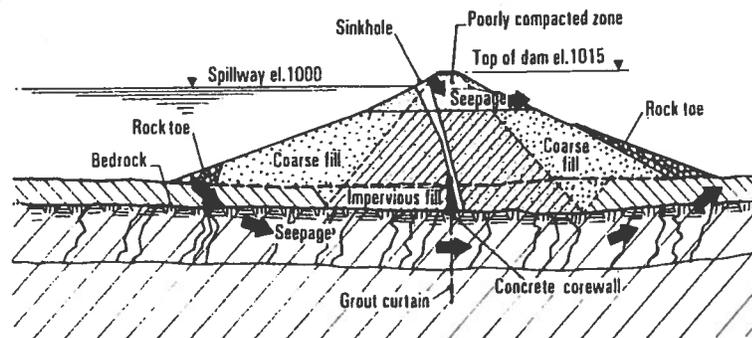
Further investigations were performed and additional professional opinions from several engineering consultants were sought to determine the next course of action. At this point Gannett Fleming became involved in the project. There was general concurrence that the failure mechanism was piping of the embankment materials into the fractured rock foundation. Numerous concerns were expressed regarding the original design, construction, and emergency repairs. As a precautionary measure, Gannett Fleming recommended that a controlled filling program be used to further evaluate the conditions in the dam, with the results to be used as a basis for determining the need for additional repairs. A controlled filling program was implemented in 1964 after installation of numerous embankment and foundation instruments consisting of 275 piezometers, several weirs to monitor seepage, and a network of survey monuments on the embankment. The reservoir first reached spillway crest elevation on October 3, 1969, almost 10 years after the dam was first constructed. Throughout the 5-year filling period there were indications of changes in seepage conditions, but none which were deemed

*Embankment Section With Sinkhole*

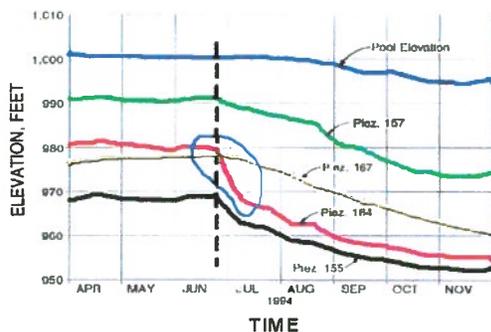
In July 1994, while the pool level was being maintained at spillway crest, piezometric levels in instruments located in the foundation rock in the sinkhole area began to decline. The decline was masked for a period of time because drawdown of the reservoir started at approximately the same time. The pool level dropped approximately 5 feet and remained at that level for several months. Records show that piezometric levels in the foundation rock continued to gradually decline during that period. By November 1994, plotted piezometric records showed a sufficient decline in seven instruments to warrant implementing precautionary measures.

*Piezometer Readings Signal Problem*

Overall, piezometric levels in the foundation rock in the vicinity of the original sinkhole declined approximately 10 to 20 feet in the 5 month interval from July to November. The changes in the piezometric levels were interpreted as a possible early warning sign of recurrence of piping. Subsequently, it was determined that a total of 15 instruments in the general vicinity of the sinkhole area were affected to varying degrees. A review of the seepage records showed that the total seepage increased to over 900 gpm which further indicated that the dam was deteriorating.

In response to the observed conditions and the overall history of Penn Forest Dam, the City of Bethlehem implemented a series of emergency response measures recommended by Gannett Fleming. The emergency response measures, summarized below, remained in effect until January 1995, at which time the pool had been drawn down to approximately Elevation 975, 25 feet below spillway crest. Following the emergency measures, the reservoir was further drawn down and held at Elevation 950 during subsequent investigations.

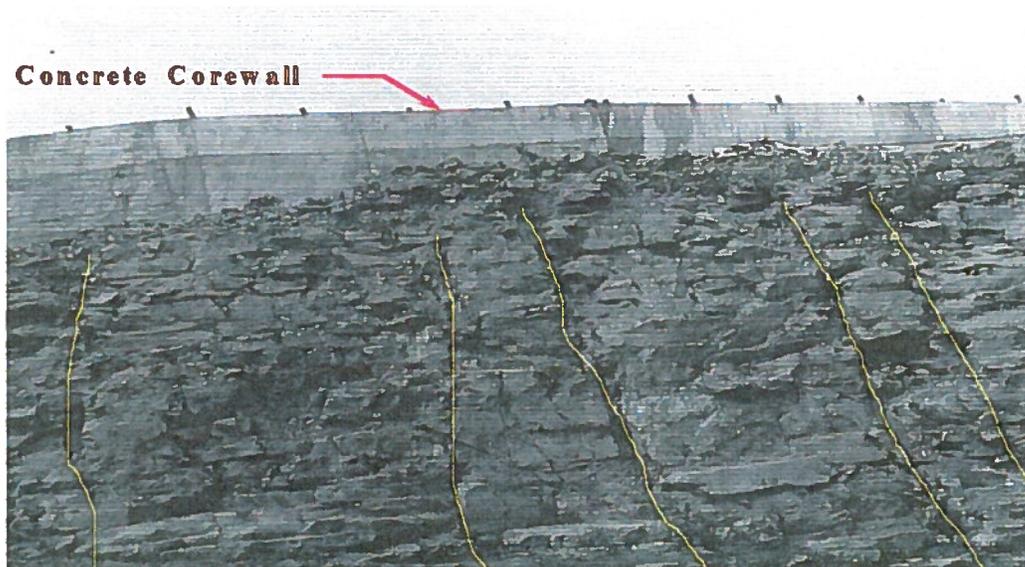
- ***The Original Foundation Grouting Program Was Ineffective.*** Grout holes were vertical and did not intersect the principal joint sets which are near-vertical. One set is orientated in an upstream and downstream direction and the other is parallel to the dam axis. The grout curtain was a single line design which is inadequate for a dam of this size and with these foundation conditions. In addition, the frequent use of sand in the grout mix limited the penetration of the grout in large fractures.
- ***The Dam Was Constructed Without Internal Filter Drains.*** Without internal filter drains, there was no mechanism to prevent piping from progressing after it began. Further, the drains that were constructed were not compatible with the rolled coarse fill or the underlying foundation soils, and had the potential to promote piping rather than prevent it.

***Construction Photo of Concrete Core Wall on Fractured Rock Foundation***

- ***The Dam Foundation Was Not Adequately Prepared.*** At the east abutment the corewall sits on a thin ridge of highly fractured rock which should have been removed to a substantially greater depth than what was performed.

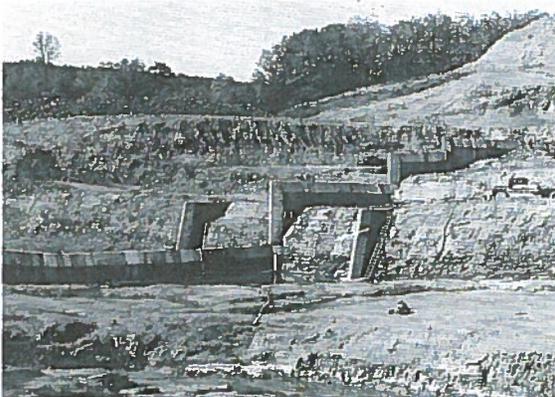
- ***The Abutments of the Dam Were Not Adequately Prepared.*** The rock foundation at the dam abutments had three to five near-vertical ledges or steps. At least one of these steps was over 25 feet high. Rather than trimming the rock ledges to a uniform slope, multiple concrete cutoff fins or walls were constructed at the vertical steps. Steps in the abutments can result in the formation of a soil arch and differential settlement. Both of these results made the embankment more susceptible to cracking.

*Vertical Steps At Abutments*

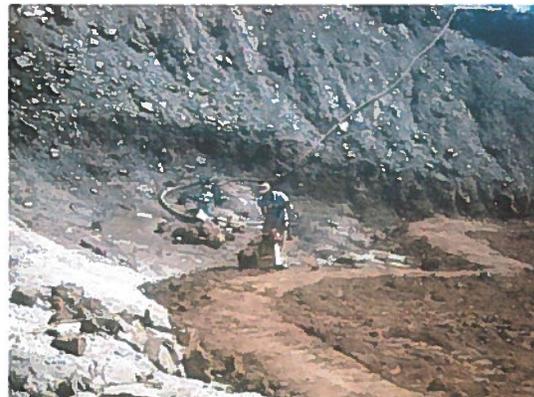
- ***Poor Quality Control During Construction.*** Subsequent excavation of the embankment found roots, oversized material, and large tree limbs and stumps in the fill. Compaction along steep abutment ledges and along the corewall is also suspect. Construction photographs show that these areas were likely compacted with small hand equipment without reducing lift thickness, which resulted in minimal compaction. In addition, the top 45 feet of the embankment was found to be only 90 percent of maximum dry density.

*Inadequate Compaction of Fill Material*

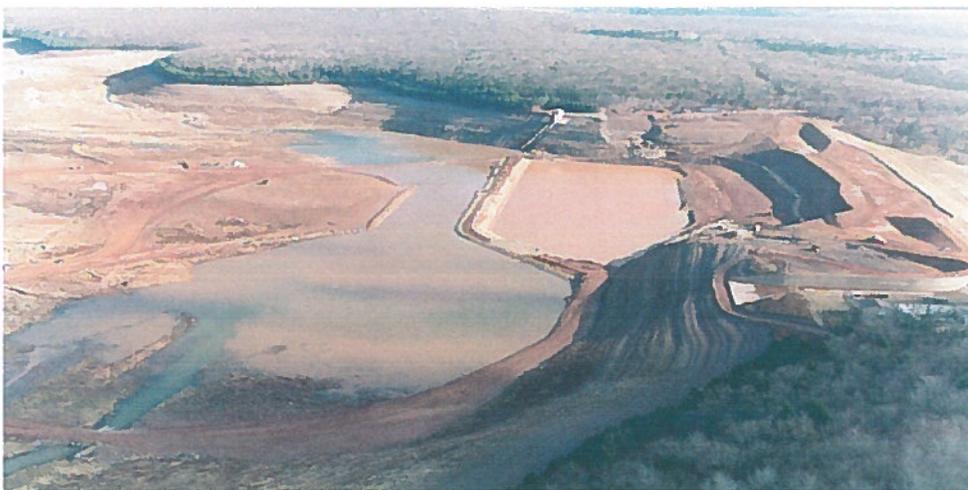
*Flooding of Work Area, December 1996*
