REEXAMINATION OF THE 2004 FAILURE OF BIG BAY DAM, MISSISSIPPI

Keith A. Ferguson, P.E., National Dam and Hydraulic Structures Practice Leader¹
Scott Anderson, P.E., National Technology Leader for Numerical Modeling²
Elena Sossenkina, P.E., National Technology Leader for Risk³

ABSTRACT

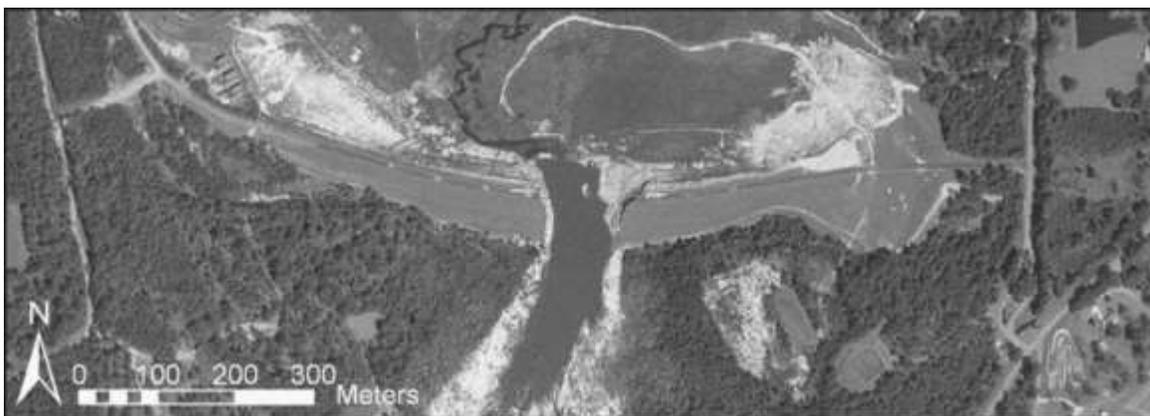
Figure 2. Aerial View of Breach Immediately Following Failure of the Dam

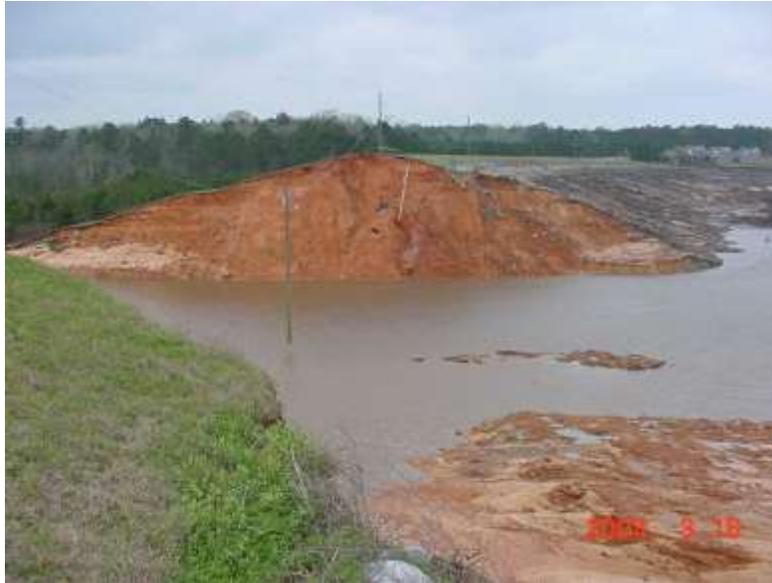
Figure 3. Photo of Dam Breach from Upstream Slope.

The breach that formed in the dam was in the general vicinity of the outlet conduit and resulted in total failure of the outlet intake structure, conduit through the embankment at the foundation contact, and the outlet discharge structure. As described in a subsequent section of this paper, the root cause of the failure was never conclusively established during the subsequent investigation and litigation phases of the project. While several theories were postulated by different parties, the author's examination of the information from the investigations and trial activities along with their general experience with seepage failure modes suggests that the failure mode development process was complex. Contributing factors may have included defects in the outlet conduit, lack of effective seepage control in the central core of the dam, poorly designed and constructed seepage filter and collection systems in the downstream portion of the dam and foundation, and lack of proper instrumentation and monitoring of the dam. The very poor design, remedial construction, and inspection/monitoring records at the dam will not permit conclusive establishment of the root cause of failure. However, a potential failure modes (PFM) framework to reexamine the available information has been highly informative.

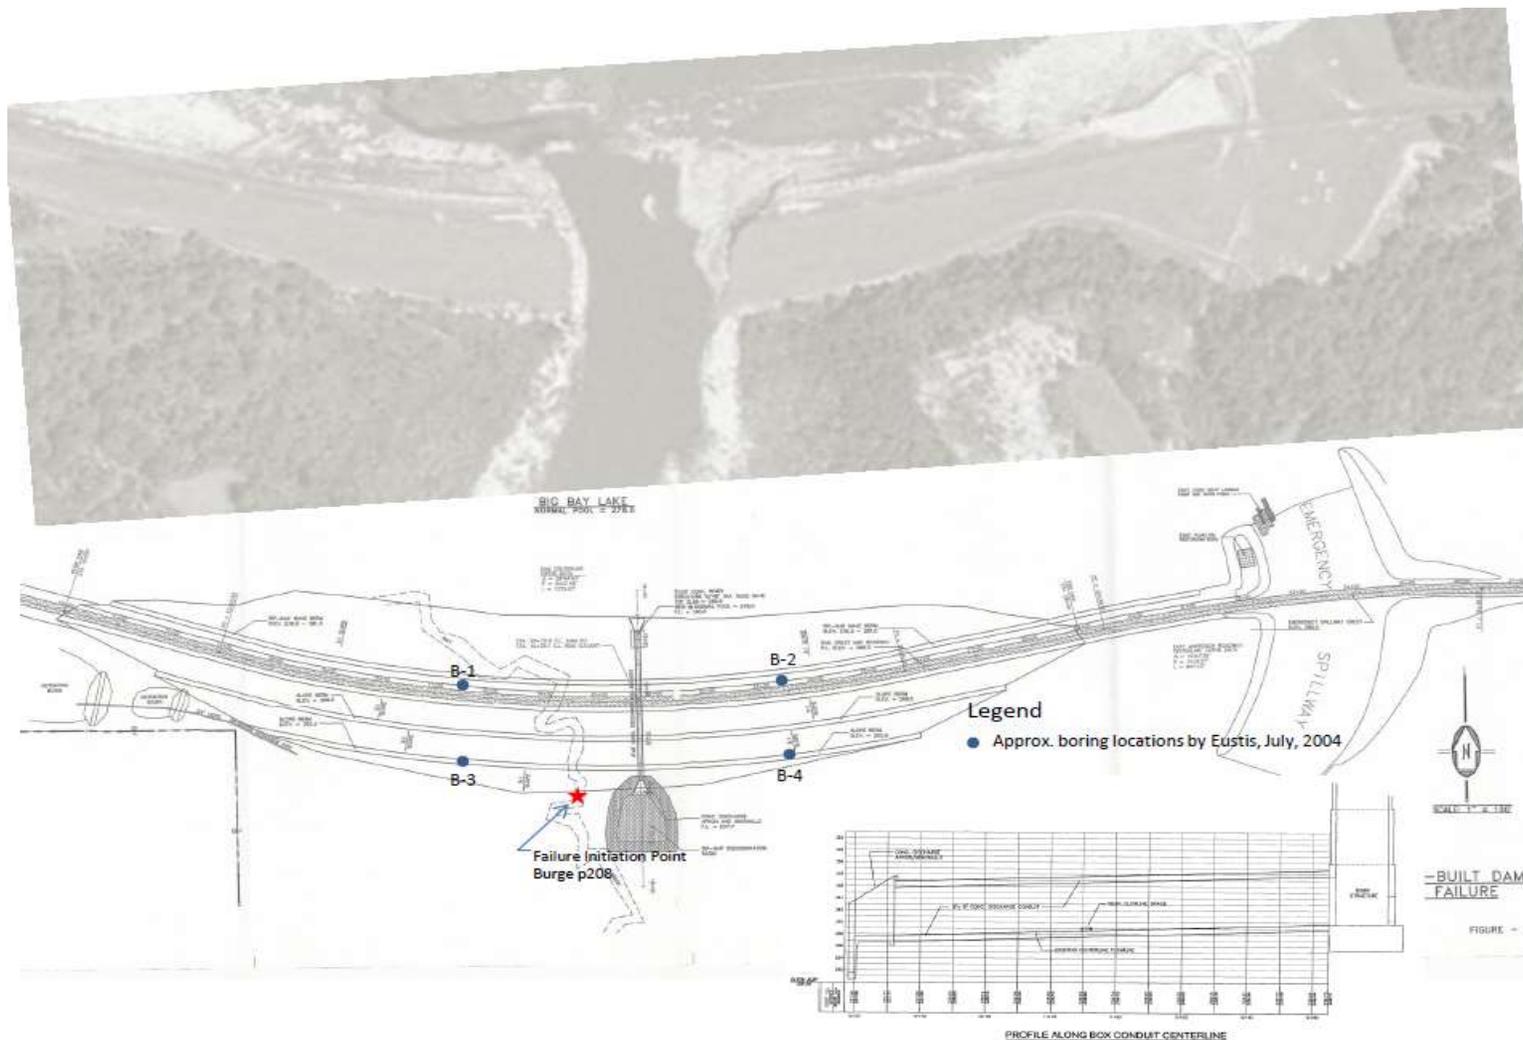
The approximate location where the failure mode breakout occurred, based on deposition by both the Maintenance Man (Daughdrill deposition, p 69, October 3, 2006) and the Engineer (Burge deposition, p 208, December 17, 2007) along with the location where several important initial borings were completed (Eustis, 2004) in the remnant embankment adjacent to the breach location are illustrated on Figure 4. You will note that the original outlet works conduit is shown on the original plan view along the bottom of this figure at a location that is approximately near the center of the final breach configuration. The outlet works intake structure, conduit, and discharge structure were completely destroyed during the breach formation process leaving no remnant structure or embankment/foundation materials available for forensic evaluation.

Figure 4. Plan View of Failure Showing Approximate Location Where Failure Mode Breakout Occurred and Original Borings Were Performed

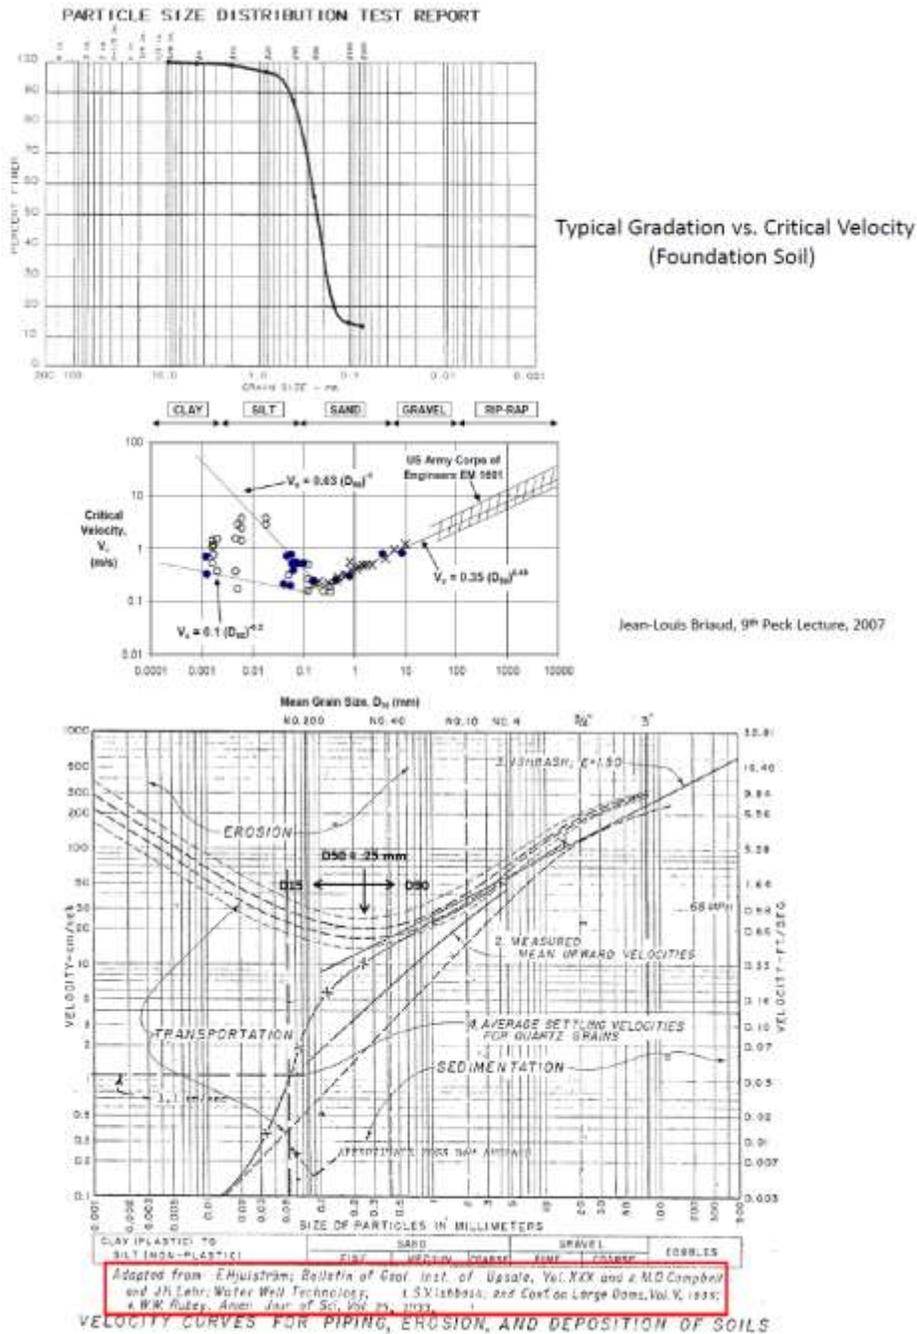
A gradation curves representing the foundation soils found at the site is shown on the upper portion of Figure 5.

Figure 5. Erodibility of Foundation, Erosion and Embankment Materials at the Site

In addition to representing the foundation soils, it is suspected that this gradation may also represent some if not a large portion of the soils used to construct the embankment dam upstream and downstream of the cutoff wall and may also represent materials used for the cutoff wall prior to the addition of bentonite. In general, the soils at the site are relatively poorly graded fine sand with some silt and clay fraction along with minor amounts of fine gravel. Over 75 to 80 percent of the material consists of sand between 0.1 and 0.6 millimeters in size.

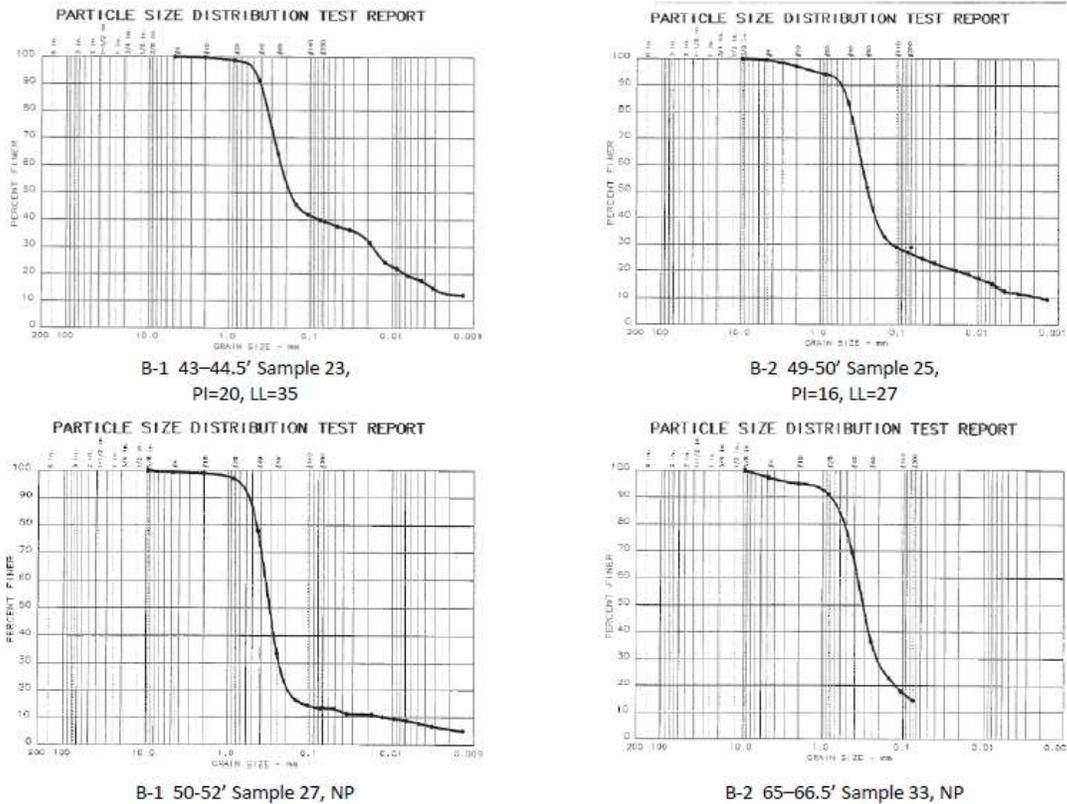
The locations of several post failure forensic borings are shown on Figure 4. A number of representative gradation curves for materials in, and below the cutoff wall are shown on Figure 6, and a summary of laboratory test results of gradation and permeability of various samples is provided in Table 1. The blue highlighted rows in Table 1 represent the four sample gradation curves shown on Figure 6. The light burgundy colored cells in the table highlight the permeability test results of the samples taken from the cutoff wall.

Figure 6. Example Gradation Curves for Embankment and Foundation Materials

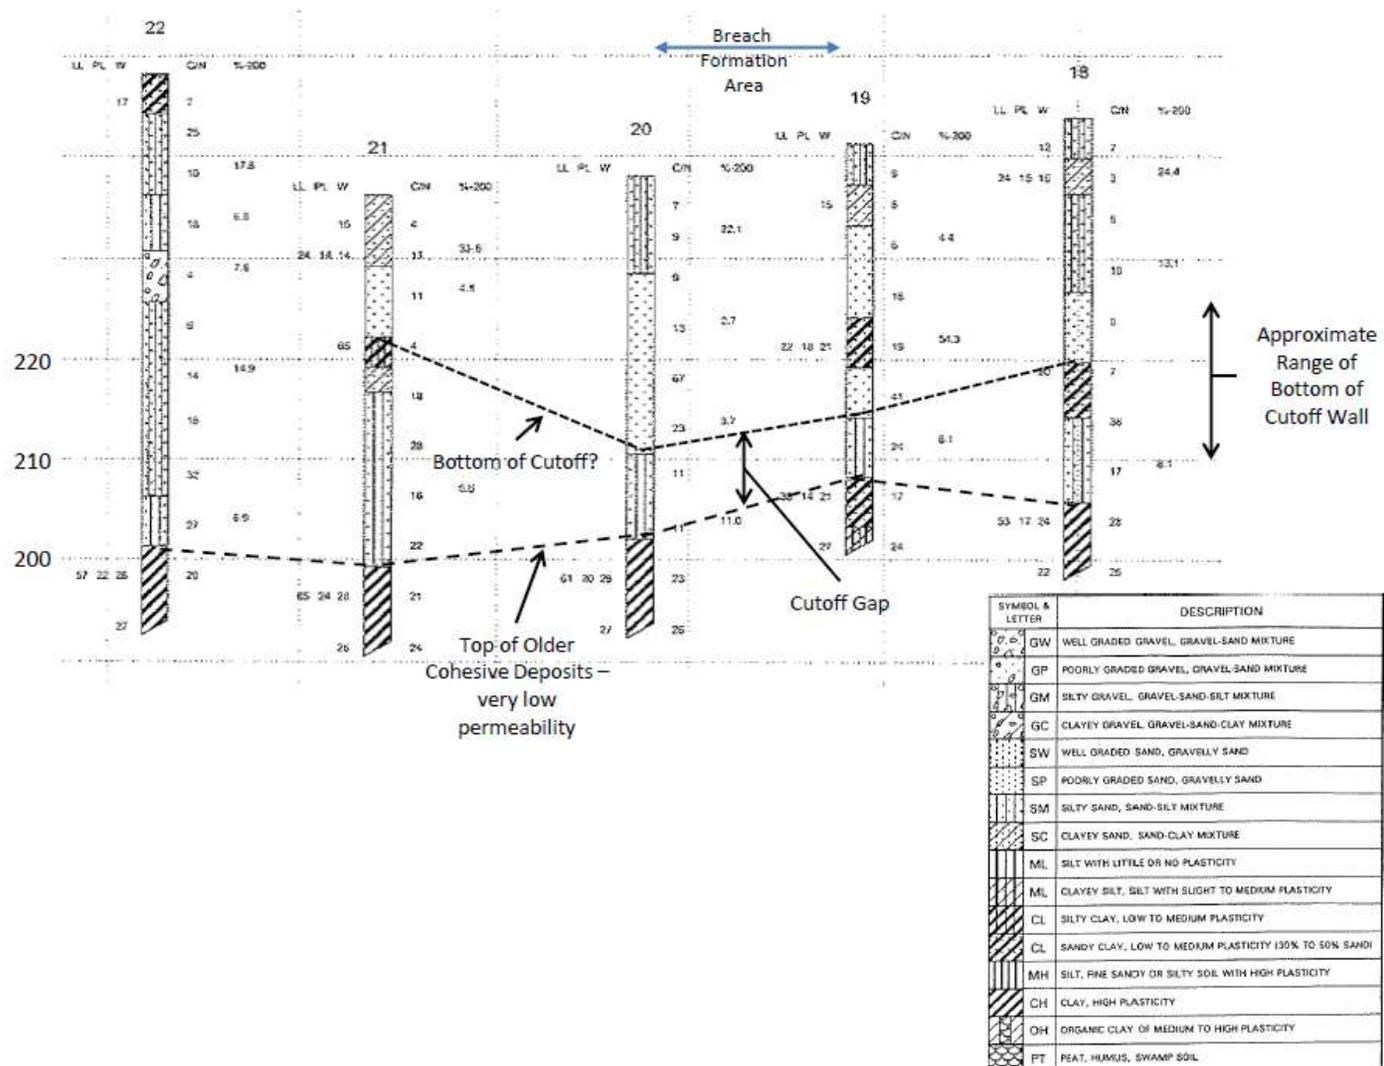
A fence diagram of boring results summarizing the foundation subsurface profile upstream of the planned cutoff wall location is shown on Figure 8. We have added two

lines to this figure showing the estimated bottom of the cutoff wall, and the approximate location of the top of the “older cohesive soils” at the site. As can be seen from the permeability results in Table 1, the upper foundation soils of the Bay Creek Basin Alluvium have permeability in the range of 10^{-3} to 10^{-4} whereas the “older cohesive soils” have permeability in the range of 10^{-8} to 10^{-9} range. The location where the breach occurred is generally indicated along the top of this figure. Comparing these two lines shows that a six- to ten-foot-thick “window” of higher permeability foundation soil was left below the cutoff wall. This window is a significant contributing factor to a potential failure mode development process as will be seen later in seepage analysis results.

In summary, data gathered following the dam failure indicates that the cutoff that was constructed did not fully penetrate the moderate to highly permeable shallow foundation soils. Older cohesive foundation soils with very low permeability are located at reasonable depth beneath the site. A complete cutoff system could have been achieved if the cutoff had been installed into this layer of “impermeable” foundation materials. In addition to this deficiency in the design and construction, the subsequent investigations of the cutoff wall summarized in Table 1 indicate that the permeability of the “cutoff” materials was variable by up to three orders of magnitude with the higher values providing “windows” that would allow for the development of preferential seepage pathways.

Figure 8. Estimated Bottom of Cutoff in Breach Formation Area

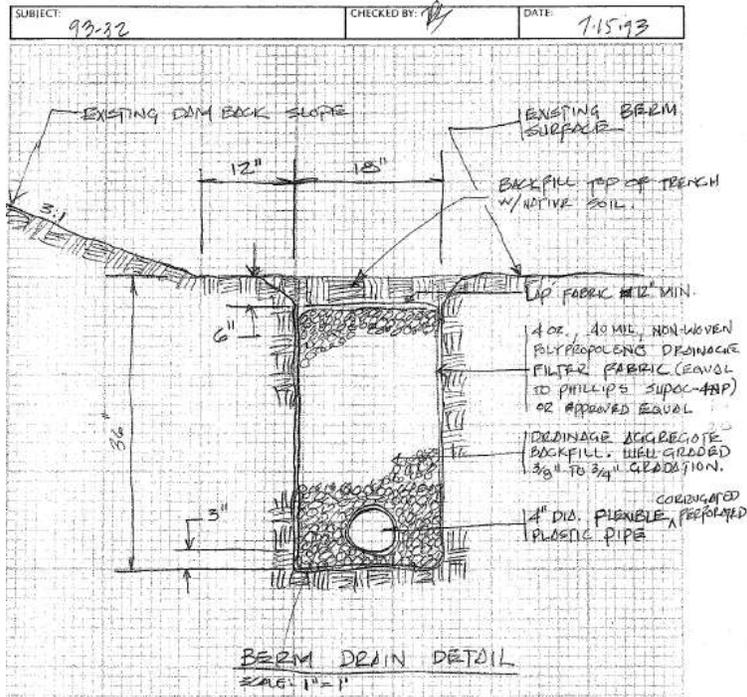
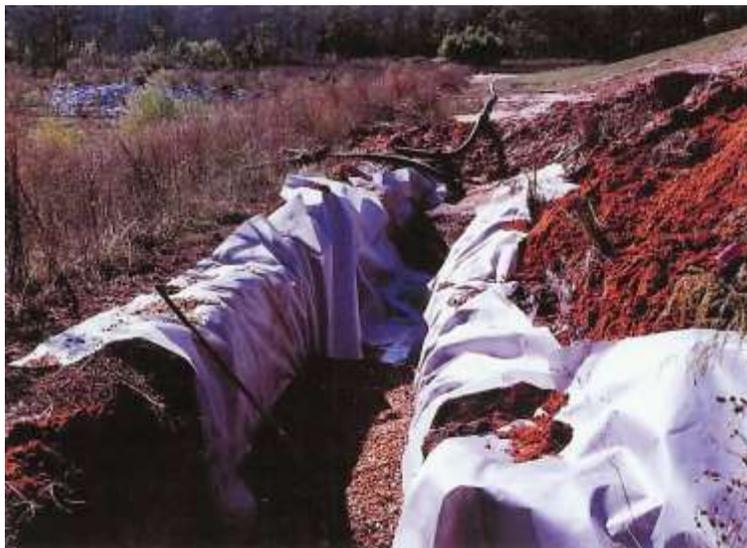
Two important seepage design and subsequent seepage repairs may have significantly contributed to the failure mode development process. First, the small toe drain system installed as part of the original construction and as part of several remedial actions were constructed with a method that would likely contribute to clogging of the drain over time. This is illustrated by the typical drain detail shown on Figure 9. A photograph of the typical installation of a toe drain is also shown on this Figure. You can see in the construction photo that the filter fabric was draped over the vertical sides of the excavation and there are numerous bubbles and very poor installation techniques that were used. This method of installation would not result in intimate contact between the filter fabric lining the trench and the adjacent foundation soils. This would allow soil particles from the soil face to move as seepage water exits from the foundation soils and flows into the drain. Over time, instead of acting as an effective filter/drain protecting the foundation and embankment materials from erosion by collecting and safely discharging foundation and embankment seepage, the filter fabric around the exterior of the drain would have clogged. A clogged drain could result in the localized increase of water pressures in the downstream toe area and a breakout of seepage at an unfiltered and/or uncontrolled location. It is also interesting to note the apparent tear/opening in the filter fabric in the lower right hand area of the photo. Such defects, combined with the possibility of clogging in other areas could result in the initiation of piping into the drain during later stages of the failure mode development process as described in items 1 and 2 of the failure mode description above.

Figure 9. Typical Trench Drain Design Detail and Construction

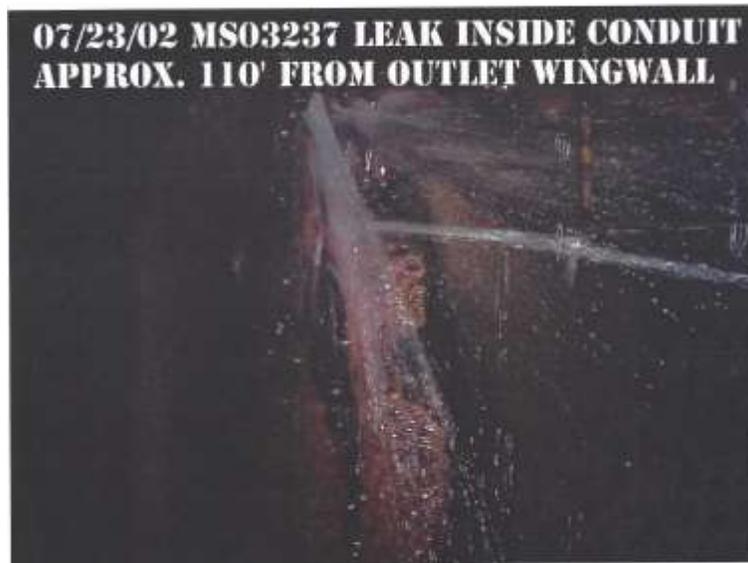
Information in the project record indicates that there were many locations where leakage was occurring into the outlet conduit once the reservoir filled. The characteristics of these leakage locations apparently changed over time. However, the two primary seepage locations indicated as distress locations 1 and 2 appeared to develop and flow for an extended period of time including the time of the July, 2002 inspection by the State Engineer. A photo of the downstream leak approximately 110 feet into the conduit from the discharge wing wall is shown on Figure 10. The discharge from the leak located near the upstream end of the conduit (254 feet from the discharge wing wall) was described as three discharges beginning about 10 inches above the box floor along the west wall. The

seepage ranged from a trickle to 1/4 to 3/8-inch stream with total flow of about 5 to 6 gallons per minute. The seepage described at both locations would be sufficient to carry the substantial majority if not all of the material sizes of embankment and foundation materials indicated on the gradation curves provided on Figure 6.

Figure 10. Photo of Leak Discharging into Conduit Approximately 110 Feet from the Outlet Wingwall. See Figure 7 for Approximate Location on Cross Section.

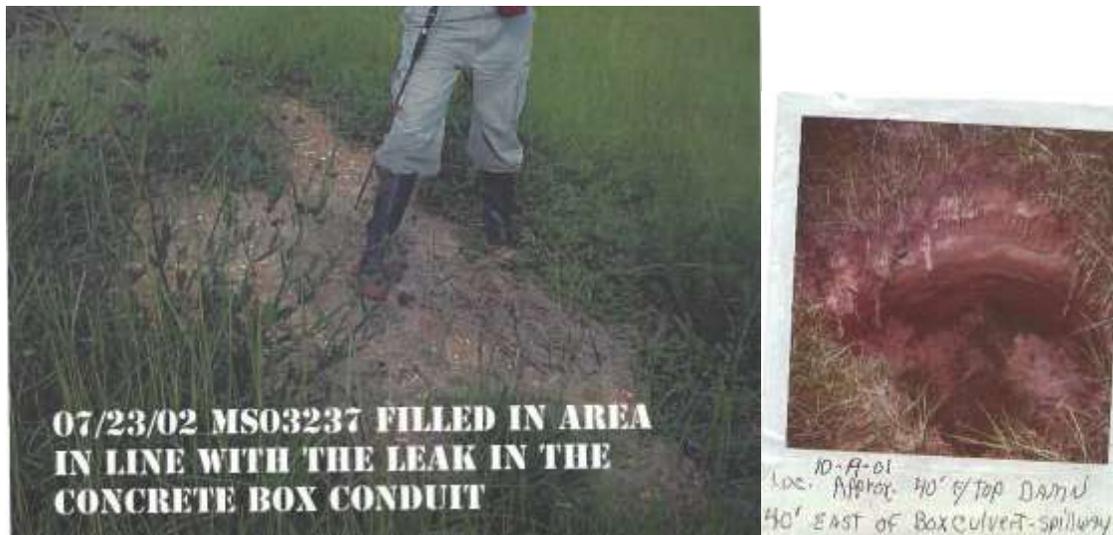
A sinkhole was discovered on a lower bench along the downstream slope of the dam. This sinkhole had been backfilled by the time of the State Engineer inspection in July 2002. Maintenance personnel indicated that the sink hole was over the top of the outlet conduit while the Engineer noted during deposition that it was located 30 to 50 feet east of the conduit. A photo of the backfilled sinkhole is shown on Figure 11. The possible locations of the sinkhole are illustrated on Figure 7. A circle with the number 3 is shown at the two possible bench locations described in the depositions.

Figure 11. Photo of Sinkhole Before and After Backfilling on the Lower Downstream Slope Bench. See Figure 7 for Approximate Location on Cross Section.

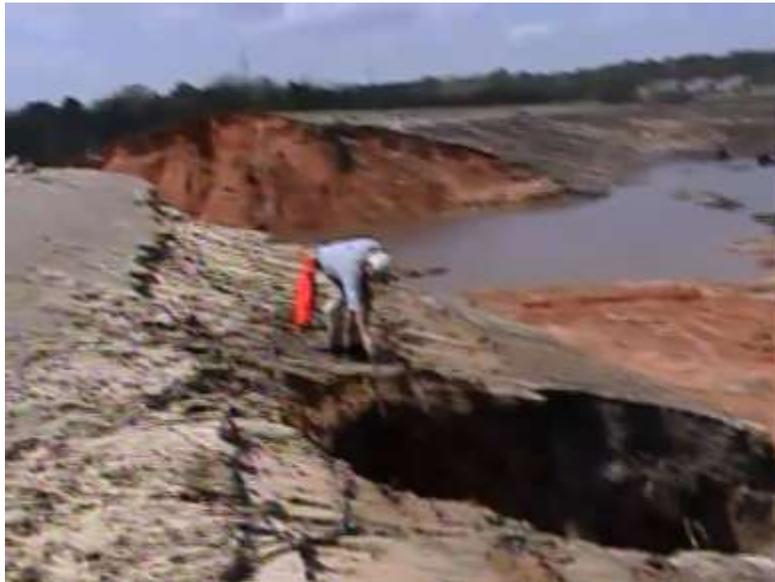
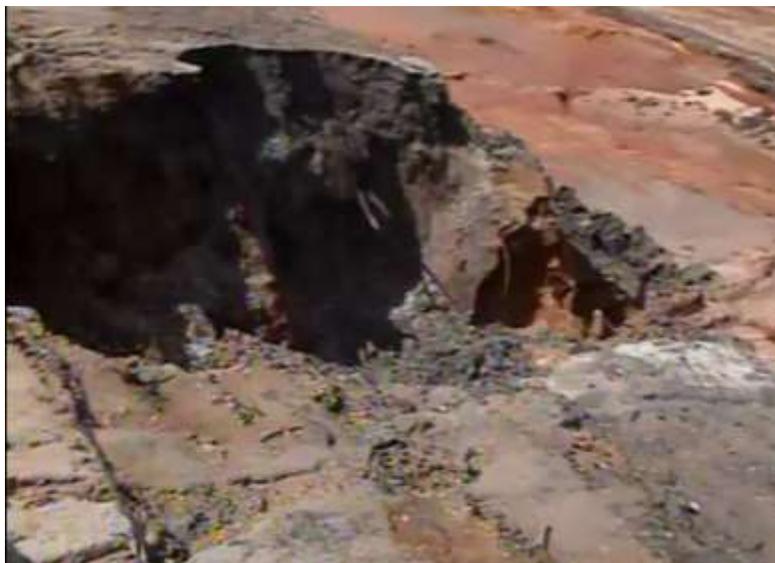
While inspecting various documents and photographs as part of this project review, a picture of a sinkhole on the upstream slope of the dam below the high water line and just outside the breach limits was discovered. A picture of this sinkhole is shown on Figure 12. While a bit unusual to be this far from the outlet conduit, there are no other identifiable conditions that could have led to its formation other than the potential failure mode associated with the outlet conduit. It is possible that several of these sink holes could have formed over the life of the structure with a different one being the primary failure mode pathway.

Figure 12. Photos of Sinkhole on Upstream Slope of Dam Following Breach Development. See Figure 7 for Approximate Location on Cross Section.

Step 4 – A partial open seepage pathway extending from the top upstream defect toward the upstream slope of the dam is added. This is consistent with the observed sink hole on the upstream face of the dam shown on Figure 12. It is the author’s opinion that such a defect and open seepage pathway developed rather quickly after the first filling of the reservoir due to the gradients, seepage quantities flowing through the conduit defect, and the highly erodible nature of the embankment and foundation soils at the site. Seepage conditions estimated by the model at the upstream end of the partially open pathway feature will help identify conditions capable of sustaining the erosion process under this step in the failure mode development process. Note that for the final seepage model, this step was modeled in two increments; 4a, and 4b.

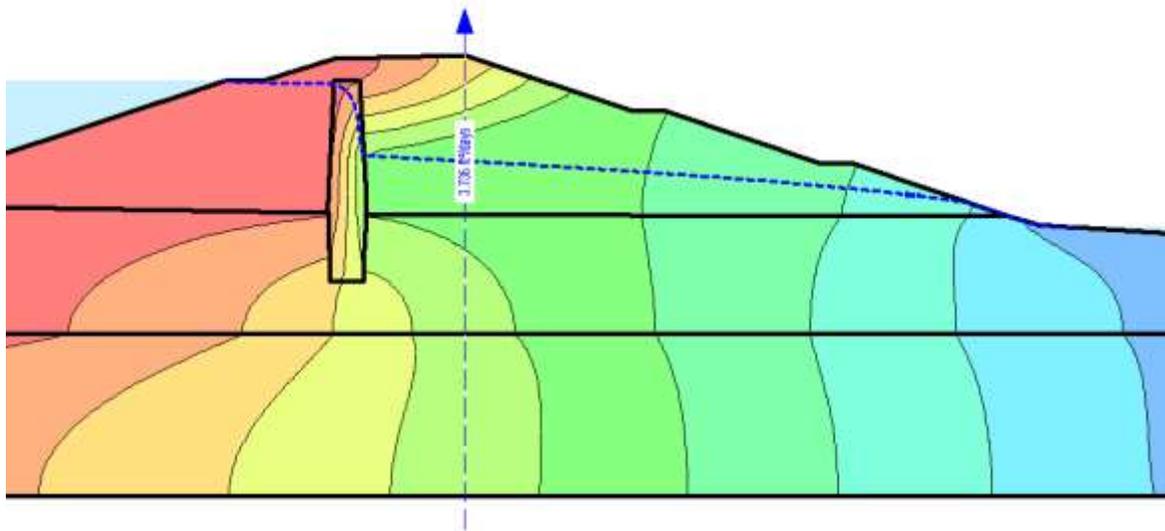
We begin by examining the results of the seepage modeling of Step 1 and Base Case 1 (with cutoff wall) at the cross-section of the embankment and foundation immediately adjacent to the conduit. These model results represent the seepage conditions that would have been expected for the as-designed condition without the influence of defects in either the cutoff wall or conduit and neglecting any consideration of the nominal toe drain system or the seepage remediation constructed around the downstream end of the conduit in 1999. Equipotential lines and seepage gradient contours for these conditions are shown on Figures 14 and 15. The equipotential lines on Figure 14 show the influence of foundation seepage through the “window” beneath the cutoff wall that would have occurred. If the cutoff wall had been extended into the low permeability older alluvium

at the site, the phreatic surface within the embankment would be substantially lower than indicated on this Figure. The phreatic surface that is shown is the result of “mounding” of seepage from the foundation up into the embankment that is typical when incomplete or defective cutoffs are installed. The total estimated seepage through this cross-section is about 0.02 gpm per foot of embankment. This corresponds to about 2 gpm per 100 feet of embankment. Significant defects in the cutoff wall could impact several important aspects of seepage within the dam and foundation that are difficult to simulate in a 2D seepage model: 1) localized increases in the phreatic surface, 2) slightly increasing seepage quantities, and 3) increasing seepage exit gradients at the toe of the embankment and from the foundation immediately below the toe of the dam.

Figure 14. Equipotential Lines for Step 1, Base Case 1, Embankment Adjacent to Conduit

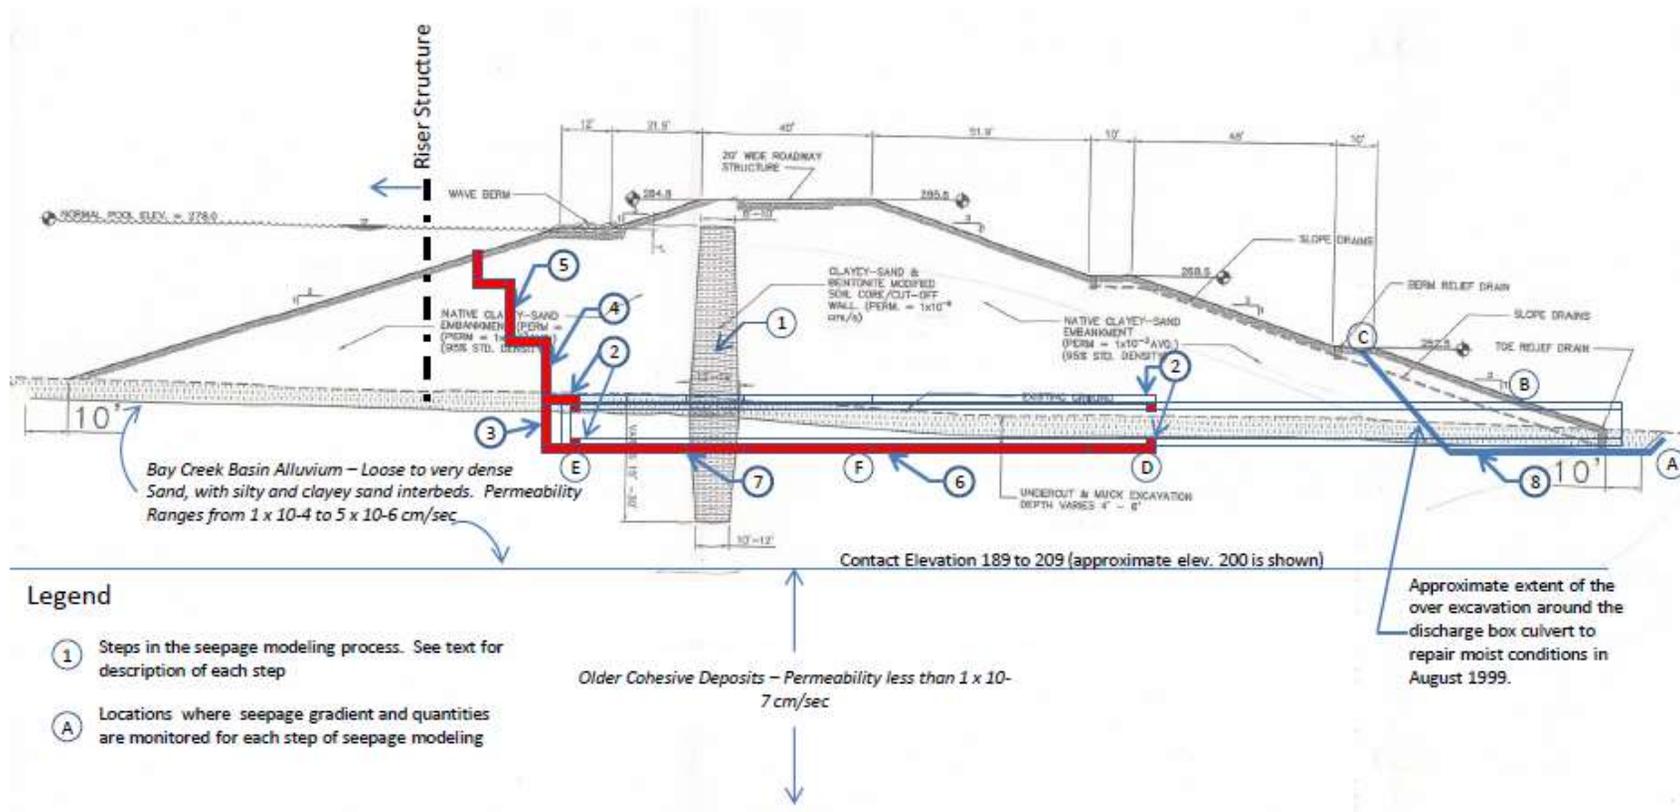
Figure 13. Cross-section of Dam and Outlet Conduit Showing Seepage Modeling Steps 1 through 8 and Model Result Evaluation Locations A through F

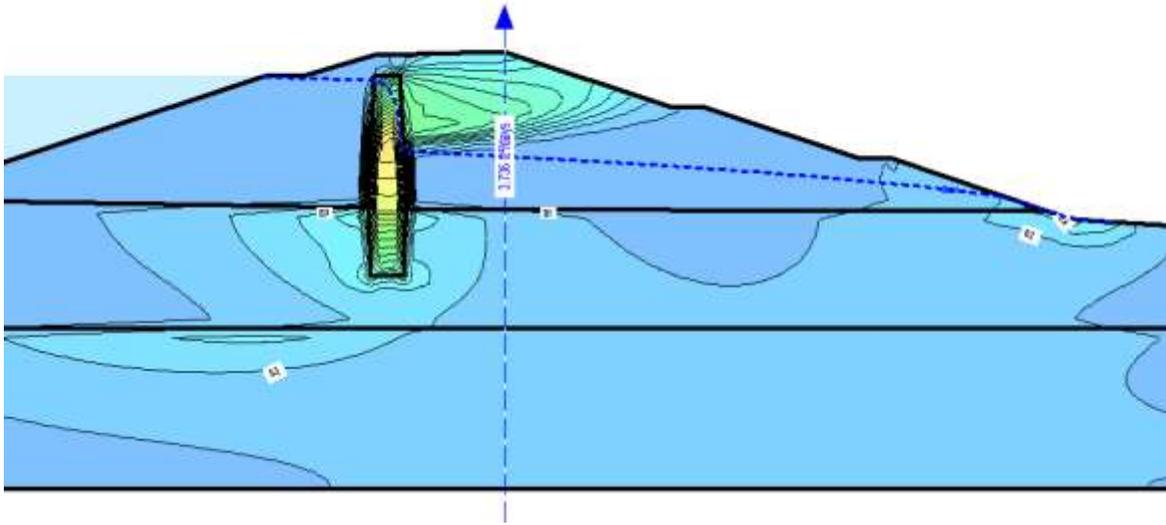
The seepage gradient contours along the cross-section including the downstream toe area are shown on Figure 15. The maximum seepage exit gradient occurs where seepage exits from the foundation immediately below the toe of the dam (location A). This would be the expected result from the partial foundation cutoff. The model suggests a maximum exit gradient that is about 0.4. This gradient is colored a cautionary yellow in the upper portion of Table 3. While it is lower than “critical” for these materials suggesting that general gradients would be less than necessary to initiate erosion along the toe of the dam, this gradient is high enough to indicate the need for a well designed and constructed embankment/foundation drainage system to account for potential geologic and construction defects, and produce an adequate level of seepage safety for the structure. When the cutoff wall is eliminated from the model, the estimate maximum seepage exit gradient at the surface of the foundation immediately below the downstream toe of the dam increases to 0.6. This high exit gradient has been colored red in the lower portion of Table 3 as it indicates inadequate margin of safety and a high likelihood of seepage distress area development associated with minor geologic or construction anomalies.

Figure 15. Seepage Gradients for Step 1, Base Case 1, Embankment Adjacent to Conduit

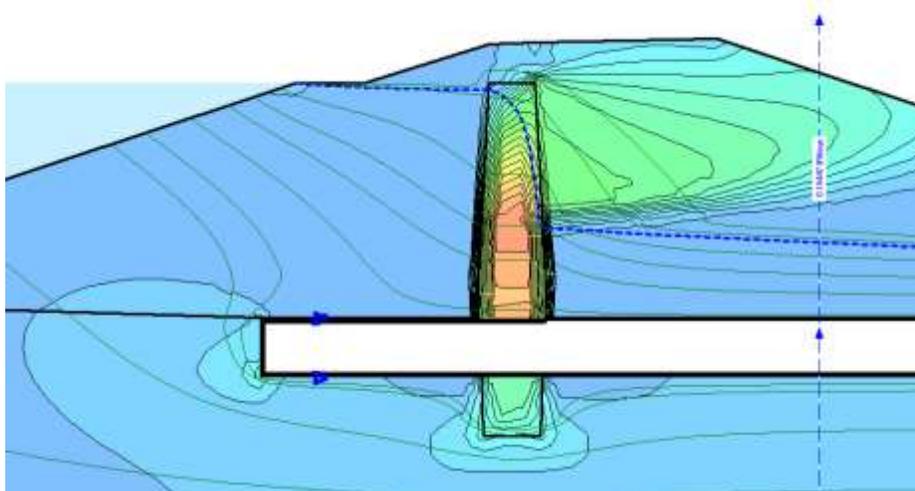
Figure 16 and 17 show estimated seepage gradients in the embankment and foundation along the model cross-section that includes the seepage conduit. Figure 16 shows gradients at the upstream end of the conduit at the end of Step 1, Base Case 1 without an open conduit defect, and Figure 17 shows the seepage gradients estimated at the end of model Step 2 when the defects at both the top and bottom of the conduit at the upstream defect are opened. As can be seen by the gradients summarize at assessment point E in Table 3, the conduit defects have a significant influence on gradients and seepage conditions in both the embankment and foundation and are high enough to indicate initiation of erosion through the defects. In fact, considering 3-D effects, the model results summarized in Table 3 suggest that the exit gradients at the defects are sufficient to initiate and sustain embankment and foundation erosion at both the upstream and downstream defect locations.

Figure 16. Seepage Gradients, Step 1, Base Case 1, Conditions along Conduit Cross Section

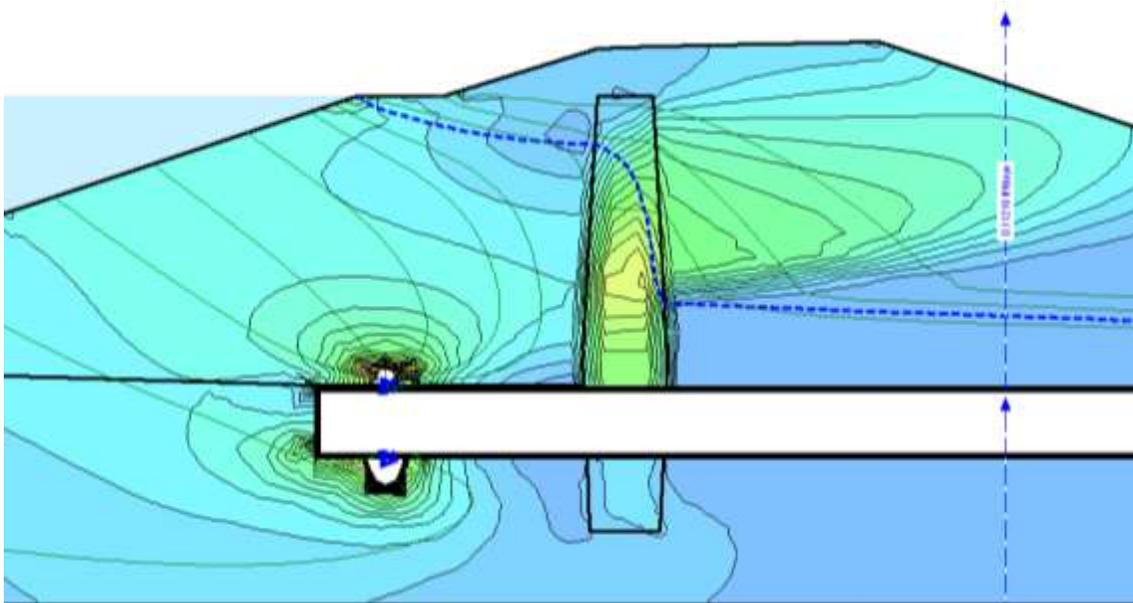
Figure 17. Seepage Gradients, Step 2, Base Case 1, Conditions along Conduit Cross Section

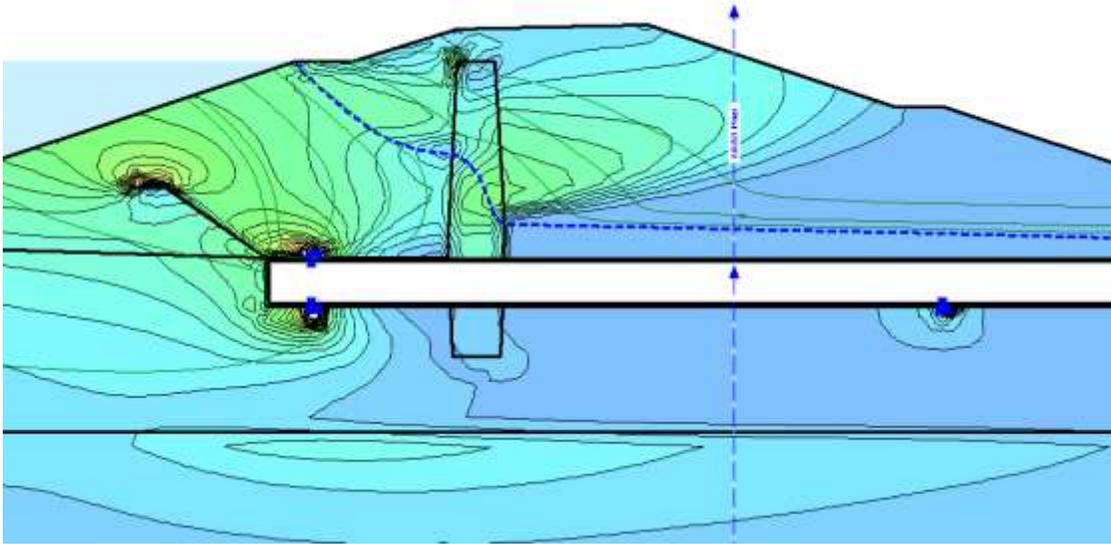
Seepage gradients in the upstream portion of the embankment and foundation, and near the downstream conduit defect at the end of Step 4b are shown on Figure 18. These results indicate that once a “piping” defect extending from the conduit defect into the embankment is introduced into the model during Steps 3, 4a, and 4b, gradients at the opening of the conduit defects drop into a cautionary range. However, exit gradients in the embankment adjacent to the upstream conduit defects as well as the into active front (upstream end) of the “piping” defects in the embankment remain very high (substantially above 1) and indicate that the erosion process would continue and accelerate as the defect approaches the upstream face of the dam. The seepage exit gradients from the embankment into the area adjacent to the conduit defects further suggest that other erosion pathways could develop even if a primary “piping” pathway has continued a portion of the distance toward the upstream face of the dam. As expected, the seepage quantities predicted by the model are substantially lower (0.03 gpm at the upstream defect, and 0.002 gpm/foot at the downstream defect) than observed discharging from the defects (up to 5 to 6 gpm at each location) during later inspections. While the model results do not indicate sufficient seepage quantities, the observed conditions at the defects described in the preceding sections indicate ample flow to sustain a steady continuation of erosion through the developing erosion features.

Figure 18. Seepage Gradients, Step 4b, Base Case 1 Conditions along Outlet Conduit Cross Section

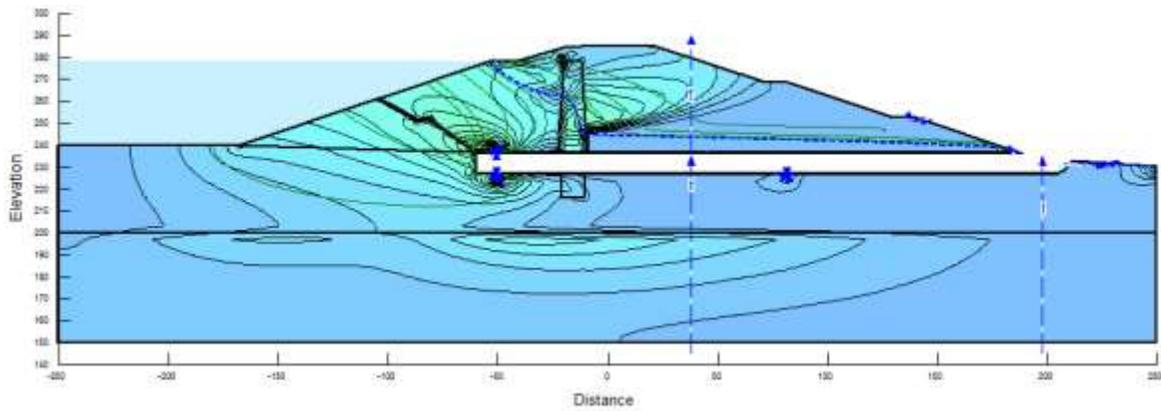
Seepage gradient contours, and equipotential lines within the model containing the outlet conduit at the end of Step 7 are shown on Figures 19 and 20. Estimated seepage gradients and flow quantities at each of the assessment points are presented for Steps 7 in Table 3.

Figure 19. Gradient Contours at end of Step 7, Base Case 1

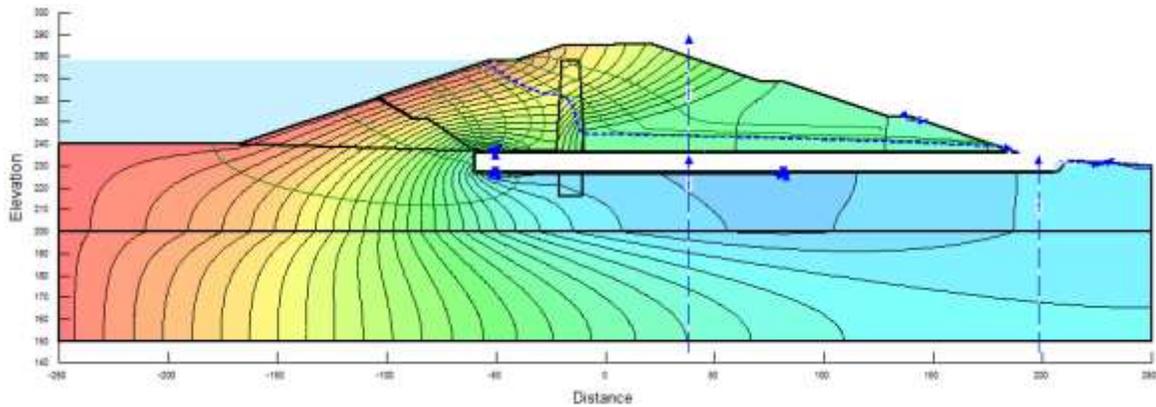
Figure 20. Equipotential Lines at end of Step 7, Base Case 1

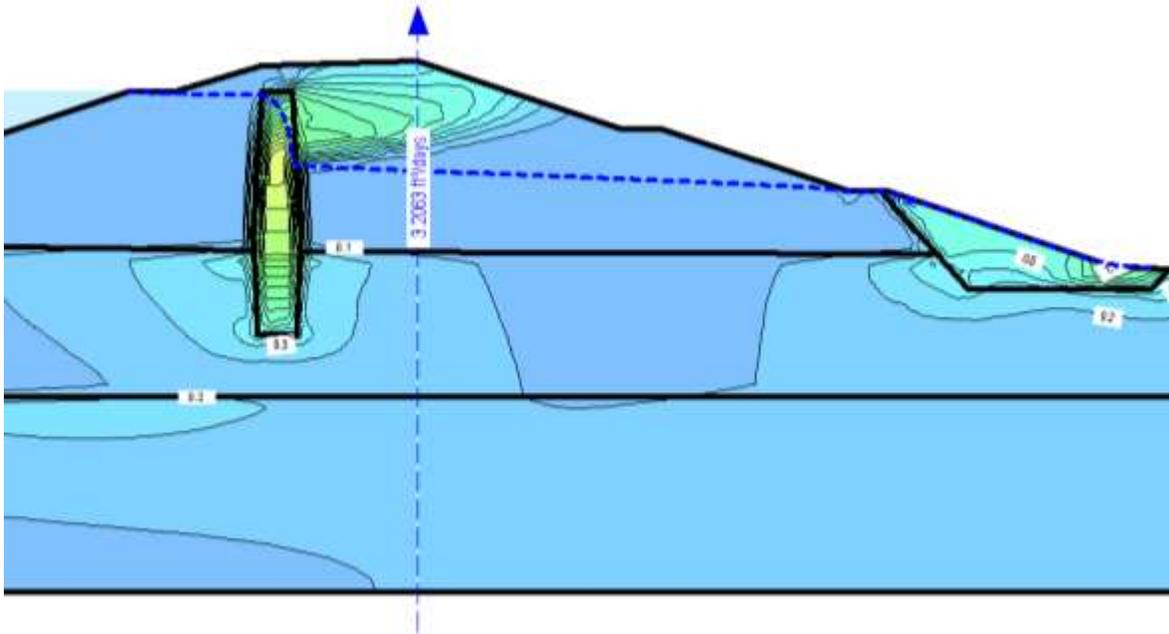
Figure 21. Effect of Clogging of 1999 Seepage Remediation Discharge End of Outlet Conduit on Phreatic Surface and Seepage Exit Gradients

However, the effect of this treatment on seepage flow patterns, and discharge gradients at the downstream toe could have been much more significant as indicated by the results shown on Figure 21. While we fully appreciate the limitations of the 2-dimensional seepage model to adequately represent the effect of clogging, the results shown on this figure would certainly suggest that the effect of the clogging of this remediation feature ,

particularly when combined with the effects of other piping defects simulated with earlier modeling steps described above, could have substantially increased the seepage exit gradients and flow quantities at the lateral and downstream margins of the feature. Further, any defect in the toe drain or in the foundation at this margin could have been easily exploited leading to the final stages of failure mode development similar to what has been described by both the Engineer and Maintenance Man during depositions. Hence, we have indicated that the exit gradients at the downstream toe of the dam (assessment point A), at this point in the failure mode development process would have been greater than (perhaps significantly greater) than the initial (Step 1) values as noted in Table 3.

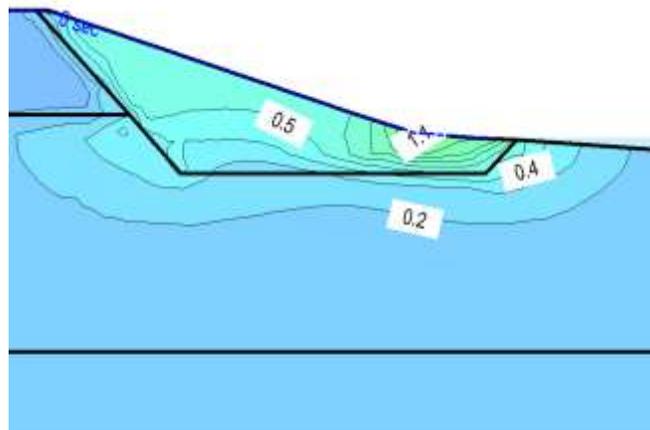
Figure 22. Close-up of Estimated Seepage Gradients Near Downstream Toe Resulting from Clogging of Seepage Remediation Feature
