Influence of Tree Roots and Mammal Burrowing Activity on Levee Performance: Volume 1. – Review of Literature and Case Histories

Technical Report · August 2013

Geotechnical Engineering
University of California, Berkeley
Report UCB GT 13-03 vol. 1

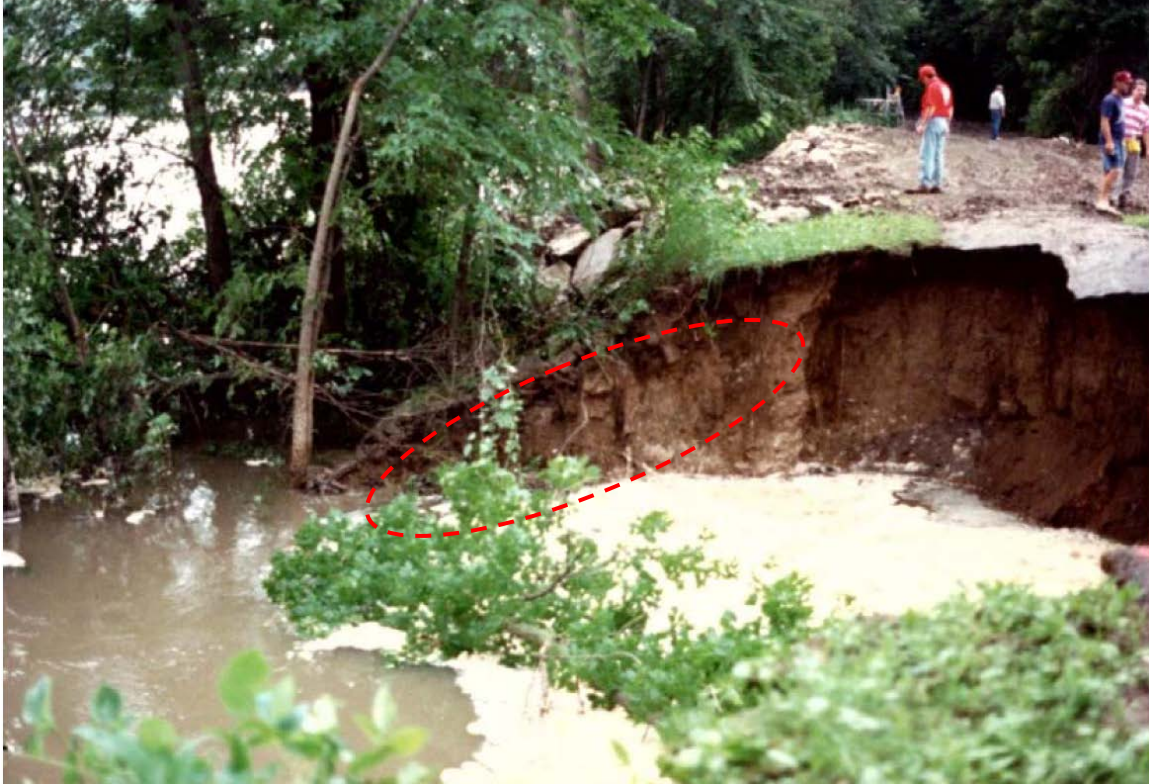
During the 1993 event, the river was reported to have crested one to two days before the breach occurred, and the breached levee was known for having been constructed with poor compaction, having no under or through seepage remediation measures, having steep slopes under constant erosion from the river and having heavy tree growth (Figure 2-2 and Figure 2-3). Once the waters began to recede, the engineer in charge of the report states that *“saturated levee embankments in this reach began a catastrophic failure, with large segments of the levee material slumping into the river. Several massive root balls were observed in the area where the levee failed. Ultimately the levee slumping passed through the levee crown and into the landside of the levee...the heavy tree growth hindered levee inspections and monitoring during the flood fight as well as the remedial constructive measures that were undertaken on the landside of the levee”*. The inspection report goes on to state that *“the large trees located on these saturated slopes added to the instability of the levee with dead and wind loads contributing to the failure of the levee. While original construction standards on material compaction were inadequate, the failed areas of the levee revealed significant root growth throughout the levee, which likely further facilitated the saturation of the levee embankment when record river stages were occurring”*.

This last statement suggests the possibility of saturation of the levee prism was enhanced by seepage paths along the roots, but no direct or specific evidence was provided. The fact that the failure occurred while the waters were receding and progressed from the waterside slope to the landside indicates that these failures could have been related to a rapid drawdown slope instability condition rather than root-aided seepage forces.

Figure 2-2. 1993 Des Moines River breach (USACE, 1993). Red oval highlights root system

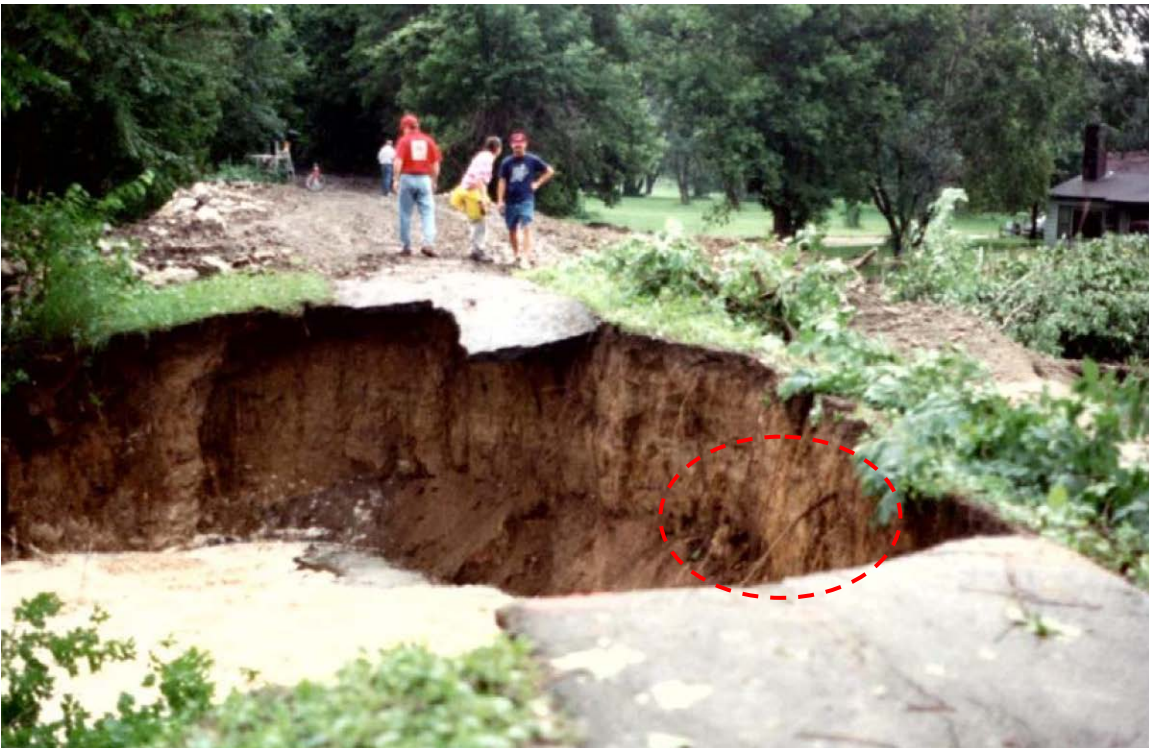
Figure 2-3. Downstream view of Des Moines River levee break (USACE, 1993). Red oval highlights root system

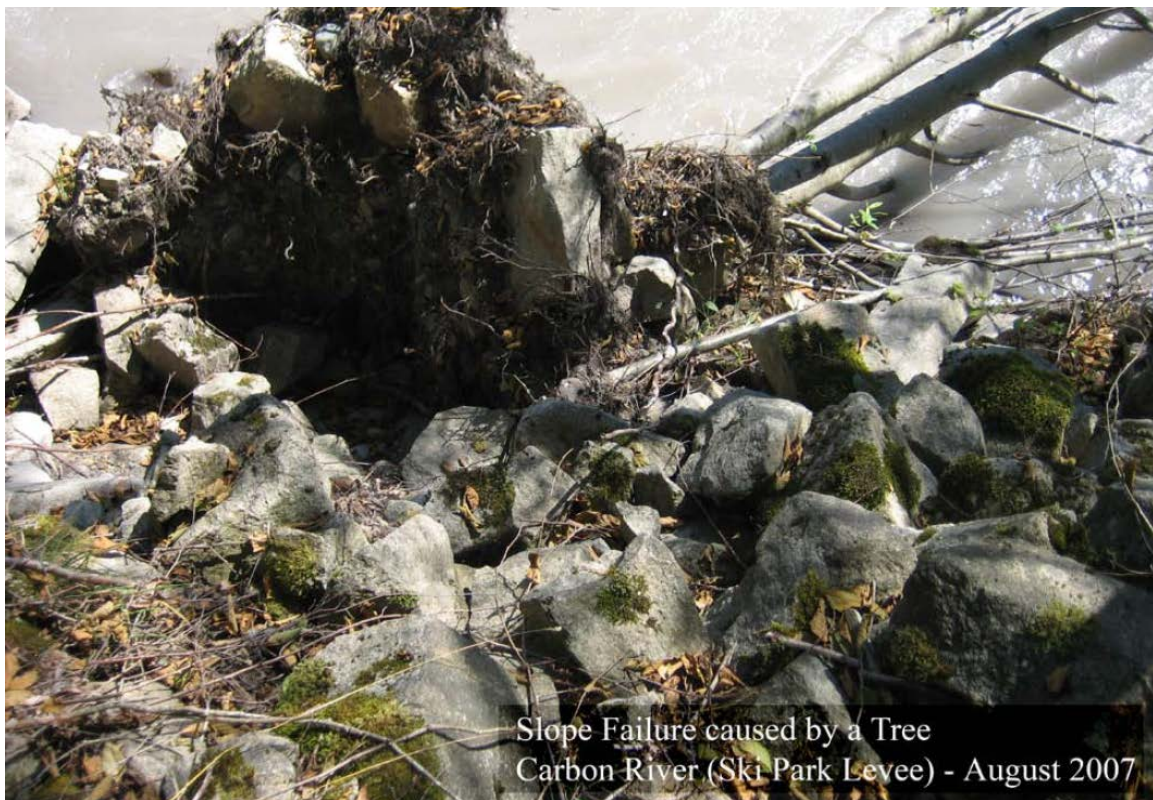
An August 2007 USACE report describes localized waterside levee slope damage near Orting, WA, after an alder tree was toppled in a windstorm and removed surficial soil and erosion armoring from the surface. No measurements of the hole left by the root system were provided, but it appears that the tree lifted a shallow 'slab' of soil (Figure 2-4). No levee failure or distress was reported at this site.

Figure 2-4. Erosion on waterside slope after tree toppling (USACE, 2007)

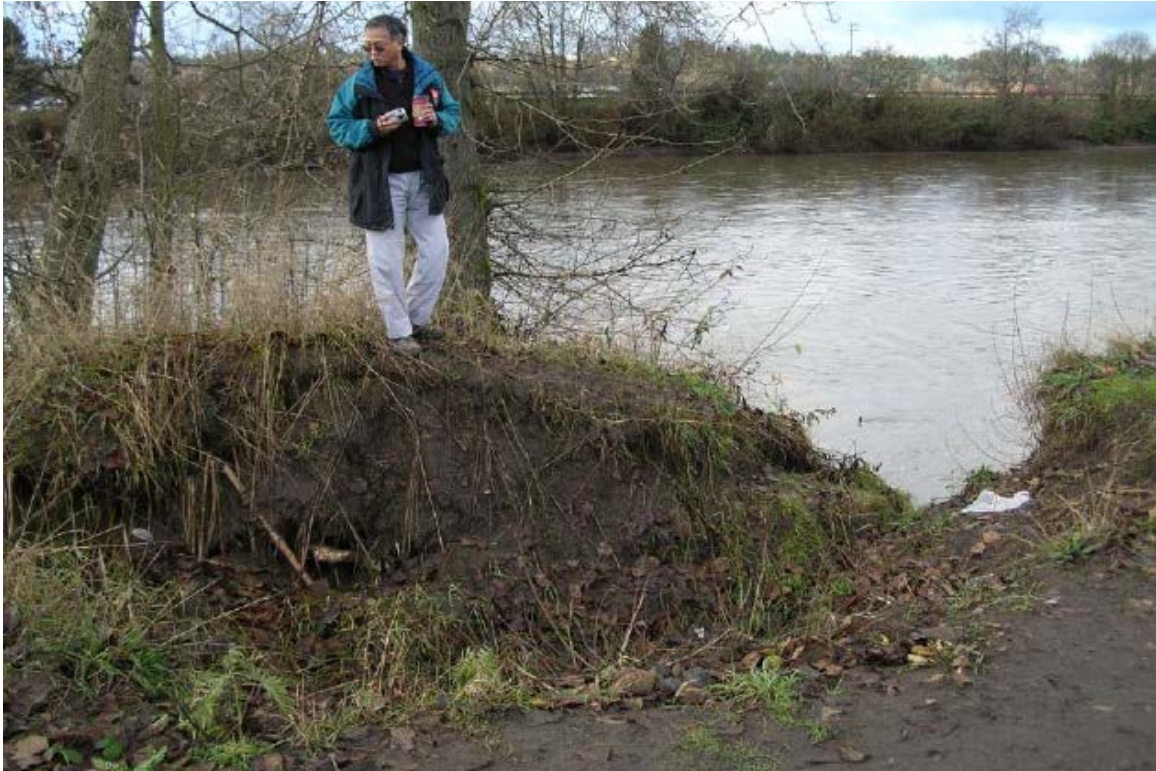
Vegetation-induced levee damage in December 2005 was reported by the USACE on the levee along the Puyallup River near Tacoma, WA. This incident report indicates that soft soil conditions, along with wind loads and river incision contributed to a cottonwood tree toppling over and removing soil from the waterside levee slope (Figure 2-5). No further indication of damage or reconstruction is provided in the incident report, but the report indicates that this type of occurrence is common in the area and toppled trees pull out material adjacent to the levee prism. In this case, the root ball pulled a mass of soil near the waterside toe of the levee.

Figure 2-5. Cottonwood root plate toppled on Puyallup River (WA). Image courtesy USACE

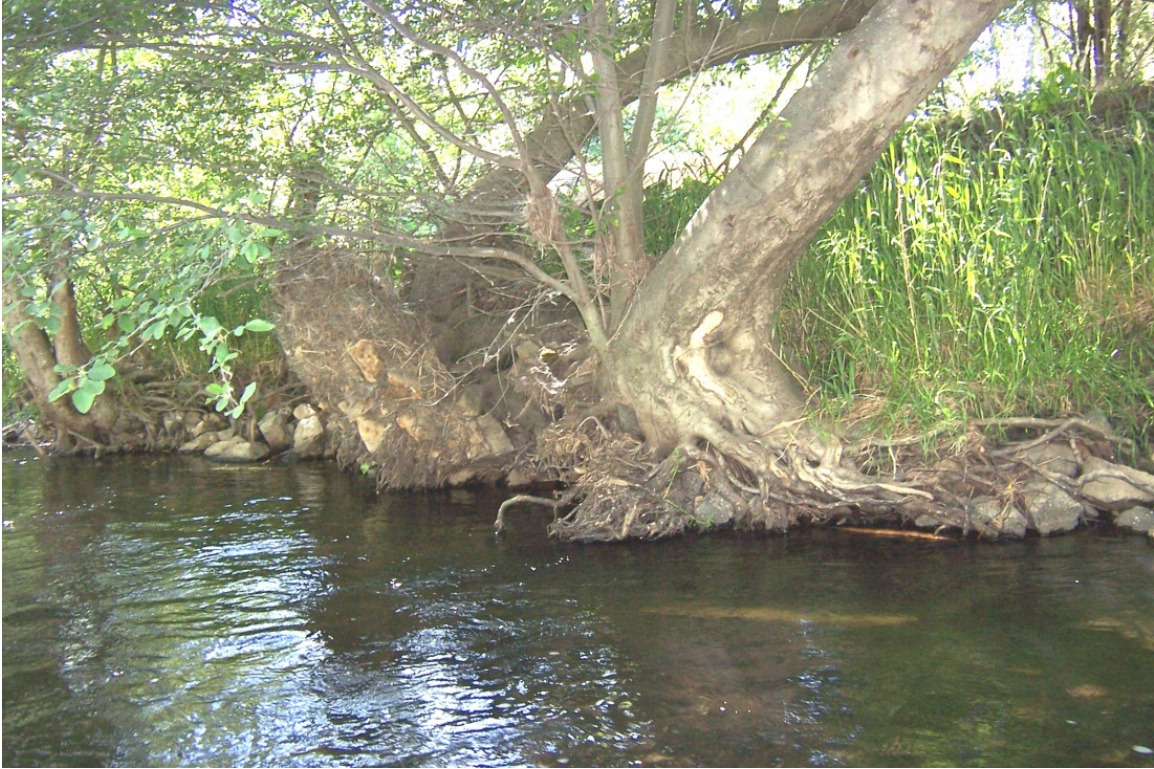
Similar to the case on the Puyallup River (Figure 2-5), in 2008 high wind caused several trees to topple and remove soil and erosion protective riprap from the waterside slope of the Lindley levee (USACE, July 2008). The levee appeared to have had very little maintenance and trees and shrubs grew uncontrolled on the waterside slope (Figure 2-6). The report does not give an indication as to how deep the hole left by the root system was as the tree toppled, nor how many of these incidents occurred along the Touchet River. A failure or breach of the levee did not occur.

Figure 2-6. Damage on waterside toe, Touchet River (USACE, 2008)

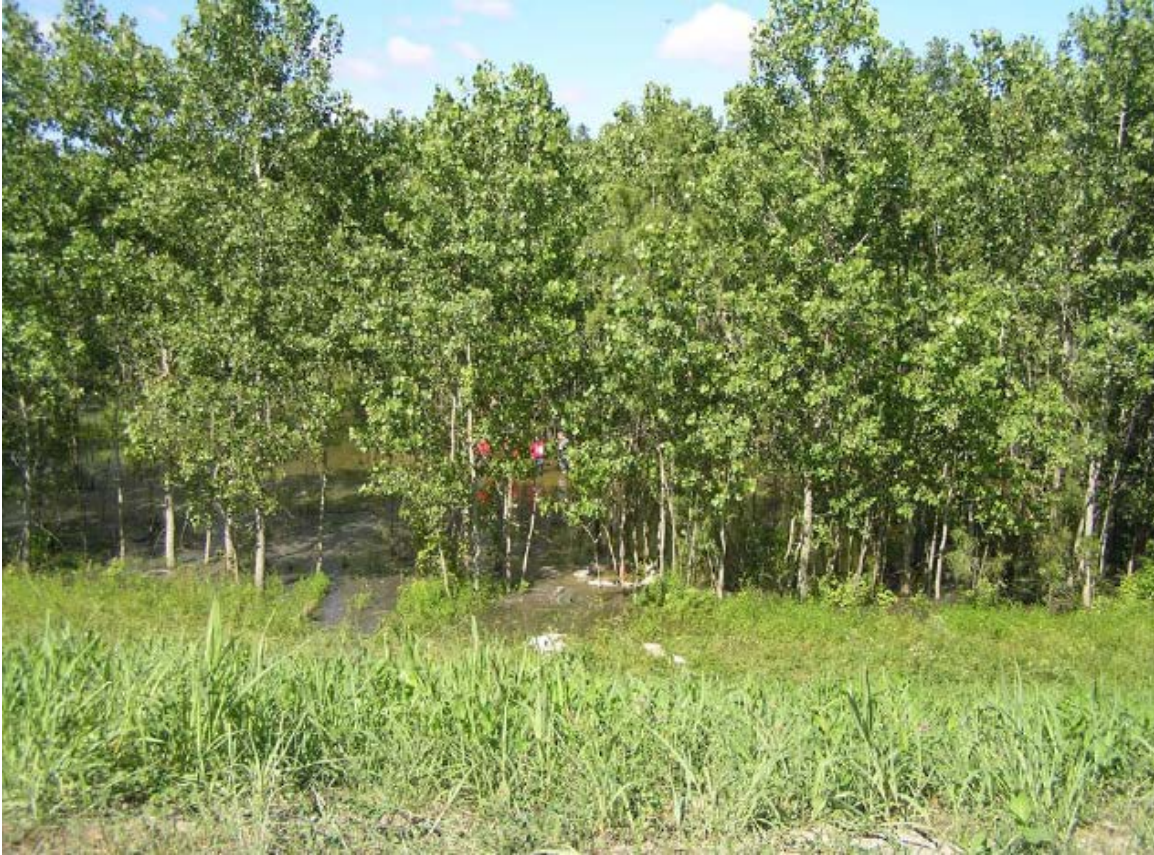
The St. Genevieve #2 levee along the Mississippi River was subjected to severe water loading during June 2008. The USACE post incident inspection report provides a description of the levee distress that seems to have been related to presence of woody vegetation near the landside toe. On 28 June several active sand boils were reported in a heavily vegetated area (Figure 2-7) which were observed to be flowing water and soil. Flood fighting activities lasted over five days; local authorities built sand bag rings around the active boils (Figure 2-8) and allowed the toe area to flood several feet to reduce the hydraulic head differential and stop the flow of material through the sand boils.

According to the incident report, the largest boil was approximately 1 meter in diameter and most of the boils were encountered in a low spot with a dense line of trees. After the fifth day of flood fighting some boils were still active and a 200 m (600 ft) long rock berm was placed to increase the stability of the toe area, but new sand boils developed upstream of the berm.

Figure 2-7. View of landside toe area, St. Genevieve levee distress (USACE, 2008)

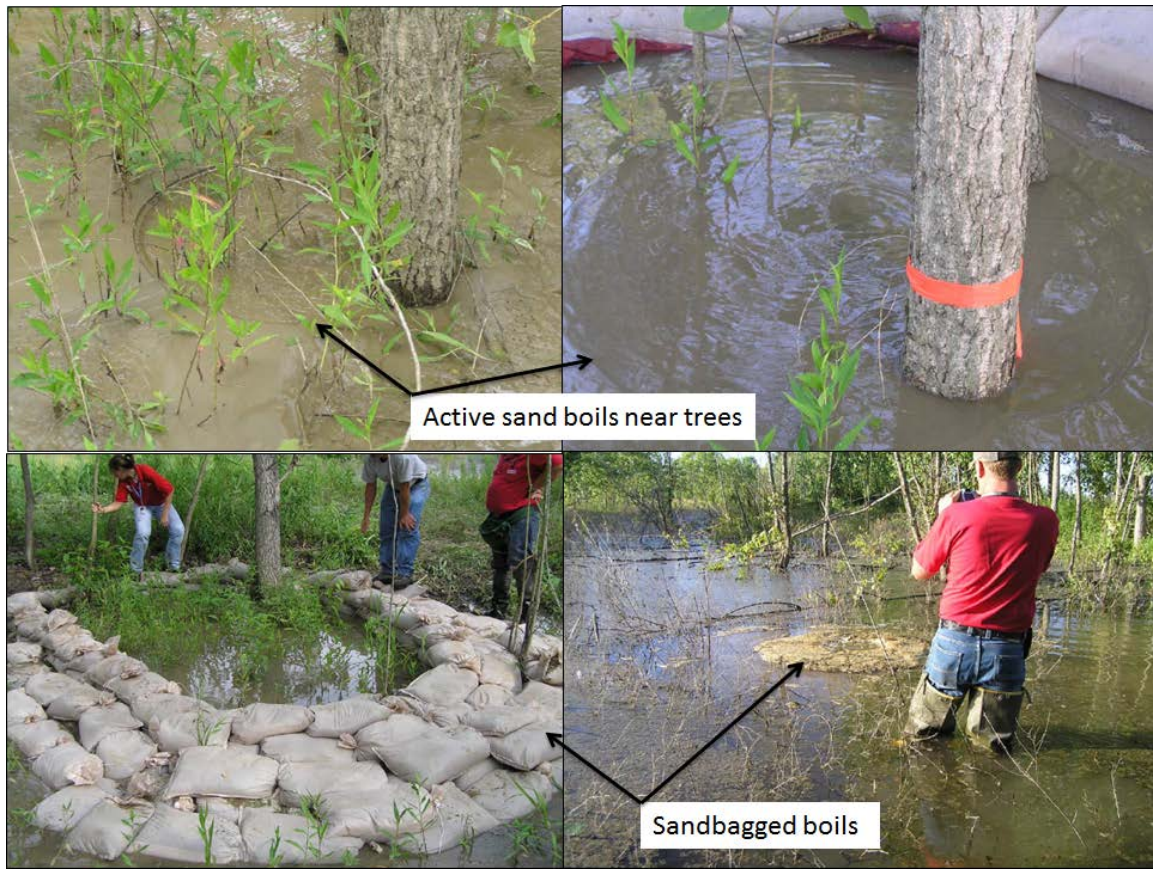
Figure 2-8. Active sand boils around trees, St. Genevieve levee distress (USACE, 2008)

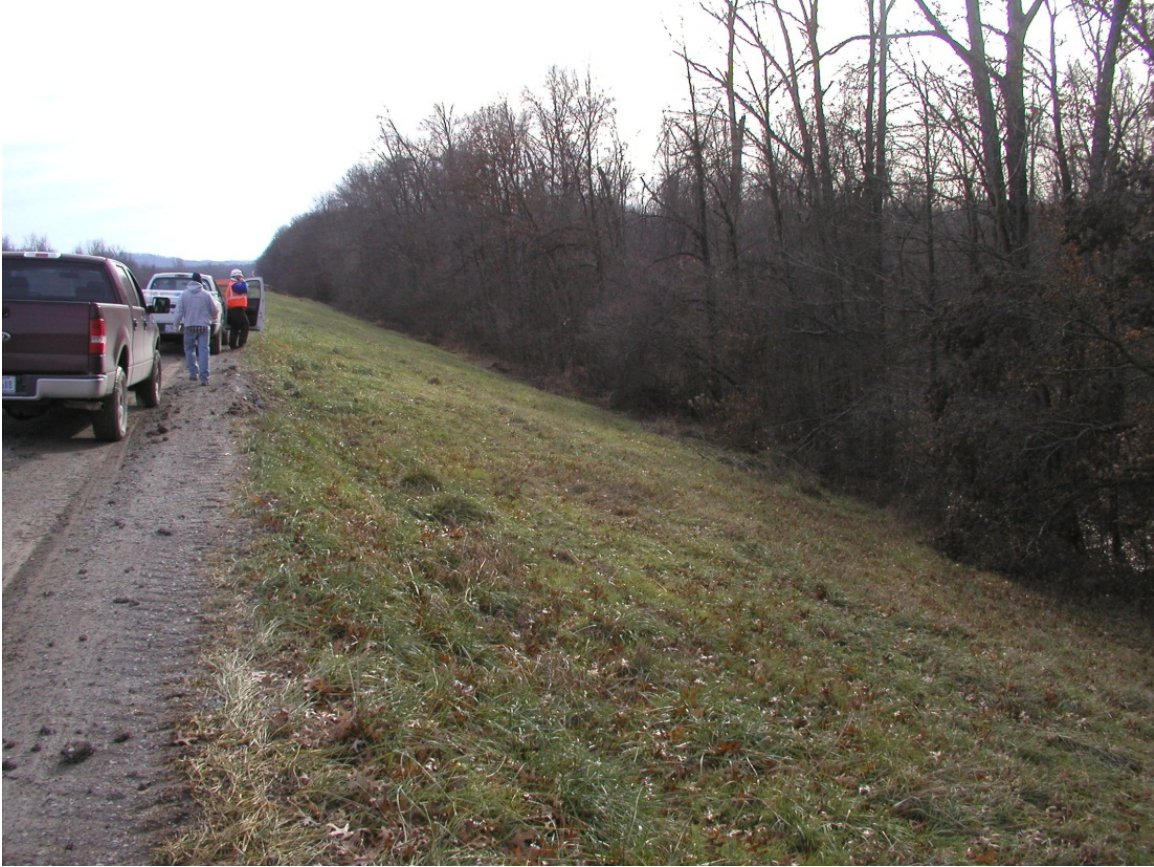
Several shallow landslides along the protected landside toe of the Grand Tower and Degognia levee in Southern Illinois occurred in 2008. At this location, trees were present along long stretches of the landside toe (Figure 2-9). Landslides appear to be a common occurrence in the area and are associated with high-plasticity clays used for embankment material and not necessarily associated with the presence of woody vegetation near the toe of the levee. The report indicates that the trees inhibited maintenance and did not allow for staging materials and equipment for repairs to be performed, but no direct relation to the observed failure was given.

Figure 2-9. Trees along landside toe. Grand Tower Levee (USACE, 2008)

However, the USACE report concludes that *“without a vegetation clear zone at the toe of the levee, the slides in the affected levee stretches cannot be repaired. If the slides are not repaired the integrity of the levee is affected by a decrease in the factor of safety which puts the protected area at increased risk for flooding. If the trees were removed and a vegetation clear zone of 15 feet was maintained the existing and future levee slides could be repaired”*.

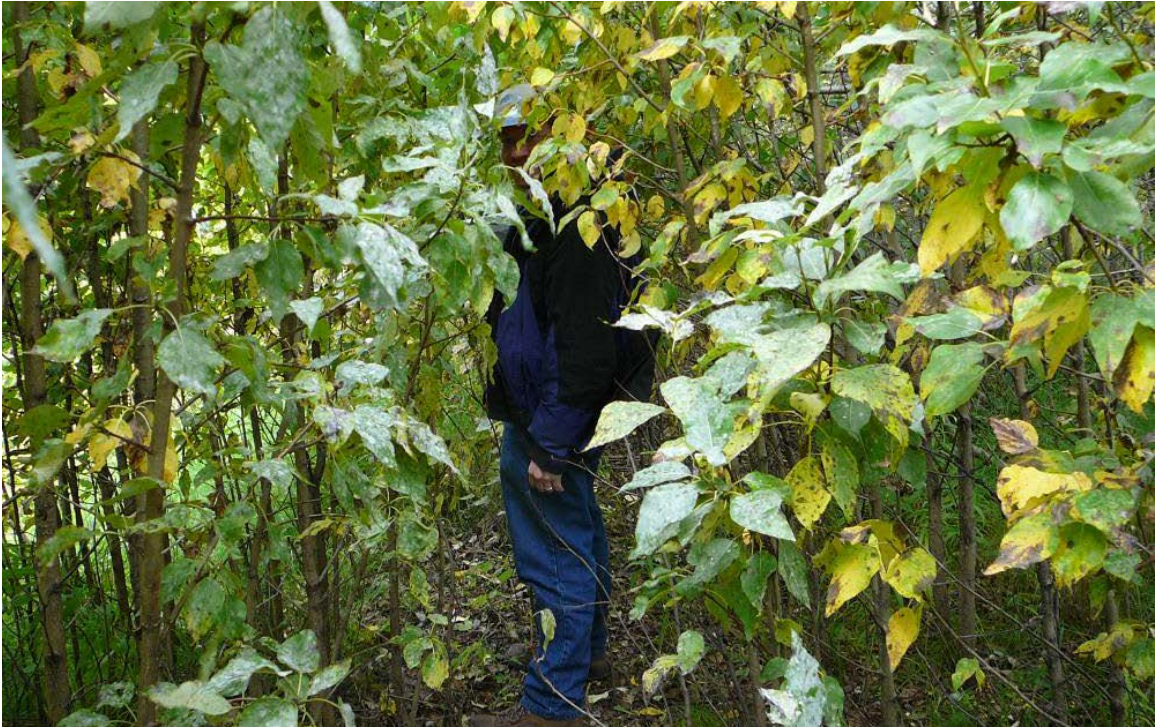
Figure 2-10. Dense vegetation inhibiting visual inspection along Aniak levee in Alaska (USACE, 2008)

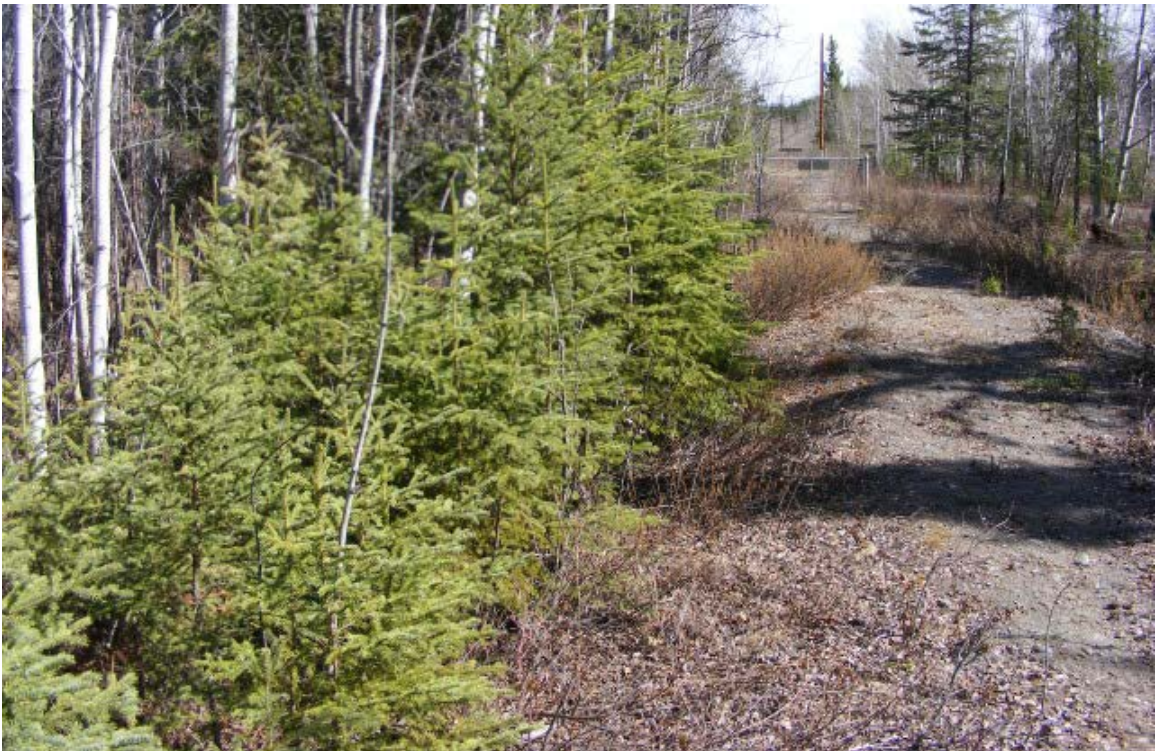
Figure 2-11. Vegetation covered slopes, Klutina River levee, Alaska (USACE, 2008)

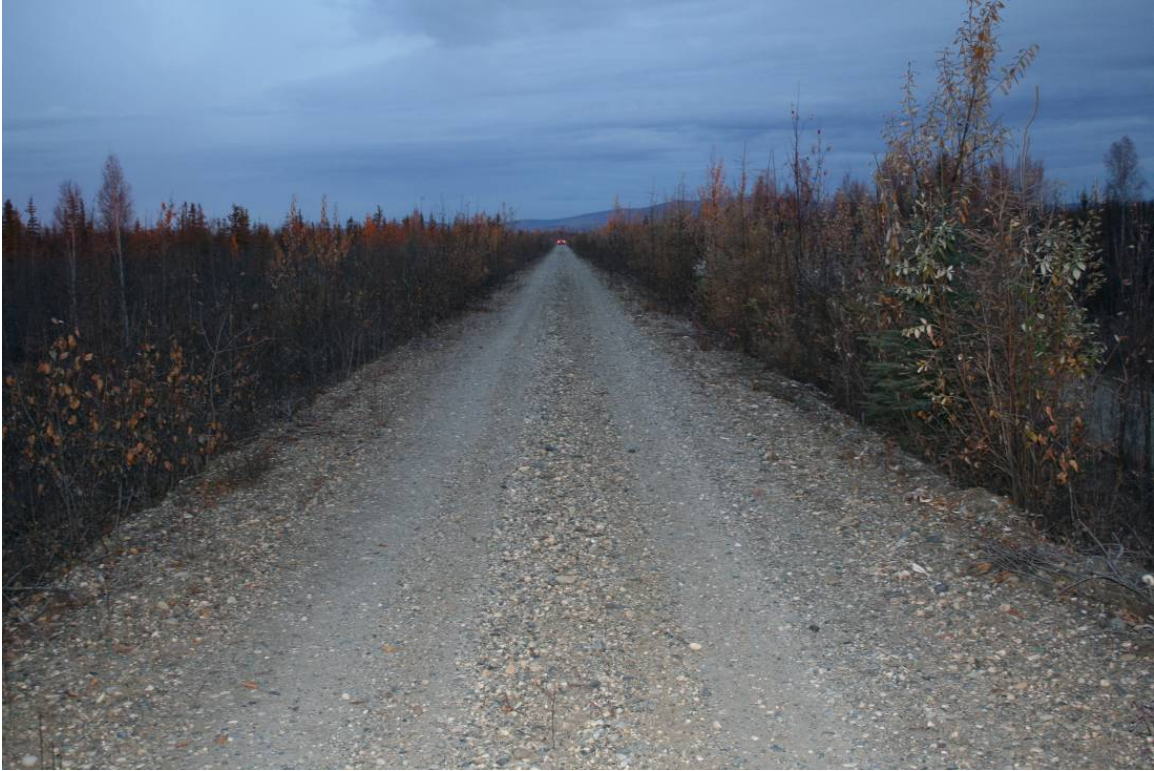
Figure 2-12. Vegetation covered slopes, Tanana River levee, Alaska (USACE, 2008)

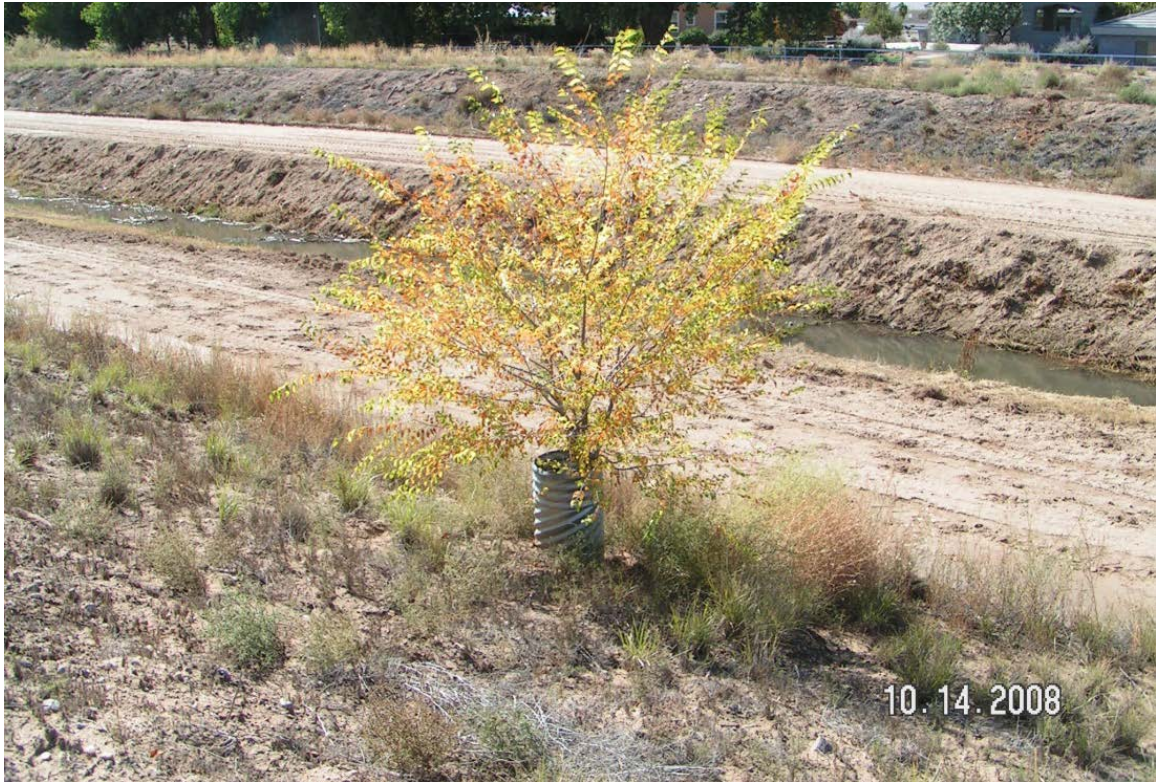
The landside drainage system of the Corrales levee unit along the Rio Grande in New Mexico is protected from underseepage by a system of subdrains comprised of a PVC pipe parallel to the levee toe and risers every 1/10th of a mile. An inspection in October, 2008, found several trees, including Siberian elms, cottonwoods, Russian olive and salt cedar growing next to or inside the risers (Figure 2-13). In some cases the roots of these trees damaged the risers and likely penetrated the slotted PVC pipe near the toe of the levee. The inspection team deemed that the subdrain system would not function as designed and recommended removing all trees and roots from the toe subdrain system and an investigation of the extent of intrusion by the woody vegetation.

Figure 2-13. Tree growing inside landside subdrain system. Rio Grande, New Mexico (USACE, 2008)

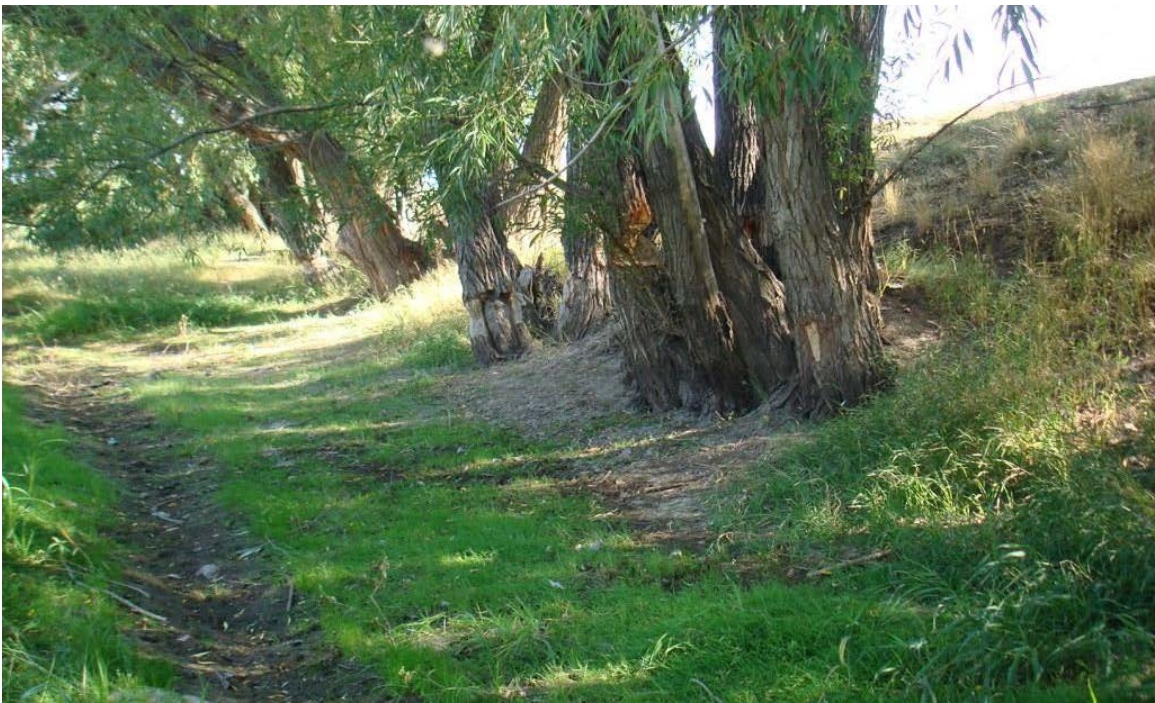
A USACE incident report for the Alamosa levee along the Rio Grande in Colorado from September, 2008, describes the waterside toe area to be populated by numerous large trees within 5 meters (15 feet) of the toe (Figure 2-14). The inspector reported that the trees were of different size and health, as some of them had been damaged by recurrent beaver activity in the area.

Figure 2-14. Trees at waterside toe and channel dug by beaver, Alamosa levee, Colorado (USACE, 2008)

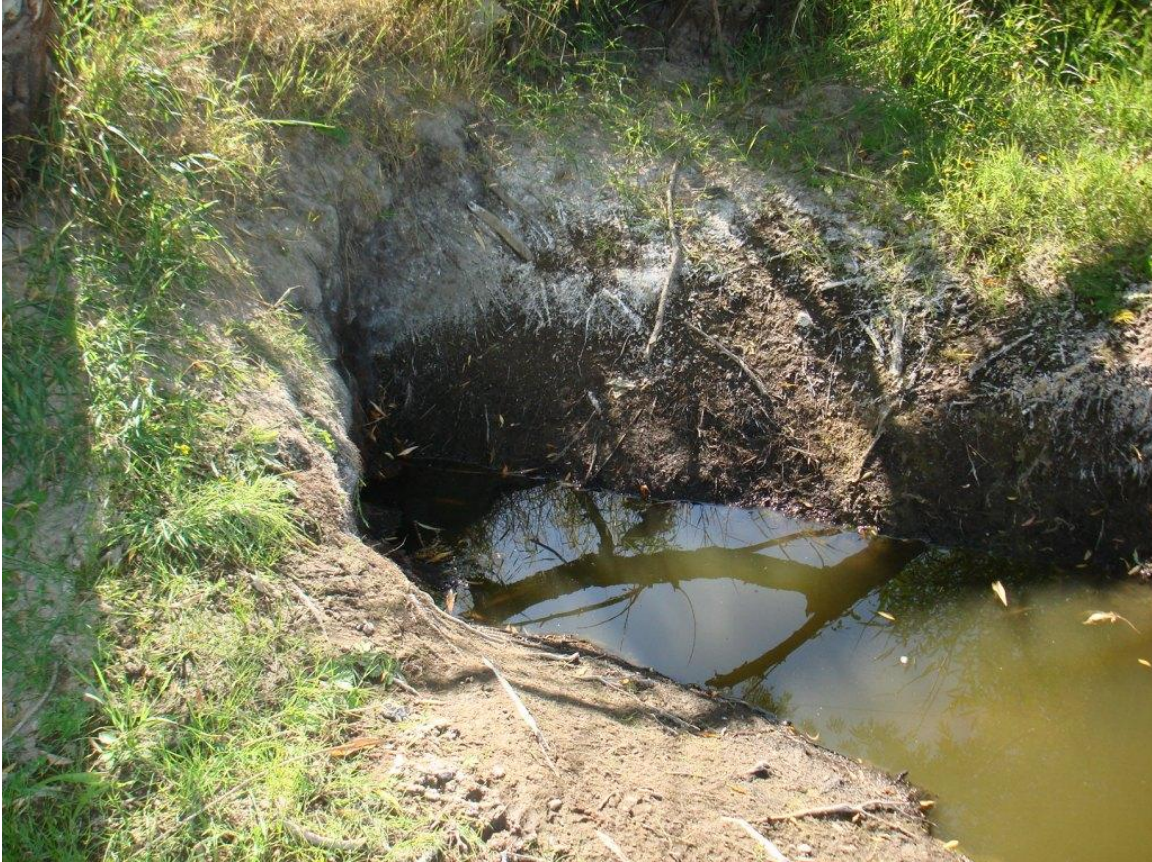
A channel had been dug by the animals from the river to the waterside toe (apparently there is a waterside berm separating the levee from the river) and two large beaver den entrances were encountered, as well as several smaller holes along the waterside slope (Figure 2-15).

Figure 2-15. Beaver tunnel on waterside slope, just below tree line. Alamosa levee, Colorado (USACE, 2008)

The report attributes the existence of beaver dens to the presence of woody vegetation because *“these trees on the riverside provide shelter, protection and food for the beavers”*.

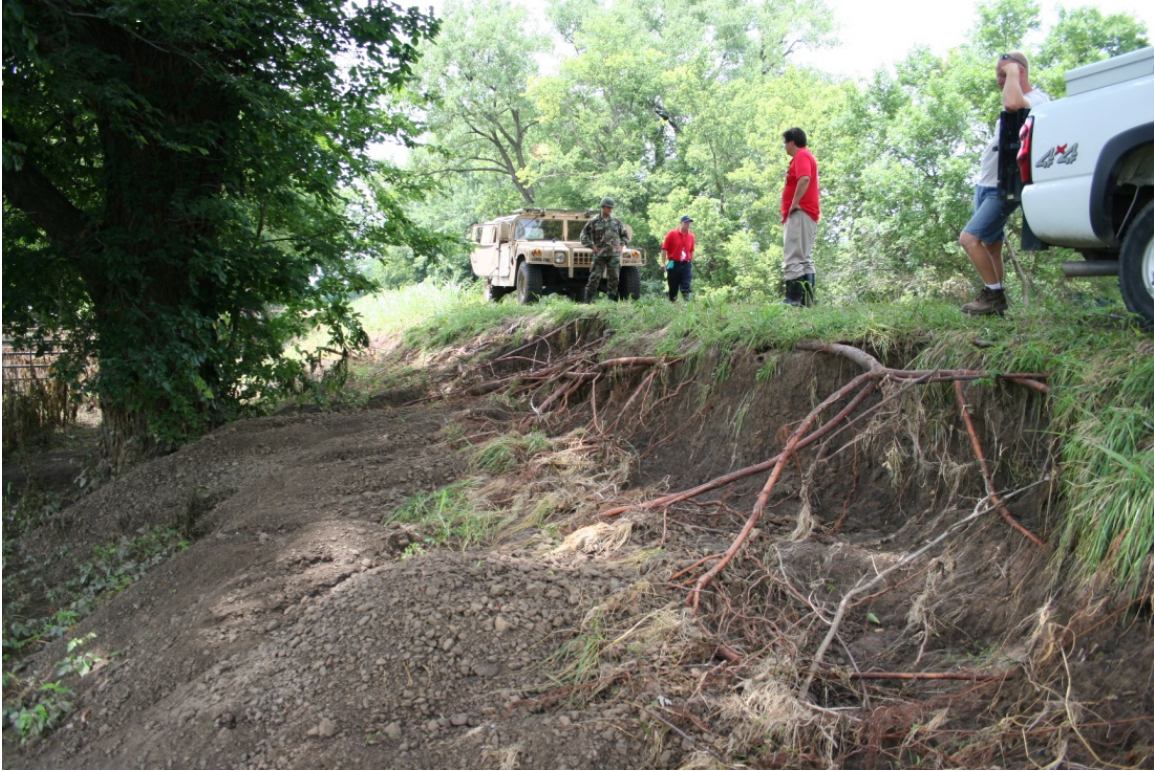
The USACE (2007) reported a small erosional feature on the landside slope of the Coffeyville levee in central Kansas following the storms of May and June of 2007. According to the incident report, the compacted clay levee was overtopped by approximately 1.2 m (four feet) of water and no breaches were reported, but an erosional feature was discovered during post flood inspections (Figure 2-16). The erosion exposed roots from a large tree near the landside toe extending upslope and reaching the crown of the levee. However, it is not clear how the roots might have contributed to the removal of approximately 1 to 1.5 meters (3 to 5.5 feet) of soil from the area near the landside hinge point of the embankment as a result of overtopping rather than internal seepage.

Figure 2-16. Levee distress, Coffeyville levee, Kansas (USACE, 2007)

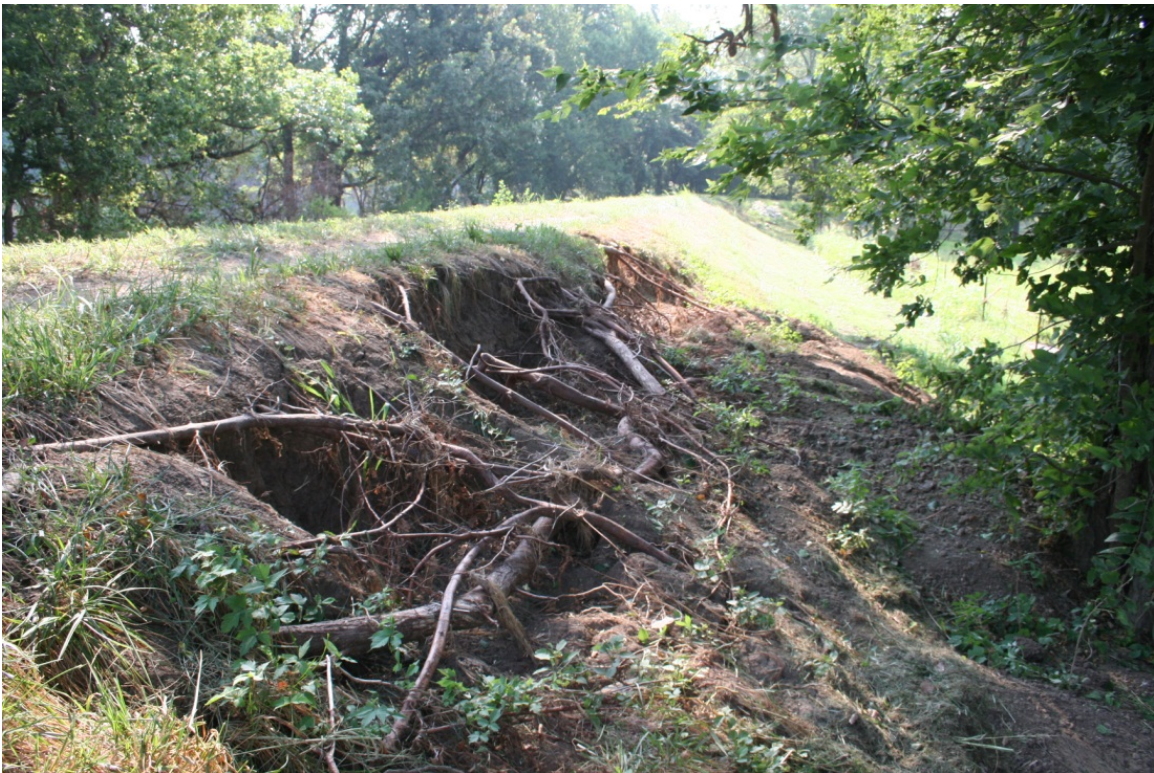
Figure 2-17. View of exposed roots on Coffeyville levee distress, Kansas (USACE, 2007)

The images show that the erosional feature roughly coincides with the zone of densest roots (Figure 2-17). However, there is no information on soil properties and their variability along the levee.

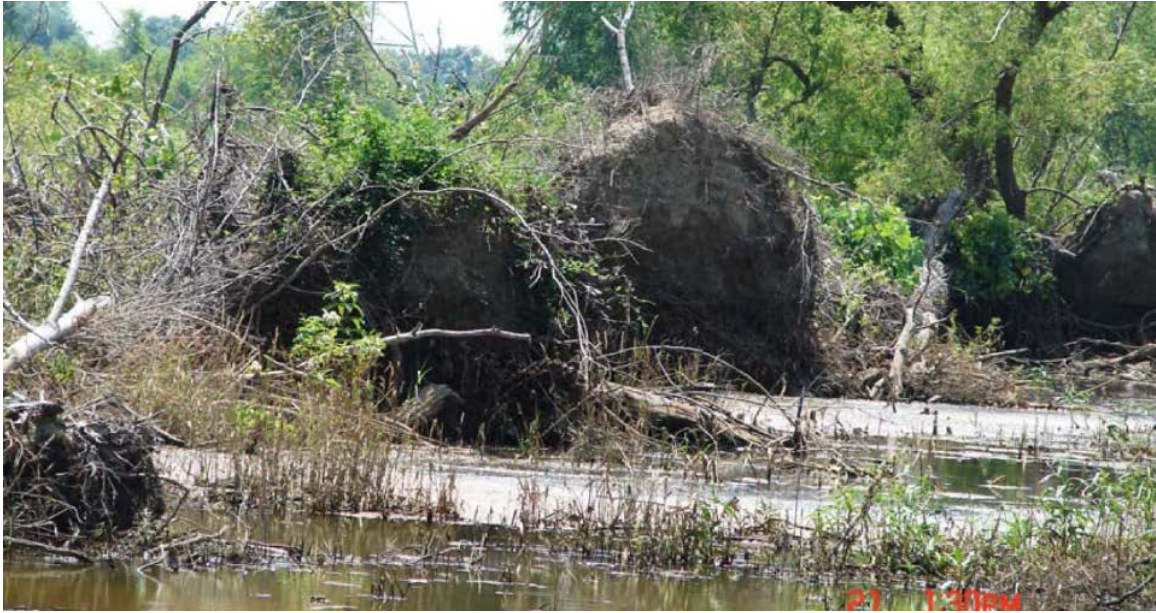
Animal burrows were observed near the crest and on the lower part of the landside slope, and several trees that were apparently uprooted some time before the 2008 floods were also observed. The root balls (Figure 2-18) were still in evidence showing that there was apparently disturbed ground near the landside toe and most likely including roots in the soil.

Figure 2-18. Uprooted trees and root balls at the East St. Louis site. (Harder et al., 2009)

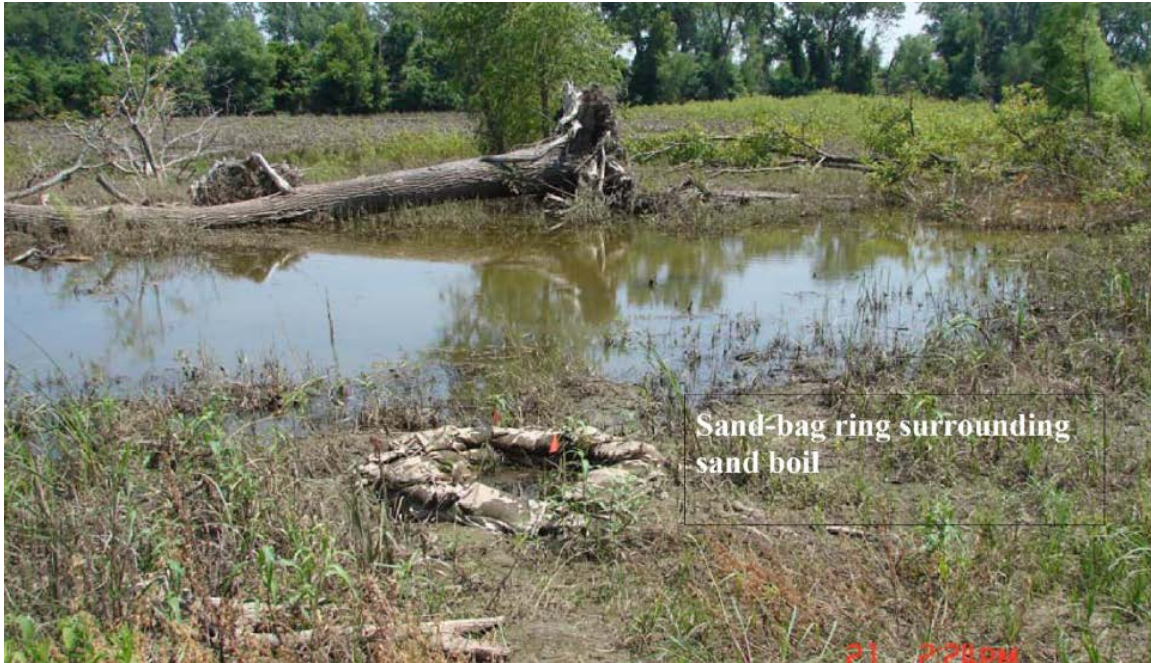
Sand boils (Figure 2-19) were observed between the relief wells, in some instances as close as 20 ft from a well, and the occurrence of the boils appeared to coincide with the ground disturbance produced by the removed trees. A previous flood event in 1993 did not produce any sand boils, despite the fact that recorded river levels were about 11 ft higher than the 2008 flood. The report by Harder et al. (2009) indicates that improper tree removal might have disturbed the top soil enough to allow the triggering of the observed levee distress in the form of sand boils.

The reported levee distress at this site seems to have been exacerbated by anthropogenic activities rather than by the presence of woody vegetation detrimental to the performance of the levee. The fact that during previous flood events with significantly higher hydraulic loading the existing remediation measures performed adequately (relief wells, stability and seepage berms) indicates that the problems presented on this site were likely a direct consequence of the ground disturbance generated by the removal of the tree and root balls near the landside toe. The report does not provide information on the presence or absence of a landside fine-grained blanket, but it is likely that the removal of root balls had damaged the blanket or created discontinuities that allowed the formation of sand boils.

Figure 2-19. Sand boil at East St. Louis site (Harder et al., 2009)

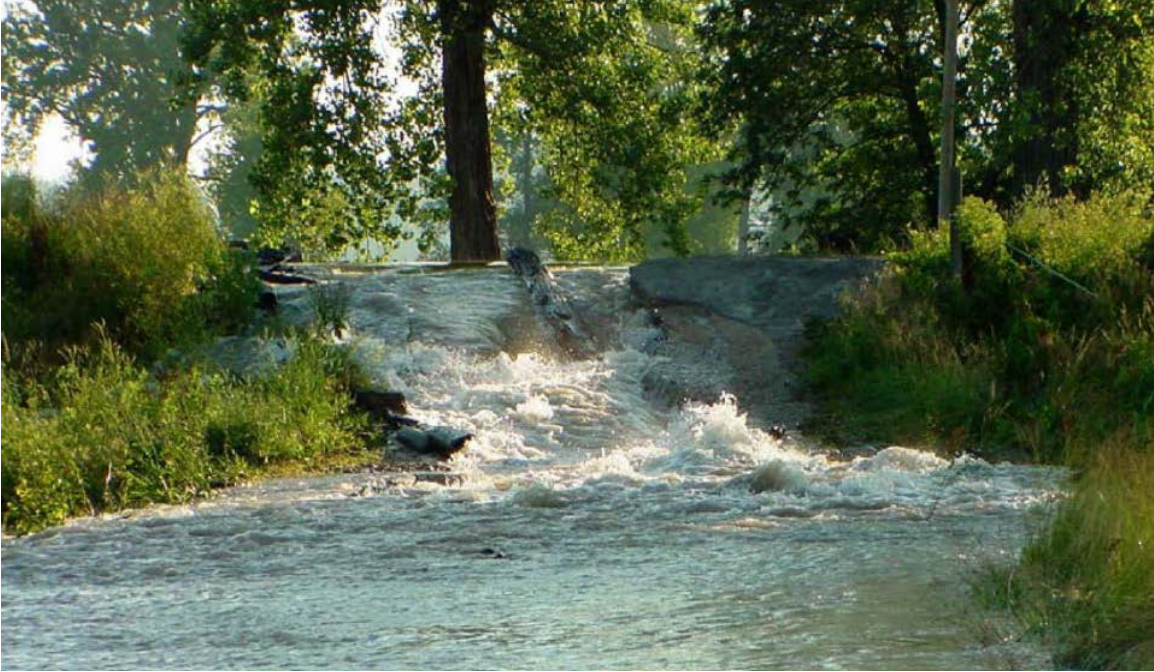
Post failure reconnaissance of the eroded embankments indicated the presence of several large (5 to 7 inches in diameter) live roots, extending across most of the embankment width. The first breach (Cap Au Gris – Site 1 in Harder et al. 2009) of a relatively low levee (9 feet high) with slopes between 3:1 and 4:1 (Figure 2-20) developed as water overtopped and concentrated on a low spot where a road access joined the levee crown. A witness account described no (through or under) seepage shortly before the failure, therefore the failure was likely due to concentrated overtopping that washed away the levee material and resulted in a 30 ft wide breach extending down to the foundation.

Figure 2-20. Cap Au Gris - Site 1 (Harder et al., 2009)

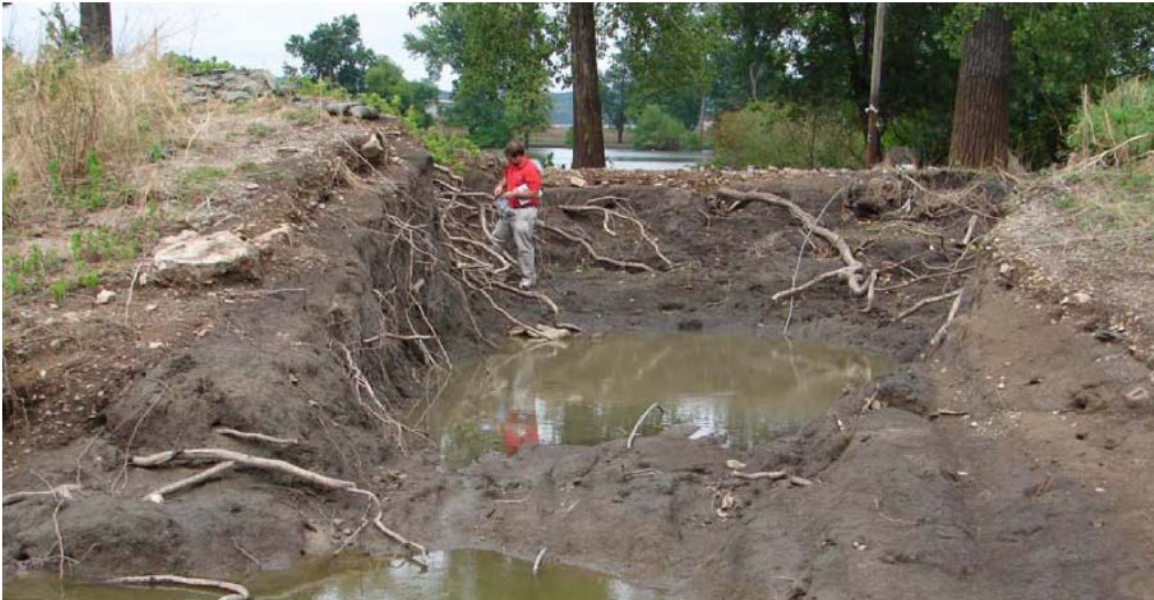
The roots encountered in the eroded area ranged from less than 1 inch to about 5 inches in diameter (Figure 2-21), and seemed to originate from two stumps encountered near the waterside toe of the eroded levee with diameters of 3 and 4 feet. The larger roots appear to have traveled distances larger than 50 ft from the stump towards the embankment. A smaller stump and a live cottonwood were also present in the vicinity of the breach.

Figure 2-21. View of eroded levee at Cap Au Gris - Site 1 (Harder et al., 2009)

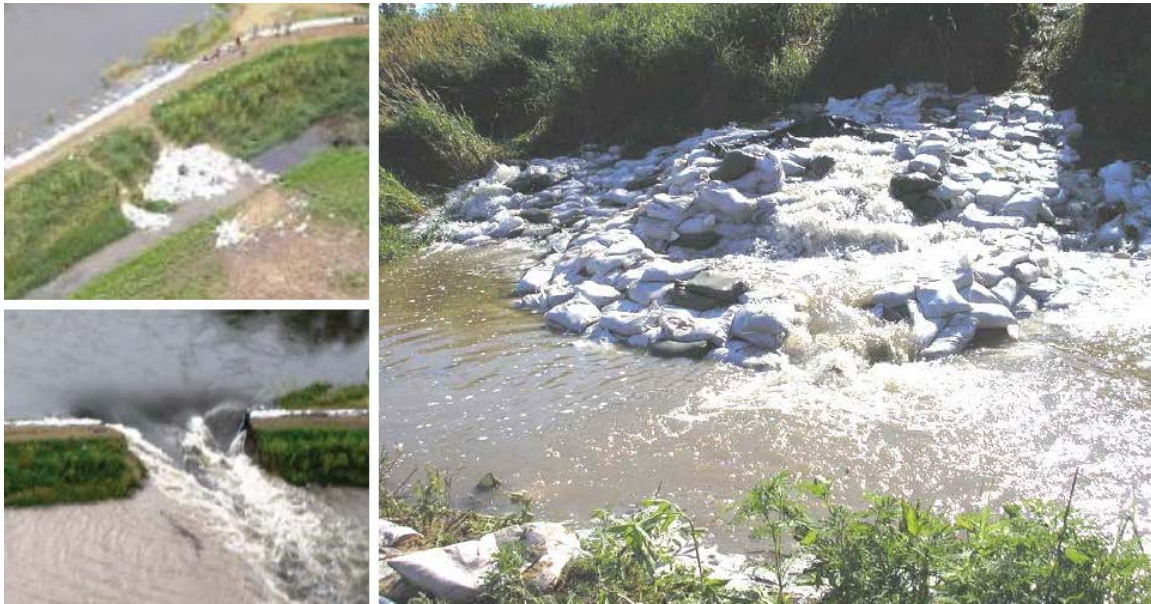
clay being ejected from the protected side. The extent of the animal activity appears to coincide with the eroded mass, as it only extended down to the elevation of the toe.

Figure 2-24. Pin Oak Levee breach (Harder et al., 2009)

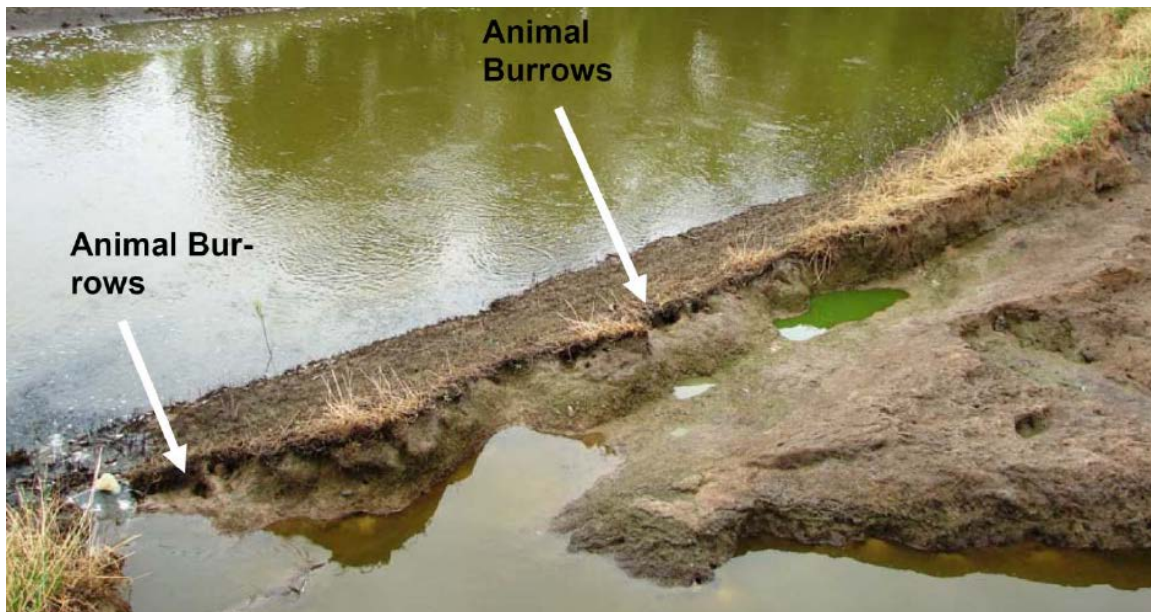
Figure 2-25. Animal burrows on Pin Oak Levee breached section (Harder et al., 2009)
