Influence of Tree Roots and Mammal Burrowing Activity on Levee Performance: Volume 1. – Review of Literature and Case Histories

Technical Report · August 2013

Geotechnical Engineering
University of California, Berkeley
Report UCB GT 13-03 vol. 1

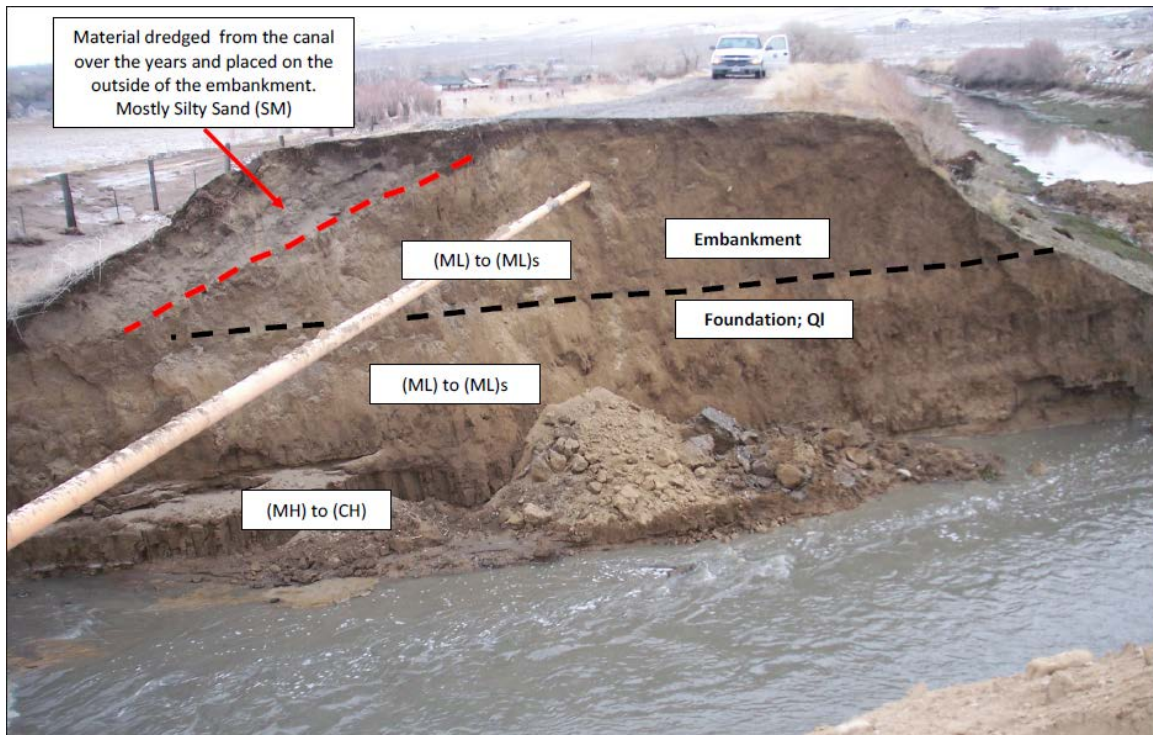
For these reasons, the specific cause of the breach was attributed to muskrat burrows, given the presence of the networks exposed and documented by URS (2008) and the fact that a previous (smaller) failure in 1996 was also related to animal burrowing in the area.

Figure 2-27. Developed breach looking downstream (URS, 2008)

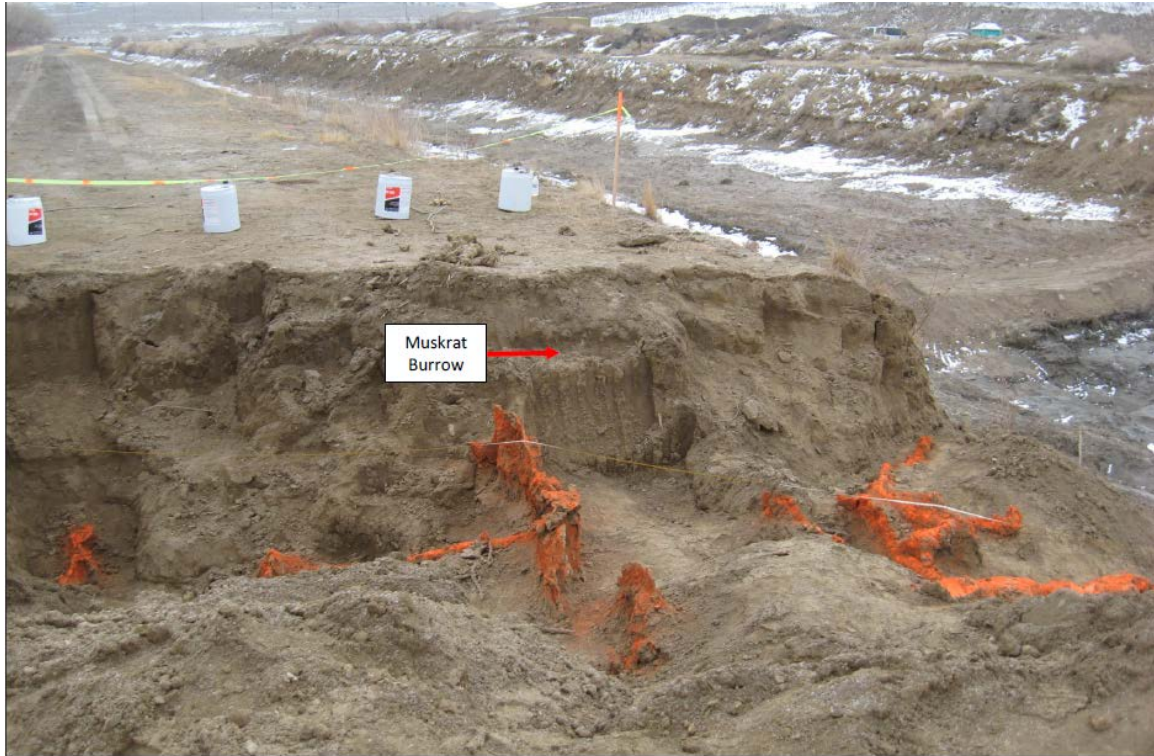
URS also performed chemical grouting at a site 250 ft downstream of the breach in order to assess the extents of the muskrat burrows present in the area. The investigation revealed a complex system of interconnected burrows (Figure 2-28) extending from the waterside

Figure 2-28. Exposed grouted burrows 250 ft downstream of breached site (URS, 2008)

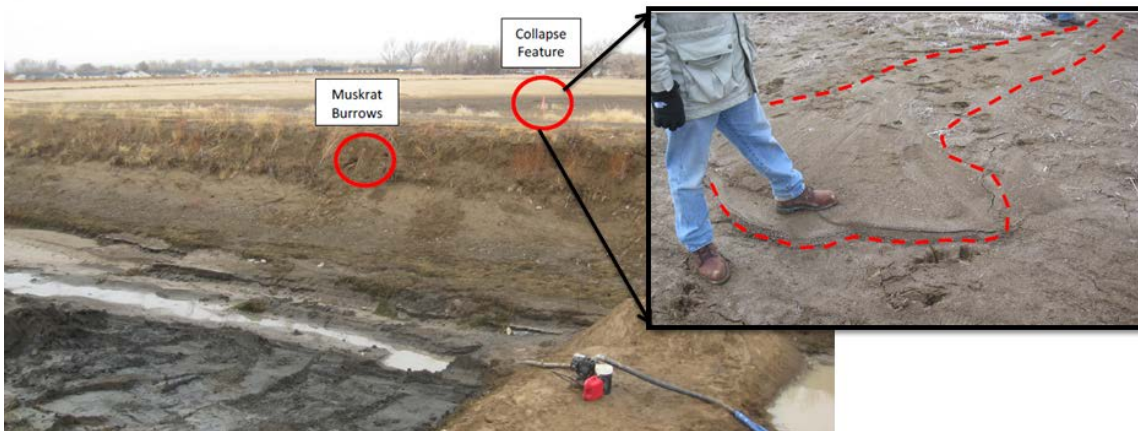
Figure 2-29. Collapse feature at the landside edge of burrow complex (URS, 2008)

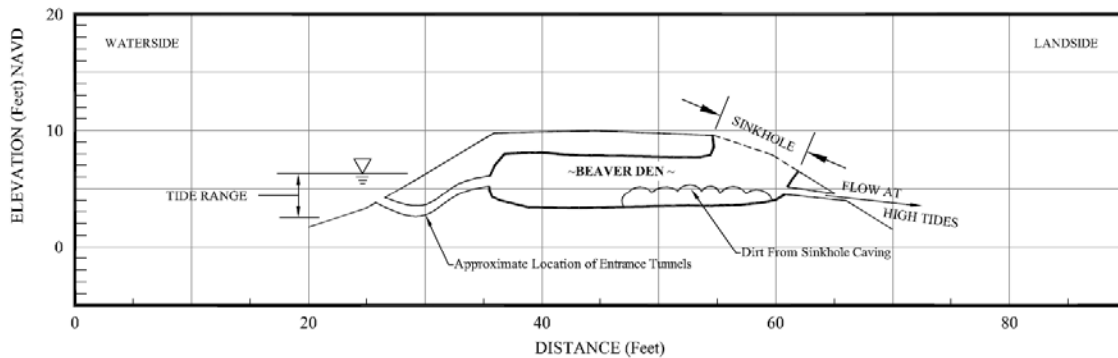
A survey of the den showed that it extended 4 meters (12 ft) from the landside hinge point of the levee towards the waterside. The void was 1.5 m (5 feet) high by 3 meters (9 feet) wide (MBK, 2009). The den extended from the landside to within 0.6 meters (2 feet) of the waterside face.

Figure 2-30. Schematic of beaver den cave-in (MBK, 2009)

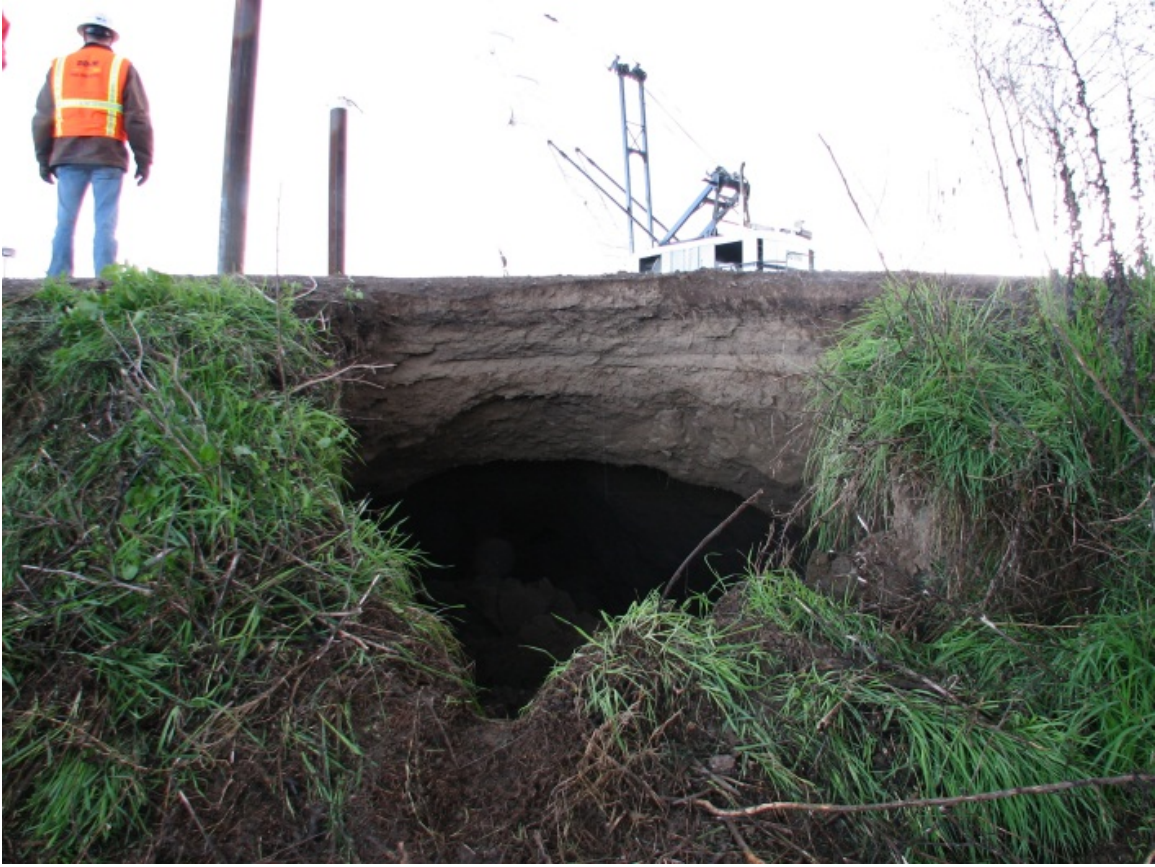
Figure 2-31. Beaver den cave-in, Medford Island, CA. Photo Courtesy Dustin Sanoski (DWR)

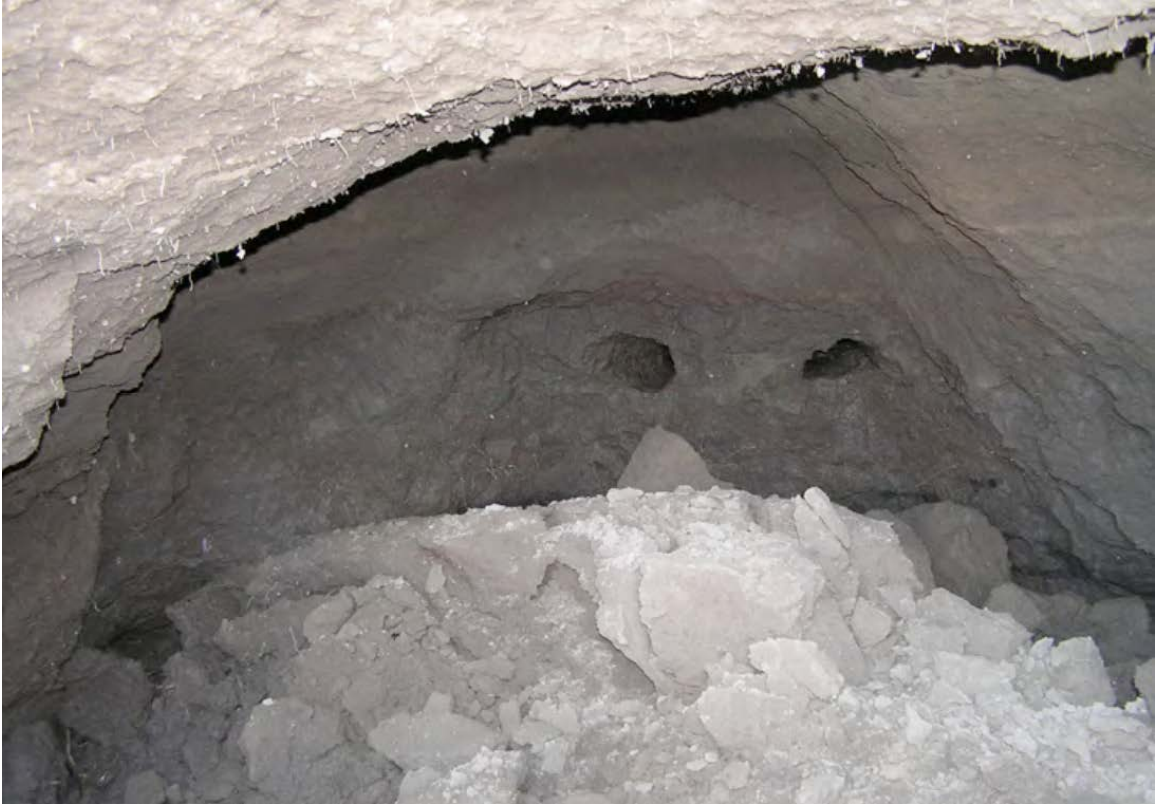
The locations of the entrances and exit to the den appeared to be within the range of tidal water fluctuations, therefore, during the daily high tides, water would flow in and out of the den possibly worsening the already critical conditions. Emergency repairs included using an excavator to collapse a series of beaver tunnels present along the waterside slope over a distance of 15 m (50 ft) upstream and downstream of the cave-in. Subsequently, the cave-in was excavated and filled with compacted material, slopes were reshaped and riprap was installed to protect the area. The characteristics and extents of the additional collapsed tunnels were not documented during the emergency repair activities.

Figure 2-32. Internal view of the den showing access tunnels from the waterside (MBK, 2009)

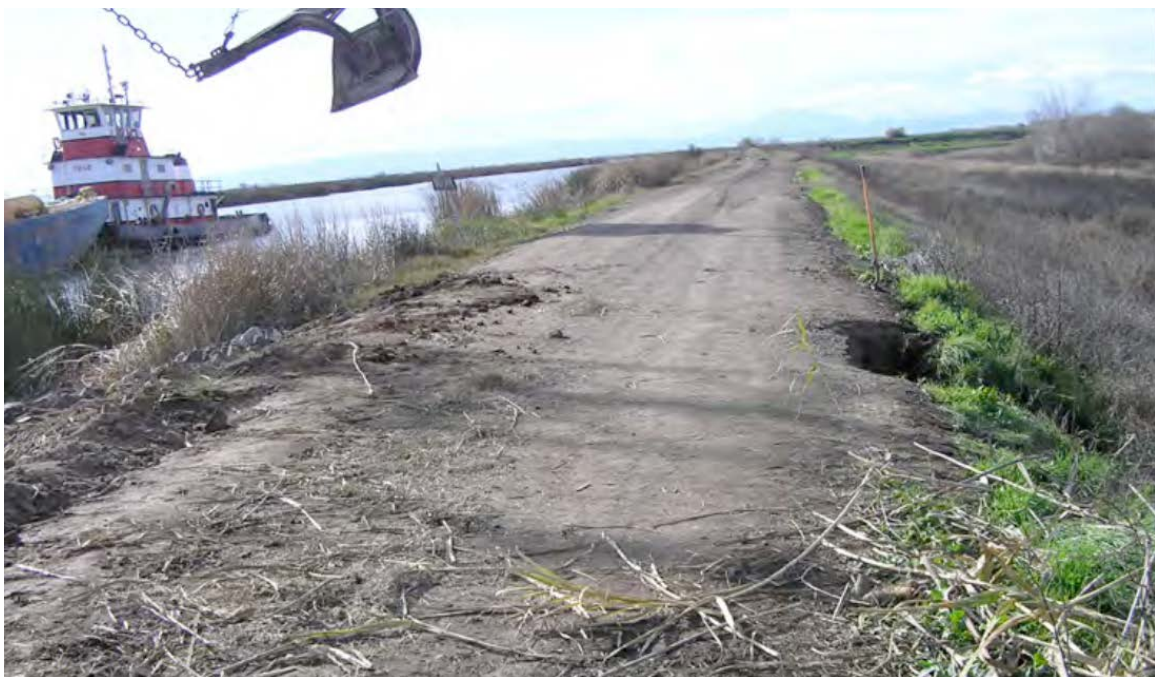
Figure 2-33. View of the landside cave-in from the levee crown (MBK, 2009)

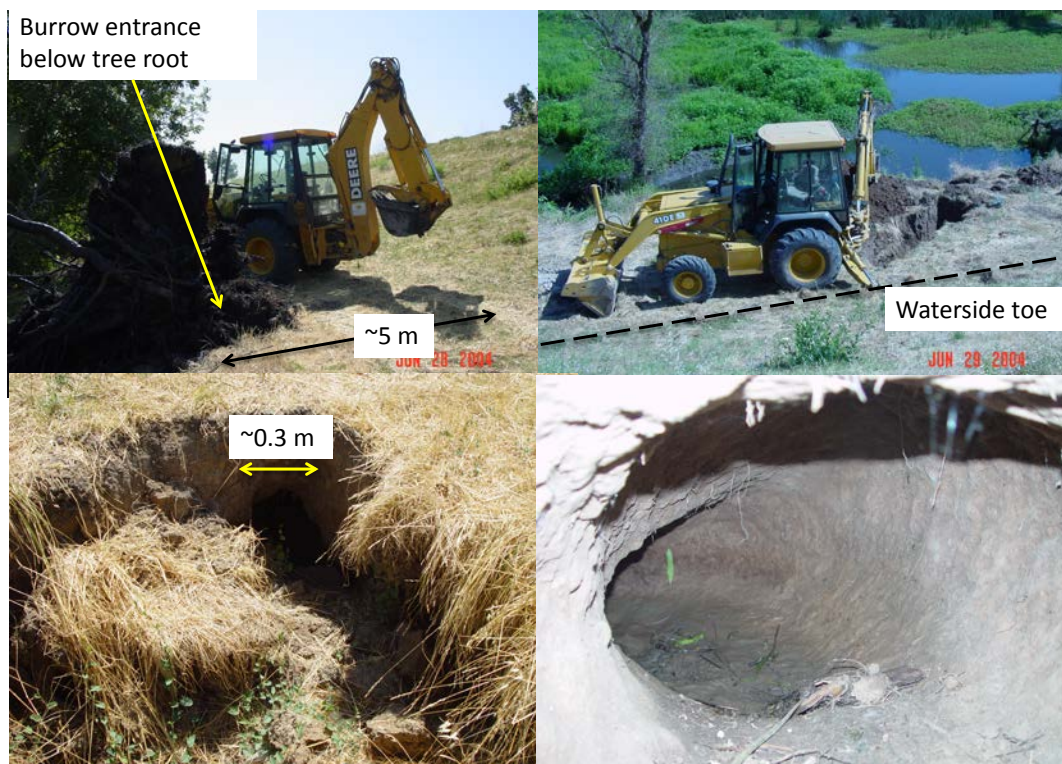
Figure 2-34. Waterside berm collapse at Arcade Creek levee. Images courtesy of Richard Marck (ARFCD)

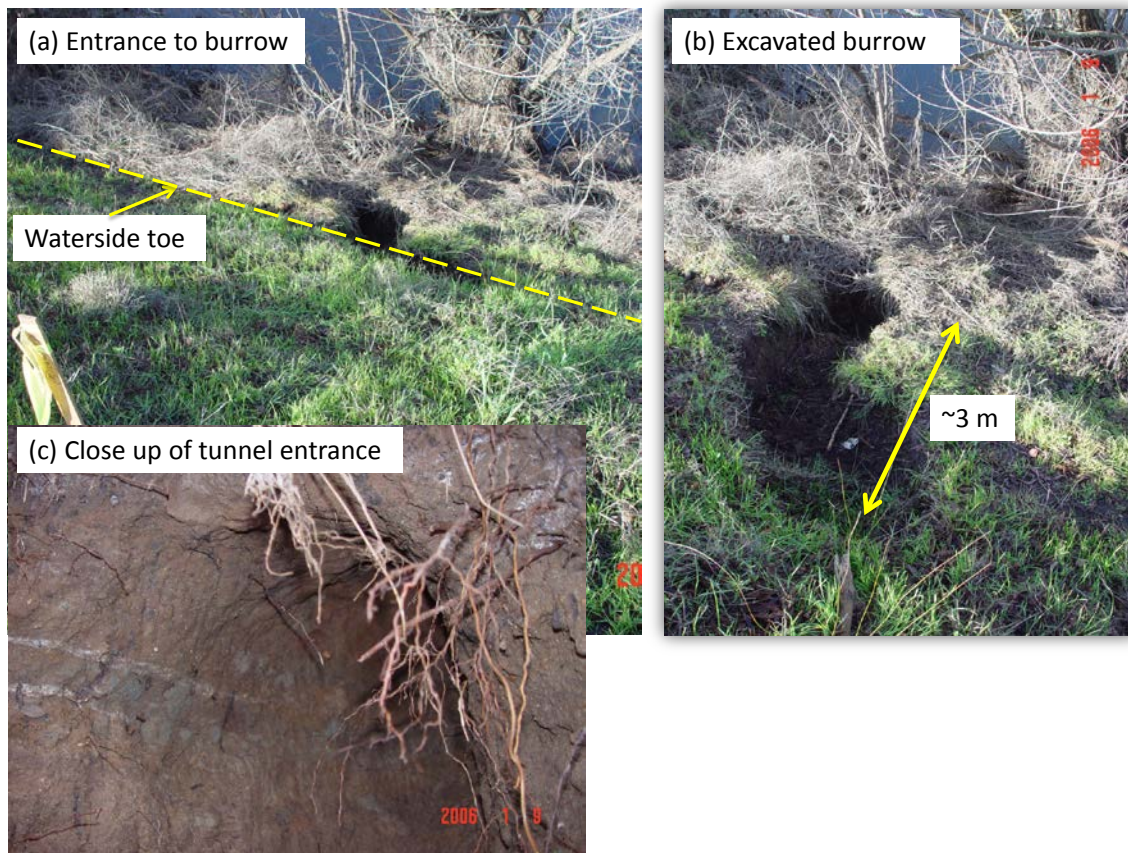
Figure 2-35. Beaver den at Arcade Creek levee in 2006. Images courtesy of Richard Marck (ARFCD)

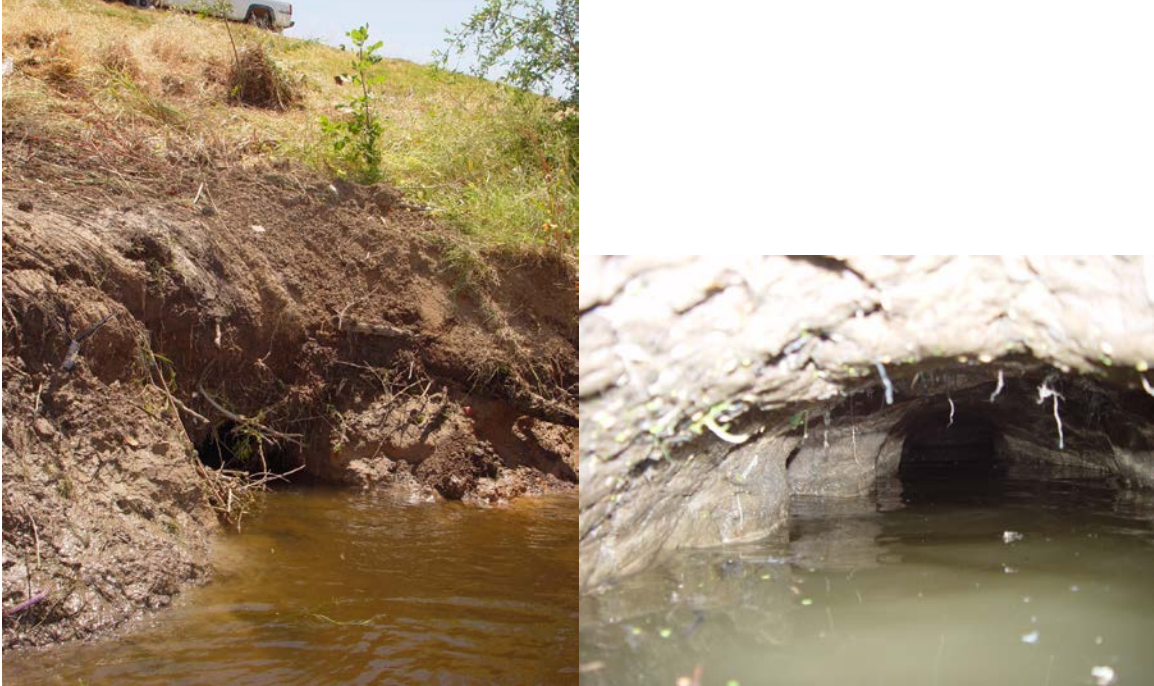
The beaver den shown on Figure 2-36 was found at the waterside toe of the levee along Arcade Creek in 2004. This levee segment did not have a waterside berm and the animal dug directly into the levee material. Obviously, this type of situation has the potential to cause more damage than dens encountered along the waterside berm, as the alteration to the phreatic surface is closer to the protected side slope. The beaver den shown on Figure 2-37 is of particular interest because of its great size (at least 3 meters in length and 35 cm in diameter) and because it is located in an area historically known for beaver intrusions. The levee borders Arcade Creek near Sacramento and it too is part of the ARFCD maintained area; ARFCD is known for rapidly mitigating this type of animal intrusion. Mitigation consists of excavating the distressed or collapsed area and backfilling it with large rocks and soil so re-burrowing is discouraged. However, this type of practice does not eradicate the problem; rather it simply makes the burrowing animals dig new dens just a few meters upstream or downstream of the repaired levee section. During the first weeks of 2012, a new den was encountered between previous mitigated burrows (Figure 2-38). The new den was only 1 to 1.5 meters in length and about 35 cm in diameter, and given the presence of a recent waterline and fresh claw marks inside the walls of the burrow it was concluded that this burrow was likely under construction.

Figure 2-36. Beaver hole at waterside toe in 2004. Image courtesy of Richard Marck (ARFCD)

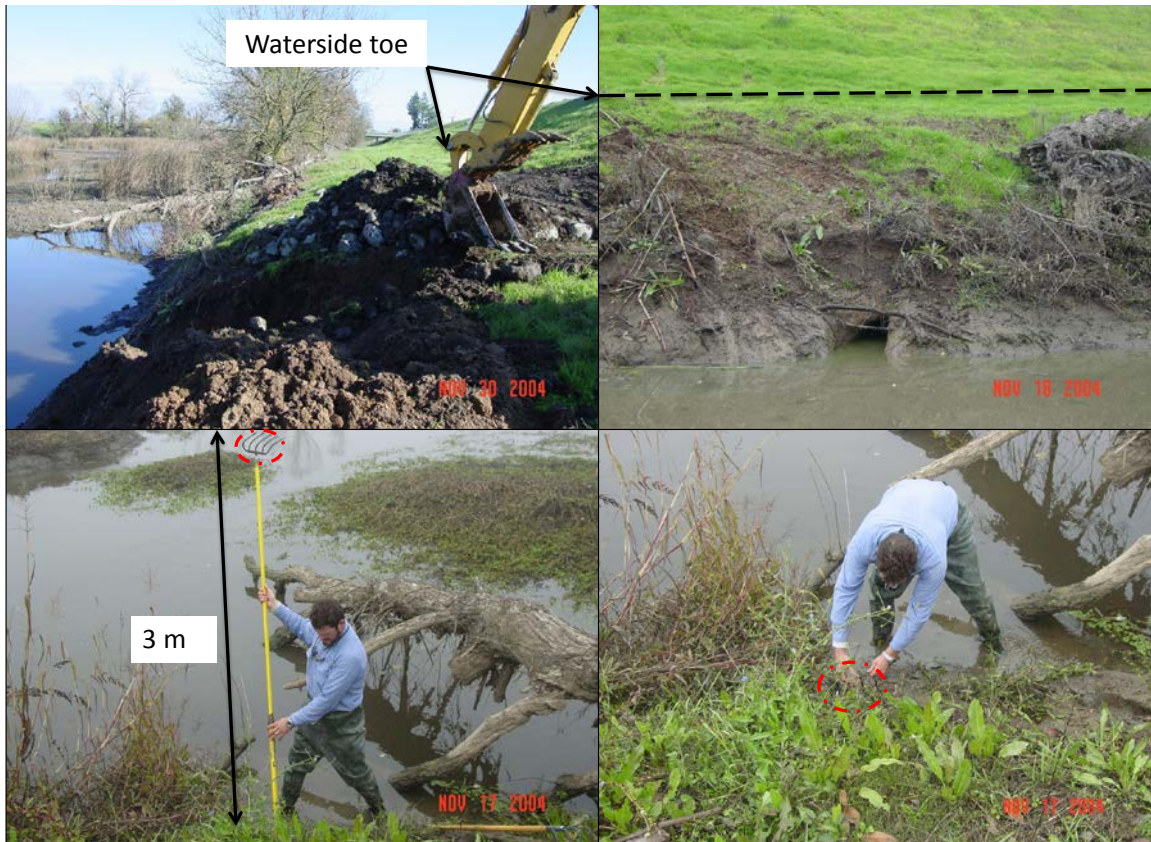
Figure 2-37. Beaver den at Arcade Creek. Images courtesy of Richard Marck (ARFCD)

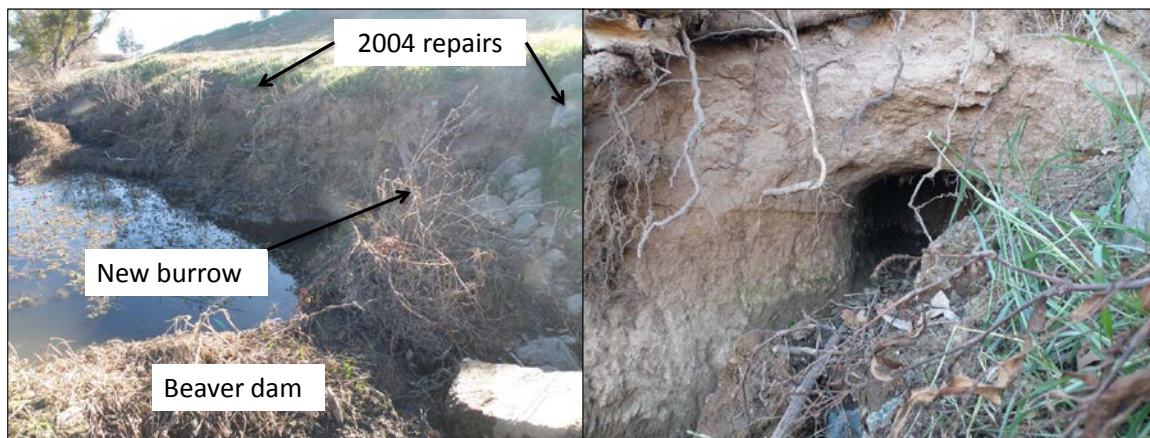
Figure 2-38. Reoccurrence of beaver intrusion in Arcade Creek

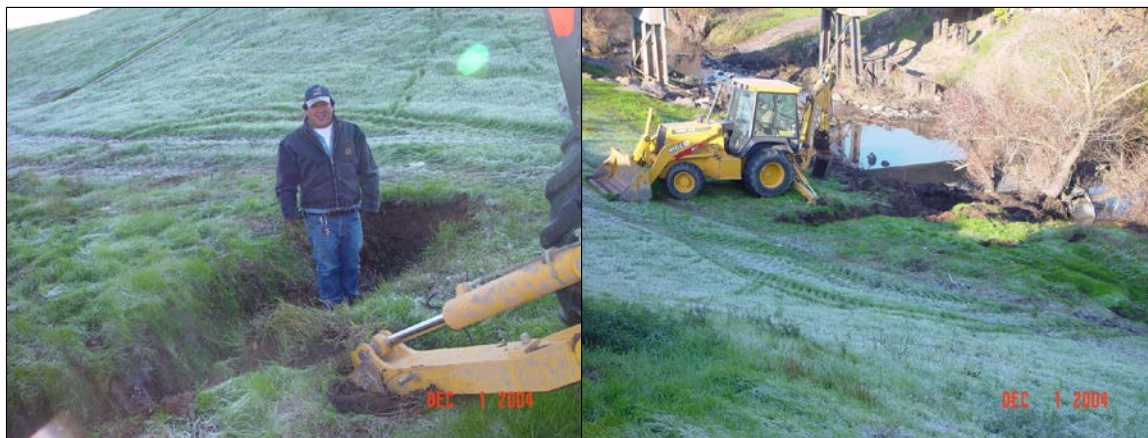
The burrow shown on Figure 2-39 near the southern end of Arcade Creek was located in the vicinity of a tree which was removed during levee repair activities. The beavers seemed to have used large roots at the roof of their burrows, as shown on Figure 2-40.

Figure 2-39. Beaver den at the southern end of Arcade Creek in 2004. Images courtesy of Richard Marck (ARFCD)

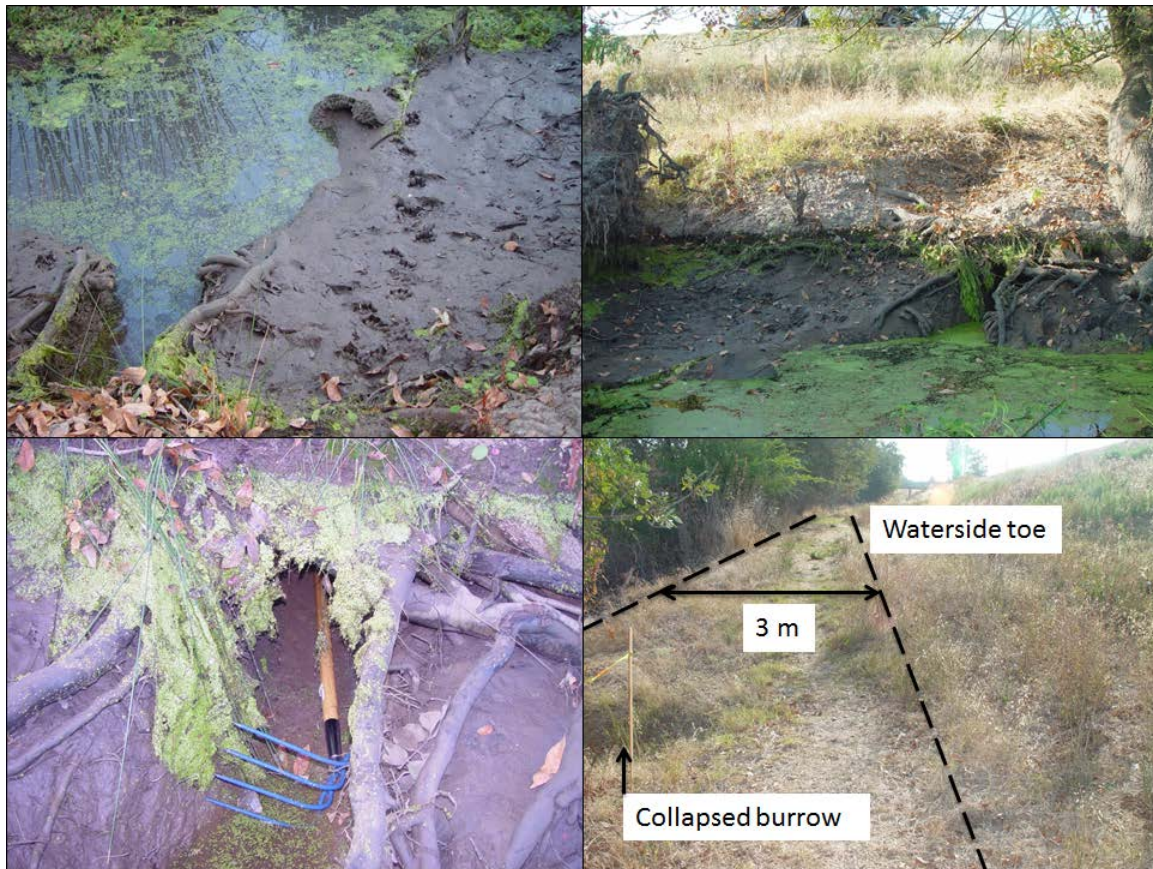
Figure 2-40. Beaver burrow collapse at waterside toe near Arcade Creek in 2004. Images courtesy of Richard Marck (ARFCD)

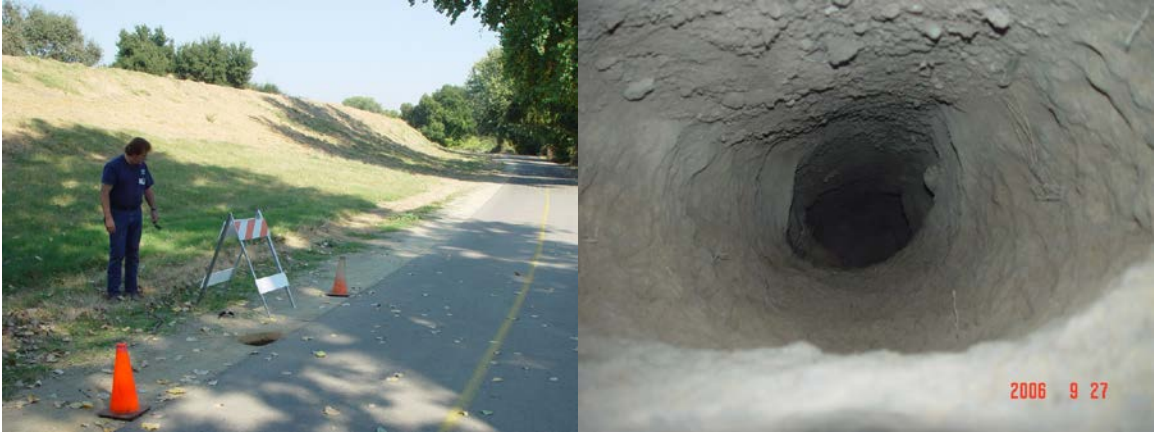
Figure 2-41. Beaver burrow below paved bike path along north levee of American River in 2006. Images courtesy of Richard Marck (ARFCD)

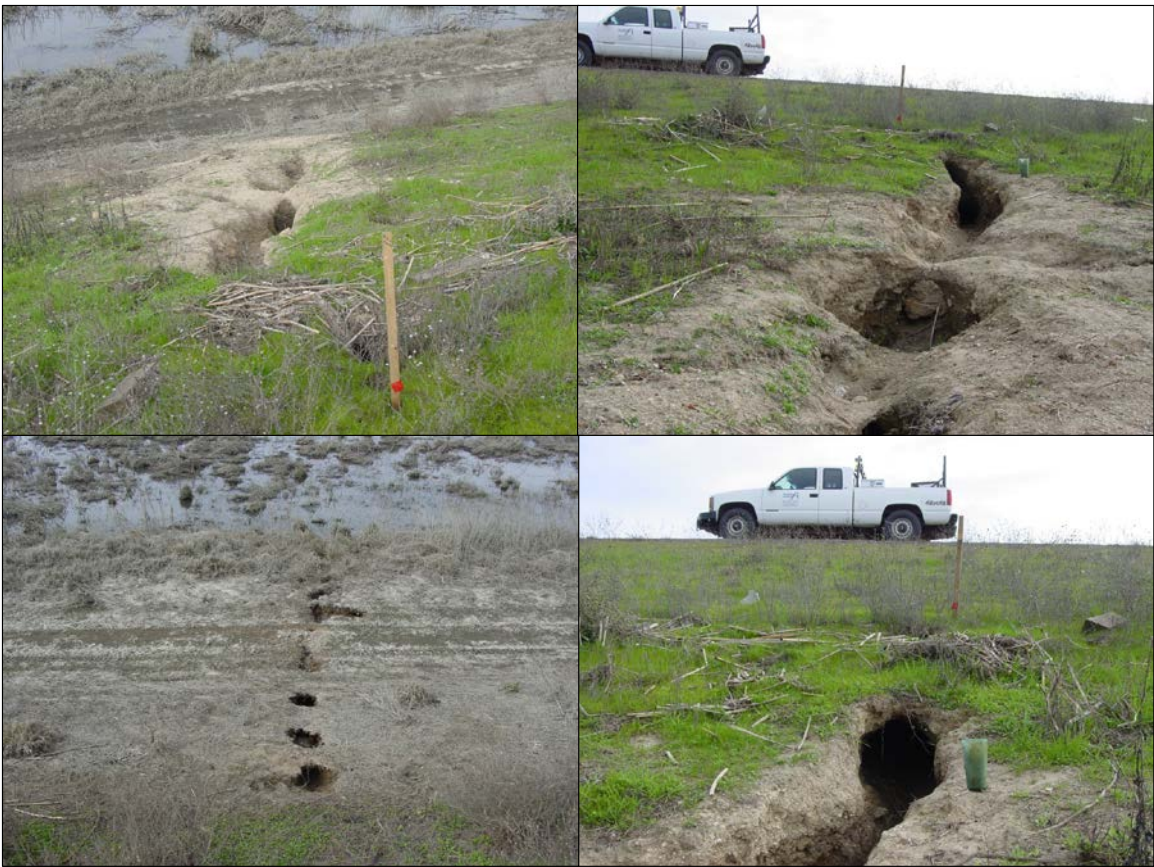
Figure 2-42. Waterside slope collapse from beaver burrow along NEMDC in 2006. Images courtesy of Richard Marck (ARFCD)

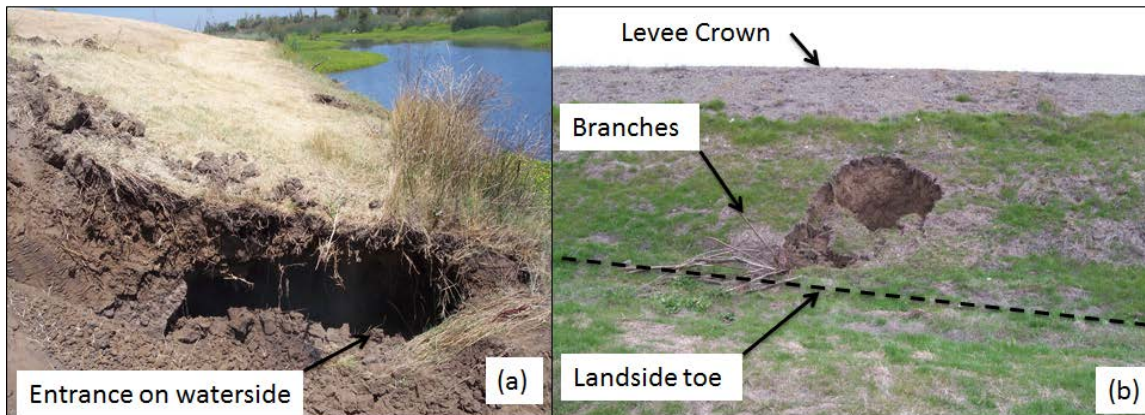
The final case history included in this document corresponds to a beaver den on the Pleasant Grove Creek Canal (PGCC) north of Sacramento, CA. The levee in this area is composed of compacted clays of medium to high plasticity, which may have allowed the beaver(s) to extend the den from one side of the levee to the other without collapsing (**Figure 2-43**). Emergency remediation consisted in excavating the sinkhole area, exposing tules, a small cavern and the tunnel extending to the waterside toe (Costa, 2012), and constructing temporary earthen plugs on both levee toes. Final remediation took place by drilling several holes along the top of the levee and filling them with concrete. Flares were placed at the entrance of the beaver den before the concrete was poured to verify that the drilled holes had in fact intersected the tunnel (Figure 2-44).

Figure 2-43. Beaver den collapse at PGCC levee near Sacramento, CA. Photo courtesy Ray Costa (2012)

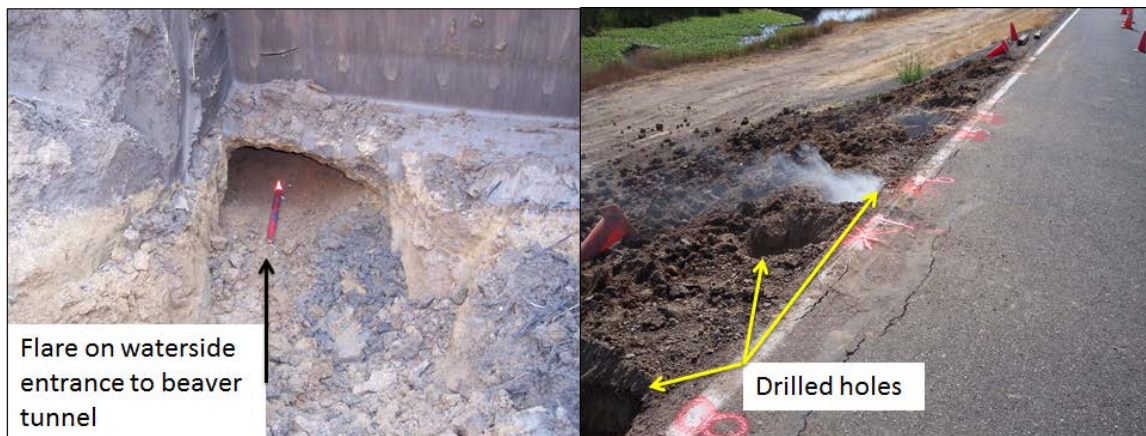
Figure 2-44. Remediation activities on beaver den at PGCC near Sacramento, CA. Photo courtesy Ray Costa (2012)
