Dodging a Bullet: Lily Lake Dam and the 2013 Colorado Flood

Mark E. Baker, P.E., Dam Safety Officer, National Park Service

This paper is about identification of high risks at a dam, multiple efforts to promptly mitigate those risks, and how the 2013 Colorado Flood severely tested those mitigation efforts. Had the National Park Service (NPS) not made major efforts to improve the safety of the dam before the event, the dam could have failed by lateral spillway erosion and head cutting, threatening the lives of people in more than two dozen homes downstream.

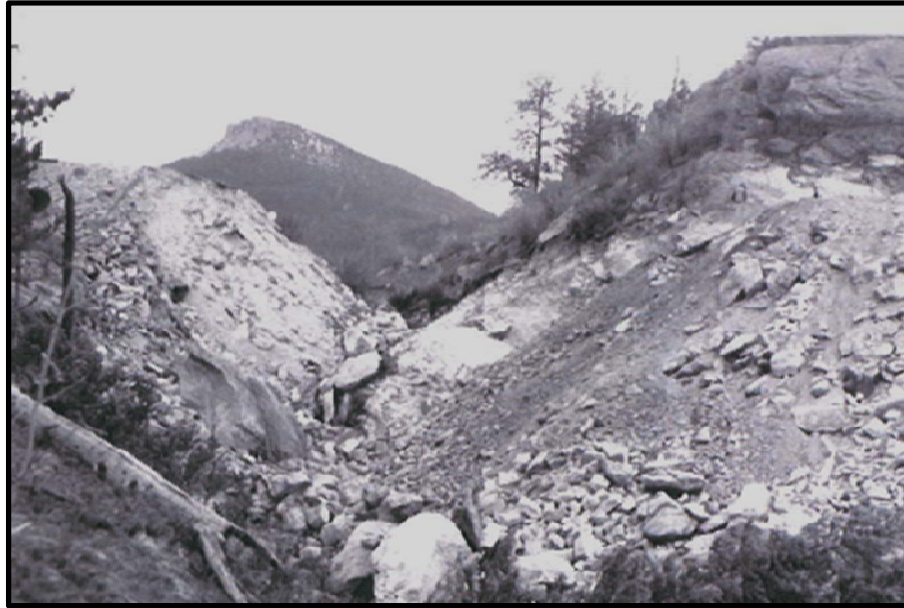
An eye witness just downstream related that when he arrived the water was overflowing State Highway No. 7, and that within 10 minutes, “the paved surface was lifted and was carried down into the canyon, trees and boulders crashing with it.” [3] There were no injuries or loss of life although 2 homes and a county road were also flooded. Damages were estimated at \$10,000.

Figure 2 - Breach in State Highway 7 just downstream from the dam. (1951)

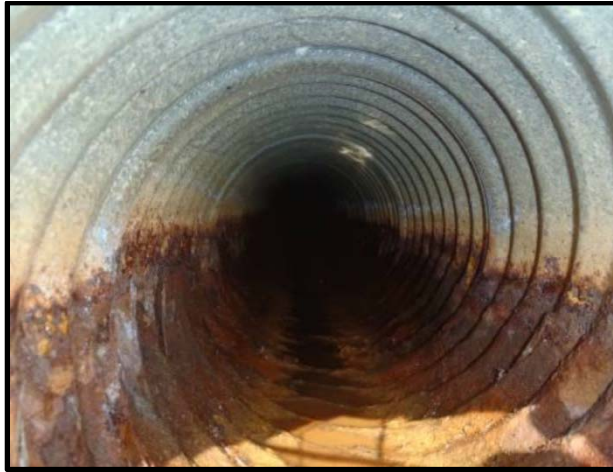
under the dam. The condition of the downstream end of the corrugated metal pipe (CMP) outlet pipe increased concerns about internal erosion failure modes.

Figure 5: Corroded interior of the outlet works pipe viewed from the downstream end (2011 Reclamation)

showed even worse corrosion that at the downstream end. So, we decided to abandon the outlet works by grouting it shut. The failure mode of internal erosion along the outside of the conduit would be addressed by covering the downstream end of the conduit with the filter/drain.

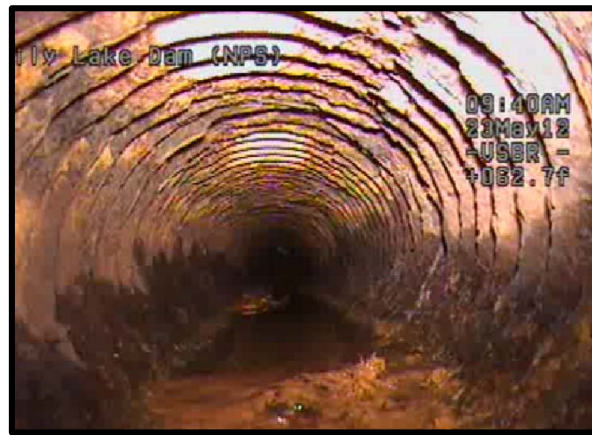
Figure 6: View of outlet works conduit 43 feet upstream from downstream end (5/23/12 Reclamation)

For the outlet works pipe-related failure modes, we used another small dams strategy. All dams should have a means to evacuate the reservoir if there is a problem with the dam. For most dam owners and regulators, this means that the dam must have adequate outlet works capacity to drain the reservoir in a specified period of time (Bureau of Reclamation requires 30 days). But there is another way of evacuating the reservoir: pumps. The dam is located next to a state highway and the park's Emergency Action Plan has the names and contact information for pump rental companies to send pumps to the dam. These pumps can evacuate the reservoir much more quickly than the 10-inch outlet works. The internal video camera inspection of the outlet works

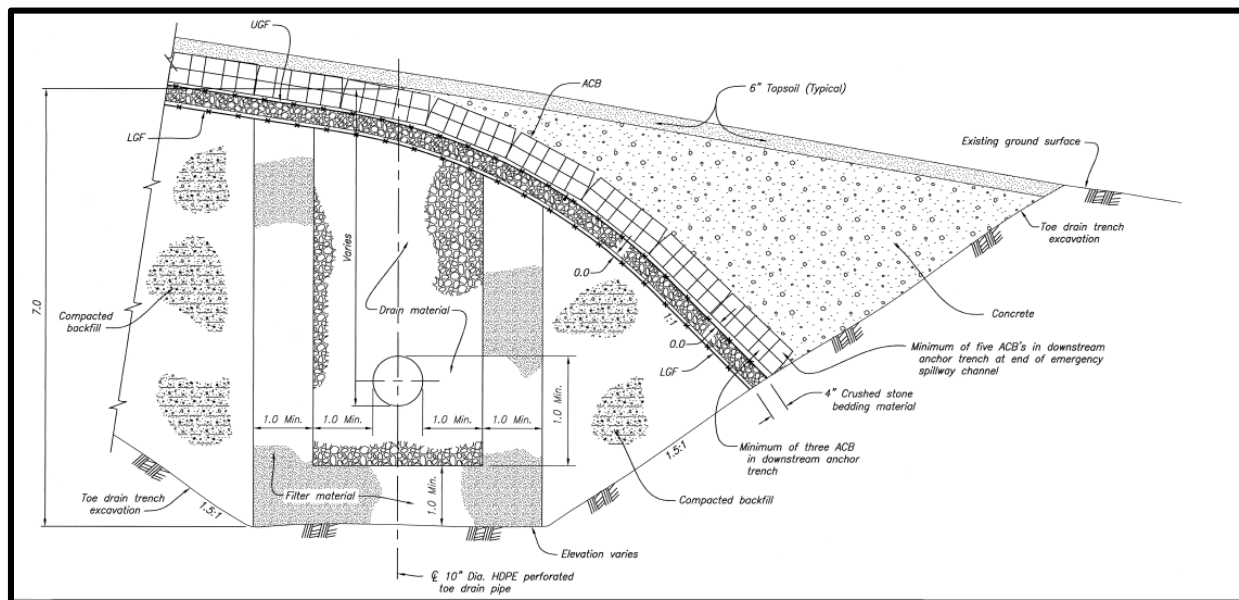
Figure 8: Design detail section of two-stage filter/toe drain and downstream end of ACB blanket (Reclamation)

For internal erosion failure modes, we decided to construct a filter/drain along the downstream toe of the dam (see figure 8). There had been wet areas below the dam and this toe drain would provide the state-of-practice protection for seepage through or under the dam.

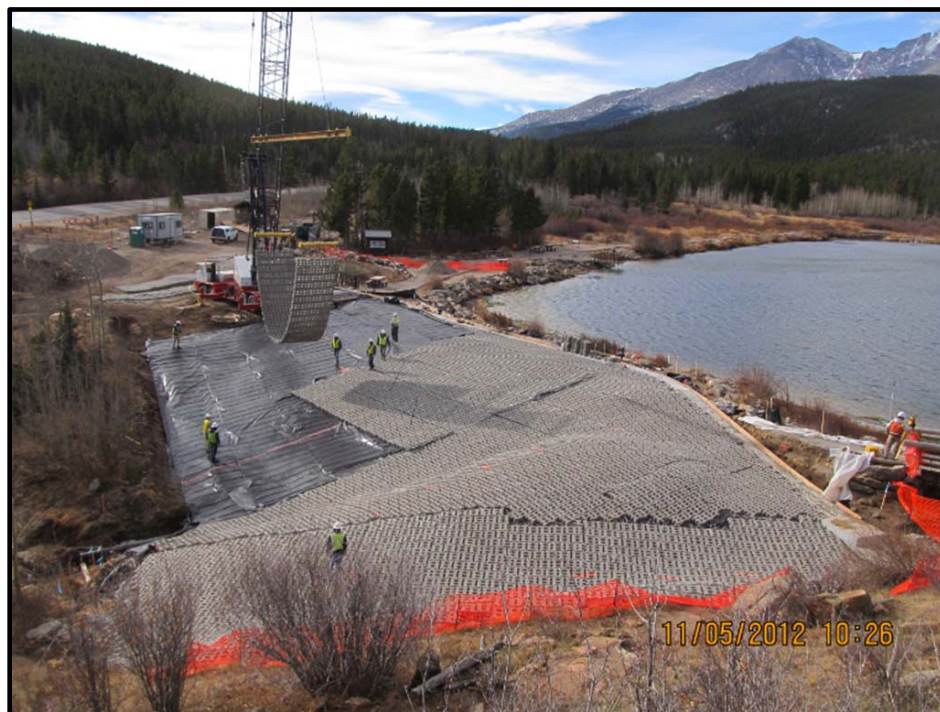
Figure 9: Installation of the ACB overtopping protection system. The spillway is in the foreground – photo dated November 5, 2012 (Reclamation).

For hydrologic analysis, we would repair for the full Probable Maximum Flood 1080 cfs. This worst case rainfall event (thunderstorm) would result in overtopping of the dam for 4 hours with a maximum depth of 0.4 to 0.9 feet. Fortunately, the NPS has experience with articulated concrete block (ACB) overtopping protection (see figure 8). This system works well with small dam, small depth applications. The NPS likes this system because soil and vegetation is put on top of the ACBs during construction gives a natural appearance to the completed dam. Furthermore, we draped the ACBs over not only the entire crest and downstream slope of the dam, but in a continuous blanket through the spillway as well. This eliminated any weakness between the dam downstream slope and the spillway reducing spillway lateral erosion concerns (a key decision as it later turned out). This decision also allowed us to use the existing timber pedestrian bridge over the spillway and minimize public perceived changes to the heavily visited dam. Boulders removed from the spillway during the repair project would be placed back on the sides of the spillway following installation of the ACBs to maintain historical appearance.

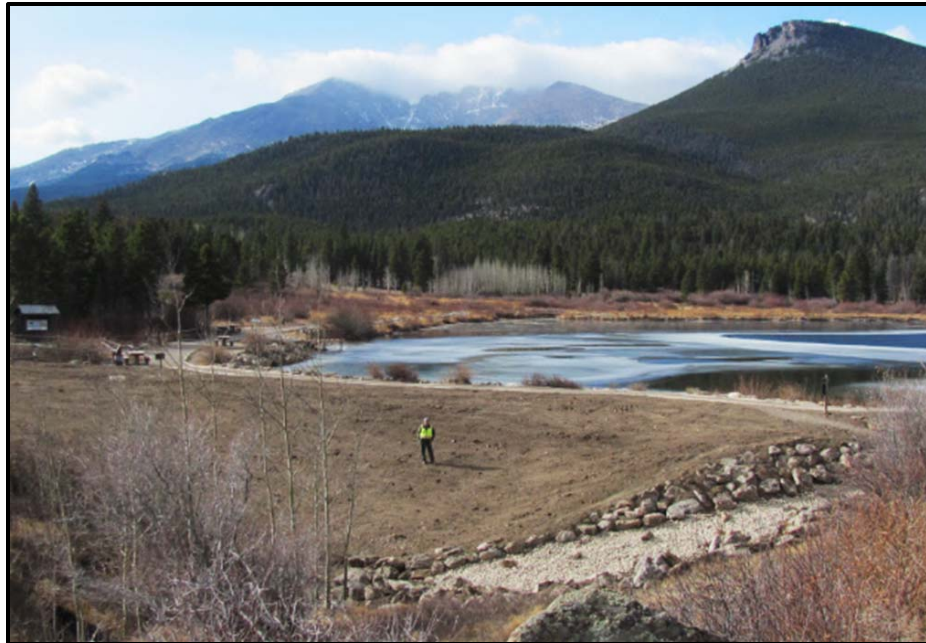
Figure 10: Lily Lake Dam following dam repair – circa December 2012 (Reclamation)

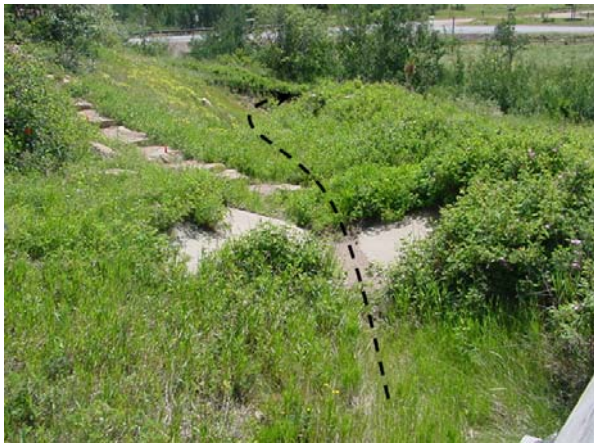
Figure 13: Pre-repair spillway channel from bridge (2011 Reclamation)

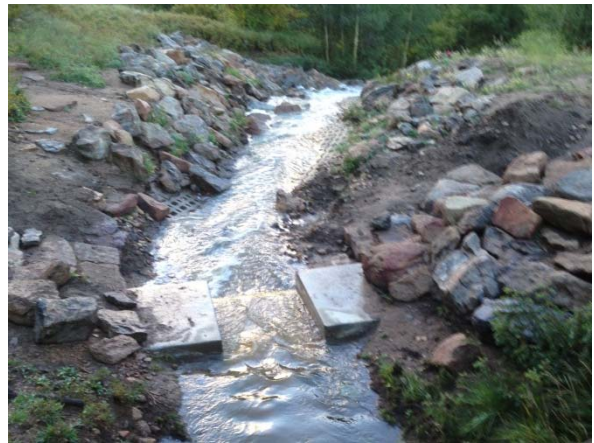
Park staff closely monitored the dam full time for the next several days. They also monitored the culvert in the downstream road embankment. Spillway flows were about 18-inches deep for days. The decorative gravel on top of the ACBs was eroded away. Some gravel within the ACB matrix was plucked out, but not to the extent to expose the underlying geotextile.

Figure 14: Post-repair spillway channel from bridge one week after flood peak (9/19/13 NPS)

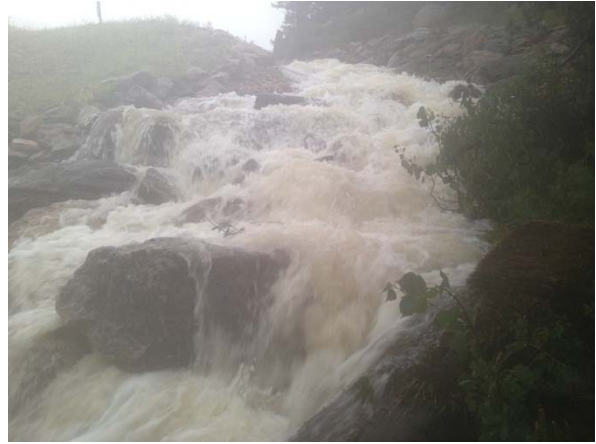
Figure 16: Flood flows down spillway chute (9/12/13 NPS)

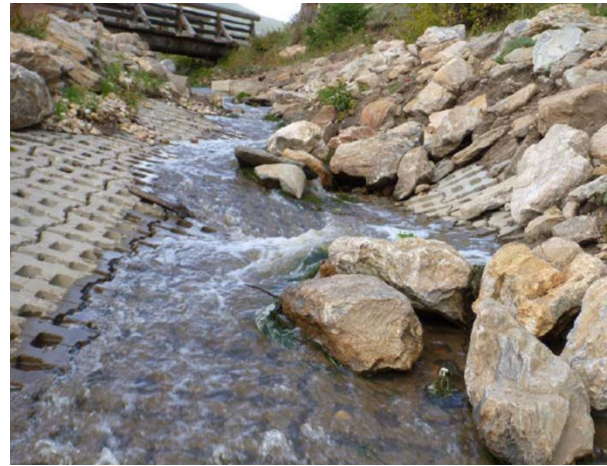
Figure 18: Spillway channel after flood. Note exposed ACBs, gravel/soil eroded away, and relocated boulders (9/16/13 Reclamation)

On September 14, the NPS Regional Dam Safety Coordinator contacted Reclamation and requested an inspection team be sent to the dam. Using an existing task order for emergency response, an inspection team visited the dam on September 16. The Reclamation engineer issued a travel report [9] with observations and recommendations. Repairs are planned for the inspection well area and replacement of gravel in the spillway chute.

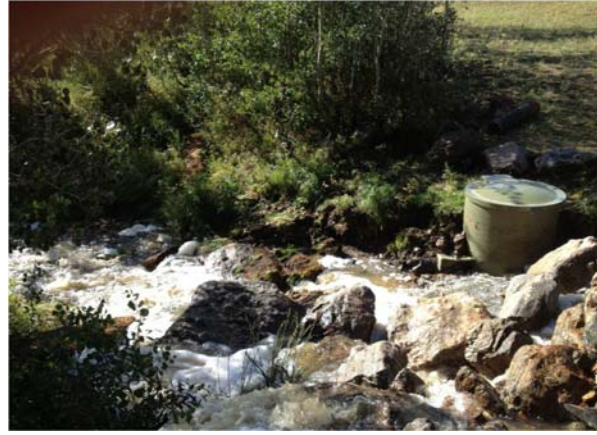
Material was also eroded from around the downstream toe outfall and inspection well area (see figures 19 and 20). This area will require a repair.

Figure 20: Inspection well area erosion damage after flood (Reclamation 9/16/13)
