# TAILINGS DAMS RISK OF DANGEROUS OCCURRENCES

*Lessons learnt from practical experiences*

**Bulletin 121**

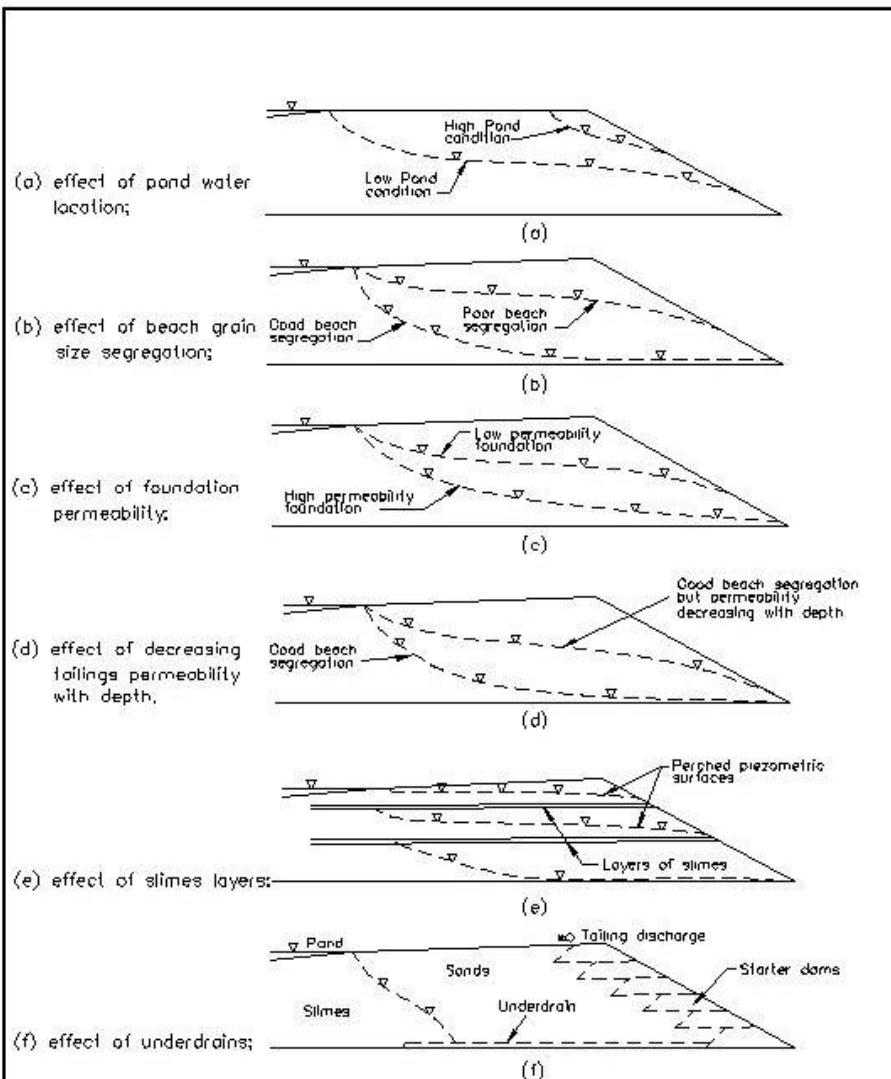
Figure 10. Factors influencing the position of the phreatic surface in dams built by the upstream method. Shows effect of lack of drainage and layers of low permeability producing perched water surfaces. (After Fell et al 1992)

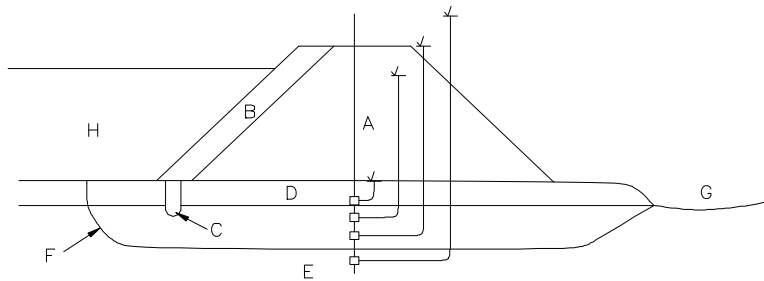
Figure 13. Section of Aznalcóllar Tailings Dam.

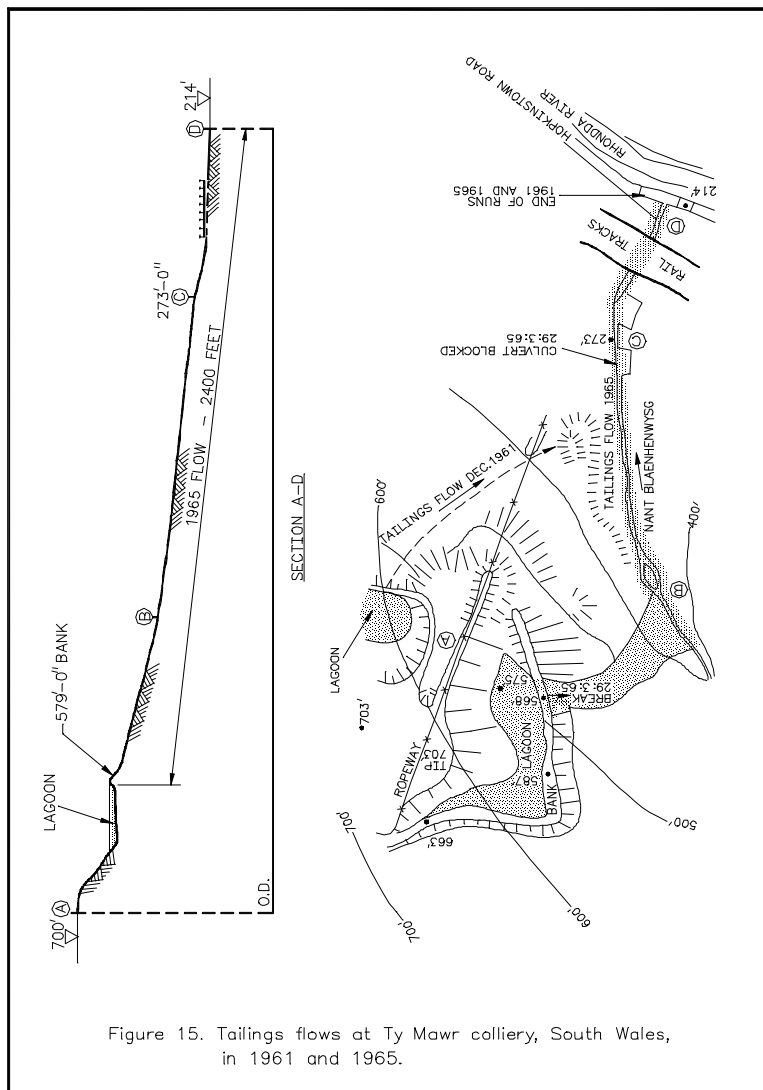
Figure 15. Tailings flows at Ty Mawr colliery, South Wales, in 1961 and 1965.

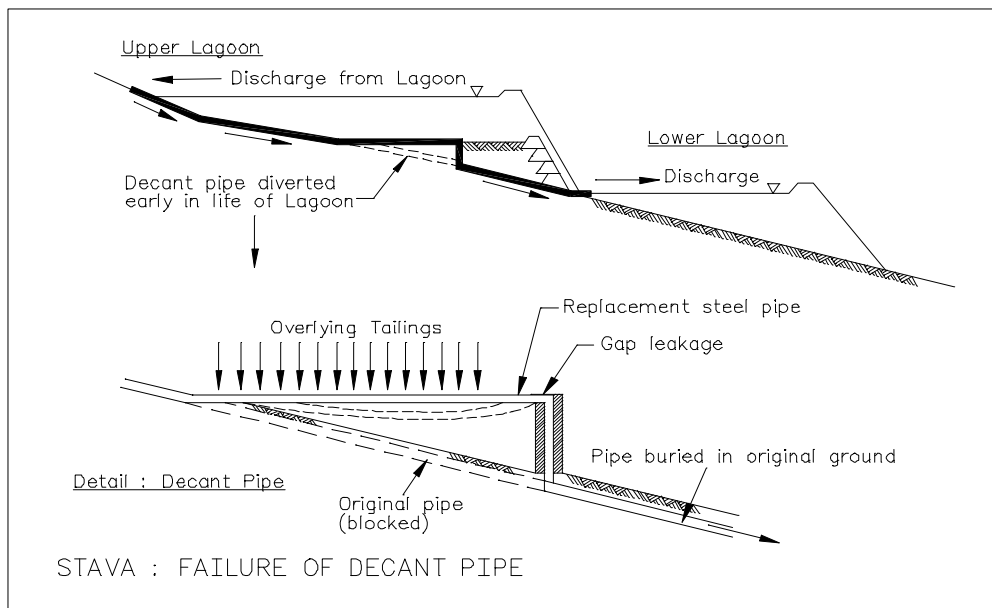
Figure 16. Failure of the decant pipe at Stava.
