**Root Cause Analysis of
TVA Kingston Dredge Pond Failure on
December 22, 2008**

Kingston Fossil Plant, Harriman, Tennessee

Project No. 60095742
June 25, 2009

Volume I – RCA Report

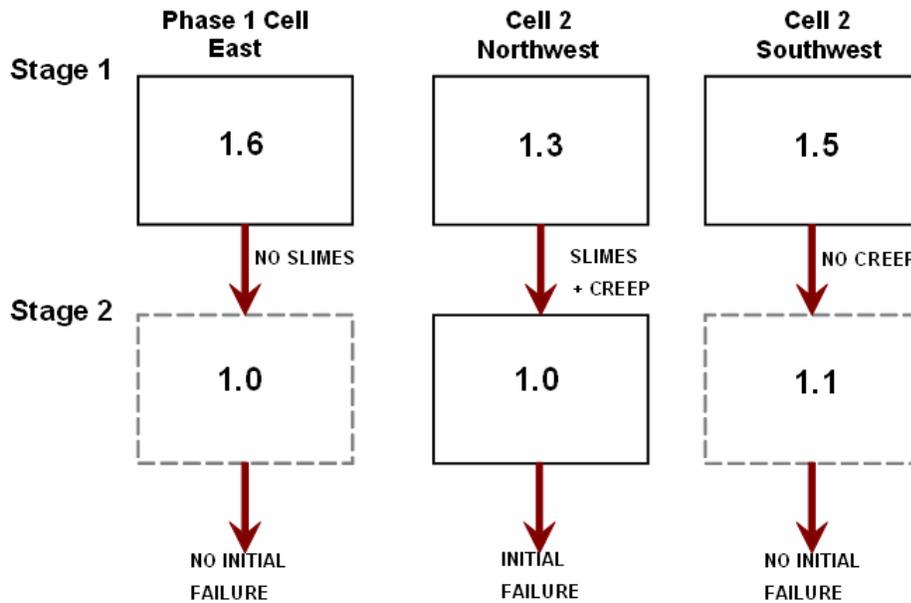
Figure 1.6.3_21 Comparison of Undrained Ash Computed Stability at Critical Sections Using SLOPE/W

It is evident to AECOM, from the known sequence of events and relic movements that the failure initiated at or very close to the Northwest Cell 2 section. Therefore, the Northwest Cell 2 section became unstable before the east side of the Phase I Emergency Dredge Cell and the Southwest Cell 2 sections were impacted. Even though ash was lost from behind the east side of the Phase I Emergency Dredge Cell and failure took place at the Southwest Cell 2 section, the order of events implies that failure at these locations was a consequence, or domino effect, caused by the failure at the Northwest Cell 2 section.

Figure 1.6.3_21 below shows the computed FS against slope stability using SLOPE/W for the three sections discussed above. In this chart, a two stage analysis was performed. Stage 1 is defined by the condition where no excess water pressures are developed in the fly ash. Therefore, the fly ash is modelled in AECOM’s analysis using drained strength parameters, representing a long term and stable condition. Stage 2 is modelled assuming that the sluiced ash develops positive excess pore water pressures due to its contractive behaviour. Therefore, the fly ash is modelled in Stage 2 using undrained strength parameters.
