## Brown Bridge Dam – Temporary Dewatering Structure

### Root Cause Analysis of the October 6, 2012, Failure Incident

June 2014

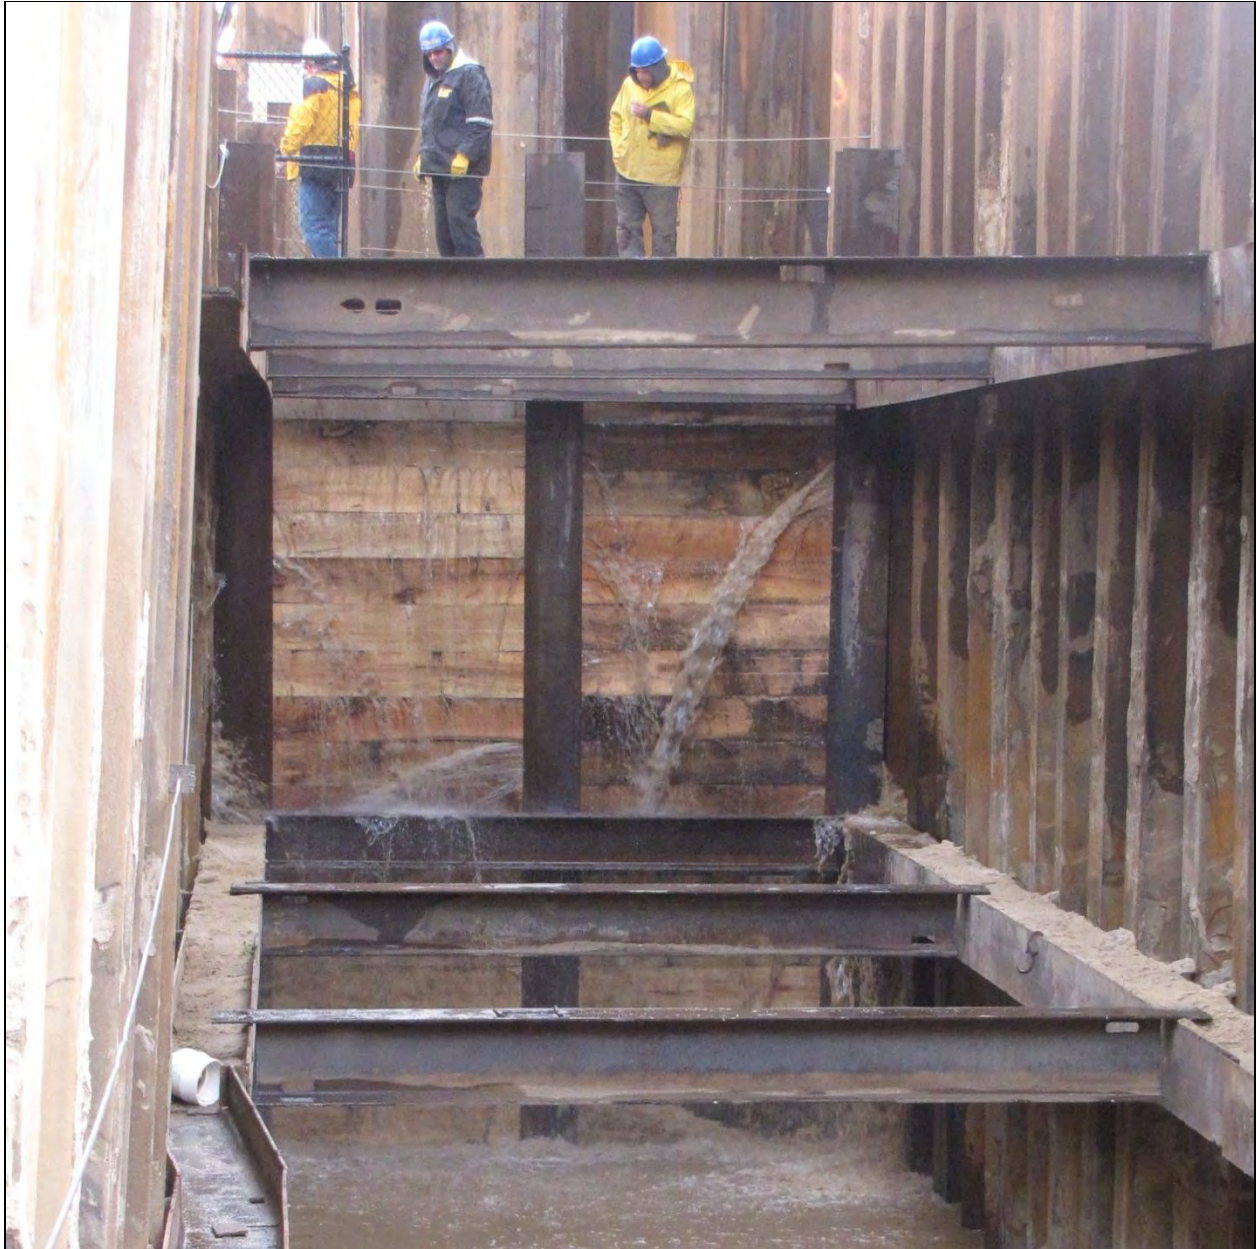
At approximately 10:00 AM on October 6, 2012, a single steel sheet was removed from the TDS headwall to allow water to flood the forebay for testing of the stoplog weir and concrete control section. As the water level in the forebay equalized with the impoundment level minimal flow over the stoplog weir, leakage between the timber stoplogs was observed, as shown in Figure II-4 below.

**Figure II-4.** Photo of TDS stoplog weir at first testing  
*Photo courtesy of AMEC*

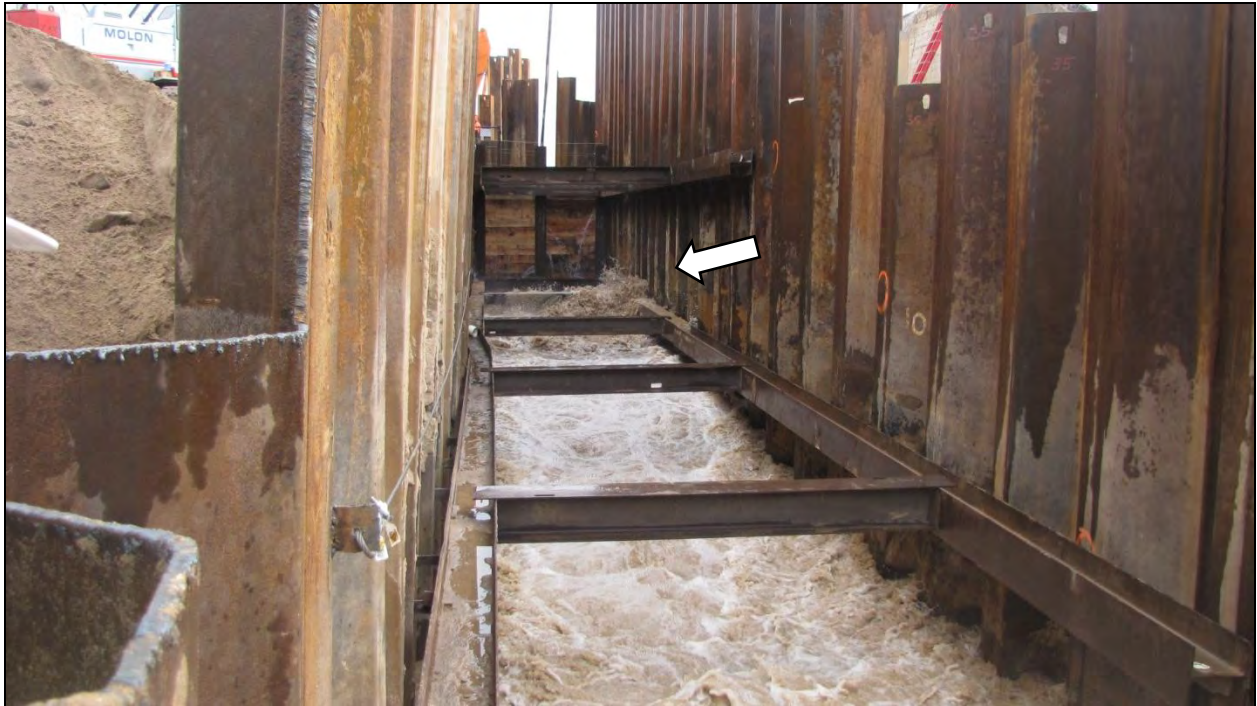
Approximately 10 minutes after the first headwall sheet was removed, water was observed to be boiling up from the TDS channel immediately downstream of the

concrete control section slab, adjacent to the southern TDS wall, as shown in Figure II-5 below.

**Figure II-5.** Photo of TDS channel at initial boil formation (arrow indicates boil location)  
*Courtesy of AMEC*

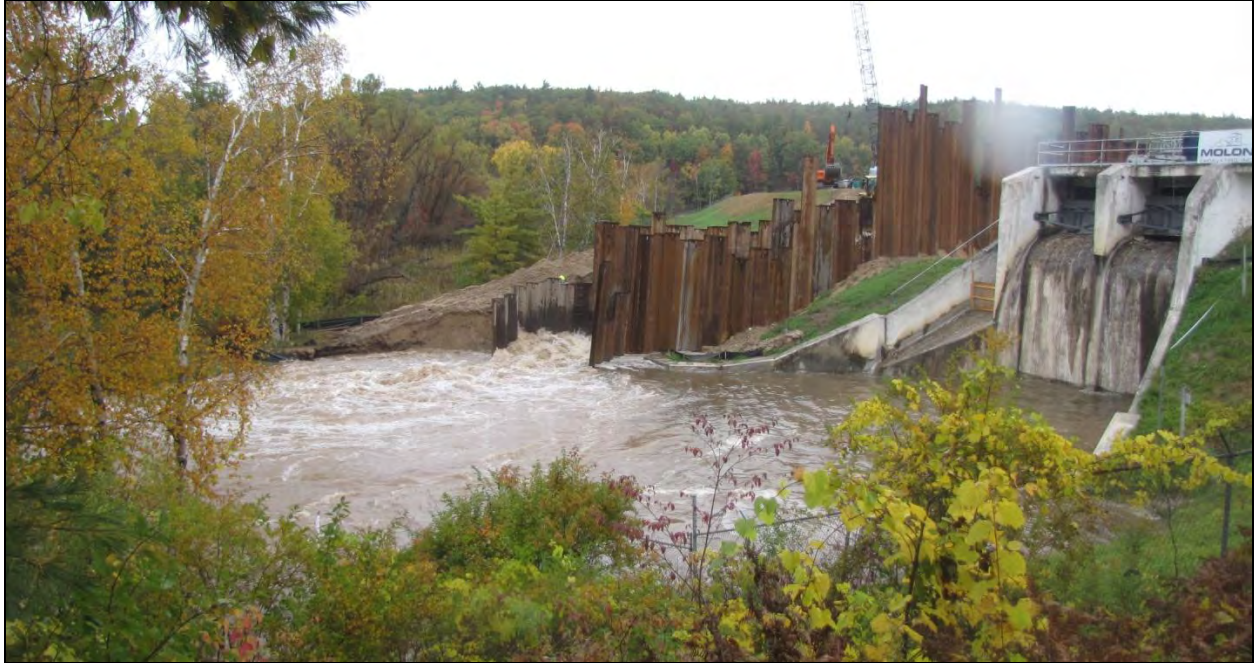
Flow from the boil increased rapidly, causing scouring of foundation soils from underneath the TDS control section, turbulent flow through the downstream TDS channel, and a rapid rise in the tailwater elevation below the TDS outlet, as shown in Figure II-6 below.

**Figure II-6.** Photo of TDS channel with turbulent flow from boil  
*Photo courtesy of AMEC*

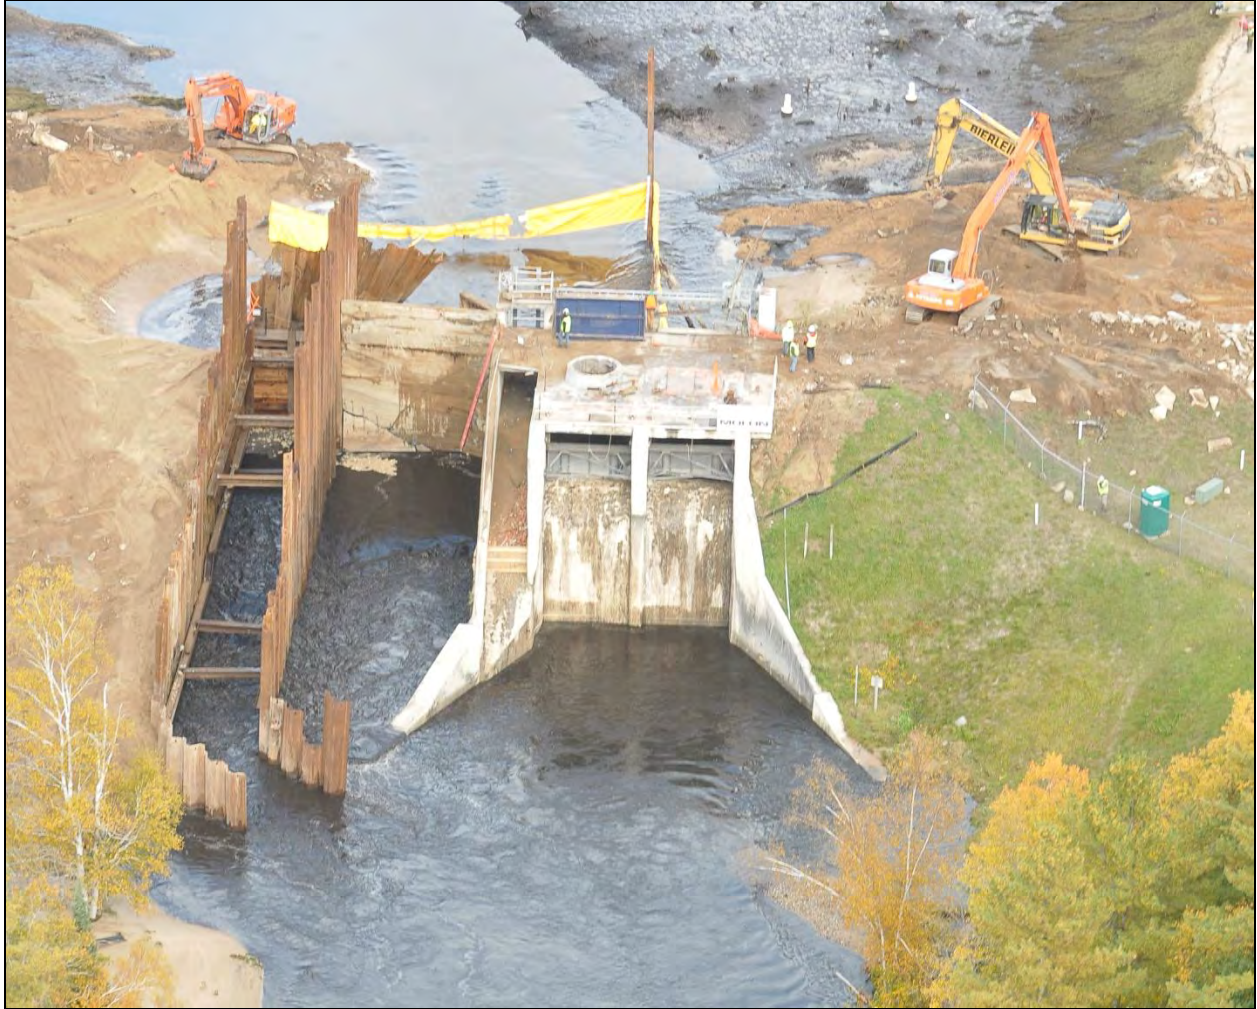
The uncontrolled release of water from the TDS caused significant scouring and erosion of the upstream earthen embankments adjacent to the TDS structure. The rapid loss of embankment soils in these areas resulted in complete failure of the embankment section located between the TDS and Brown Bridge Dam spillway structures. The rapid release of impoundment waters through the TDS and failed embankment section ultimately resulted in draining of the Brown Bridge Pond in approximately 6 hours, causing a flood wave to travel downstream.

**Figure II-7.** Photo of the dam and TDS after complete failure  
*Photo courtesy of John Russell, Great Lakes Imaging*

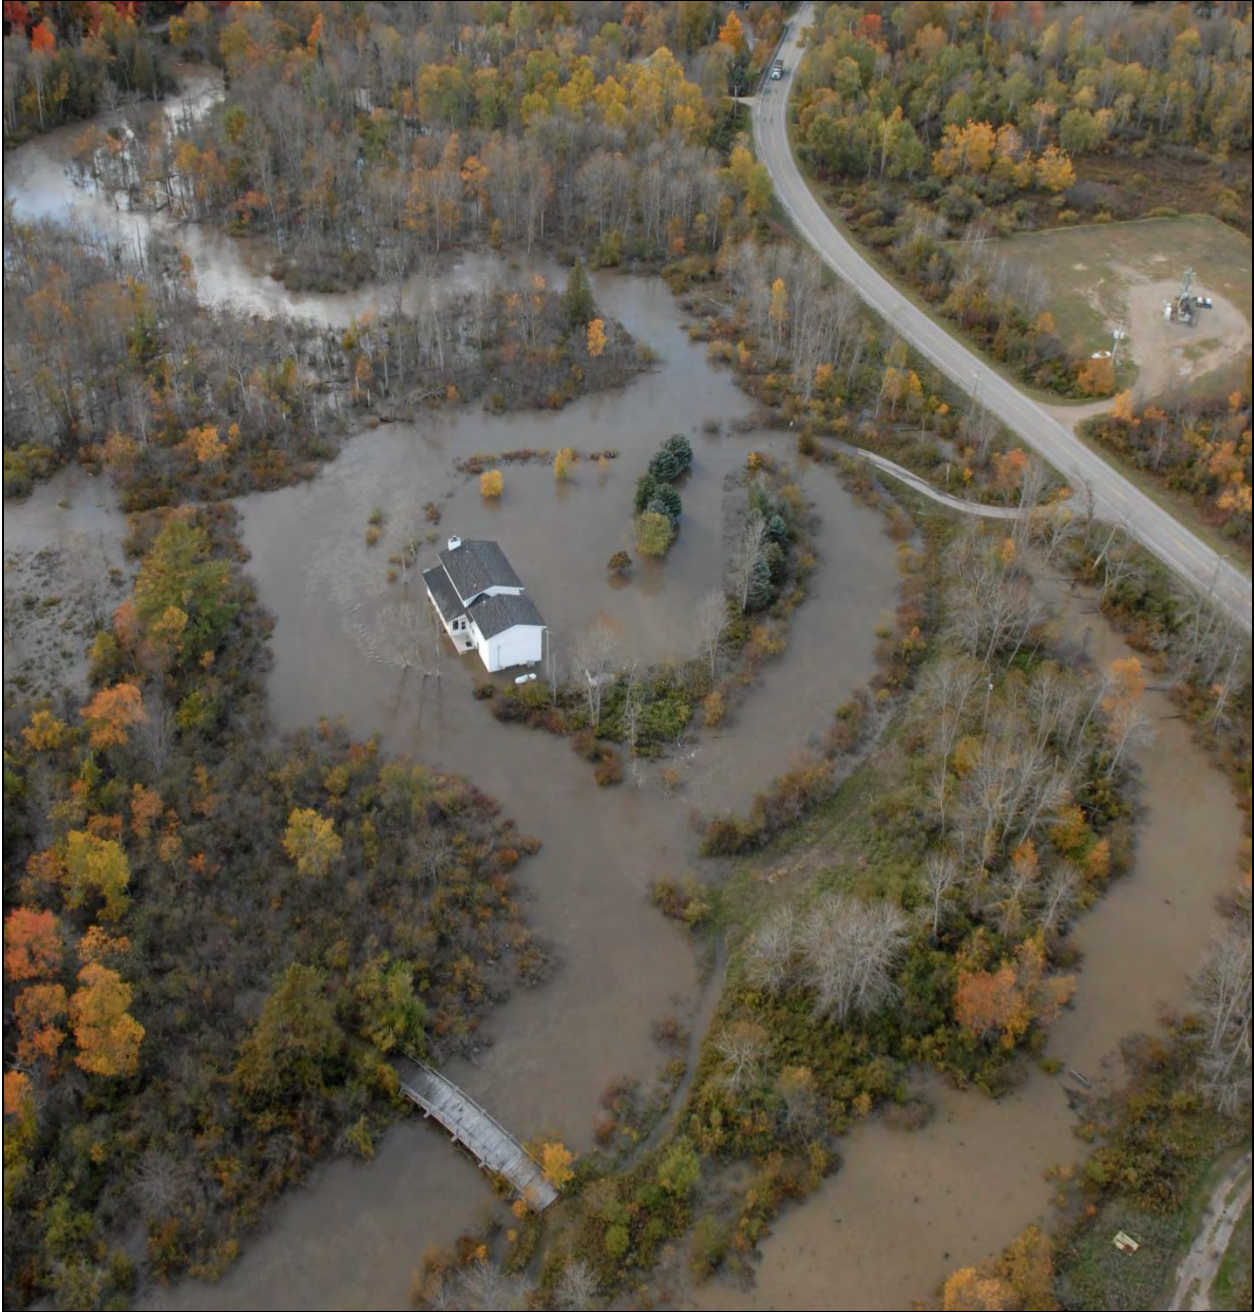
**Figure II-8.** Photo of downstream flooding  
*Photo courtesy of John Russell, Great Lakes Imaging*

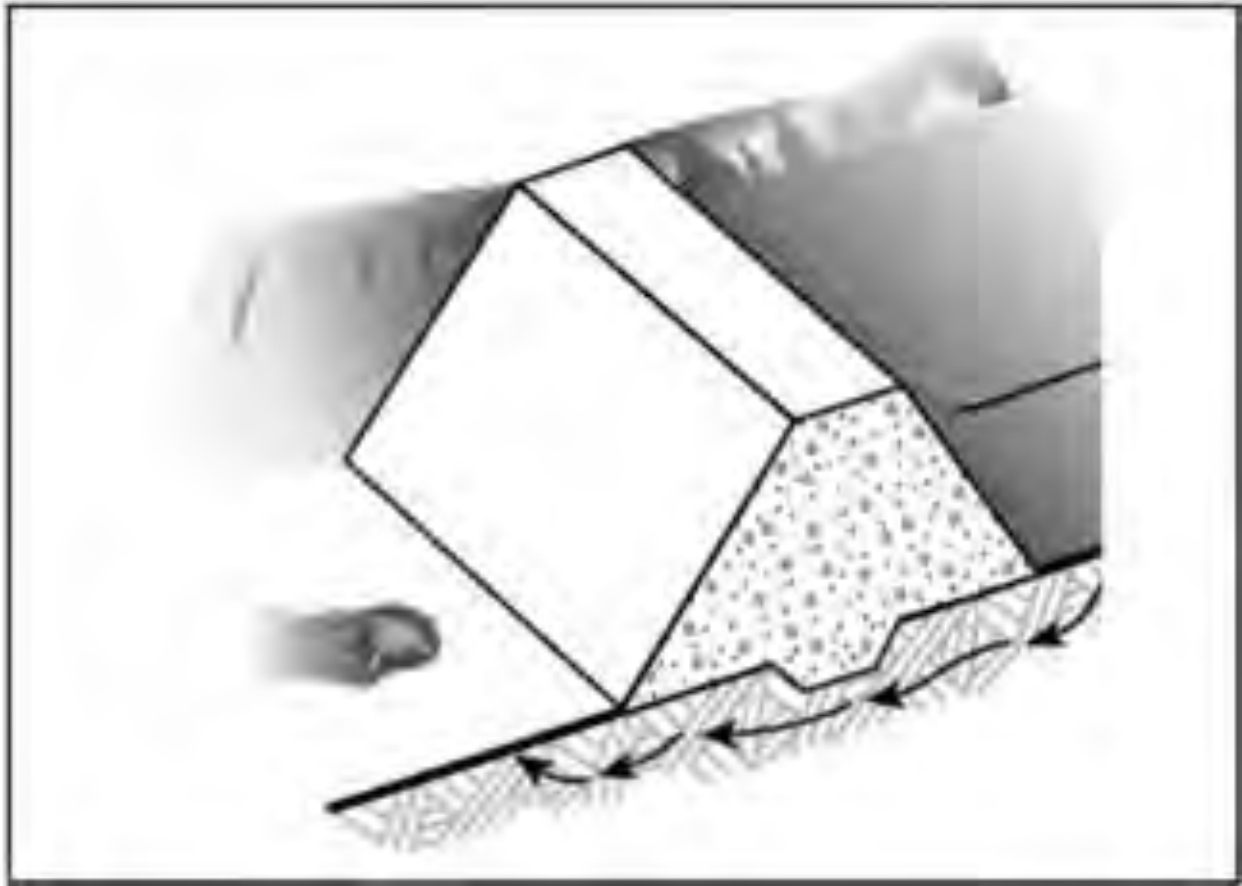
Three possible primary failure modes were considered as part of this analysis. The first failure mode considered was that a pipe formed in the embankment/foundation material directly underneath the TDS control section, eventually leading to the uncontrolled release of water and sediments through the TDS, breaching of the left adjacent embankment section, and total failure of the dam. A diagram of piping through the foundation of a dam is shown in Figure IV.3 below.

**Figure III-3.** Diagram of a foundation piping and sand boil formation

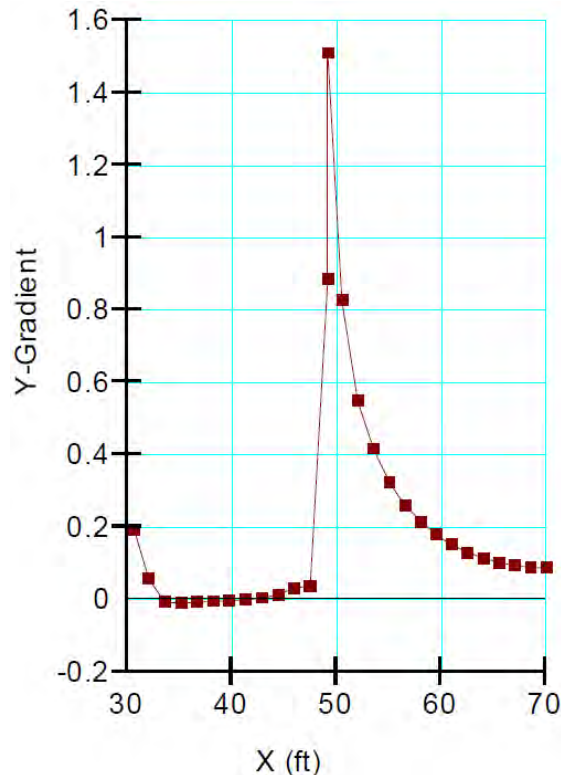
Based on the analysis,  $i_{exit}$  was estimated to be approximately 1.50 at the end of the concrete slab, as shown in Figure VI-1 below. It should be noted that hydraulic exit gradient is independent of hydraulic conductivity when the soil is homogenous and isotropic.

**Figure VI-1.** Plot of  $i_{exit}$  versus downstream distance

Critical hydraulic gradient occurs when the hydraulic exit gradient approaches a value of 1.0, much less than the value of 1.5 predicted by the model. This indicates that the hydraulic loading of the TDS foundation soils very likely resulted in a “quick” condition as described above. Additionally, a factor of safety (FS) against piping for the TDS soil foundation can be computed using the following equation:

The FS calculated from the above estimated critical and exit gradients for the TDS foundation is 0.67. Generally, an FS of 3 to 4 is required for the safe performance of a structure; thus indicating an inadequate FS for the TDS structure to perform safely.

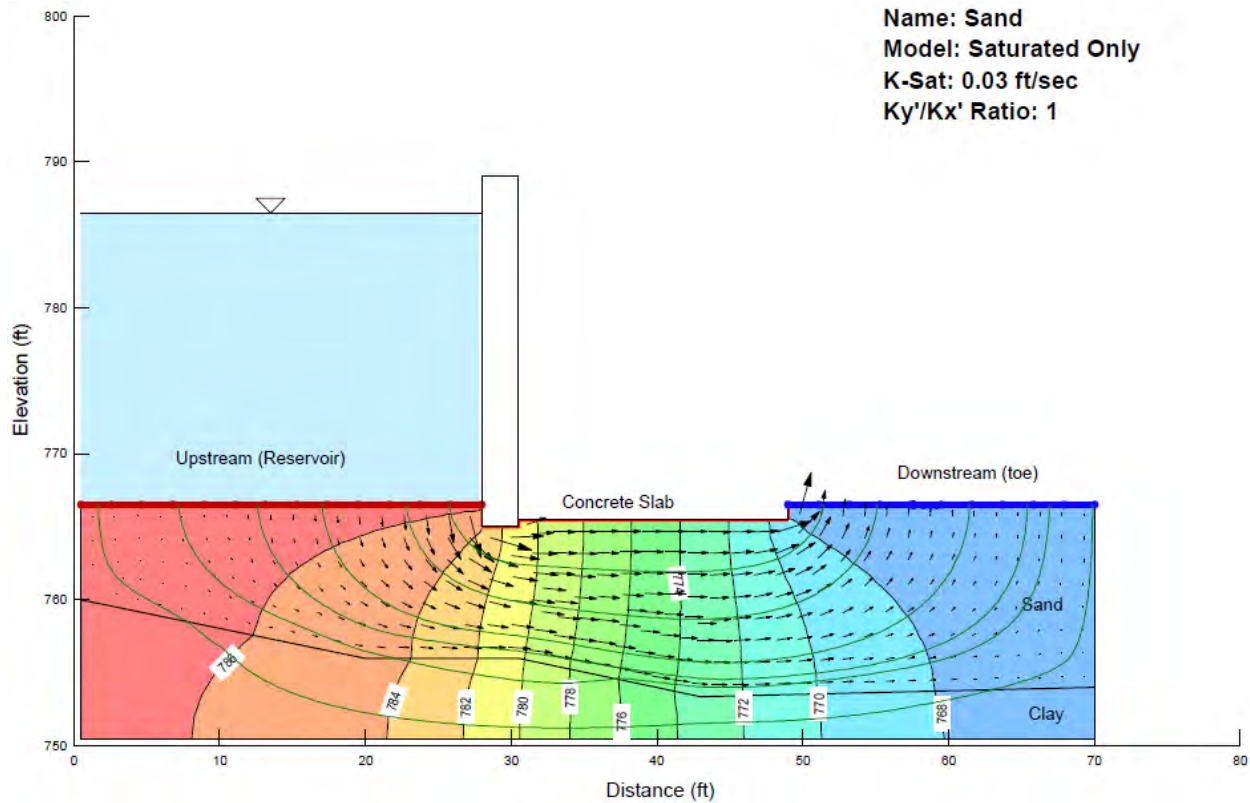
Also shown below in Figure VI-2, is a flow net developed by the SEEP/W model showing the potential flow paths for seepage under the structure. The  $k = 0.03$  ft/sec condition is shown in Figure VI-2. It should be noted that the model predicts high seepage velocities at the terminal end of the concrete slab in both cases. This is consistent with the location of the initial boil that developed during the TDS failure.

**Figure VI-2.** SEEP/W flow net for  $k = 0.03$  ft/sec
