# *REPORT OF THE COMPTROLLER GENERAL OF THE UNITED STATES*

## **Actions Needed To Increase The Safety Of Dams Built By The Bureau Of Reclamation And The Corps Of Engineers**

GED-77-85

JUNE 3, 1977

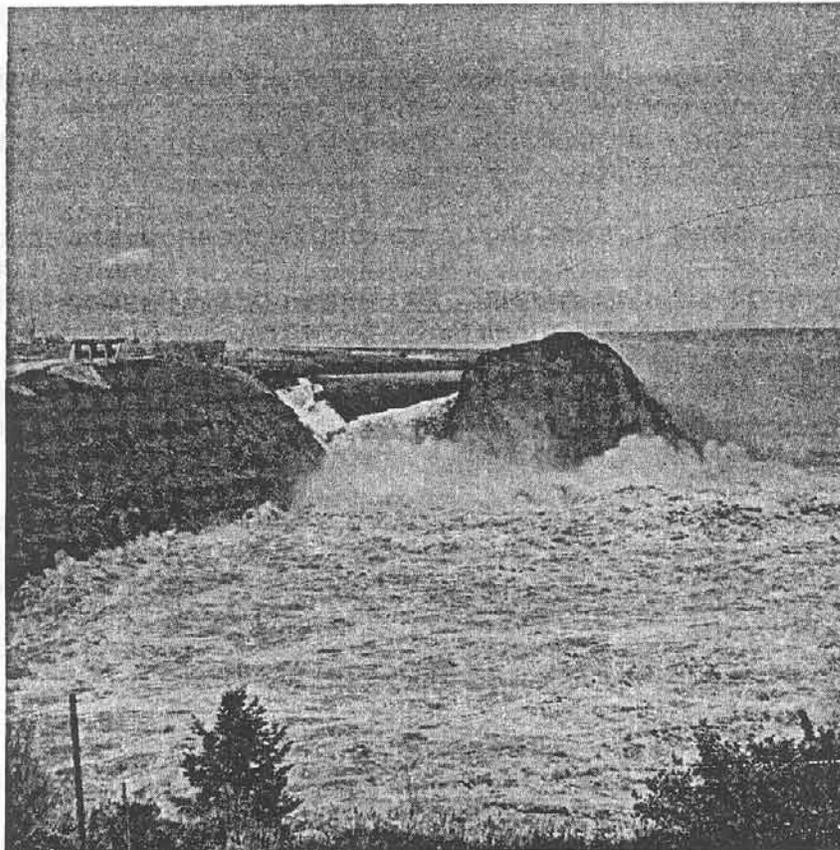
WATER GUSHING THROUGH THE RIGHT SIDE OF THE 305-FOOT  
TETON DAM IN THE EARLY AFTERNOON ON JUNE 5, 1976

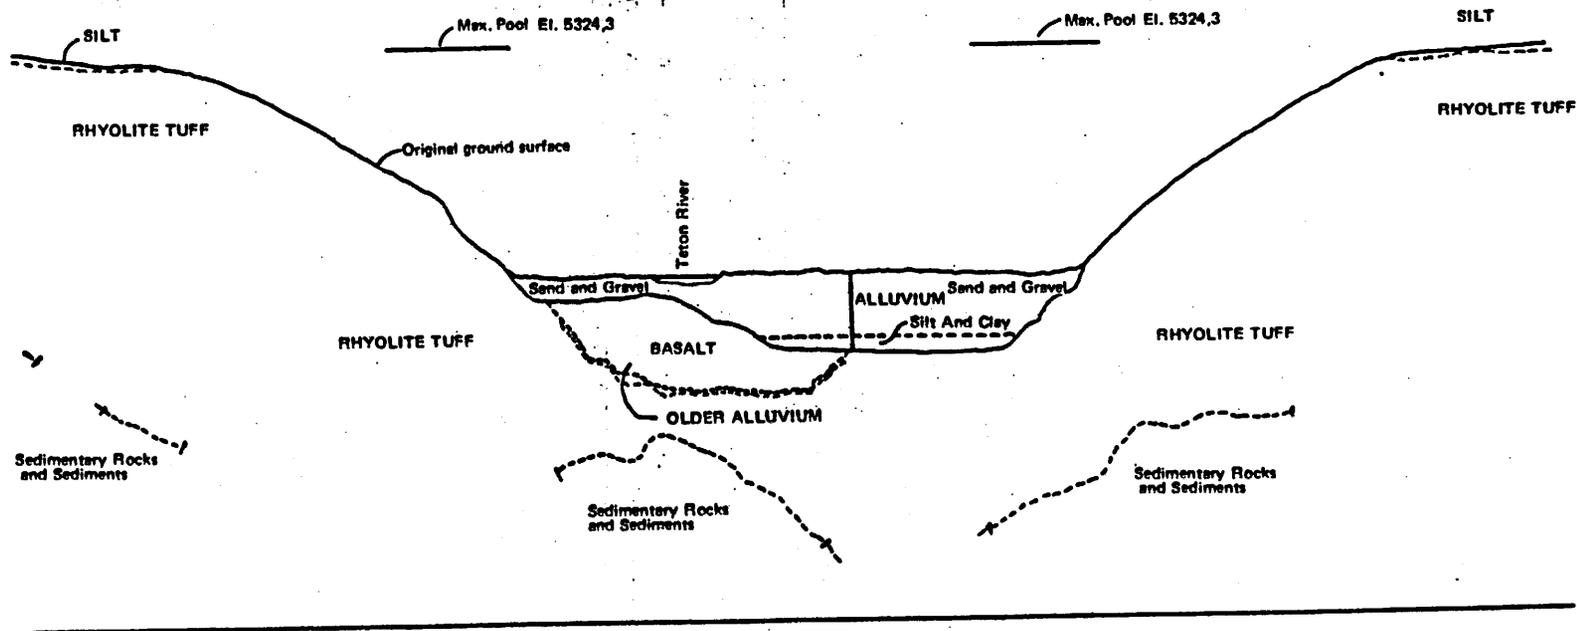
**TETON DAMSITE**  
**SIMPLIFIED GEOLOGIC CROSS SECTION ALONG DAM AXIS**  
**(VIEW DOWNSTREAM)**

During excavation of the foundation, large openings or fissures in the rock were found in both the left and right abutments. One opening, for example, was explored by a Bureau employee for a distance of about 100 feet both downstream and upstream of the dam's axis. He described the cavity on the downstream side as being about 4 feet wide. He said further exploration was blocked by a large rock. He said a room or passage could be seen beyond but that the opening into it was too small to enter. The Independent Panel concluded that these cavities increase the permeability of the foundation.

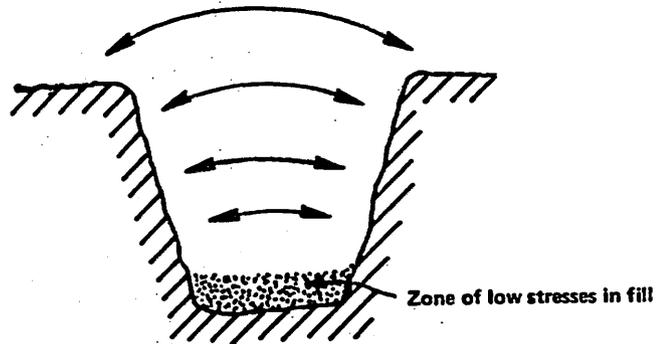
The Panel said that in the bottom of the key trench in the vicinity of the failure, there was a concentration of steps and overhanging rocks which made proper compaction of soil in the trench difficult and was conducive to arching as

First order arching in fill over and between walls of key trench

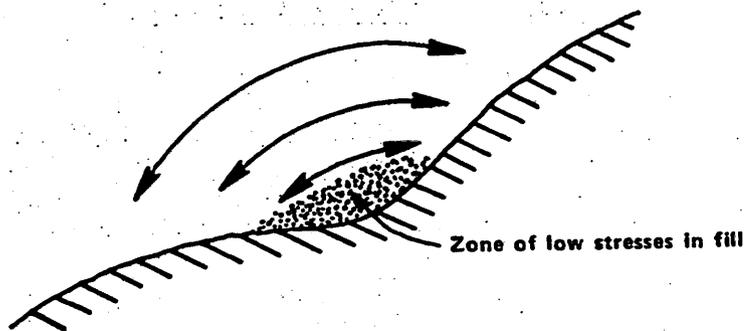
Second order arching produced by longitudinal topography of rock surface in key trench

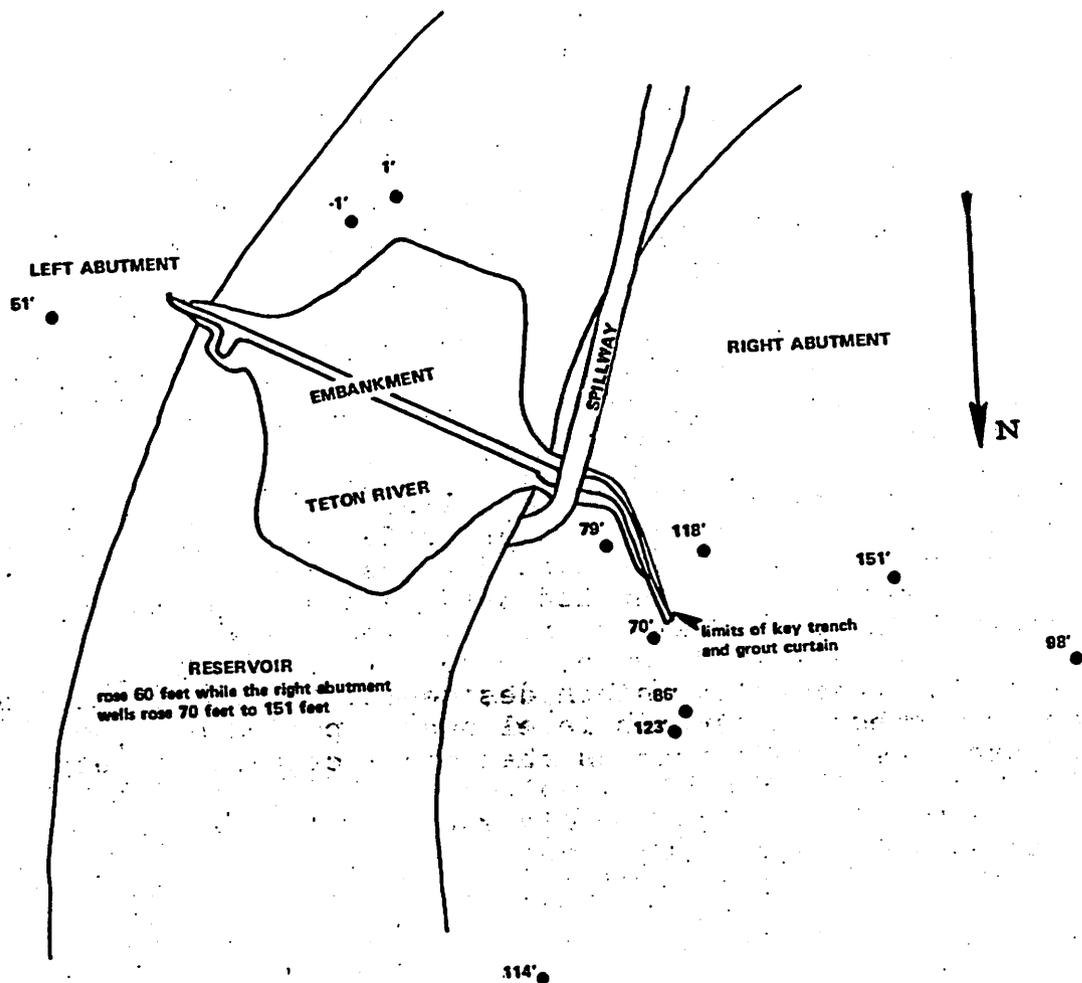
**TETON DAM**

Bureau designers told us that had they seen such information earlier, they probably would have initiated action to check the accuracy of the data and to evaluate the effects of the seepage, if any, on dam safety. They told us that this could have led to opening the main river outlet to drain a portion of the reservoir.

Location of observation wells (●) and rises in feet for the wells and reservoir from May 13, 1976 to June 1, 1976

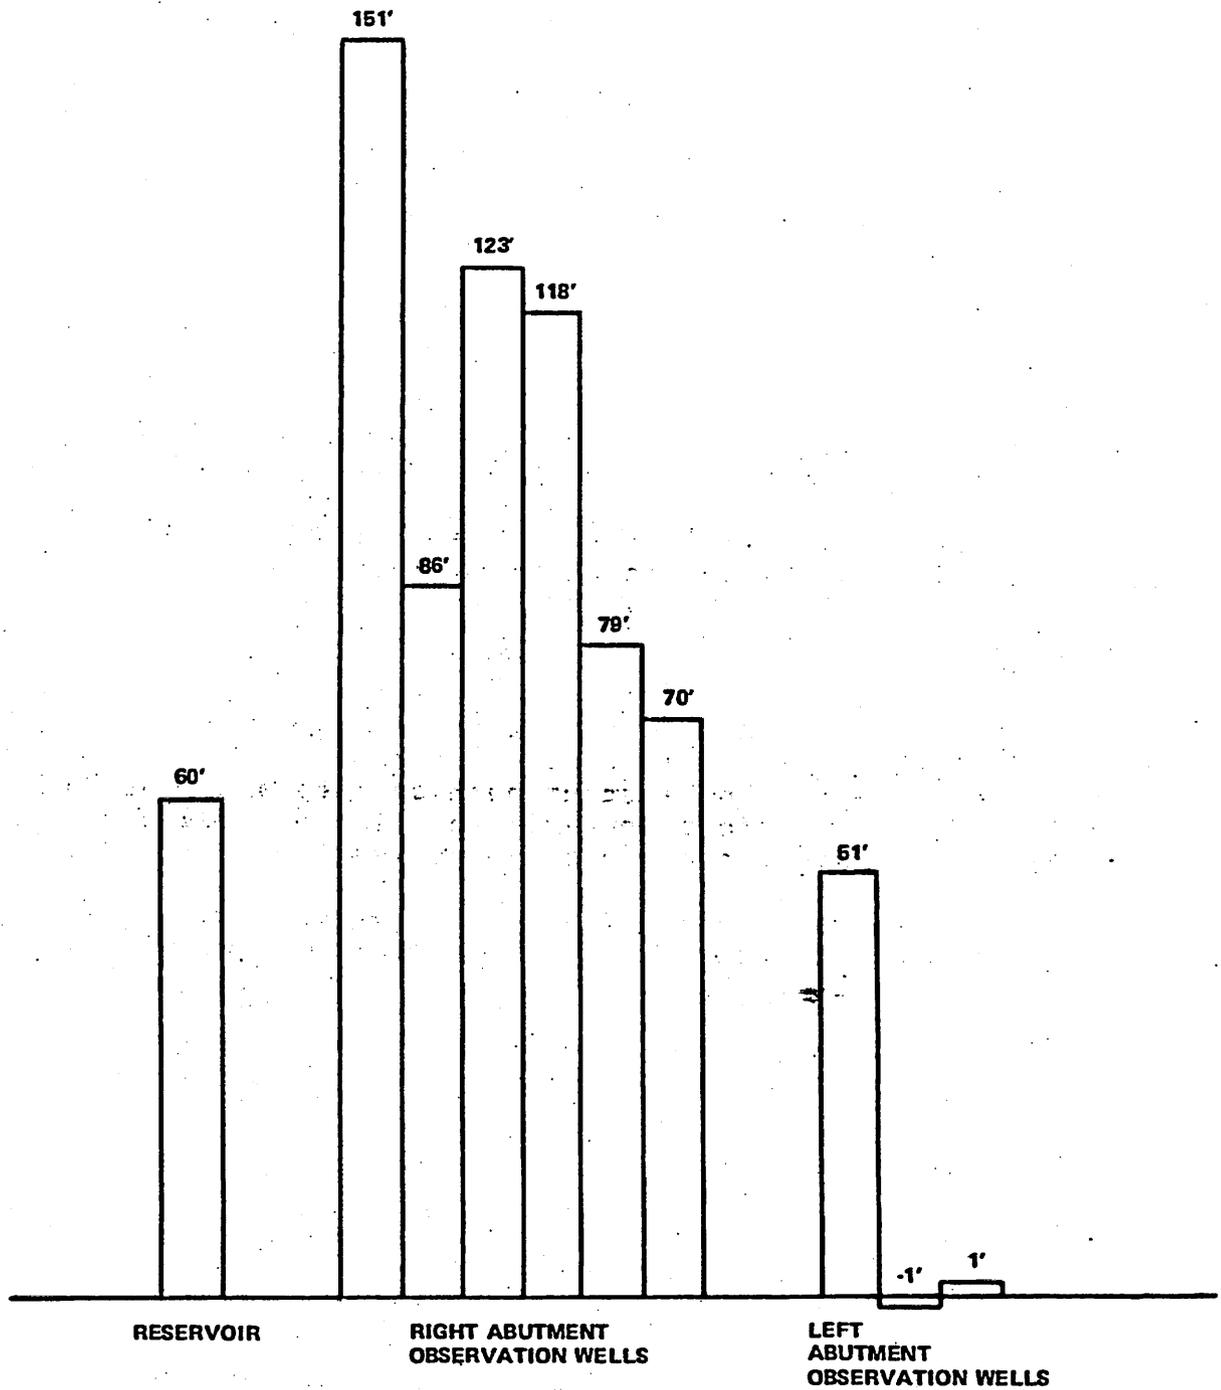
# RELATIONSHIP OF THE WATER RISE IN THE TETON DAM RESERVOIR TO THE WATER RISE IN THE SURROUNDING GROUND WATER OBSERVATION WELLS

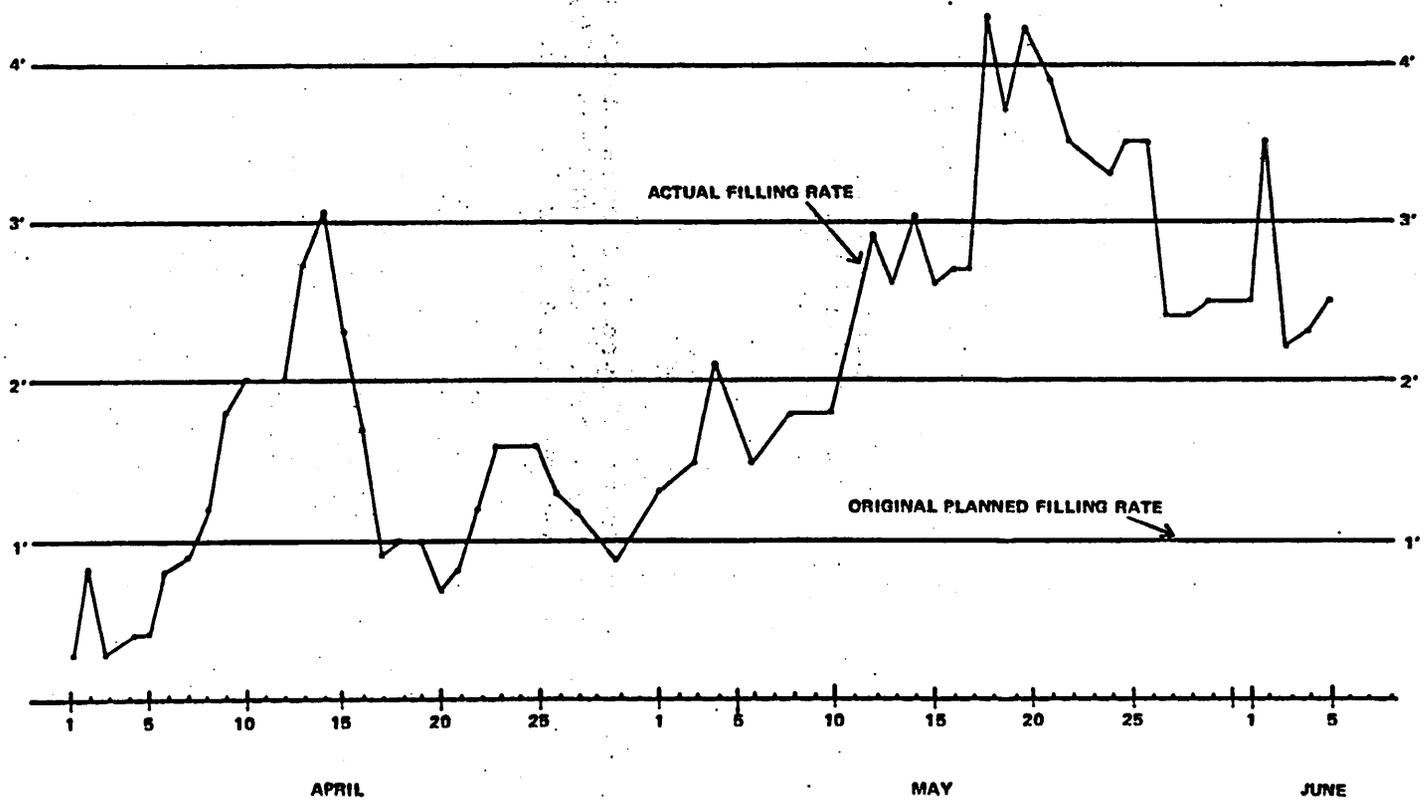
## DAILY INCREASE OF RESERVOIR HEIGHT IN FEET FROM APRIL 1, 1976 TO JUNE 5, 1976

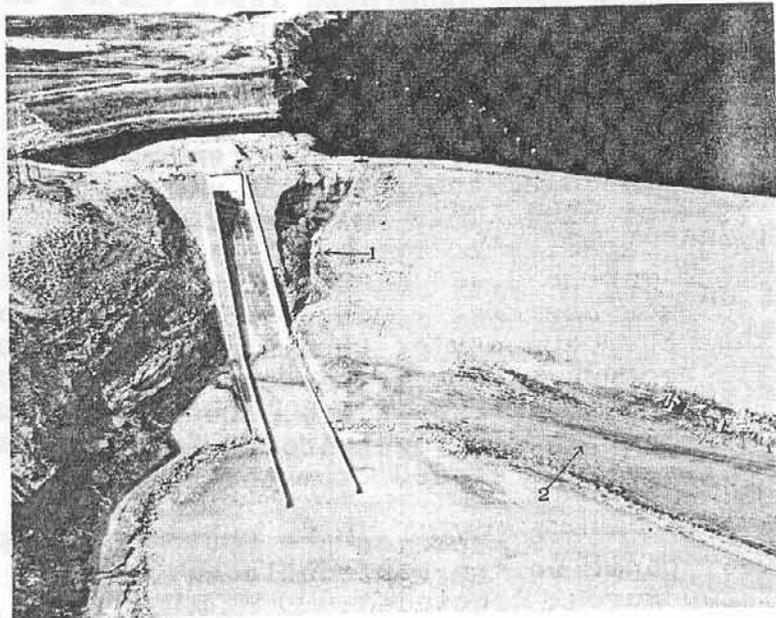
We believe that the failure of Teton Dam and the near failure at Fontenelle Dam should clearly illustrate to dam-builders the importance of (1) a slow, controlled filling rate during first filling to closely monitor the behavior of the dam and (2) an operable outlet of sufficient size to release enough water to lower the reservoir level when emergencies arise affecting dam safety.

**FONTENELLE DAM— LEAKAGE AND THE RESULTING EROSION OF THE RIGHT SIDE OF THE DAM (see arrow 1) AND EROSION ON THE FACE OF THE DAM ( see arrow 2)**

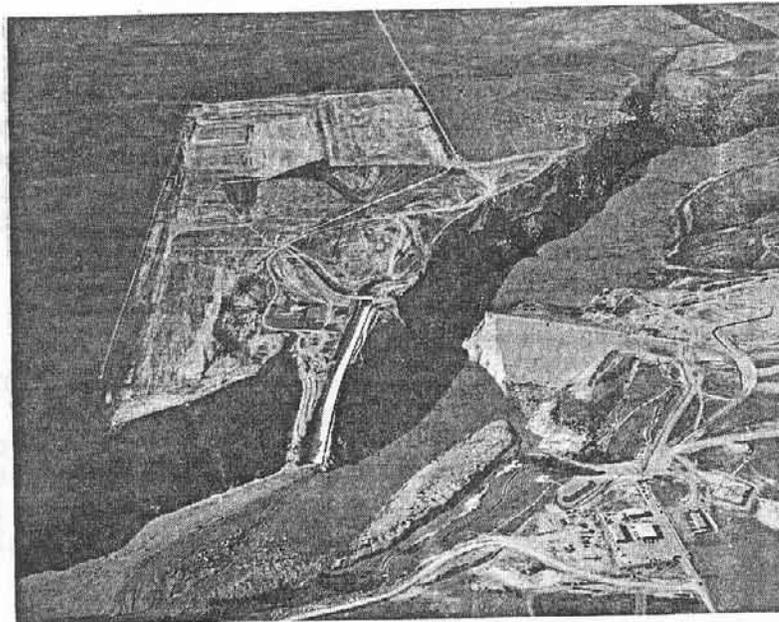
**TETON DAM— AFTER THE FAILURE**

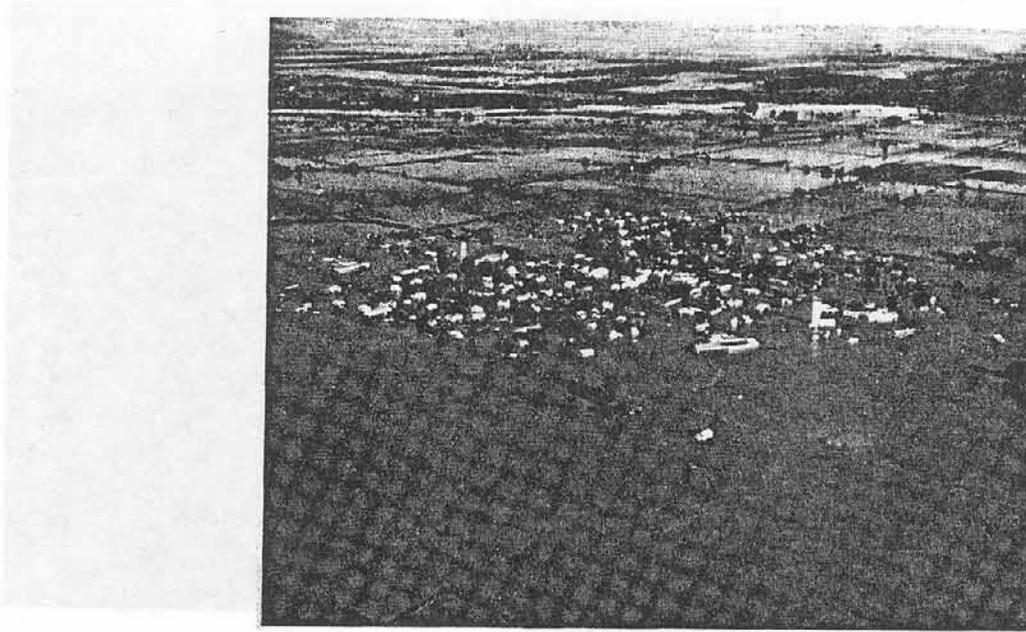
**SUGAR CITY, IDAHO— FLOODING ON JUNE 5, 1976, CAUSED BY THE FAILURE OF THE TETON DAM EARLIER THAT MORNING**

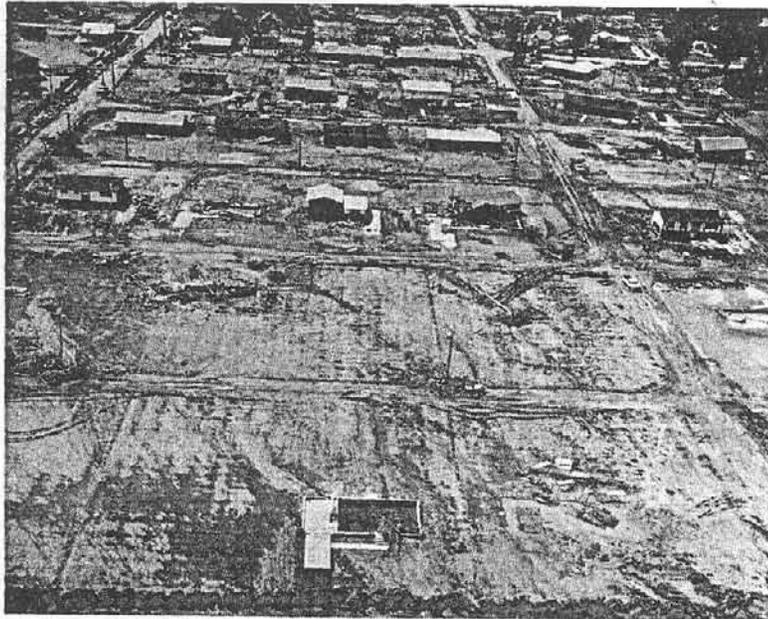
**SUGAR CITY, IDAHO—VACANT FOUNDATIONS WHERE HOUSES WERE WASHED AWAY AS A RESULT OF THE TETON DAM FAILURE**

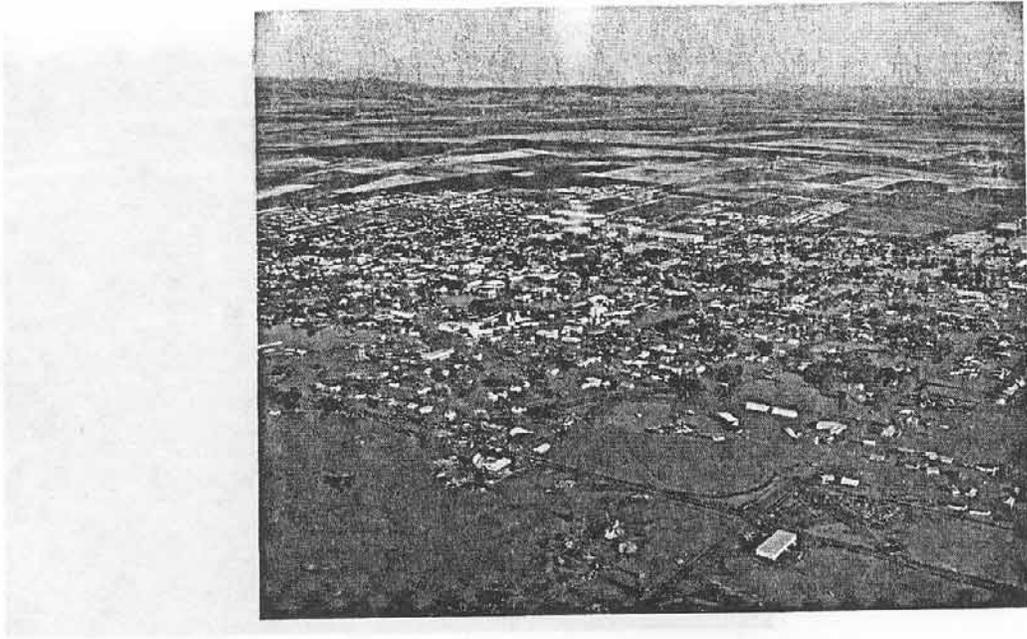
REXBURG, IDAHO—FLOODING ON JUNE 5, 1976, CAUSED BY THE FAILURE OF THE TETON DAM THAT MORNING

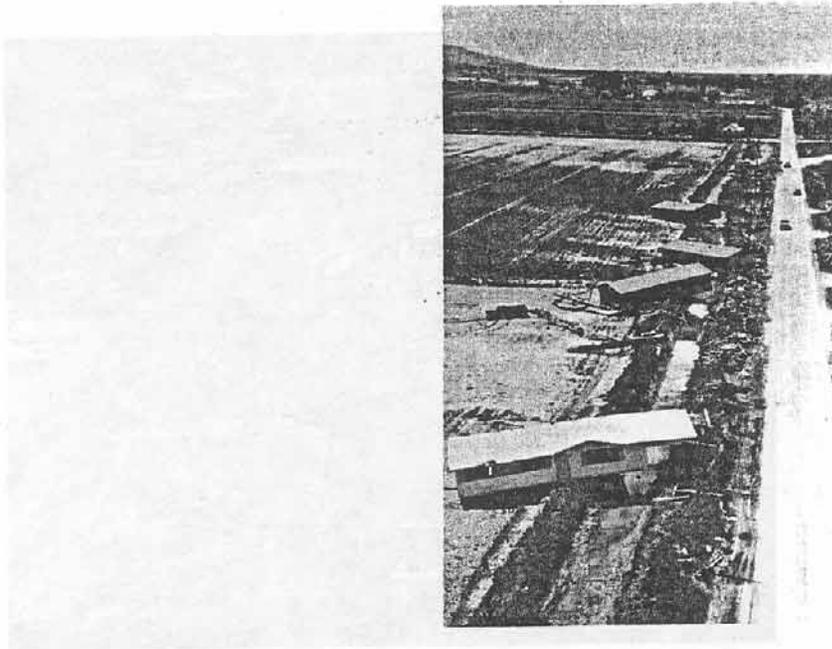
REXBURG, IDAHO—HOUSES MOVED FROM THEIR FOUNDATIONS AS A RESULT OF THE TETON DAM FAILURE
