GEI Consultants, Inc.

**FORENSIC INVESTIGATION
MEADOW POND DAM
ALTON, NEW HAMPSHIRE**

New Hampshire Department of Environmental Services

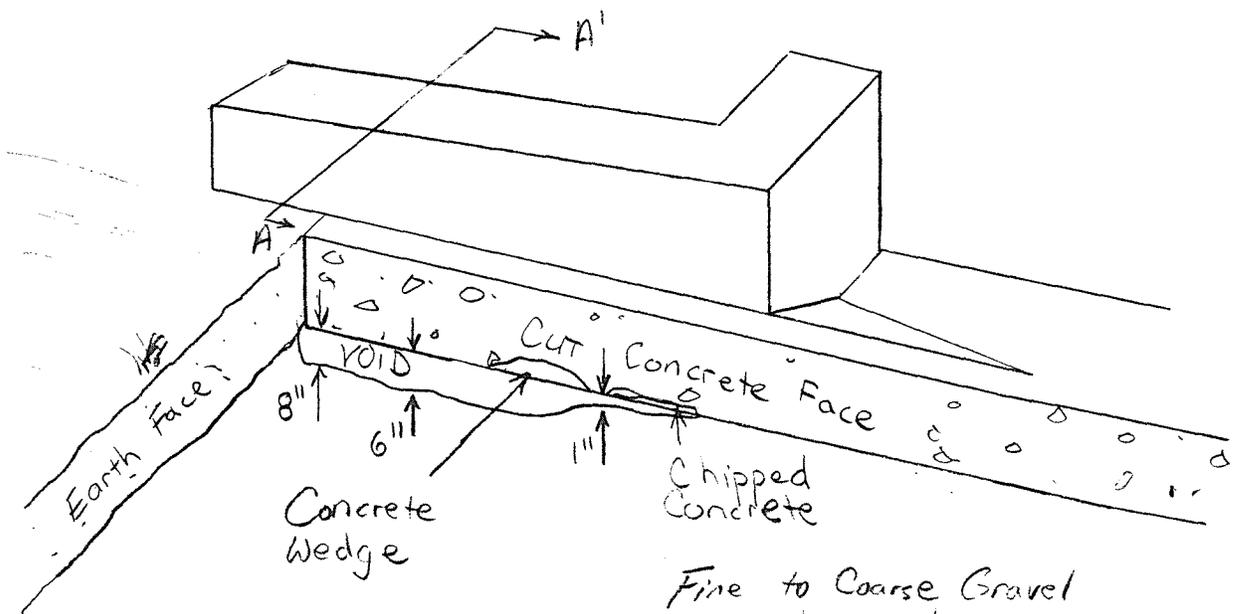
SECTION A-A'

Fine to Coarse Gravel
was observed on
the surface of the void

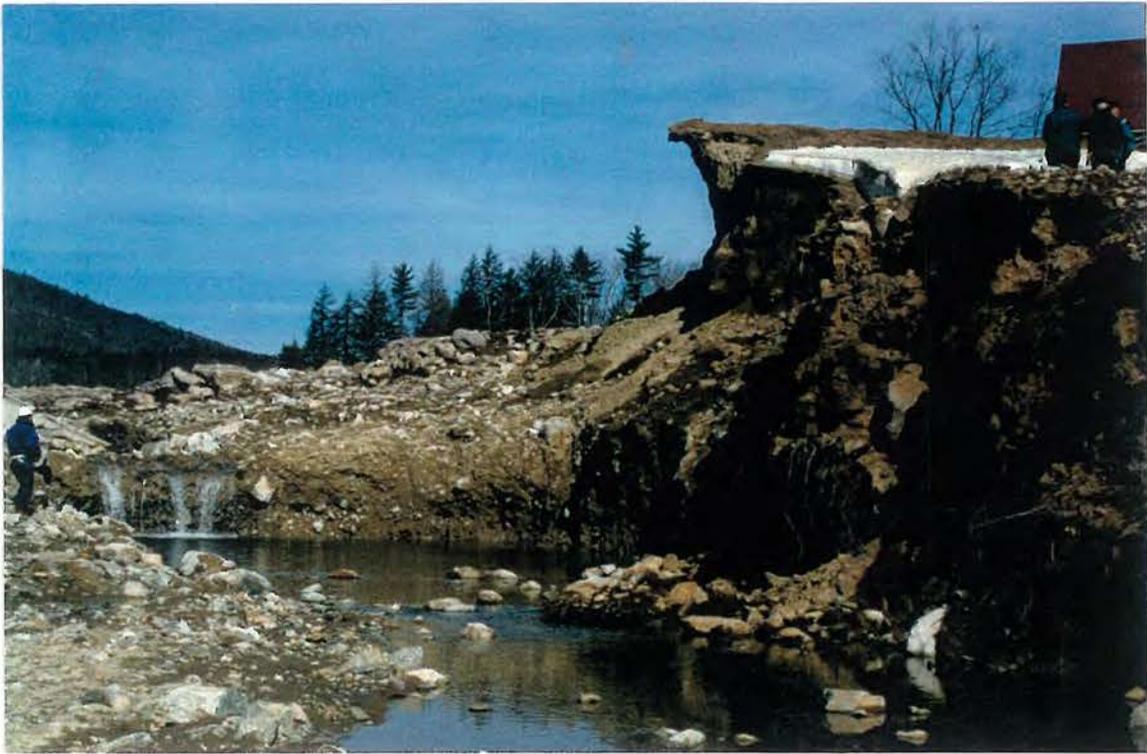
Left side of breach (looking upstream) after failure. (3/19/96)

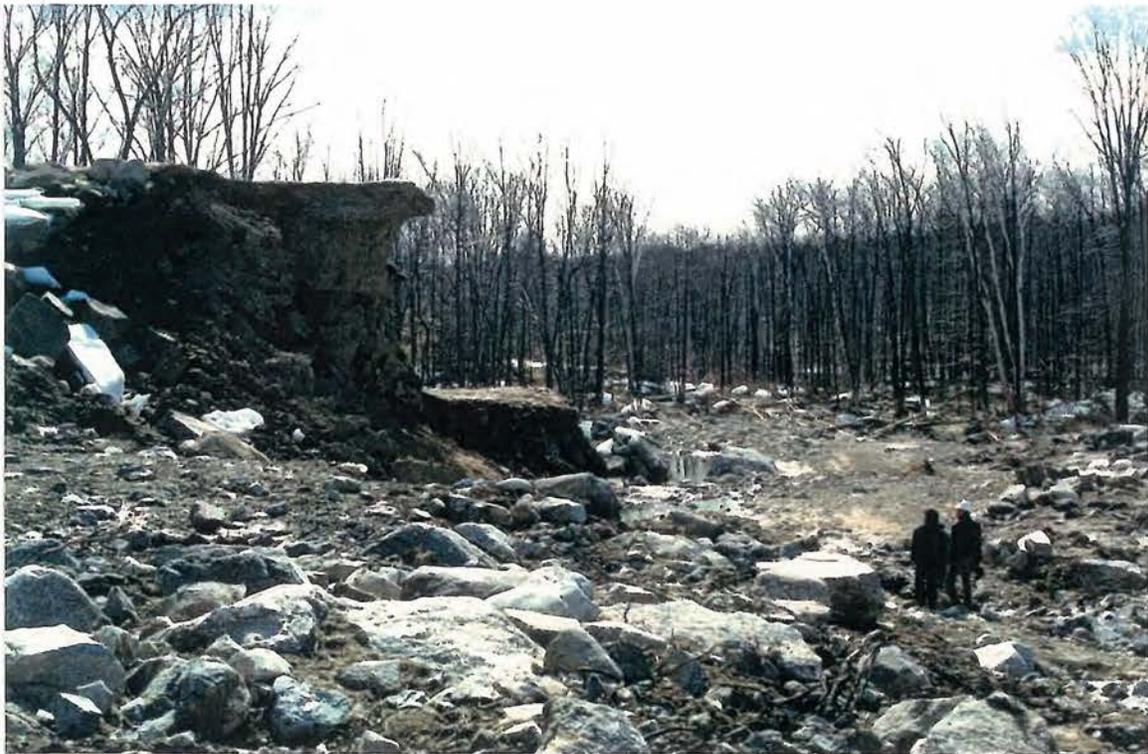
Left side of breach (looking downstream) after failure. (3/19/96)

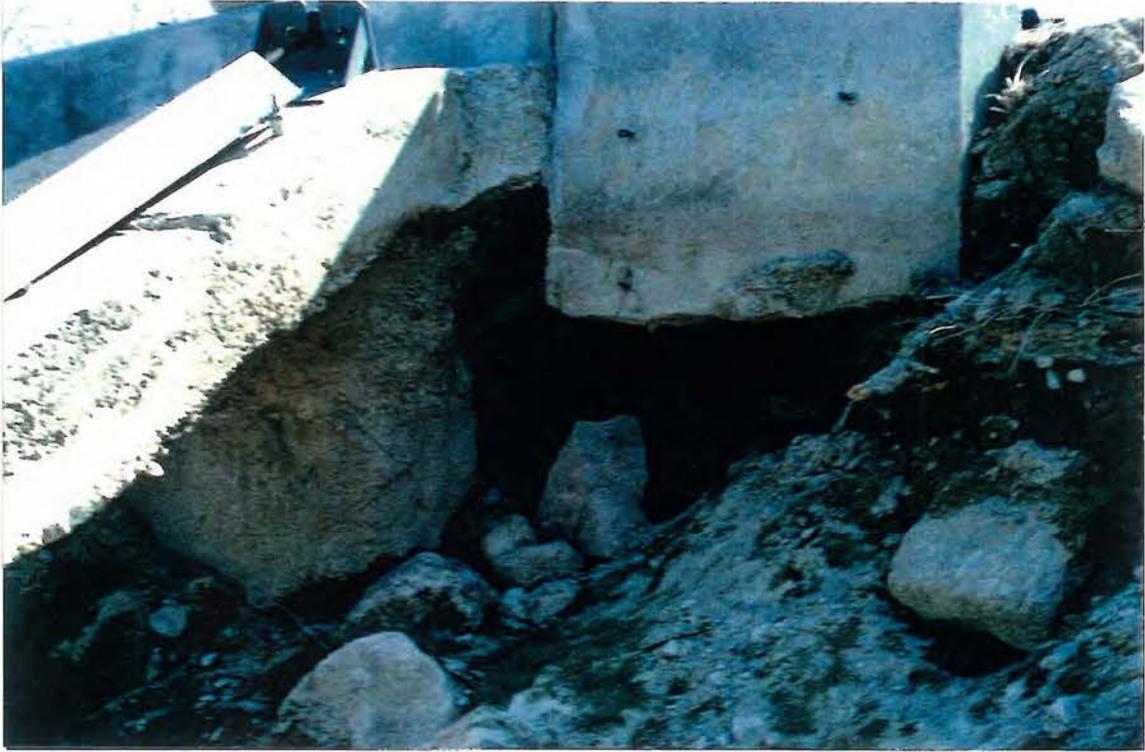
- A void was observed at the right end of the spillway cutoff wall. During the removal of the spillway slab, the void was observed to continue along the downstream side of the cutoff wall, near the intersection of the cutoff wall and the spillway slab. Based on observations of the soil along the bottom of the void, it appears that the void was caused by erosion and piping. Evidence of erosion was also observed on the subgrade for the sloping portion of the spillway slab, downstream of the cutoff wall. The approximate extent of the void and apparent subgrade erosion is shown on Figure 2.

Void at right end of cutoff wall (looking downstream). Stem guide and cutoff wall on left side of photo. (4/1/96)

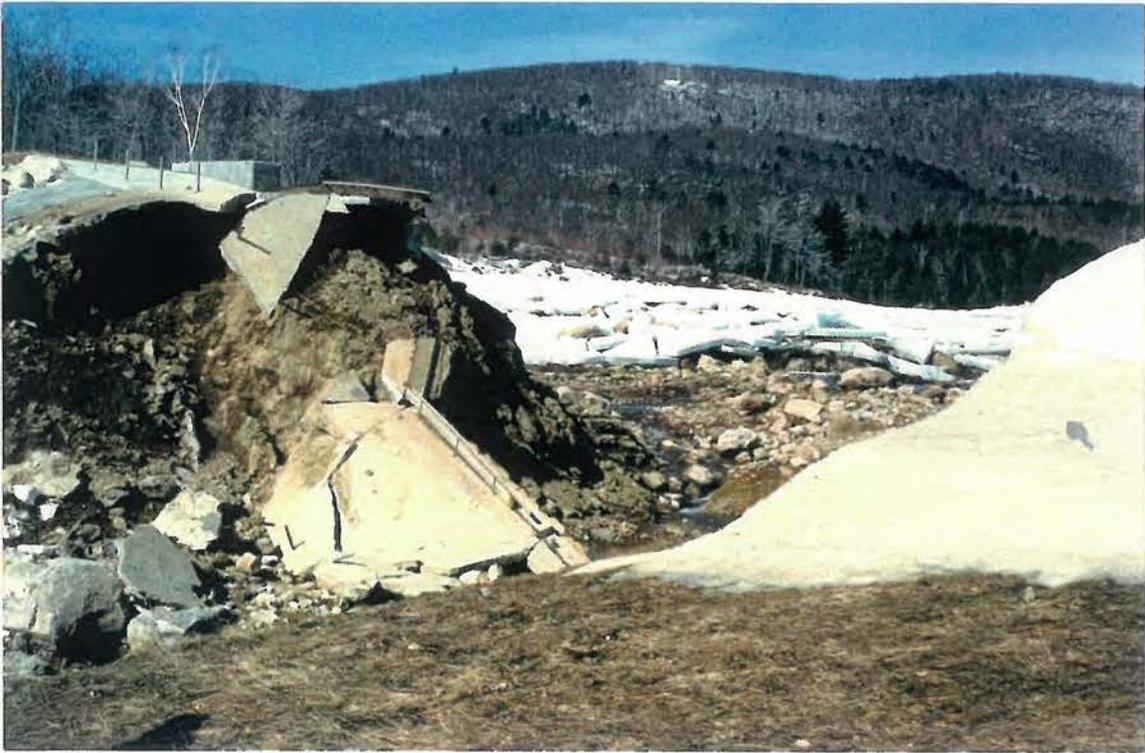
Right side of breach (looking upstream) after failure. (3/19/96)

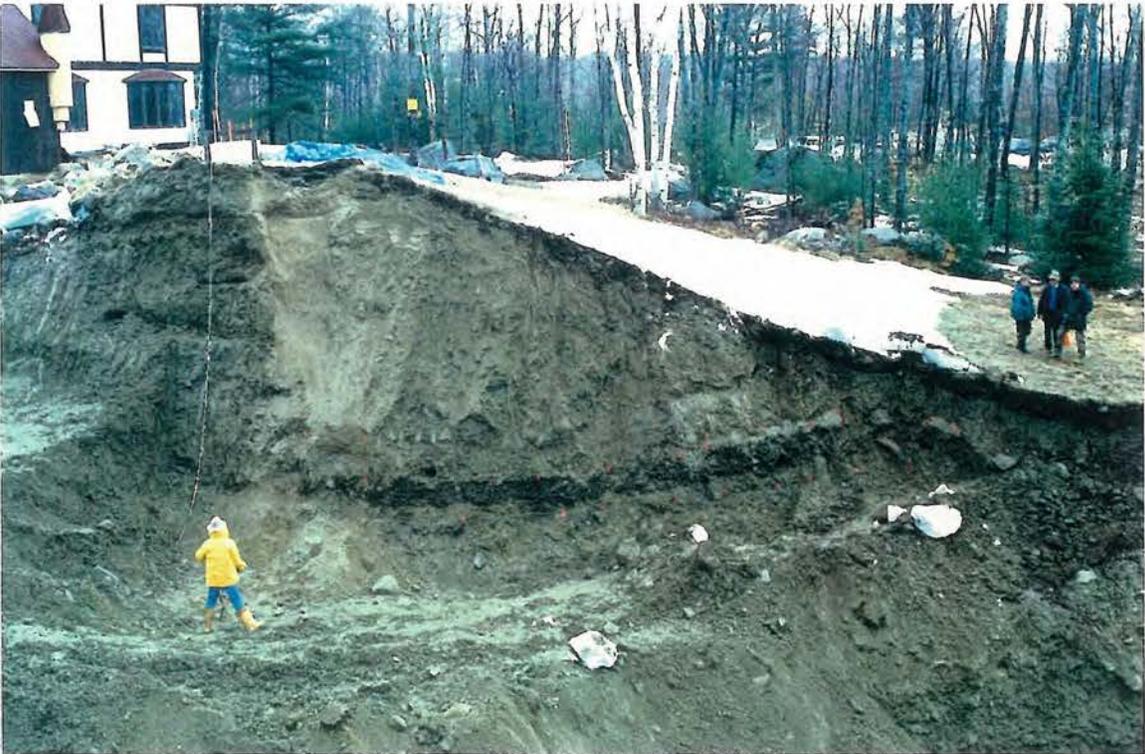
Left side of breach after the first day of field investigations. (3/20/96)

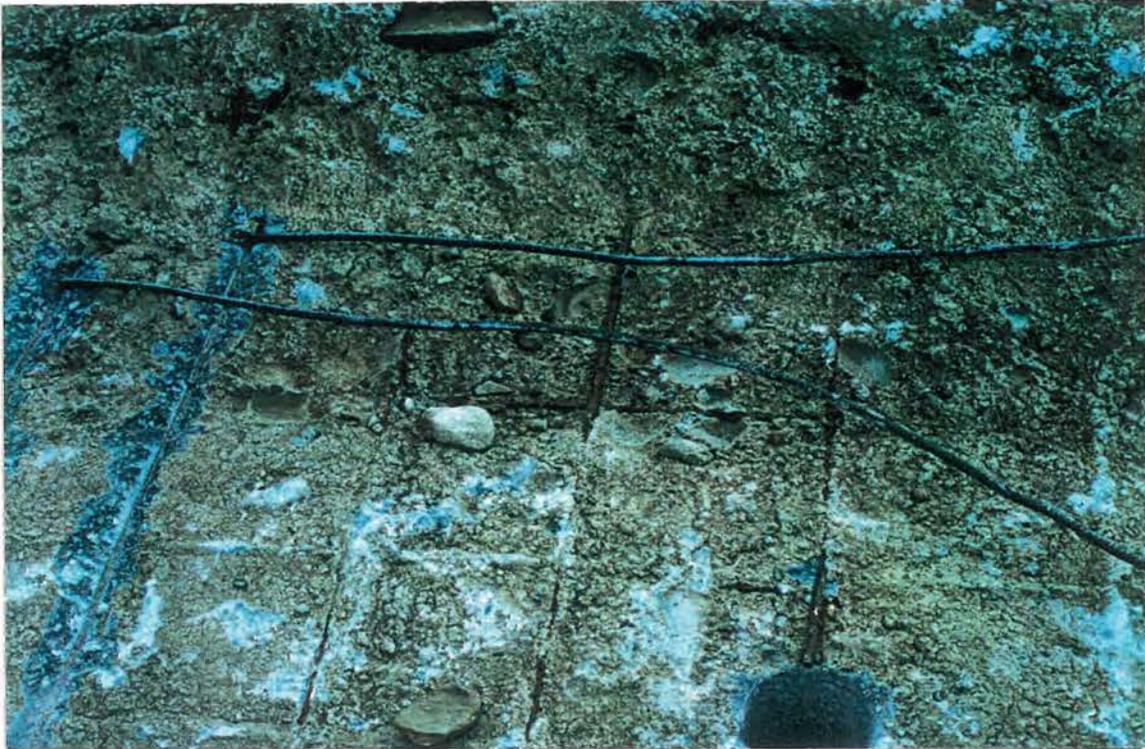
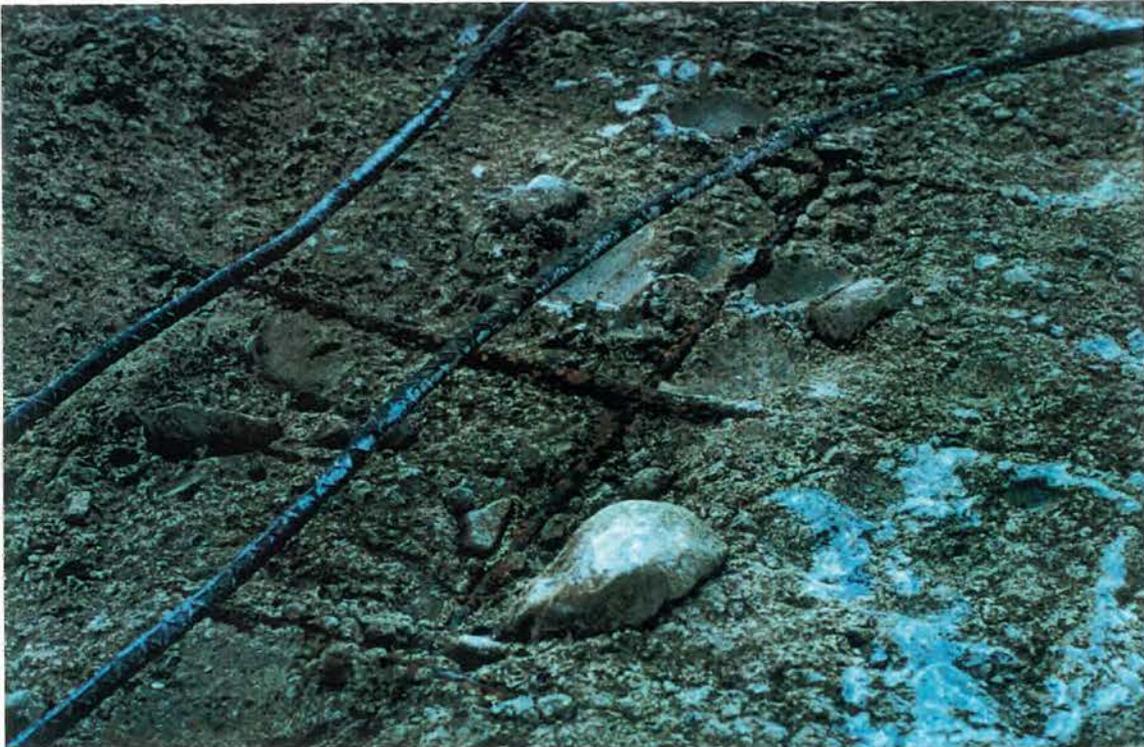
- Heavily rusted steel reinforcing bars and staining of the concrete were observed on the underside of a portion of the concrete slab from the left side of the spillway (in debris pile). The approximate area of the staining and heavily rusted reinforcing bars is shown on Figure 2.

Rusted reinforcing steel and staining of concrete on underside of sloping spillway slab from left side of spillway. (4/5/96)

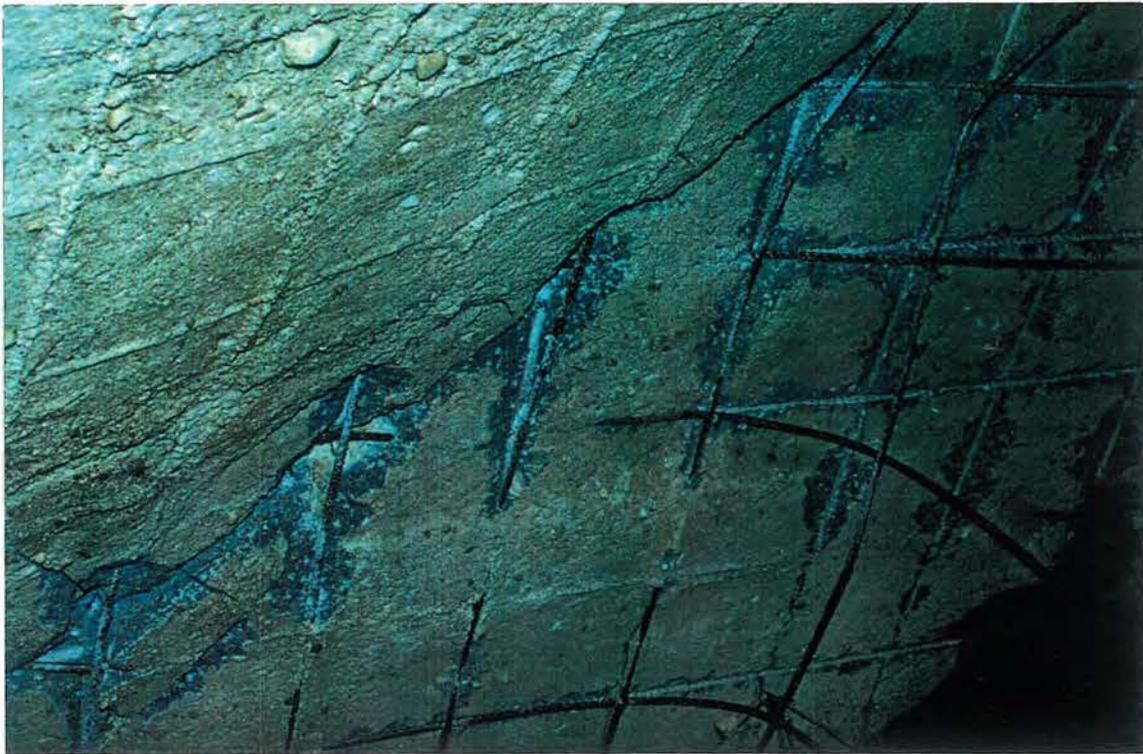
- Although required in the design, no longitudinal reinforcing steel was observed at the ends of broken sections of the concrete cutoff wall.
- Reinforcing steel in the spillway slabs were observed on the bottom surfaces of the slabs, with little or no concrete cover.

Underside of spillway slab section in breach of dam. Note limited cover over reinforcing steel. (3/20/96)

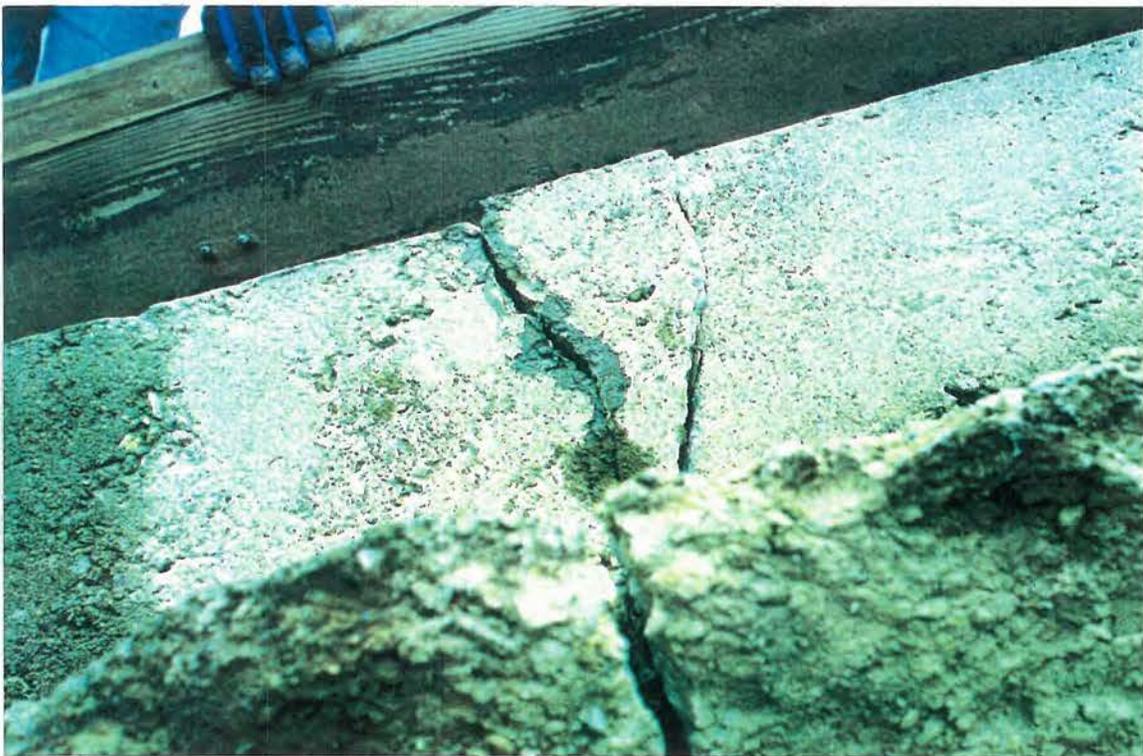
- A slope failure appeared to have occurred on the upstream slope of the embankment due to rapid drawdown conditions that occurred during the breach.
- Cracks were observed in the portions of the spillway slab and cutoff wall that remained intact on the right side of the breach. Caulking observed in some of the cracks indicates that the cracks occurred prior to the failure.

Crack in cutoff wall and spillway slab. Note repair material at top of crack. (3/20/96)

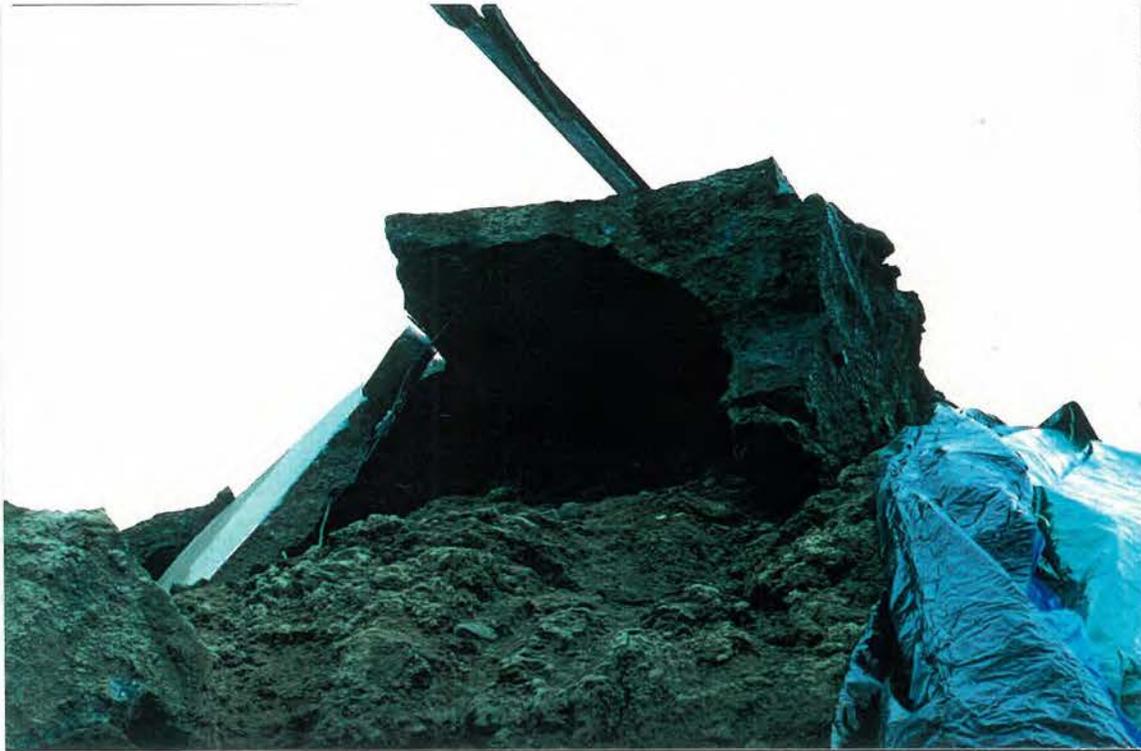
End of spillway cutoff wall and slab. Note the absence of longitudinal reinforcement in the cutoff wall. (3/20/96)

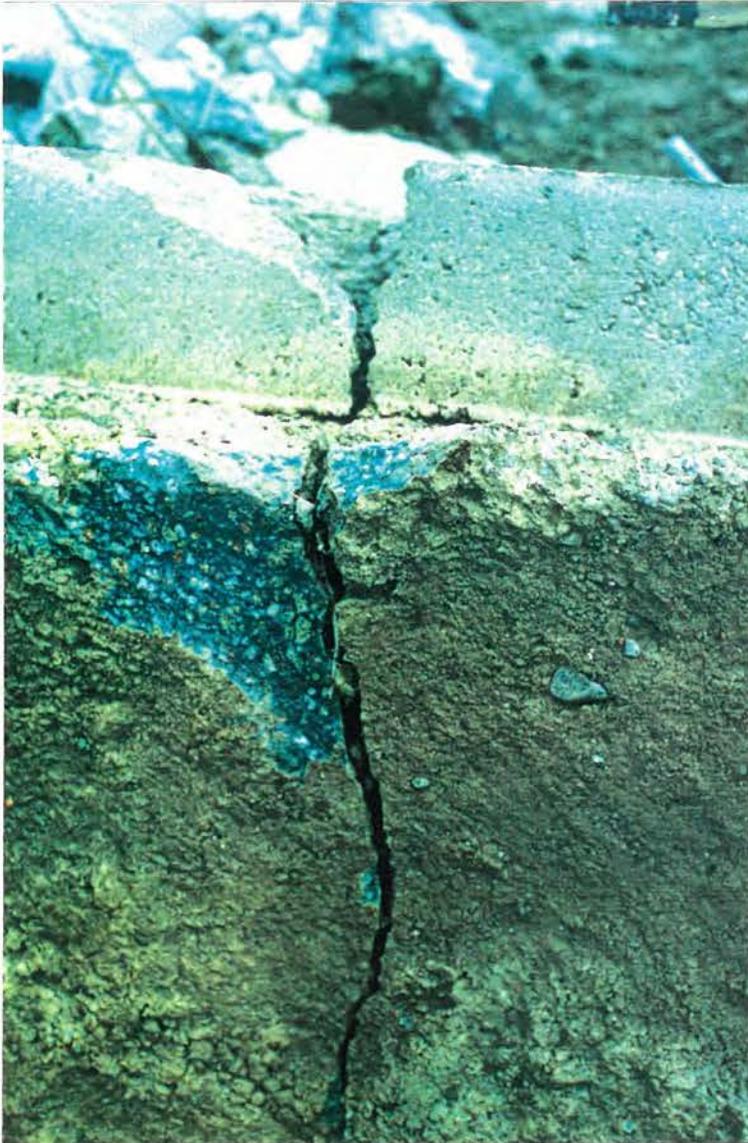
- Cracks in the cutoff wall and in the spillway slab and the horizontal construction joint between the spillway slab and cutoff wall provided a direct hydraulic connection to the gravel blanket downstream of the cutoff wall. These cracks were probably caused by a combination of factors, including: the lack of longitudinal steel reinforcement in the cutoff wall, which was required in the design; settlement of the embankment core material, which was not compacted sufficiently to meet the specifications; and heaving of the spillway slab and cutoff wall due to the formation of ice lenses in the gravel blanket and the underlying core material. The specified gradation for the gravel blanket material did not adequately limit the fines to avoid frost susceptibility. The frost susceptibility of the gravel blanket was further increased by the use of material containing more fines than allowed in the specifications and the presence of zones of contamination with silty core materials. Also, the gravel blanket was not thick enough to avoid frost penetration into the underlying frost susceptible core materials.

Crack in cutoff wall and spillway slab. Note cold joint between cutoff wall and spillway slab. (3/20/96)

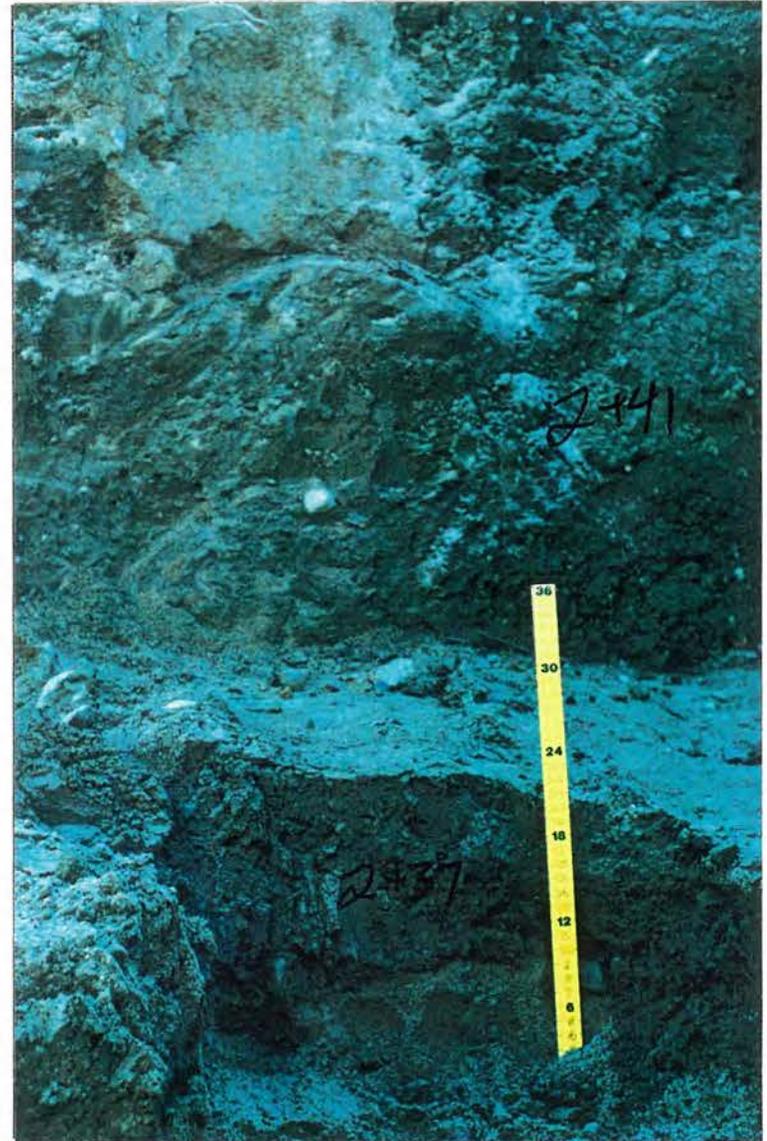
Chimney drain contaminated with core materials. (4/4/96)
