GEOLOGICAL SURVEY CIRCULAR 667

West Virginia's Buffalo Creek Flood:
A Study of the Hydrology and
Engineering Geology

By William E. Davies, James F. Bailey,
and Donovan B. Kelly

First printing 1972

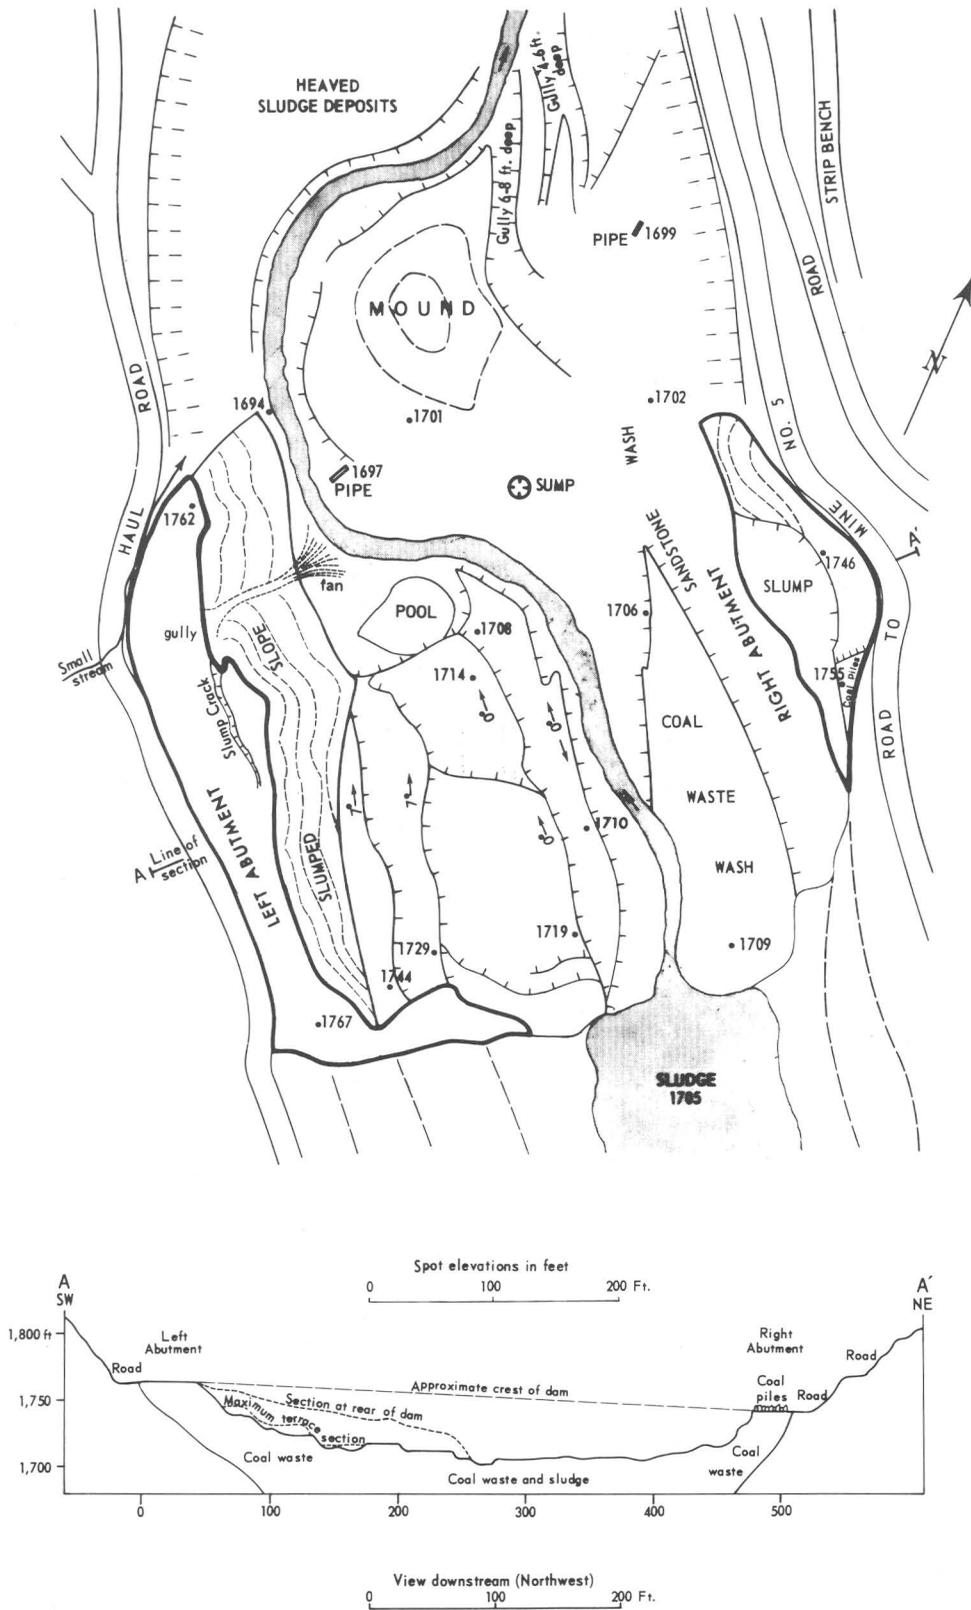
FIGURE 13.—Plan and cross-section through coal-waste dam No. 3 after failure, on Middle Fork, Saunders, W. Va.

Five distinct levels of flow are discernible on the left abutment (figs. 13 and 16). The highest two levels are about 39 feet and 24 feet above the bottom of the breach. They consist of benches about 30 feet wide, sloping 7° downstream, and ending abruptly at the sump pool near the left abutment where they

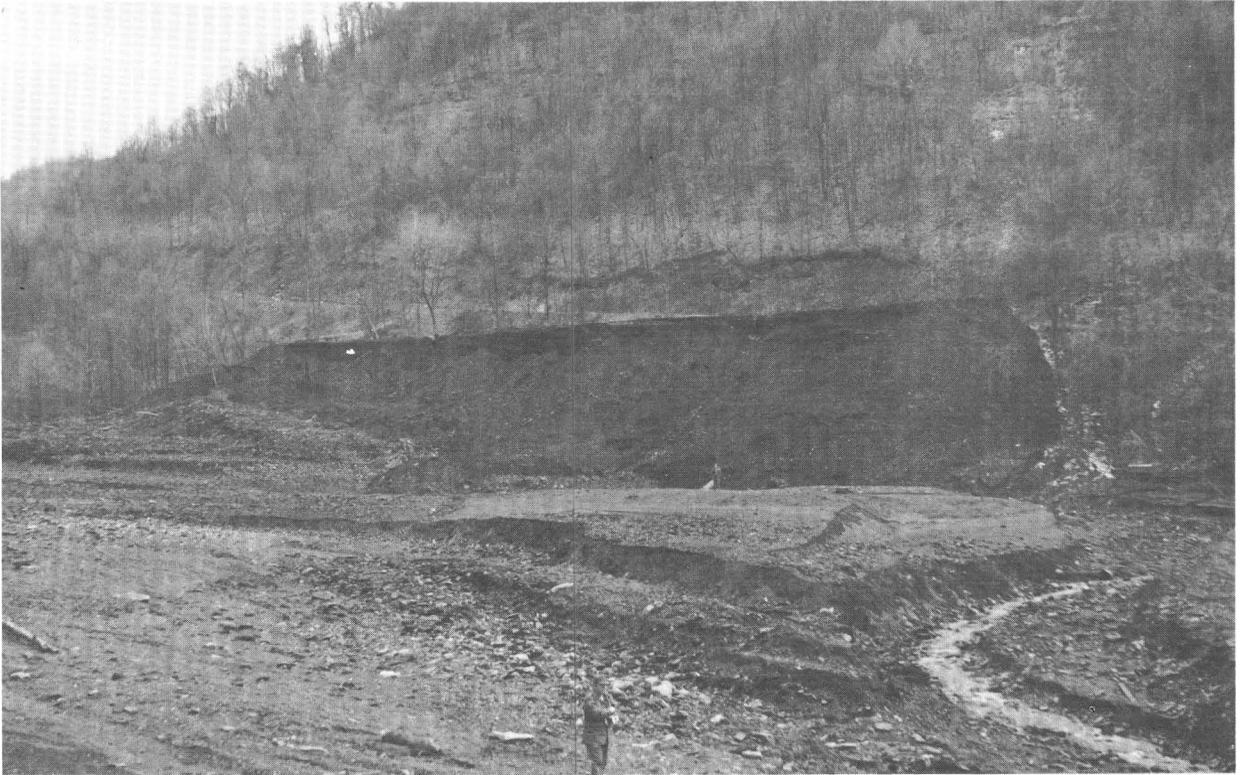
The large volume of water passing through dam No. 3 has removed most of the evidence of slumps. However, a large dome-shaped mound, not eroded or scoured by water action, is at the toe or former front of the dam about 120 feet from the left abutment (figs. 13 and 14). The mound is about 100 feet in diameter and is cut by five tension cracks one-half inch to 1 inch wide and spaced 1 to 22 feet apart. The cracks trend 10° to 20° true north azimuth in comparison with the former front of the dam, which trended about 60° . The mound is apparently a remnant of a heave at the toe of a slump that moved diagonally to the left at the front of the dam.

FIGURE 14.—Looking upstream at the left abutment of coal-waste dam No. 3. Unsoured mound in center foreground is apparently a heave at the toe of a slump that moved towards the left front on the dam.

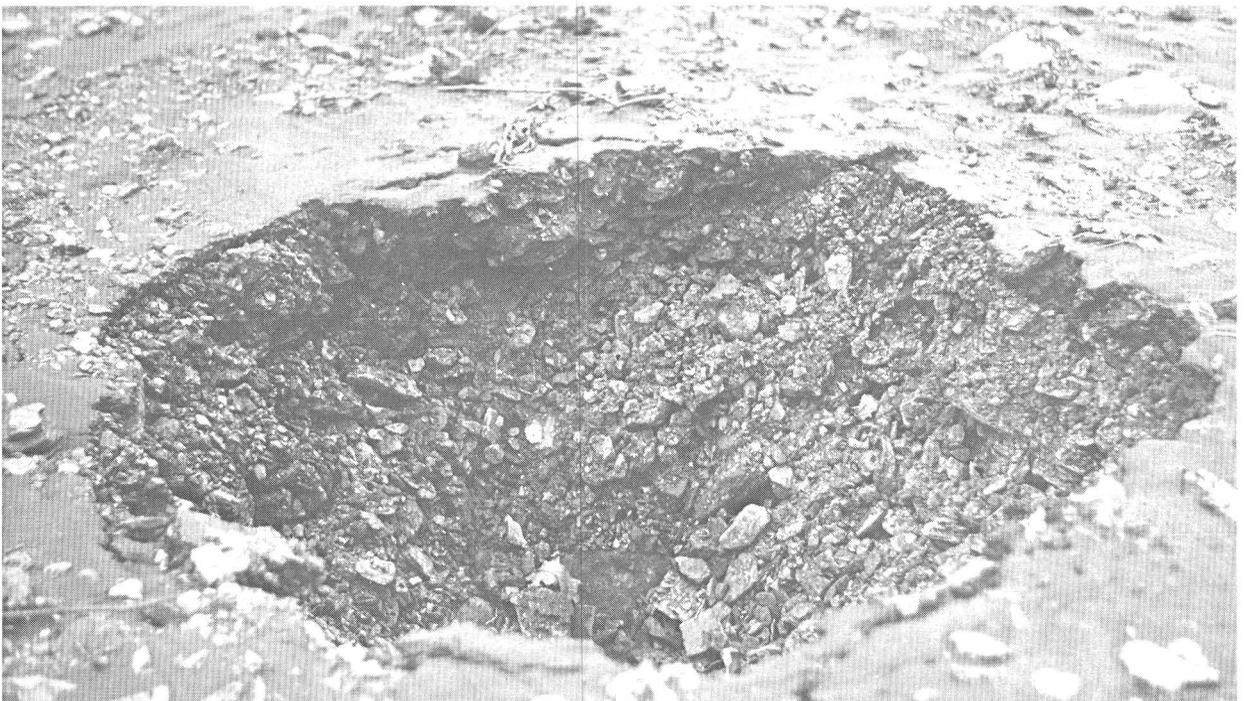
The floor of the breach at scour level shows two distinct sump features. Two sump holes, one about 3 feet in diameter and 2 feet deep and the other 6 feet in diameter and $4\frac{1}{2}$ feet in depth, indicate an outflow of water along the foundation or below it in the sludge base (figs. 13 and 15). These holes contain only coarse material; all the fine material has been removed by subterranean flow.

FIGURE 15.—Sump near former front of coal-waste dam No. 3. Hole is 6 feet in diameter and $4\frac{1}{2}$ feet deep.

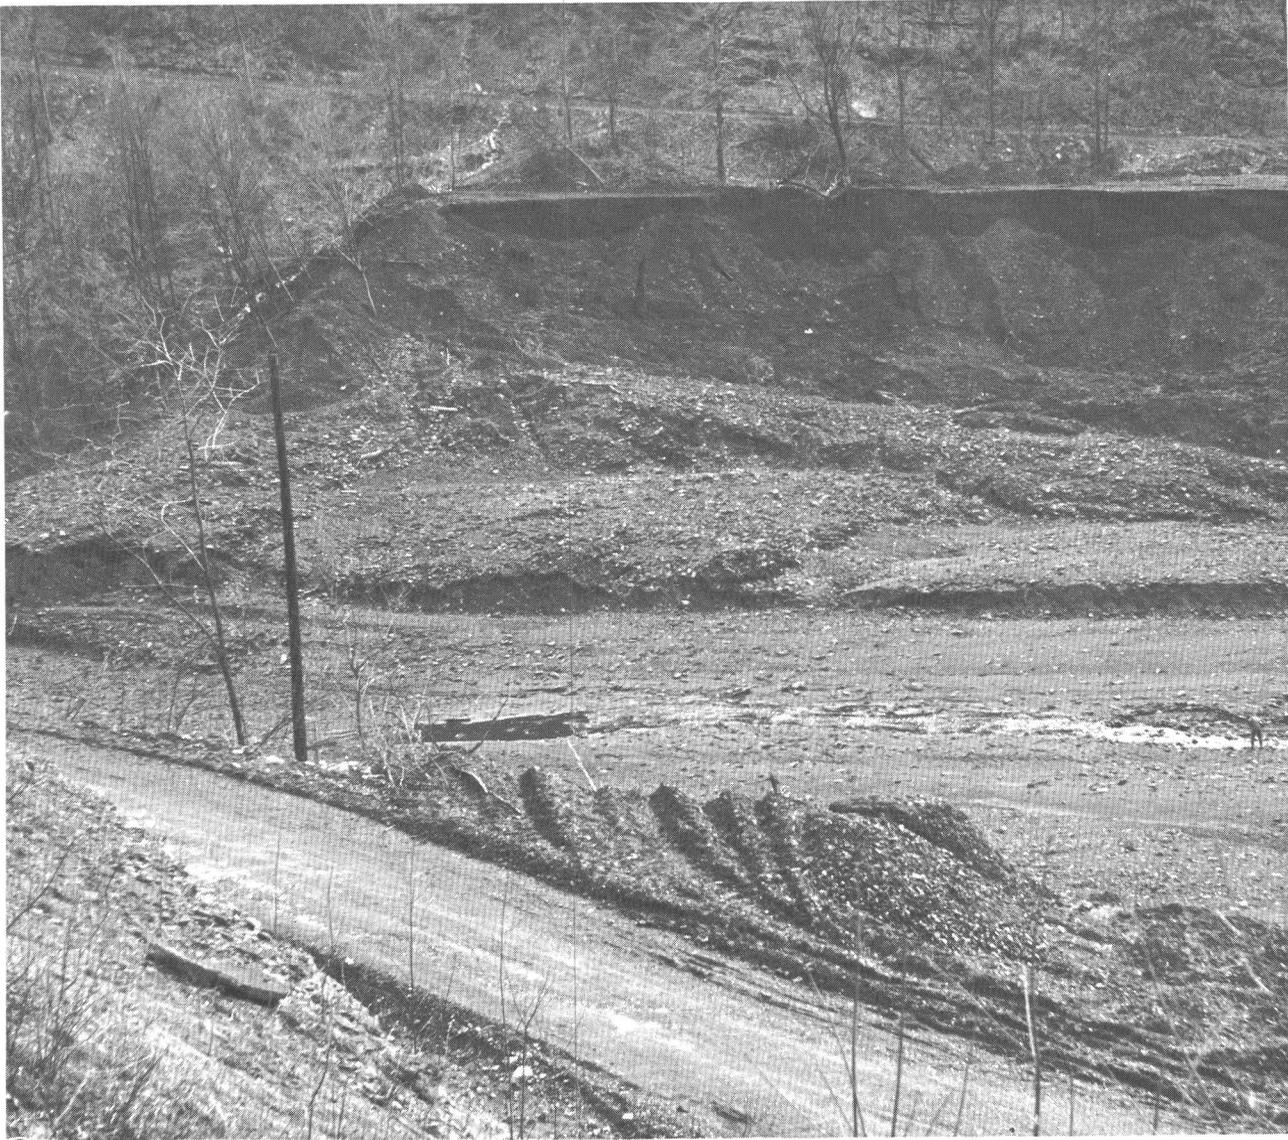
A large subsidence feature is visible on the left front of the former dam (fig. 16). This sump, about 80 feet in diameter and over 10 feet deep, was occupied by a large pool during the final stages of draining and is now filled with fine material. Both the rim and the outlet of the pool contain coarse, water-washed material, indicating that the pool extends into the foundation to an unknown depth. The pool probably was formed by material being removed in the foundation during failure. This large area of subsidence is opposite the mouth of a small hollow that drained into the haul road at the left abutment. It is possible that water from this hollow entered the side of the dam, causing a large pocket of saturated material which gave rise to a slump and subsidence along the left side of the dam.

FIGURE 16.—View across coal-waste dam No. 3 from right abutment.

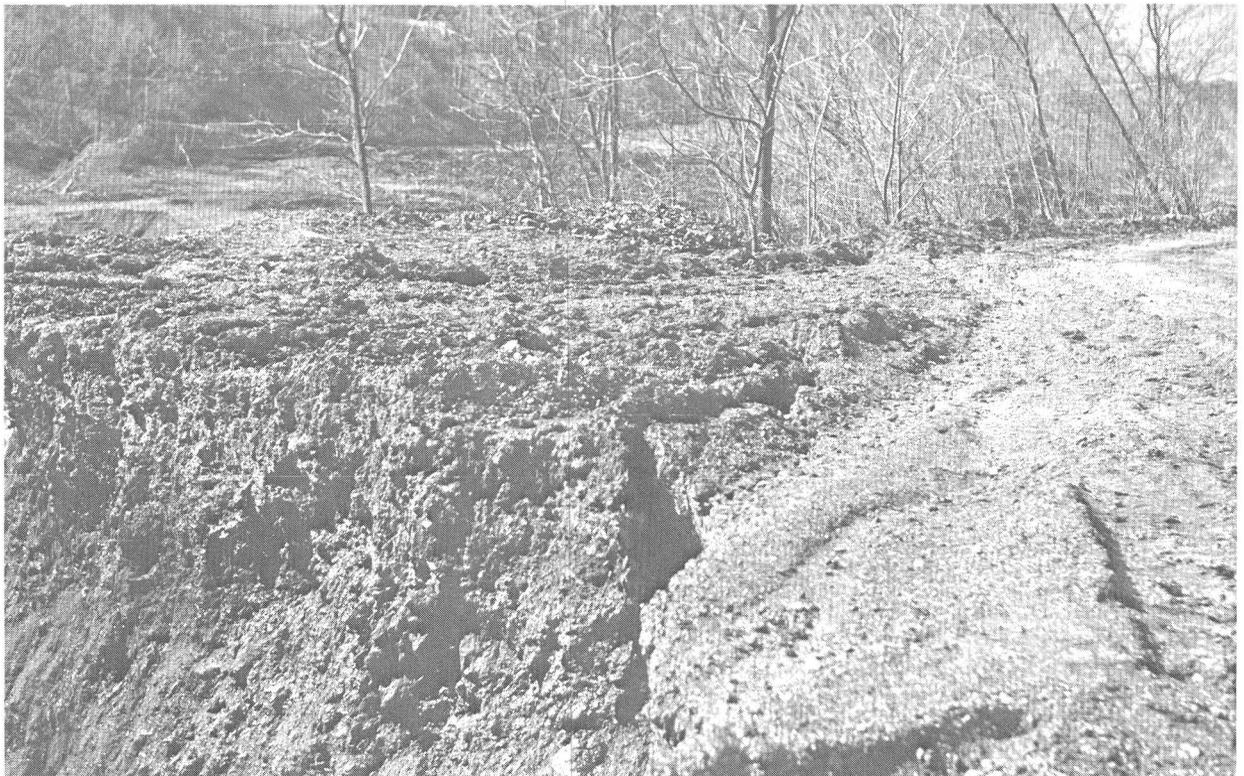
FIGURE 17.—Top of right abutment of coal-waste dam No. 3 showing 14-inch-wide water channel developed along bulldozer tracks.

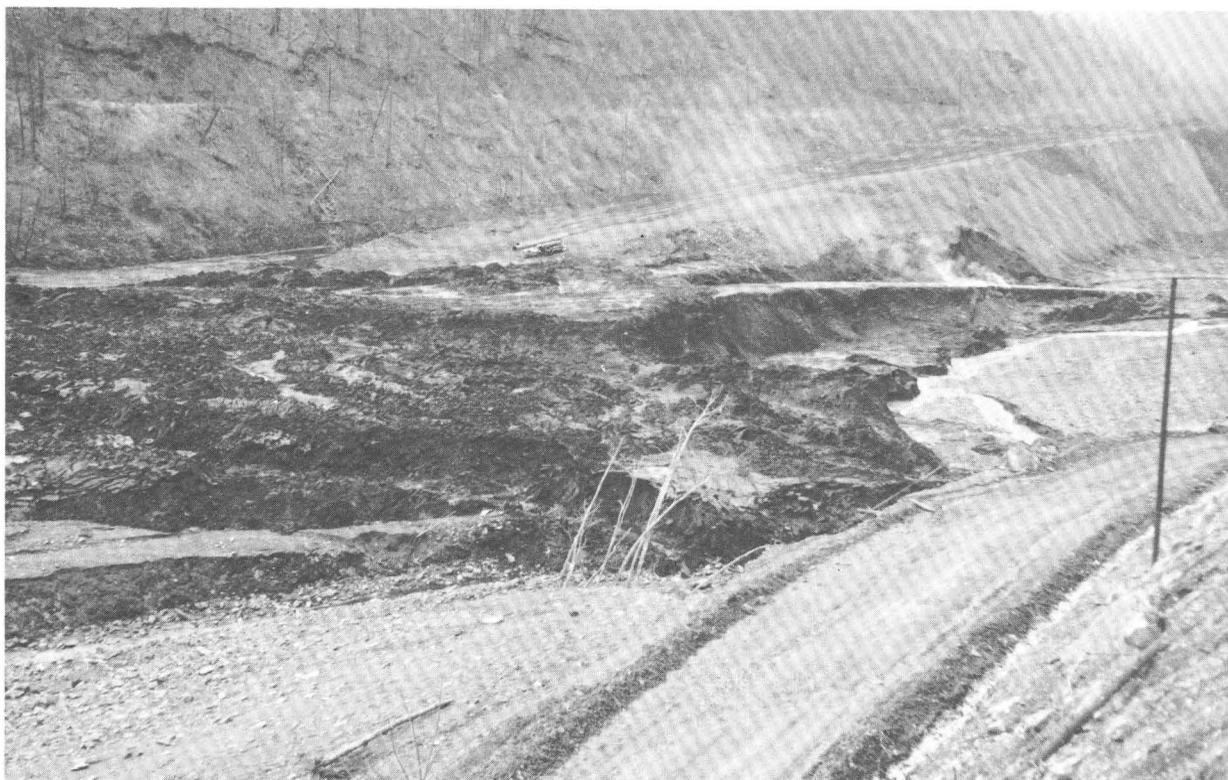
the right side of the dam breached along a line starting about 120 feet from the front of the right abutment and trending diagonally towards the valley wall at the rear. Extreme turbulence threw coal-laden water 300 feet from the dam and splattered cars on the haul road. Within seconds, dam No. 2 was topped on both the right and left sides, the existing breach on its right abutment was enlarged, and the sludge behind was thrown into great convolutions by the slump blocks (fig. 18). The sludge ridges raised by these blocks protected the center part of dam No. 2 from overtopping and breaching. The clear pool was filled, overtopped, and the small dike on its right side breached (fig. 19), and the shed and transformer pole was destroyed at 8:00 a.m. Water pouring through the breach in dam No. 2 rebounded from the sandstone wall and scoured the left side of the clear pond (No. 1) cutting away most of dam No. 2 and leaving steep undercut banks.

FIGURE 18.—Breach in coal-waste dam No. 2. Most of original dam was washed away; parallel ridges of sludge behind dam No. 2 were pushed against the dam by slump blocks during the failure of dam No. 3.

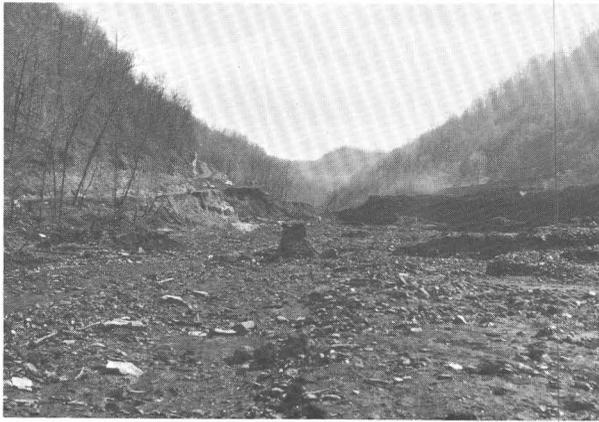
FIGURE 19.—View upstream across former clear pond behind coal-waste bank No. 1. Remnants of coal-waste dam No. 2 are visible in the middle ground.

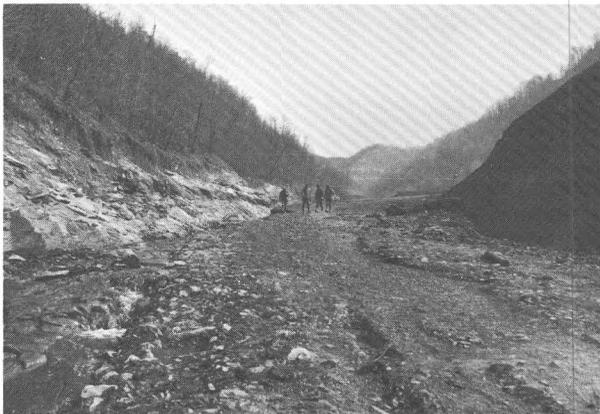
The torrent of water crossed the haul road at the south end of the burning coal-waste bank No. 1, but the compacted road bed was only slightly eroded (fig. 20). At the lower end of the burning coal-waste bank, the water increased the hydrostatic pressure within the bank, causing explosions of steam and producer-type gas. The three or four explosions reported were severe enough to shake the ground at Saunders and raise mushroom-shaped clouds of ash and smoke. Moments later, at about 8:01 a.m., the torrent of water en-

FIGURE 20.—Haul road looking upstream midway along the right edge of coal-waste bank No. 1. The haul road served as the initial water gap around the upstream edge of bank No. 1. Height of floodwater is shown by bedrock scar on left; haul road itself suffered only slight erosion at this point.

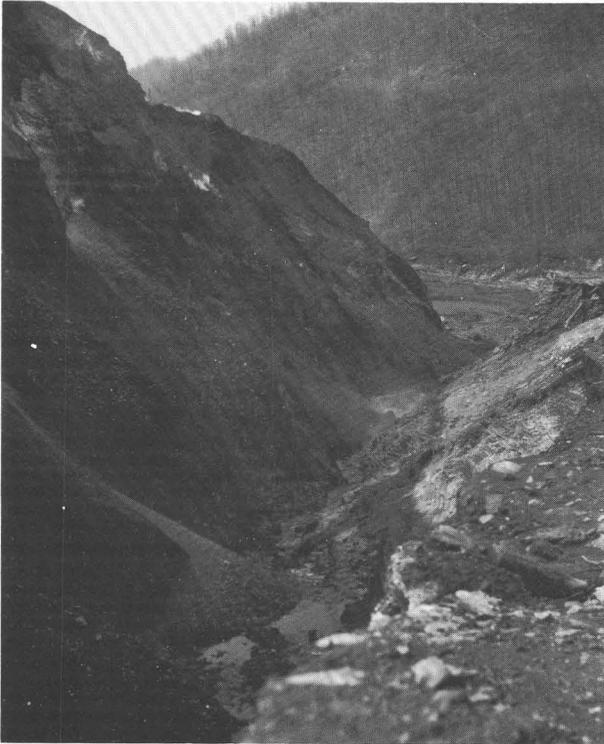
FIGURE 21.—View down the canyon cut along the right side of coal-waste bank No. 1 at the mouth of Middle Fork.

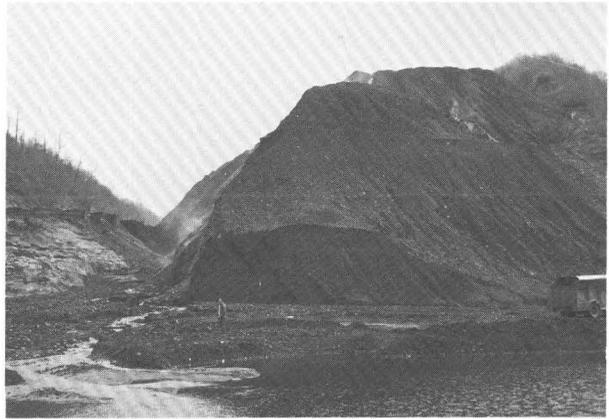
FIGURE 22.—Face of coal-waste bank No. 1 at the intersection of Middle Fork and Buffalo Creek. Canyon was eroded in area of explosions on the left.

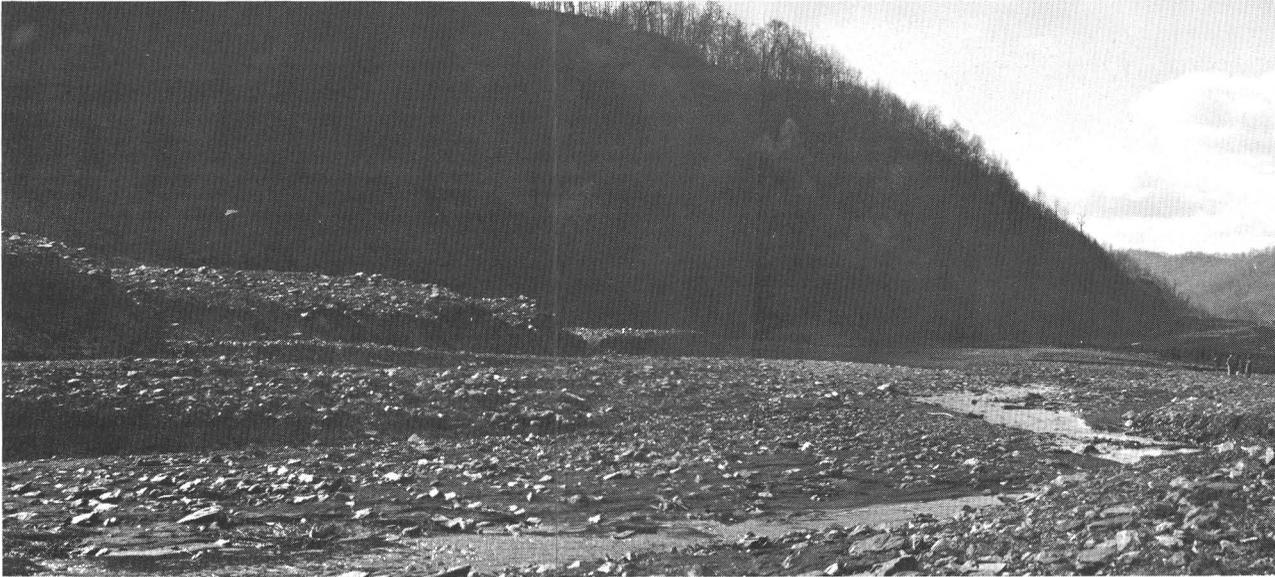
FIGURE 23.—Panorama view downstream through the breach in coal-waste dam No. 3. Initial linear breach extended into valley wall on right, ripping out sandstone.

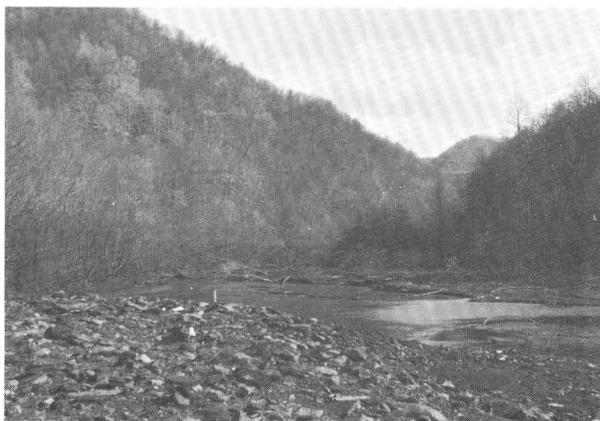
FIGURE 25.—Pool area above coal-waste dam No. 3 following failure of the dam. Floor is saturated sludge.

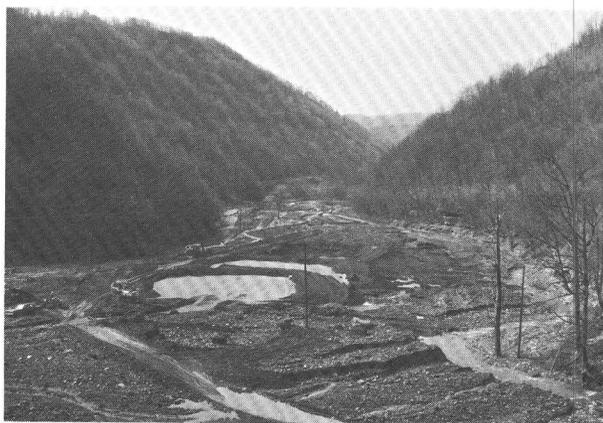
FIGURE 27.—Debris from Middle Fork deposited in Buffalo Creek, looking downstream over former site of Saunders. Middle Fork enters to the left of the photograph.
