I am transmitting herewith my report on the failure of the Mammoth Dam.

REPORT ON THE FAILURE OF THE MAMMOTH DAM

The Mammoth dam is situated on the southwest quarter of Section 6, T. 13 S., R. 6 E., twelve miles east of Fairview, Utah, and is owned by the Price River Irrigation Company of Salt Lake City. The officers of the company are

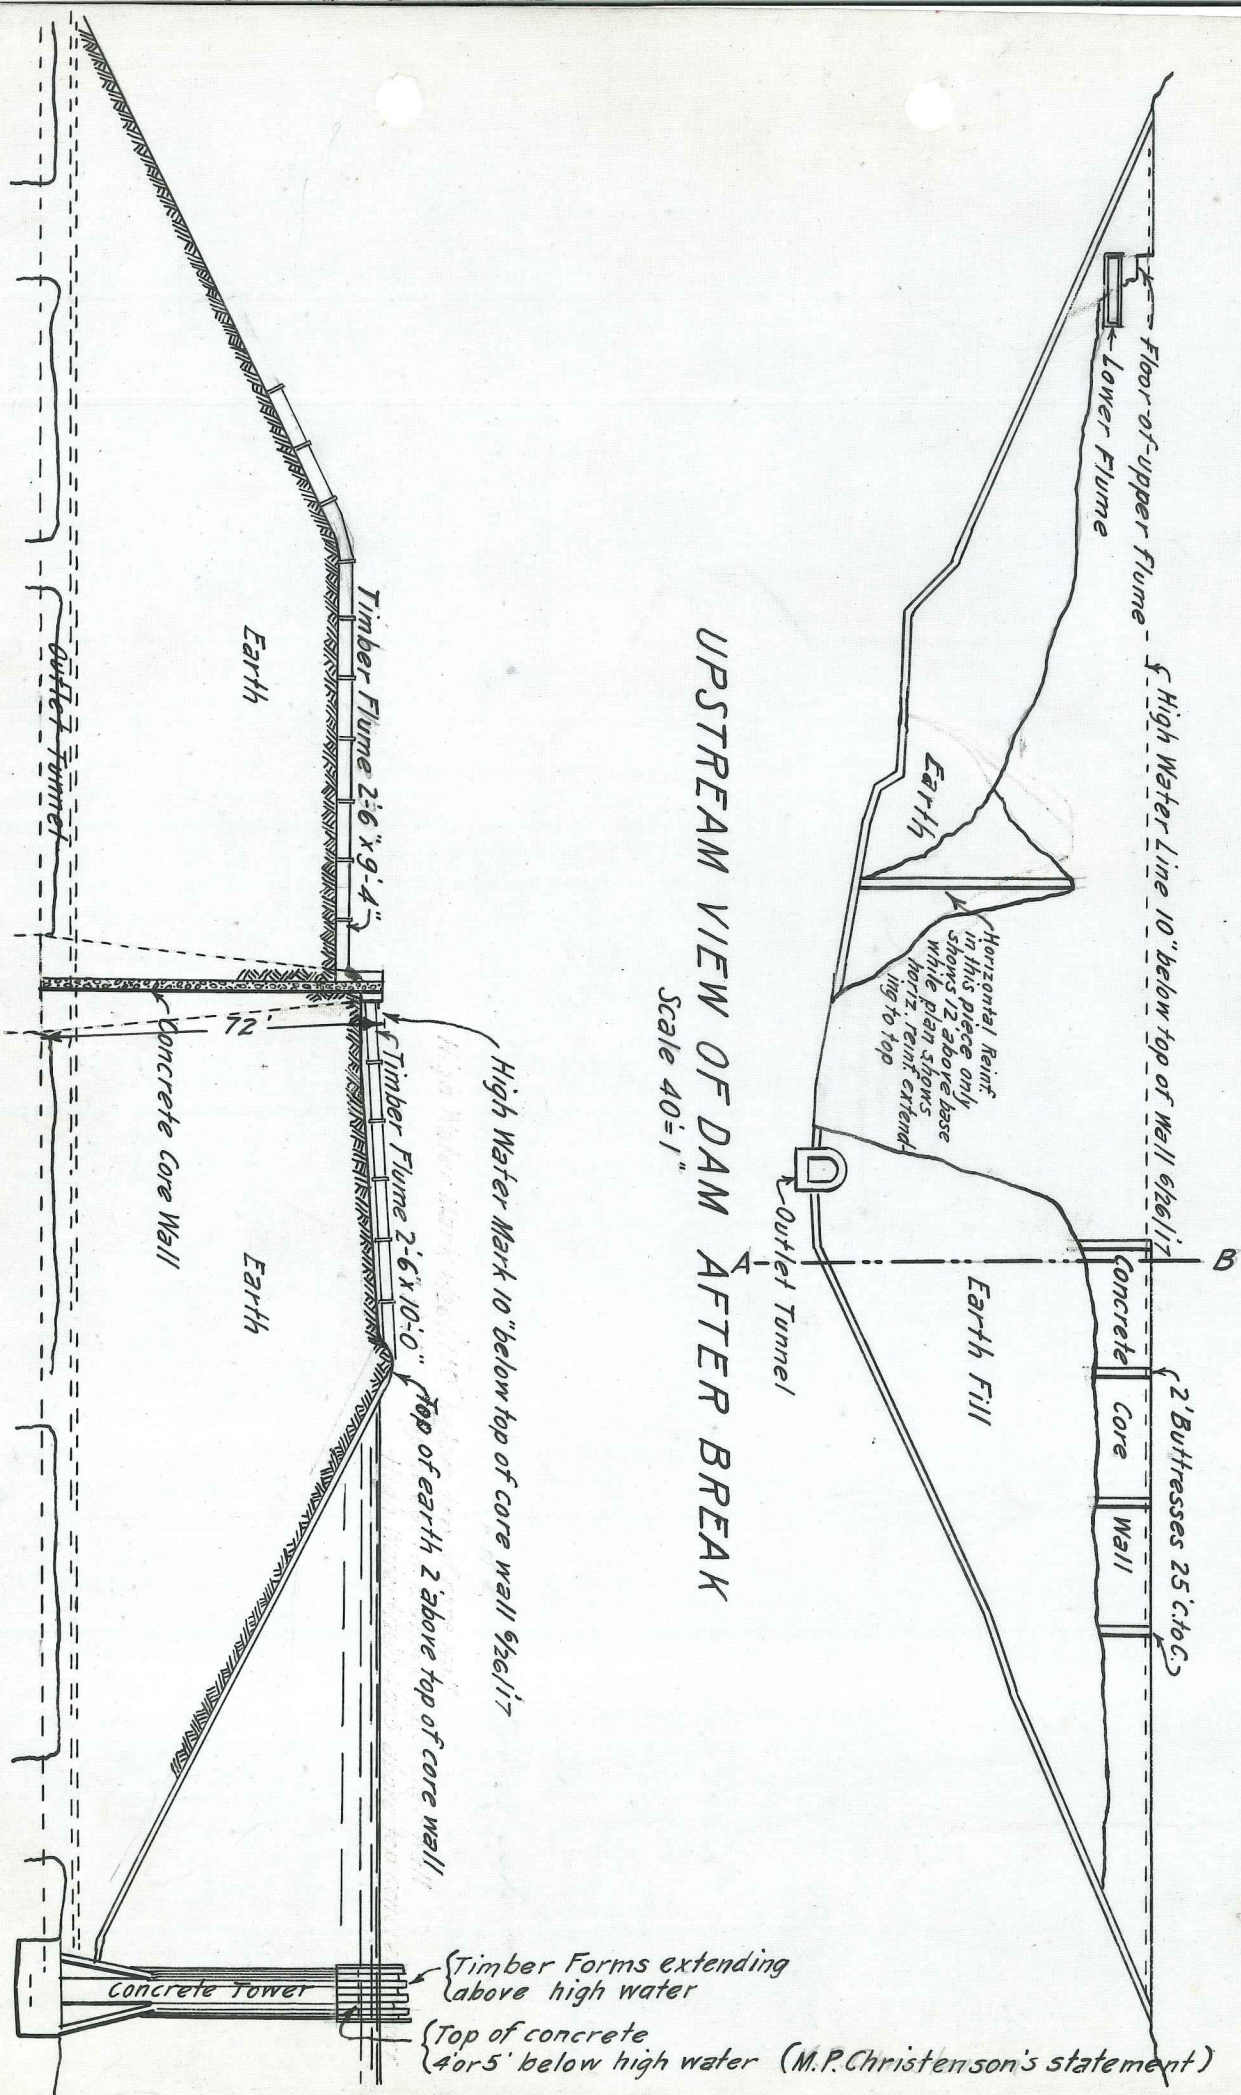
On Sunday, June 24th, Watchman Hall left the dam at 11:00 A.M., and went to lunch at the bunkhouse, about a thousand feet distance. On his return, two hours later, the water had broken through the earth dyke along the side of the temporary flume, had filled the intervening space between the dyke and the core wall, and a section of the core, about five feet high and thirty feet in length, had fallen outward, allowing the water to pour through this breach onto the earth fill forming the lower half of the dam. As the earth washed away, leaving the core unsupported, sections of the core continued to fall until seventy-five per cent of the dam had gone out and the reservoir emptied.

UPSTREAM VIEW OF DAM AFTER BREAK

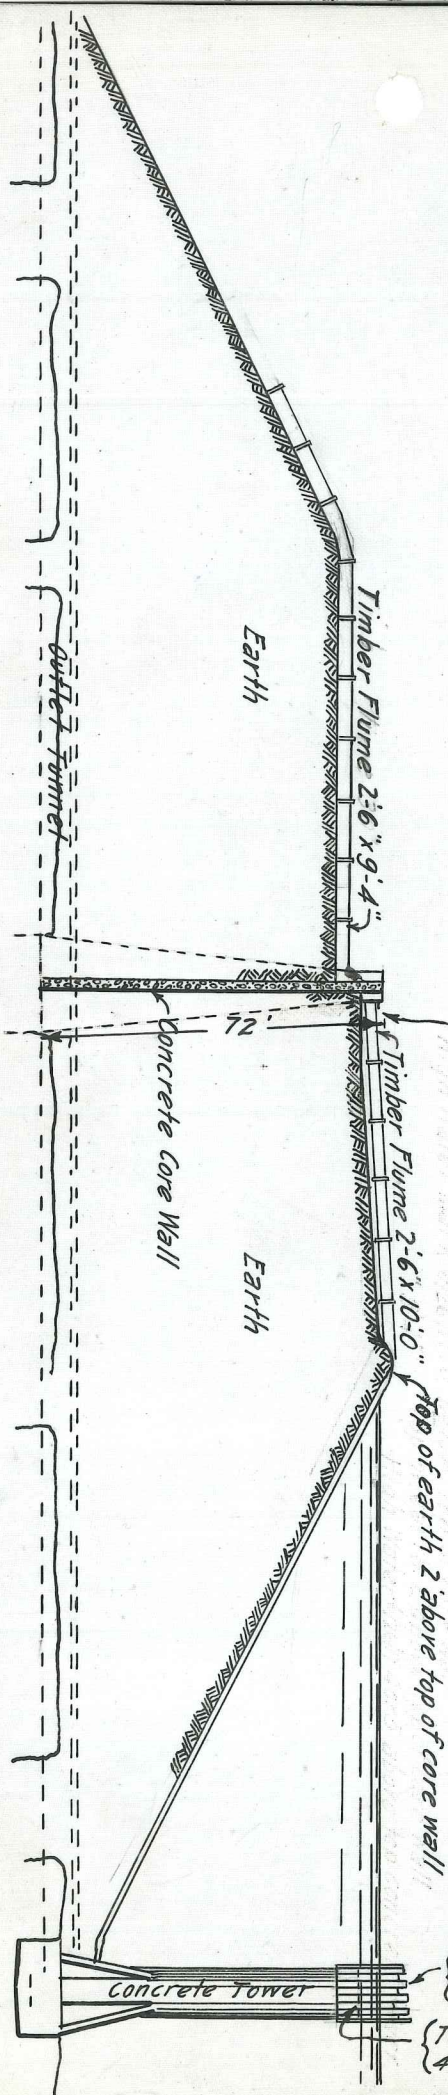
At the junction of the up-stream slope and the top of the dam, an earth dyke had been erected eighty feet up-stream from the core and parallel to it, the top of this dyke being two feet higher than the top of the core.

The water in the dam was two feet ten inches below top of earth dyke, or ten inches below the top of the core wall.

the dyke to a rectangular notch in the core, the flume being 2'6" deep, 10 feet wide, and eighty feet in length, this flume being intended to carry flood waters from the dyke to the core wall, thence over a vertical drop of 6'6" into a temporary wooden spillway butted against the lower side of core. This flume was laid through the earth dyke without any bulkheads or cut-off walls.

SECTION A-B SHOWING CONDITIONS BEFORE BREAK
