MADISON RIVER, MONTANA
REPORT ON
*FLOOD EMERGENCY
MADISON RIVER SLIDE*

*VOLUME I
MAIN REPORT*

U. S. ARMY ENGINEER DISTRICT, OMAHA
CORPS OF ENGINEERS
OMAHA, NEBRASKA
SEPTEMBER 1960

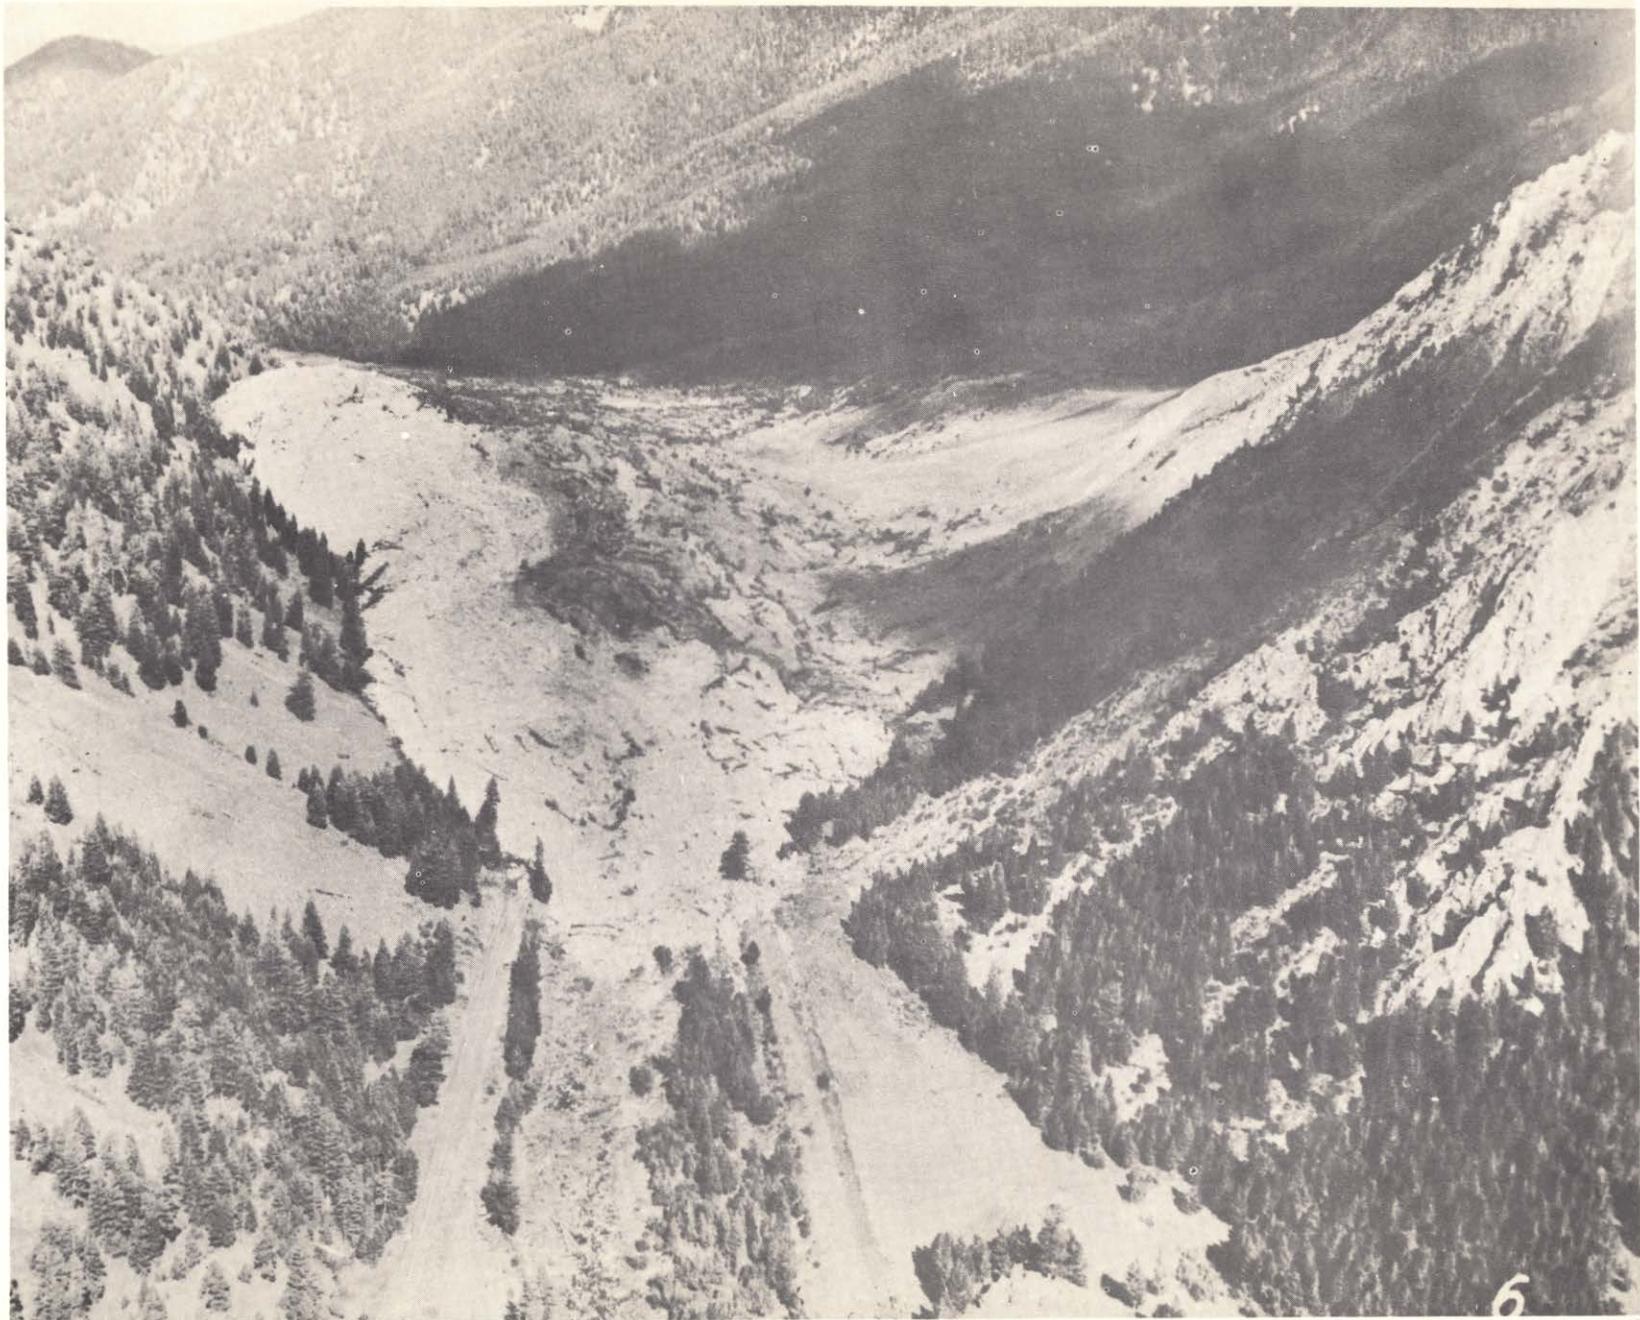
Photo 1. About 20 August 1959. Aerial view of Madison River slide about 2 days following earthquake. USDA - Forest Service photo.

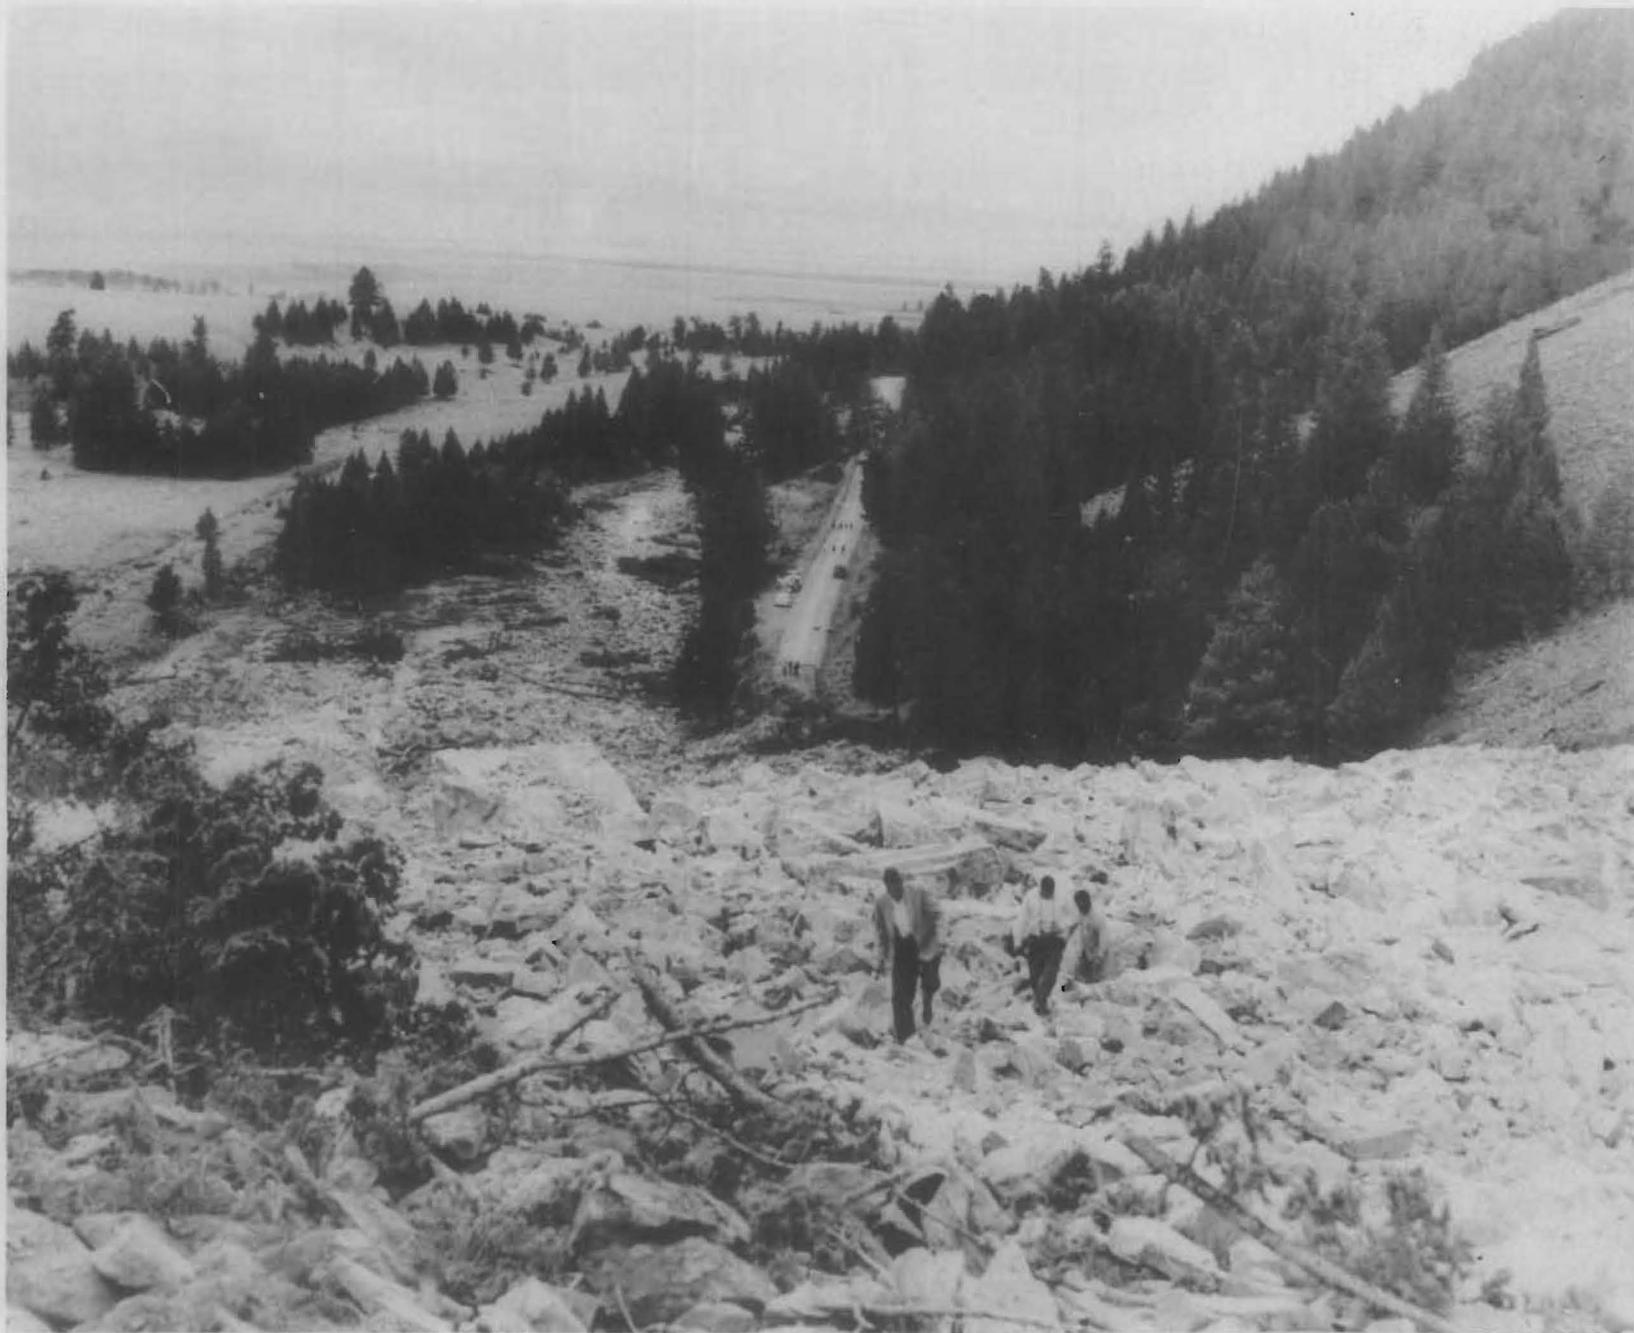
Photo 2. About 21 August 1959. A Forest Service photo, looking downstream at large rocks on downstream slope of slide and at the streambed below slide. (For later view, see Photo 27).

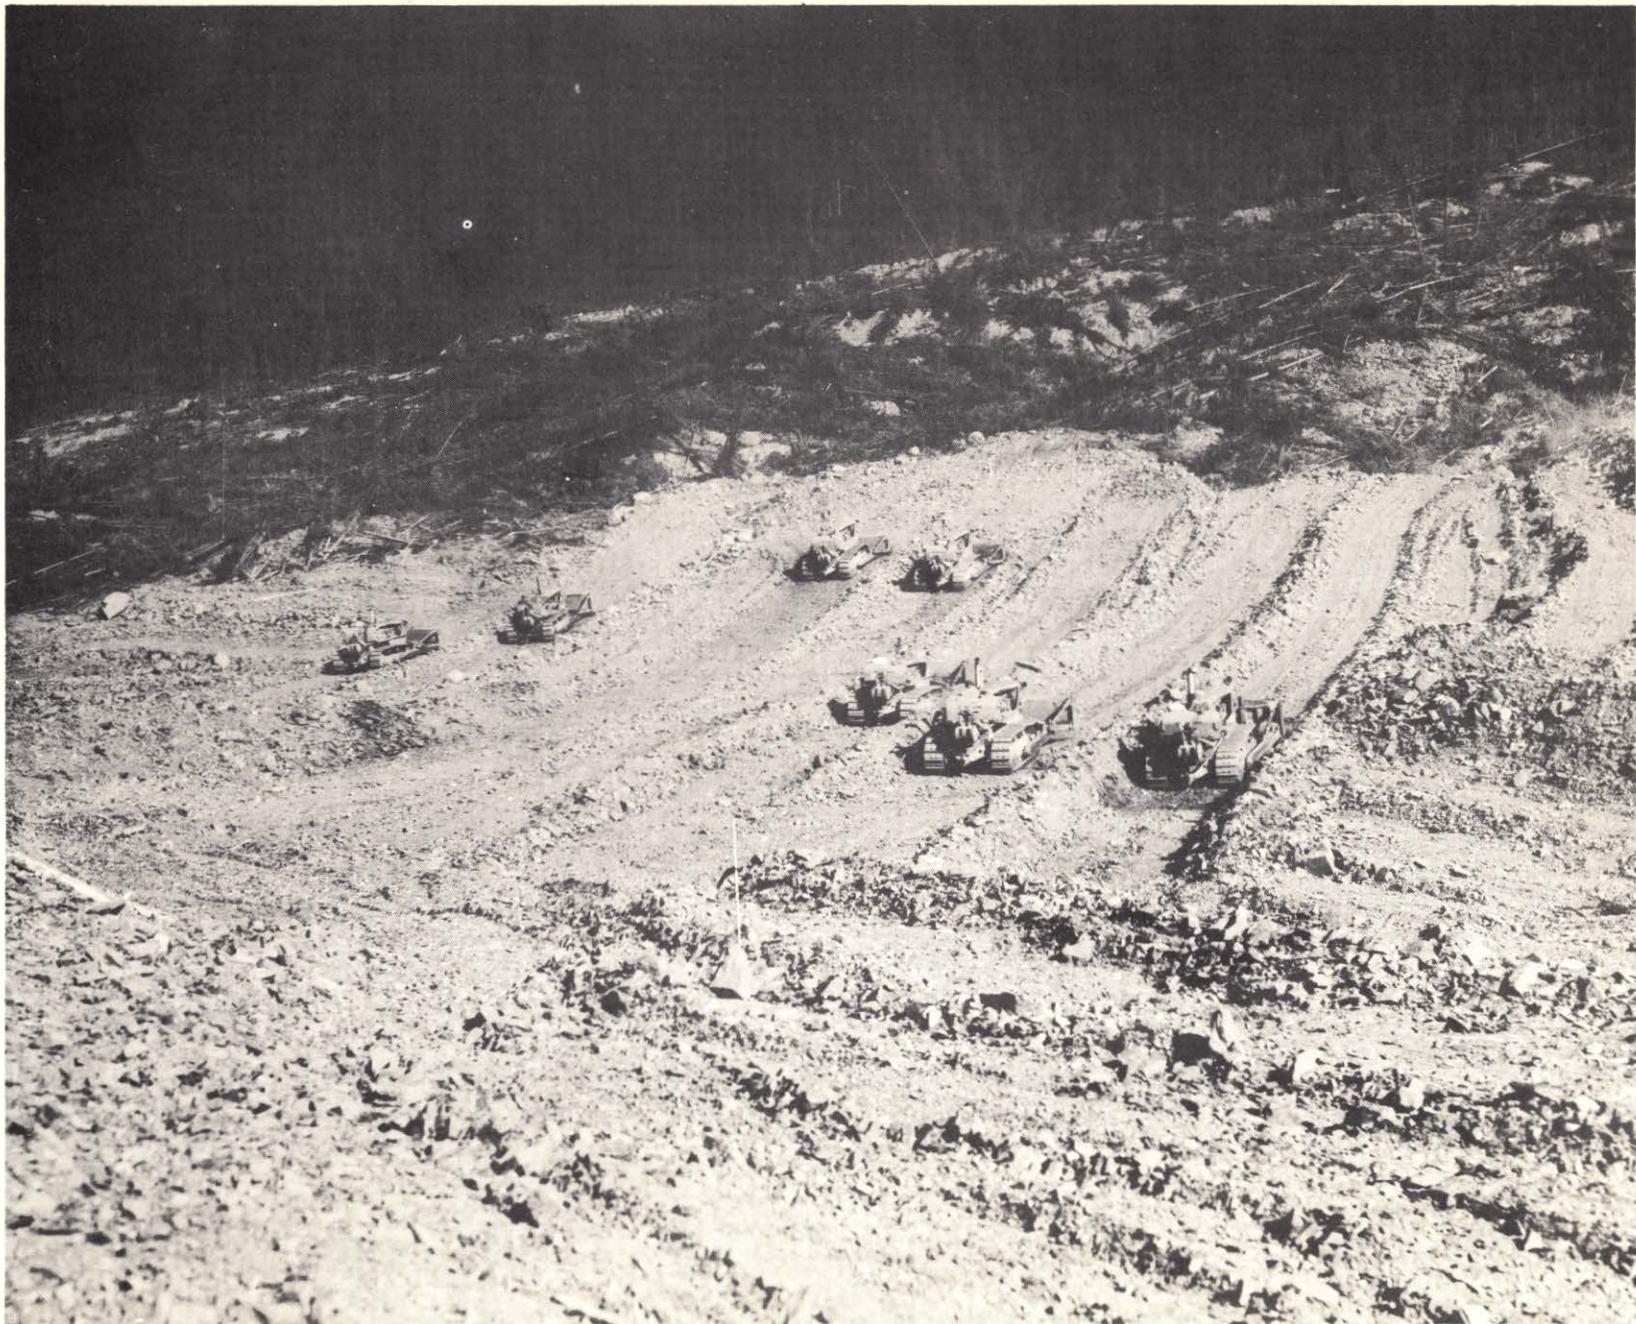
Photo 3. 27 August 1959. Bulldozers grading slide crest.

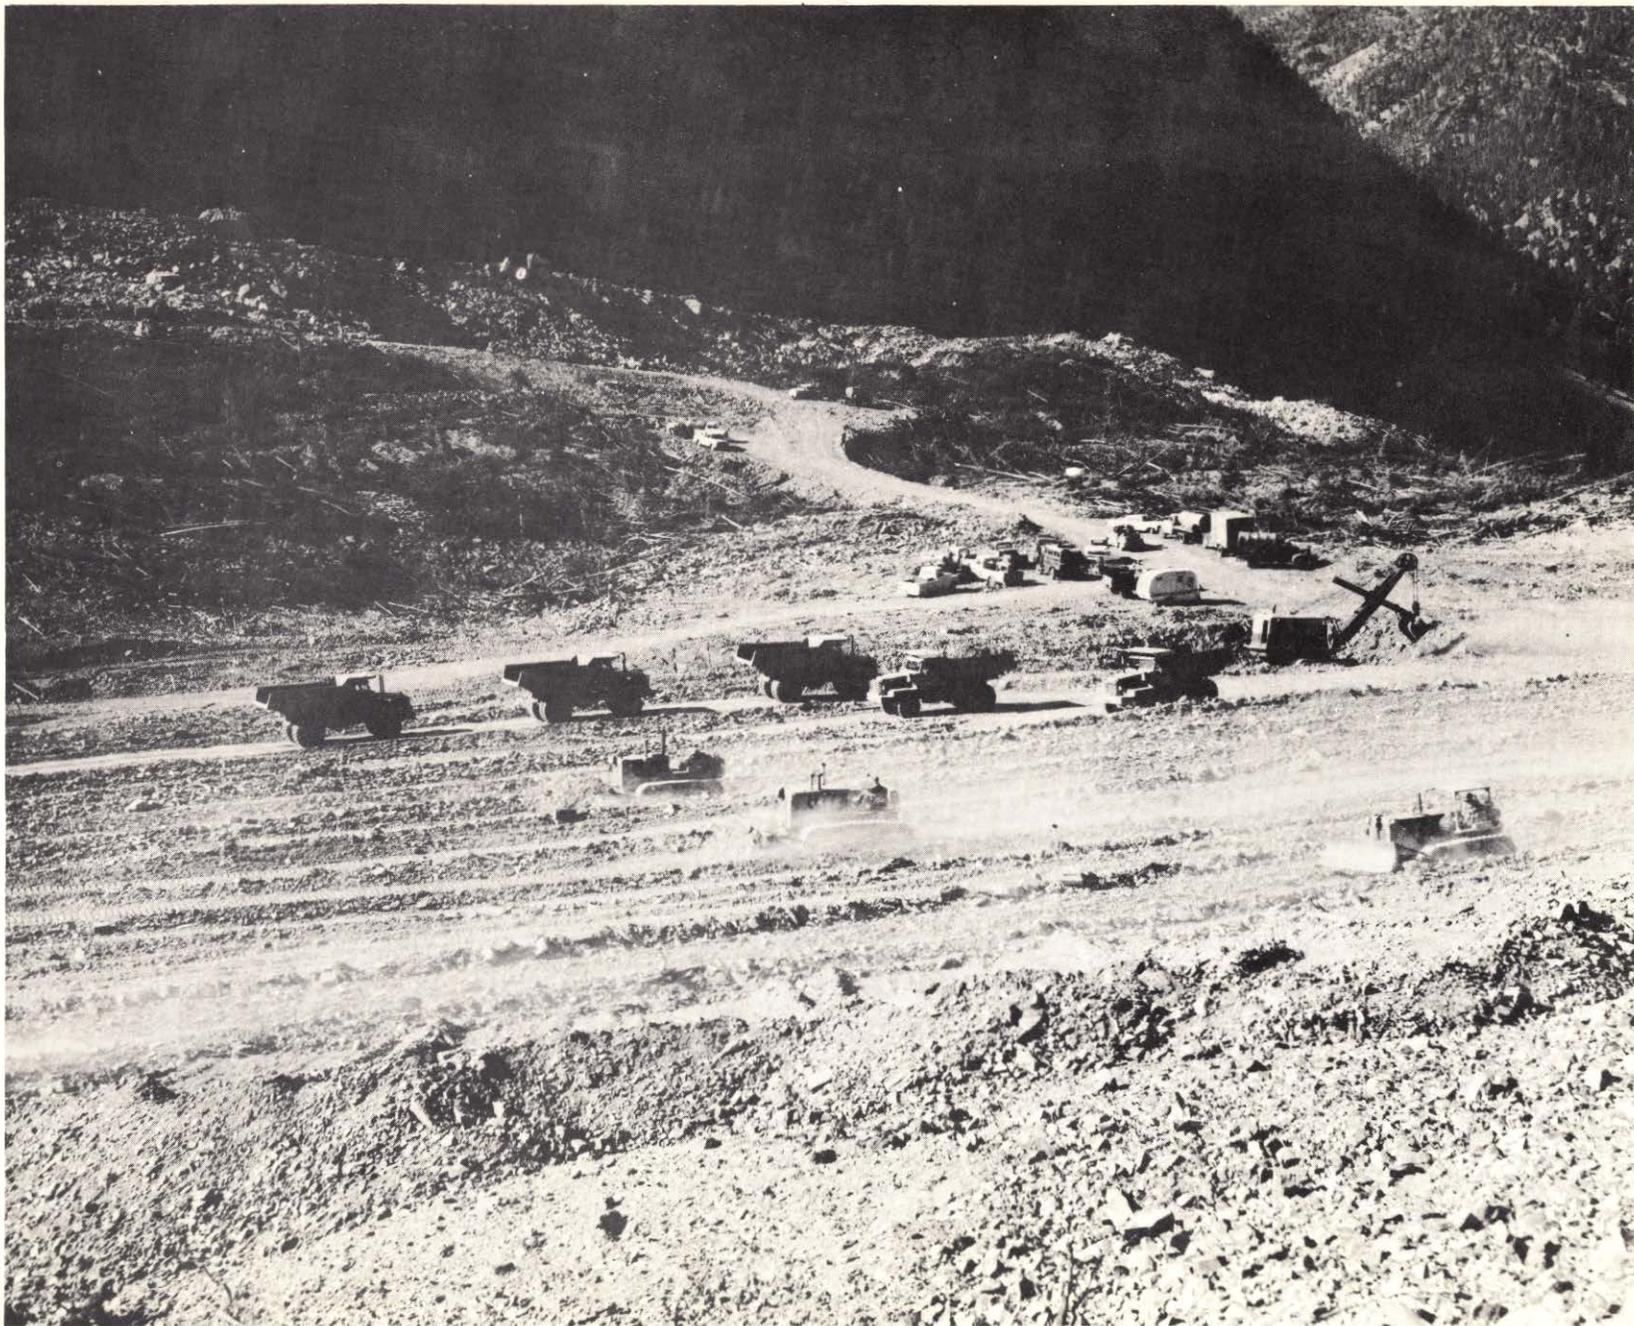
Photo 4. 28 August 1959. Equipment constructing initial spillway.

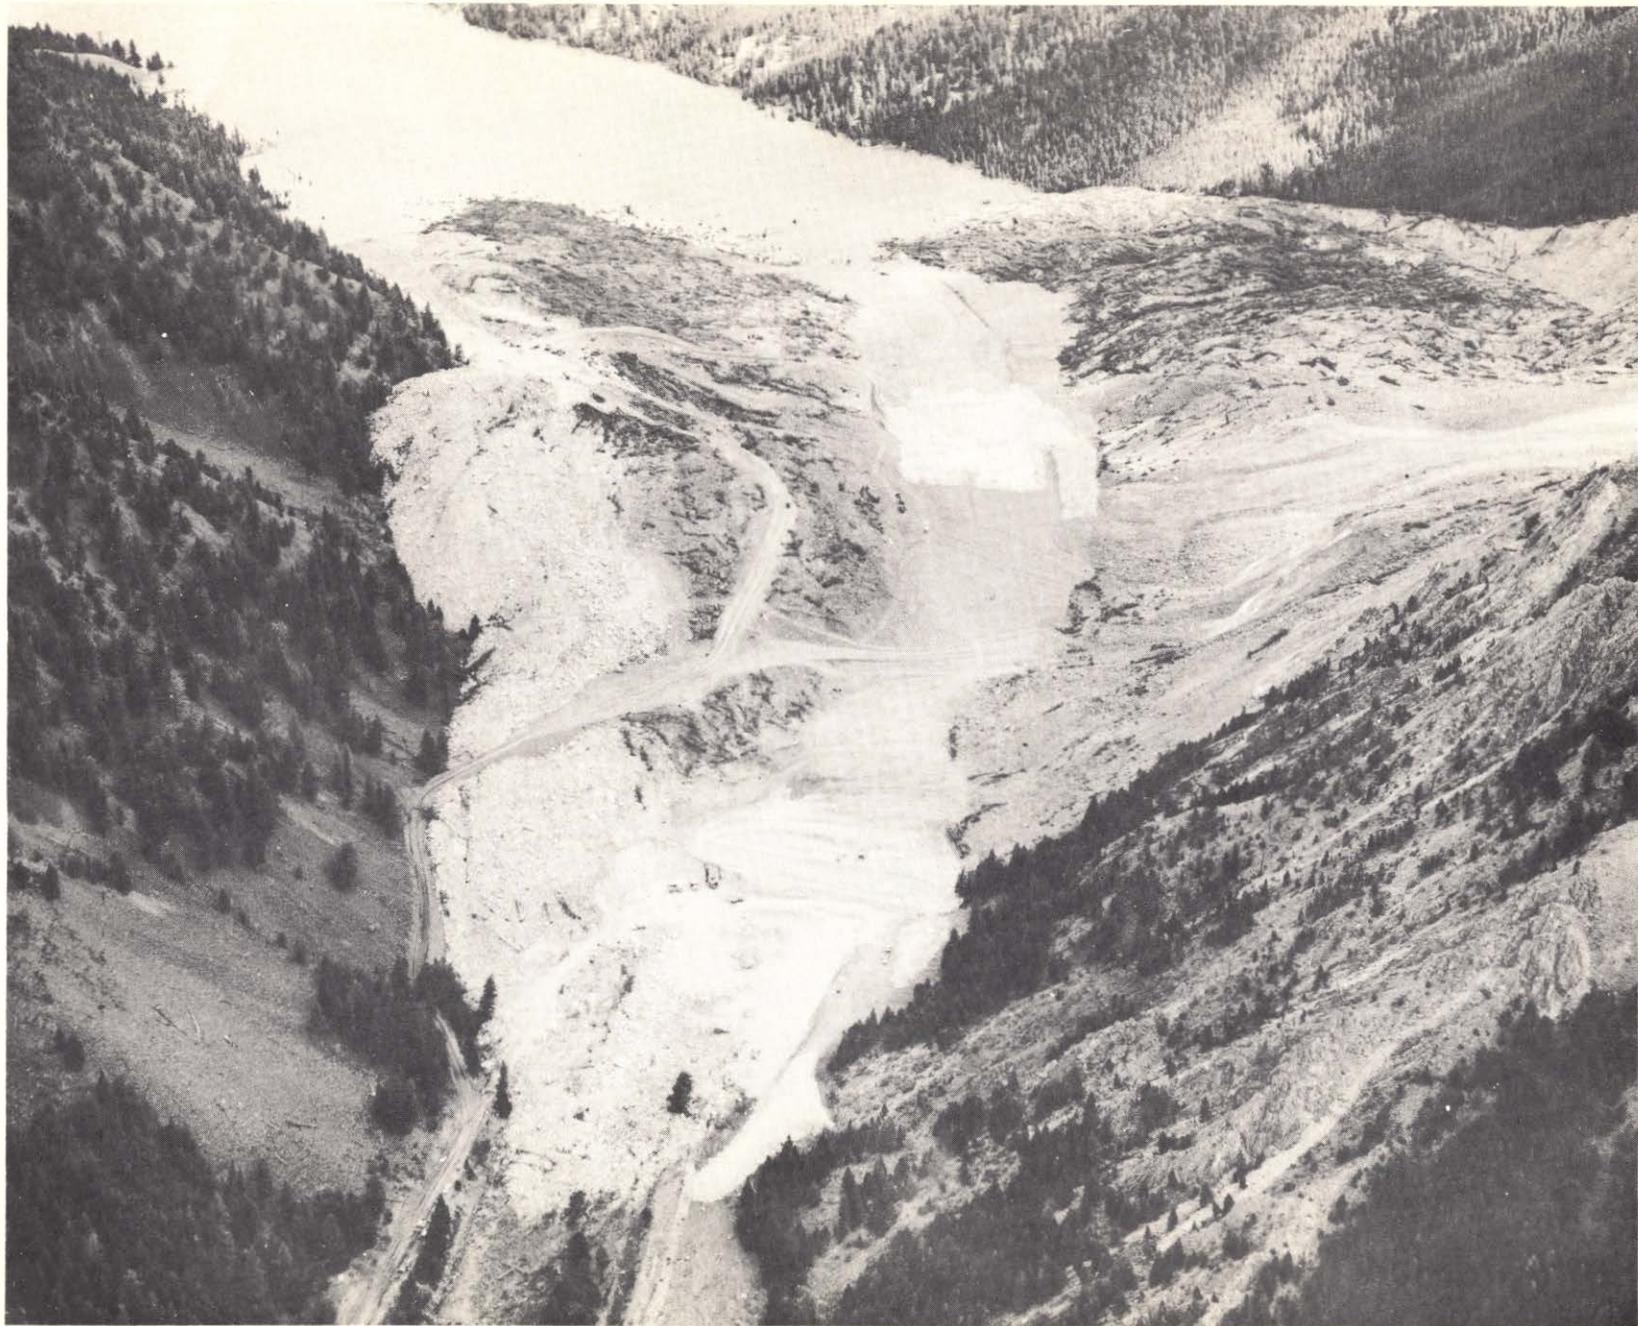
Photo 5. 3 September 1959. Aerial view of initial spillway construction.

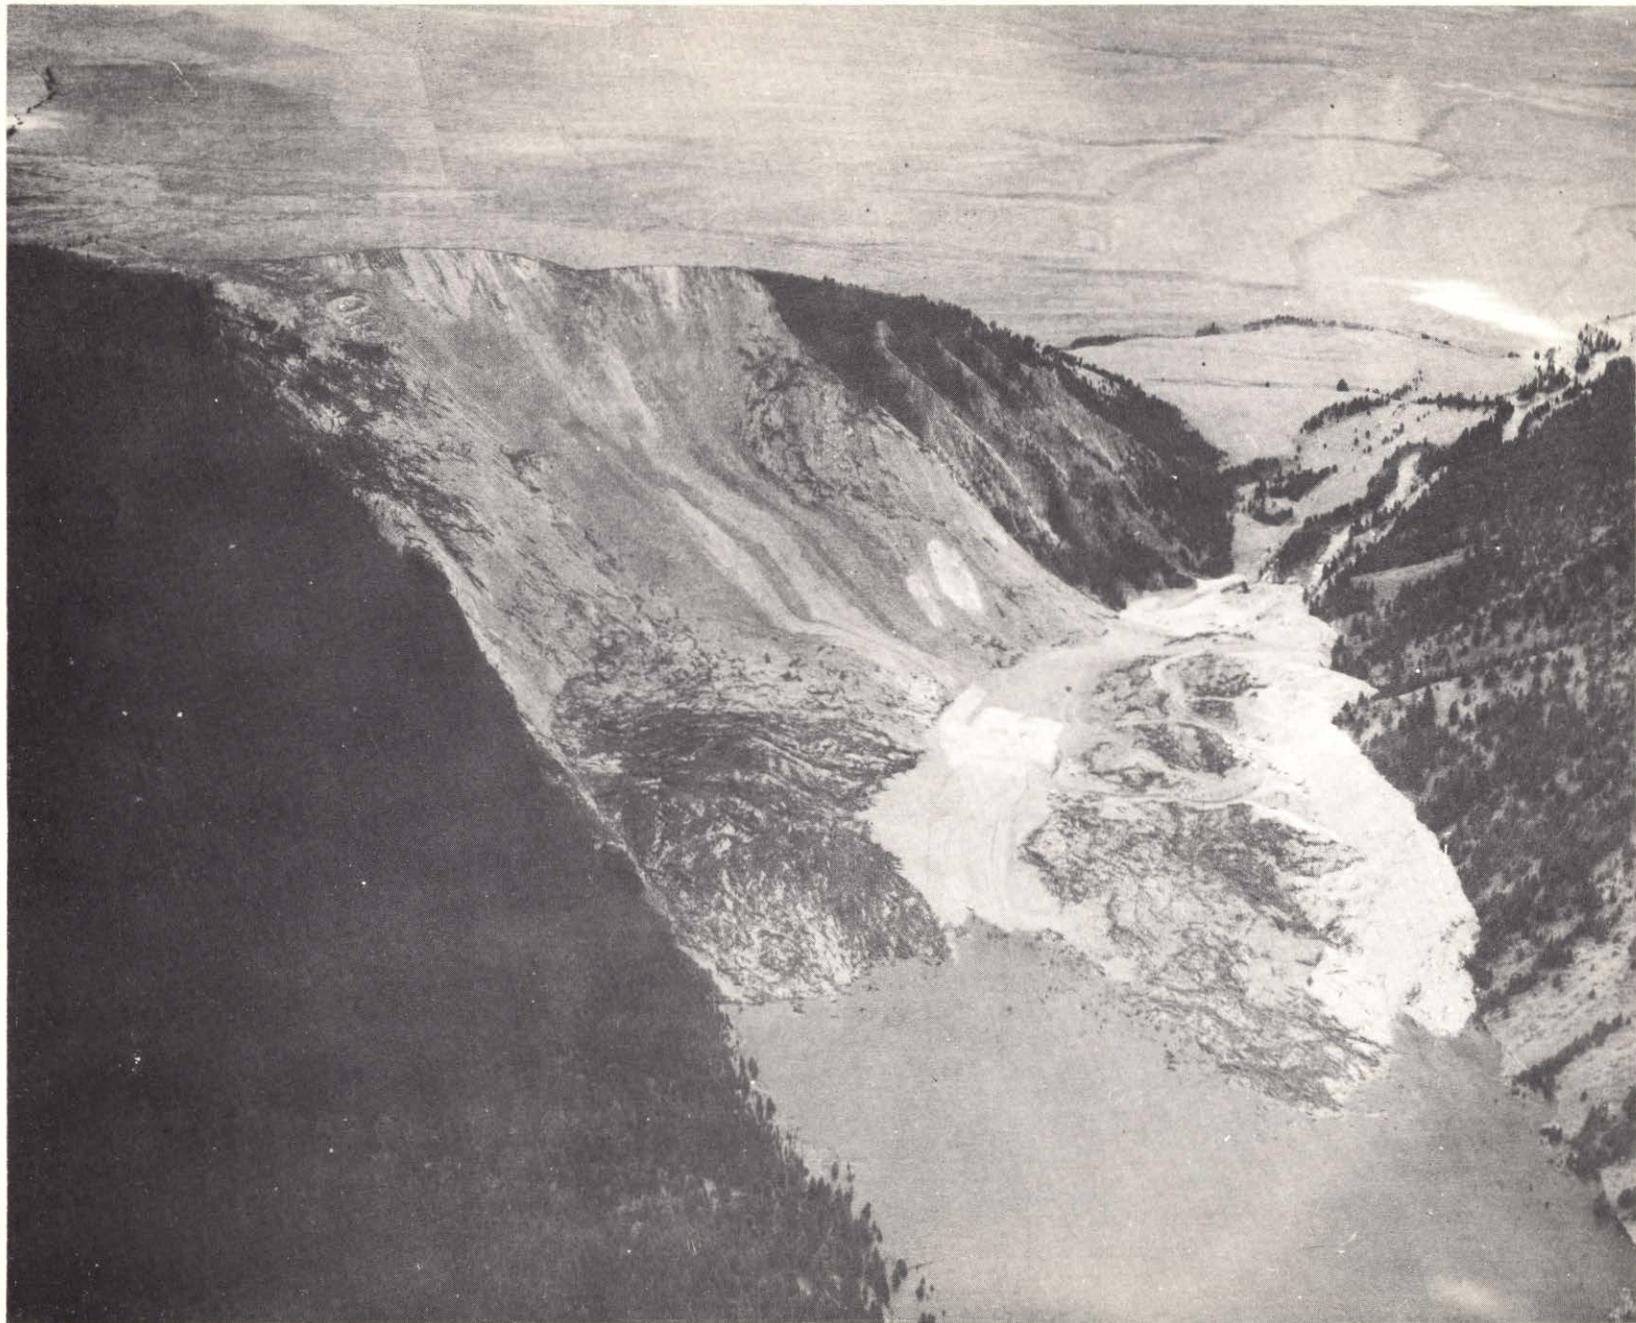
Photo 6. 3 September 1959. Over-all aerial view looking downstream showing initial spillway construction and a view of the slide scar.

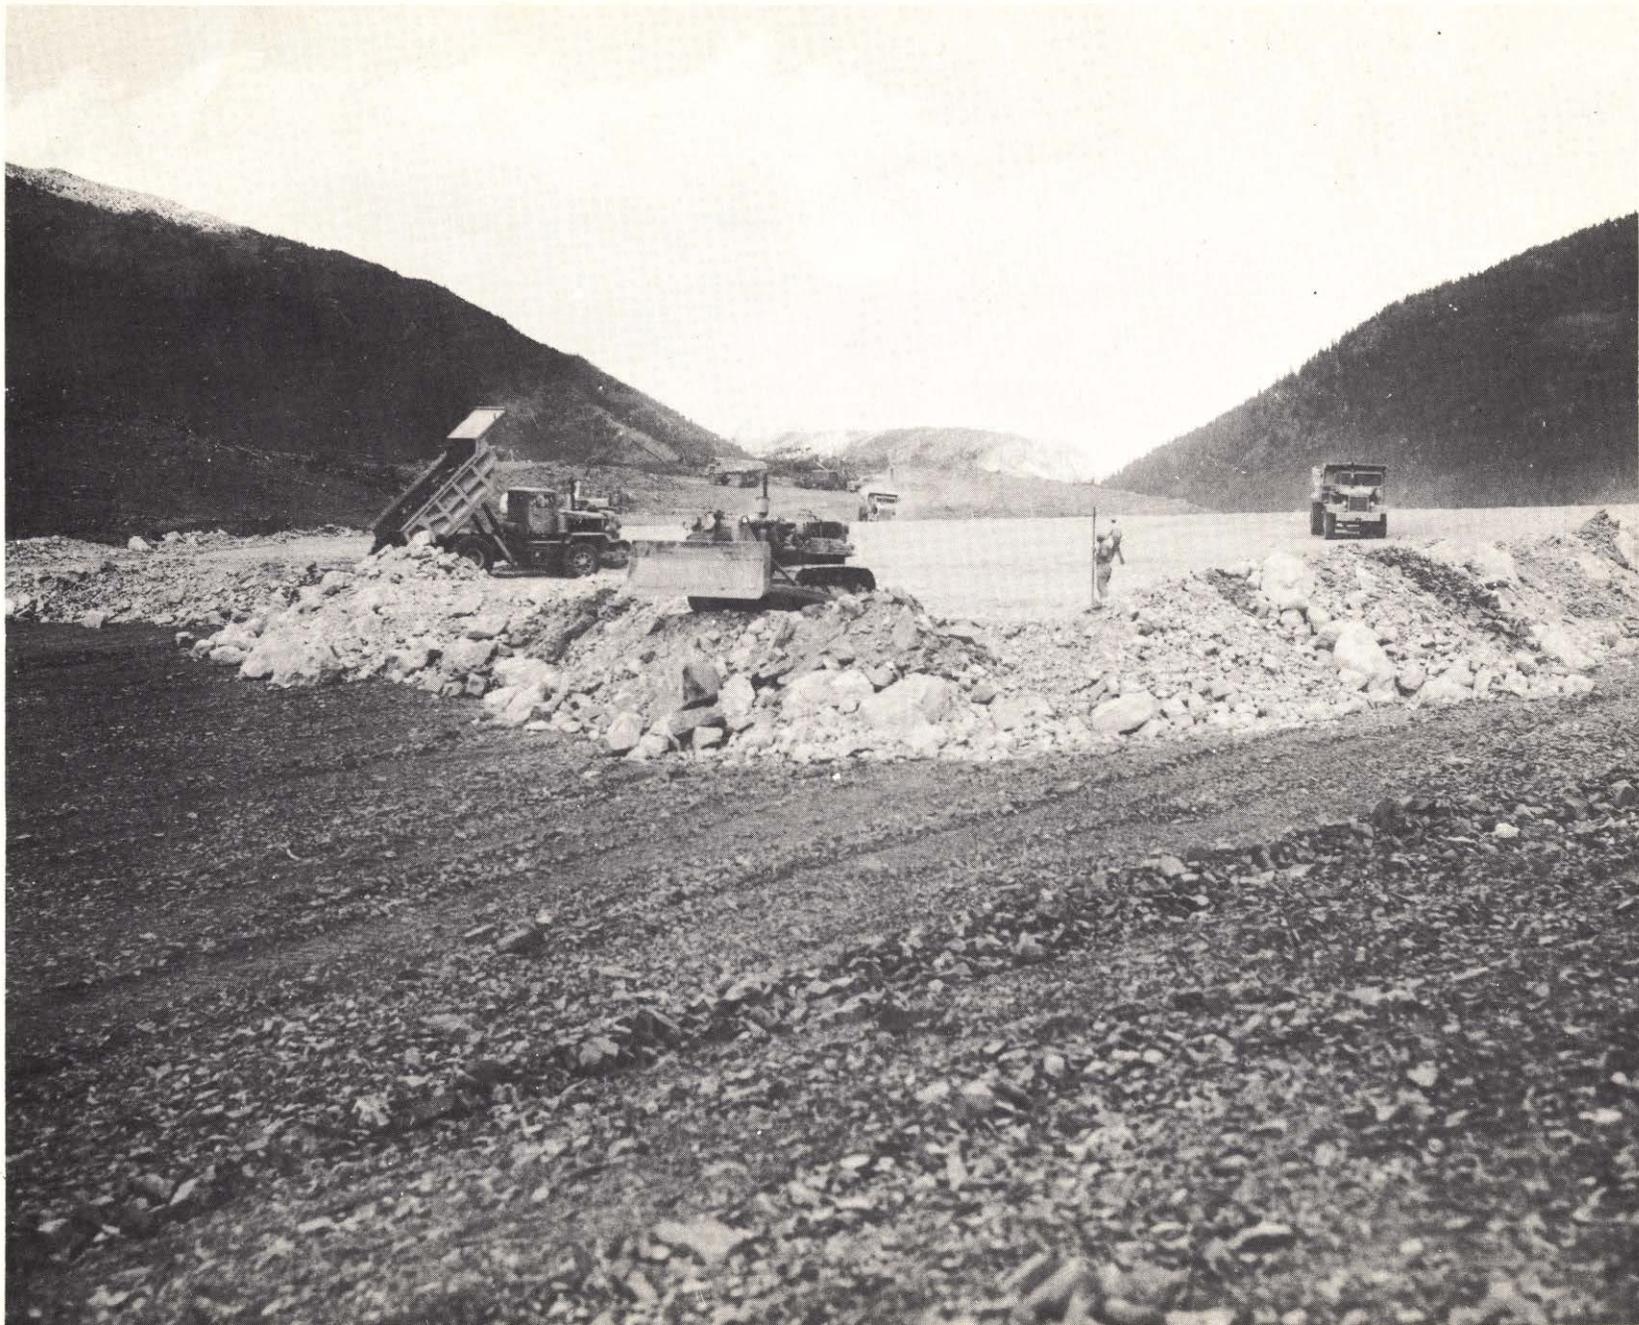
Photo 7. 4 September 1959. Placing spillway armor material in channel.

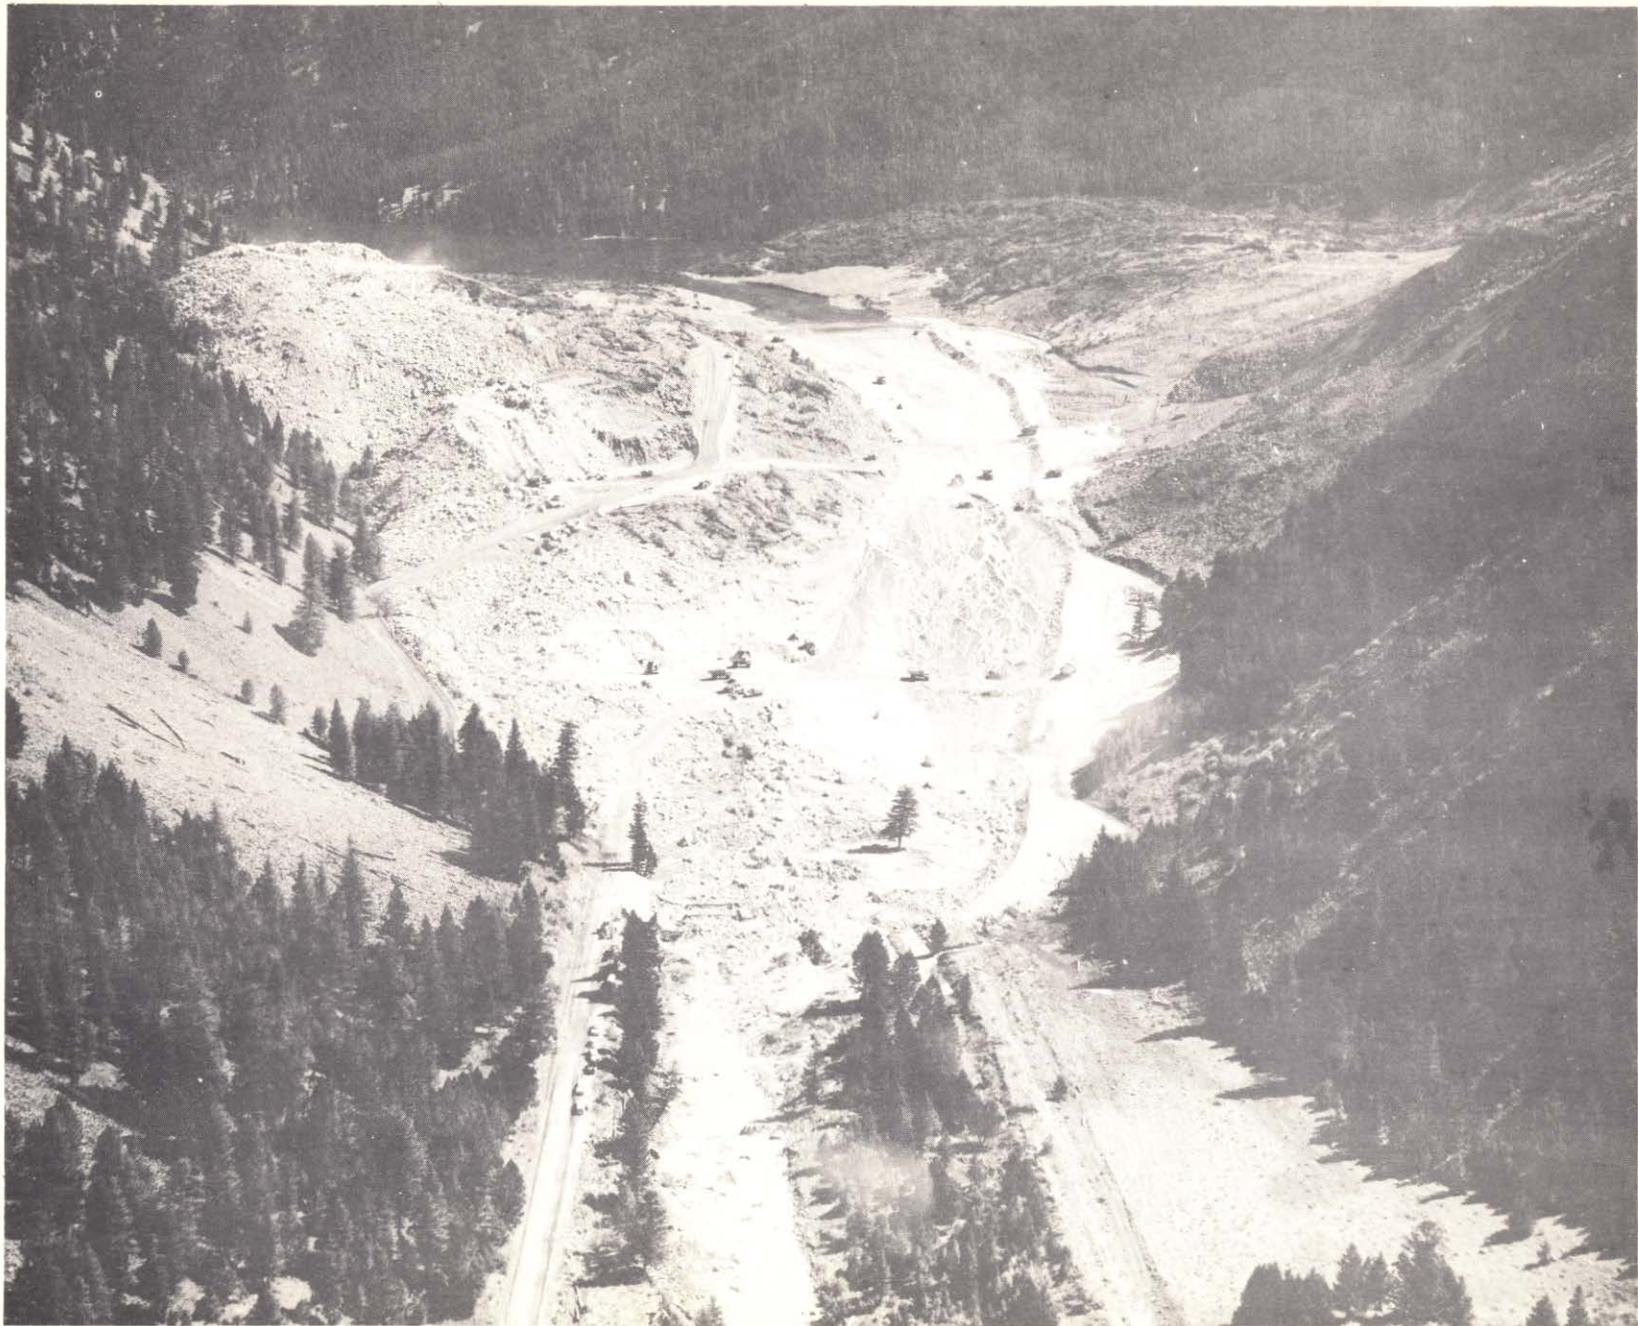
Photo 8. 10 September 1959. Upstream aerial view of spillway channel on first day water passed over slide.

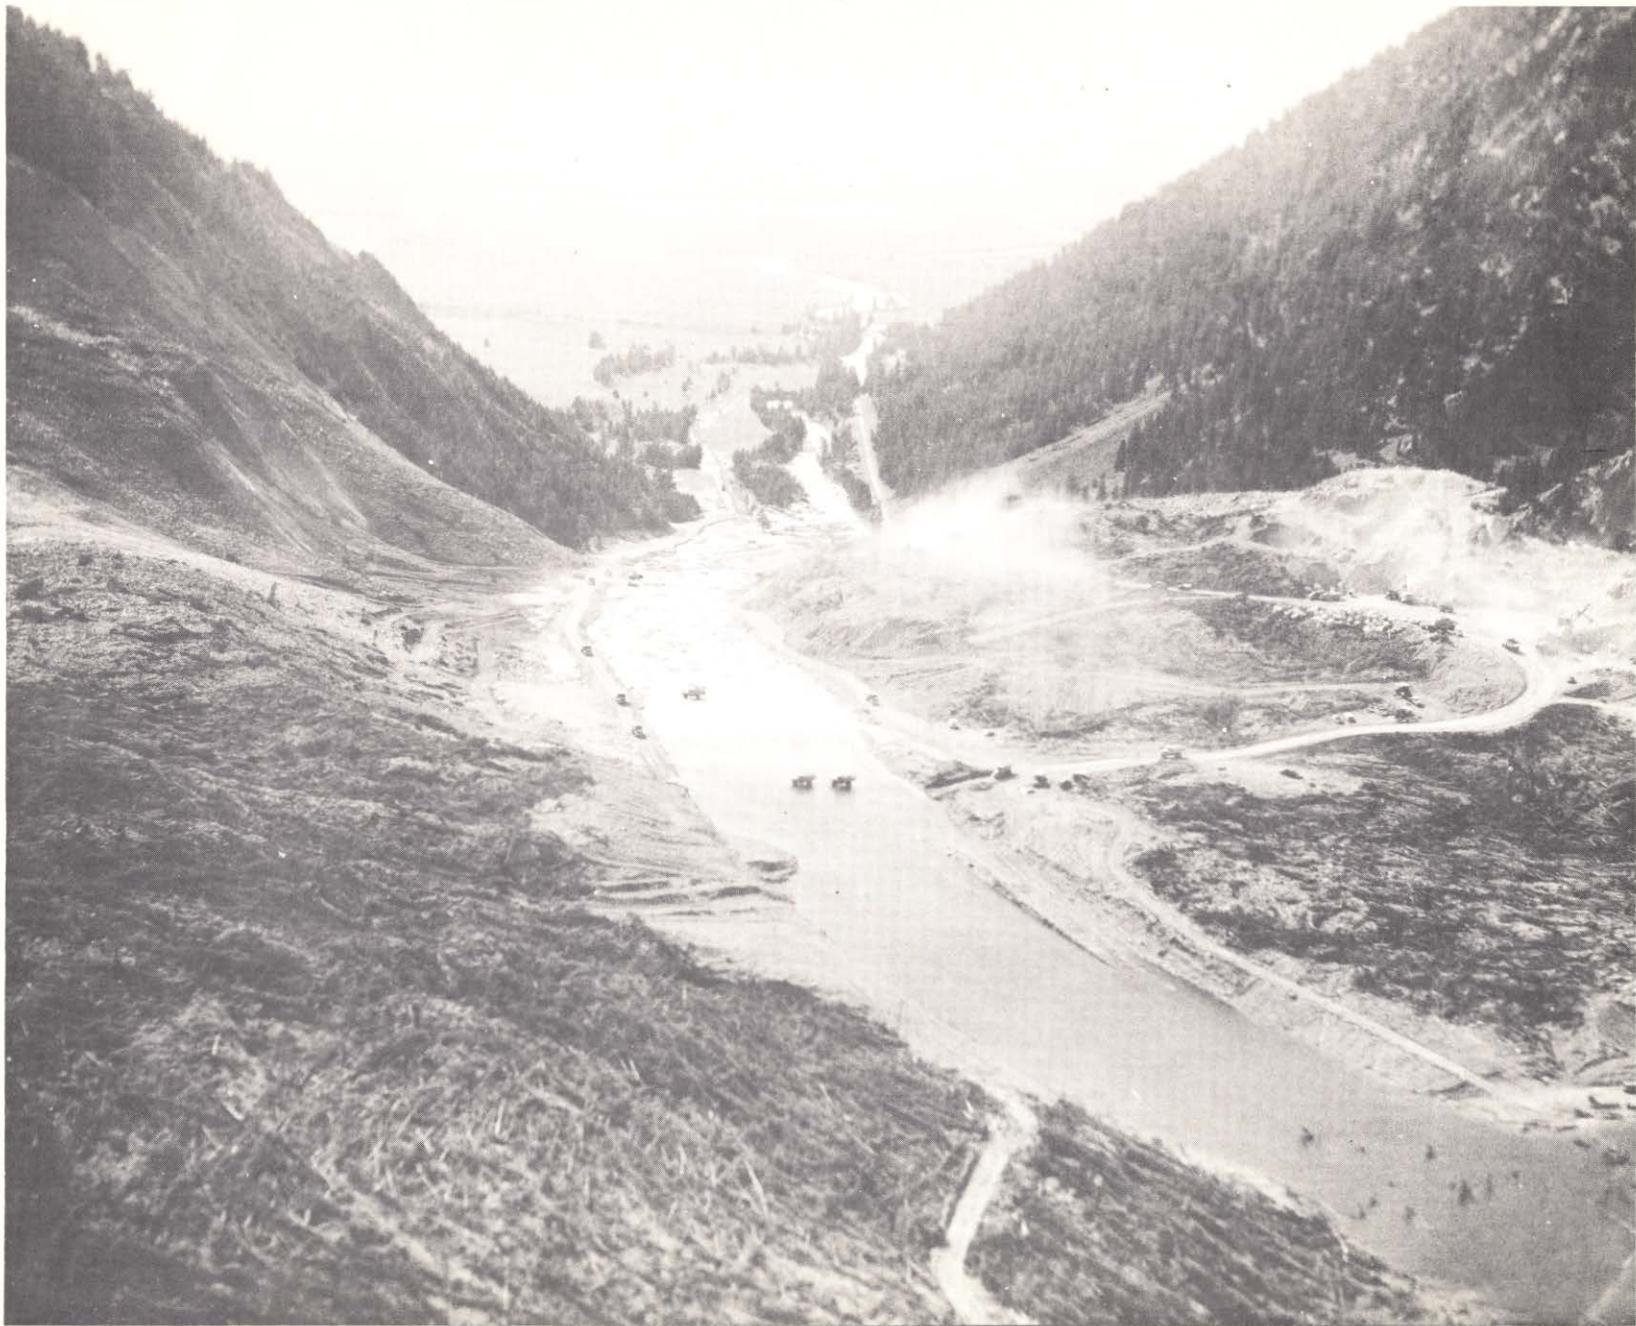
Photo 9. 11 September 1959. Downstream aerial view of water passing over slide in spillway channel.

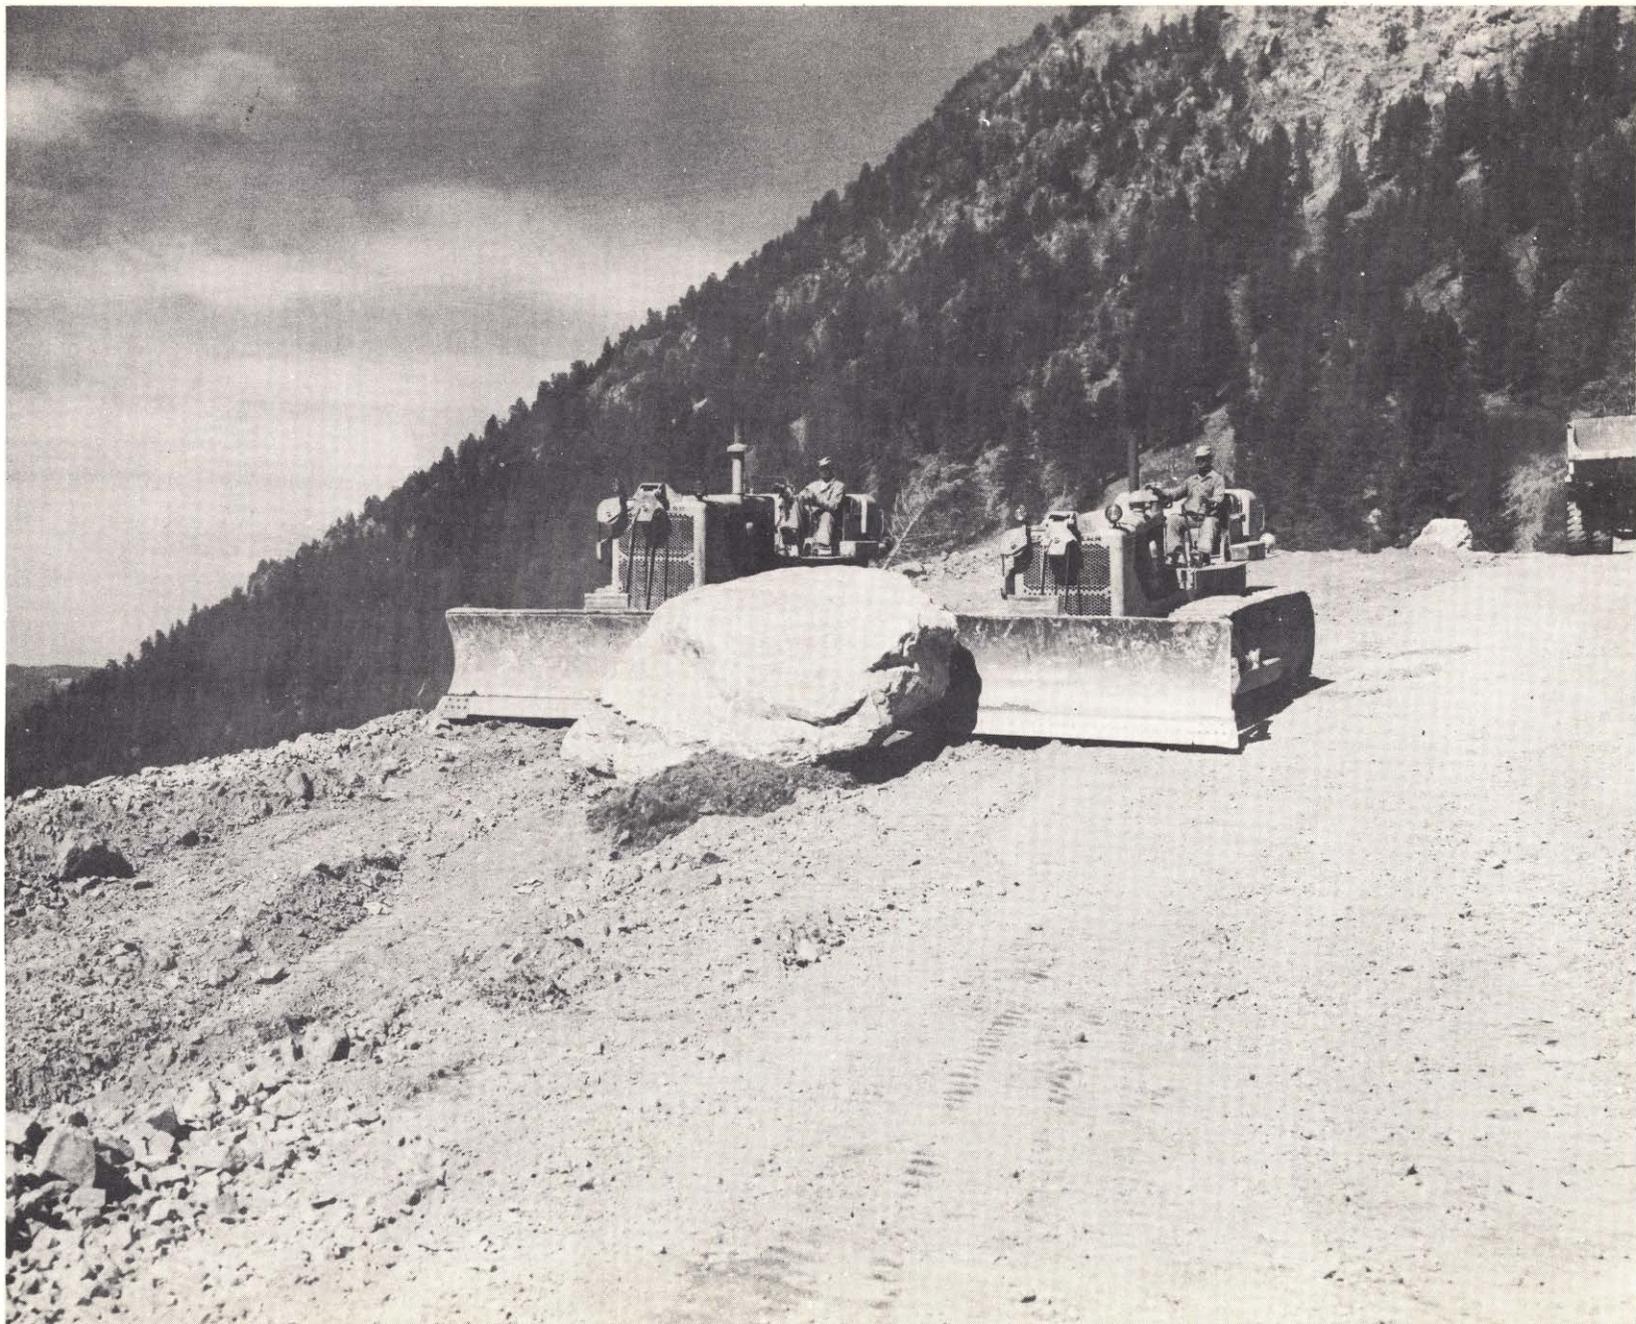
Photo 10. 11 September 1959. Two bulldozers pushing large rock.
