MADISON RIVER, MONTANA
REPORT ON
*FLOOD EMERGENCY
MADISON RIVER SLIDE*

*VOLUME I
MAIN REPORT*

U. S. ARMY ENGINEER DISTRICT, OMAHA
CORPS OF ENGINEERS
OMAHA, NEBRASKA
SEPTEMBER 1960

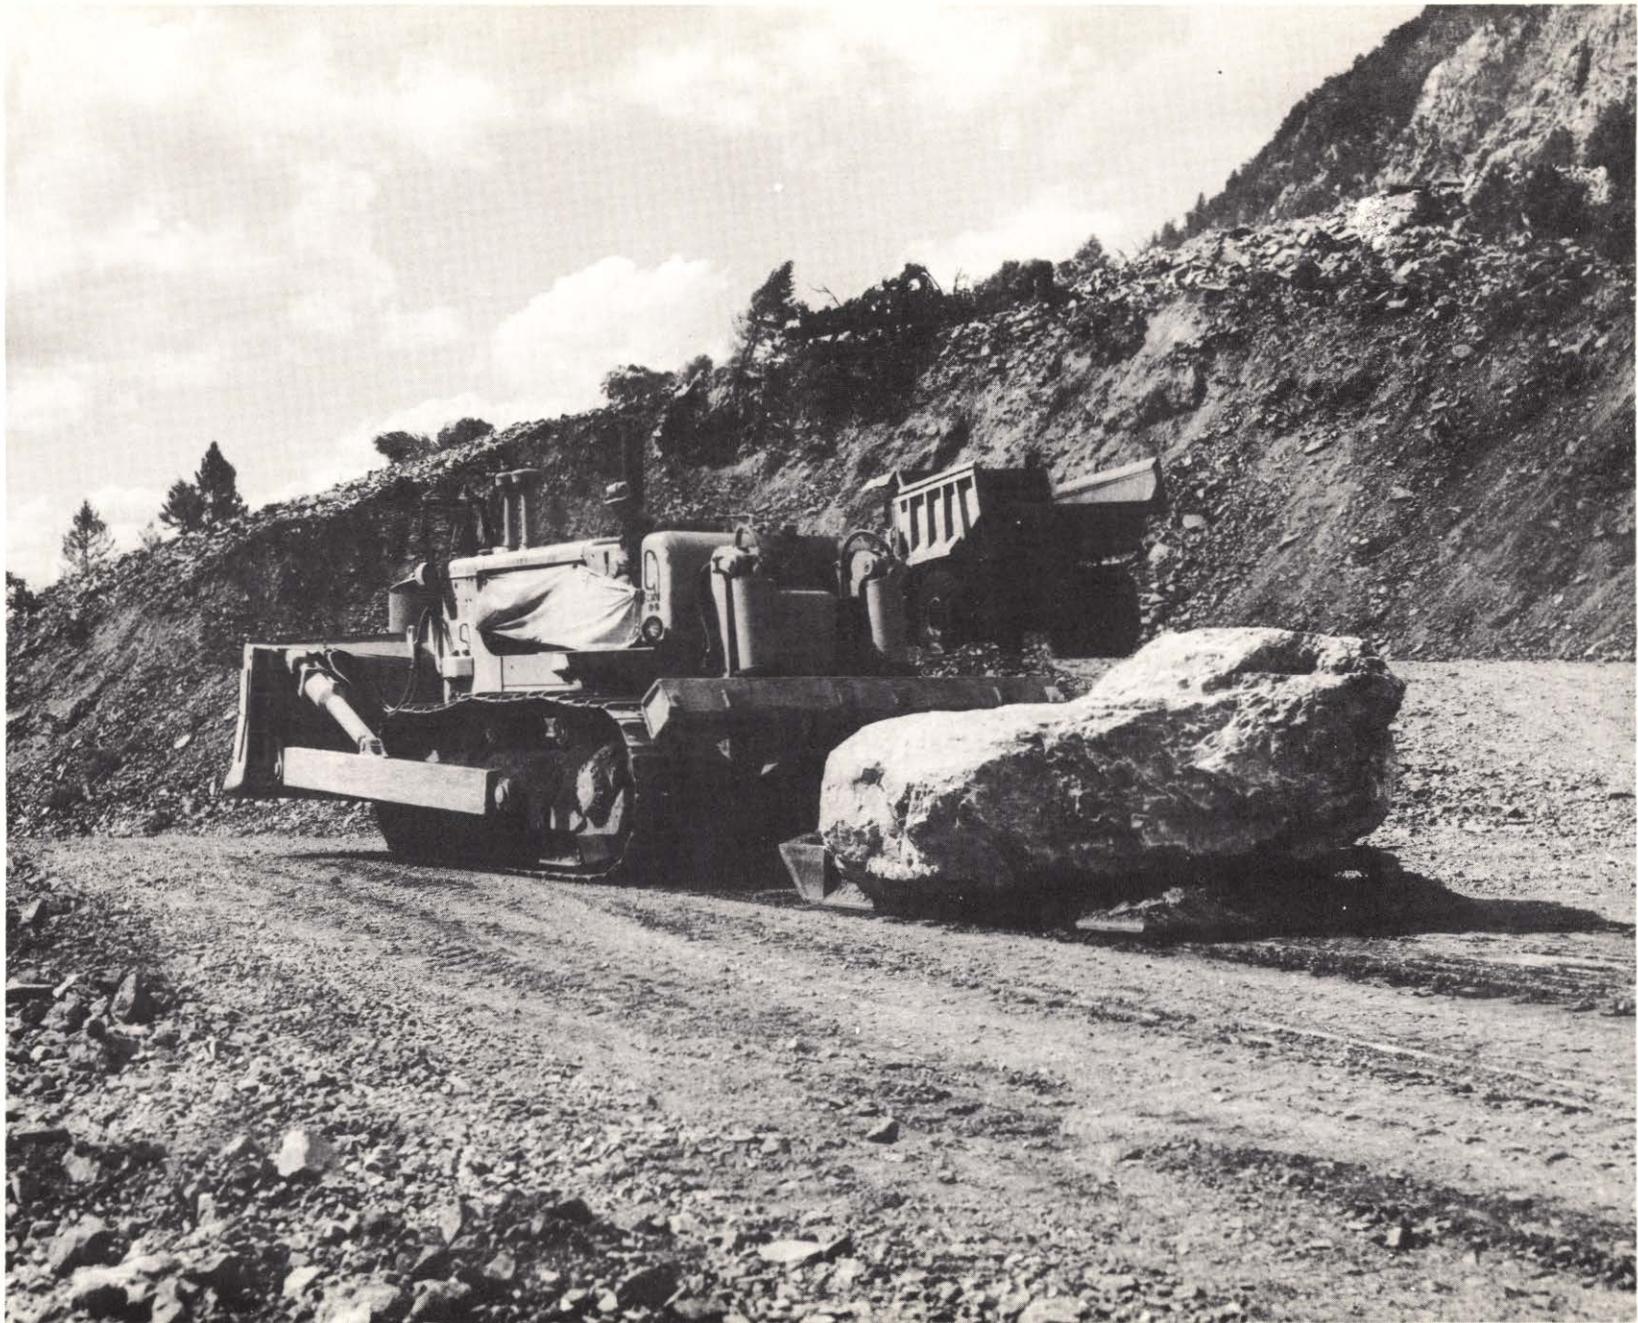
Photo 11. 16 September 1959. Tractor pulling large rock on rock sled.

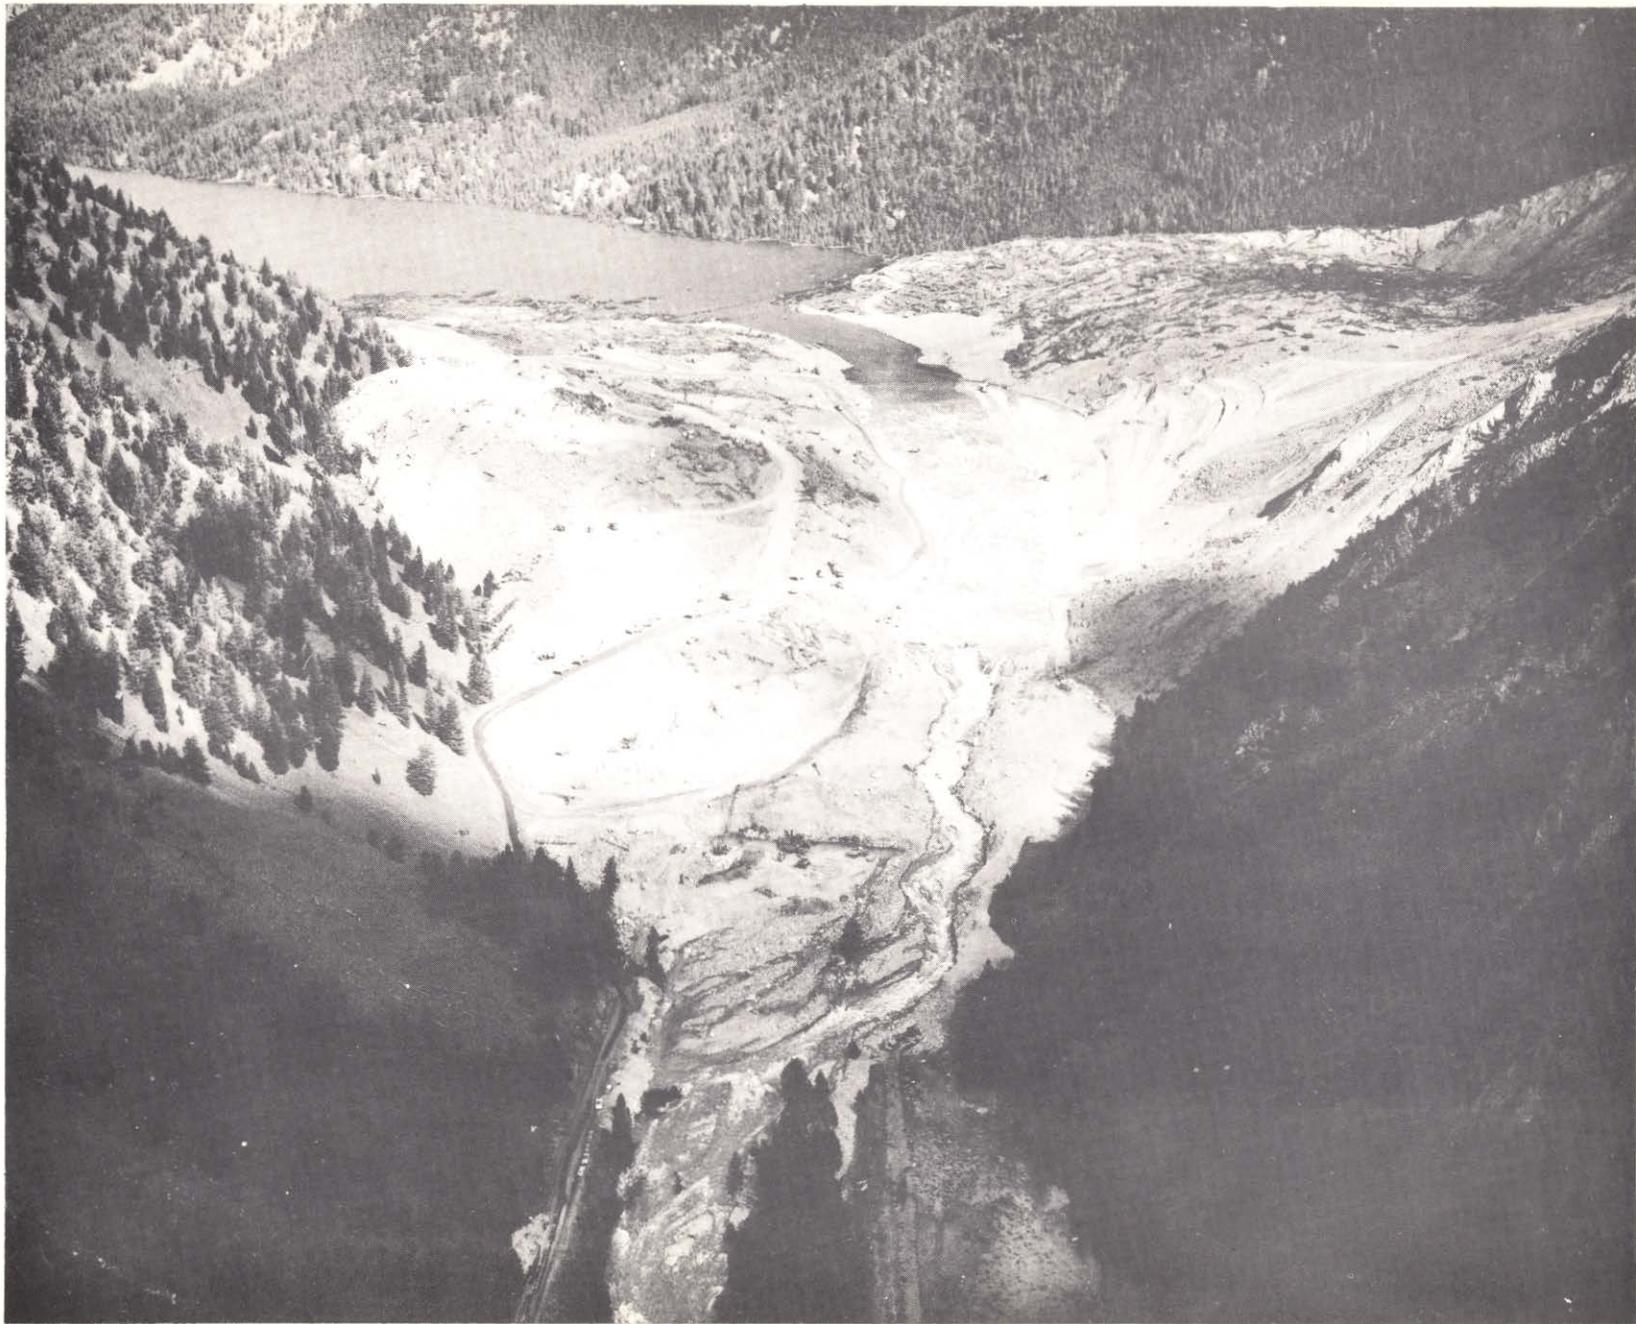
Photo 12. 16 September 1959. Aerial view of slide and spillway.

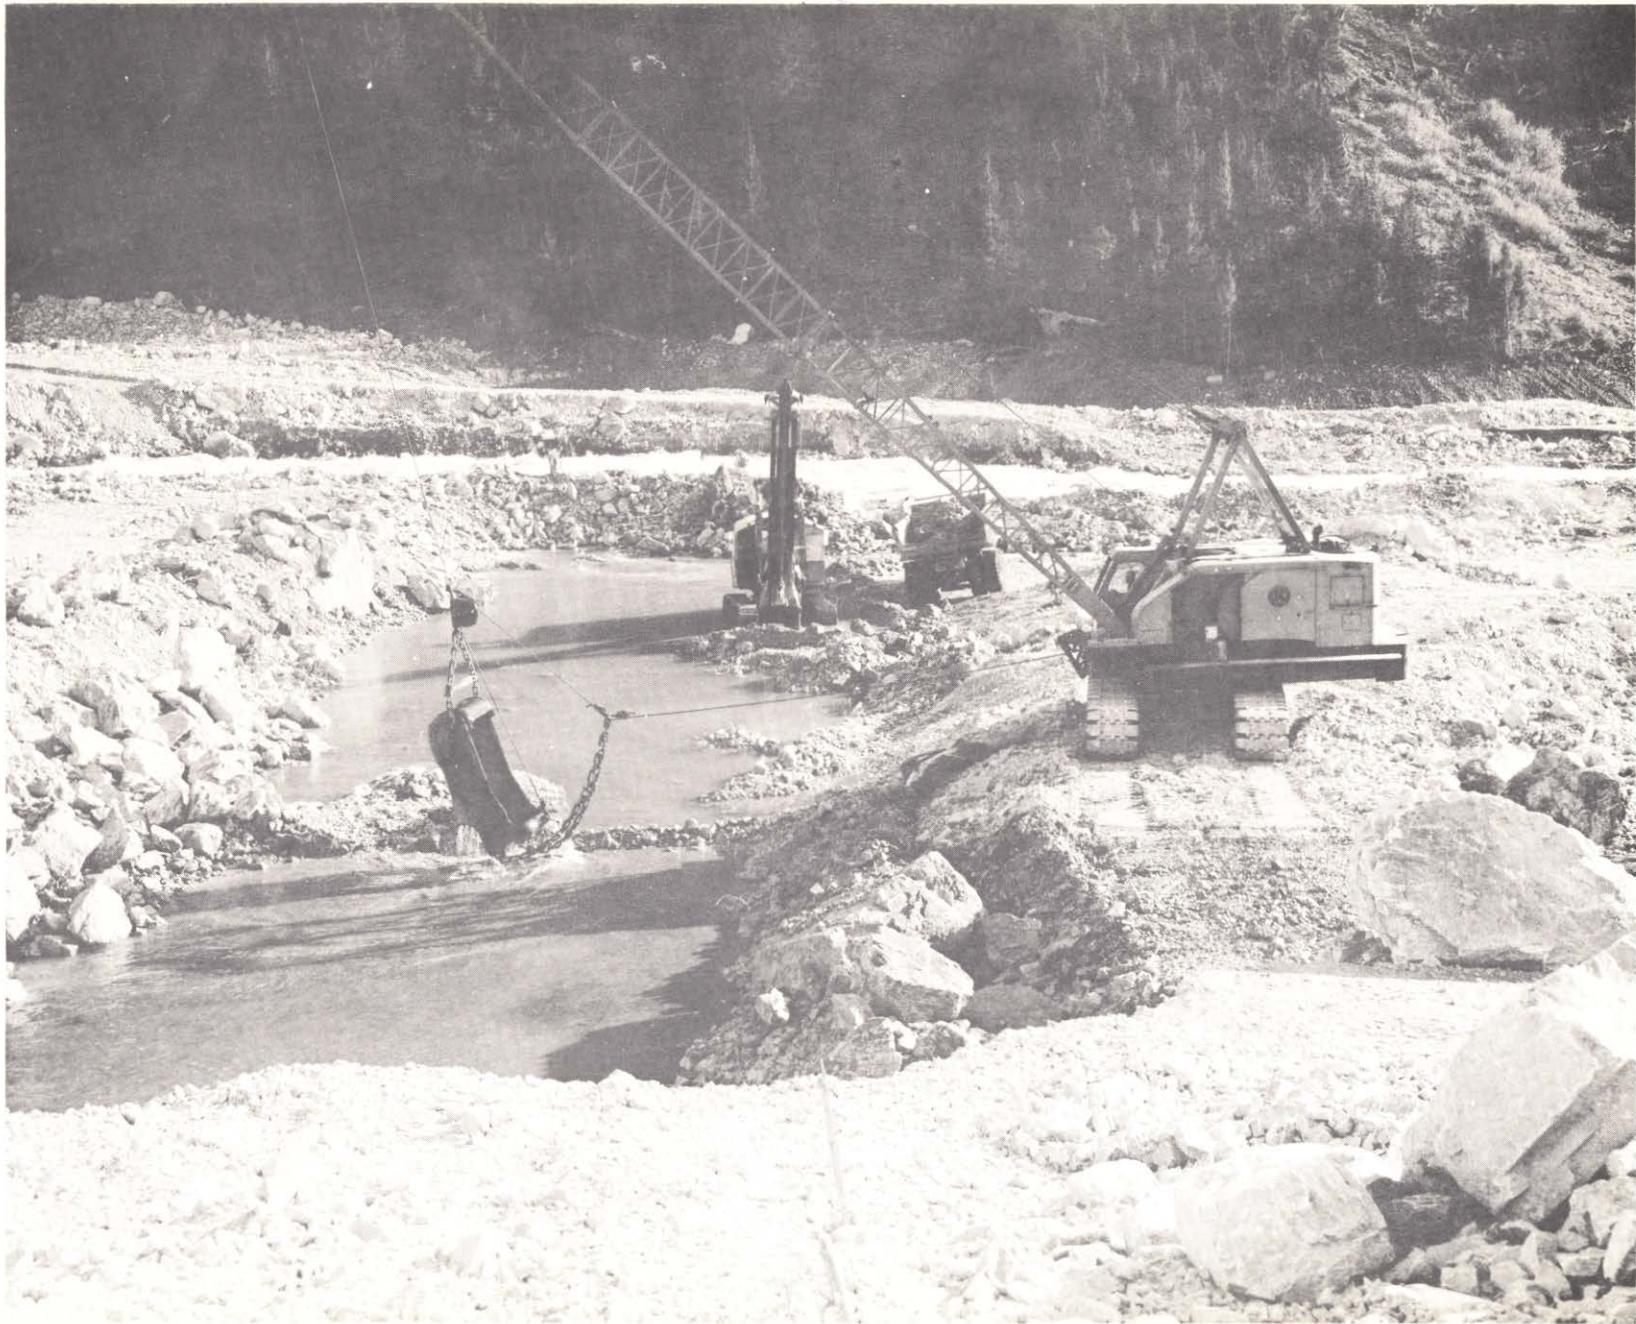
Photo 13. 16 September 1959. Foundation excavation for first rock filled drop structure at about Station 6+00.

49. Serious consideration was given at this time to obtaining durable rock from suitable quarry sites in the mountains nearby, in quantities sufficient to construct two or three permanent rock drop structures, with rock stilling basins, to stop the continued erosion of the spillway, which several times threatened to get out of control. Obviously, such a plan would be both time-consuming and costly, and it was discarded in favor of a plan to lower the spillway and reduce the storage in Earthquake Lake. Foundation excavation for part of the first drop structure is shown in Photo 13.

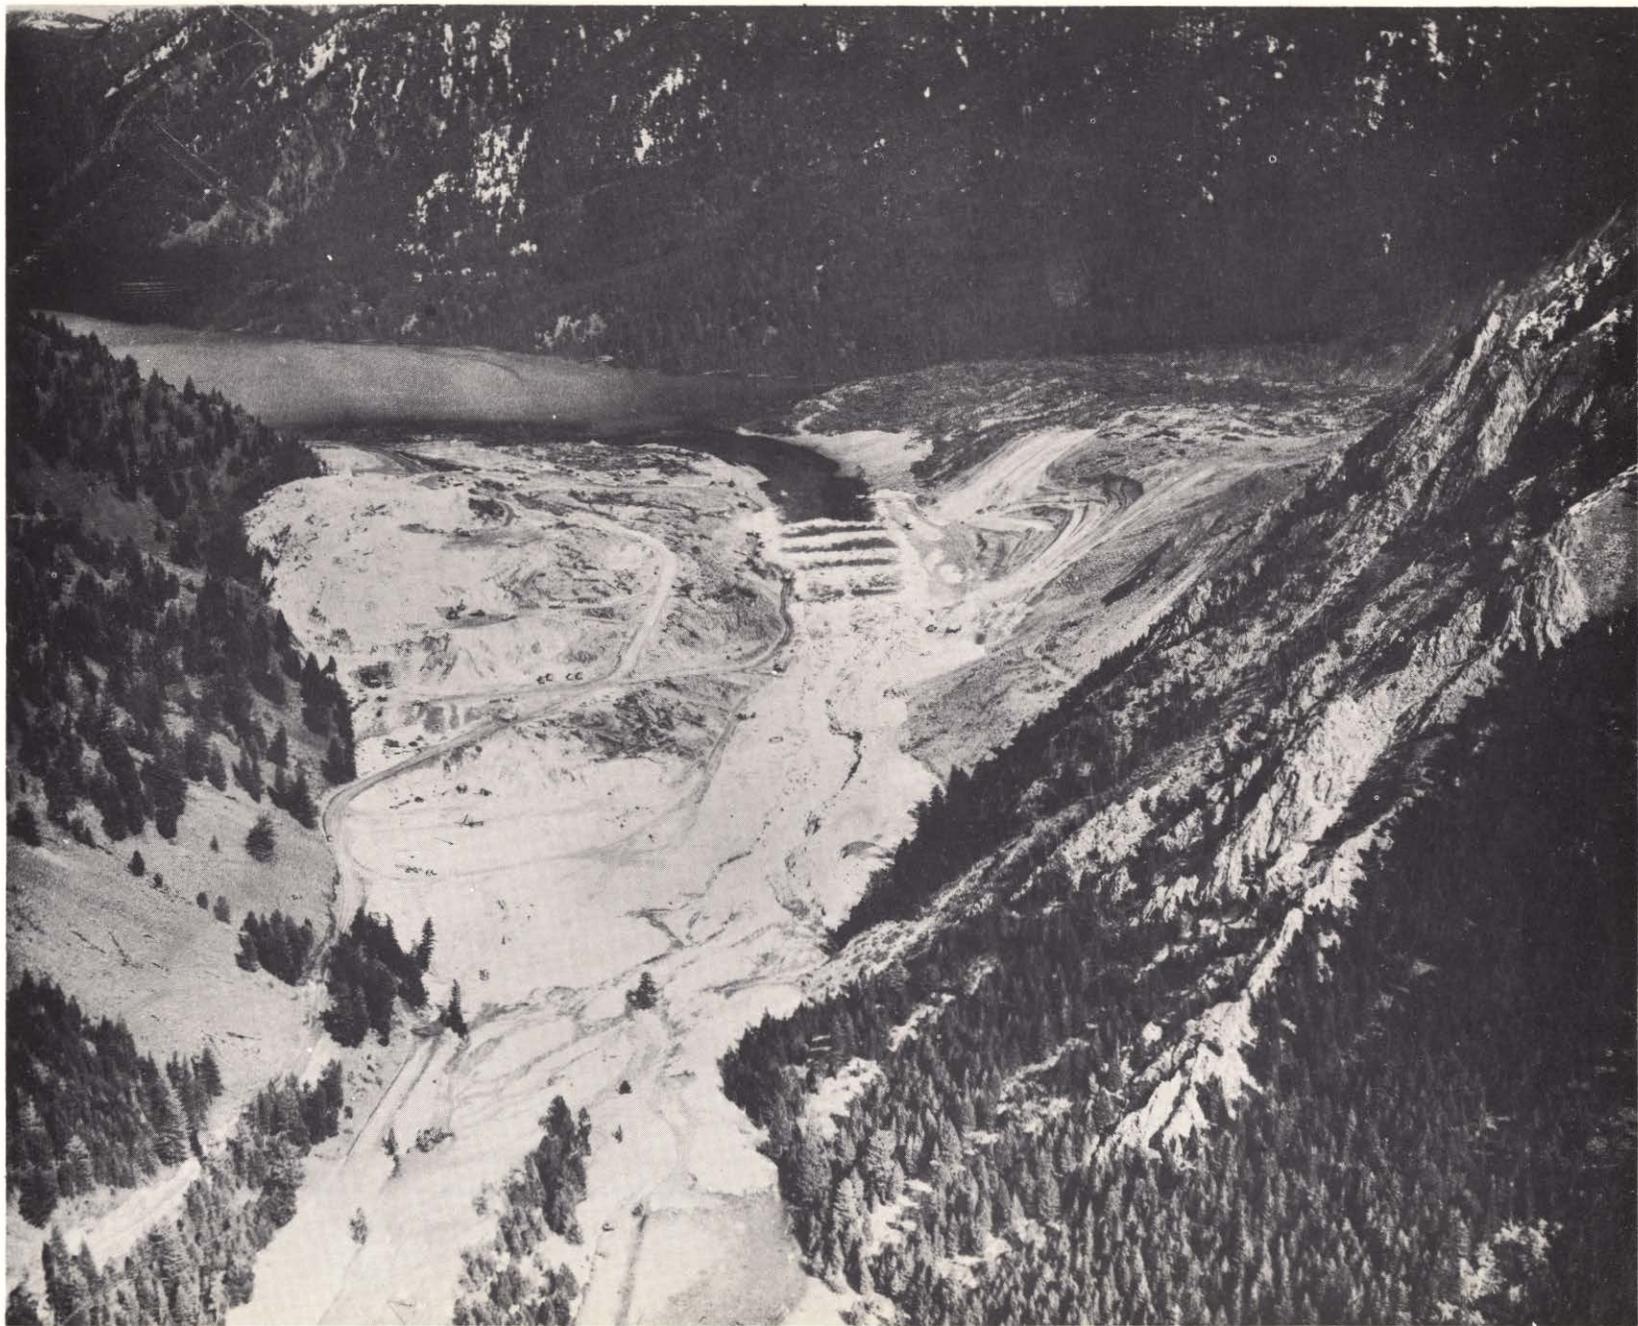
Photo 14. 22 September 1959. Aerial view of slide showing water pouring over rock terraces.

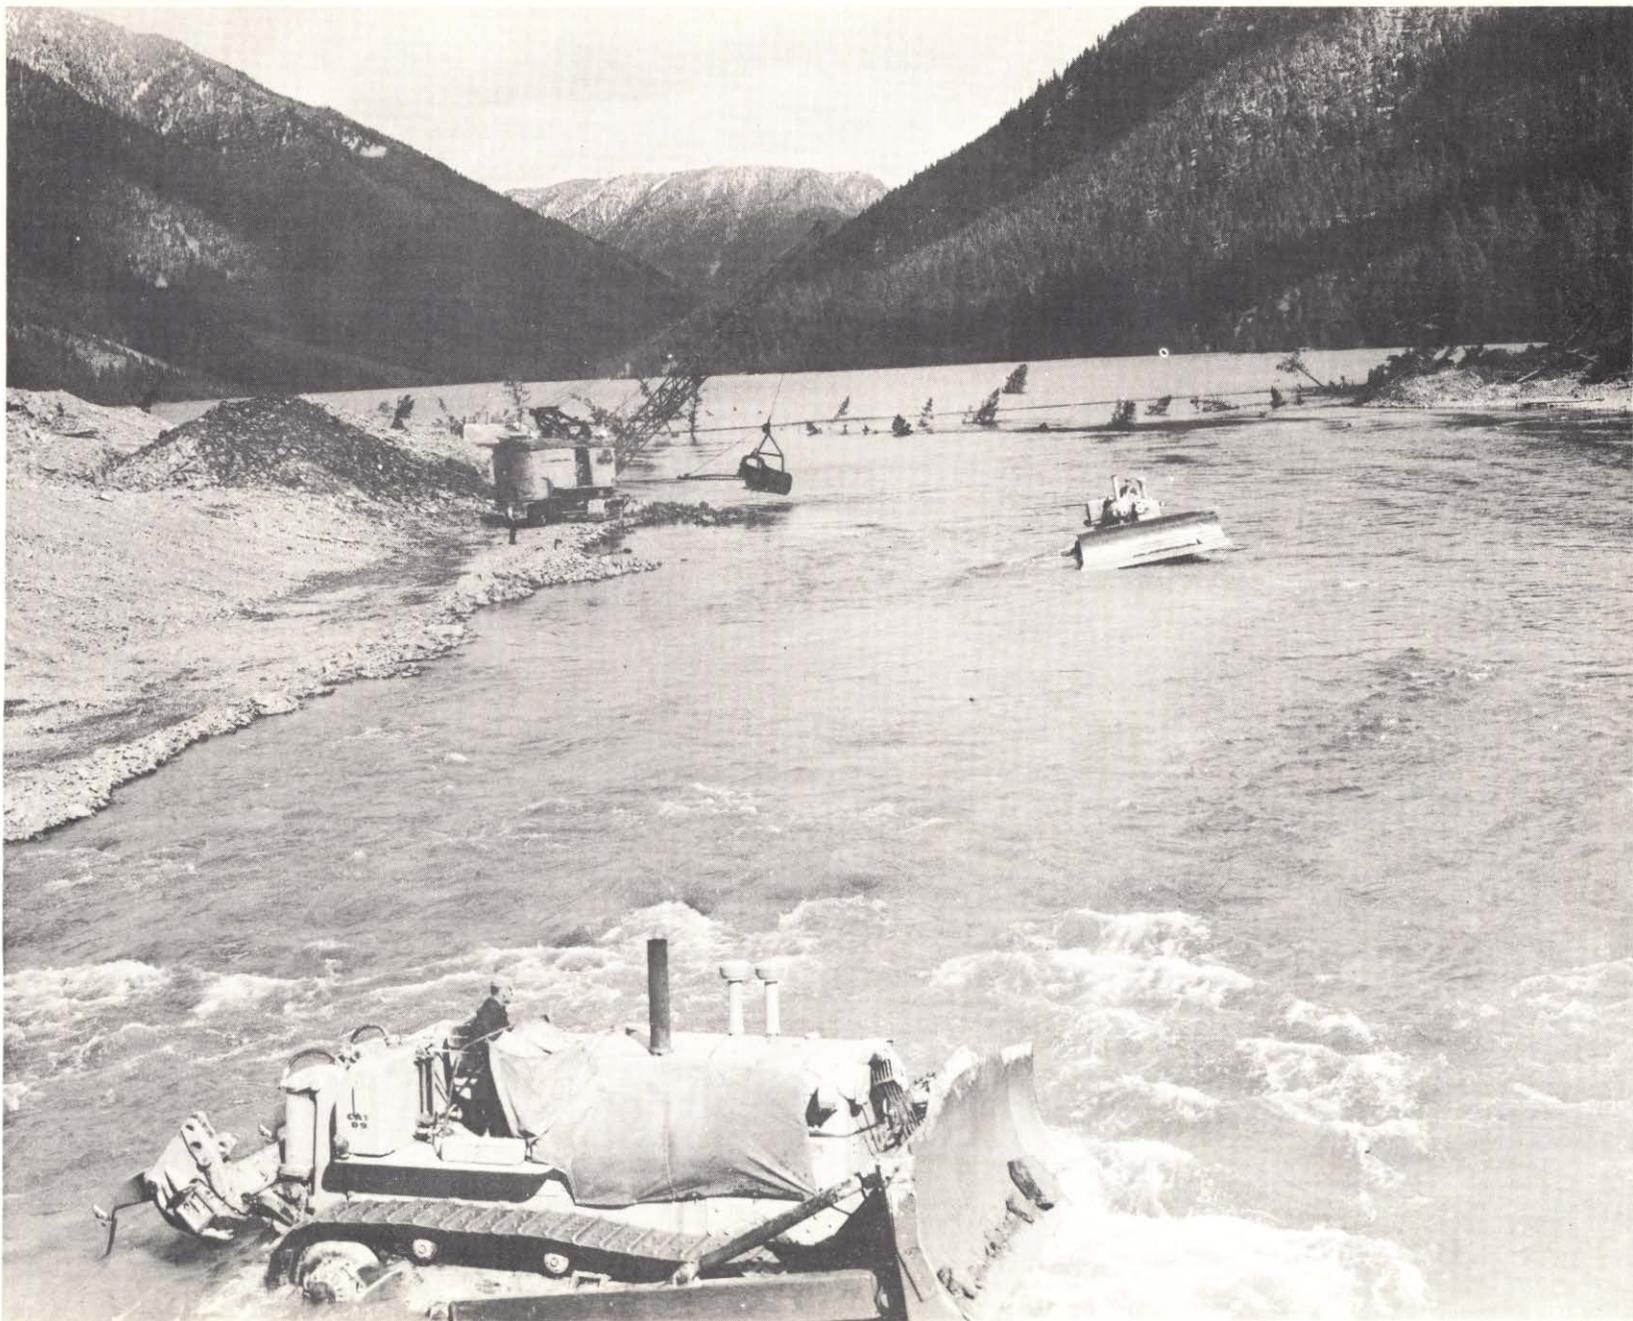
Photo 15. 29 September 1959. Starting to lower the spillway channel near the outlet of Earthquake Lake.

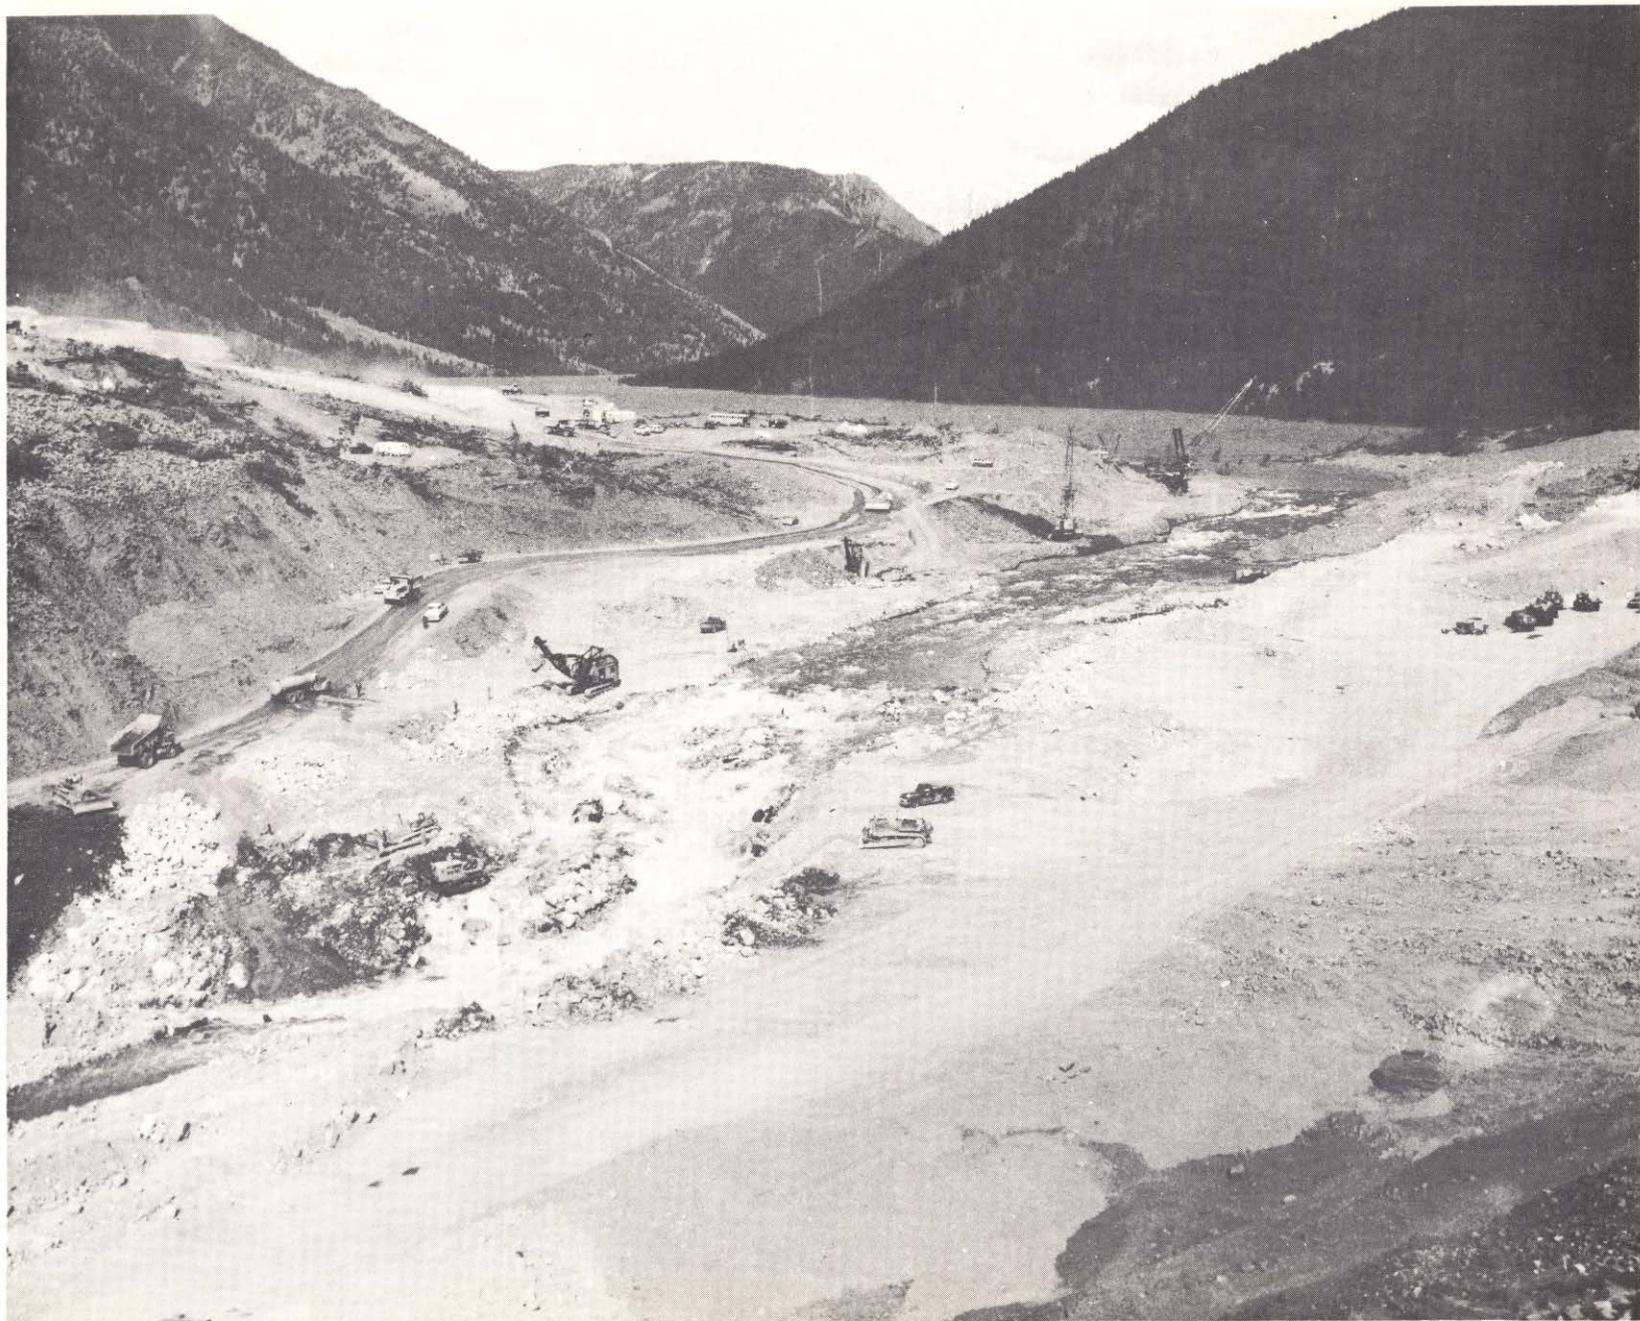
Photo 16. 5 October 1959. General view of spillway lowering operation. Draglines are working in channel and shovels are maintaining a work berm.

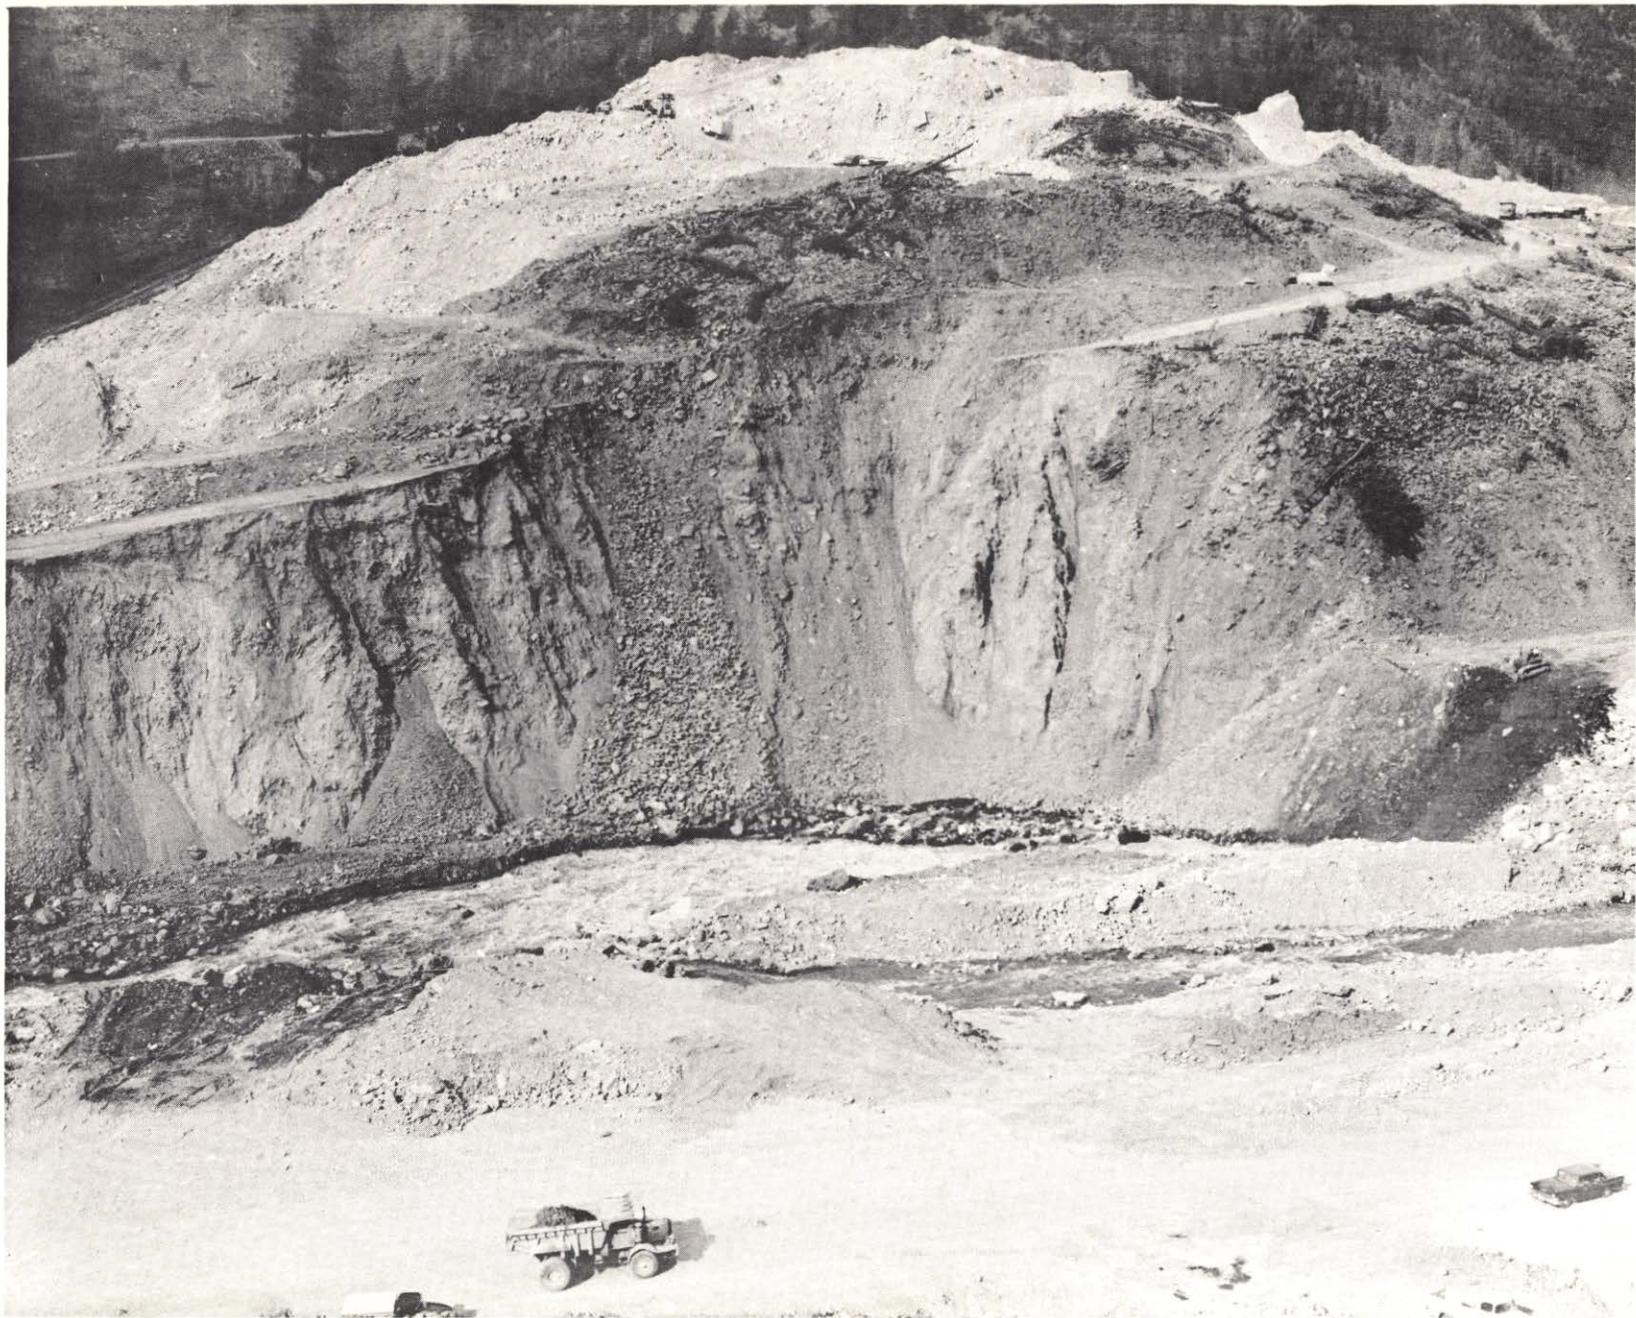
Photo 17. 5 October 1959. Rapid erosion of right bank between Stations 11+00 and 15+00.

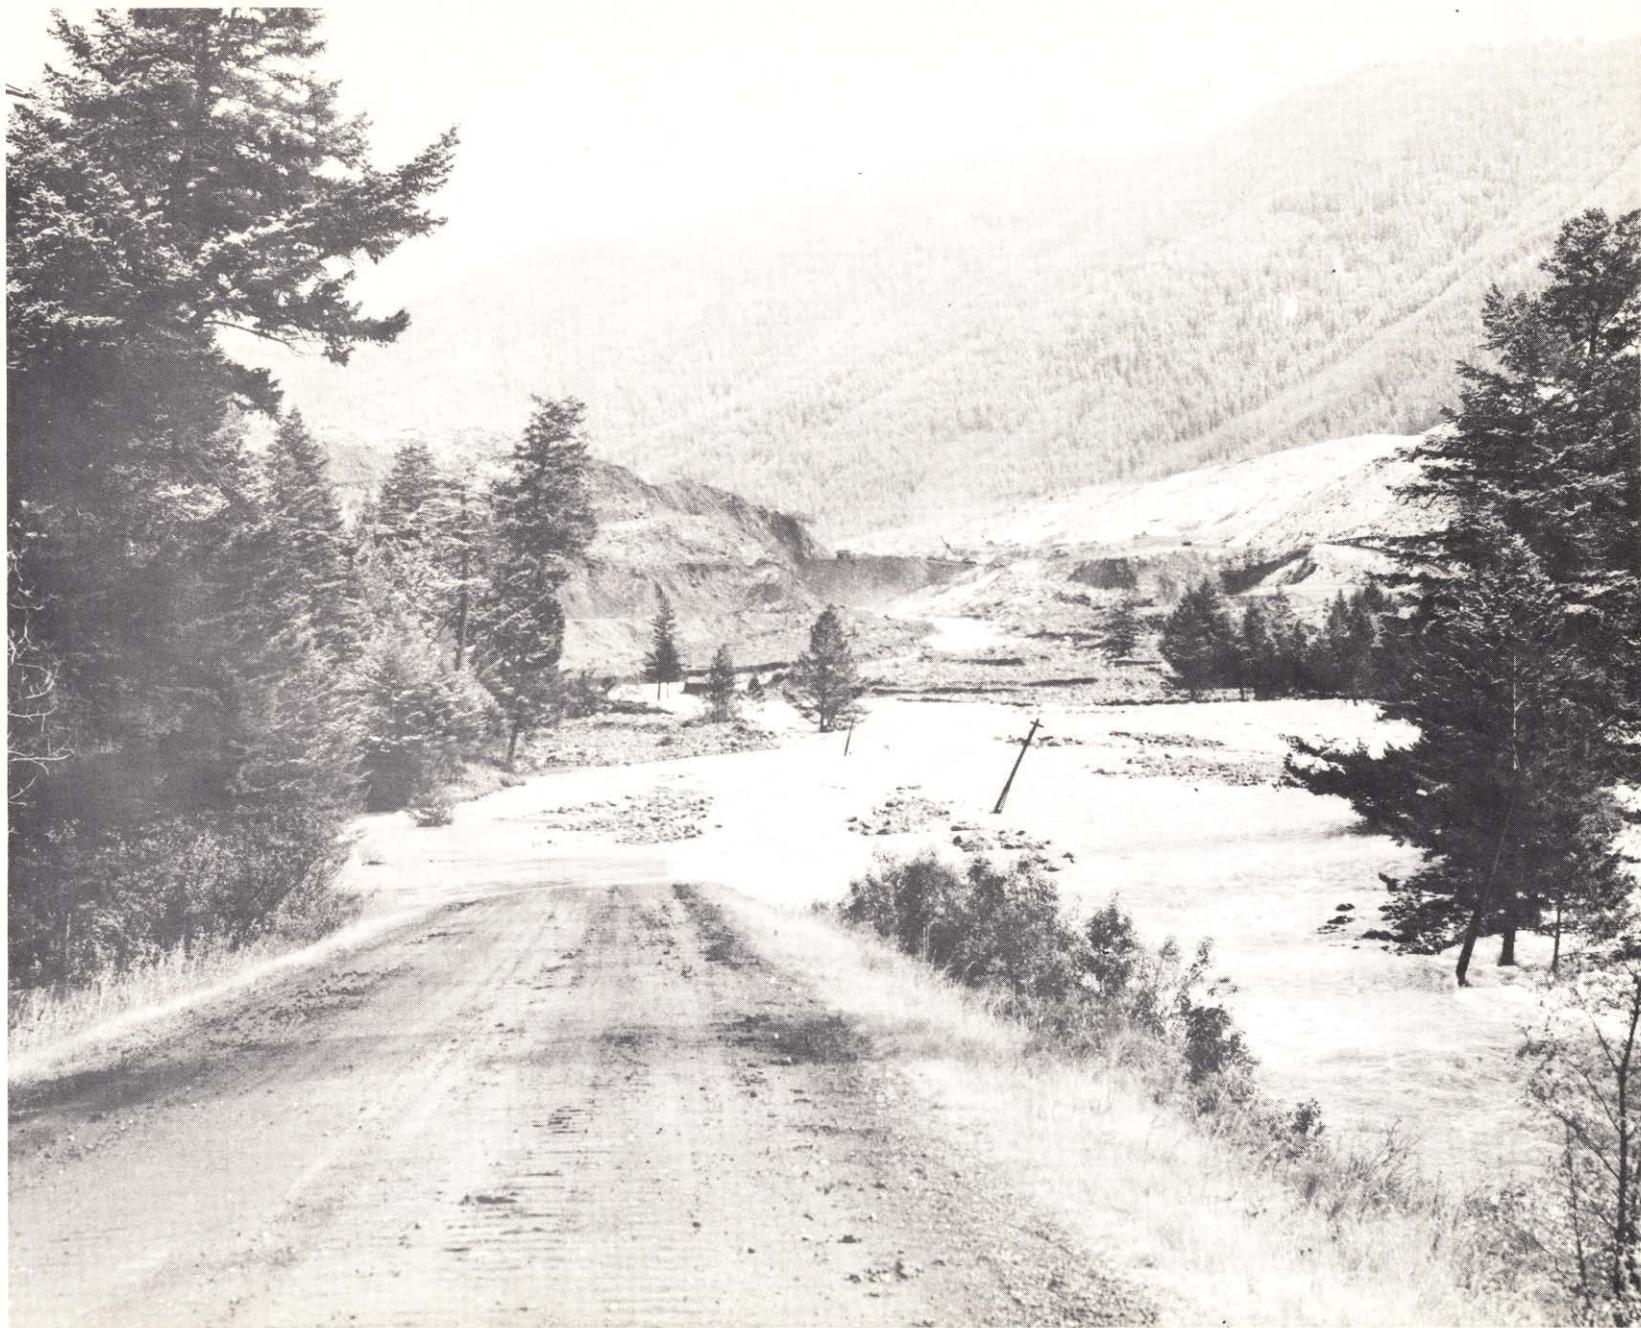
Photo 18. 7 October 1959. First in a series of three photographs showing rapid development of the fan below the slide.

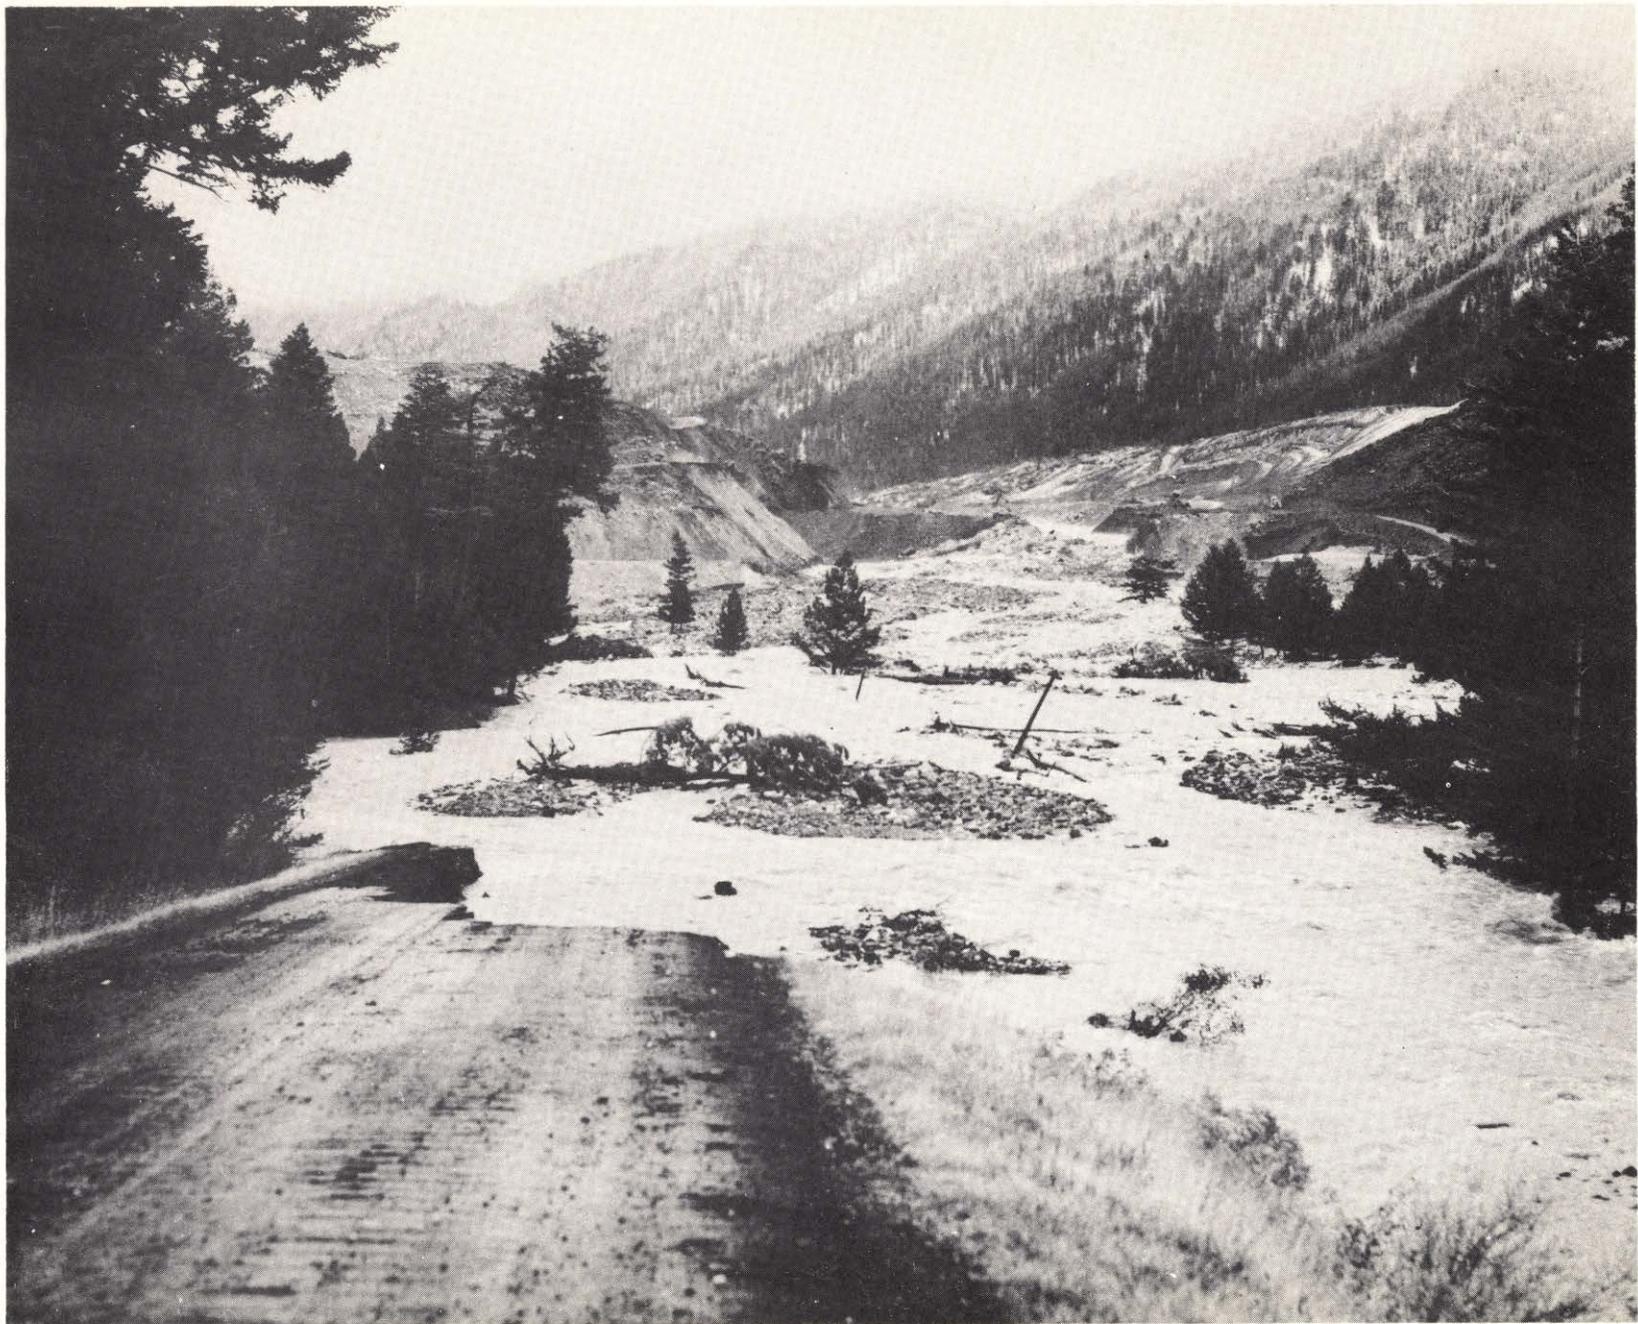
Photo 19. 9 October 1959. View showing rapid development of fan and damage to access road.

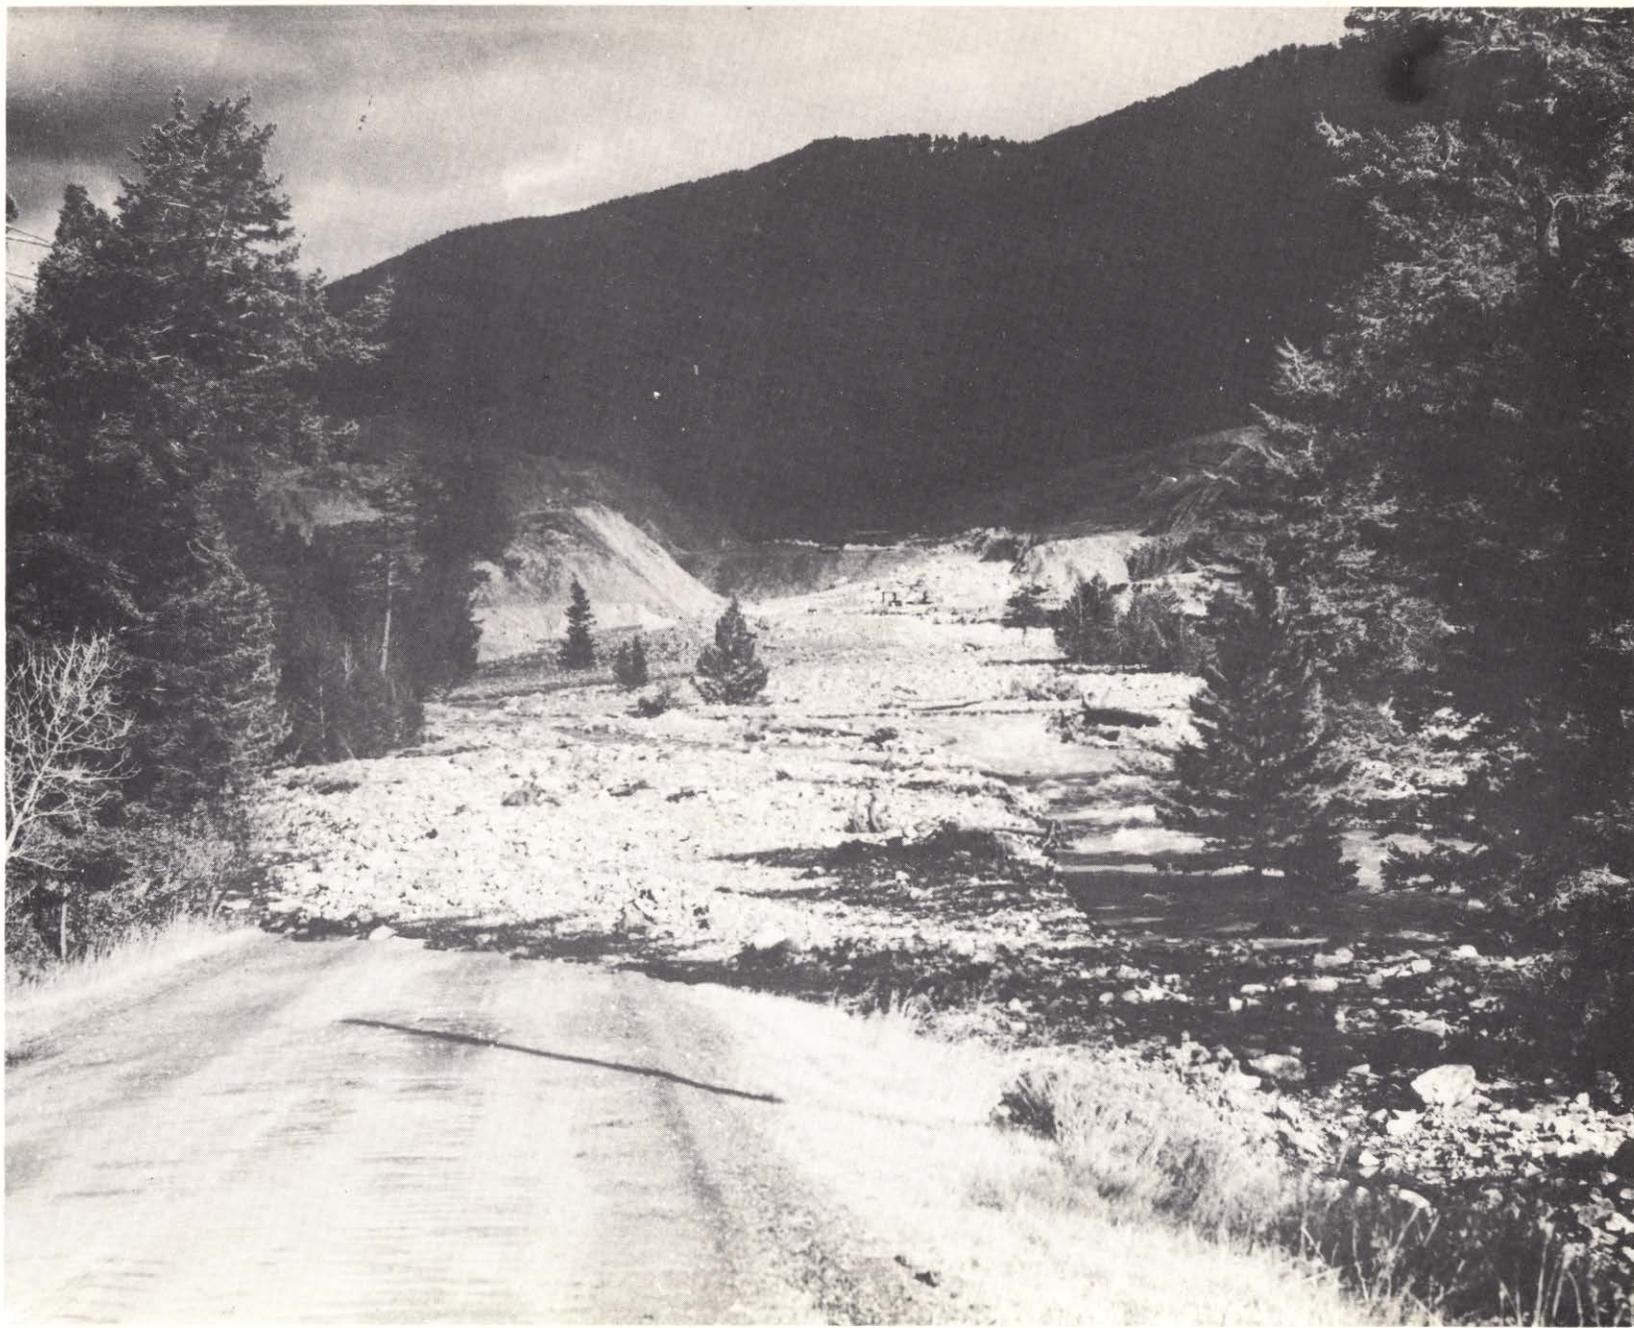
Photo 20. 11 October 1959. View showing rapid development of fan.
