MADISON RIVER, MONTANA
REPORT ON
*FLOOD EMERGENCY
MADISON RIVER SLIDE*

*VOLUME I
MAIN REPORT*

U. S. ARMY ENGINEER DISTRICT, OMAHA
CORPS OF ENGINEERS
OMAHA, NEBRASKA
SEPTEMBER 1960

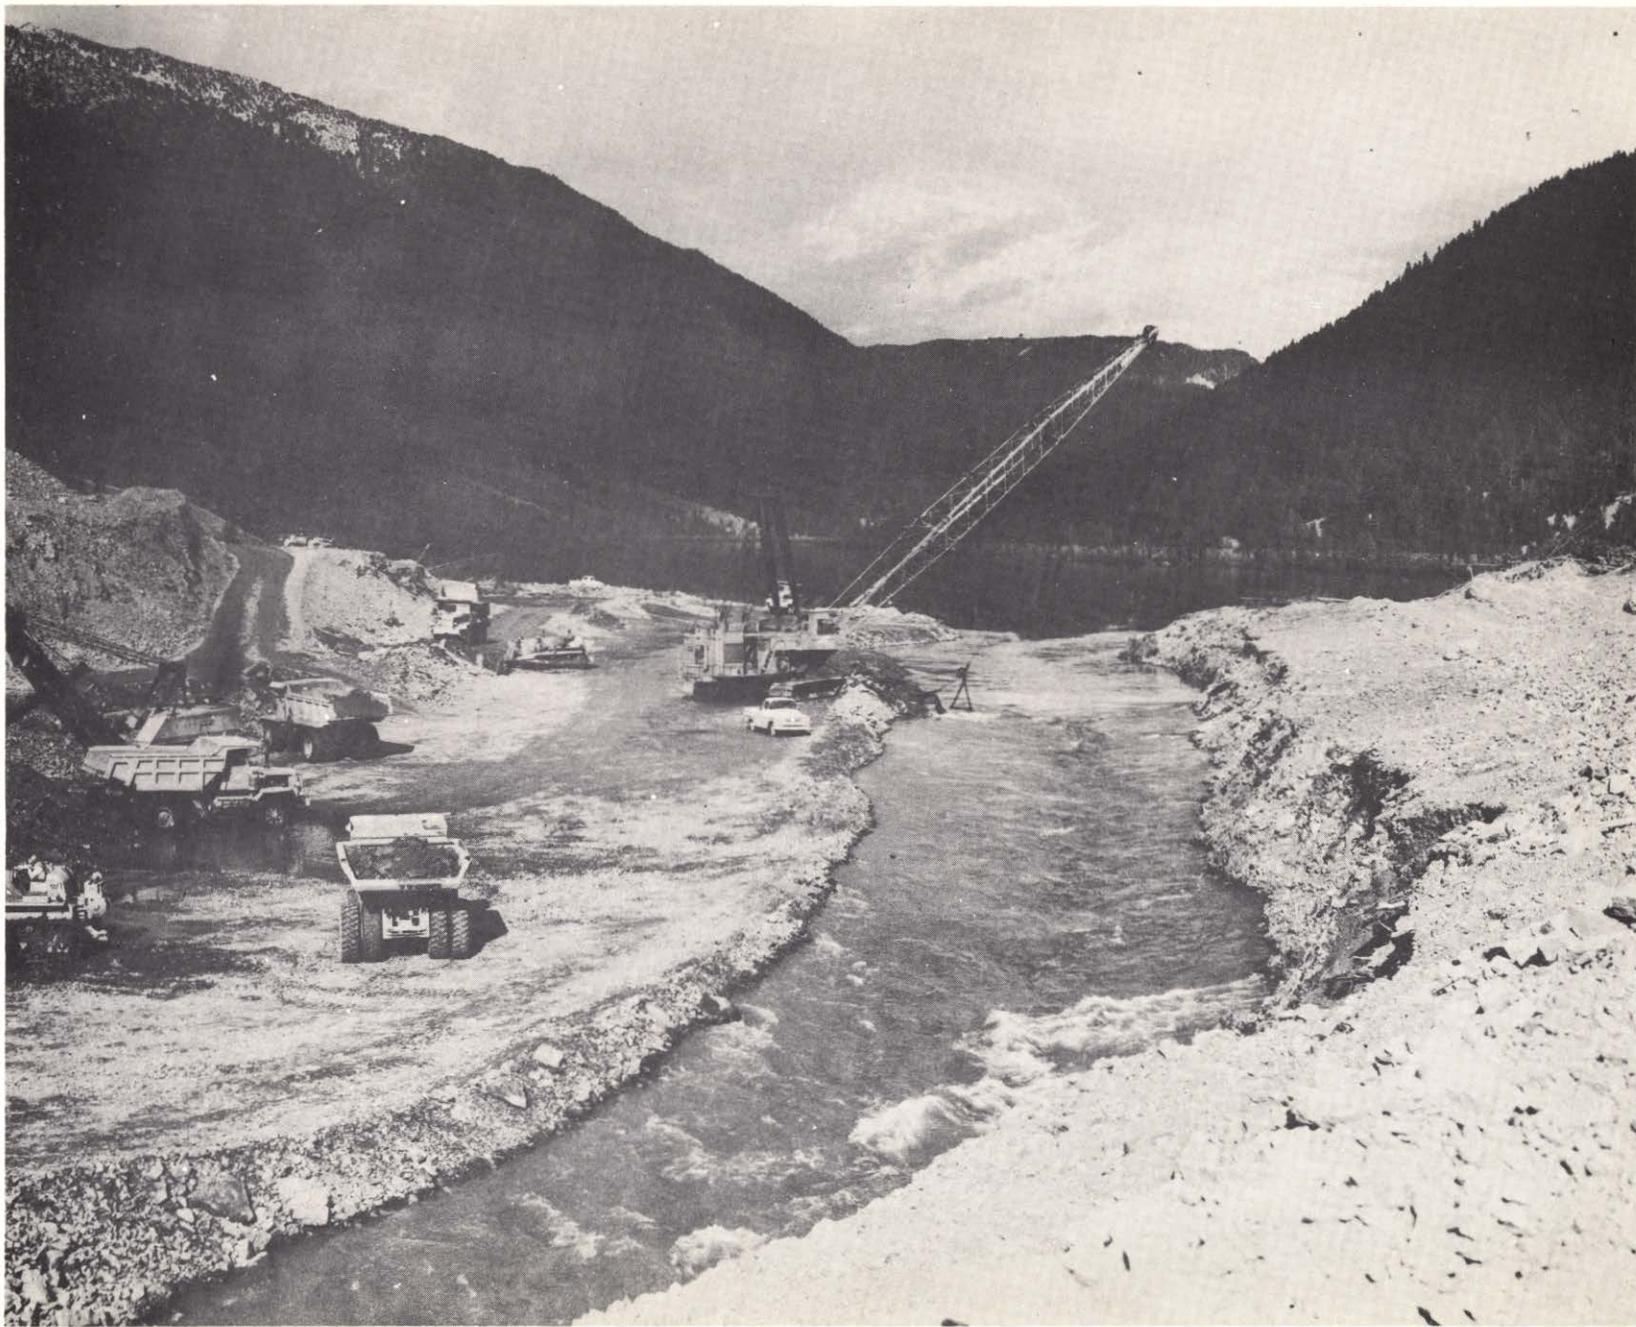
Photo 21. 11 October 1959. Large dragline lowering spillway channel near the outlet of Earthquake Lake.

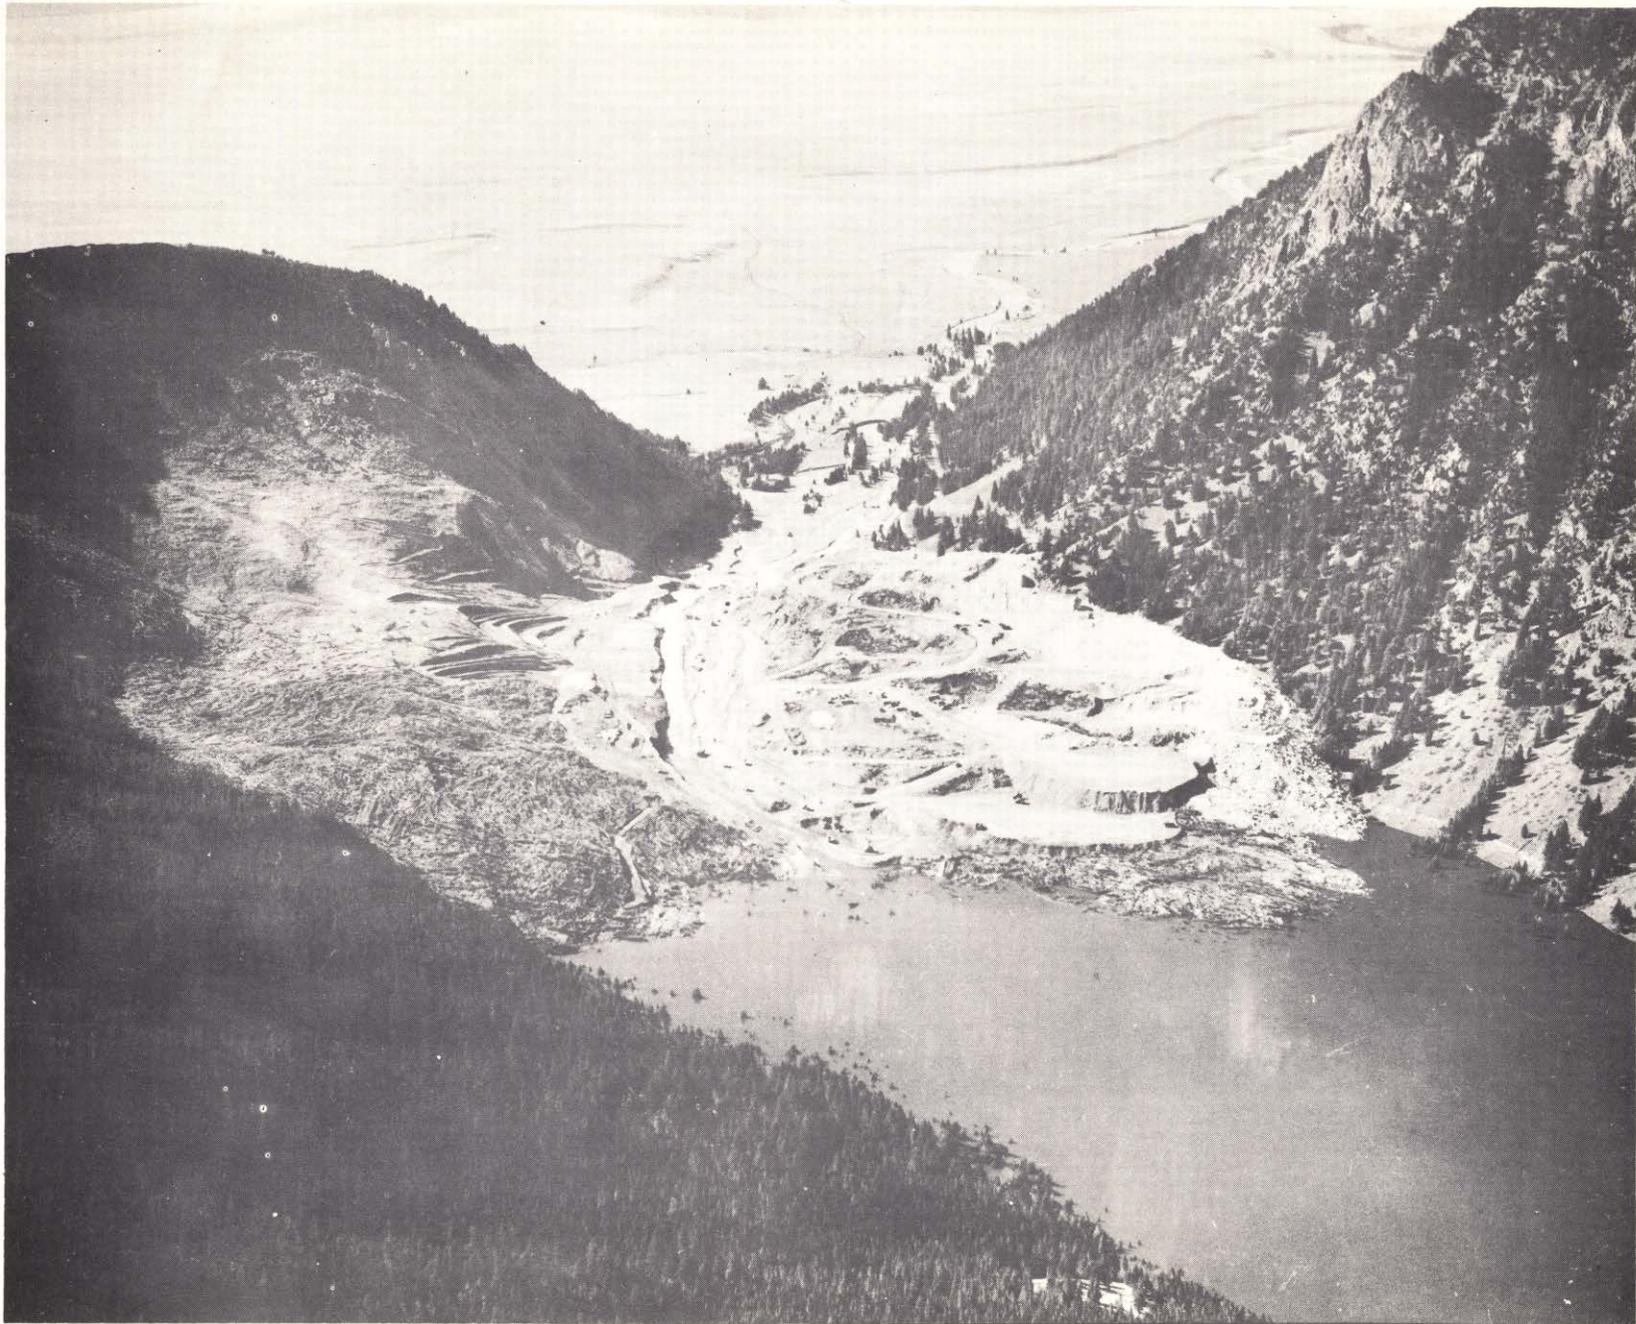
Photo 23. 17 October 1959. Aerial view of slide looking downstream.

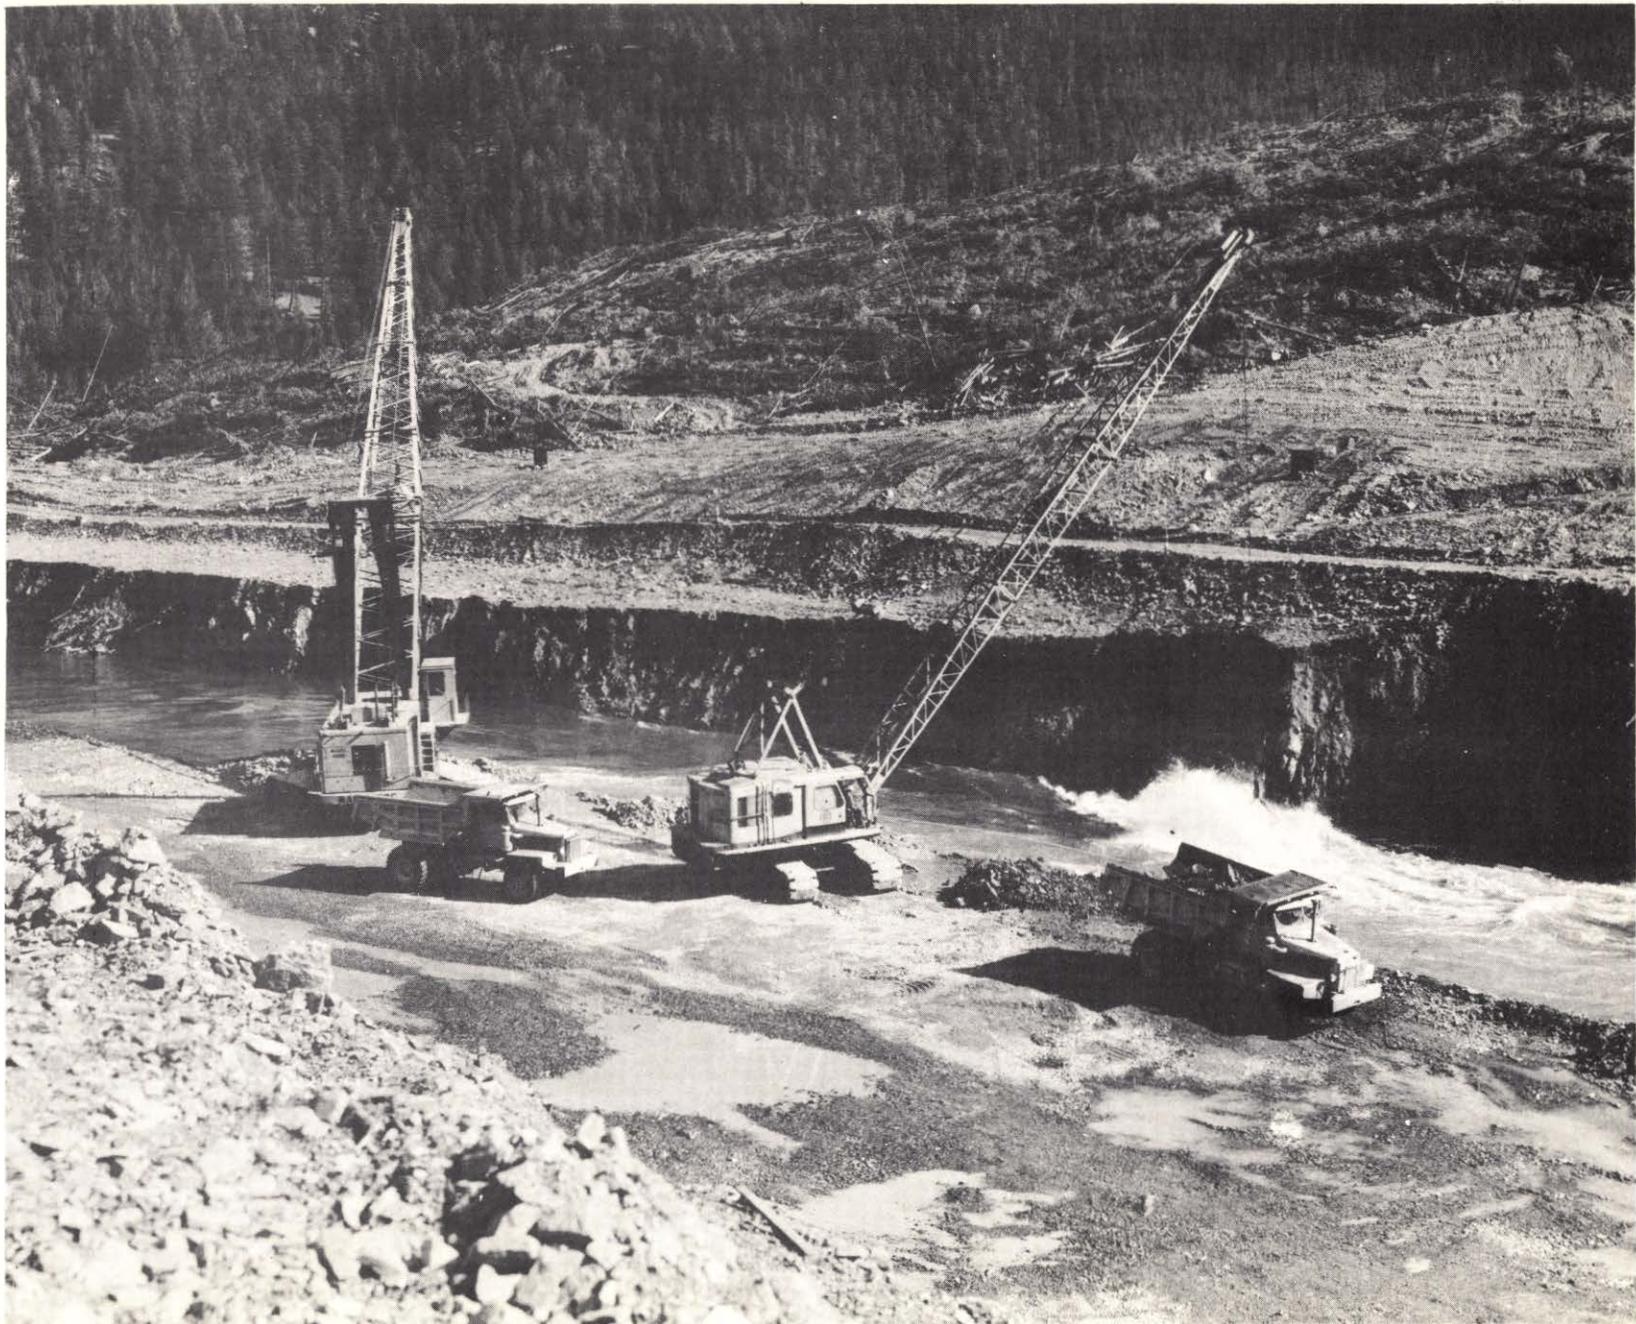
Photo 22. 14 October 1959. Draglines lowering spillway channel near Station 31+00.

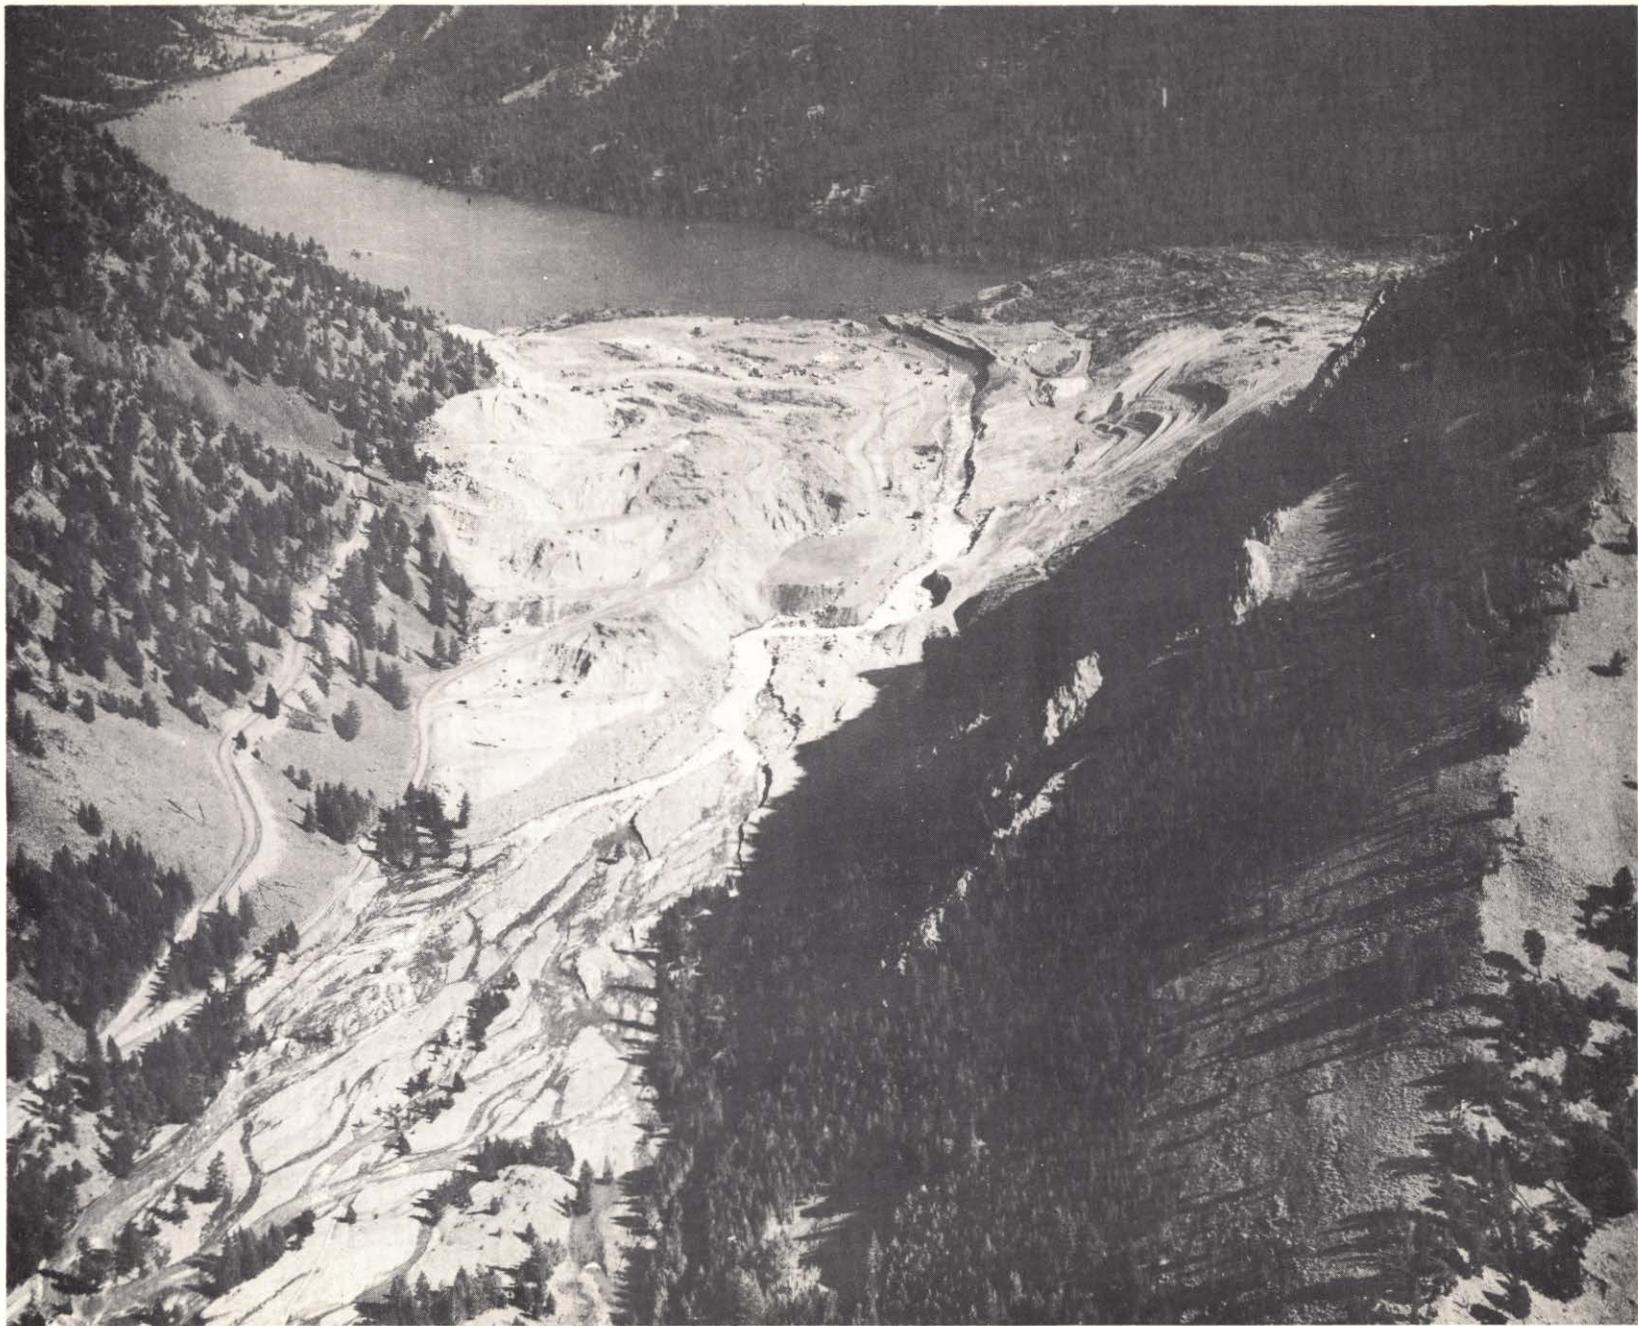
Photo 24. 17 October 1959. Aerial view of slide looking downstream showing spillway channel and buildup of fan below the slide.

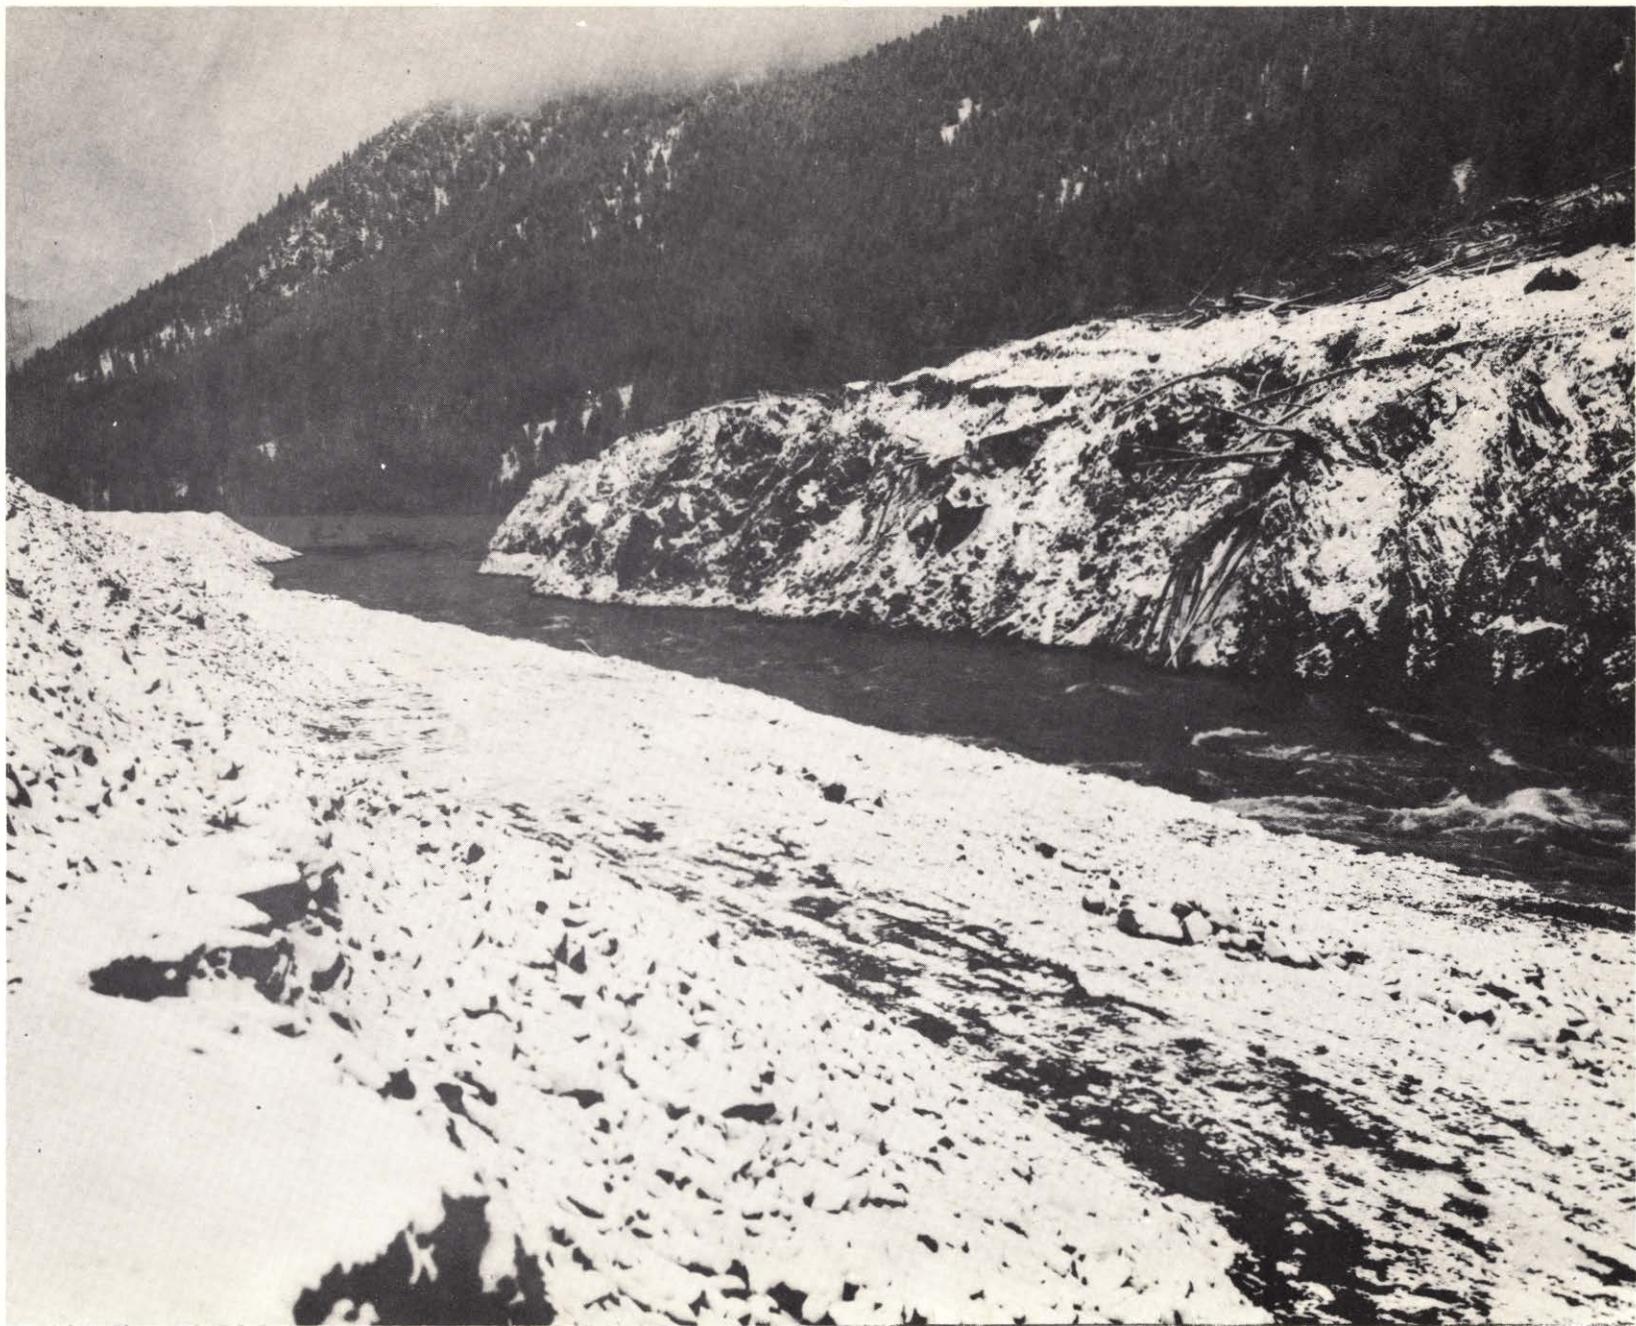
Photo 25. 29 October 1959. Completed spillway entrance looking upstream from about Station 30+00. Note high water line on trees about 50 feet above Earthquake Lake.

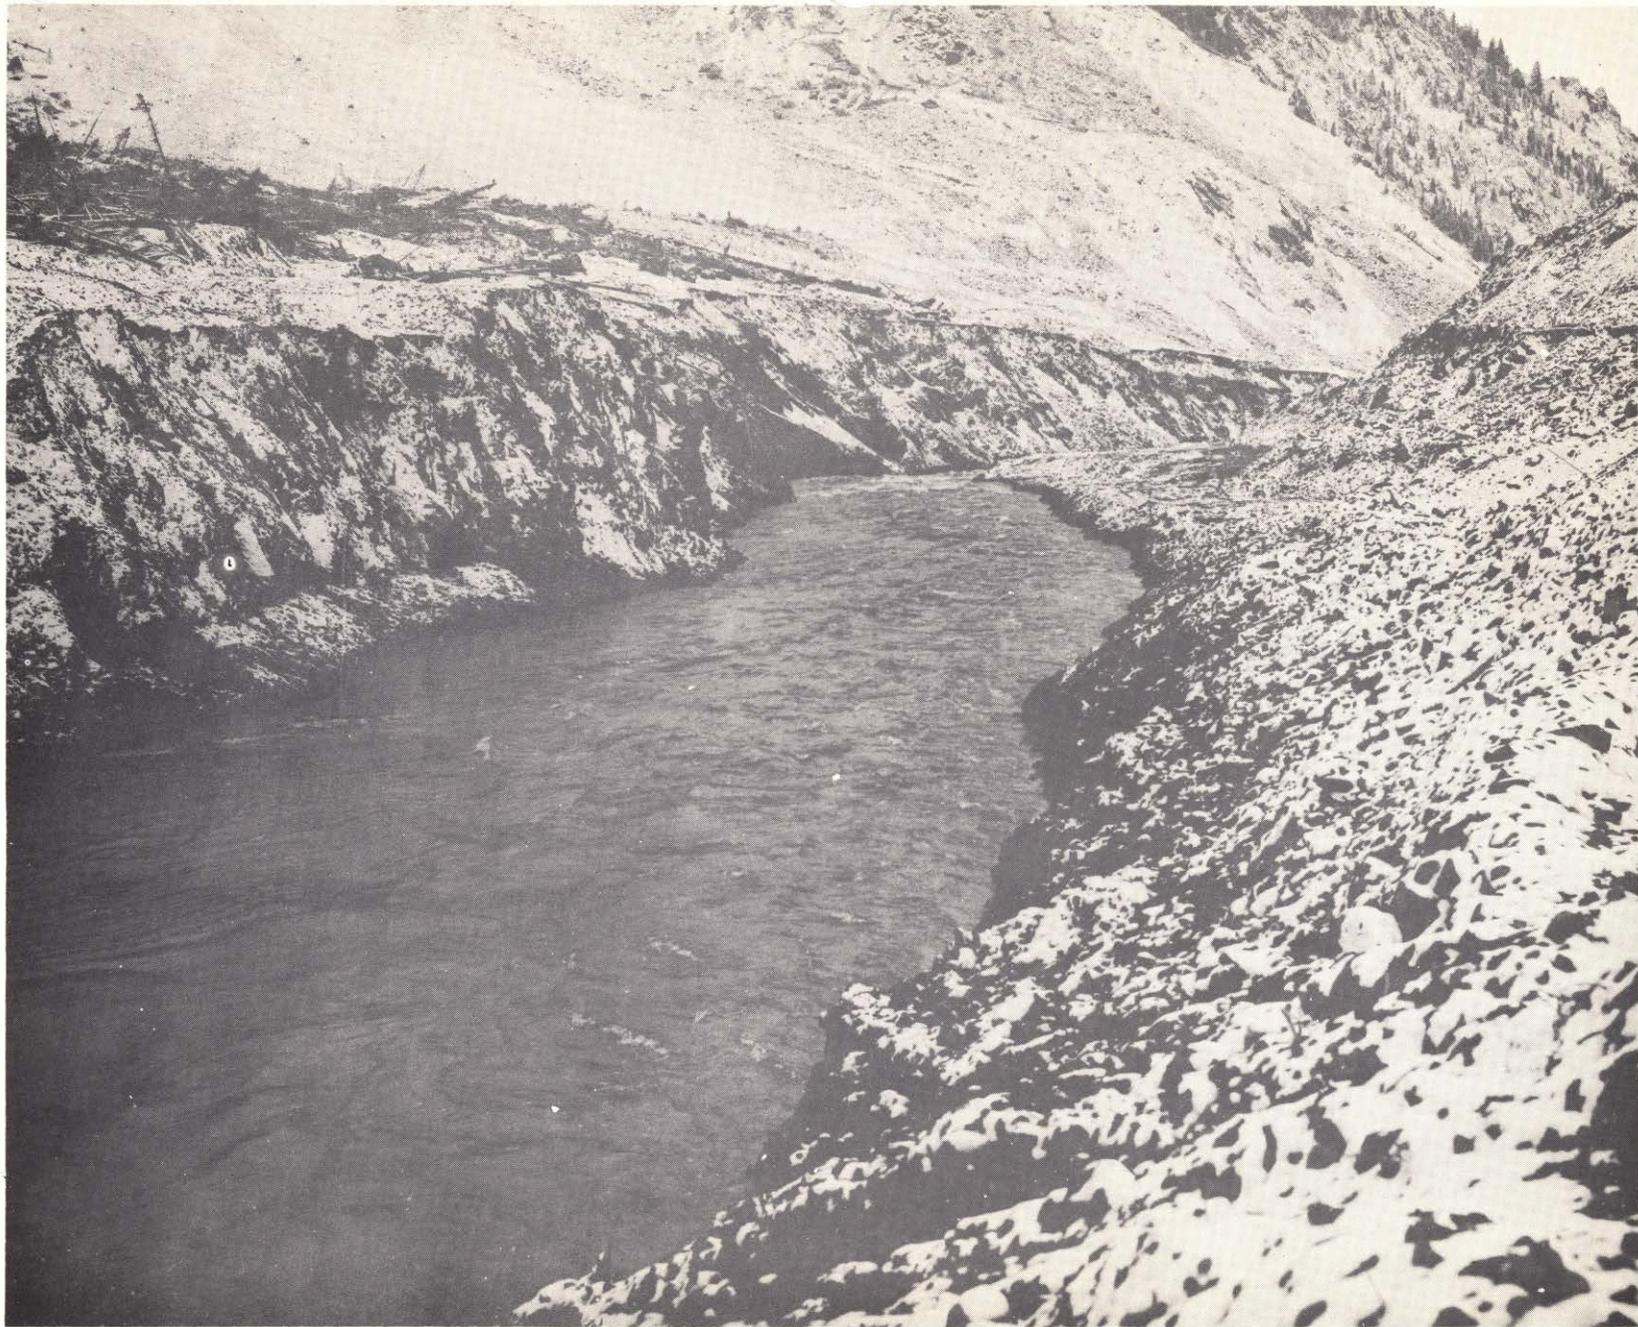
Photo 26. 29 October 1959. Completed spillway looking downstream from about Station 30+00.

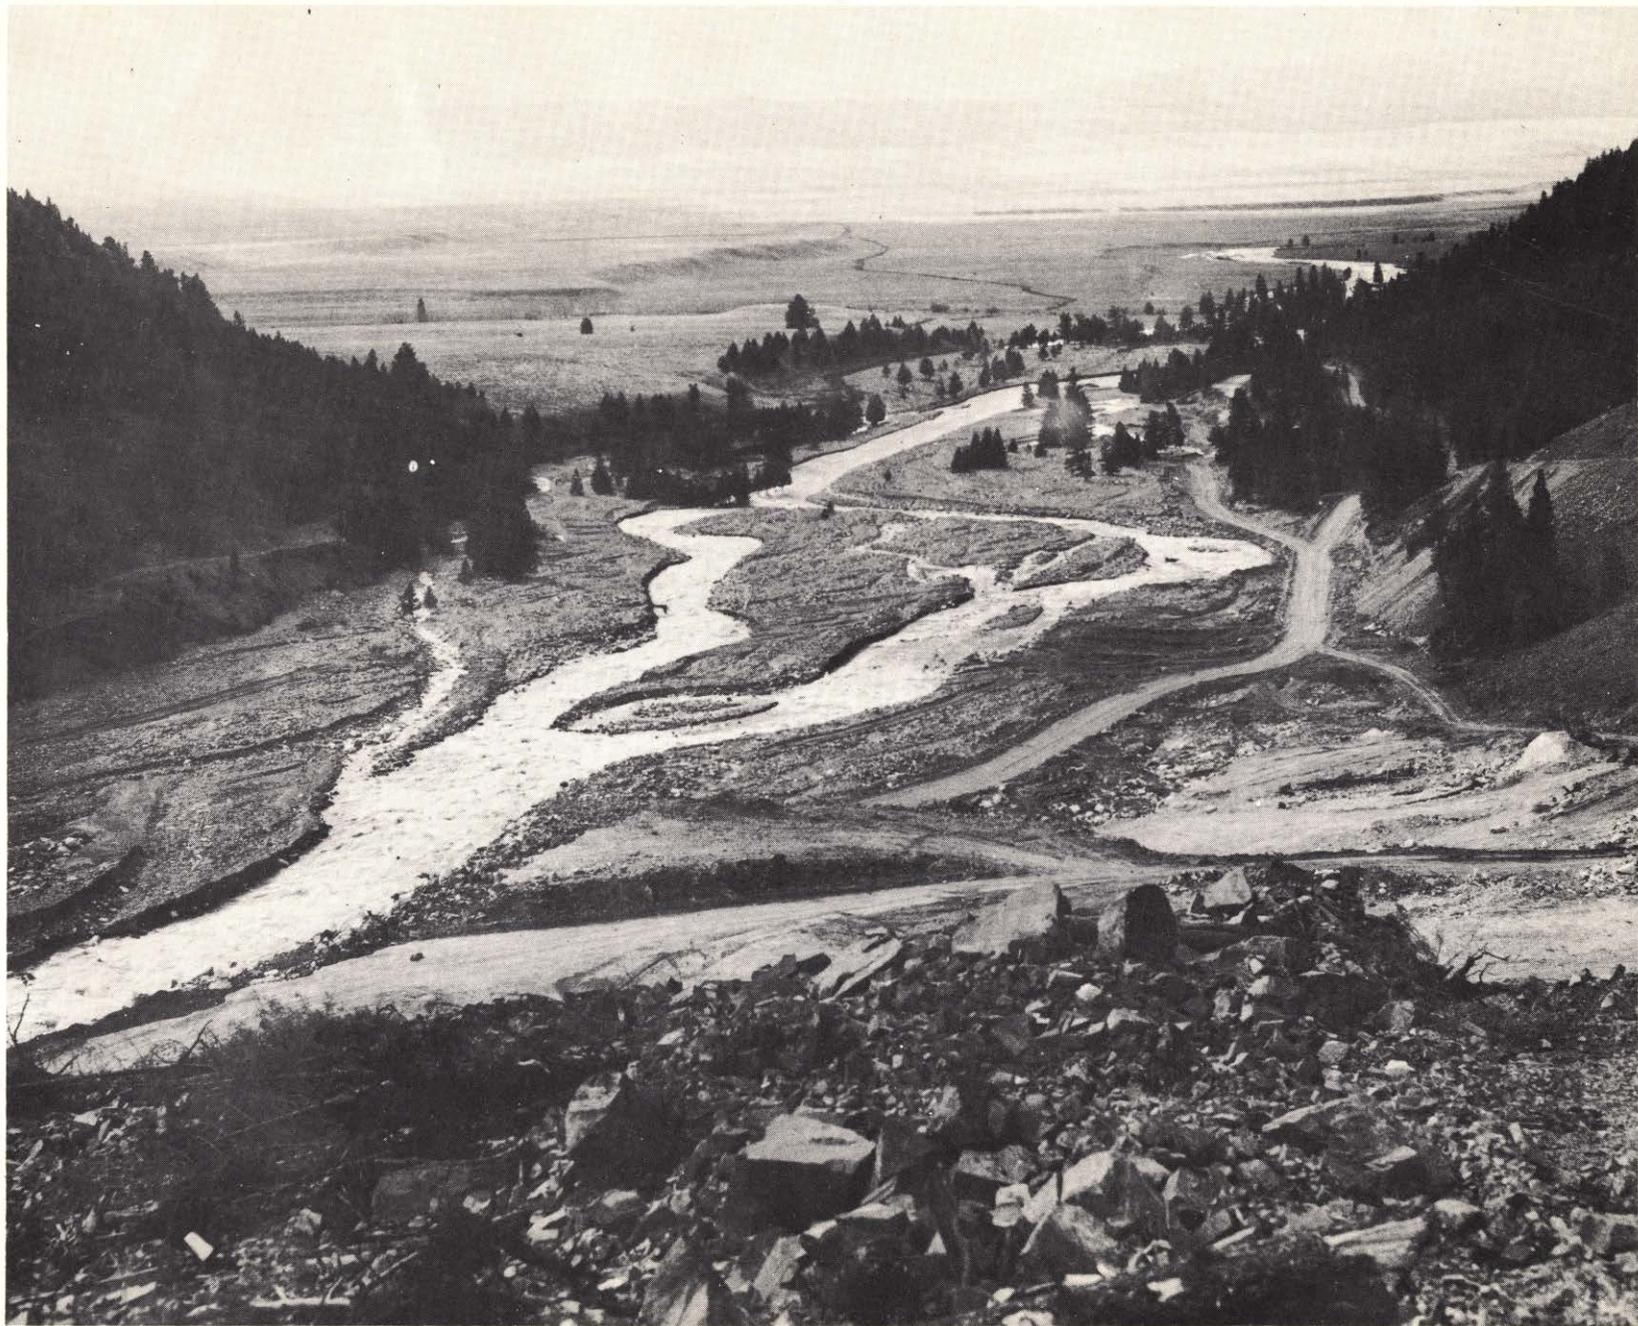
Photo 27. 28 October 1959. View of fan at lower end of slide at end of construction period (for earlier view, see Photo 2).

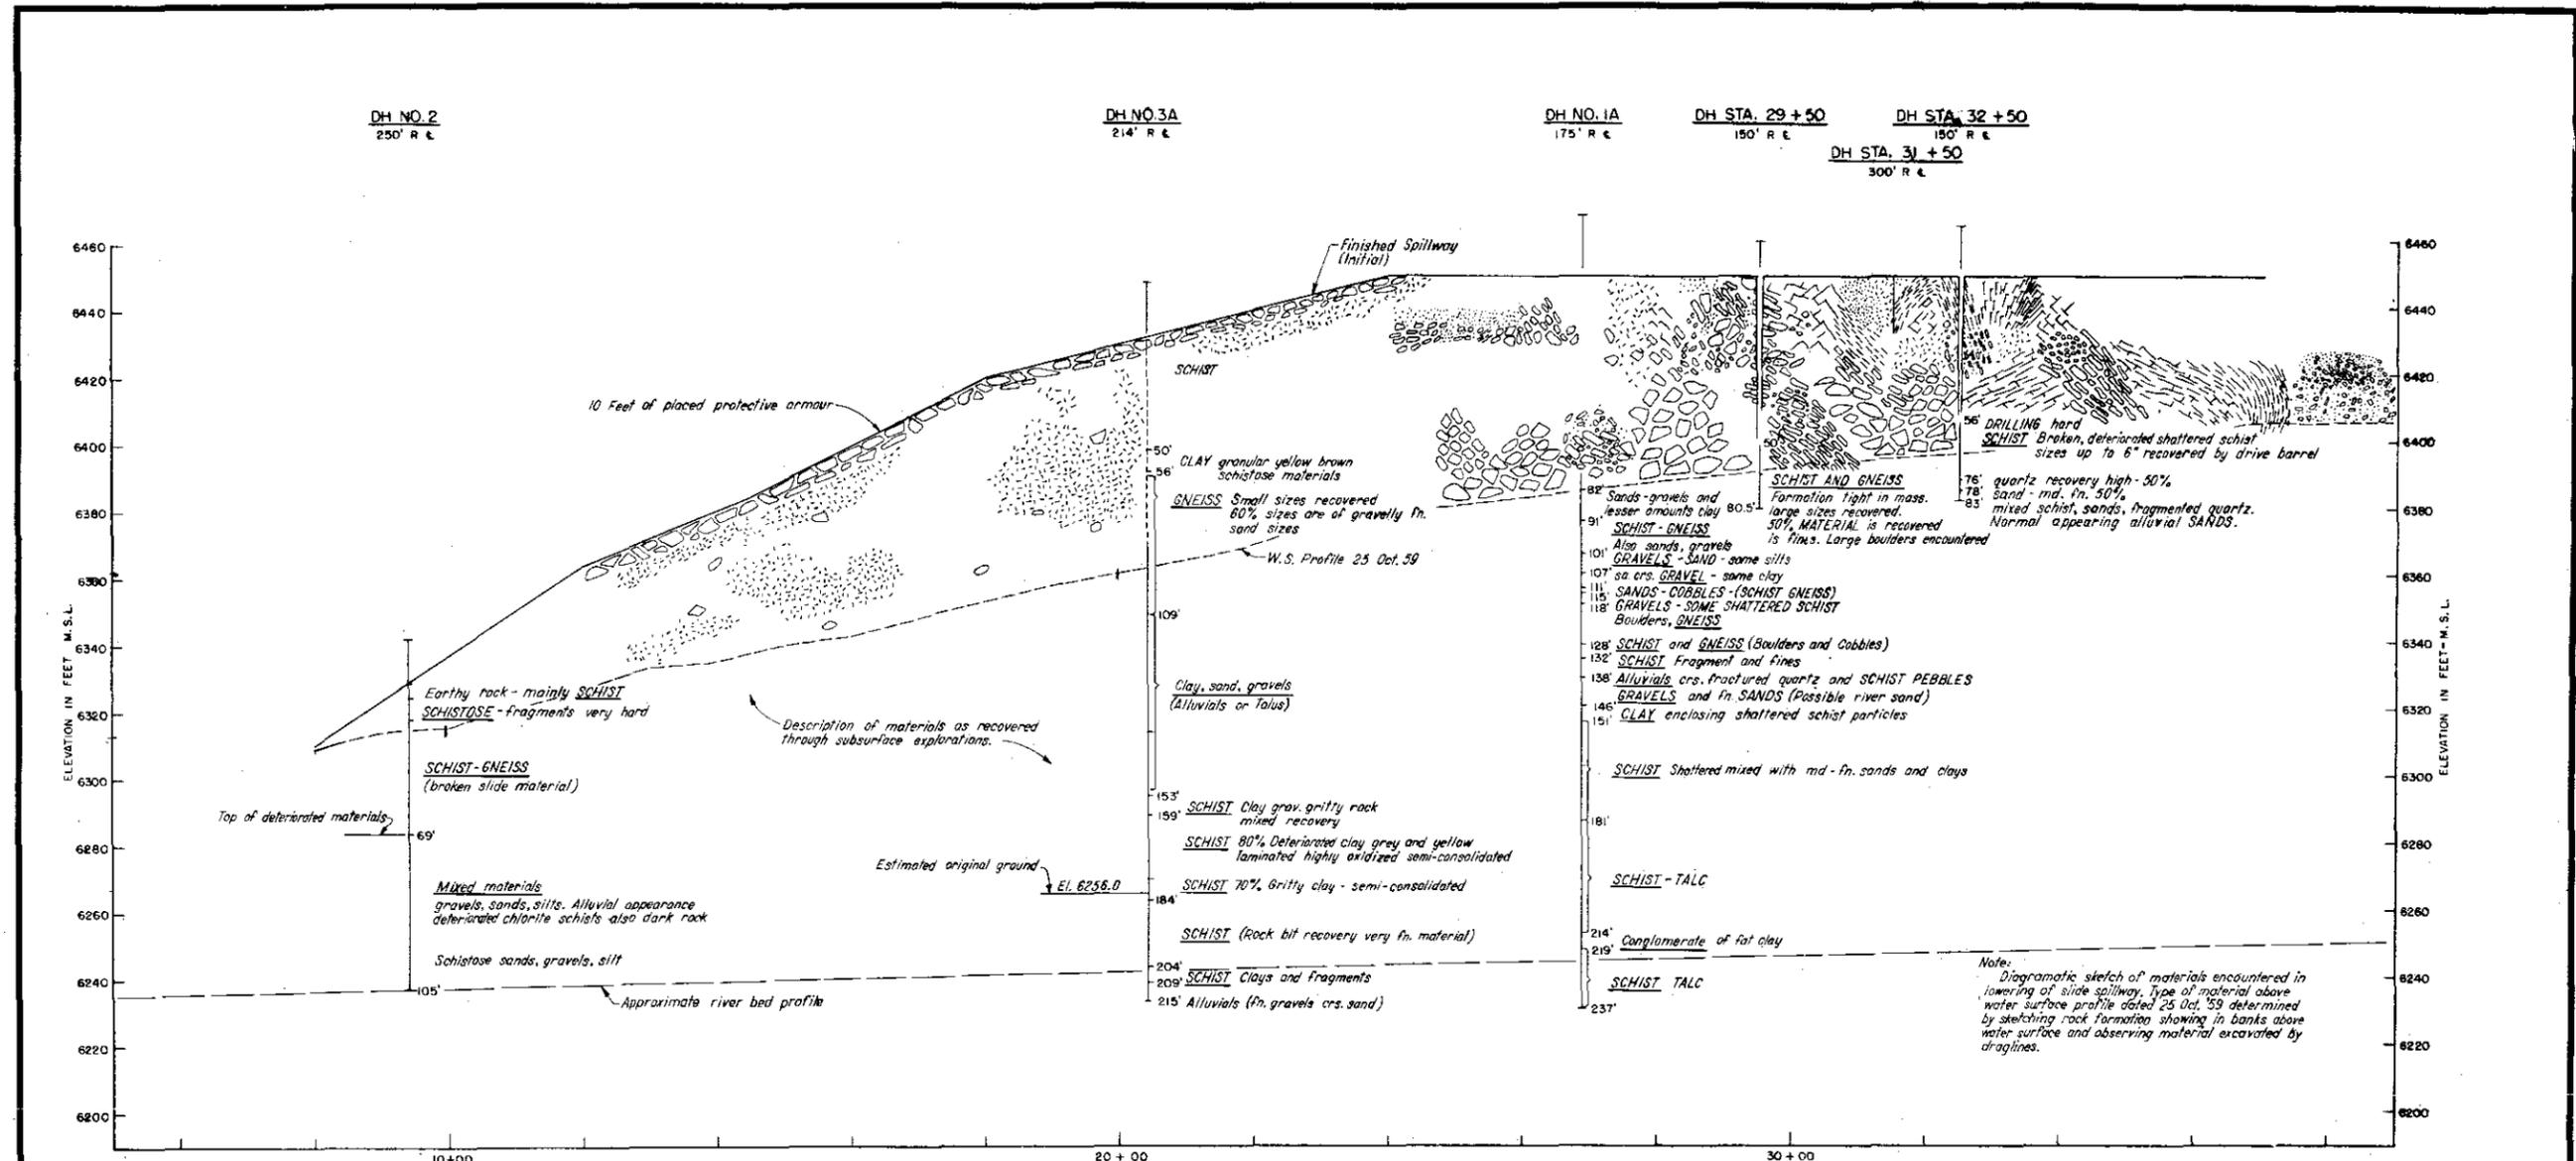
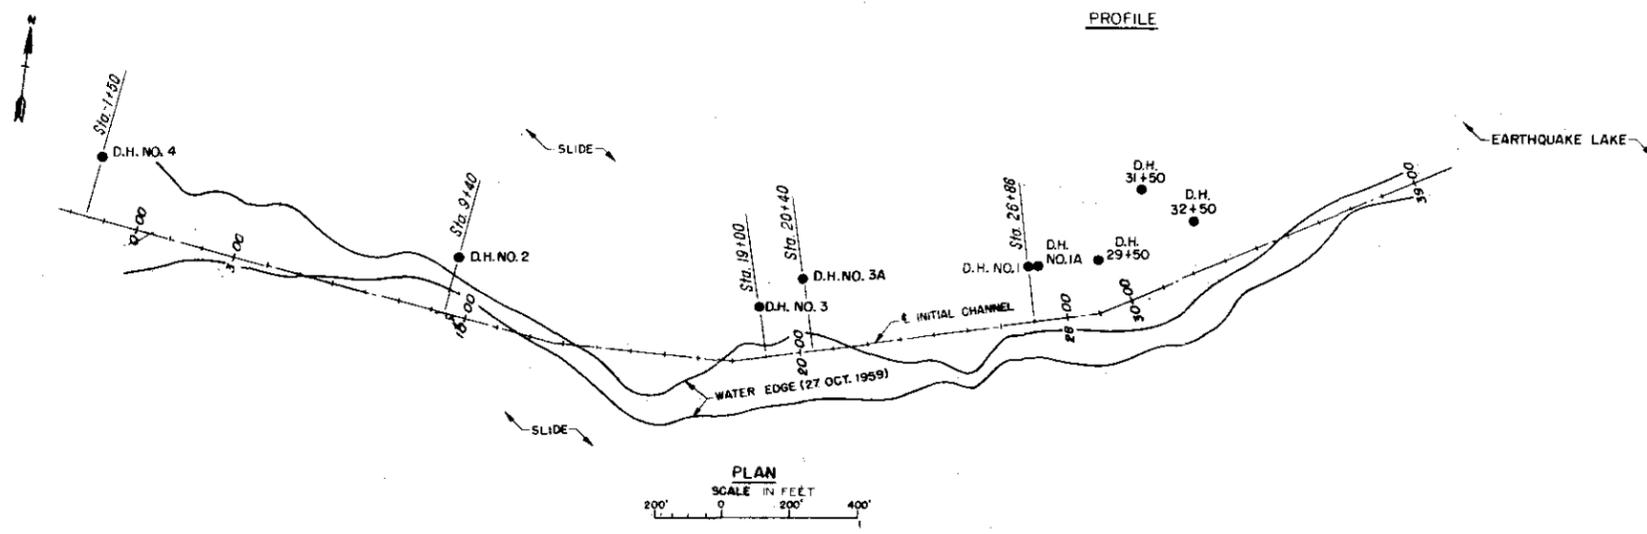
MADISON RIVER, MONTANA
 FLOOD EMERGENCY
 MADISON RIVER SLIDE
 MATERIALS ENCOUNTERED IN
 SPILLWAY AND DRILL HOLES
 SEPT. 1960

Note: Diagrammatic sketch of materials encountered in lowering of slide spillway. Type of material above water surface profile dated 25 Oct. 59 determined by sketching rock formation showing in banks above water surface and observing material excavated by draglines.
