MADISON RIVER, MONTANA
REPORT ON
*FLOOD EMERGENCY
MADISON RIVER SLIDE*

*VOLUME II
APPENDIXES*

U. S. ARMY ENGINEER DISTRICT, OMAHA
CORPS OF ENGINEERS
OMAHA, NEBRASKA
SEPTEMBER 1960

PRELIMINARY STUDIES OF MADISON
CANYON SLIDE AND HEBGEN DAM

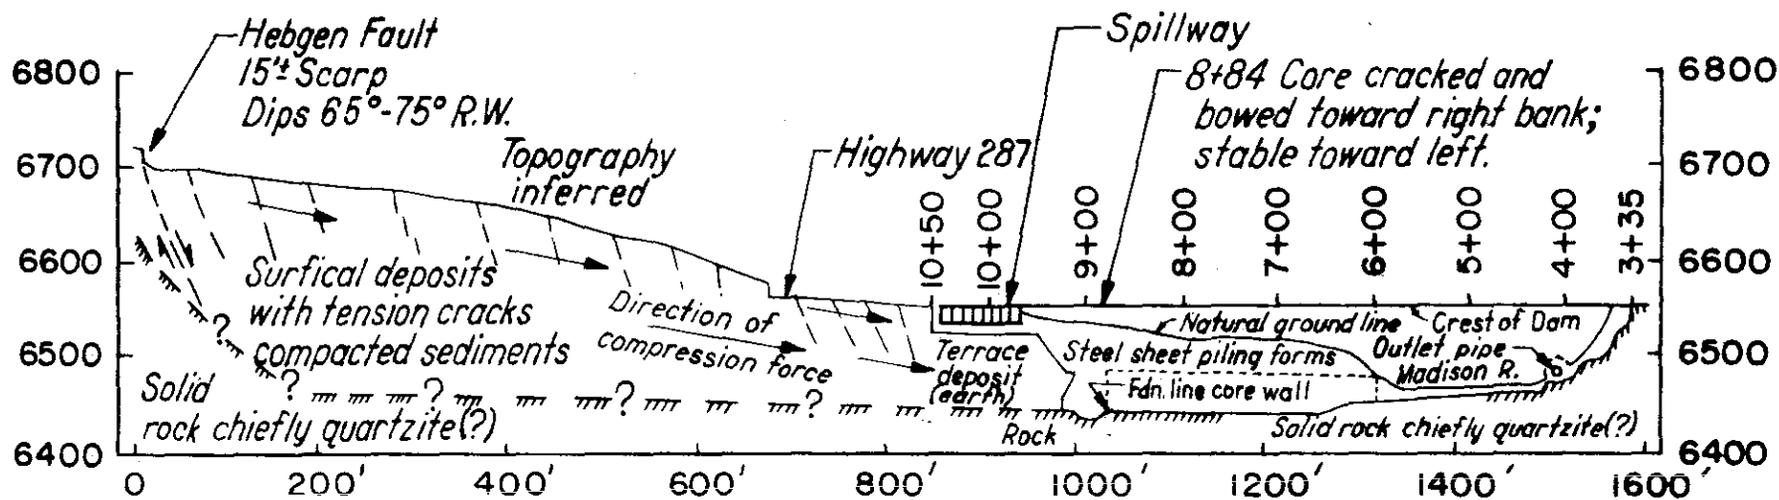
SECTION A-A

The weakest structural foundation of the dam underlies the spillway which is superimposed on a terrace deposit. The jolt moved the overburden and spillway structure horizontally and slightly vertically against the rigid core wall. The core wall at station 8 + 84 imposed rigid restraint against compression forces. The spillway and about 85 feet of the core wall broke; greatest damage was sustained by the spillway.

HEBGEN FAULT
AND EARTHQUAKE FORCES
THAT DAMAGED HEBGEN DAM
17 AUGUST 1959

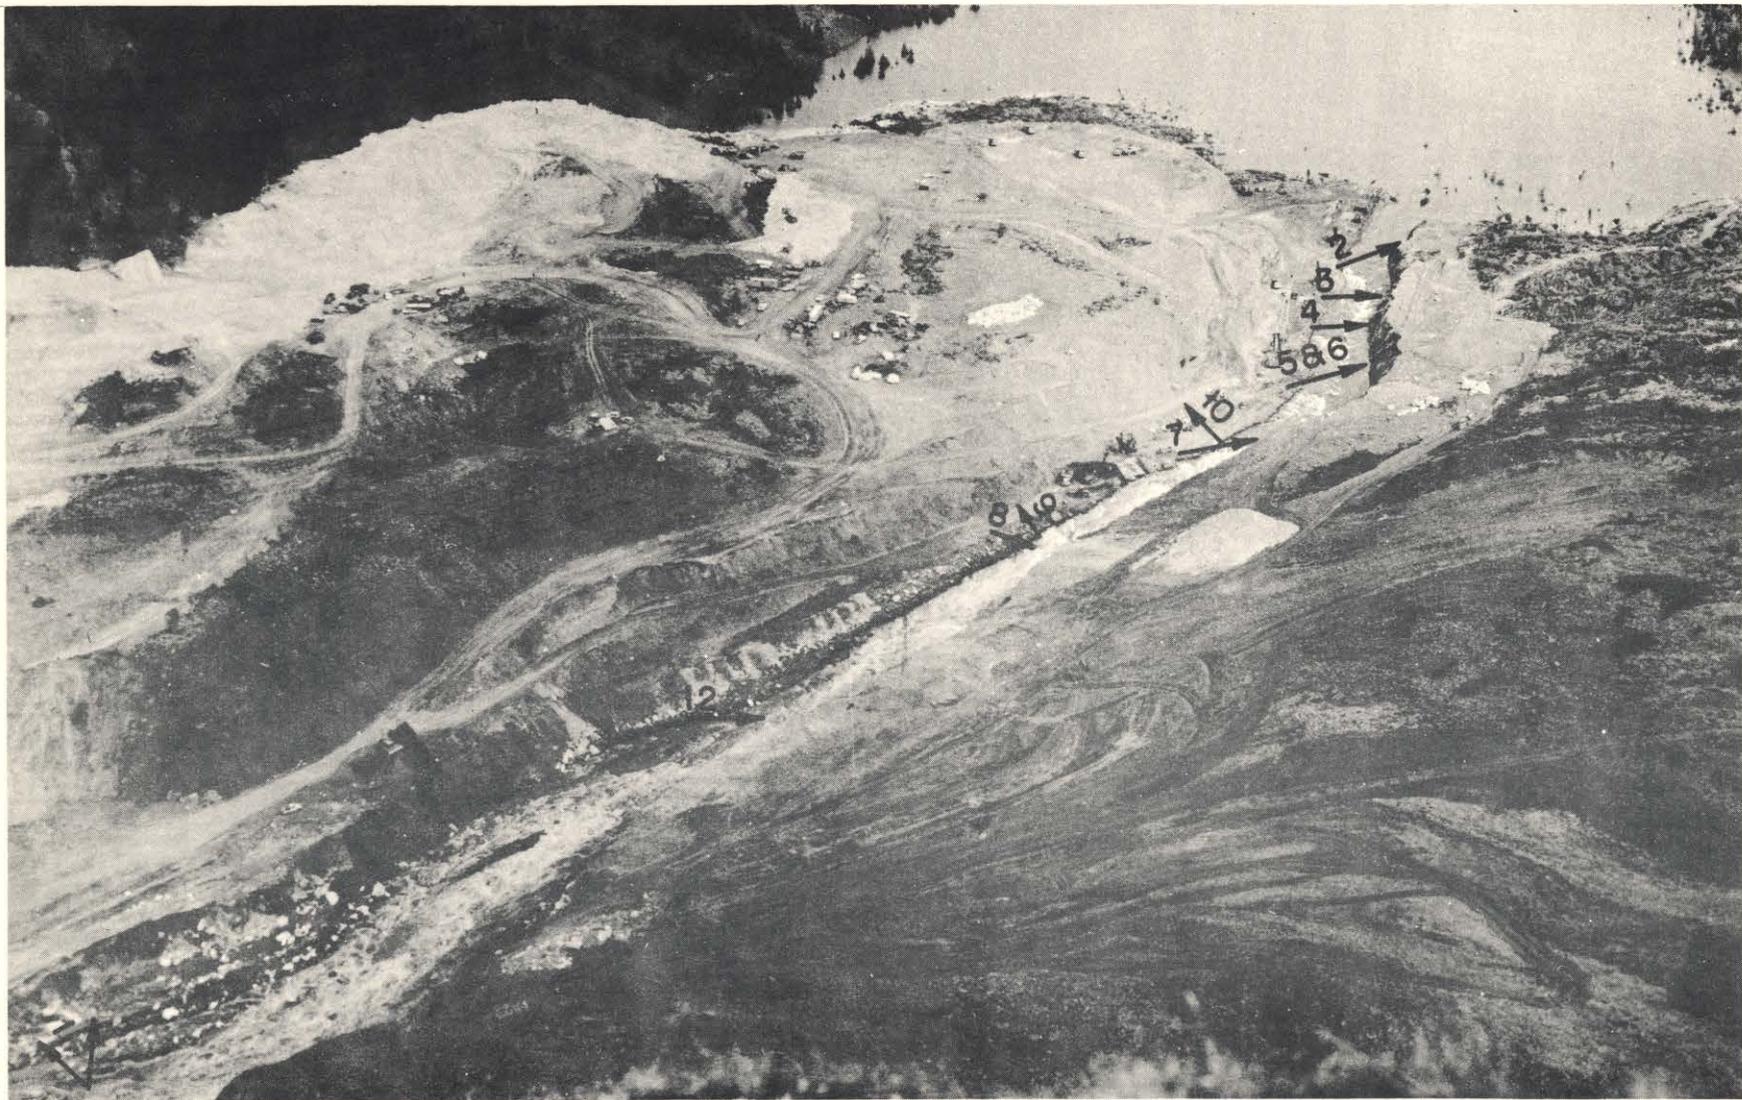
View of slide from station 12 upstream to earthquake lake taken 21 October 1959. Number and arrows indicate the area covered by photos on the following pages. (Photo #1)

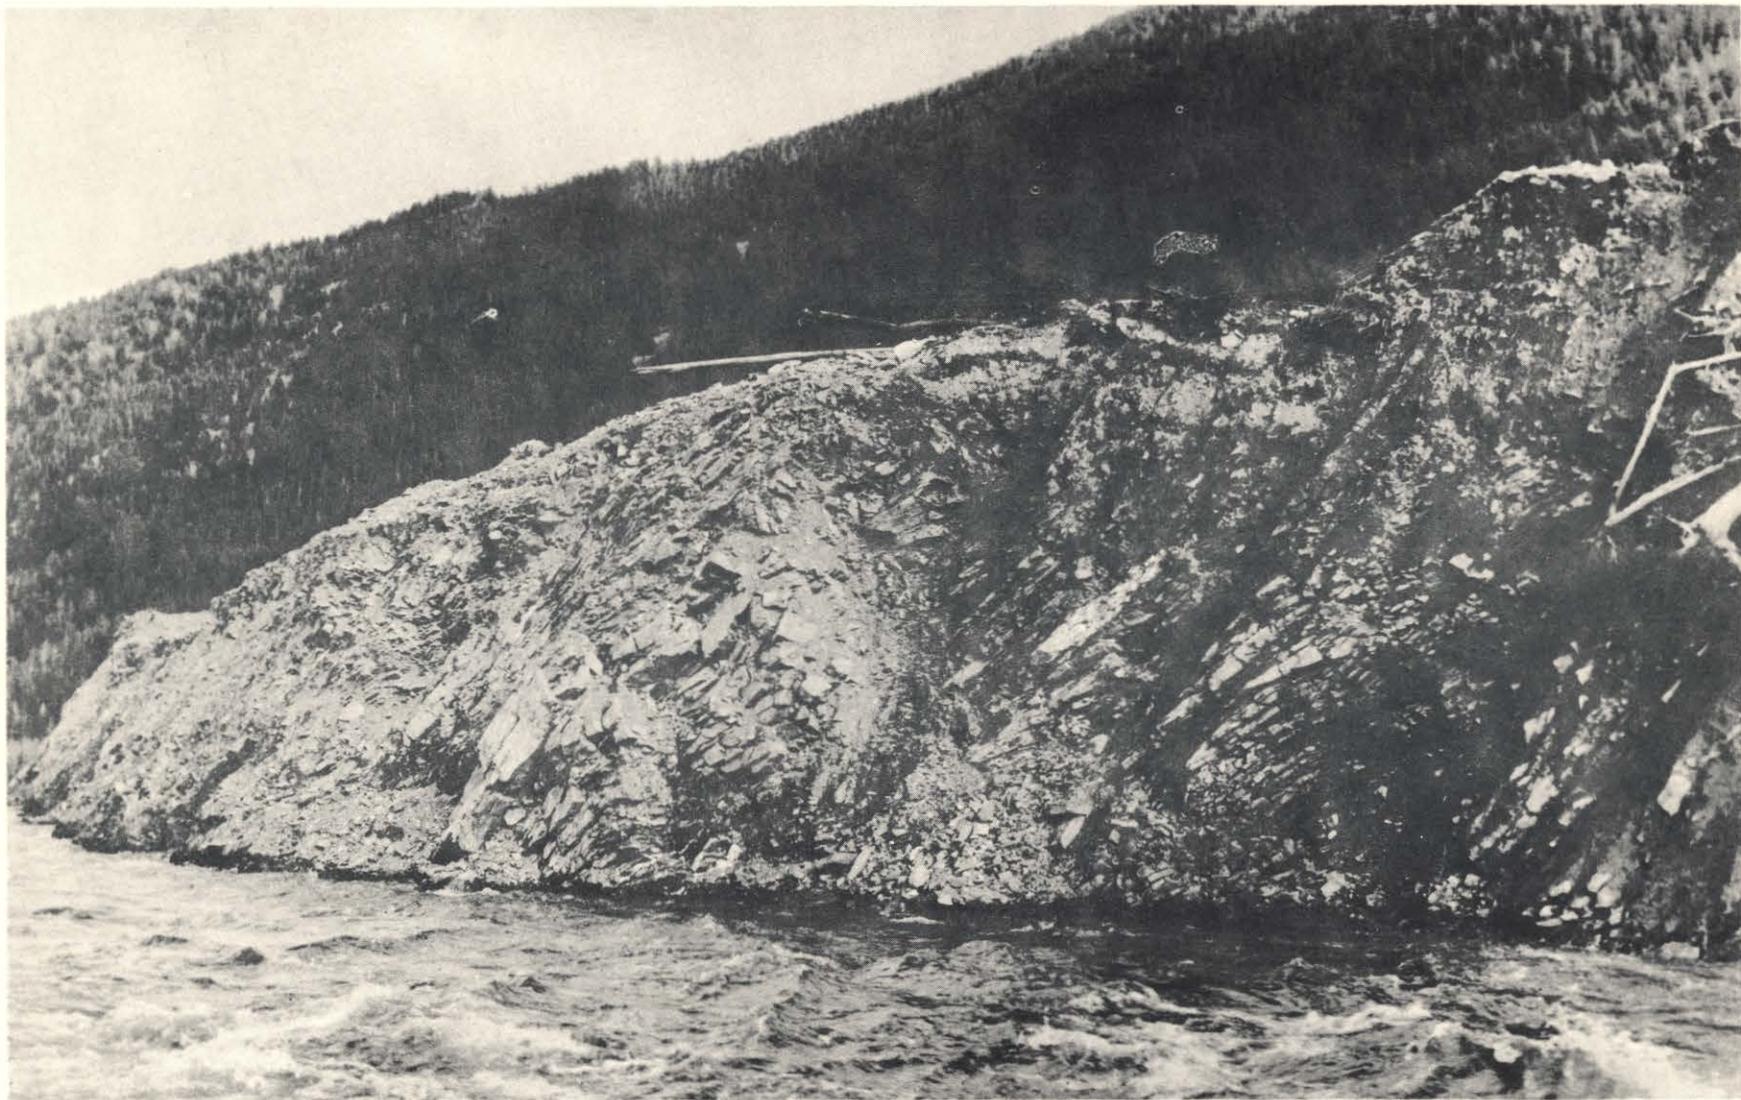
Oblique view of slide spillway taken from waters edge at station 35 looking upstream to lake entrance. View shows the rock and soil conditions of the left bank at this location before the start of bank sloughing from lateral erosion. Water surface of lake approximately 6412. Photo taken 23 October 1959. (Photo #2)

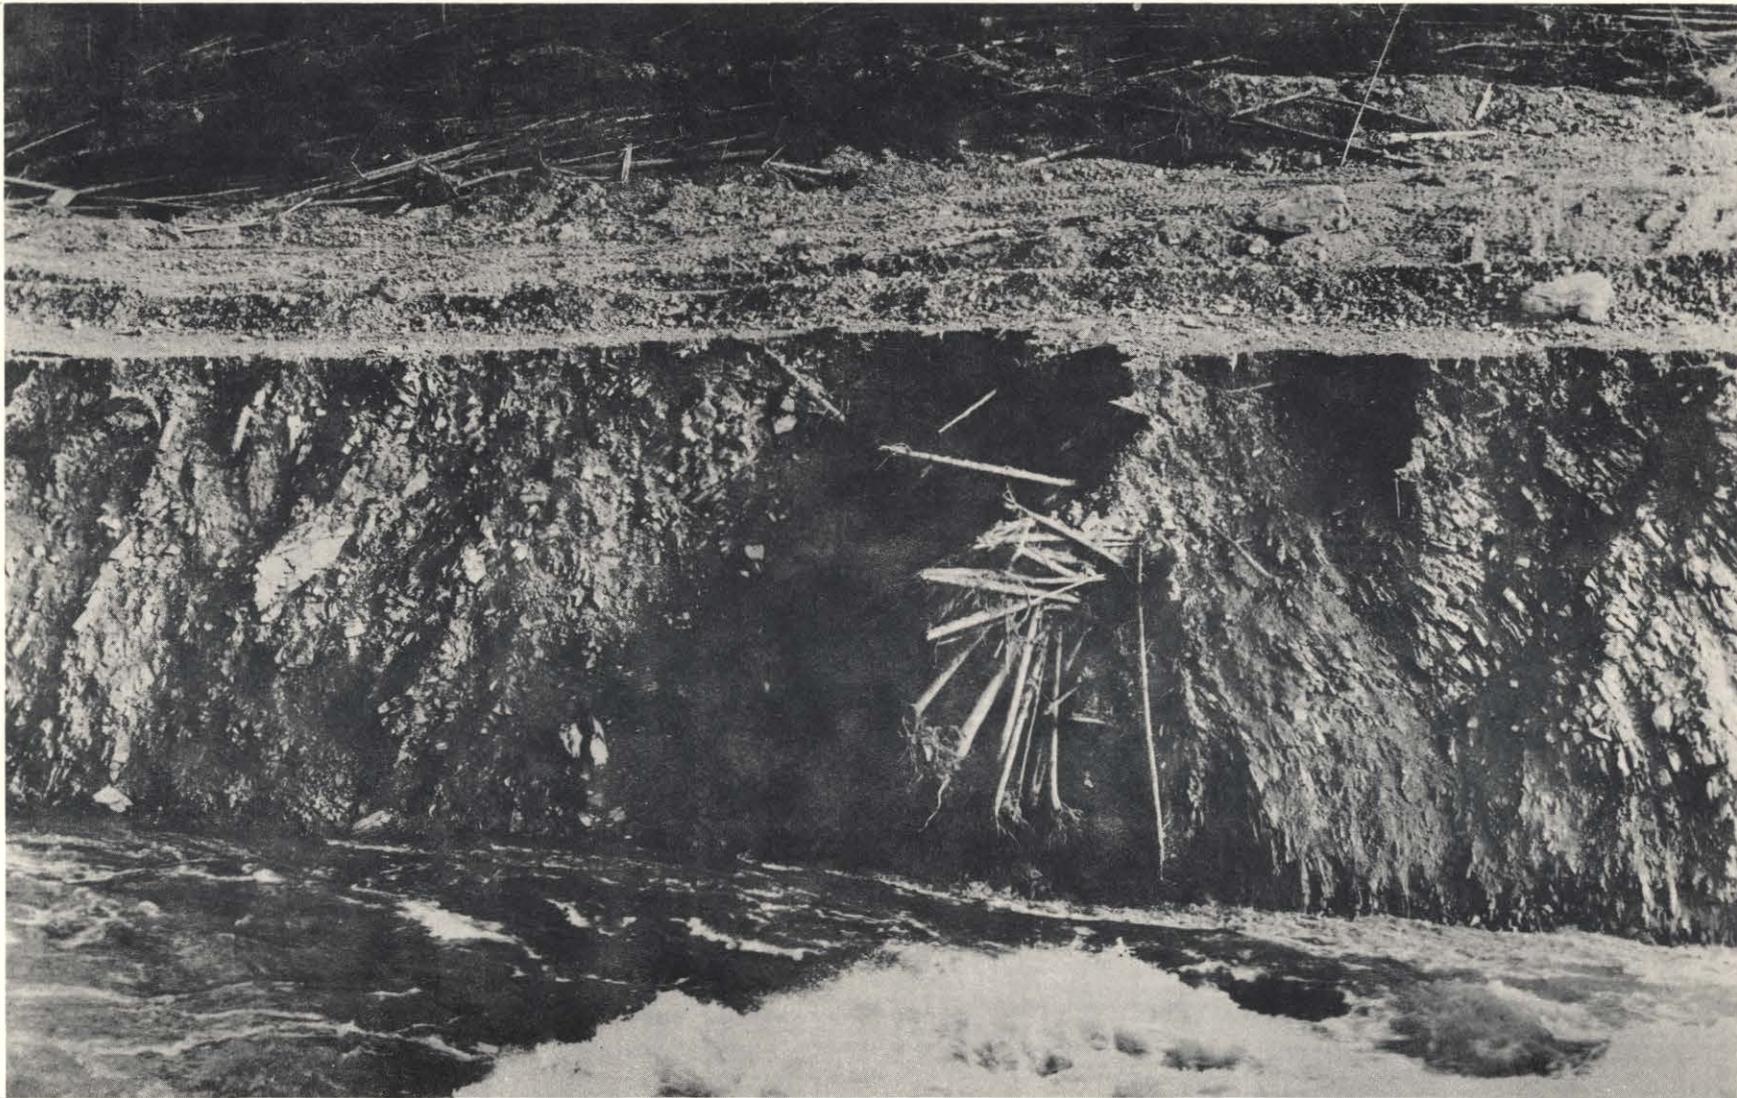
Oblique view of slide spillway taken from station 33 right bank looking upstream showing soil and rock formation of left bank. Water surface approximately elevation 6404, (top of bank 6450). Photo taken 23 October 1959. (Photo #3)

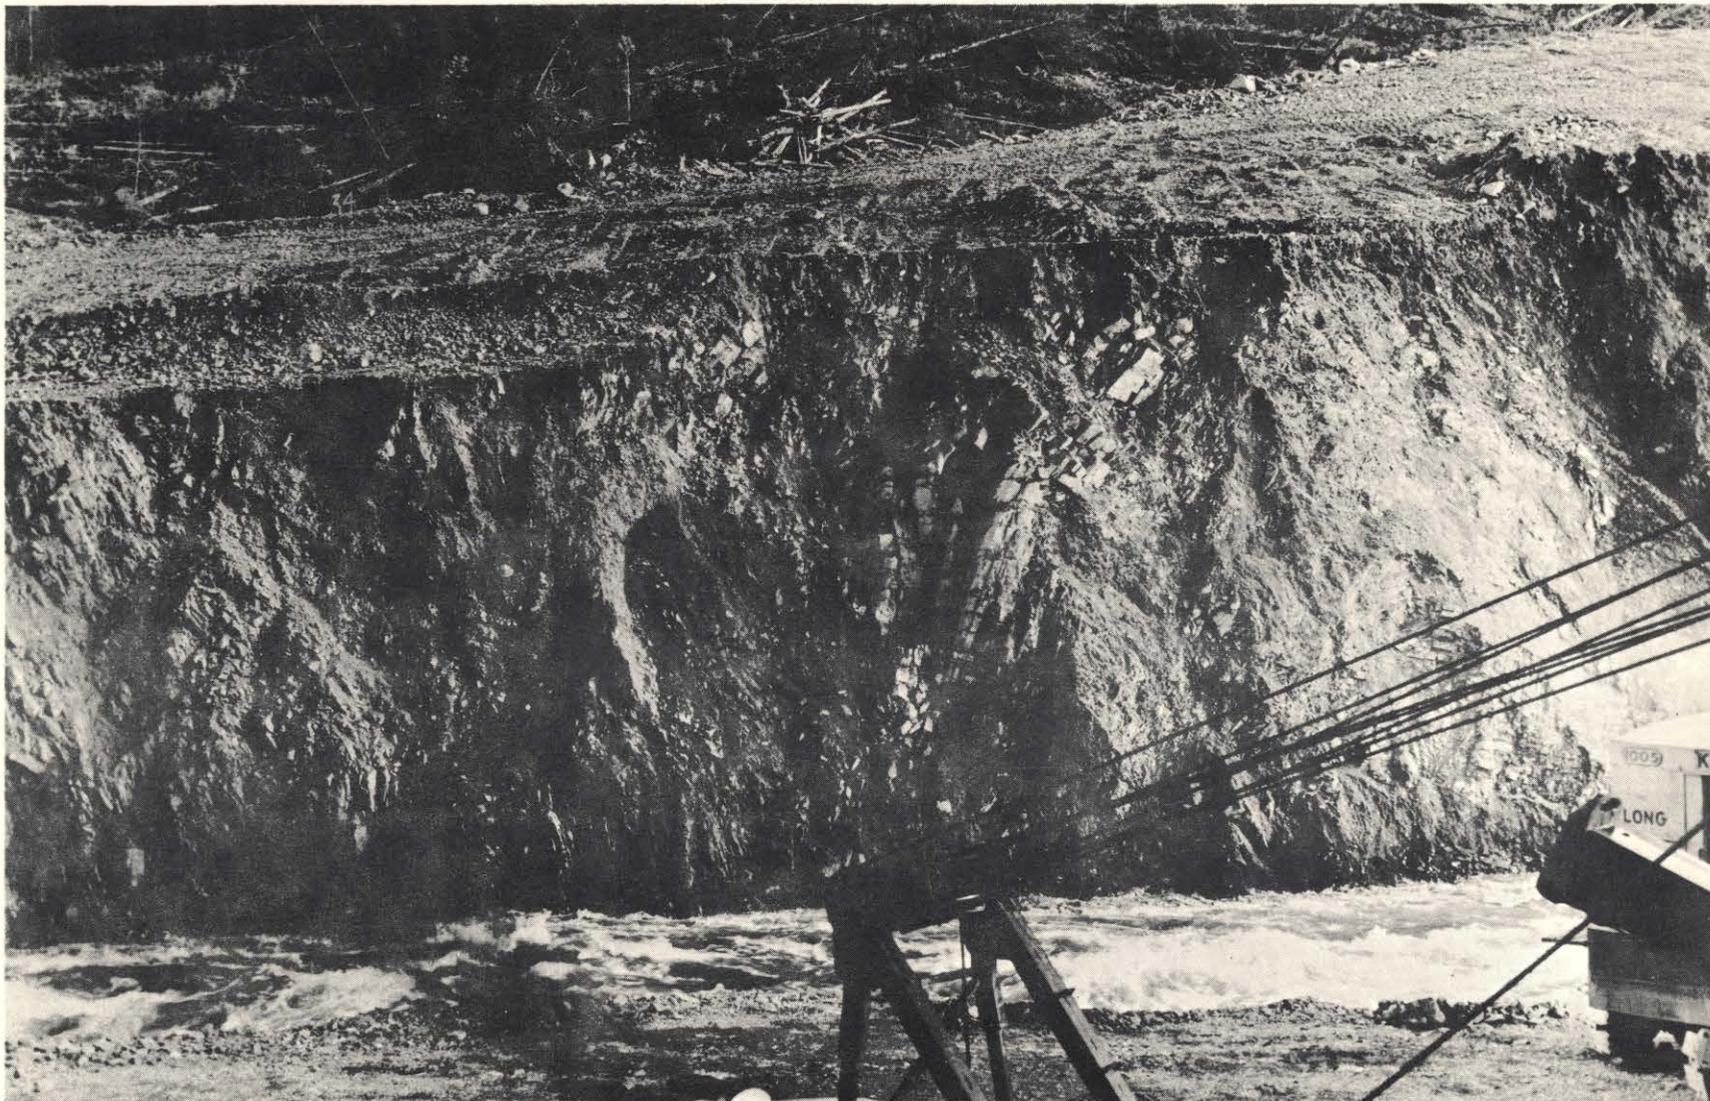
Oblique view of slide spillway taken from station 32 right bank looking upstream to station 34 left bank, showing the rock and soil conditions. Top earthy material tended to cover the rock formation as lateral erosion progressed. Water surface at station 34 approximately 6404. Photo taken 23 October 1959. (Photo #4)

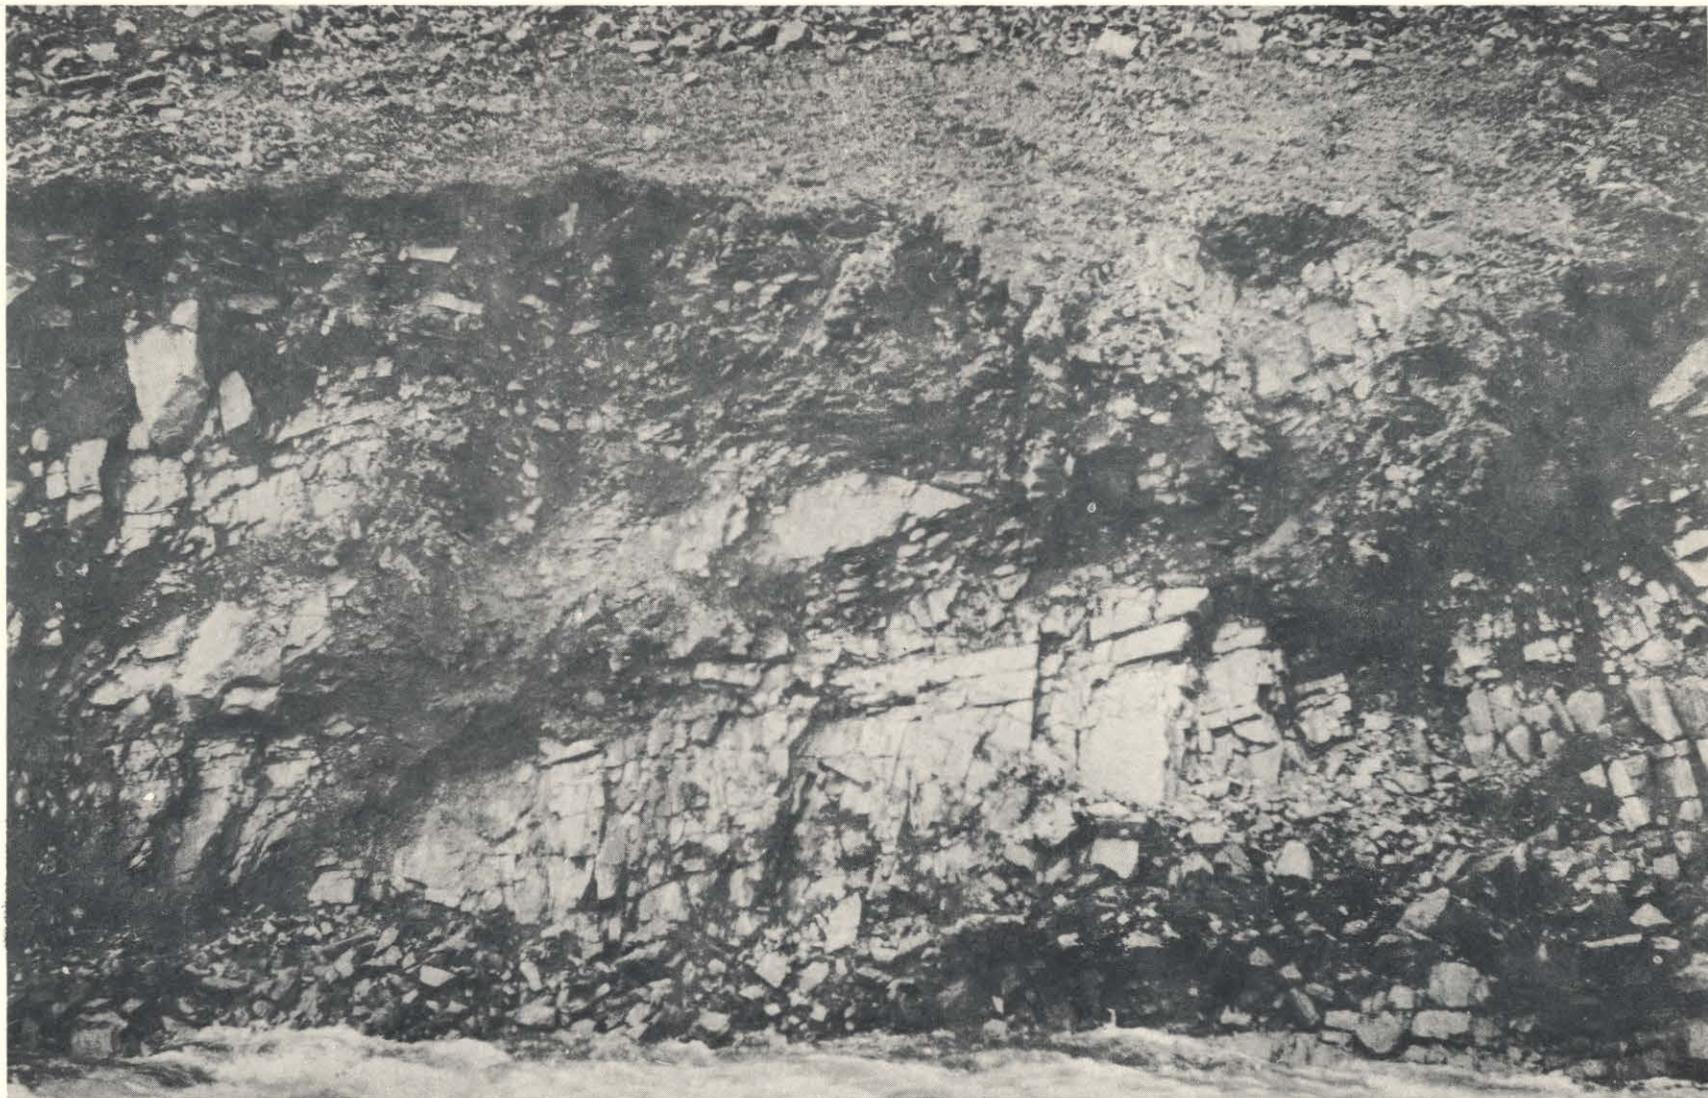
View looking at station 30 on left bank of slide spillway showing typical rock formations encountered in the upstream area during early stages of spillway lowering operations. Photo taken 13 October 1959. See photo #6 taken 23 October 1959 at same location, which shows massive rock formation becoming less apparent as lateral erosion progressed. (Photo #5)

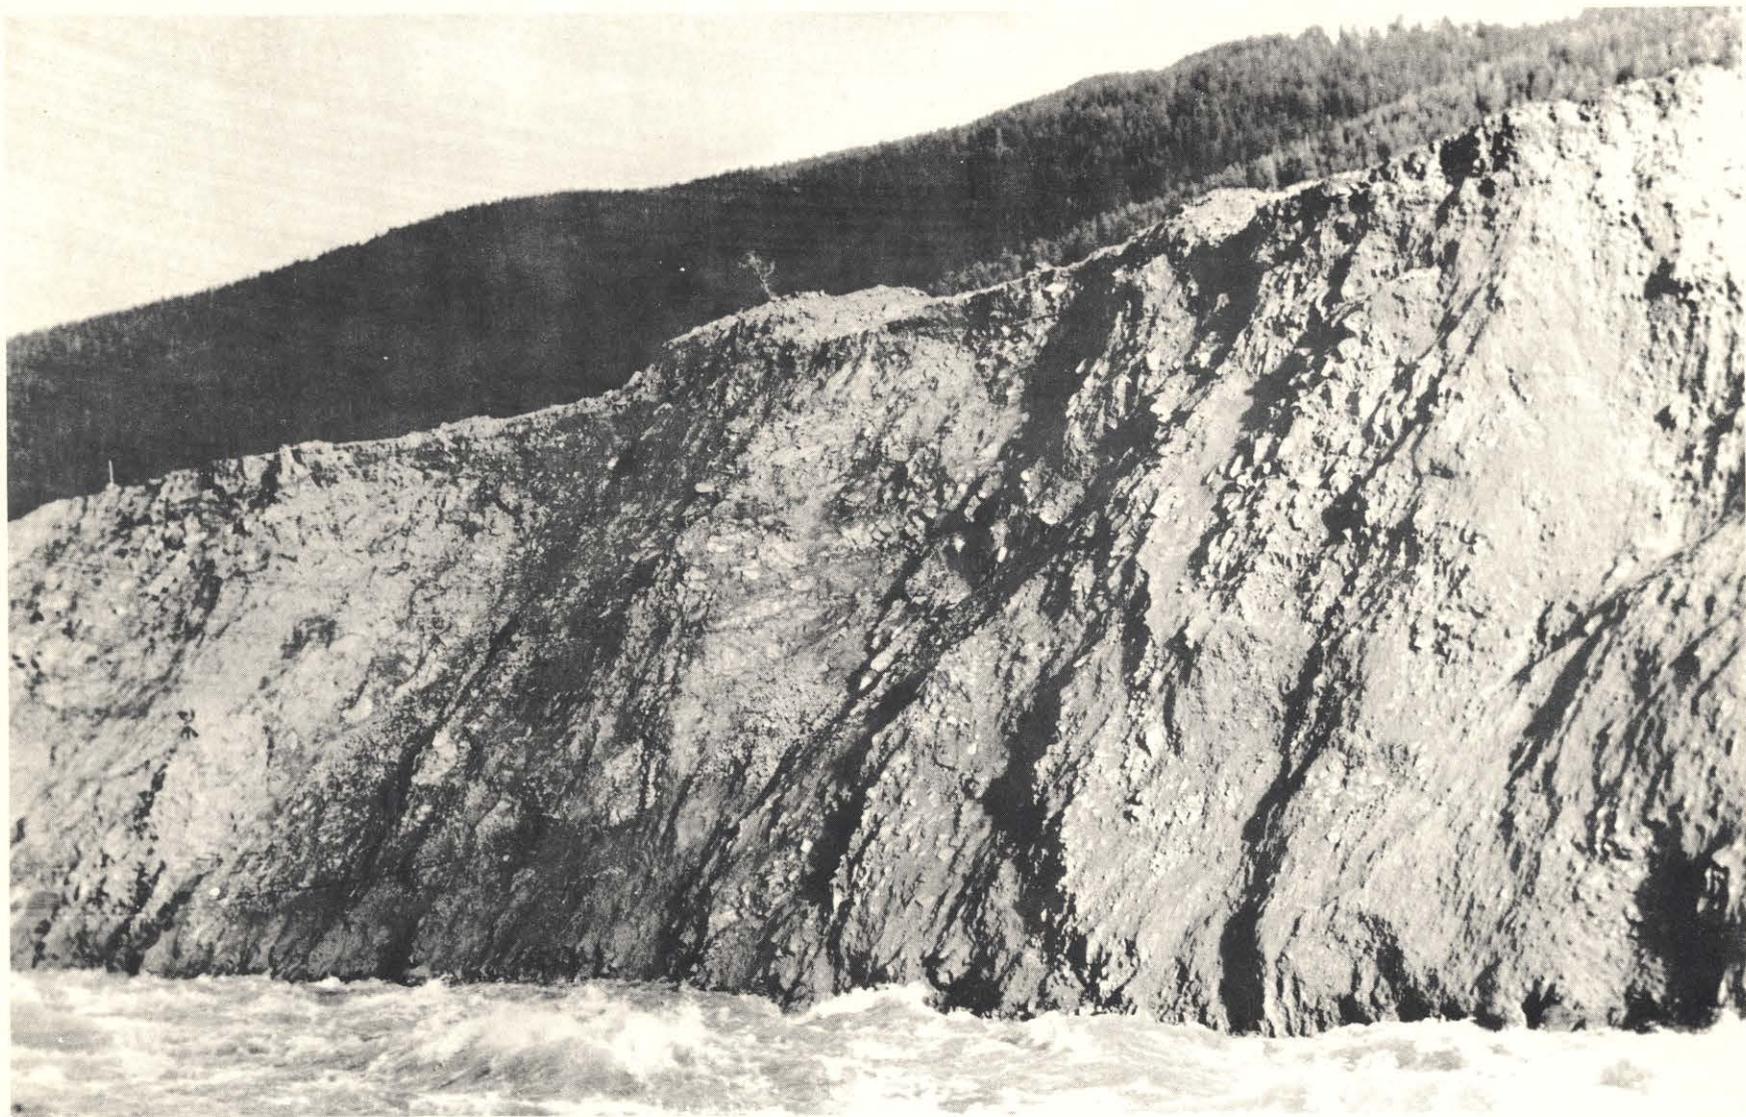
Oblique view of slide spillway taken from station 30 right bank at waters edge looking upstream showing rock and soil conditions of left bank. Lateral erosion was extensive at this location and rock formation became less apparent as erosion progressed. Photo taken 23 October 1959. (Photo #6)

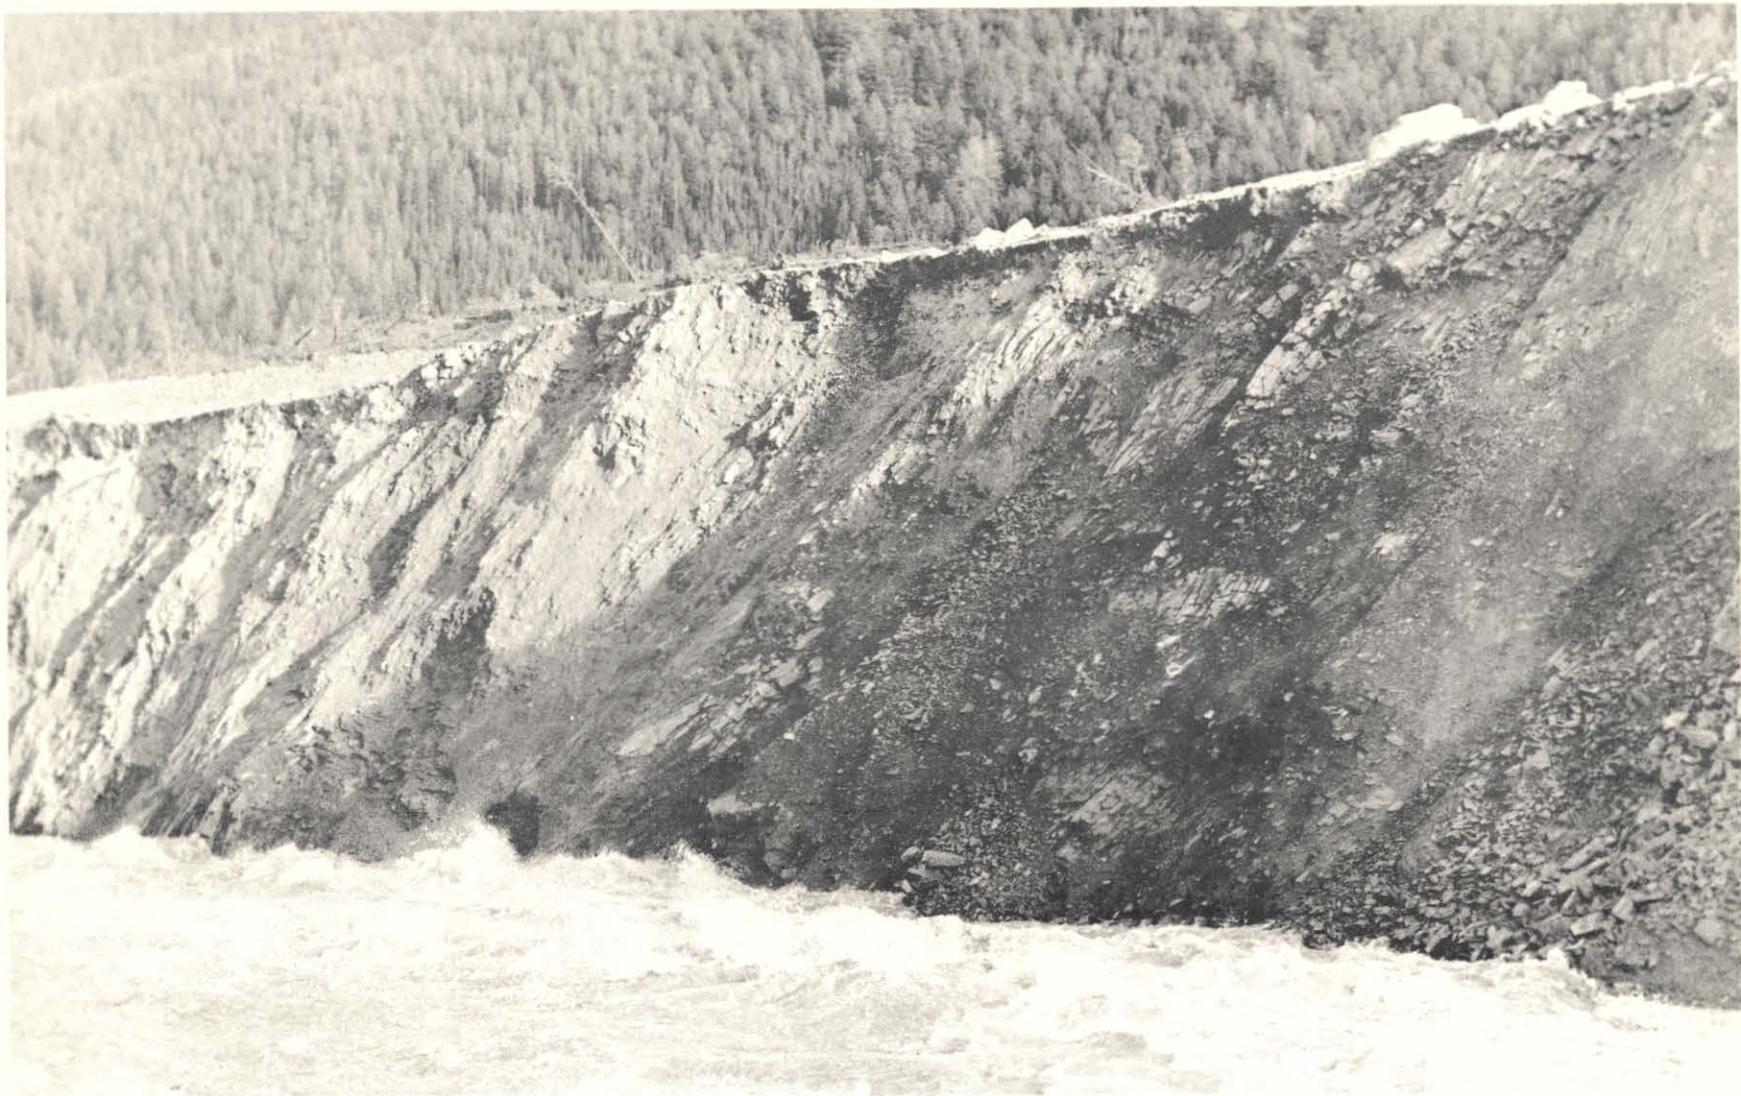
Oblique view of slide spillway taken from station 28 right bank at waters edge looking upstream with station 32 marker showing in picture. Picture shows rock and soil conditions of left bank. Rock formation shows through the light covering of dirt in the foreground. Water surface at station 30 approximately 6397 at time of picture. Photo taken 23 October 1959. (Photo #7)

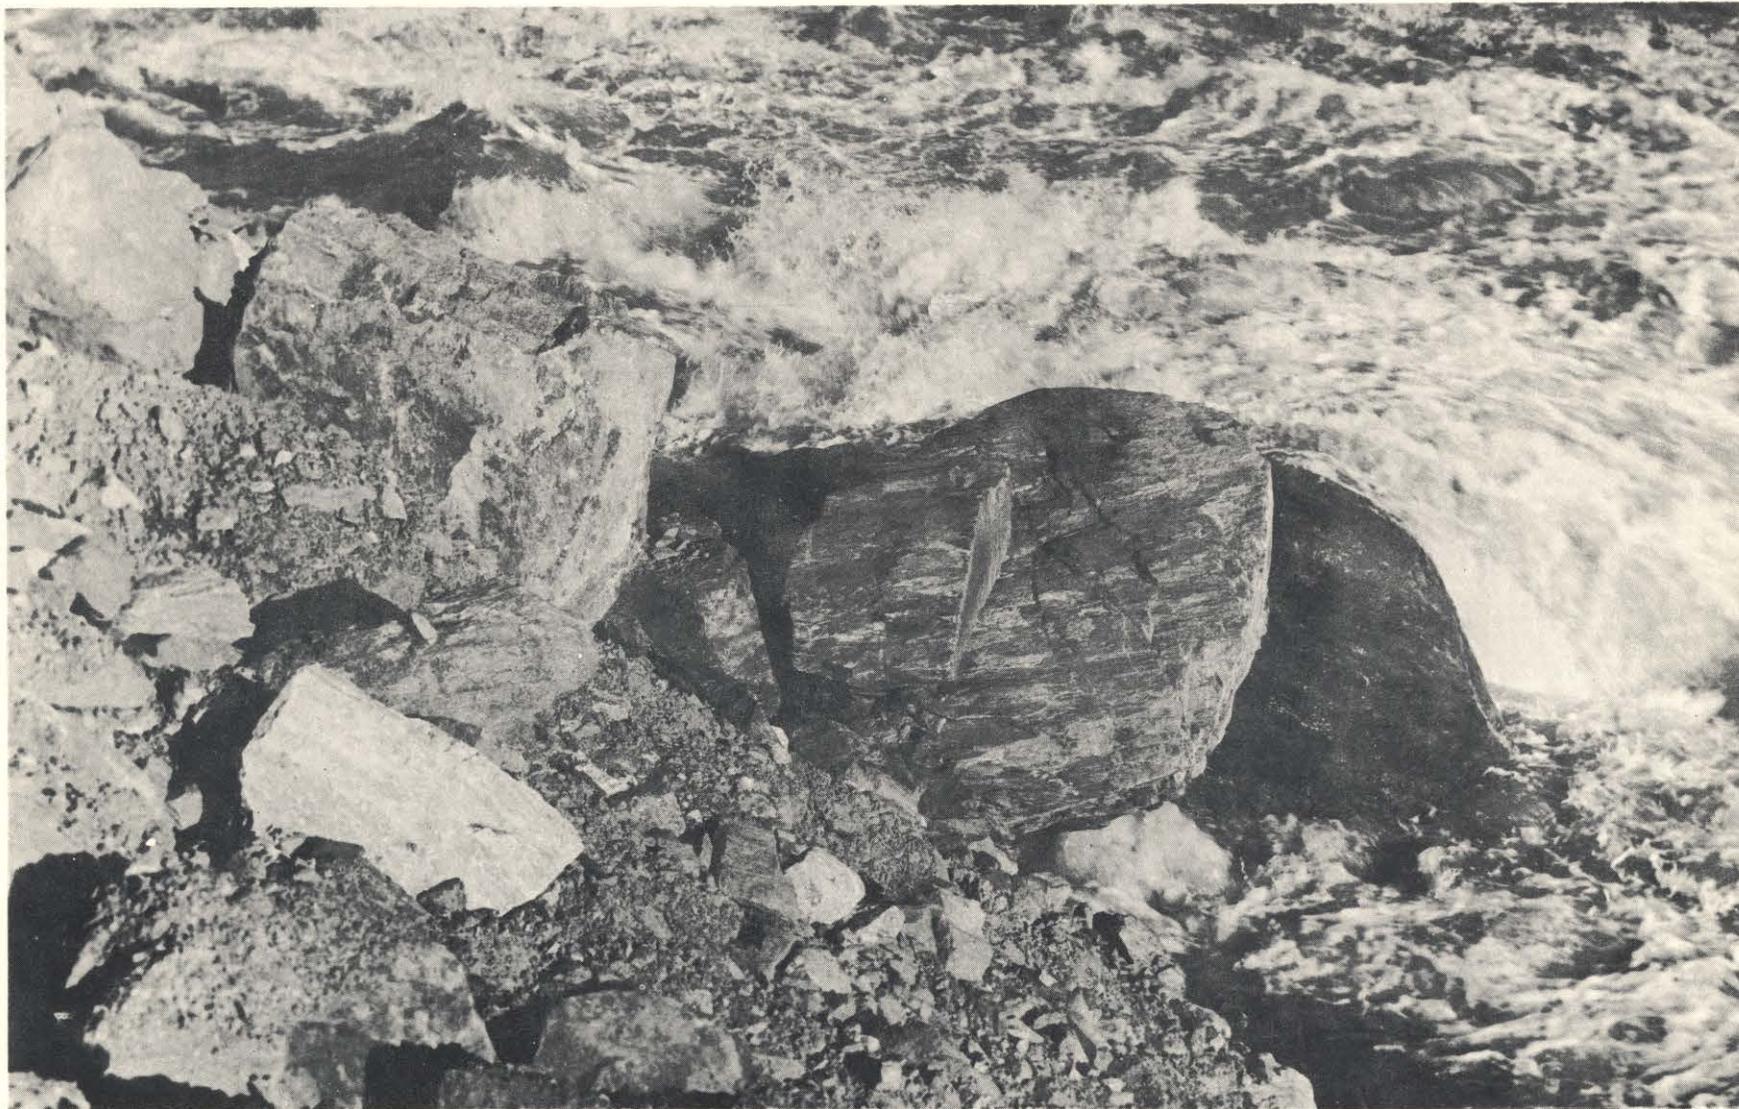
View showing the large gneiss rock which were dragged out of channel at station 26 to 26+50. Channel constricted at this location. Photo taken 23 October 1959. (Photo #8)

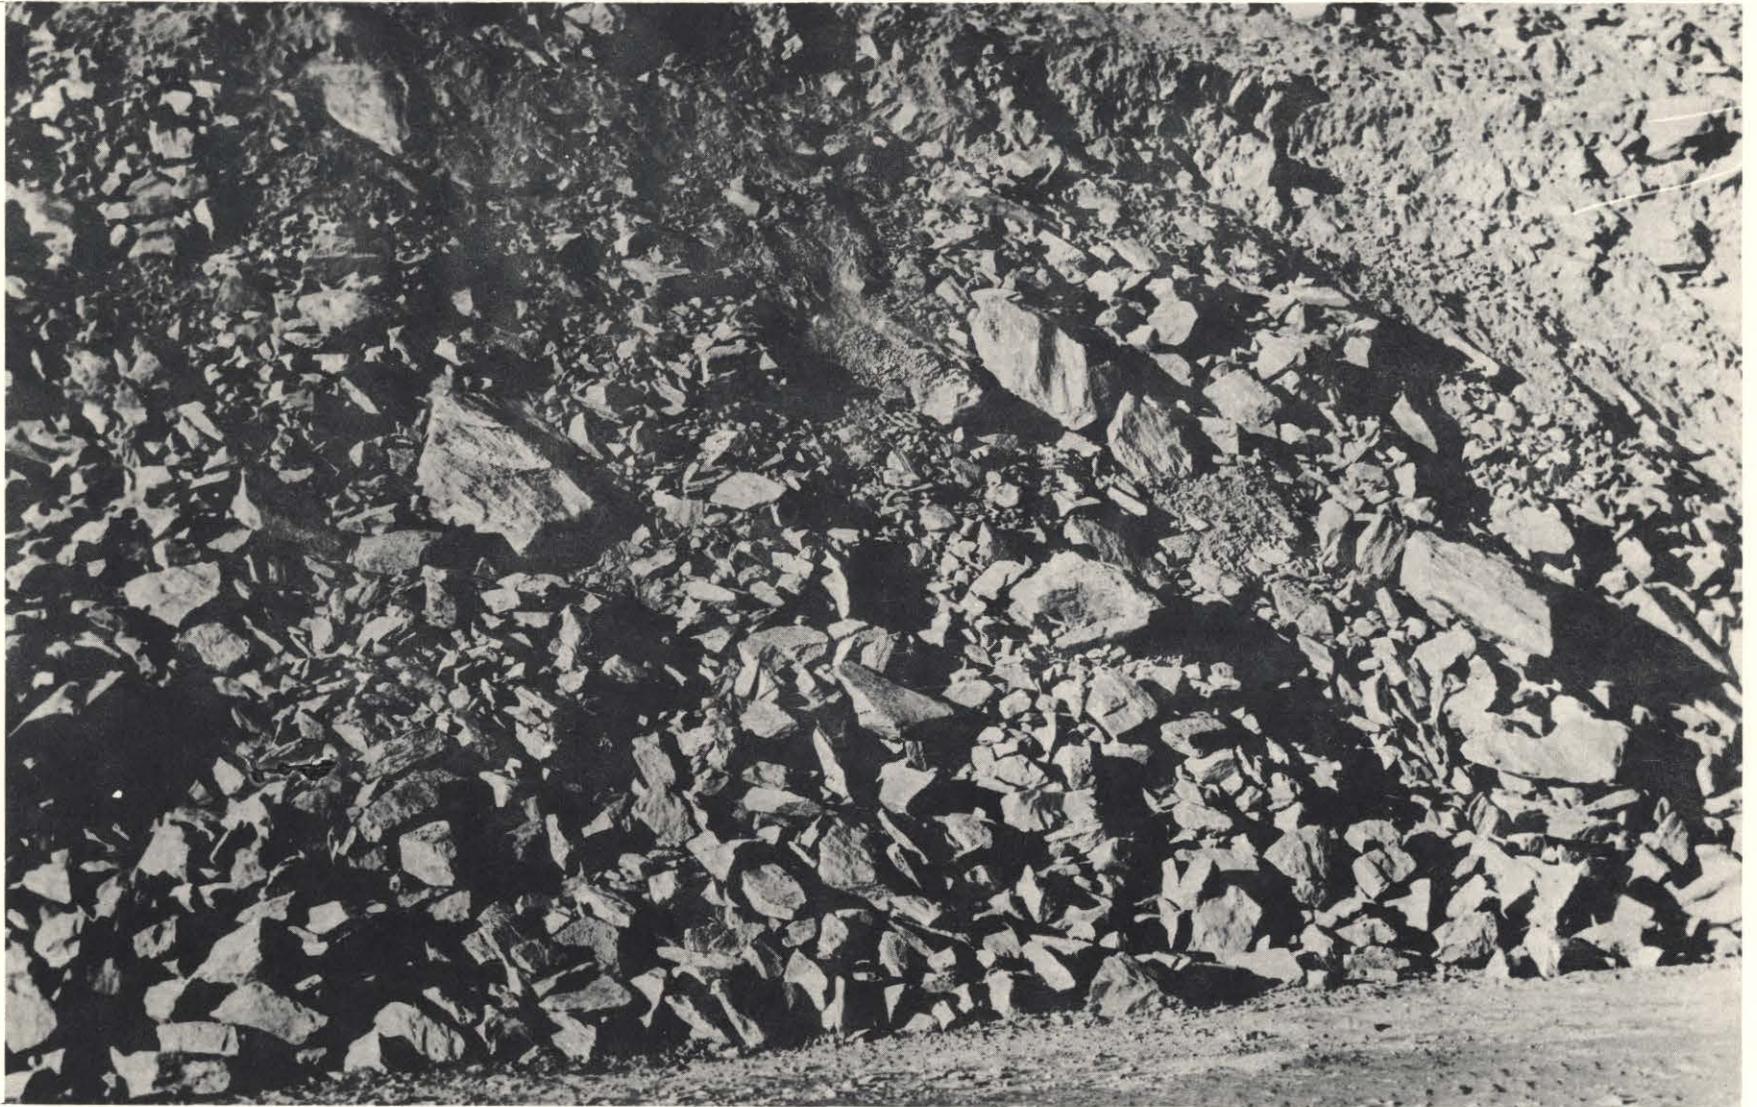
View of right bank at station 26 showing the blocky rock encountered at this location. Photo taken 23 October 1959. (Photo #9)

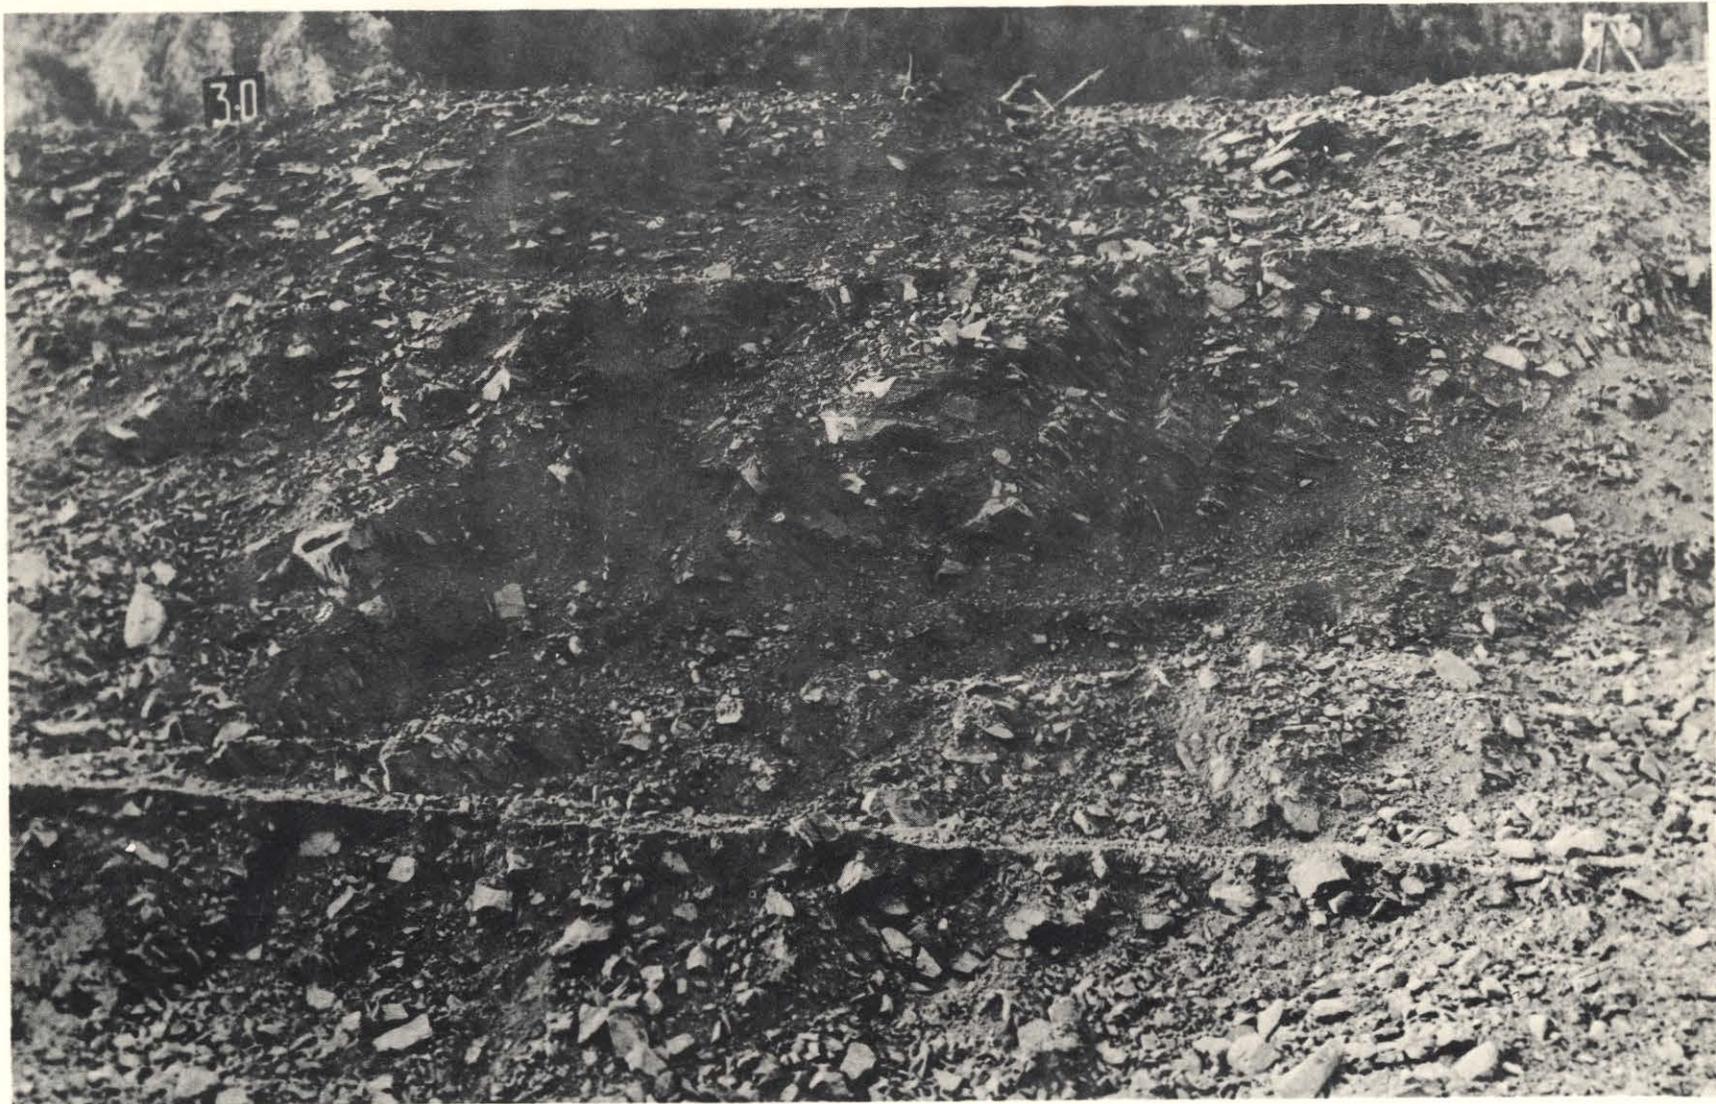
Oblique view of slide spillway taken from station 31 right bank at waters edge looking downstream at station 30 marker showing rock and soil conditions of right bank. Right bank was shovel excavated and most of rock formation covered with layer of loose rock and dirt. Note rock formation visible in several locations. Photo taken 23 October 1959. (Photo #10)

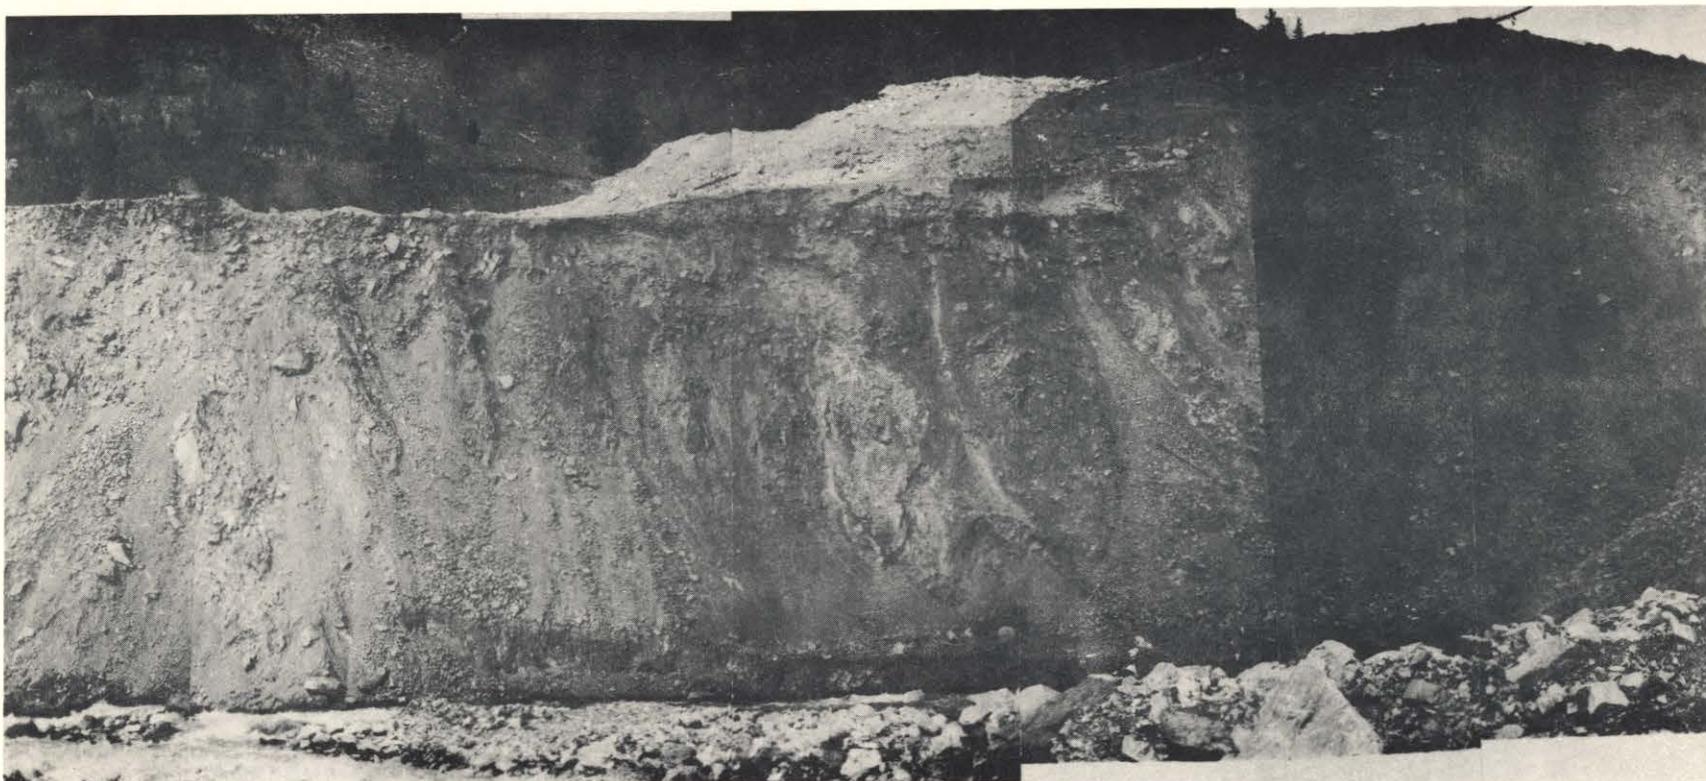
Panoramic view of right bank of slide spillway channel walls from approximately station 16 and downstream. Excessive lateral erosion occurred on right bank when water bypassed rock terraces in channel. Typical of material encountered in downstream reach of spillway. Photo taken 13 October 1959. (Photo #11)
