**Observed Performance
of Dams
During Earthquakes
Volume II**

October 2000

Prepared by the USCOLD Committee on Earthquakes

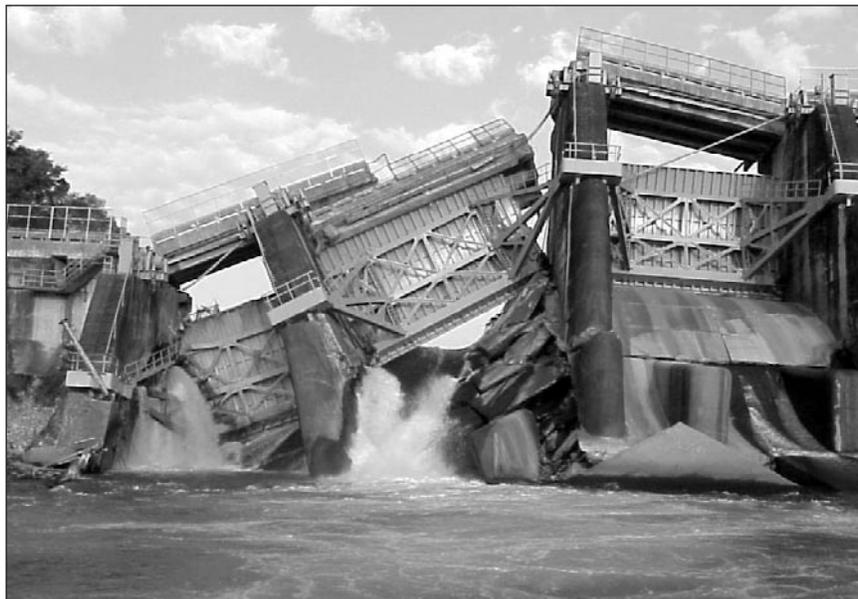
Shih-Kang Dam, located about 50 km north of the Chi-Chi Earthquake epicenter, is a buttress gravity dam which regulates the Tachia River in its lower course. Shih-Kang Dam is about 82 feet high, and has about 18 gated bays that serve as spillway. The dam was directly intersected by the Chelungpu fault rupture, with a differential movement of about 29 feet vertical and 6.5 feet horizontal under bays 16 to 18. The fault had not been mapped at the site prior to the earthquake. Bays not affected by the fault rupture survived essentially undamaged. Peak ground acceleration was reported at 0.56g in a town nearby (Charlwood, 2000).

Fault crossing rupture across Shih-Kang Dam. (Photo courtesy of Robin G. Charlwood, Acres International; and Tim Little, BC Hydro.)

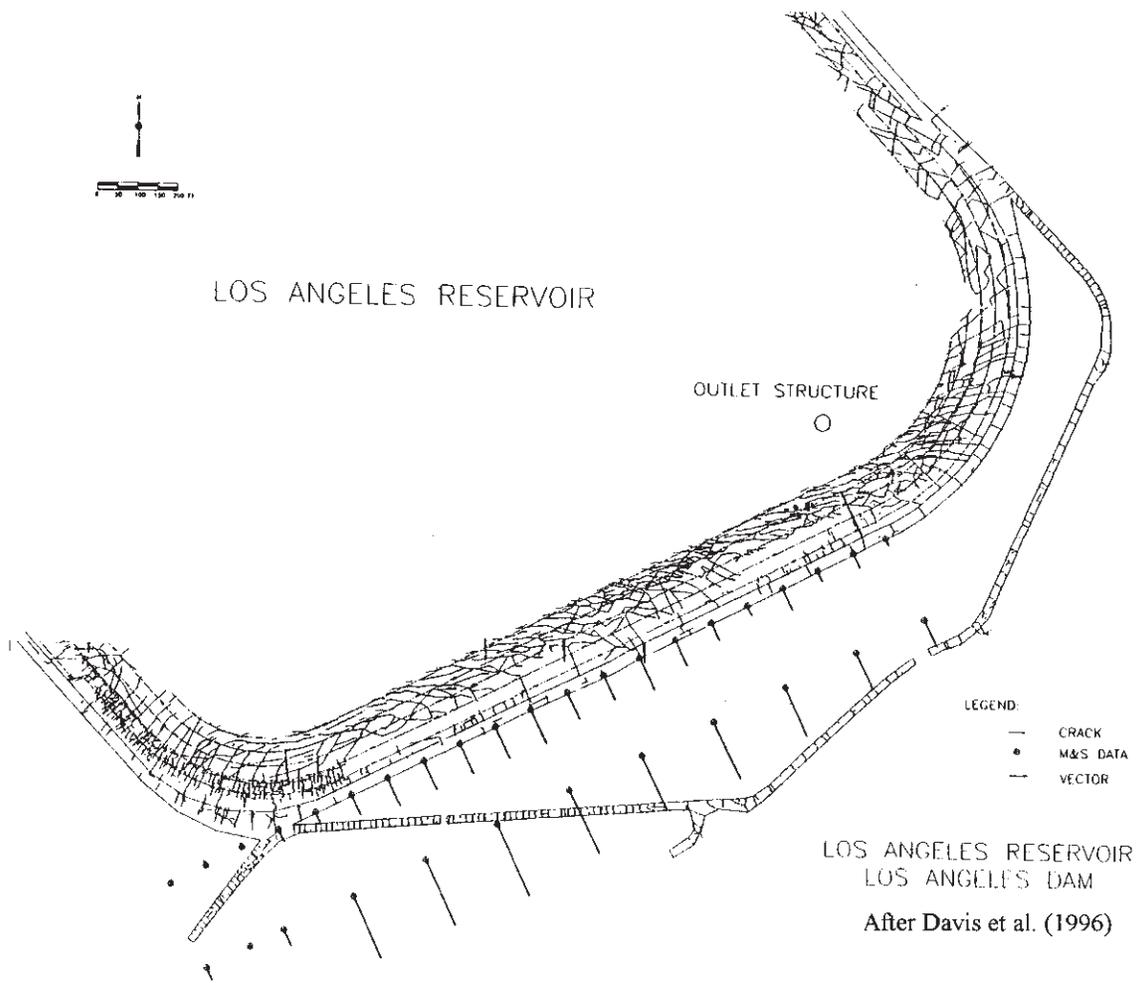
Figure 2
**CRACKS & TRANSVERSE MOVEMENTS
 INDUCED BY NORTHRIDGE EARTHQUAKE**
 Los Angeles Dam

The 130-foot-high Los Angeles Dam, which now replaces the two San Fernando dams, is located between these two flood-control, dry embankments. It experienced extensive, but not safety-threatening, cracking of its asphalt lining and settled 3.5 inches near its maximum section. Maximum horizontal crest movement was about 2.2 inches. The Los Angeles Dam experience is covered in more detail as one of the case histories presented in this report.
