*Reprinted from the Proceedings of the Conference
Water for Resource Development, HY Div./ASCE
Coeur d'Alene, Idaho, August 14-17, 1984*

Operation of Glen Canyon Dam Spillways - Summer 1983

Philip H. Burgi 1/, M., ASCE, Bruce M. Moyes 2/, Thomas W. Gamble 3/

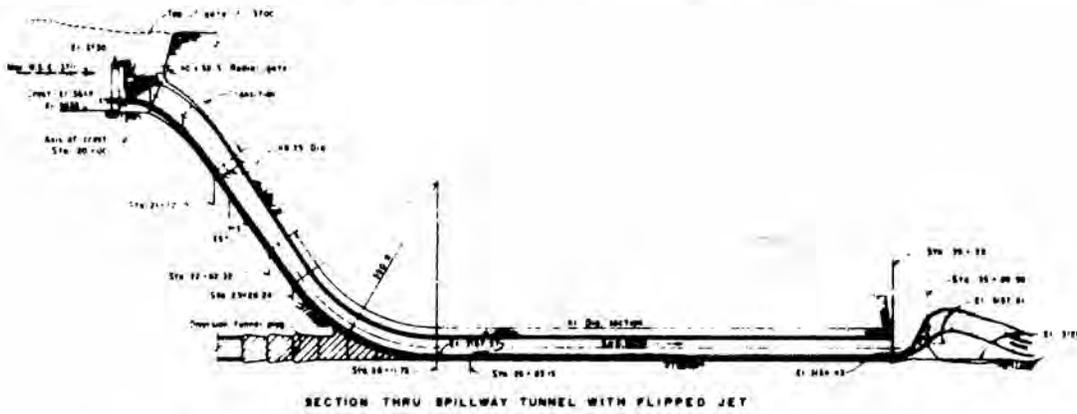
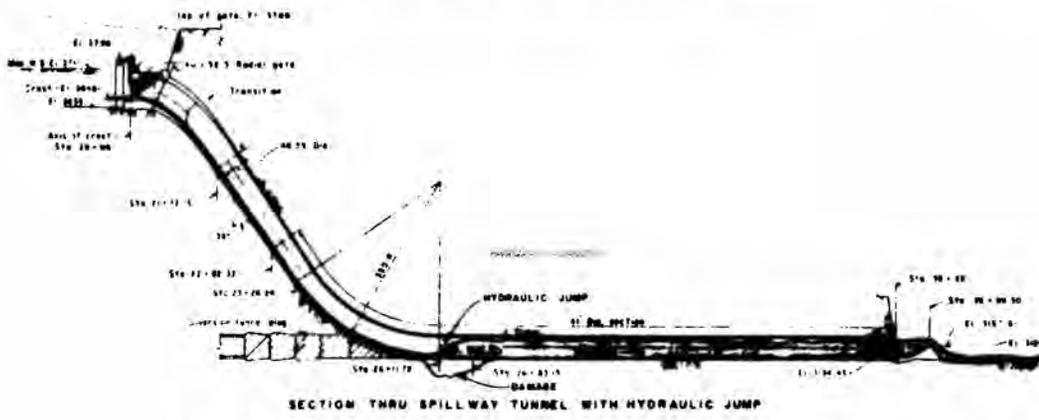
Figure 2b Elevation view of tunnel spillway.

From June 16-23, the discharge through the left tunnel spillway was increased as needed from 12 000 to 23 000 ft³/s (339.8 to 651.3 m³/s) to ensure a continued flip from the tunnel bucket, figure 2b. This operational plan proved successful and provided an additional 16 days of "productive life" for the right spillway. To increase storage capacity in Lake Powell and continue controlled releases through the spillways, 8-ft (2.4-m) high metal flashboards were designed and used to replace the wooden flashboards on top of the gates. Analysis indicated that 8-ft flashboards would only marginally overstress the gates. This was acceptable on a temporary basis. The metal flashboards provided an additional 1.3 million acre-ft (1.60 x 10⁹ m³) of storage in Lake Powell. The flashboards proved to be very useful on the downside of the hydrograph when the spillway gates were closed on July 23 with a reservoir El. 3707.8 (EL 1130.0), some 7.8 ft (2.38 m) - 1.25 million acre-ft (1.5 x 10⁹ m³) - above the top of the gates.

3. For the particular situation at Glen Canyon Dam it proved beneficial to maintain the jet flip from the tunnel spillway flip bucket as long as possible. This operation provided a means of observing the spillway jet to detect tunnel invert deterioration and it also prevented formation of a hydraulic jump in the tunnel as long as possible.

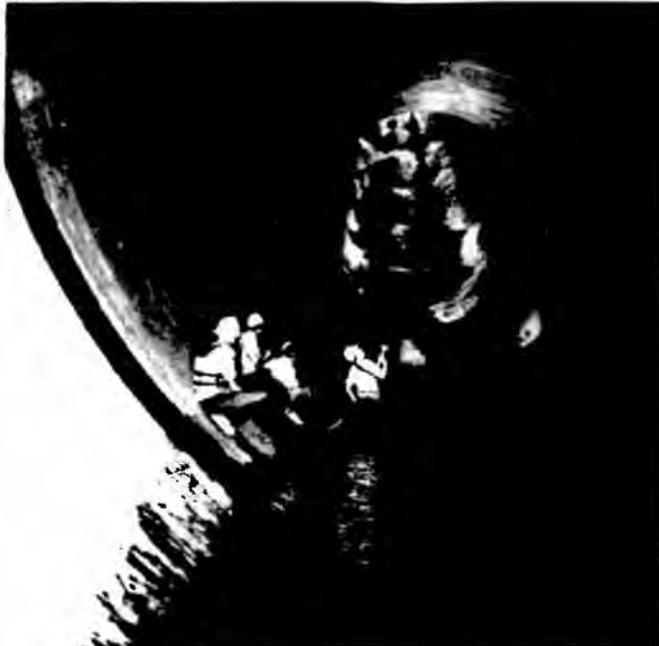
were heard coming from the left spillway. That afternoon engineers inspected the tunnel and found several large holes in the invert of the vertical bend. The damage was initiated by cavitation which had formed as a result of a calcite deposit 0.25 in (0.64 cm) high on the tunnel invert at approximately Sta. 25+00. Four-foot (1.2-m) high plywood flashboards were immediately installed on top of the four spillway gates. By June 8 it was clear that both spillways would have to be used to pass the flood without overtopping the spillway gates. An analysis of the potential for cavitation damage in the tunnel spillways indicated that if the releases could be held below 6000 ft³/s (169.9 m³/s), it would take several months of operation to produce serious damage. The fact that the left spillway was already seriously damaged and continued high inflows into Lake Powell would force higher releases through the spillways prompted a decision to continue to use the left tunnel spillway and reserve the right spillway (maintain releases of 6000 ft³/s or less) should the need for its use arise in the future. In making the decision to increase the discharge through the left spillway, it was recognized that the invert of the vertical bend and downstream tunnel would be seriously damaged. It was also recognized that the spillway flip bucket would eventually be unable to flip the jet as the velocity decreased due to increased damage, with time, along the tunnel invert. However, it was hoped that this action would direct the high energy jet downstream along the tunnel centerline producing damage in the horizontal tunnel away from the tunnel plug.

Tunnel Spillway Damage. - In early August the tunnel spillways were dewatered and engineers entered the tunnels from the downstream flip buckets. Upon entering the left tunnel it was obvious that serious damage had occurred. There was approximately 300 yd³ (230 m³) of concrete, reinforcing steel, and sandstone in the flip bucket. Once inside the tunnel the first 200 feet (60 m) were relatively free of debris. A large sandstone boulder, 8 by 15 by 15 ft (2.4 by 4.6 by 4.6 m), was found in the tunnel invert some 500 ft (150 m) upstream from the bucket. Debris several feet deep was found in the invert of the tunnel downstream from the boulder. Except for some debris immediately upstream from the boulder, the invert to the vertical bend was relatively clean. Extensive damage had occurred in the vertical bend from approximately Sta. 23+90 through Sta. 26+90. Immediately downstream from the P.T. of the vertical bend, a hole 35 ft (10.7 m) deep, 134 ft (40.8 m) long, and 50 ft (15.2 m) wide had been excavated in the sandstone by the high energy flow. Three-fourths of the tunnel liner circumference had been removed in the area of the deep hole, figure 3.

a. View looking upstream across flooded hole at cavitation damage in the vertical bend. Note that the tunnel liner has been removed well above the springline August 1983.
