U. S. ARMY
CORPS OF ENGINEERS

REPORT
ON
INVESTIGATION OF FAILURE OF SHEFFIELD DAM
SANTA BARBARA, CALIFORNIA

OFFICE OF THE DISTRICT ENGINEER

JUNE 1949

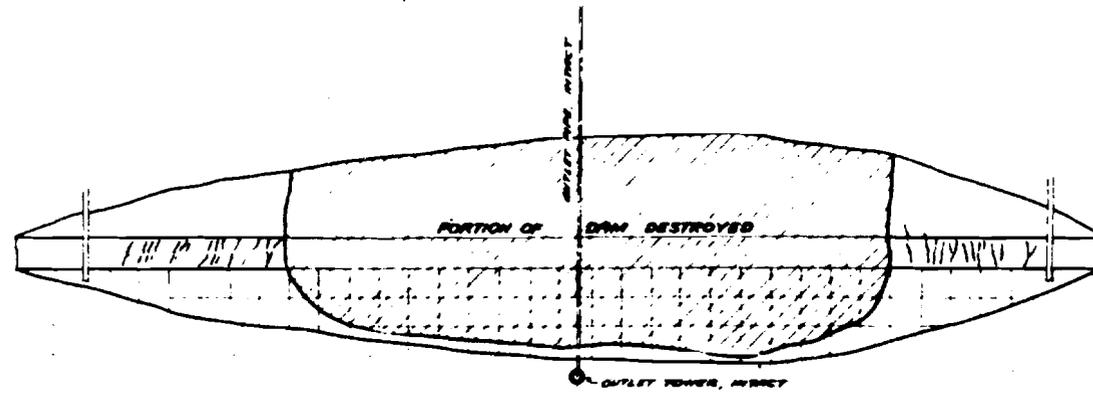
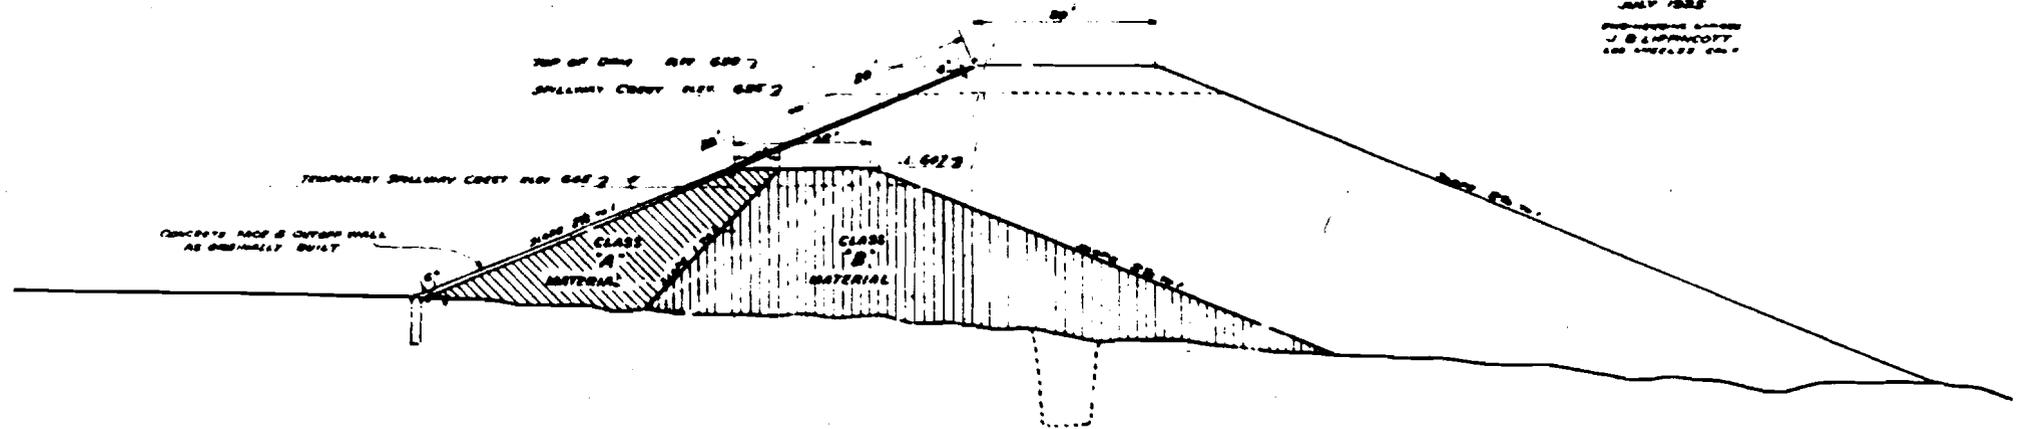
DRG. NO. 3

At 6:00 A.M. on June 29, 1925, a severe earthquake, rated by Dr. Bailey Willis of Stanford University between VIII and IX on the Rossi-Forel scale, occurred at Santa Barbara which caused the central portion of the main dam to move out as though it were hinged at the lower left corner. Of interest is the fact that the plant growth on the downstream side of the displaced mass was undisturbed after the slip. Before the failure, seepage which was percolating either through the foundation or embankment was noted by observers near the downstream toe.

- PLAN OF INSIDE FACE -
SHOWING
CONDITION OF CONCRETE PAVEMENT
SCALE 1" = 50'

- AREA OF CONCRETE WASHED OUT
- AREA OF CONCRETE TO BE REMOVED

In 1925, a temporary structure was constructed to elevation 647. The foundation was removed to bedrock and replaced with a well-compacted fill. As shown in various photographs¹ the stock piles at the ends of the dam were not removed. Figure 3 shows a section of the reconstructed dam.

- SECTION -
SHOWING TEMPORARY DAM
SCALE 1" = 10'

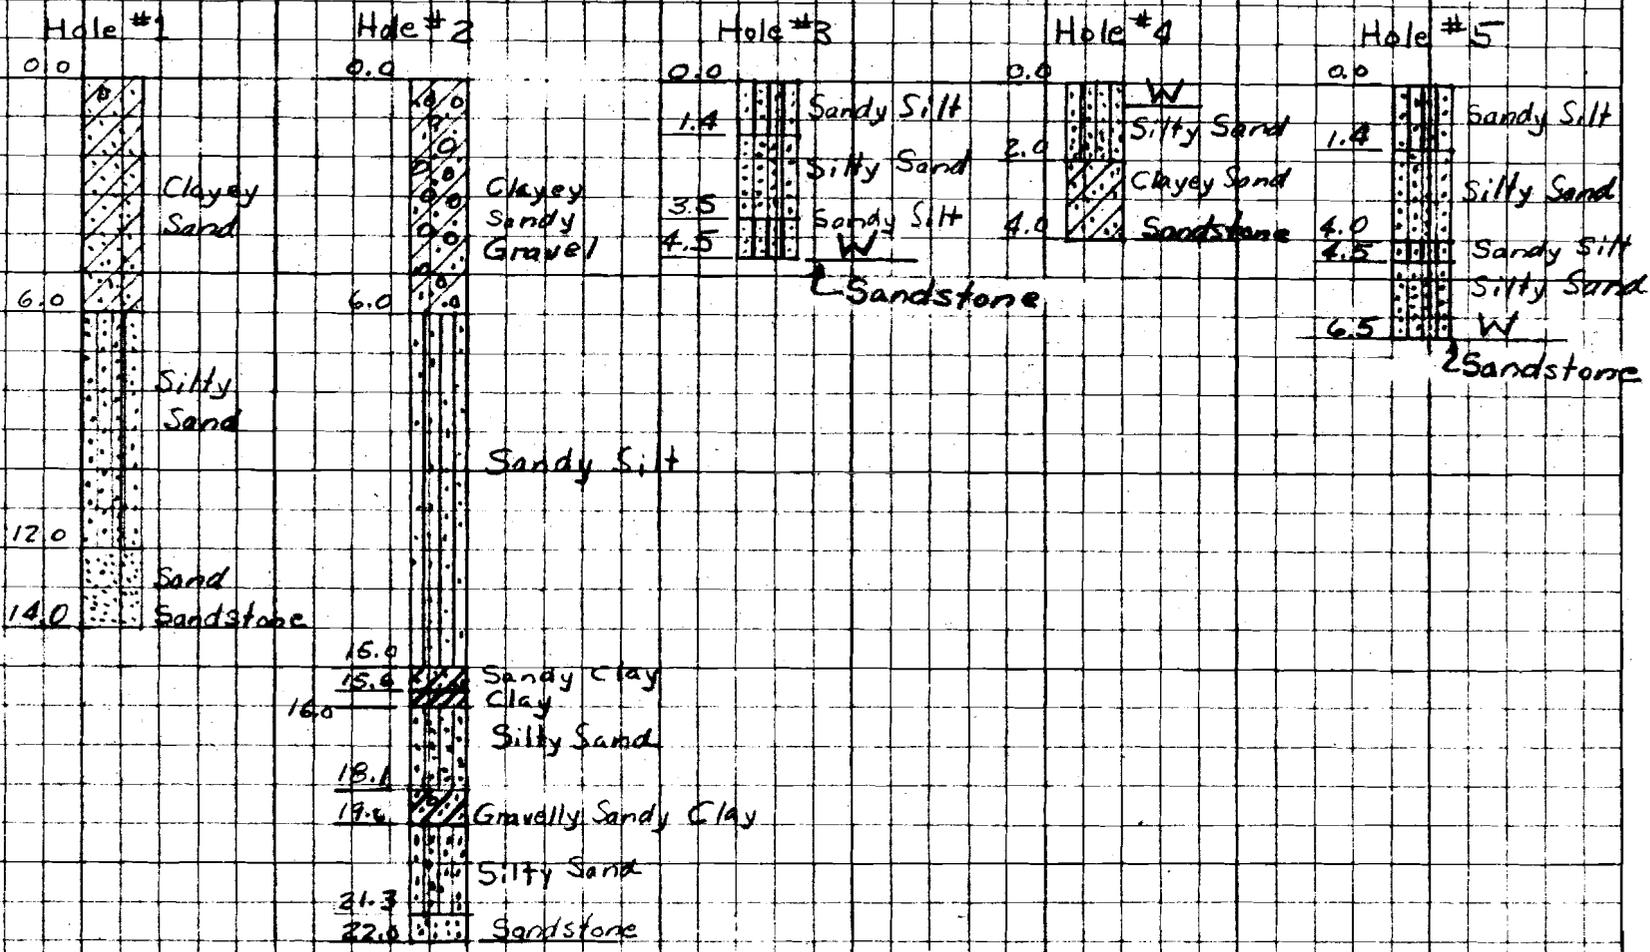
TABLE 8

7. Material encountered.--The materials encountered in nearly all of the auger holes consist predominantly of silt, sand, and sandstone with cobbles varying from 3 to 6 inches in diameter. Holes 1 and 2 consist predominantly of clayey sand interspersed with silty sand layers. Sandstones up to 6 inches in diameter were encountered in these holes. A layer of clay was found from 15.6 to 16.0 feet in hole 2. Sandstone which is believed to be bedrock was encountered at a depth of 14 feet in hole 1, and at a depth of 22 feet in hole 2. Holes 3, 4, and 5 consist predominantly of silty sand. Sandstone which is believed to be bedrock was encountered at 6 feet in hole 3, at 4 feet in hole 4, and at 6.5 feet in hole 5. Detailed logs of the holes are shown in figure 8.

8. Ground water.--No ground water was found in holes 1 and 2. Ground water was encountered at 6 feet in hole 3, at 0.6 foot in hole 4, and at 6.5 feet in hole 5. The source of this water was a small spring located about 25 feet upstream from hole 4.

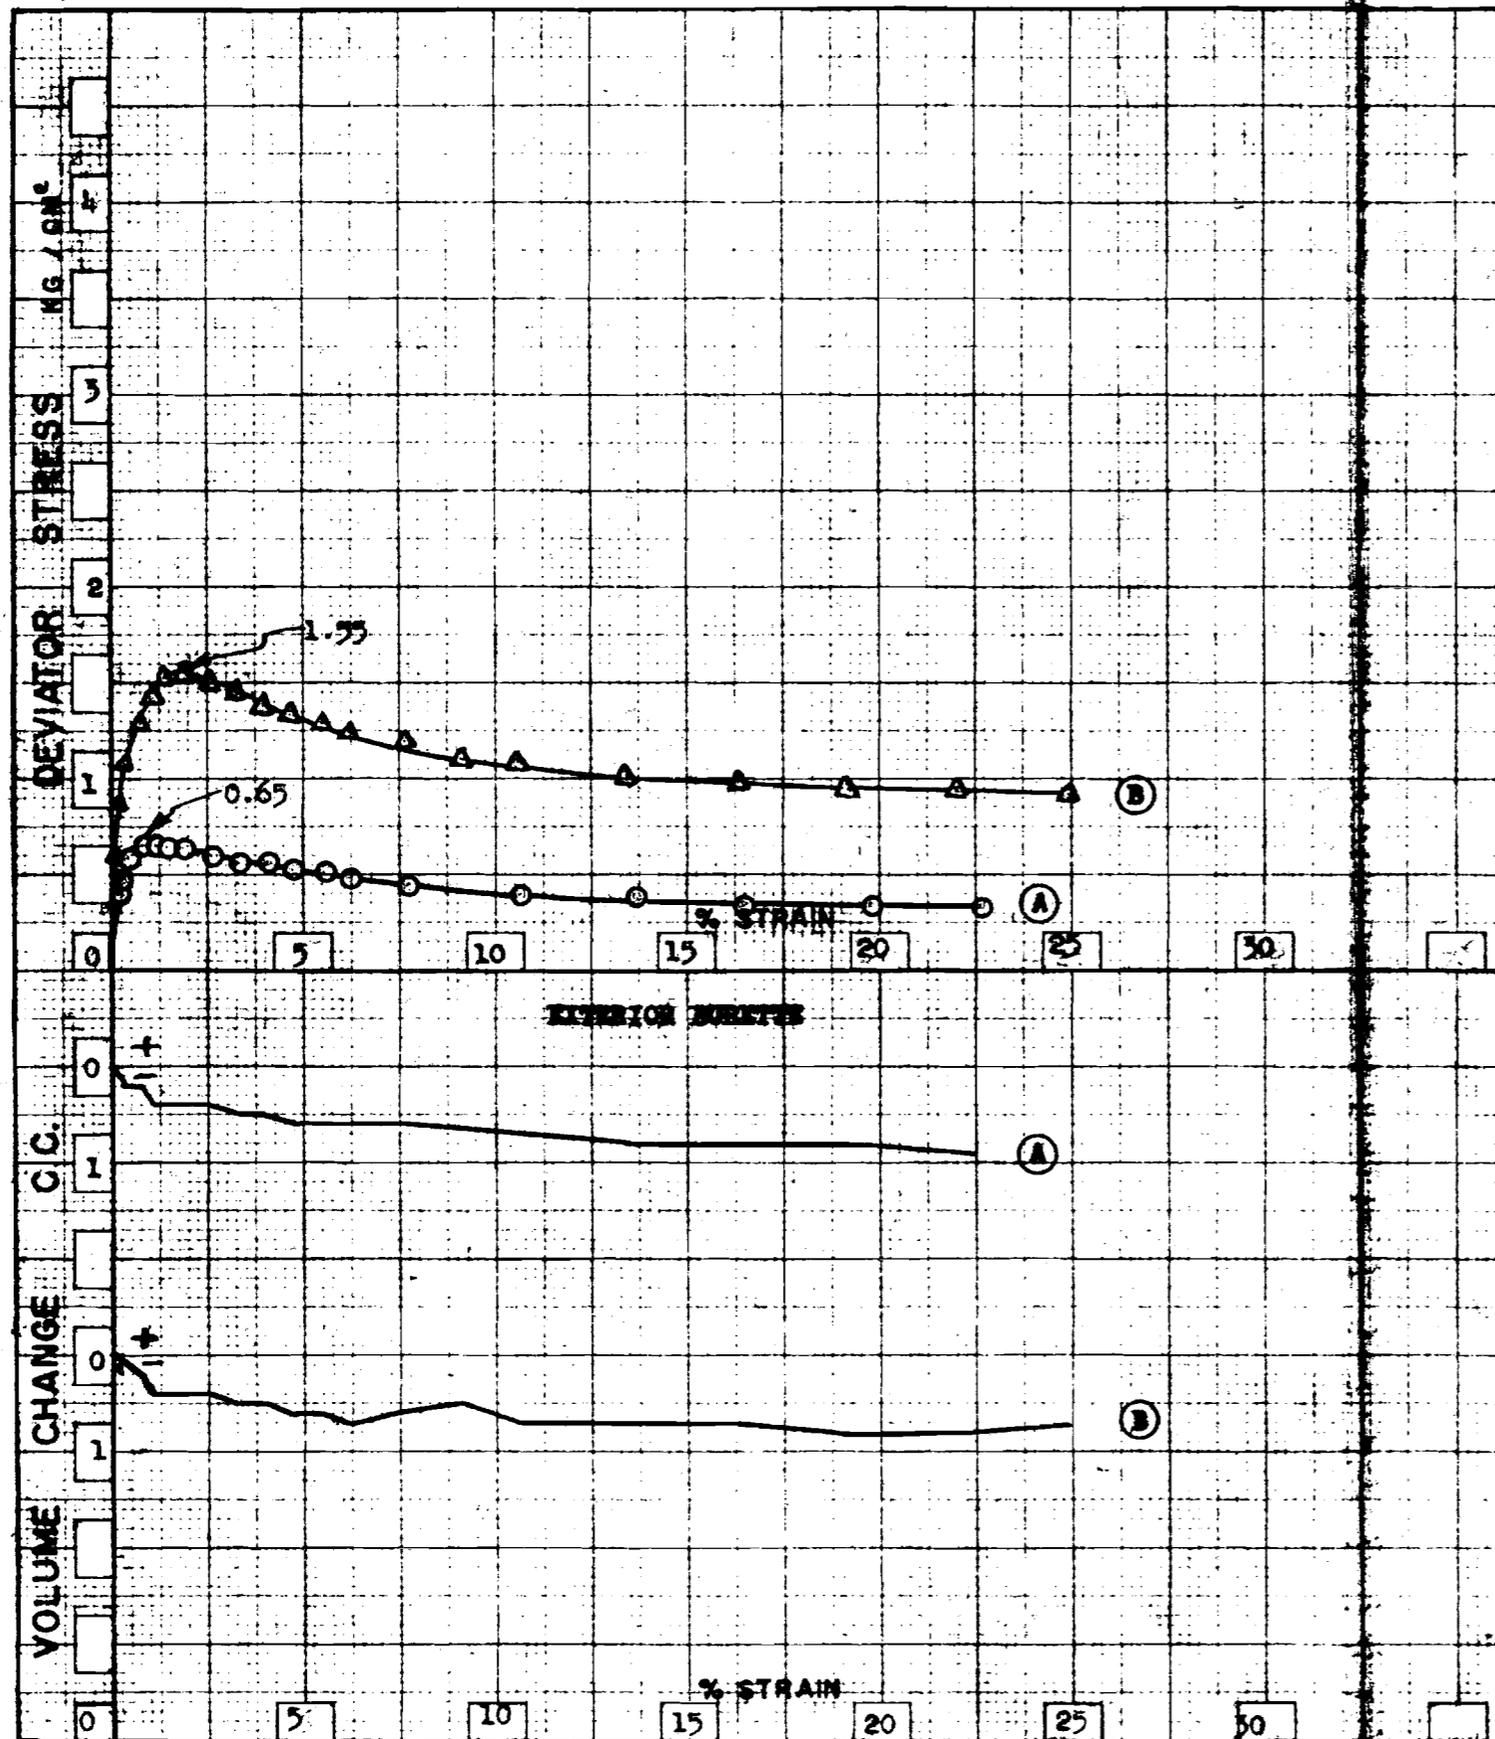
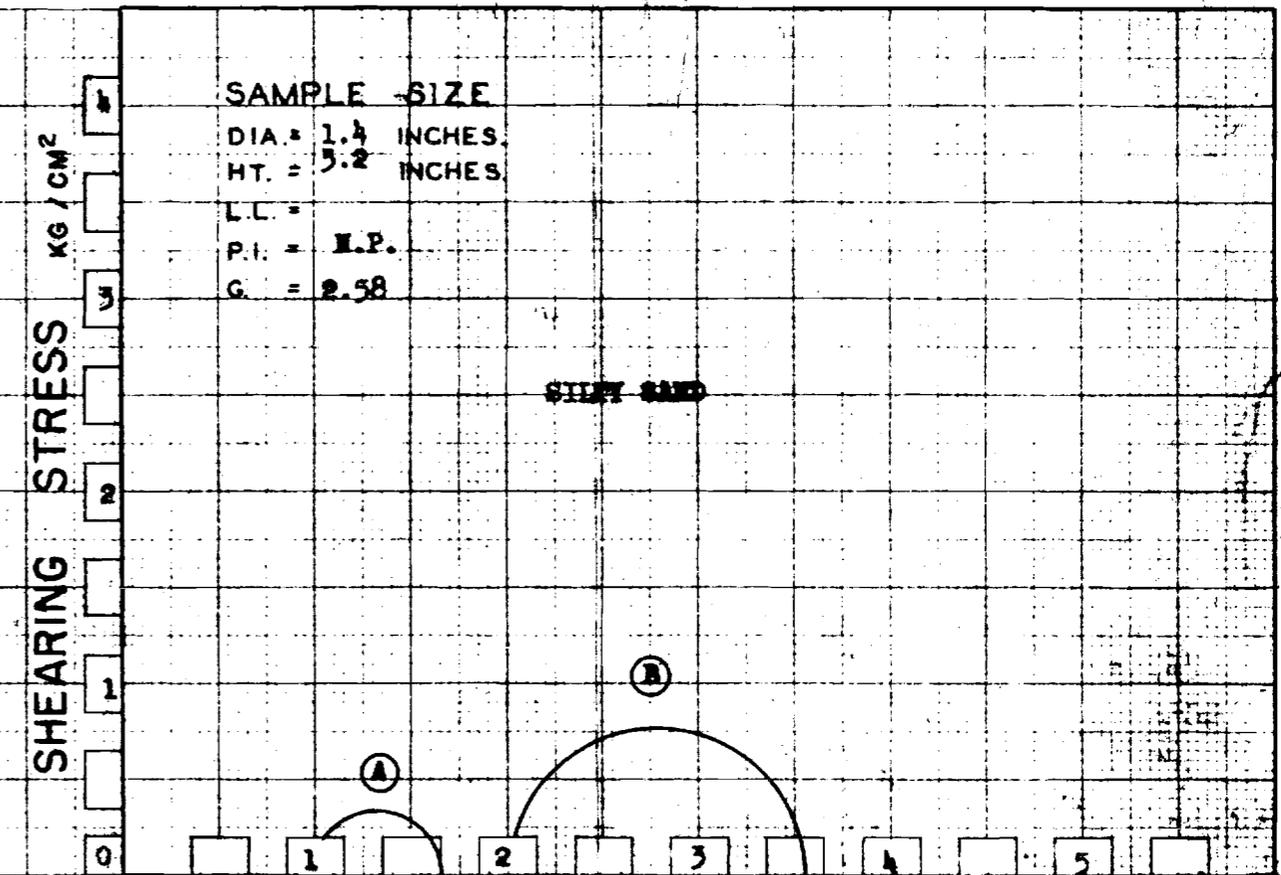
FIGURE 10

Based on the consolidation test data, the triaxial shear tests were performed for consolidated-undrained conditions. The results of these tests indicate that shear constants, varying between an angle of internal friction ϕ , equal to 16.5 degrees and zero cohesion, and ϕ equal to 21.5 degrees and zero cohesion, may represent the range in shear strength for the foundation material at the time of failure. A value of $\phi = 19^\circ$ was adopted for both the foundation and embankment. The sample of clay obtained from test hole 2, which conceivably might be representative of the original foundation material, was tested in an unconsolidated-undrained condition in both undisturbed and remolded states to determine the probable loss in strength due to remolding. The test results indicate little loss in strength.

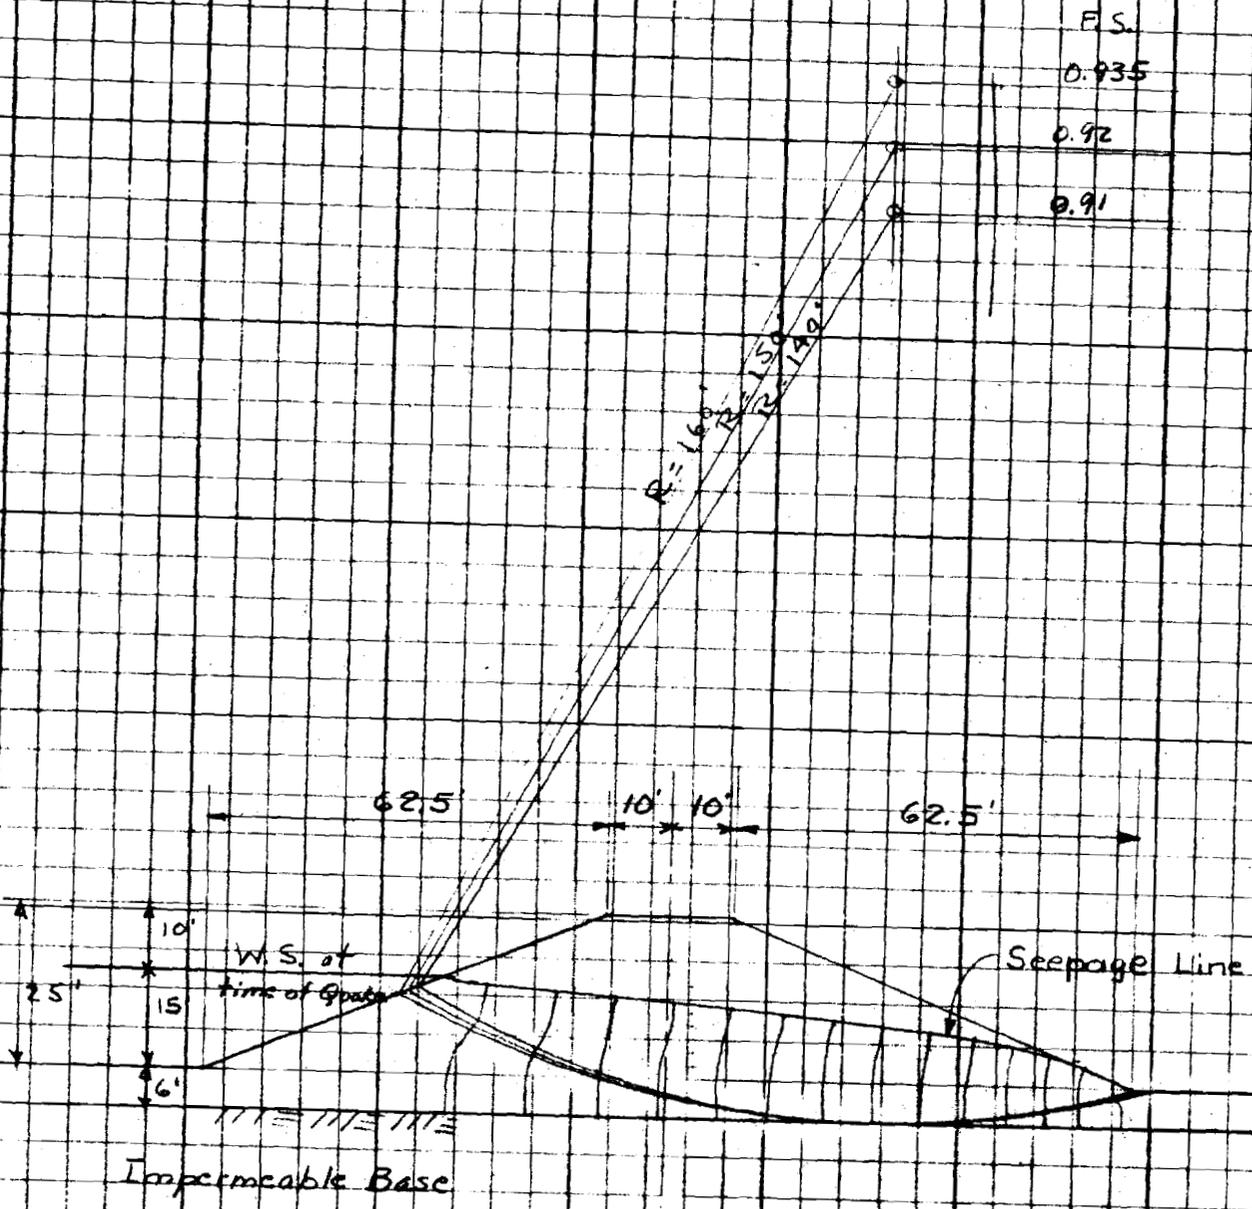
FIGURE 15

17. Stability analysis of embankment.-A stability analysis of the embankment was made on the basis of the following assumptions: (1) the material composing the embankment and foundation had physical properties as shown in the above table, (2) bedrock existed at a depth of 6 feet below ground surface, (3) the motion of the foundation during the earthquake was normal to the axis, and (5) the acceleration due to the earthquake was equal to 0.1 g.

By the critical circle method, the following safety factors have been determined:

- (1) Before earthquake, F.S. = 1.61
- (2) During earthquake, F.S. = 0.91

Results are shown on figure 15.
