## MEMORANDUM

Date: November 15, 2012

Re: Santa Clara Dam Failure / UT00443

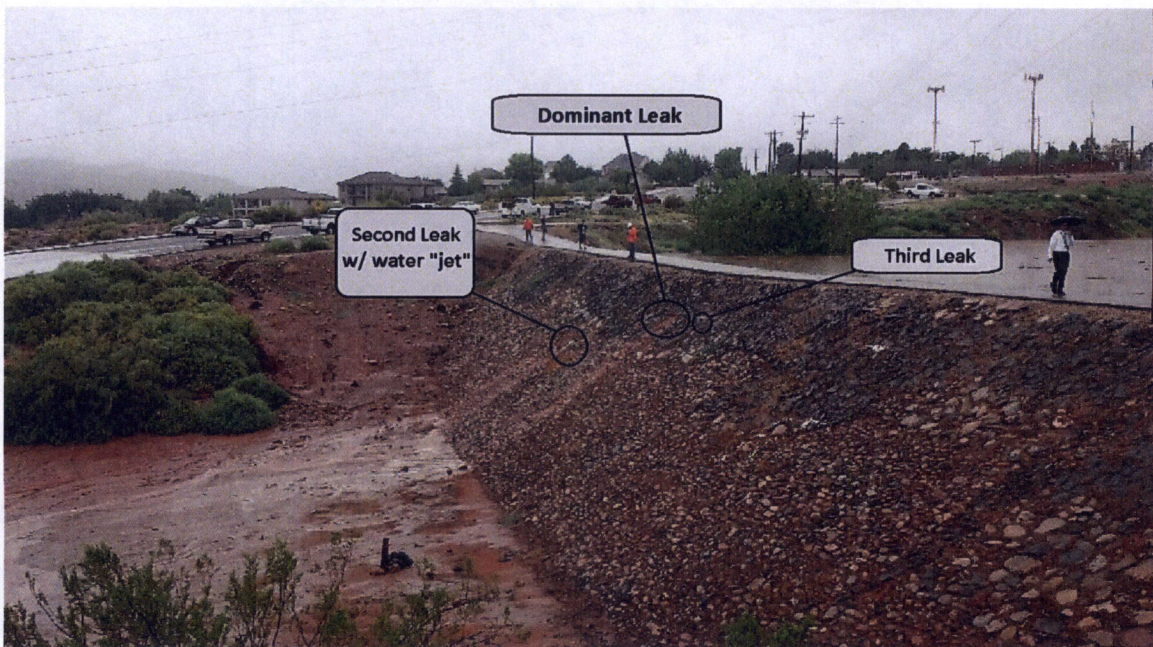
- Photography (video and still) taken during the breach confirms witness accounts of leaks in discrete locations at elevations 4 to 8 feet below the crest (Photograph 2).

Photograph 2 – Concentrated leak through the dam

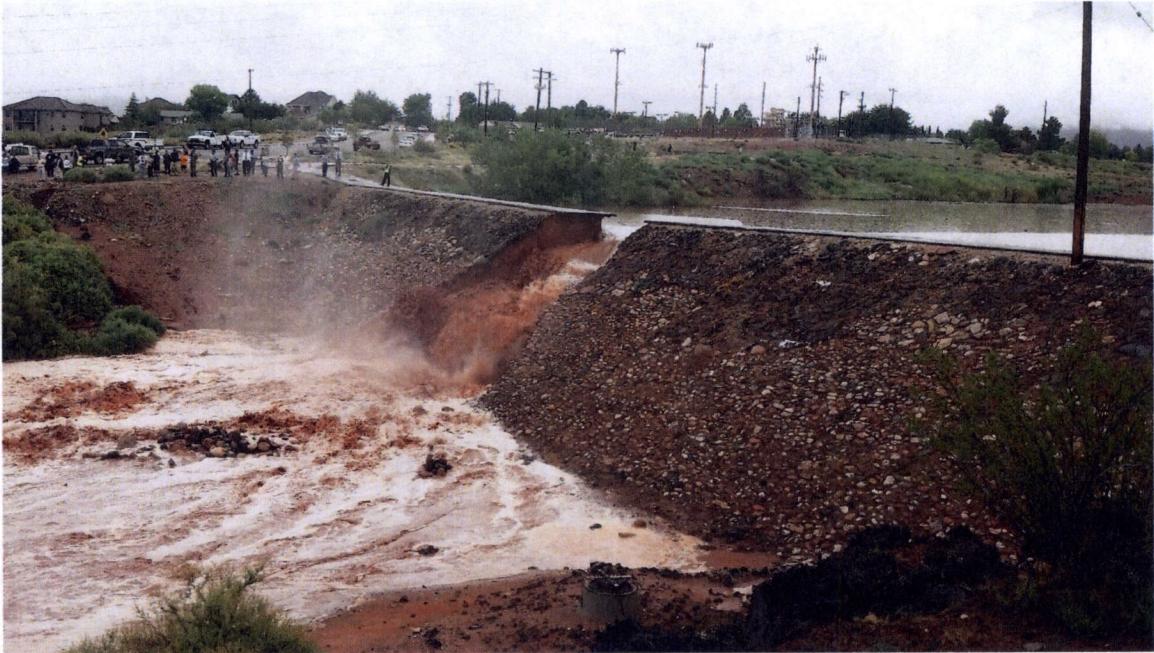
Photograph 3 – Failure progression

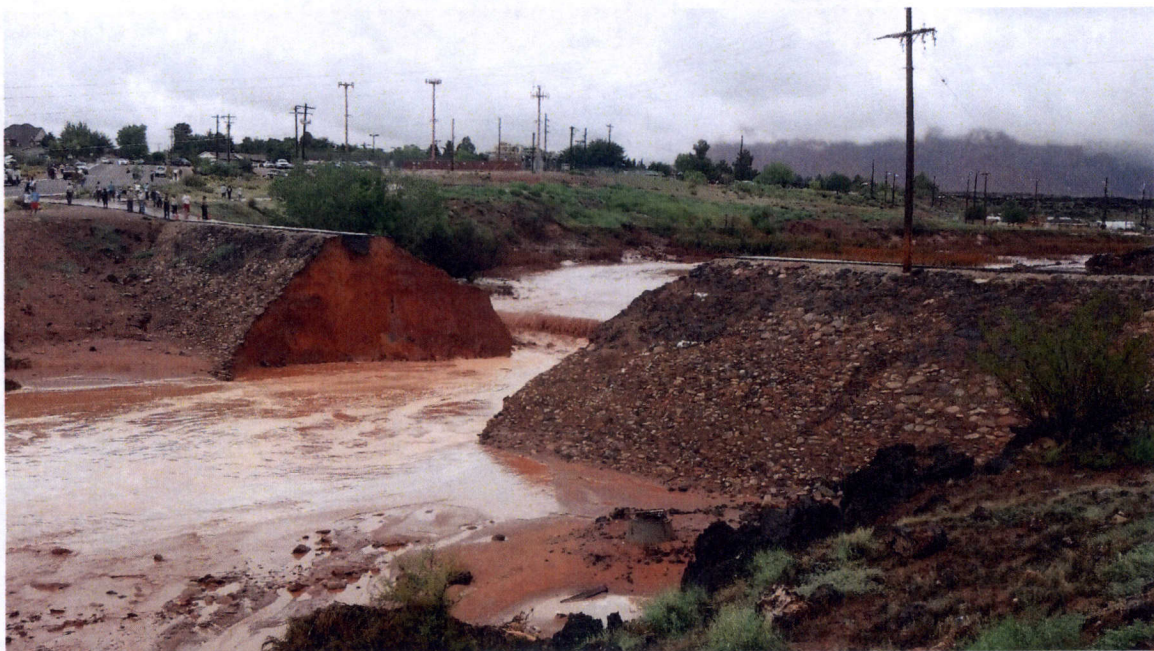
Photograph 4 – Failure complete

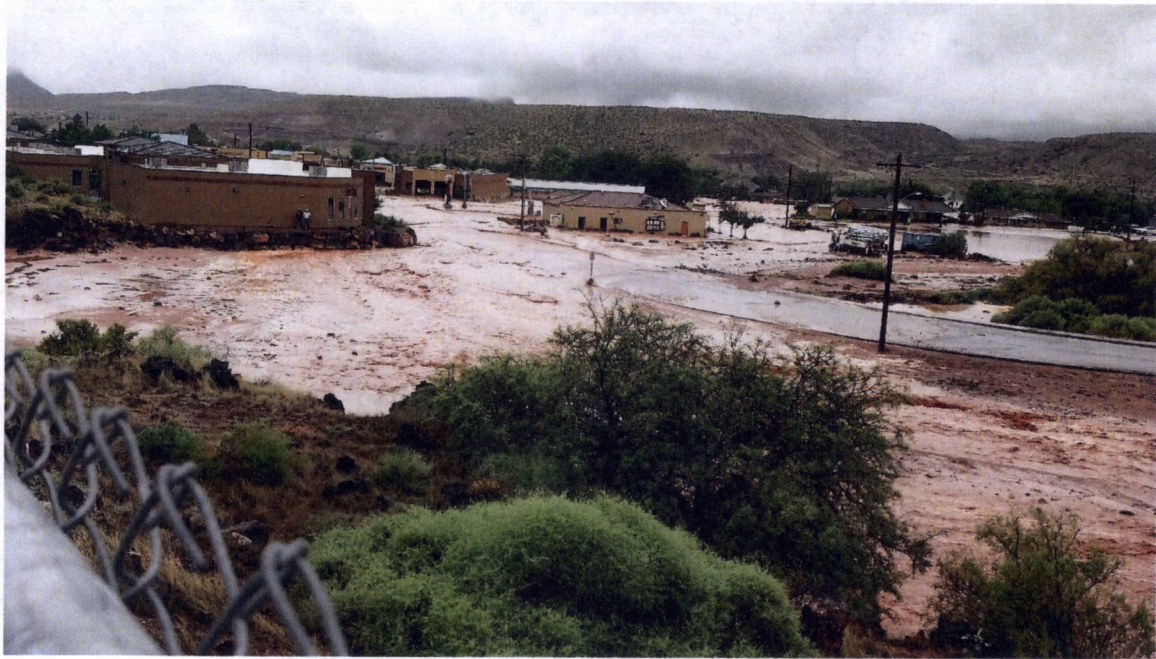
- While significant property damage occurred, no injuries were reported (Photograph 5).
- While infrequent, there are reports that the reservoir has previously filled to near the spillway, but there are no reports of previous flow through the spillway. It is possible that the reservoir reached a slightly higher elevation than has previously occurred.

Photograph 5 – Downstream flooding

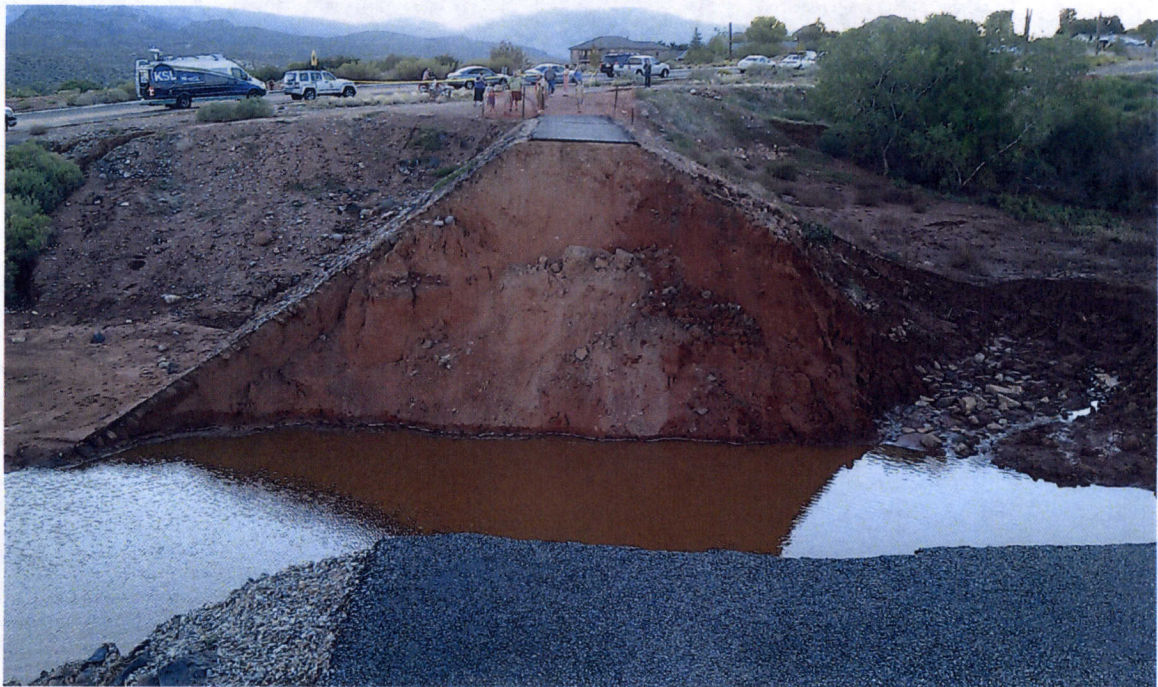
- Gullies were formed in the upstream face of the dam from backflow out of rodent holes as the reservoir dropped during the breach (Photograph 8).
- The central and downstream portions of the embankment the day following the breach appeared to be dry while only the upstream shell was wet (Photograph 6).

Photograph 6 – Post failure

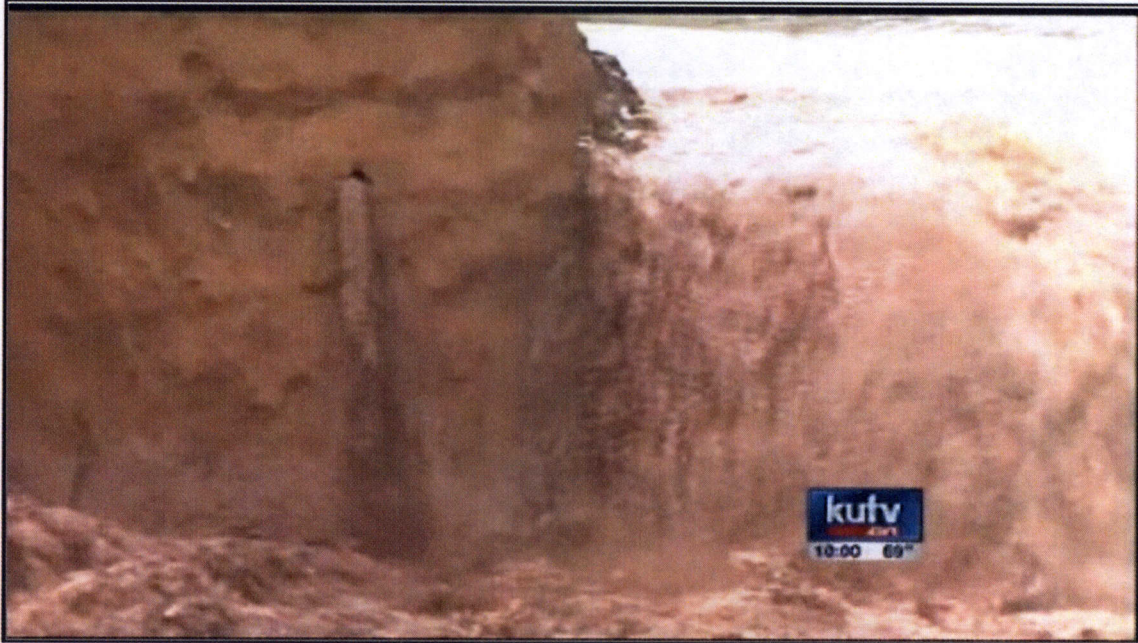
Photograph 7 – Concentrated flow through hole into breach

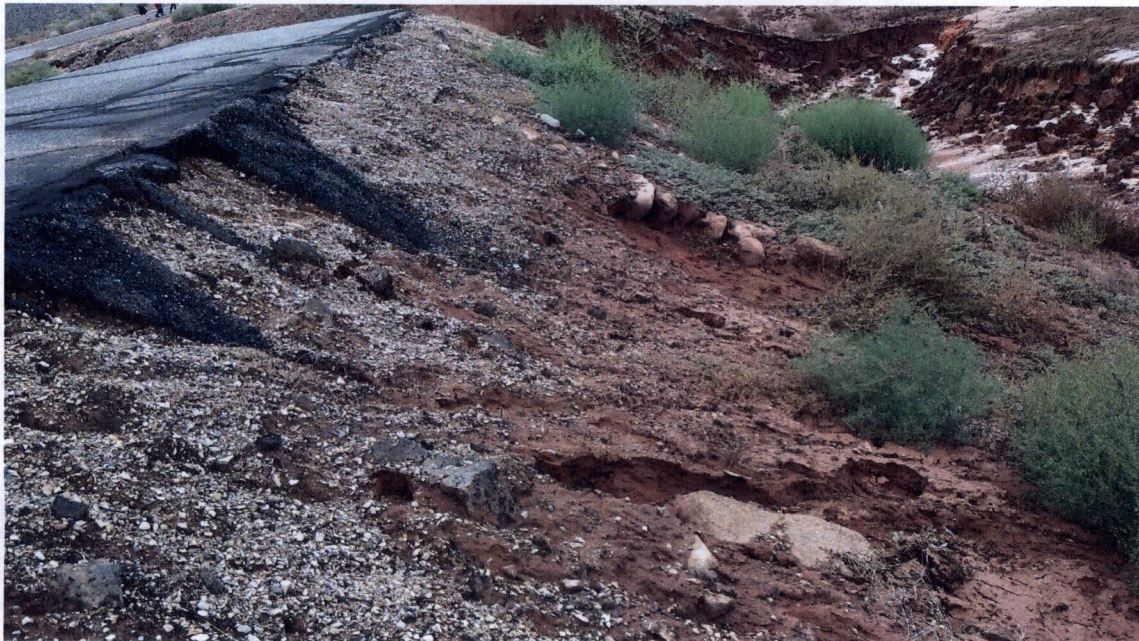
Photograph 8 – Post breach, rodent holes with gully from backflow

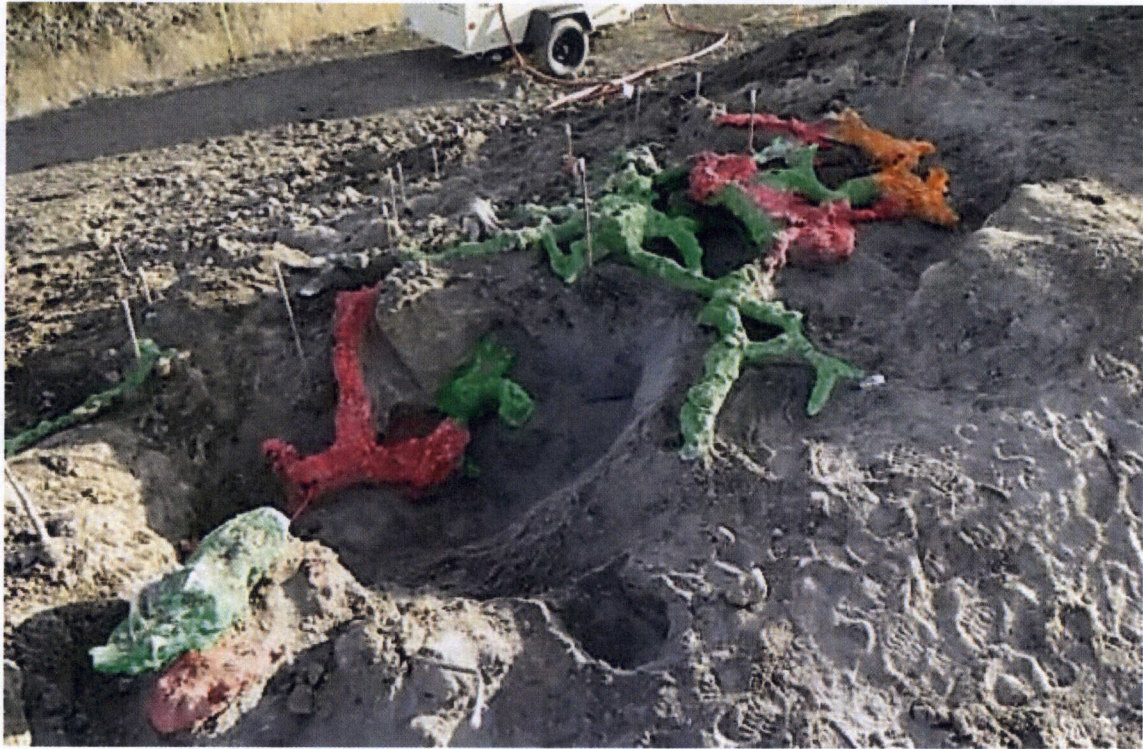
Photograph 9 – Grouted ground squirrel burrows exposed in landslide levee slope at Robbins, California
