LESSONS FROM SERIOUS INCIDENTS AT SEVEN ARCH DAMS

G. S. Sarkaria, Consulting Engineer, Vista, CA

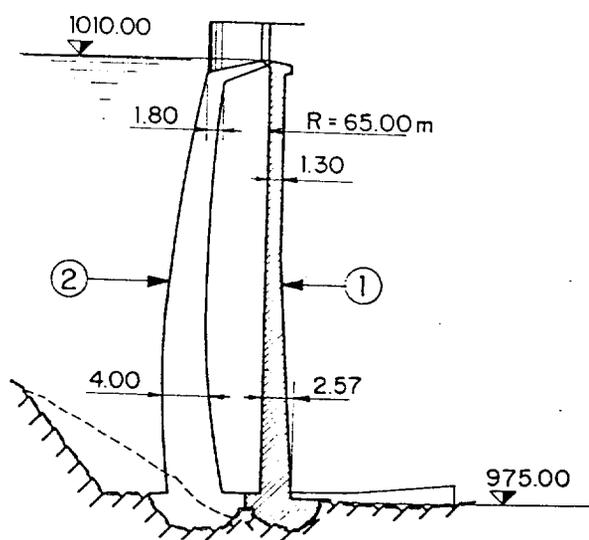
FIG 1. LE GAGE DAM

A photo taken by USBR⁵ engineers in September 1960 shows leakage through radial contraction joints and possibly through cracks and horizontal construction joints near the foundations. They agreed with the design engineers, (nine months after the failure of Malpasset dam), that *“the structure had the tendency to relieve itself of high stresses by cracking, without any serious effects.”* However, the cracking continued to progress and the responsible authorities decided to abandon Le Gage dam and build a new thicker arch dam upstream in 1963. (Fig. 1).

(1) Old ultra thin dam. (2) New dam

- The foundations for an arch dam should be properly treated by replacement of poor rock with concrete, grouting and drainage.
- Extensive and progressive cracking can seriously impair the safety and durability of a thin arch dam. A cracked dam is not as strong as an uncracked one.
- To reduce tensile stresses thicken the arch, particularly towards the abutments and the river bed.
- Provide interlocking keys in the contraction joints in all arch dams and grout them.

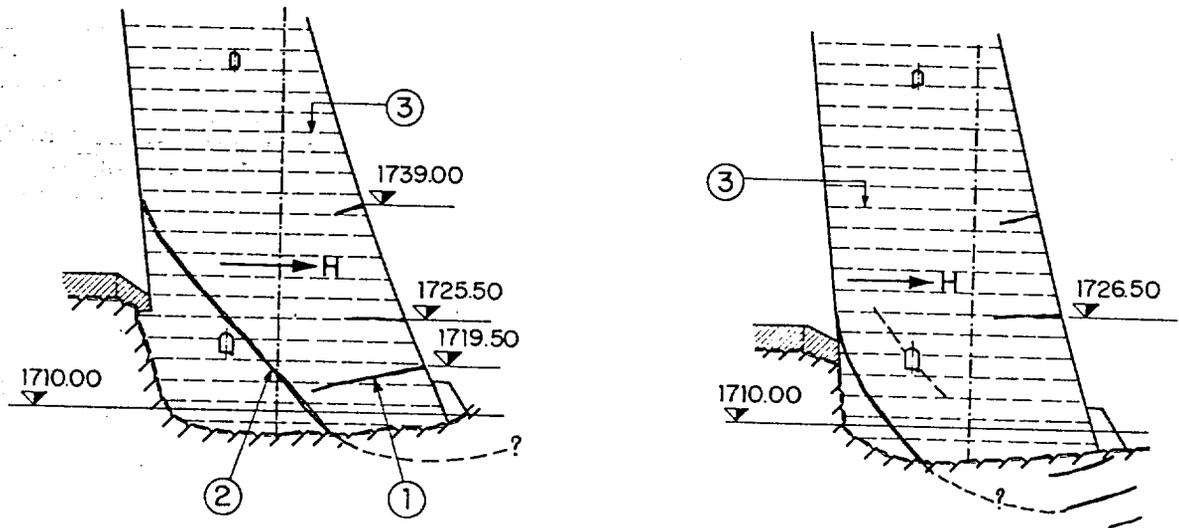
FIG. 3 KOELNBREIN DAM

(1) Downstream Cracks. (2) Main Cracks with Full Uplift.

Cracking in and movement of the lower part of the arch dam have been attributed to several factors⁸: trapezoidal shape of the site, downstream cracking during construction, subsidence of a weak schistose gneiss zone in the foundations and slenderness of the dam. The schistose gneiss zone was 30 to 100 ft. wide and traversed the central part of the river bed foundation and dipped downstream at about 45°. The deformation modulus and shear strength of this weak foundation zone were about 900,000 psi and 15 psi, respectively, (Fig. 3). Yet this substantial weak zone did not receive any special strengthening treatment because of the fallacious notion that a thin arch dam can adjust itself to excessive foundation deformations.

- Strengthen the weaker features in the foundations with concrete shear keys or plugs.
- Thicken the arch dam.
- Change the type of dam if foundations cannot be economically strengthened.

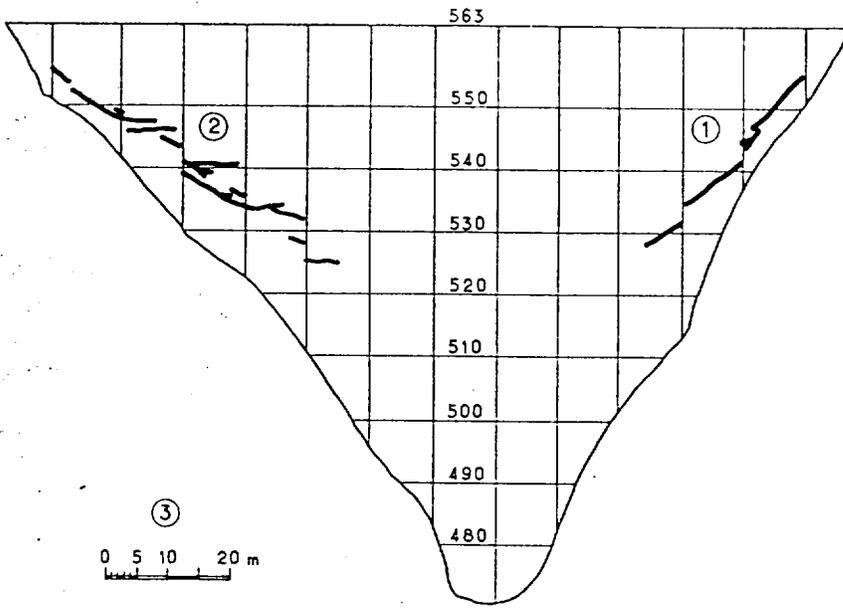
Severe cracking occurred on both faces in the upper half of the dam at both abutments. (Fig. 2.1). The measured deflections of the crest were far different from those calculated in design; almost like one of the modes of dynamic response to an earthquake.

In reality, the principal cause of cracking was that the dam was too thin, and its margins of safety against cracking and eventual failure were negligible.

2.1 Downstream Face Showing Cracks

- Arch dams should be thick enough so that there is no significant structural (stress) cracking, particularly on the upstream face, under normal loading conditions.
- Progressive structural cracking on both faces can lead to eventual failure of the dam.

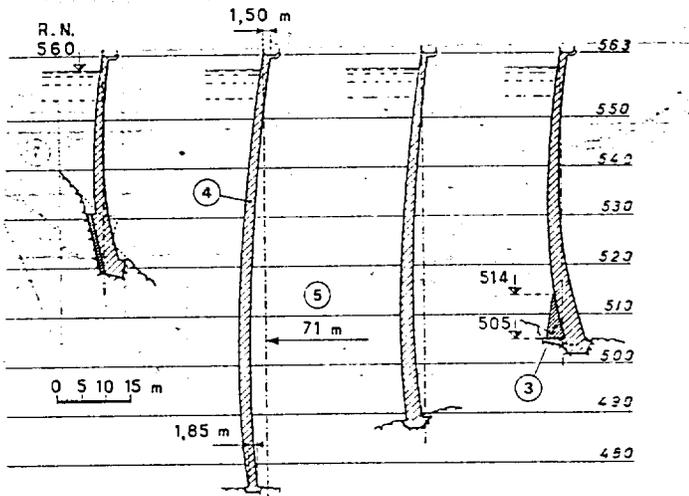
This ultra thin arch dam was completed two years after the failure of Malpasset. Apparently the designers had ignored the progressing cracking at Le Gage and Tolla was even more slender than the former, which was half its height (Fig. 2.2).⁶

2.2 Cross-sections

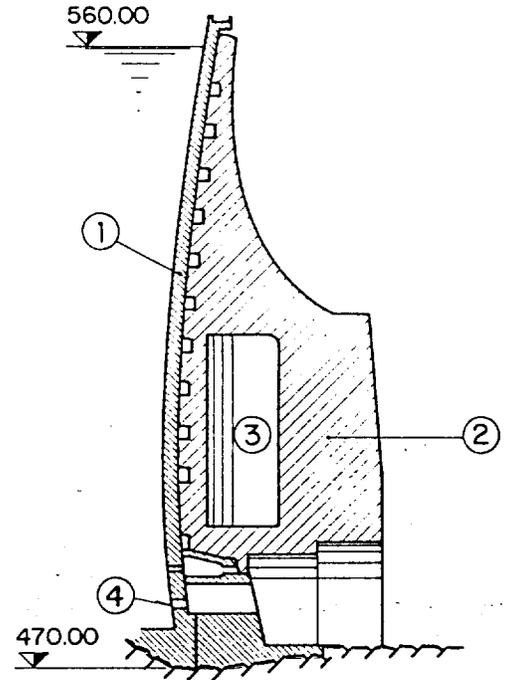
The ultra thin arch dam was completed two years after failure of Malpasset. Upon first filling of the reservoir in 1961, extensive cracking appeared on the downstream face near the abutments of the upper half of the dam. Since cracking continued to progress, for the next 8 years, a new downstream arch and buttresses were built to strengthen the original arch.

2.3 New Support Arch & Buttress.

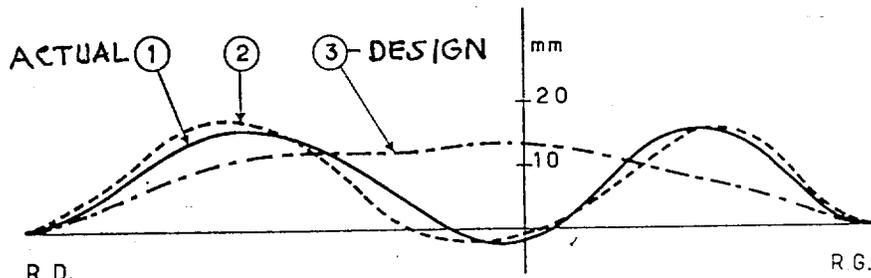
2.4 Crest Deflections
