## **WILL YOU BE ABLE TO ACCESS YOUR DAM DURING EMERGENCIES?**

Jeffrey Racicot, P.E.<sup>1</sup>

David Lord, P.E.<sup>2</sup>

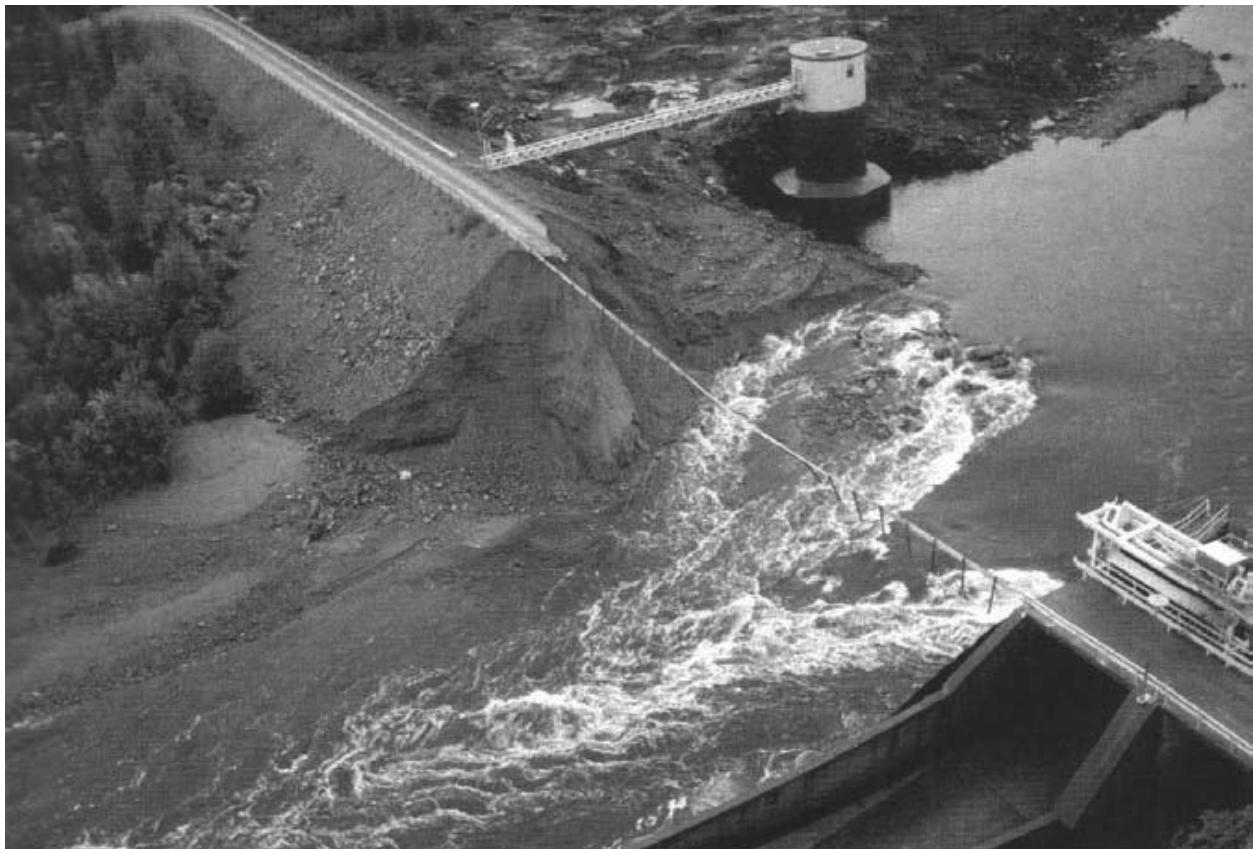
On September 7, 1985, Noppikoski Dam on the Ore River in Sweden failed by overtopping, and the subsequent erosion reached the river bed within minutes. The volume of the reservoir was approximately 811 acre-ft and the dam height was 54 feet. The reservoir was emptied within 45 minutes after overtopping began. During the failure, the total outflow was about 21, 200 ft<sup>3</sup>/s. Neither the discharge nor the stage hydrograph were measured downstream of the dam prior to the failure. Fortunately, there was no loss of life. Several bridges and the forest downstream were severely damaged.

- 3:30 a.m. Phone communication is lost from Noppikoski dam
- 4:25 a.m. Crane arrives but is **unable to access** project because of a washed out road a few hundred meters from the dam

- 5:25 a.m. Water begins to overtop and erode downstream embankment
- 6:10 a.m. 811 acre-ft is released through the breached embankment

Breach of Noppikoski Dam on September 7, 1985
