# OVERVIEW OF THE TAUM SAUK PUMPED STORAGE POWER PLANT UPPER RESERVOIR FAILURE, REYNOLDS COUNTY, MO

**Conor M. Watkins**

**J. David Rogers**

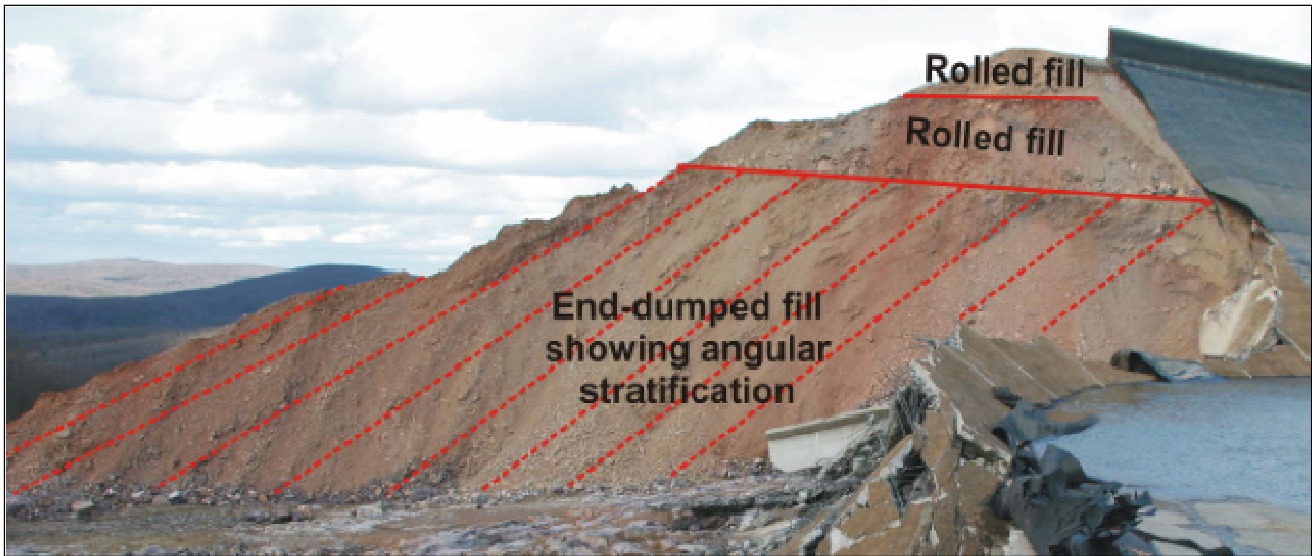
The majority of the upper reservoir's rockfill embankment appears to have been constructed through simple end dumping of the excavated material. The fill was allowed to tumble down the side of the embankment, lying near its natural angle of repose. The embankment materials were not mechanically compacted until the upper 16 feet of fill, which was compacted in four separate 4-foot thick lifts. According to FERC (2006), this was the last uncompacted concrete faced rockfill dam constructed in the United States. The boundaries between the different methods of fill placement were easily observed in the breached section of the embankment after the failure (see Fig. 2).

Fig. 2. – North side of the breached embankment shows the lower three quarters was end-dumped while the upper quarter was placed into two sequences of rolled filling. There does not appear to have been any significant effort made to mechanically compact the embankment because it was assumed to be a clean rockfill.

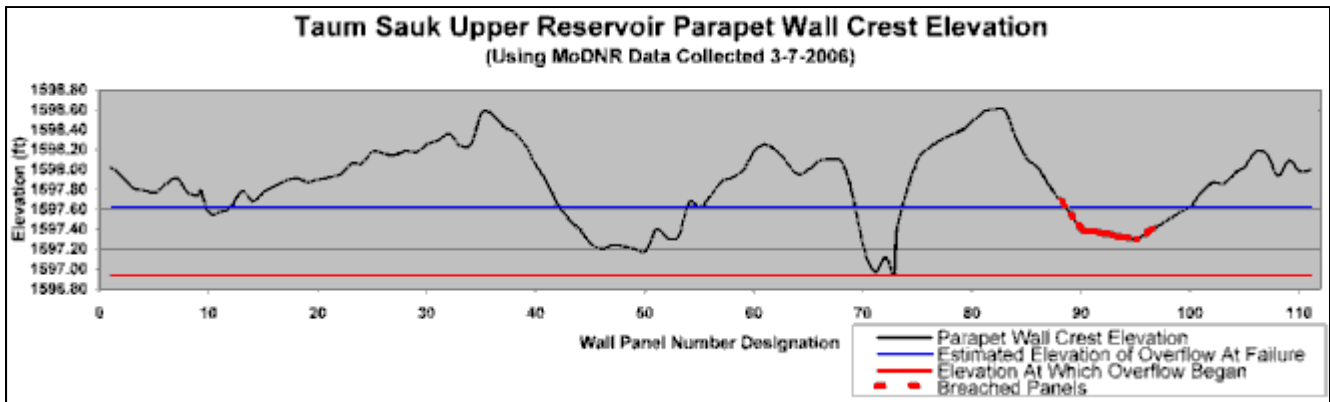
Settlement continued up to the time of failure in December 2005, with differential settlements approaching two feet along the crest of the reservoir’s parapet wall (see Fig 3). This differential settlement also led to a cracking of the concrete lining and continual problems with leakage. Leakage became so severe in 1963, only months after operations began, it necessitated shutdown of the facility and additional grouting of the reservoir floor in the northwest portion near where the reservoir failed in 2005 (FERC Independent Panel, 2006).

Fig. 3. – This figure illustrates the differential settlement along the crest of the upper reservoir parapet wall. Four segments of the parapet wall were almost two feet lower than their original elevation. The elevations of the breached panels (shown here in red) were estimated by AmerenUE after the failure and may not be accurate. (Data: MoDNR (2006))

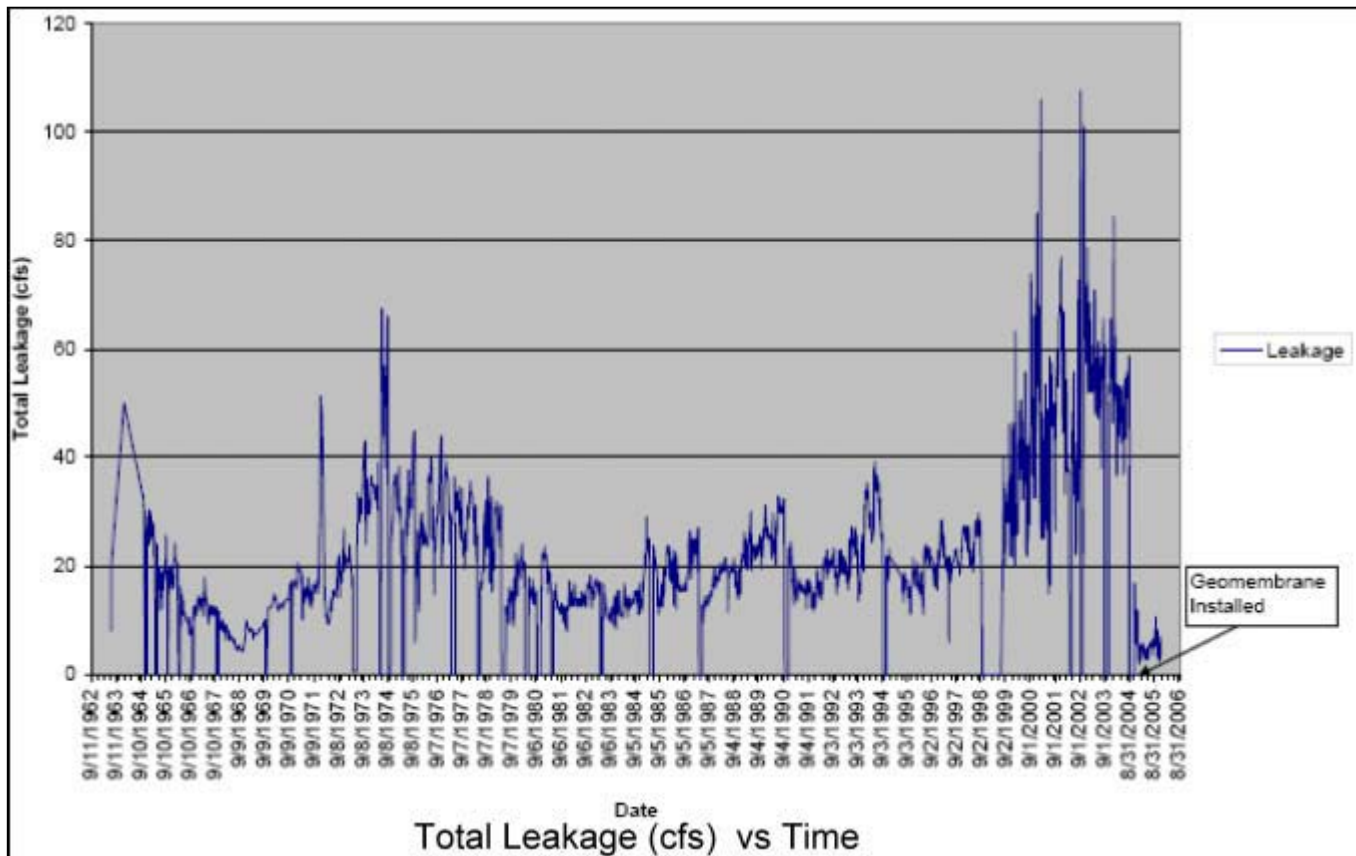
Fig. 4. – This figure from FERC’s Independent Panel of Consultants Report (2006) shows a gradual upward trend in leakage rates until it was lined in 2004, dramatically reducing seepage.

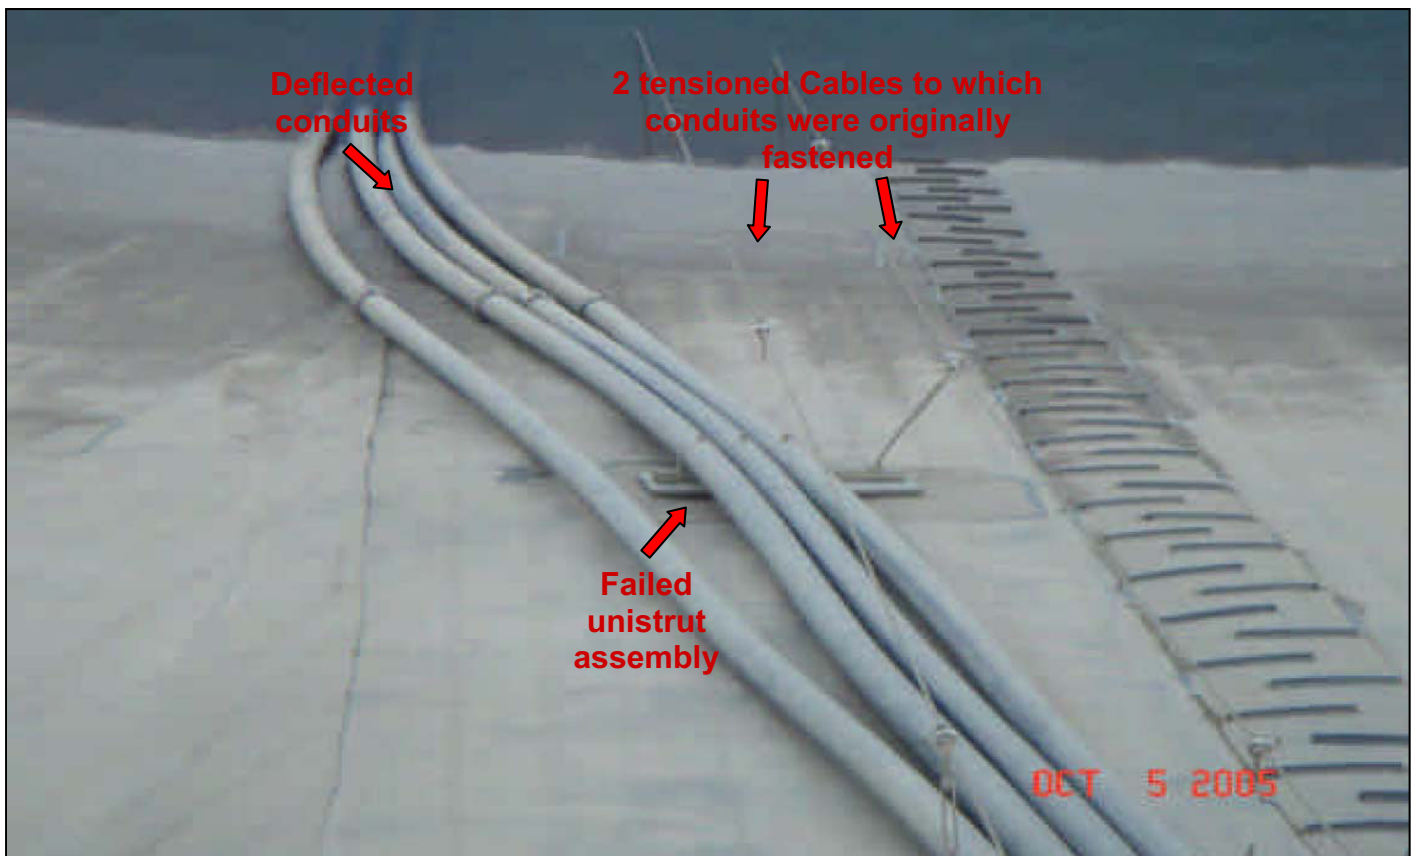
Divers were summoned and they ascertained that the new sensor conduits had become detached from their mountings along the sloping concrete face of the reservoir. Maximum water levels in the reservoir were re-programmed to reduce the operating level by two feet to provide a temporary “margin of error.” Unfortunately, permanent repairs were postponed until regularly-maintenance the following spring (FERC Taum Sauk Investigation Team, 2006) to avoid an additional shutdown of the facility. Fig. 5 shows a Photo taken by AmerenUE on Oct 5<sup>th</sup>, 2005 when the reservoir pool was drawn down. This shows the sensor conduits have detached from their anchorages.

Fig. 5. – This photo taken on October 5, 2006 by AmerenUE shows the gross deflection of the reservoir’s instrumentation array (photo from Rizzo Associates, 2006).

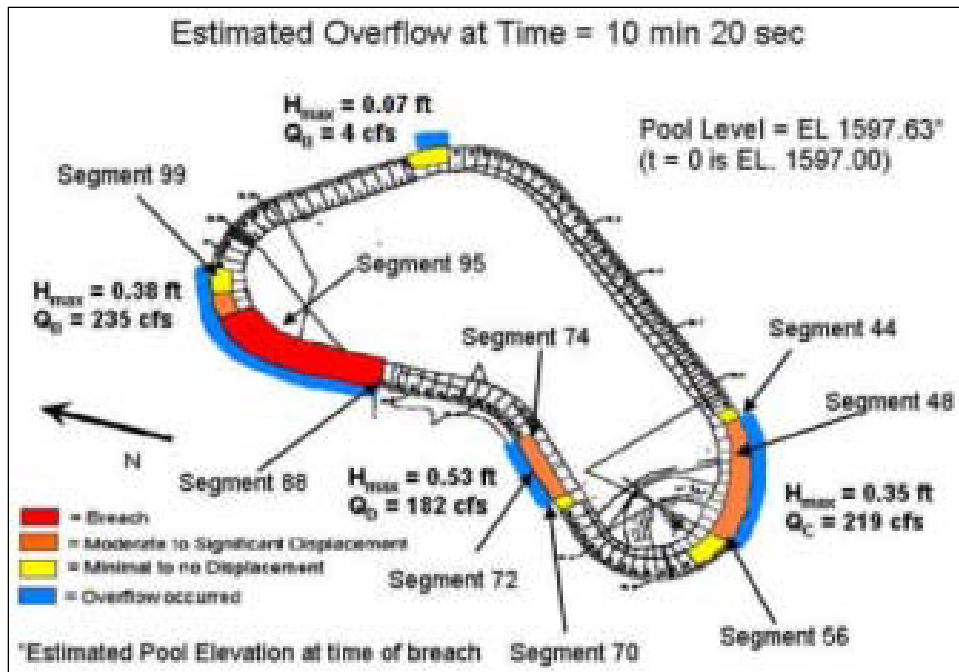
The 6,562 ft long parapet wall was comprised of 111 panels, each about 60 feet long. Each wall panel was designated by a number, between 1 and 111. These numbers are referred to in the description that follows. See Fig. 6 for locations of overflow (shown in orange) and the eventual breach (shown in red).

Fig. 6. – This graphic from Rizzo Associates, Inc. (2006) shows panel locations where overflow and failure occurred.

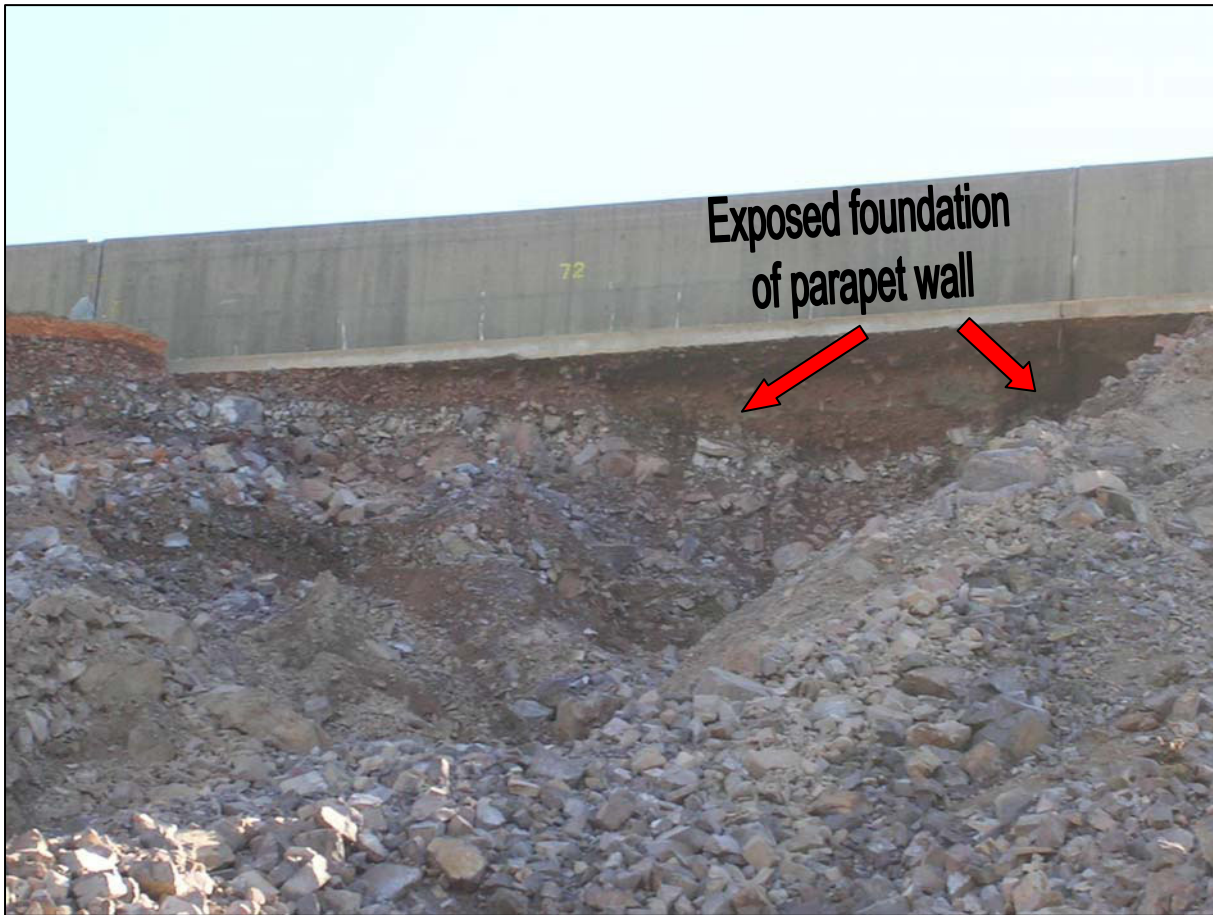
The discharge passing over the parapet wall initially spilled onto the wall’s outboard footing, which was three feet wide. When the depth of overtopping exceeded 4.1 inches the lower nappe of the spillage would have begun spilling onto the unprotected embankment materials, scouring the rockfill beneath the wall. Post-failure observations at Panels 10-12, 43-56, and 69-74, (which all survived) suggest that the water quickly scoured deep plunge pools where it poured directly onto the unprotected rockfill. These materials were rapidly transported downslope and deposited in fans towards the toe of the embankment. The plunge pool deepened itself within a matter of minutes, displacing the largest clasts onto the rim of the plunge pool. Plunge pools normally excavate themselves to a depth of 1.5 times the free fall height on level ground, but the steep face of the rockfill dike (1.3:1, horizontal to vertical) may have exacerbated this situation, allowing an even deeper pool to develop. This statement is based on post-failure observations below Panels 71-72 (shown in Figure 7). The overtopping flow appears to have undermined three adjacent panels of the parapet wall in about six minutes, centered around panel 95, on the northwest side of the reservoir. Excerpts from a reconstructed failure sequence and complementary photos illustrative the failure mode (see Figs. 8-18.).

Fig. 7. – This photo taken below panels 71-72 show the deep plunge pool that developed and subsequent undercutting of the parapet wall. (Photo courtesy of David Hoffman).

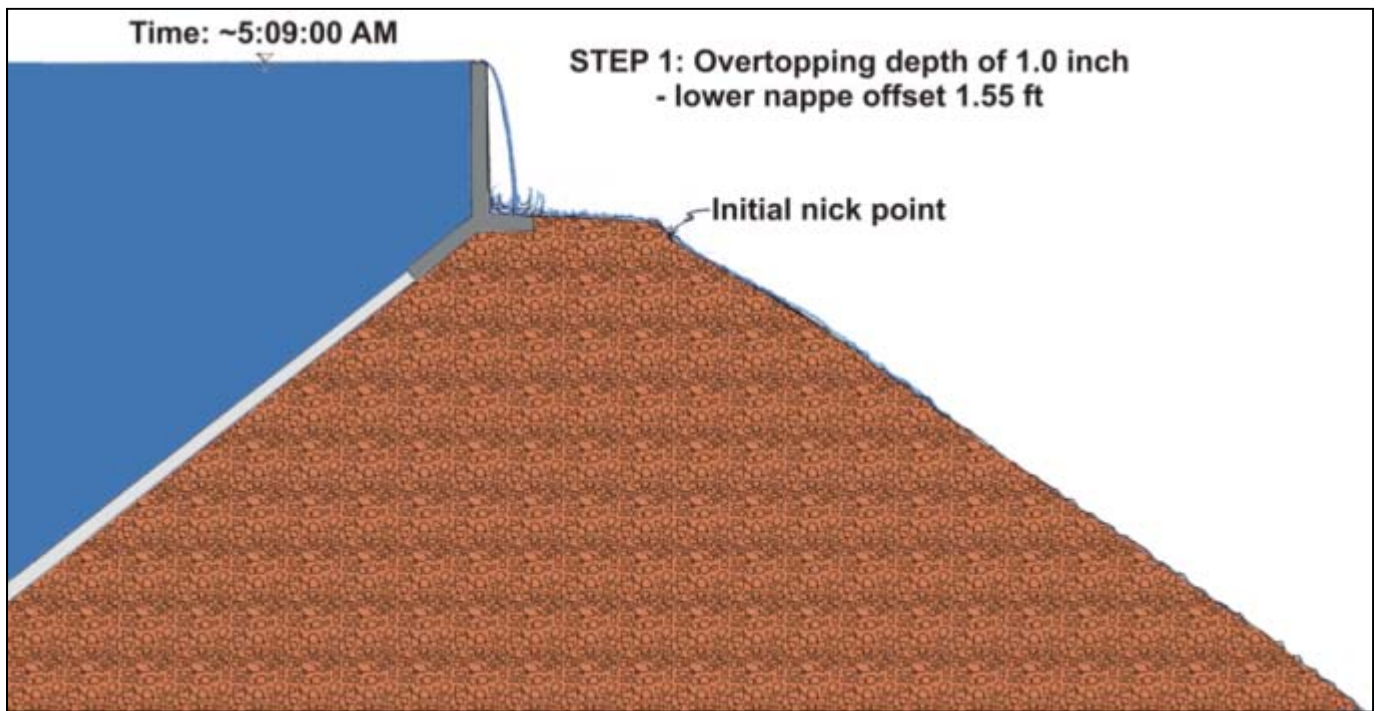
Fig 8. – The first figure from the reconstructed failure sequence shows the initiation of overtopping around 6 minutes prior to failure. Water is spilling onto the 3 foot wide parapet wall footing and just beginning to erode crest of the embankment.

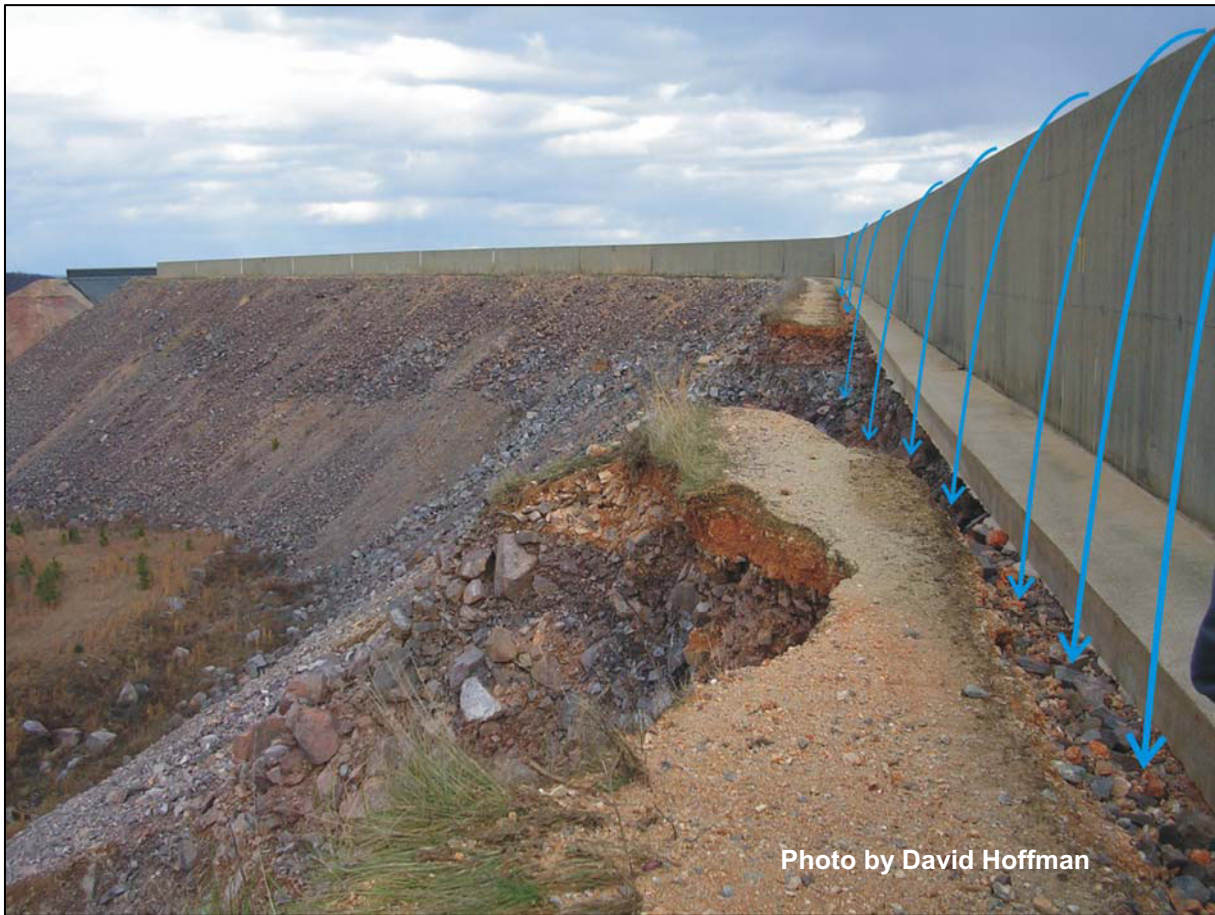
*Fig 9. – This photograph shows arrows representing the overflow nappe once it extended beyond the 3 foot wide wall footing and directly onto the underlying rockfill. The rate of scour and erosion increased dramatically once this occurred.*

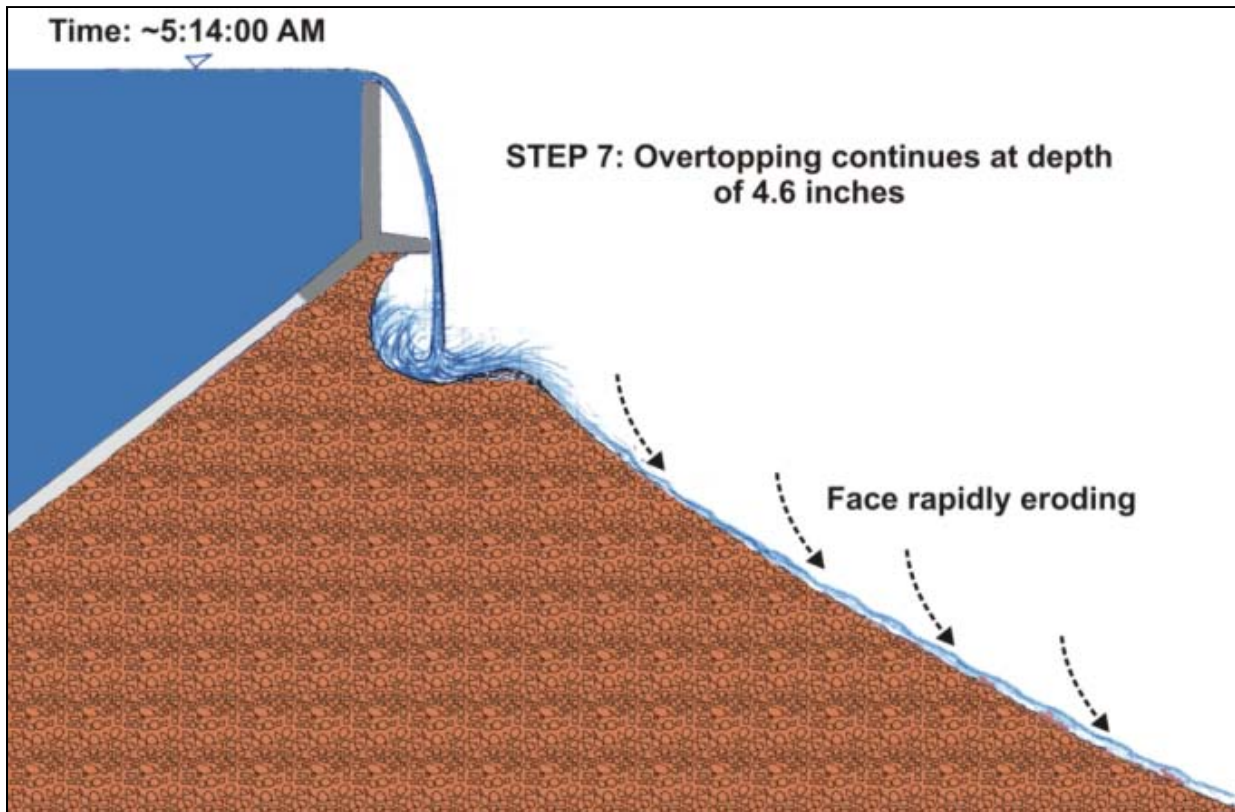
Fig 10. – This step of the reconstructed failure sequence illustrates the undermining of the parapet wall and rapid erosion of the embankment. The wall remained standing at this point due to the hydrostatic load on the inclined portion of the wall footing and 3-dimensional effects from surrounding wall panels.

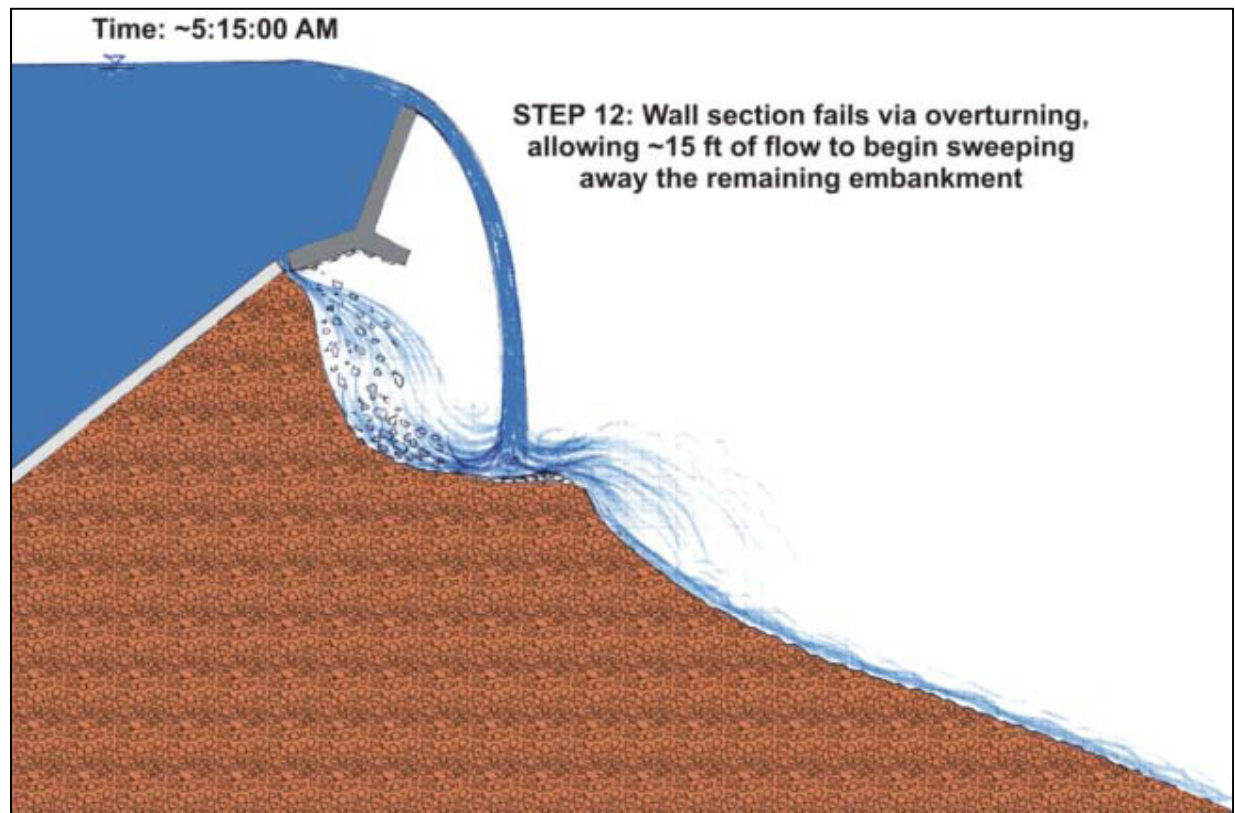
Fig. 11. – This step portrays how the parapet wall toppled in vicinity of panel 95, initiating the catastrophic failure of the reservoir by unleashing around 15 feet of flow over the remaining embankment.

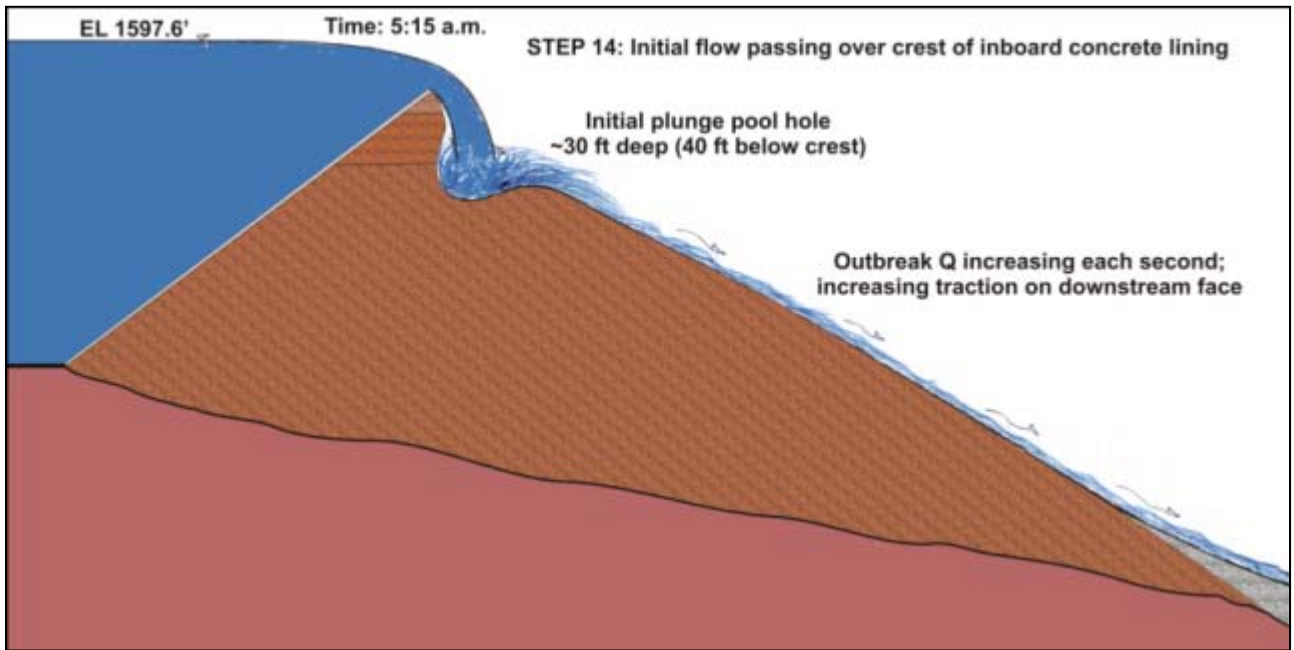
Fig. 12. – This figure illustrates ~15 feet of water overflowing the embankment immediately after the failure of the parapet. The reinforced concrete liner behaved as a thin-crested weir and allowed for the formation of a deep plunge pool.

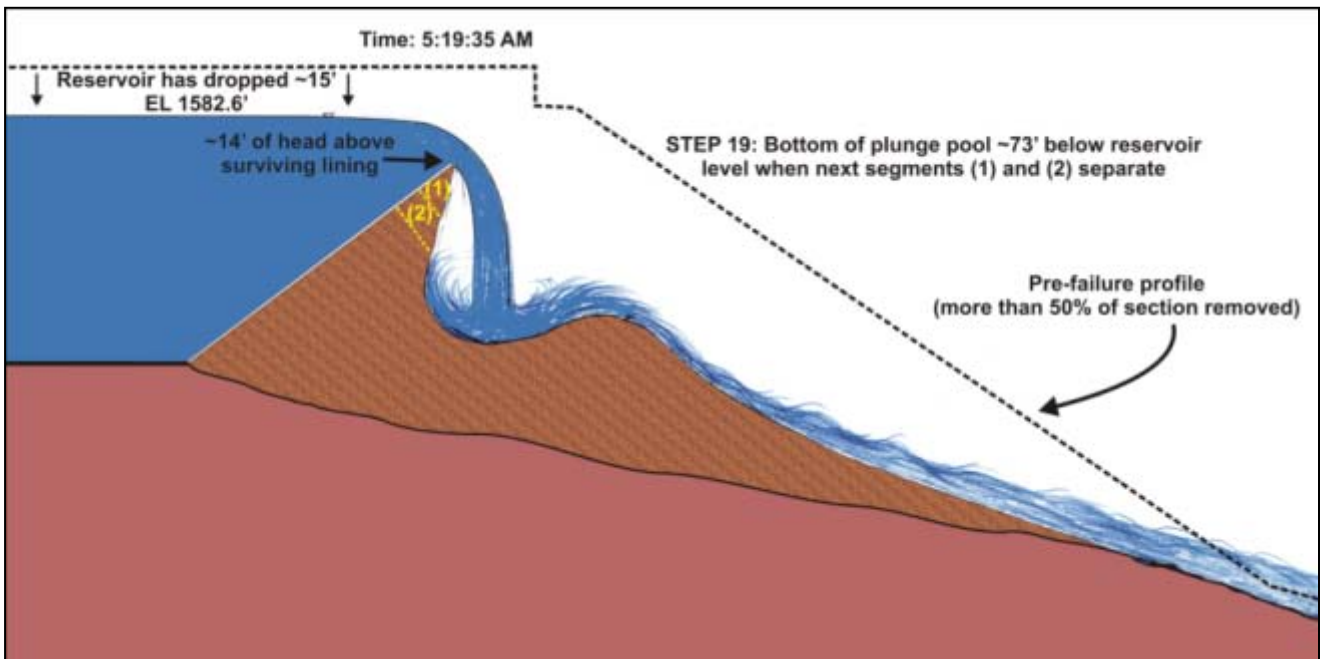
Fig. 13. – The embankment and concrete liner are progressively removed by the outflow. About one half the embankment remains at this stage.

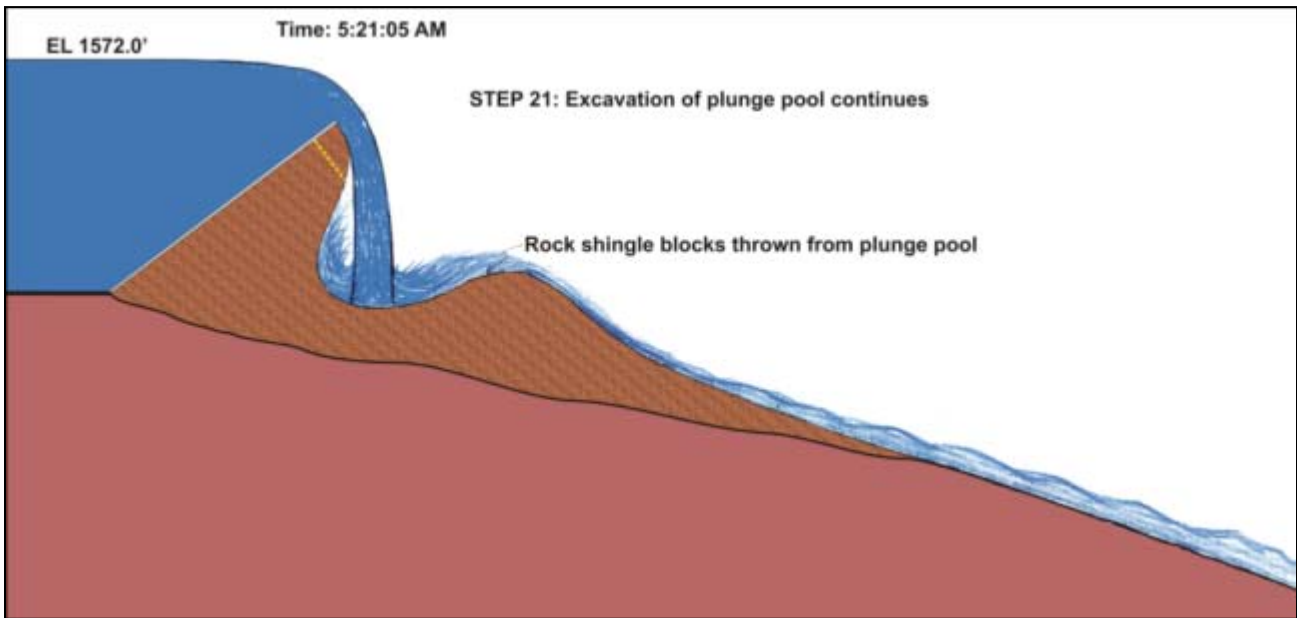
Fig. 14. – A continuation of the sequence show deepening of the plunge pool and ejection of large shingle blocks/boulders.

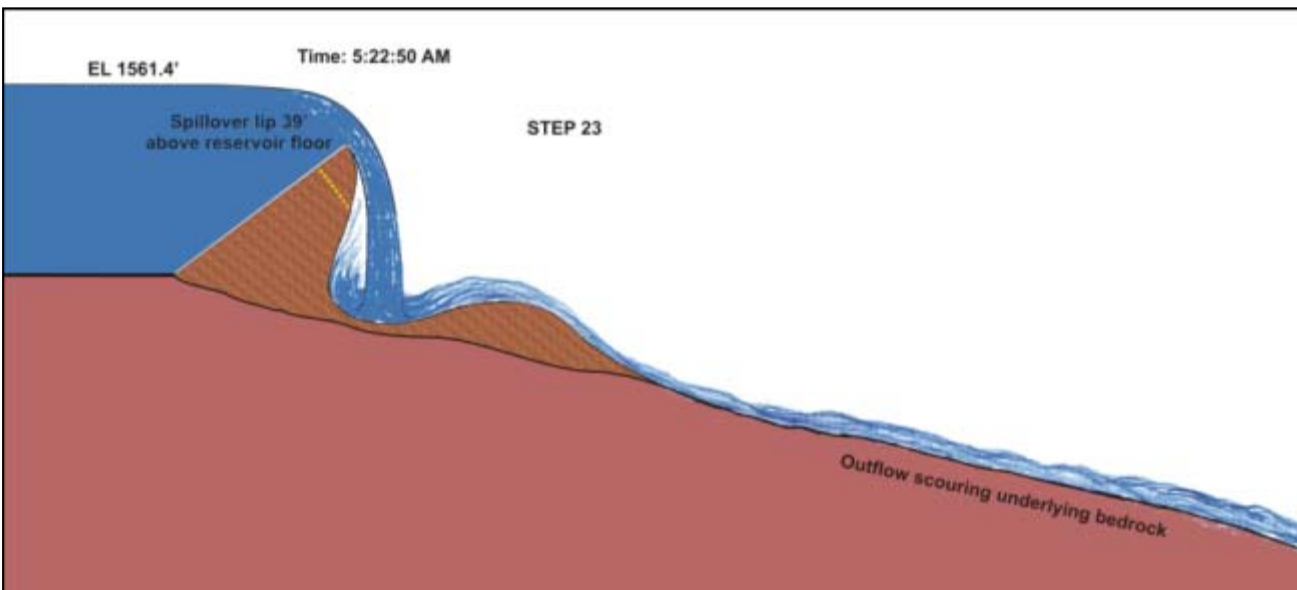
Fig. 15. – The plunge pool deepens towards the foundation interface and outflow has exposed much of the underlying bedrock, which is then scoured.

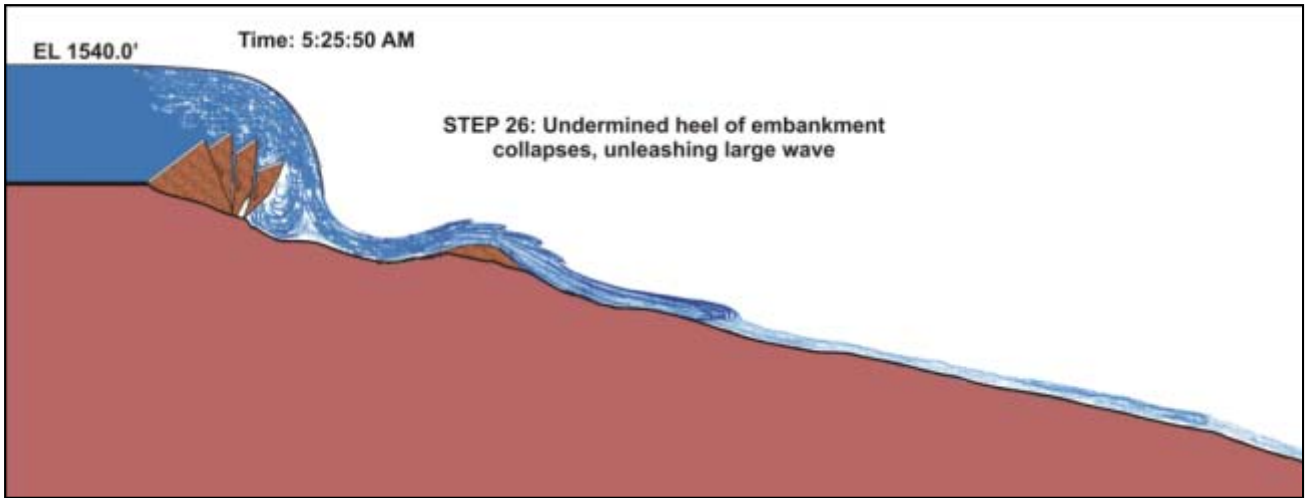
Fig. 16. – The embankment undergoes one final large collapse involving the concrete liner, sending one final surge down the slope.

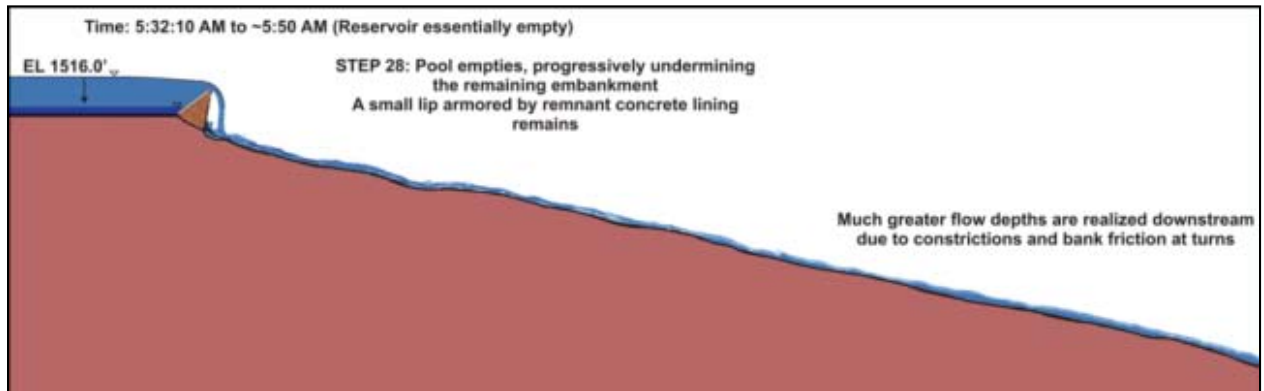
Fig. 17. – A small lip formed by the concrete liner armored the final last remnants of the embankment. Only a small amount of water remained in the reservoir.

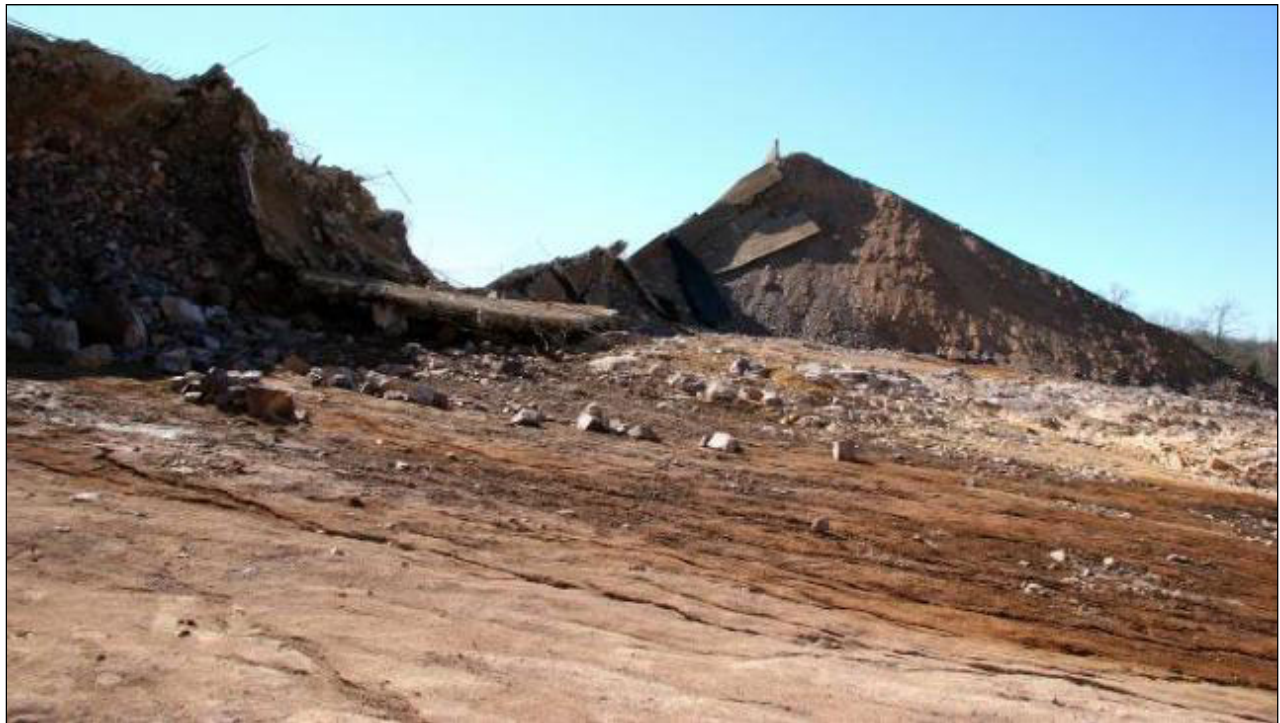
Fig. 18. – The remnant lip as seen at the failure site.

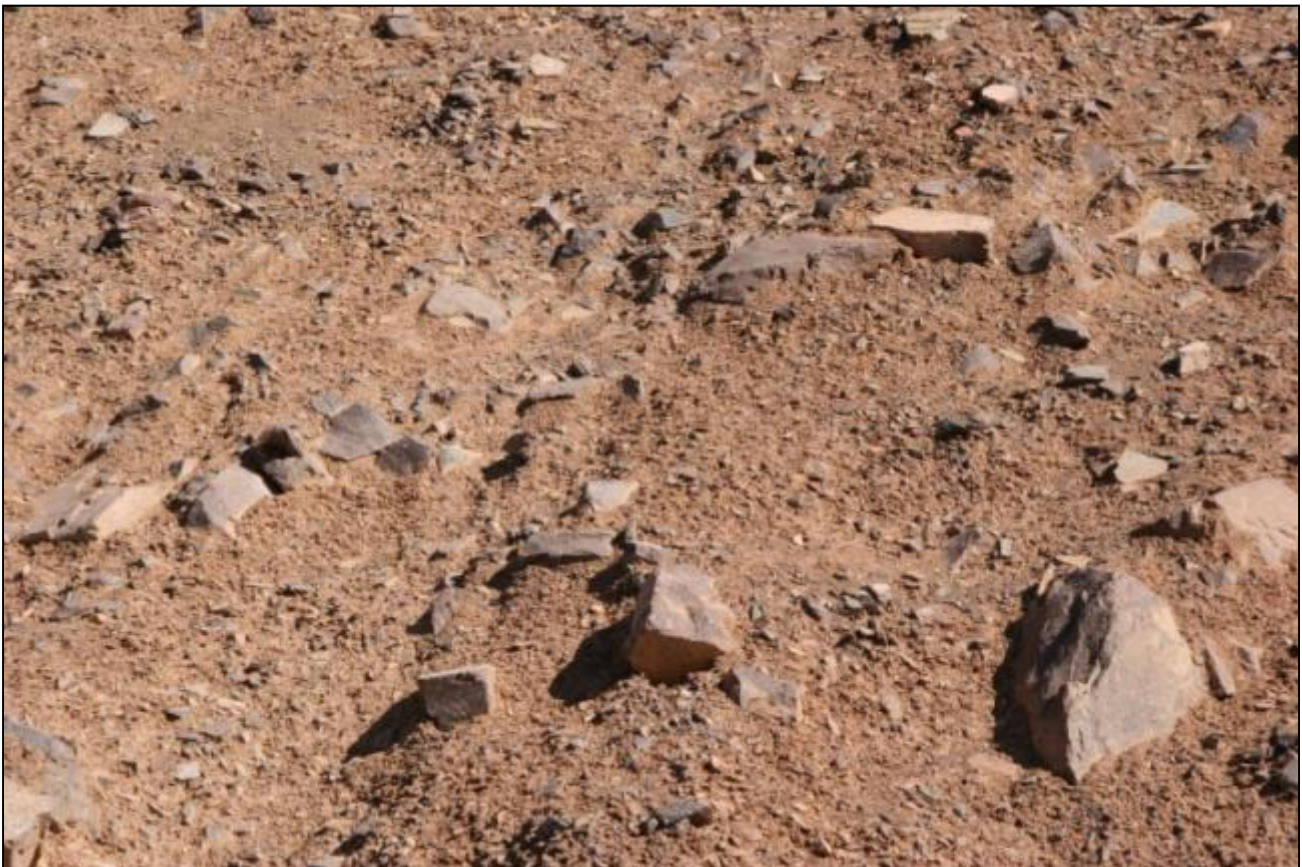
After the reservoir failure, The Federal Energy Regulatory Commission (FERC) and the Missouri Department of Natural Resources, Dam and Reservoir Safety Division (MoDNR-GSRAD) conducted investigations into the failure. Although the embankment was intended to be clean rockfill (less than 5% passing the No. 200 sieve) an excessive amount of fine-grained material was visually recognized in the exposed dike one day after the failure (Leonard, 2005). Forensic analyses by FERC's Taum Sauk Investigation Team (2006), FERC's Independent Panel (2006), and by Rizzo Associates, Inc. (2006) confirmed a fines content of between zero and 20% in the exposed embankment bordering the breach (shown in Figs. 2 and 19). In addition, the percentage of sand sized material within the embankment was as great as 45% in certain locations, creating a far more erodible mixture than normally expected of clean rockfill (FERC Independent Panel, 2006). This problem was manifest by the unusual level of surficial erosion during the project's 42 year life, from rainfall-induced runoff (FERC Independent Panel, 2006). Cooke (1967) surmised that the dike could not have been clean rockfill because the observed settlement was almost an order of magnitude greater than those recorded on other concrete-faced rockfill dams (prior to 1967).

*Fig. 19. - Close up of "dirty" rockfill exposed on lateral margins of the breach. The large clasts are 10-12 inches diameter.*

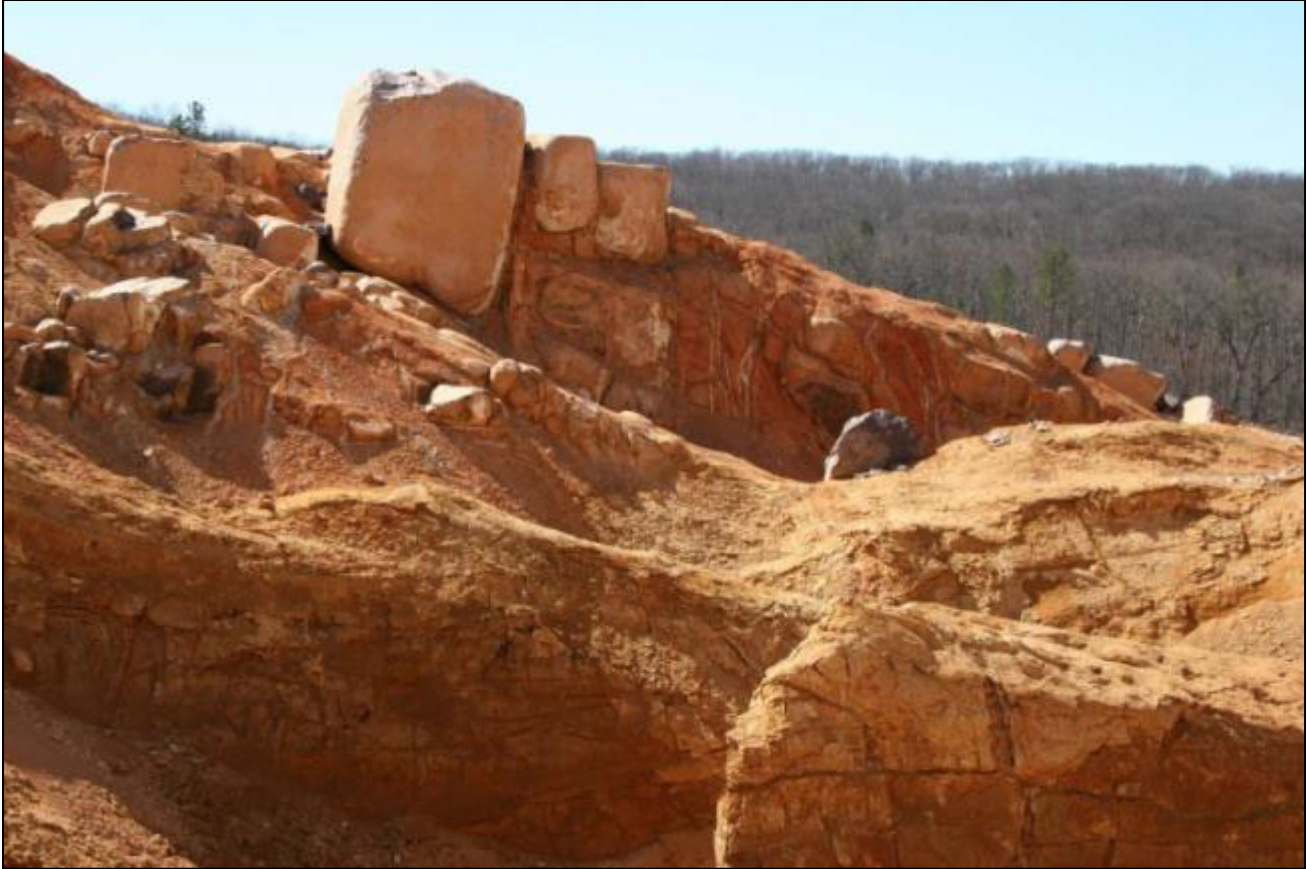
High rates of settlement were experienced at the upper reservoir during the first four and a half years of operation. Between 0.5 and 0.8 feet of settlement were experienced during this time, which correlates to 0.53% to 0.73% of the total embankment height, respectively. J. Barry Cooke (1915-2005), a member of the National Academy of Engineering, served as a consultant to Union Electric for the project, from the time of its design and many years thereafter. In 1967 Cooke summarized his observations about the reservoir’s performance in a letter to Union Electric (Cooke, 1967). Cooke felt that the average settlement rate of over 0.1 ft/year was unprecedented when compared to other rockfill dams, but was acceptable for this project. He concluded that “*The Taum Sauk Rhyolite Porphyry is an excellent high compressive strength rock that should have stabilized in its settlement. However, the formation contained frequent zones of soft weathered rock, all of which could not have been selectively wasted*” and that “*I believe that a fill of 100% competent rock would have stabilized and that the percentage of weathered rock in the Taum Sauk is the cause.*” An example of such a weathered zone is shown in Fig. 20.

*Fig. 20. – A zone of deeply weathered bedrock (saprolite) on the upper slopes of Proffit Mountain appears to have formed due to the disintegration of a diabase dike or sill and nearby hydrothermally altered granites.*

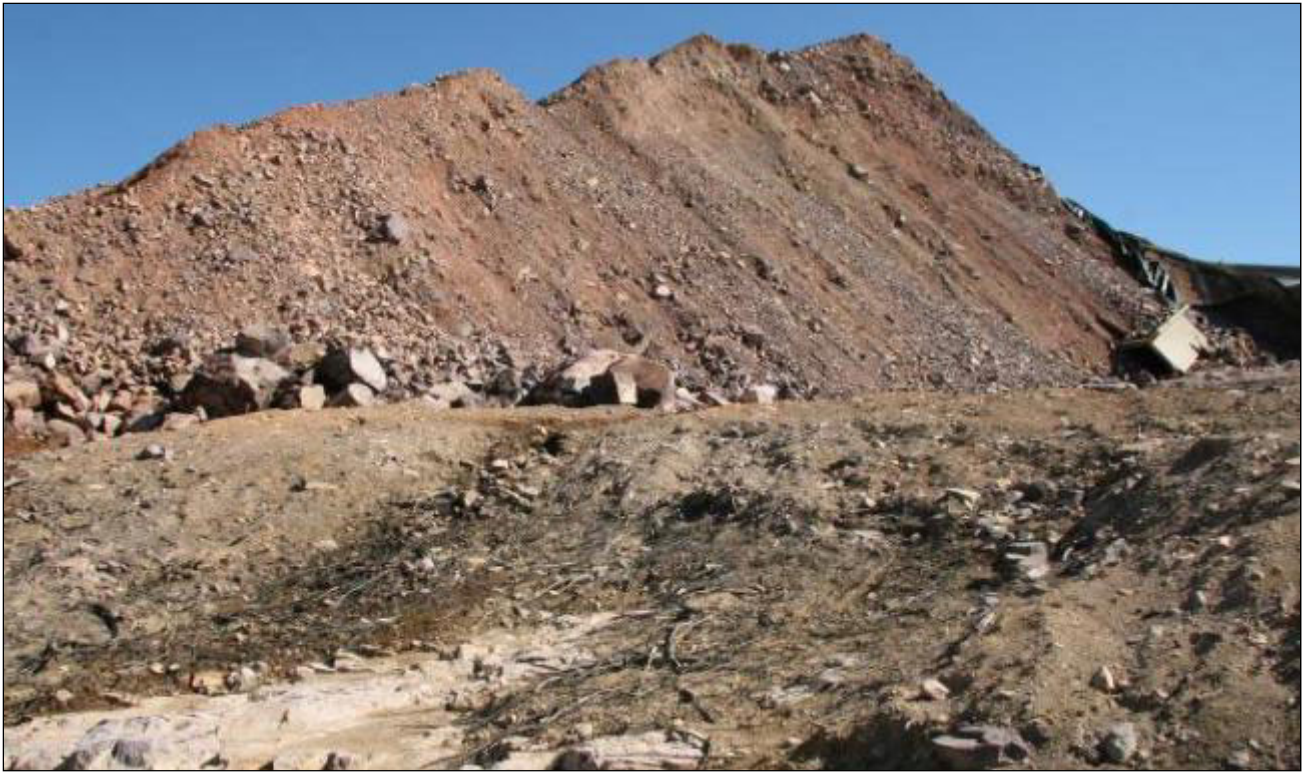
Post-failure investigations included exploratory drilling through the embankment-foundation interface to ascertain the character of the contact. These borings revealed that up to 18 inches of residual soil were not stripped off prior to placement of the rock fill. Soils containing tree roots and other organic matter were also observed beneath the breached section of the embankment (see Fig. 21). This may have contributed to the increased settlement and shifting of the embankment in this area, due to the high fines content, poor drainage, and higher compressibility of the un-stripped residual soil cap, as well as the 'dirty' rockfill.

*Fig. 21. – Residual soils, including tree roots and other organic matter, were observed left in place beneath the failed portion of the upper reservoir embankment.*

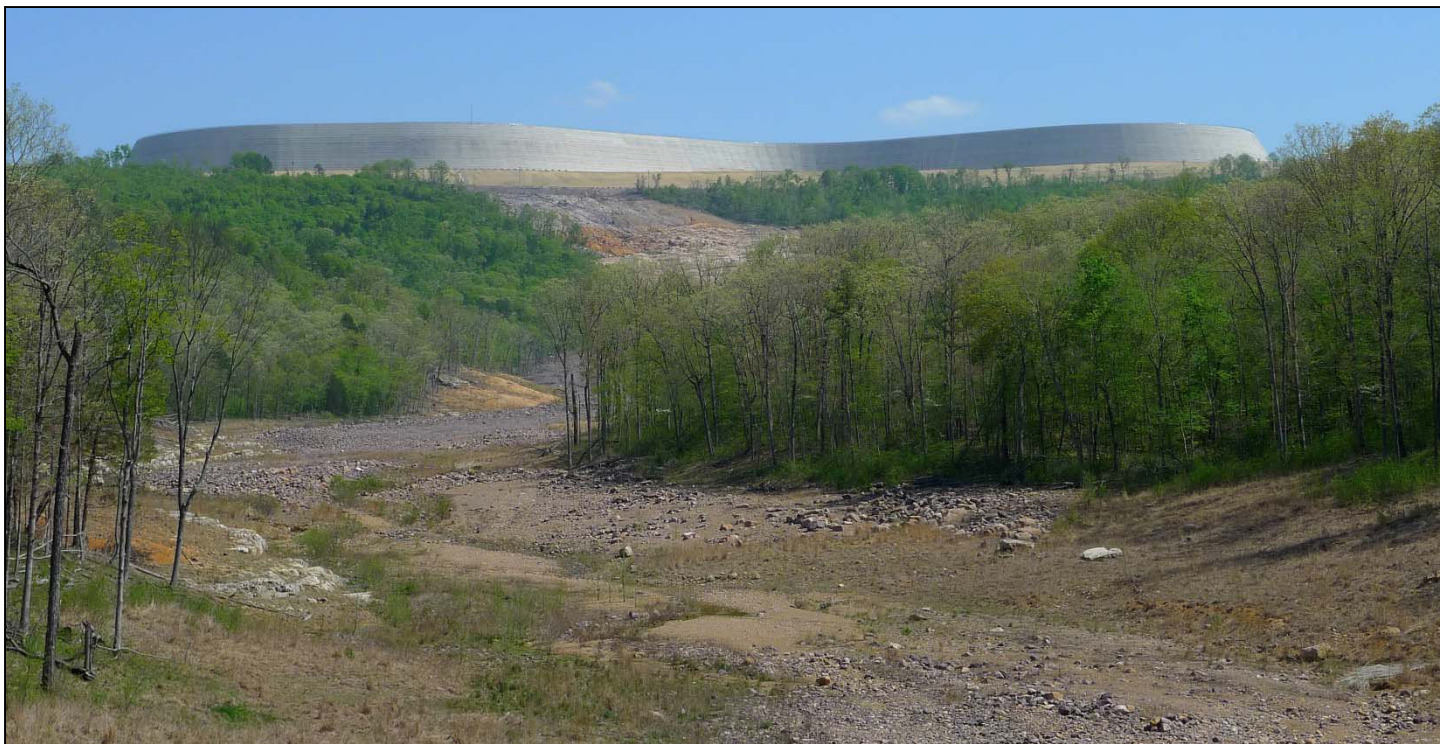
*Fig. 21. – Overlooks within Johnson’s Shut-ins State Park provide excellent views of the scour path formed during the failure and rebuilt structure. This photograph shows the rebuilt RCC upper reservoir during the spring of 2010, just prior to the resumption of operations at the facility.*

AmerenUE is paying for 100% of the clean-up and repair at Johnson's Shut-ins State Park. FERC approved AmerenUE's plan to rebuild the upper reservoir and the utility recently completed the rebuild, successfully renewed its FERC permit, and resumed operations in the spring of 2010. The utility is involved in a lawsuit and investigation by the Missouri Attorney General's office. In November 2007 another suit was filed against AmerenUE by the Great Rivers Environmental Law Center alleging that FERC has failed to properly monitor the reconstruction project. Both of these suits have slowed the approval process. AmerenUE reconstructed the upper reservoir from scratch using a roller compacted concrete (RCC) embankment with a similar footprint, height and capacity to the original structure, creating the largest RCC dam in North America (see Fig. 22 for view of the rebuilt structure). Much of the aggregate material from the failed structure was washed, crushed, and resorted to make it suitable for reuse in the RCC mix. Sections of the foundation containing deeply weathered zones were over excavated and replaced with concrete and the footprint of the structure was altered slightly to avoid other such zones. The rebuilt structure includes a spillway discharging over the eastern side of Proffit Mountain in case of another overtopping. This location discharges onto uninhabited lands that the utility owns and controls and in a direction away from Johnson's Shut-in State Park. Additional measures will also be undertaken to reduce the risk of overtopping.
