LAKE DELHI DAM BREACH – TWO PERSPECTIVES

Lori McDaniel, Iowa Department of Natural Resources, Des Moines IA; Jonathan Garton, Iowa Department of Natural Resources, Des Moines IA; William Fiedler, Bureau of Reclamation, Denver CO; Wayne King, Federal Energy Regulatory Commission, Atlanta GA; Neil Schwanz, U.S. Army Corps of Engineers, St. Paul District, St. Paul MN

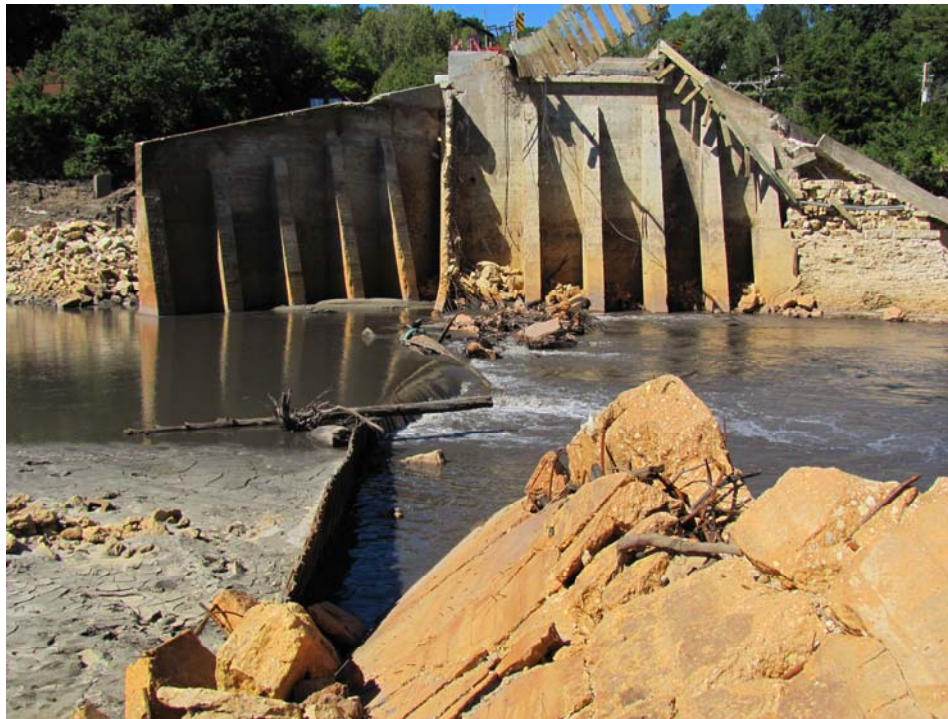
The concrete core wall (see Figure 8) was placed on top of steel sheet piling that extended to rock for some distance near the right abutment wall of the gated spillway. The core wall was founded directly on bedrock from the spillway wall to a distance of about 20 ft from the wall. South of that point the sheet piling is shown extending to bedrock for a short distance where the depth to bedrock was known. The top of the cutoff wall extended to within about 6 ft of the crest of the dam.

Figure 8. Remnants of sheet pile, core wall and spillway wingwalls. Source: Iowa DNR

The concrete cutoff wall on top of a sheet pile wall created a vertically rigid element in the dam that would not settle over time, as compared to the embankment on either side of the cutoff wall which could settle. This situation likely created differential settlement in the area of the cutoff wall that caused low stress that could have lead to cracks in the embankment fill emanating from the top of the cutoff wall. The potential seepage path created by the cracks from the cutoff wall and the low plasticity embankment material created a situation where internal erosion of the embankment could initiate and progress quickly.

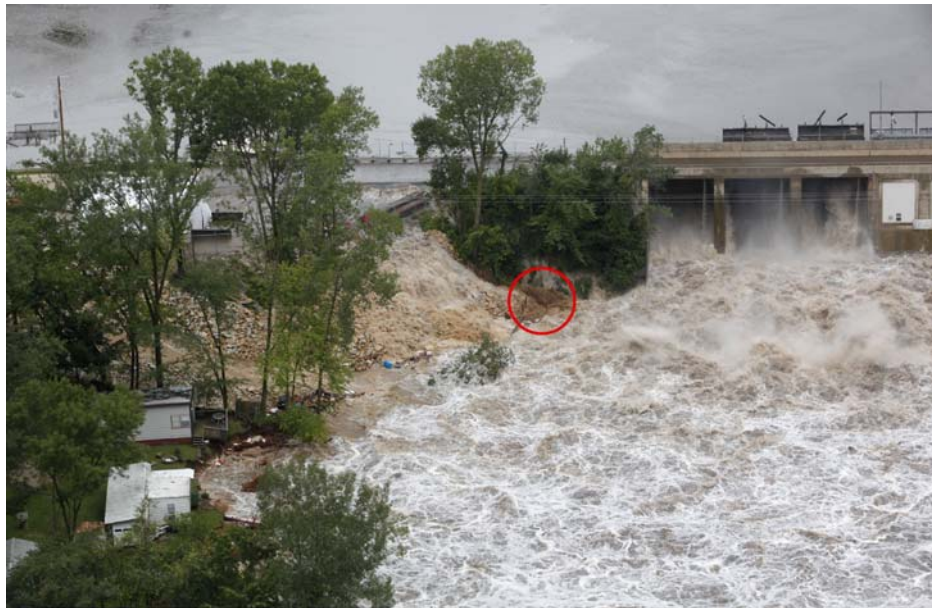
Seepage from the downstream slope was first observed around 6:00 am July 24, 40 to 50 ft south of the spillway training wall. At 6:00 am, settlement of the dam crest was observed in the areas where the vortices and sinkholes were first observed. All of this evidence is consistent with internal erosion occurring in the portion of the embankment above the top of and downstream of the concrete core wall.

Figure 9. Discolored water (circled) exiting the dam, indicating piping. Source: SourceMedia Group News

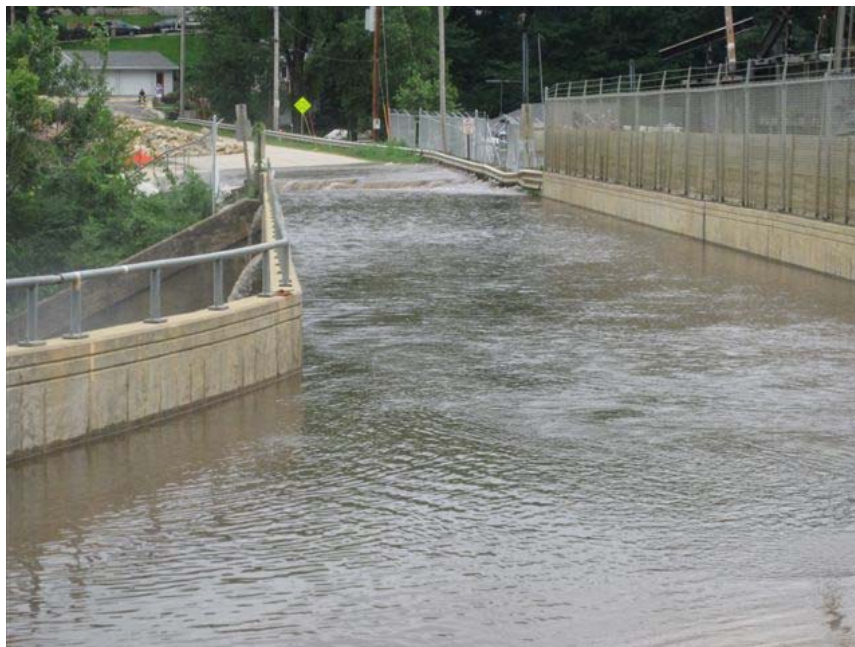
The dam breach began to accelerate around 12:30 pm on Saturday, July 24th. The dam breach was caused by internal erosion of the embankment, flows over the embankment and structural failure of the thin concrete core wall. A full breach of the embankment dam occurred at about 1:00 pm on July 24th. The concrete core wall appeared to have failed due to differential loading caused by the flood and erosion of downstream embankment soils. As erosion of embankment soils continued, sections of the core wall also toppled, eventually ceasing at a maximum breach width of 235 ft. It is likely that the concrete core wall slowed down the rate at which the embankment dam breached.

Figure 10. Breach in progress, headcut completely through roadway. Source: Iowa DNR.

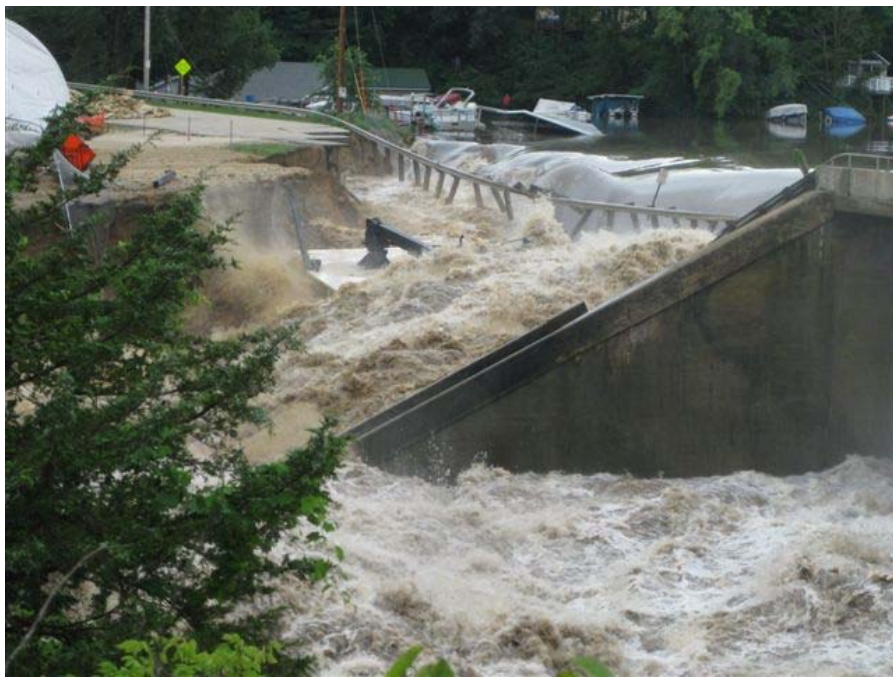
Figure 12. Breach in progress, core wall still in place. Source: Iowa DNR.

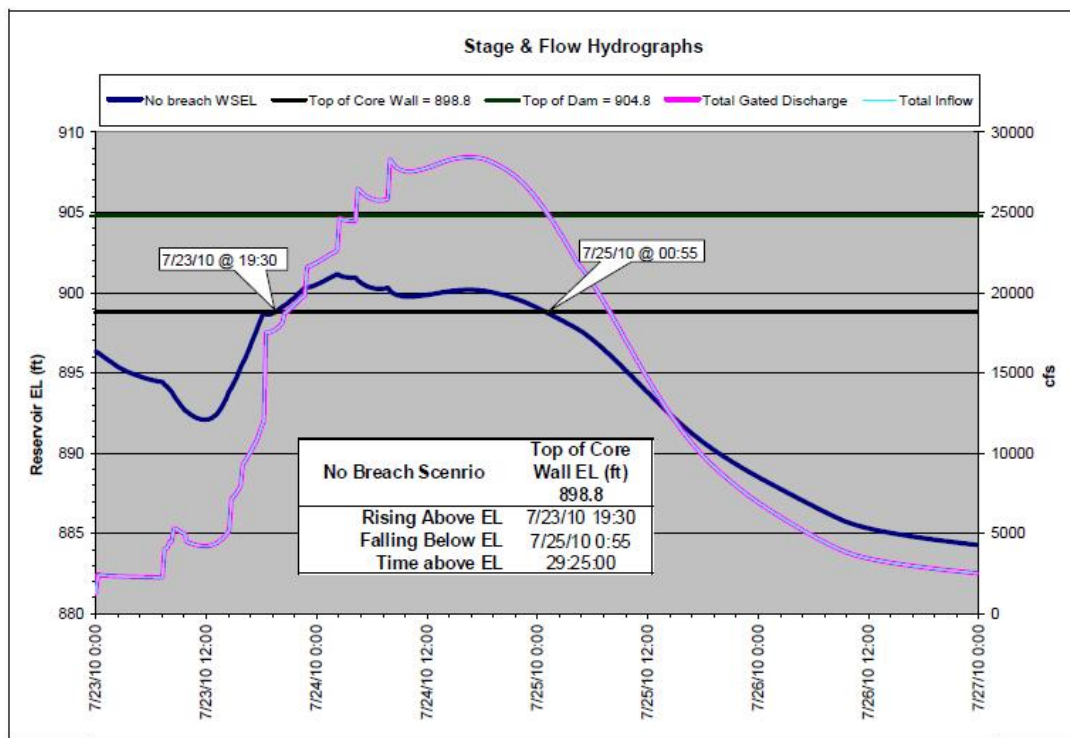
One of the items explored was the effect of the partially closed spillway gate. A routing was performed in which all three gates were opened to 18 ft, which was the maximum opening achieved by Gate 1 during the July 22- 24, 2010 flood. The flood routing results indicated that Delhi Dam would not have overtopped if all three gates had been fully opened. However, the reservoir would have exceeded the top of the core wall by up to 2.4 ft for about a day, and it is likely that internal erosion would have initiated in the embankment. Figure 14 shows the results of this analysis. Based on the duration of seepage that likely would have occurred through the embankment, it is judged that the dam would have suffered damage and possibly a total breach, even with all three gates fully open.

Figure 14. Hypothetical Scenario using Logbook Controlled Gates with all 3 Gates Fully Operational to 18 feet Maximum Opening. Source: Lake Delhi IPE Report.

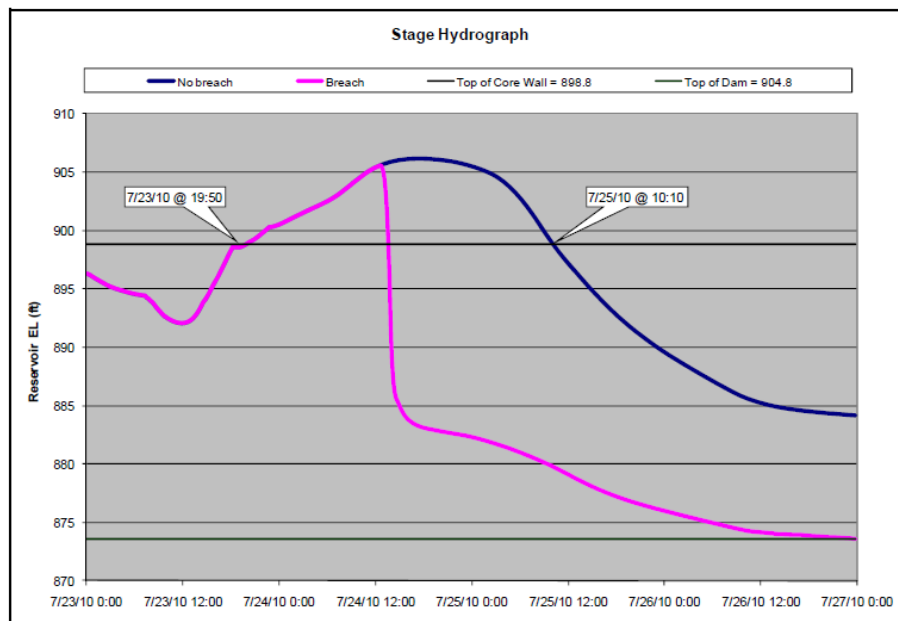
If internal erosion did not occur, the duration of 16 hours and maximum depth of 1.4 ft of overtopping predicted by the flood model (with one gate malfunctioning) would have likely caused a breach via overtopping and headcutting erosion. The results of this analysis are shown in Figure 16. Overtopping erosion to the point of breach was predicted with WINDAM, a NRCS erosion program. A summary of the WINDAM analysis is included in the full IPE Report referenced at the end of this article. Several other factors that would add to the likelihood of overtopping erosion are the downstream slope of 1V:2H, erosion features located at the toe as described in recent inspection reports, the rock toe and inclusion of the 1920's roadbed, unknown (but likely low) insitu soil densities and the trees and vegetation on the downstream slope. Conversely, if the dam had not experienced overtopping flows above the original dam crest elevation (this would have required that Gate 3 was fully functional July 22-24, 2010 flood event), it is possible that the internal erosion mechanism by itself would have lead to the breach of the dam.

Figure 16. Estimated time of reservoir levels higher than the top of core wall (shown at EL 898.8ft NGVD) Source: Lake Delhi IPE Report.
