REASSESSMENT OF THE ST. FRANCIS DAM FAILURE

J. David Rogers, C.E., C.E.G., and David J. McMahon, C.E.

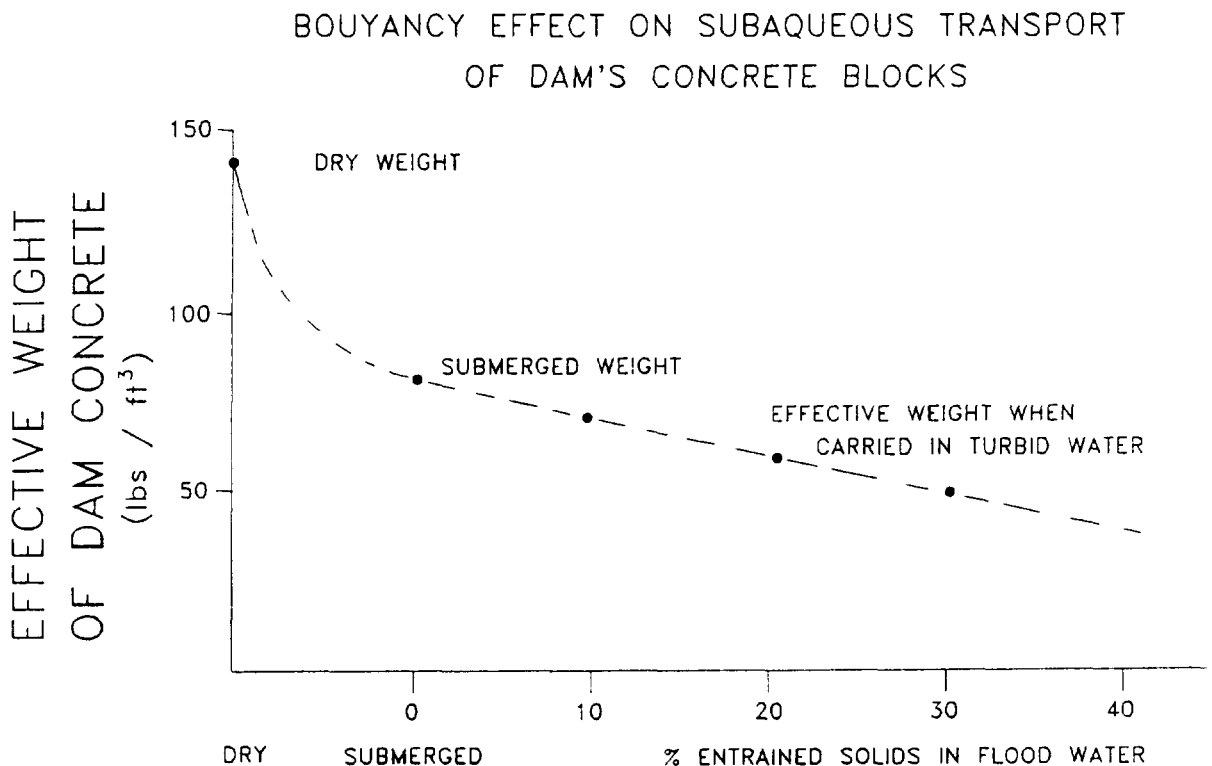
Over 500,000 cubic yards of landslide debris from the left (east) abutment were washed away by the flood wave. Survivors of the flood wave 7,000 feet downstream of the collapse described the flood wave as a wall of mud, rock and trees. Clearly the outpouring incorporated a large percentage of entrained solids. By comparing the volume of solids washed away with the total reservoir volume, a preliminary assessment of buoyancy effects on the downstream transport of the dam's many blocks can be approached quantitatively. Such evaluations suggest that the dam's displaced blocks could have weighed as little as one-third their dry weight while submerged in the muddy deluge, as shown in Figure 2. Post-failure assessment of scour lines on San Francisquito Canyon and eyewitness reports of water elevations in the flood wave were combined with flow calculations using the HEC II program to demonstrate that the peak flood wave was as great as 1.7 million cfs at the dam and up to 1.3 million cfs at Powerhouse 2 (7000 feet downstream). The high flood flows combined with the low effective weights of the concrete blocks help to explain how large blocks of the dam were washed so far downstream.

Figure 2: The effective weight of concrete blocks was decreased up to two-thirds by rock and other debris that was incorporated into the turbid flood waters.

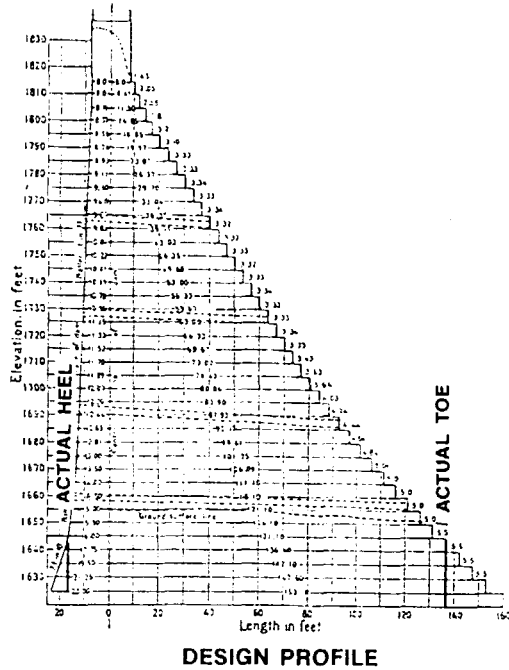
In his testimony before the Ventura County Coroner's Inquest, Mulholland stated that the St. Francis dam was designed with a safety factor (presumably against overturning) of 3 or 4. The dam's maximum cross section was presented as shown in Figure 1a. Eight uplift relief wells were provided beneath the dam's maximum cross section, but not beneath the sloping abutment sections. Re-analysis of overturning assuming full hydrostatic pressures acting at the heel of the dam and atmospheric pressures acting at the toe (a triangular distribution) suggests that the actual safety factors against overturning were just under 1 for much of the dam, as shown in Figure 1b. Comparing these results with Mulholland's testimony, it would appear that considerations of uplift were not accounted for in the original design.

Figure 1a: The actual toe and heel of the dam were slightly less than shown in the design profile (design profile was used in the analyses).

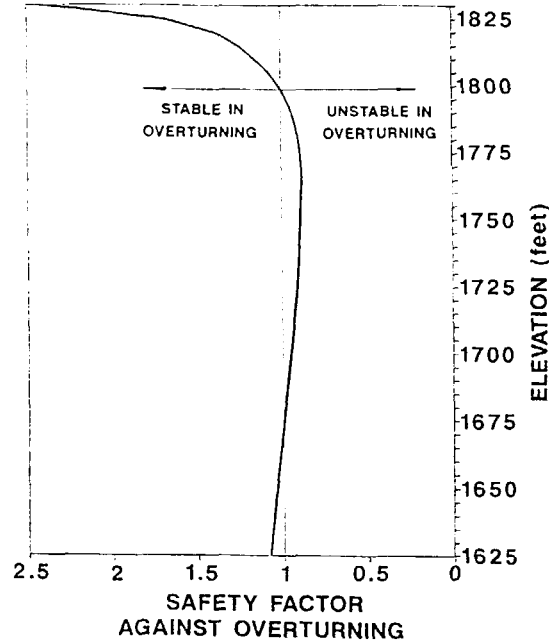
Figure 1b: The safety factor against overturning was less than one for most of the the middle portion of the dam, resulting in arching.

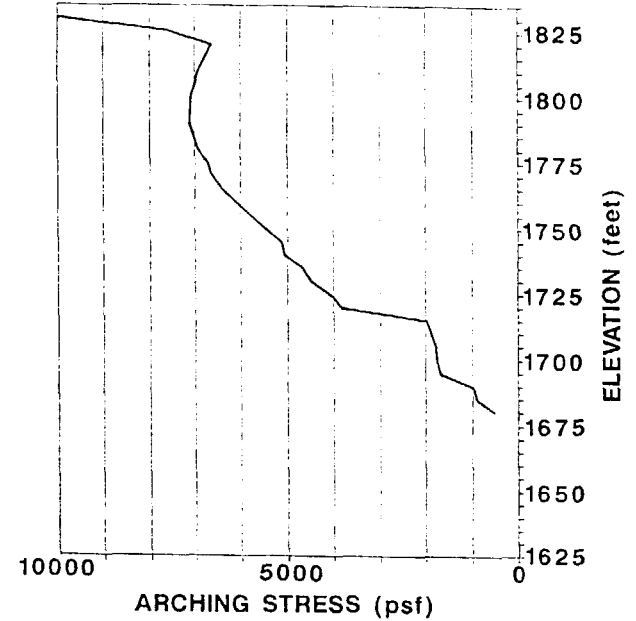
Although conceived as a concrete gravity dam, the St. Francis dam was arched upstream on a constant 492-foot radius. Even though portions of the dam appear to have been over-stressed with respect to overturning, the dam may have maintained stability through the shedding of excess overturning loads to the abutments through arching. A crude estimate of the arching stresses at the abutments was made by determining the loads required to stabilize a given section. These loads were distributed vertically within a section based on the area of layers in proportion to the total area of the cross-section. The vertically distributed loads were then summed horizontally to estimate the arching stresses. The resulting distribution of arch thrust on the abutments is shown in Figure 1c.

Figure 1c: The arching stresses were largest near the top of the dam. Stress concentrations are due to dam and abutment geometry.
