2004 FAILURE OF BIG BAY DAM

Lamar County, Mississippi

Irfan A. Alvi, PE

February 2015

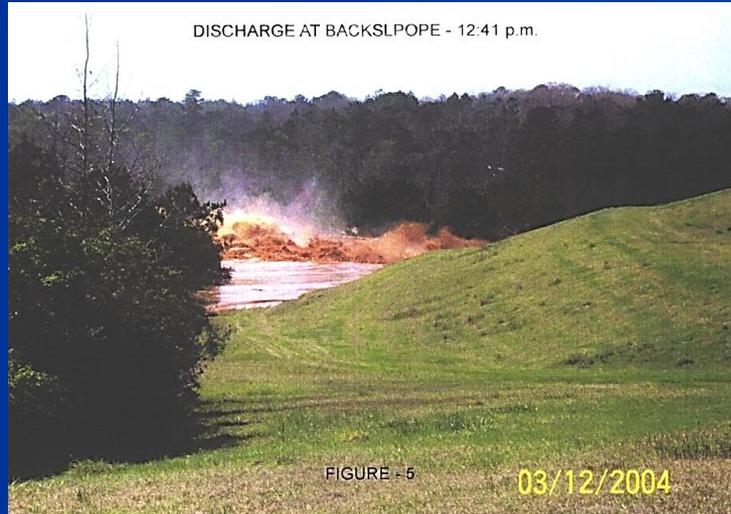
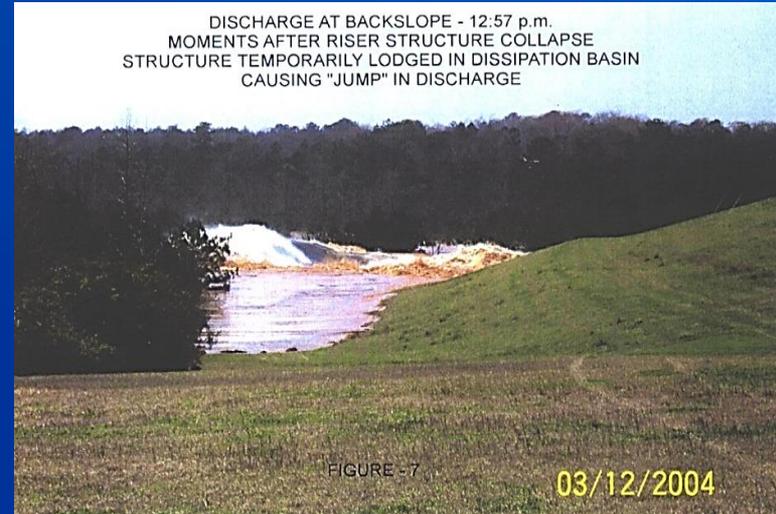
Breach in Progress

- Breach centered on outlet works
- Less than 2 hours to empty reservoir

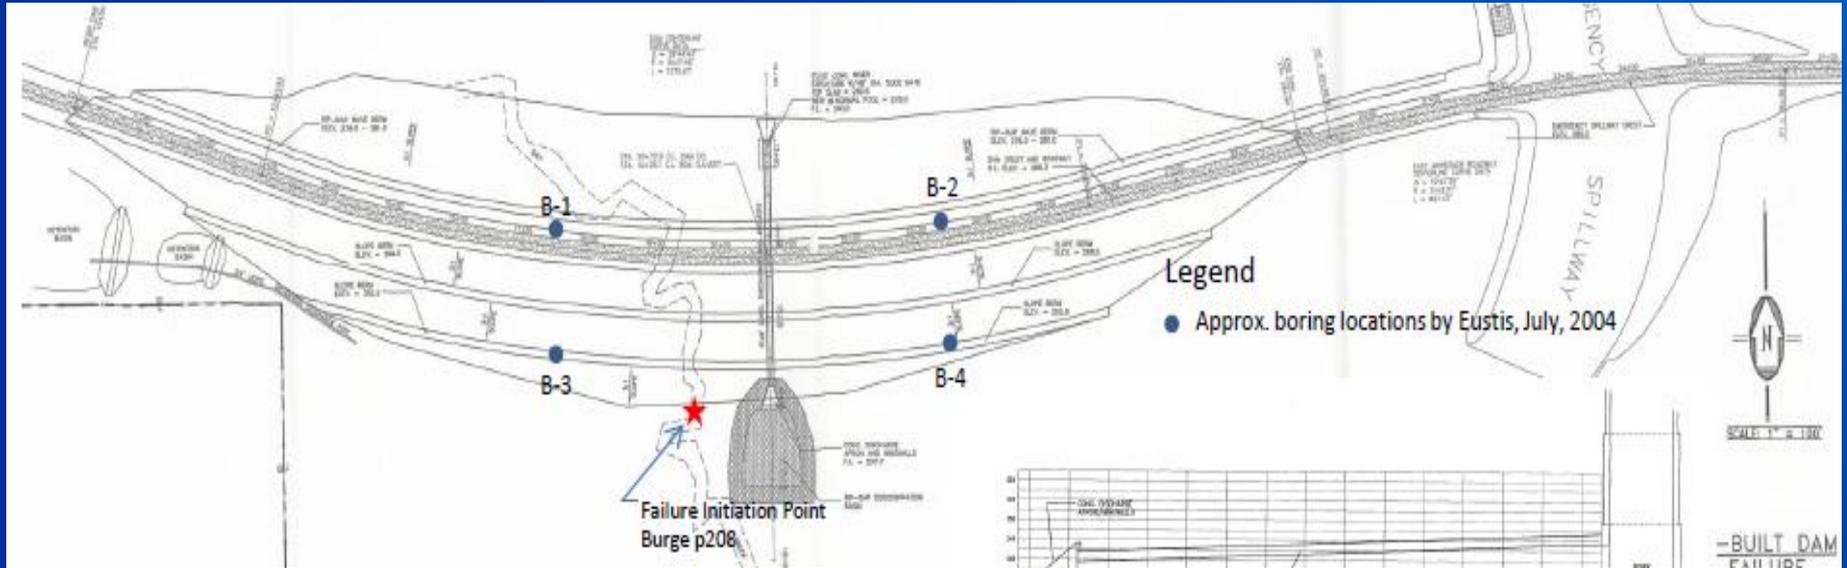
Plan View – Failure Initiation Point

- 12:00 to 12:15 – Maintenance Person returns to site, sees **muddy water spraying 30' to 40' into the air** from an area 20' to 30' southwest of outlet, calls Engineer
- 12:20 – Engineer returns to site and sees the water spouting about **2' to 3' into the air** with a **flow diameter of about 18"**
- 12:25 – Erosion rapidly grows and progresses upstream, resulting in breach

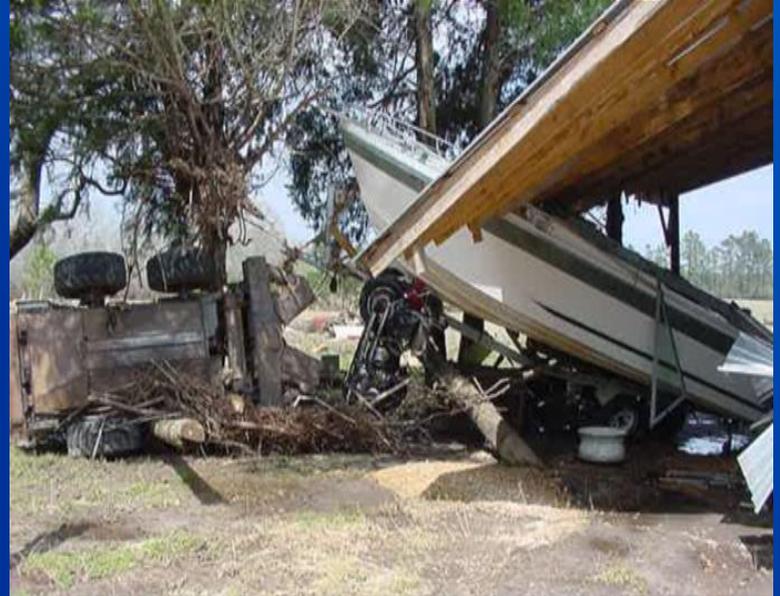
Downstream Damage

- Over 100 structures impacted
 - Destruction of 48 homes, 1 bridge
 - Damage to 53 homes, 2 churches, 3 businesses, 1 fire station
- No fatalities (EAP activated)
- \$1.1 million legal settlement

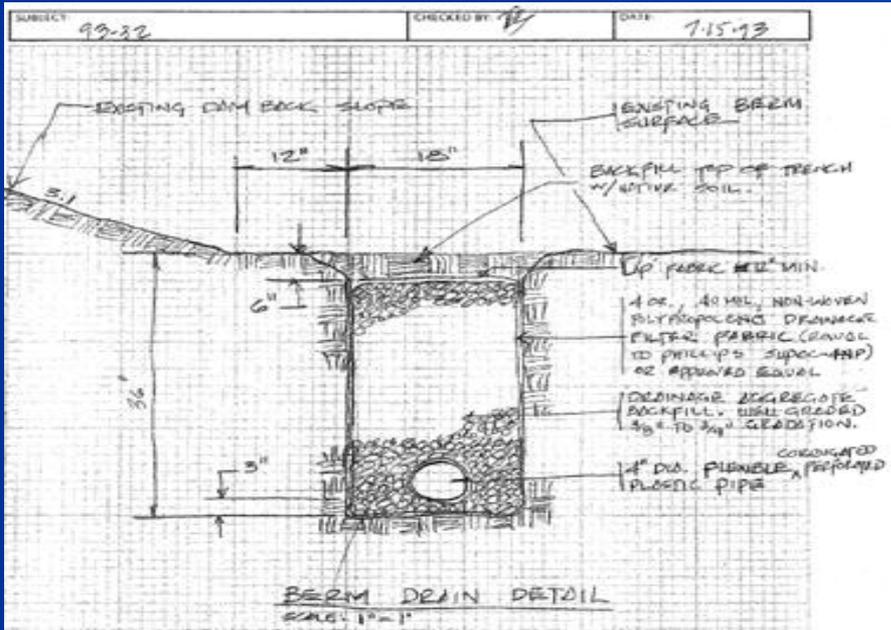
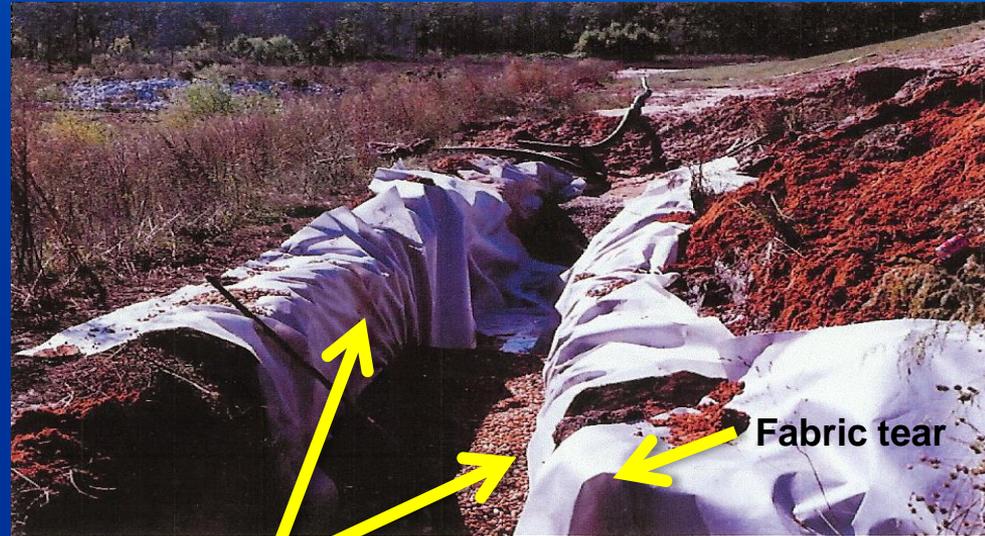
Downstream Toe Filters/Drains

Gravel fill and wrinkles – lack of intimate contact between fabric and native soil

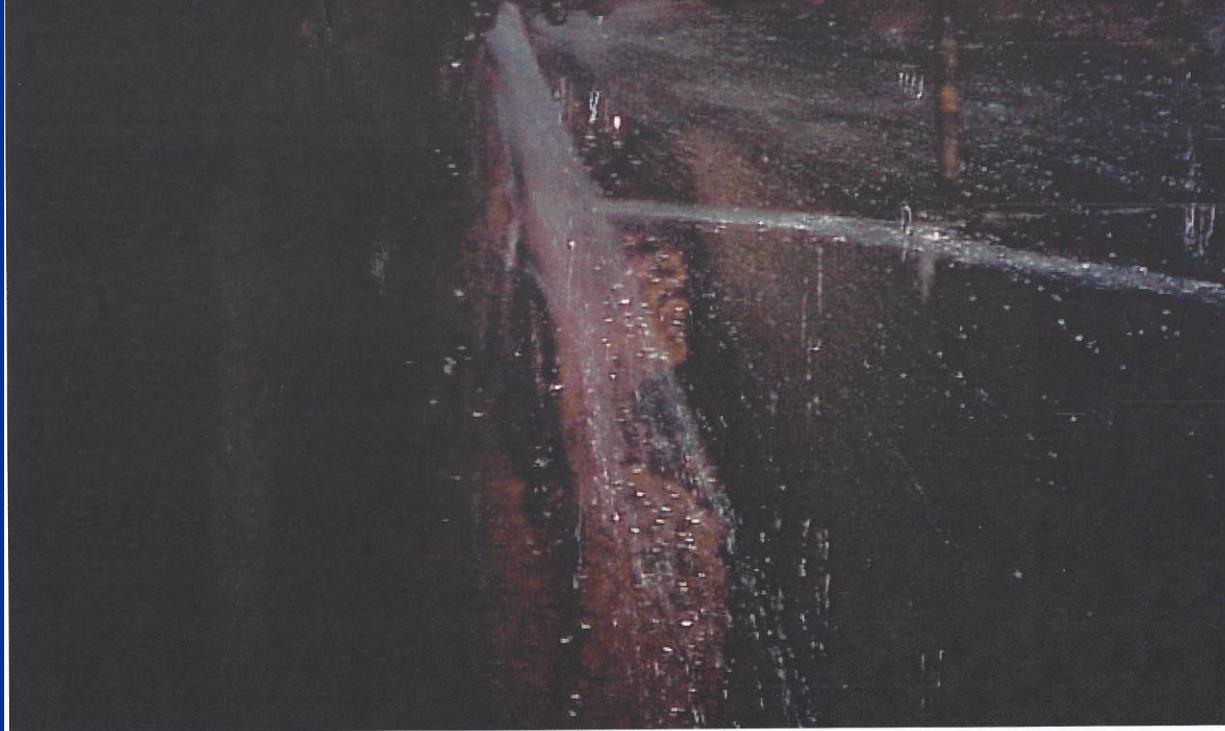
**07/23/02 MS03237 LEAK INSIDE CONDUIT
APPROX. 110' FROM OUTLET WINGWALL**

**Significant
leaks through
culvert
defects**

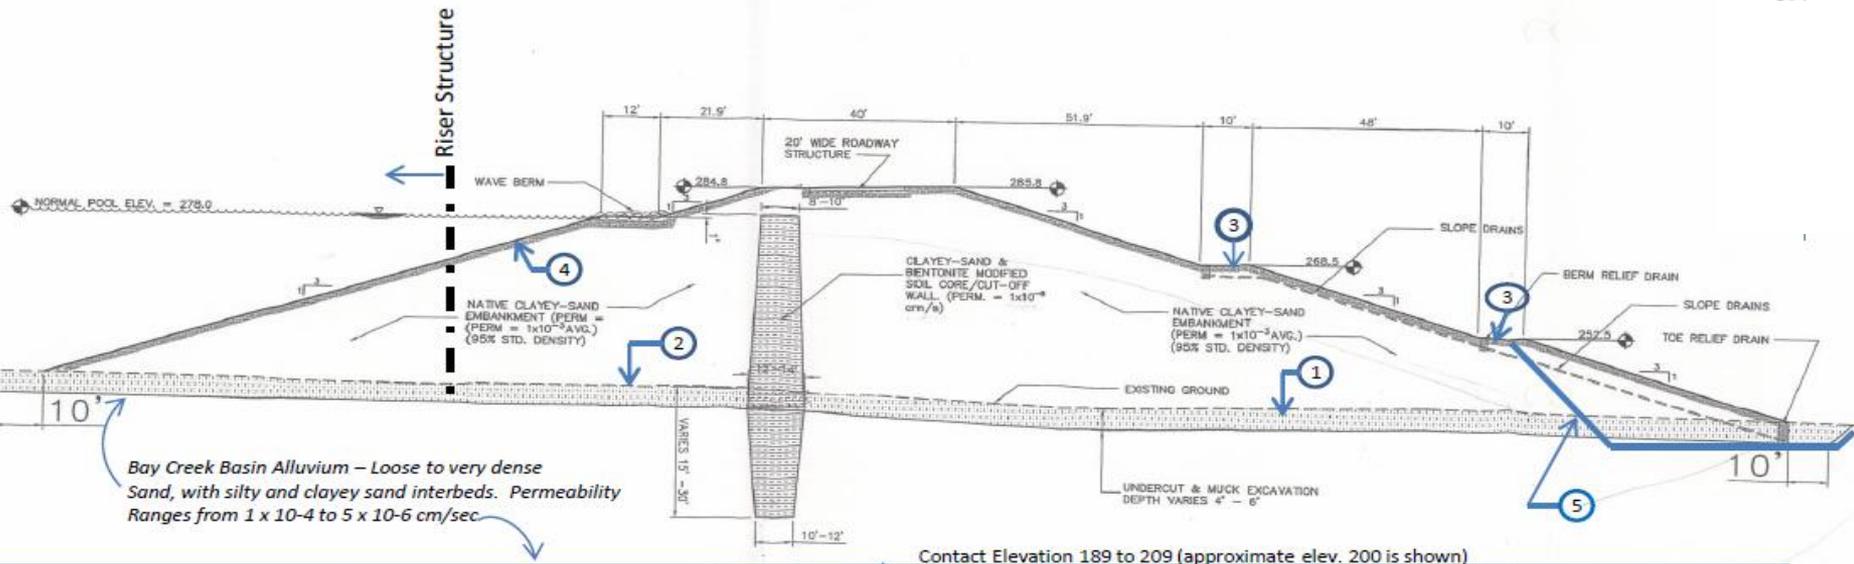
- ① Approximate location of seepage into box culvert conduit. Three 1/8 to 1/4 inch discharges from the west upper corner of wall/ceiling interface.
- ② Approximate location of 2nd seepage into box culvert conduit. Three discharges beginning about 10 inches above the box floor along west wall. Seeps ranged from a trickle to 1/4 to 3/8 inch stream with total flow about 5 to 6 gallons per minute.
- ③ Approximate location of backfilled sinkhole notes in photo dated 7/23/02. Exact location not well described
- ④ Possible sinkhole noted along U.S. Slope outside of breach area when reviewing project files for failure review.
- ⑤ Approximate extent of the over excavation around the discharge box culvert to repair moist conditions in August 1999. Filter likely clogged due to fabric placement methods
