FAILURE OF CONCRETE DAMS

Dr. Charles L. Bartholomew*

EXAMPLE - AUSTIN DAM:

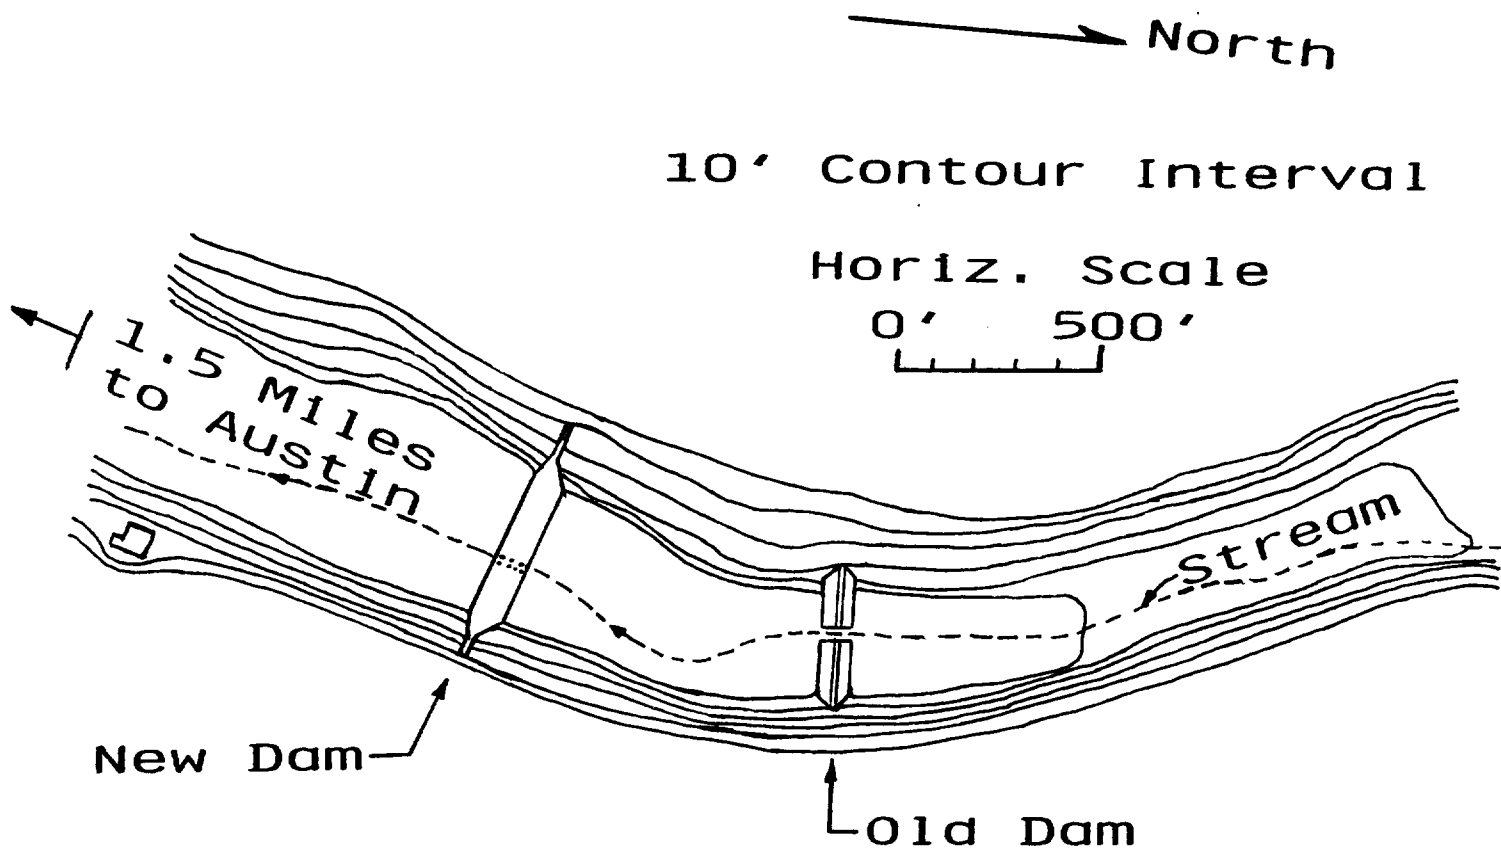
FIG. 2

As shown in Figure 2, an earlier dam was built on Freeman's Run in 1899. This old dam was about 20 feet high and was constructed of timber grillage filled with rock and soil and then topped with compacted earth. The old dam impounded about 25 million gallons of water for use at the Bayless Pulp and Paper Co. Mill located in the valley between the dam and the town of Austin. The valley walls are relatively steep, rising about two hundred feet above the valley floor. The Bayless Co. needed additional water reserves for dry weather, so in 1909, Mr. T. Chalkley Hatton, a noted engineer from Wilmington, Delaware was hired to design a new high dam to impound at least 200 million gallons of water. The dam was designed and construction was completed on Dec. 1, 1909. Statistics on the dam are given in Table 3. This data was obtained from an Engineering News² article published in 1910.

It is interesting to note that the original design called for an 8-foot deep keyway, but the owner, in an effort to reduce costs reduced the size to only 4 feet. The designer then required the compacted earth fill on the upstream face in an attempt to reduce underseepage. The foundation rock was hard sandstone, but contained many thin interbedded shale layers which appeared to soften rapidly when exposed to free water. The foundation was cleaned to a hard sandstone surface prior to placement of concrete. Good workmanship was reported.

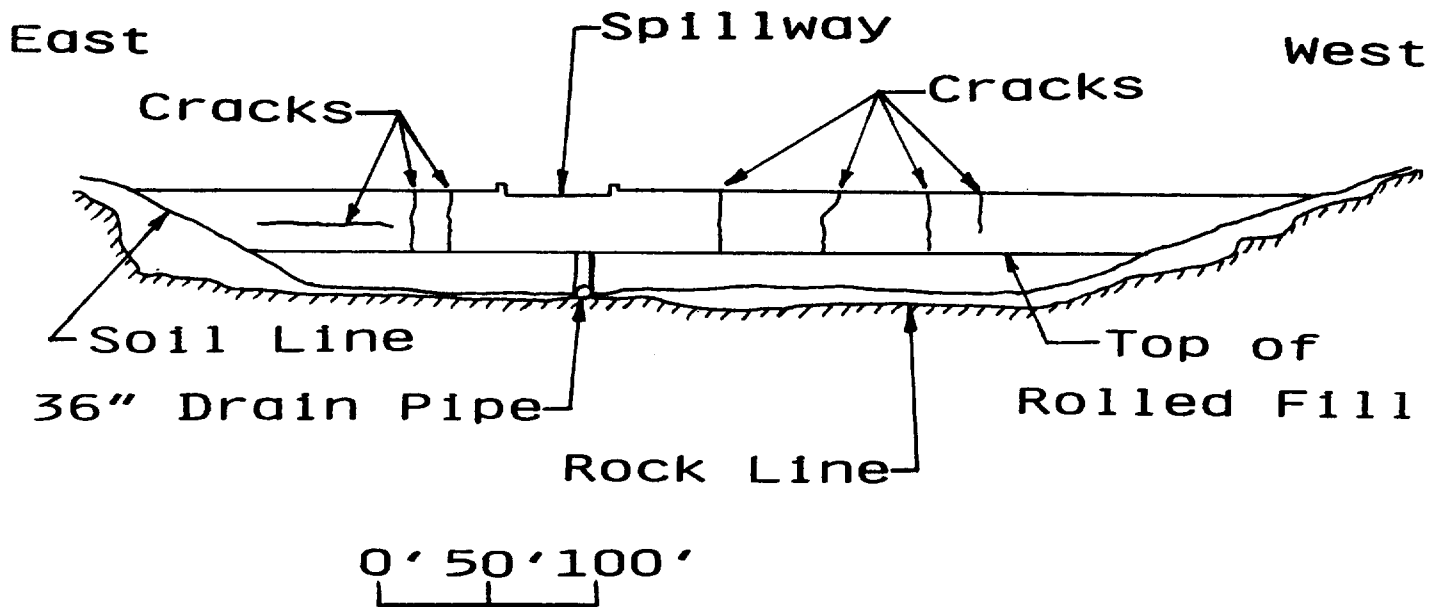
FIG. 3
ELEVATION-UPSTREAM
END OF CONSTRUCTION

Figure 3 shows the completed dam, while Figure 4 shows cross-sections through the dam. As seen in Figure 3, at least 6 vertical cracks were noted in the dam soon after completion. The cracks were blamed on concrete shrinkage. One horizontal crack east of the spillway likely represents the "cold" joint which occurred during the labor strike.

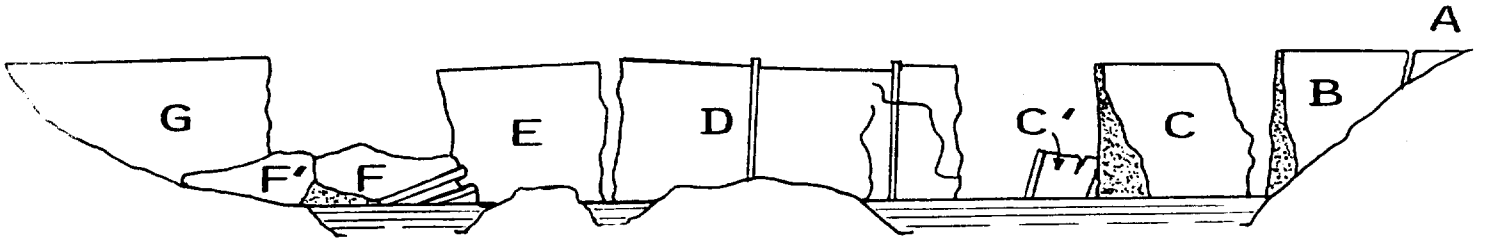
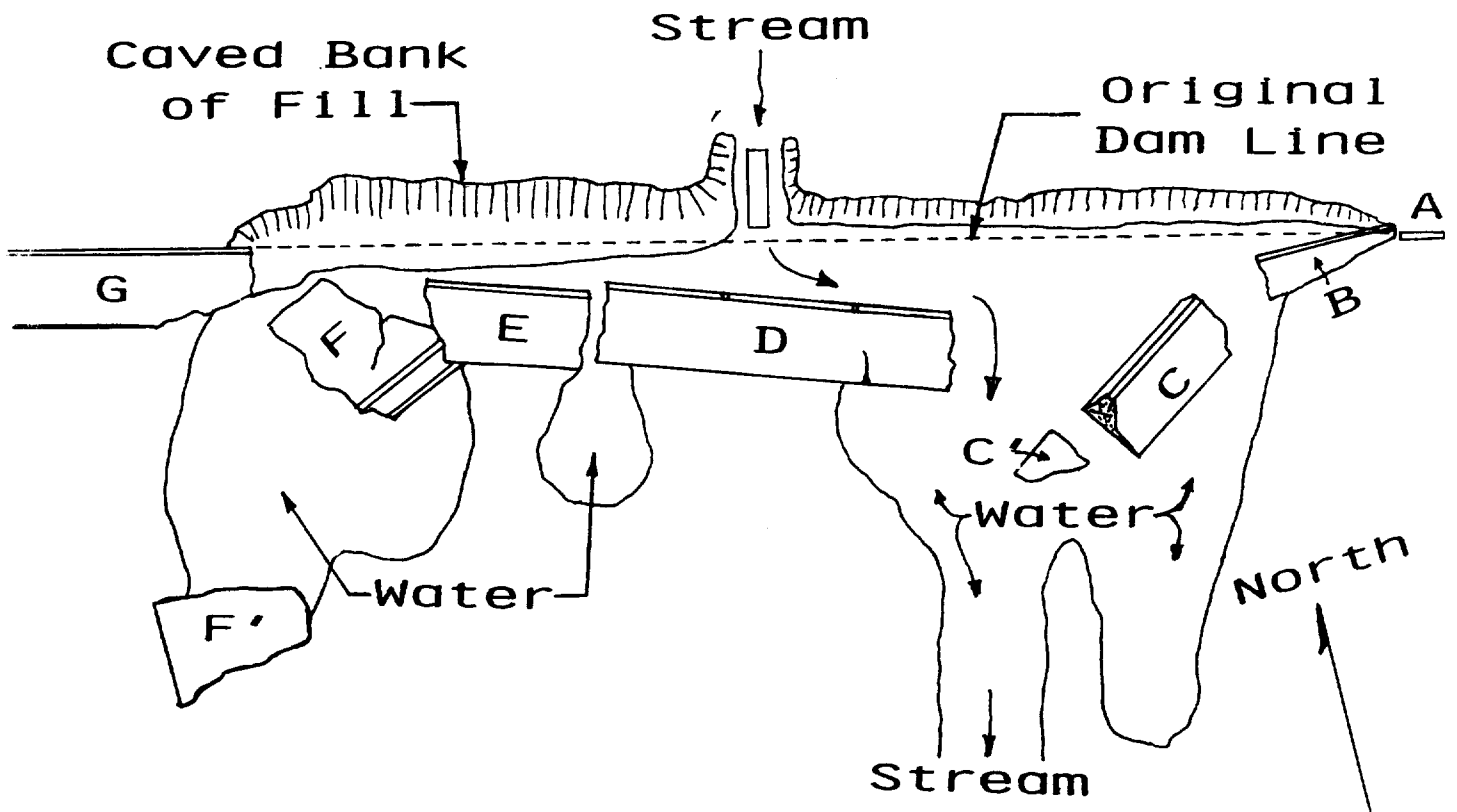
FIG. 5

The dam break occurred between 2:00 and 2:30 p.m. on a calm Saturday afternoon, September 30, 1911. The dam collapse is described in an account in the Engineering News³ issue of October 5, 1911. The appearance of the dam did not suggest a gradual failure, but a telephone warning from a nearby house did allow some residents of Austin to flee to safety on the hillsides. The reported failure sequence was that a small segment of the dam west of the spillway "blew" out first, and almost simultaneously a section east of the spillway cracked and swung downstream. (The towns of Austin and Costello were destroyed with at least 78 lives lost.) Figure 5 shows an elevation of the broken dam and a plan view showing the distortion of the failed structure.

An unusual feature of this dam is that now, almost 78 years after the break, the ruins of the dam still stand just as they did at the time of the failure. Some concrete spalling has occurred, but it is easy to identify the fragments and to reconstruct the failure. No attempt was ever made to rebuild the dam or to clean up the site. Soil and shale fragments still lie as they were pushed upward downstream from the sections that slid. Depending upon the values used for shearing strength of the soft shale, the safety factor against sliding may be computed between 0.6 and 1.0.
