# SEEPAGE FAILURE, EVALUATION AND REMEDIATION OF PENN FOREST DAM

by W. B. Bingham, P.E.<sup>1</sup>  
R. E. Holderbaum, P.E.<sup>2</sup>  
W. S. Sherman, P.E.<sup>3</sup>

## ABSTRACT

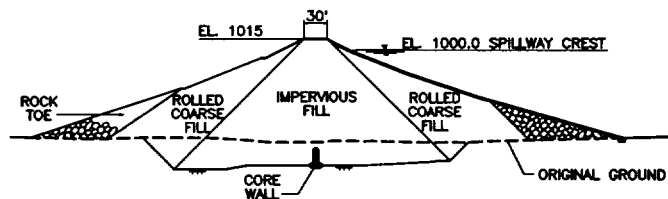
Typical Dam Section  
Penn Forest Dam

Penn Forest Dam is a zoned earth and rockfill embankment dam with a central impervious core and a low concrete core wall founded on rock. The dam is approximately 1930 feet long and 145 feet high. A concrete chute spillway is located in the right abutment and a concrete intake tower is located on the left abutment. Construction of the dam was completed in 1959, on Wild Creek, a tributary to the Lehigh River, in northeastern Pennsylvania. The dam is a large high-hazard structure, Pennsylvania DEP Class A-1. Penn Forest is situated just upstream of Wild Creek Dam, the other Bethlehem supply.

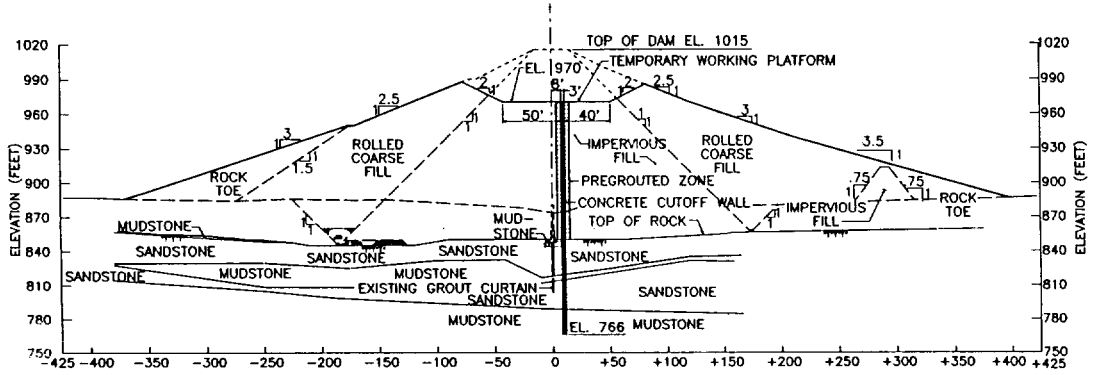
**Figure E**

## Cross Section of Option 1 Concrete Cutoff Wall Through Dam

**Description:** This option would restore Penn Forest Dam to its normal operating condition. The major work elements of this option would consist of excavating the entire length of dam to Elevation 970, performing compaction grouting in known and suspected damaged areas of the embankment, installing a thin, continuous concrete cutoff wall through the dam and into the foundation rock, special treatments at the conduit and tunnel to tie the wall to these structures, and reconstructing the top of dam. A brief description of each of these work elements follows:

- Excavation of Top of Dam: Excavation of the top of dam to Elevation 970 is planned for two reasons. First, it is necessary to provide a broad working platform for the equipment used to install a cutoff wall, and second it allows removal and replacement of the upper 45 feet of the dam that was not properly compacted during original construction. The core material, random shell material, and the riprap on the upstream face would be selectively excavated and stockpiled so that these materials can be used in reconstructing the top of dam.

- Compaction Grouting: Compaction grouting is planned in known and suspected damaged embankment areas including the sinkhole area, the vicinity of the west abutment foundation ledges, and on the east abutment. Compaction grout holes would be drilled or driven to the top of rock with low mobility (compaction) grout injected in 5- to 10-foot stages as the casing is withdrawn. Compaction grouting is required in these areas to remediate cracks or voids within the embankment prior to excavating the cutoff wall trench.

- Cutoff Wall Construction: A concrete cutoff wall could be installed through the dam and into foundation rock using one of three different techniques. Each of these methods are essentially proprietary systems. These methods include using a rock mill to excavate rectangular panel holes through the earth embankment and rock under a head of bentonite slurry that is used to support the trench sidewalls in the embankment. Each panel is then backfilled with concrete, and successive panels are overlapped to make a continuous cutoff. A second method of installing a concrete cutoff is to install overlapping concrete piles called secant piles. In this method, the wall is constructed by constructing 34-inch-diameter piles to the desired depth at a primary spacing of approximately 22 inches center-to-center. After these primary piles have been backfilled with concrete and cured, secondary 34-inch-diameter piles are installed midway between the primary piles to form a continuous cutoff. A third possible method consists of constructing a wall of 24-inch nominal thickness which consists of round primary elements connected by panel-type secondary elements. The round primary elements are installed by a combination of clamshell excavation in earthfill and rotary drilling in rock. Steel casing is used to maintain an open hole in the embankment materials. The secondary elements are installed by excavating a trench between the primary elements under a head of bentonite slurry using a clamshell and rock chisels. In all of these schemes, the holes or panels are backfilled with

conventional or plastic concrete by the tremie method to displace the slurry and form a continuous concrete element. All three methods have the potential to provide comparable performance at similar schedules and costs.

- **Reconstruction of Top of Dam:** After construction of the cutoff wall is complete the top of dam would be reconstructed using the previously excavated material to the fullest extent possible. The replacement section would be a zoned embankment containing a filter and drain. The top of dam will be raised to Elevation 1018.0 in this option to contain the PMF.

Preliminary details for this option are shown on Figure E.

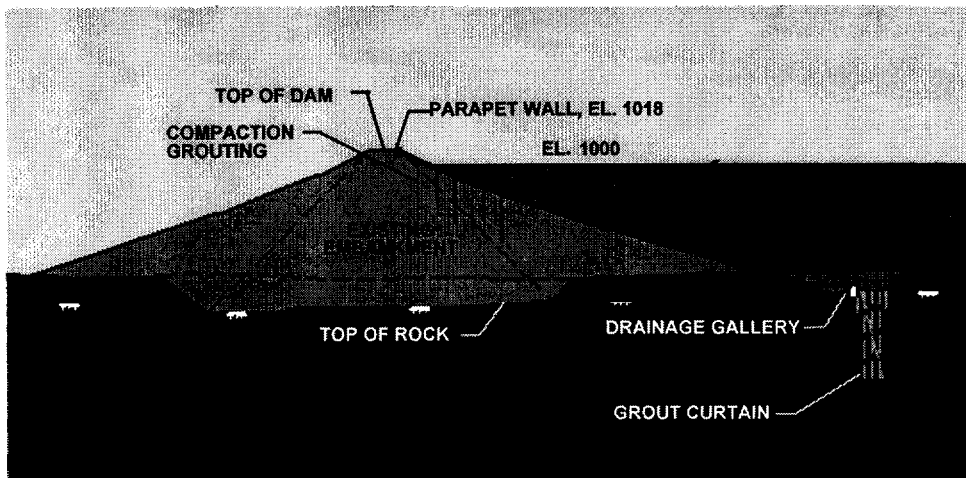
**Figure F**

## Cross Section of Option 2 Liner with Grout Curtain

**Description:** This option consists of restoring Penn Forest Dam to its normal operating condition by installing a liner system on the upstream slope of the dam and a cutoff into the foundation rock at the upstream toe of the dam. The liner system and cutoff would be interconnected at a drainage gallery at the upstream toe of the dam. Other major elements of this option include excavation and backfill of the sinkhole area, compaction grouting in known and suspected damaged areas of the embankment, special treatment at the tunnel to tie this structure to the cutoff, and installation of a cofferdam and associated diversion works. Option 2 is shown on Figure F. A brief description of each of the major work elements follows:

Of the three materials, the synthetic liner and hydraulic asphalt are believed to have the lowest cost. Concrete is estimated to have the highest cost. Regardless of the type of material selected for the liner system, a drainage system should be installed between the liner and embankment to collect any seepage through the liner and from surface infiltration and groundwater entering behind the liner from the abutments and embankment. Seepage from the drainage system would be routed to a drainage gallery constructed in the foundation rock at the upstream toe of the dam. The drainage gallery would also be used to collect seepage in the foundation rock intercepted in drilled drain holes located downstream from the foundation cutoff.

Foundation Cutoff: Several methods are available for constructing the cutoff in the rock foundation at the upstream toe of the dam. Two options have been investigated for

Penn Forest Dam: a conventional grout curtain and a concrete cutoff wall. The cutoff wall could be constructed with any of the methods described in Option 1.

- Compaction Grouting: Compaction grouting similar to that described for Option 1 would also be used for this option. The purpose of the grouting would be to strengthen weak areas in the embankment so that sufficient support is provided for the liner system.
