# **The Bayless Dam Failure: Separating Fact From Folklore**

*Robert A. Kline, Jr., P.E., Gannett Fleming, Inc.*

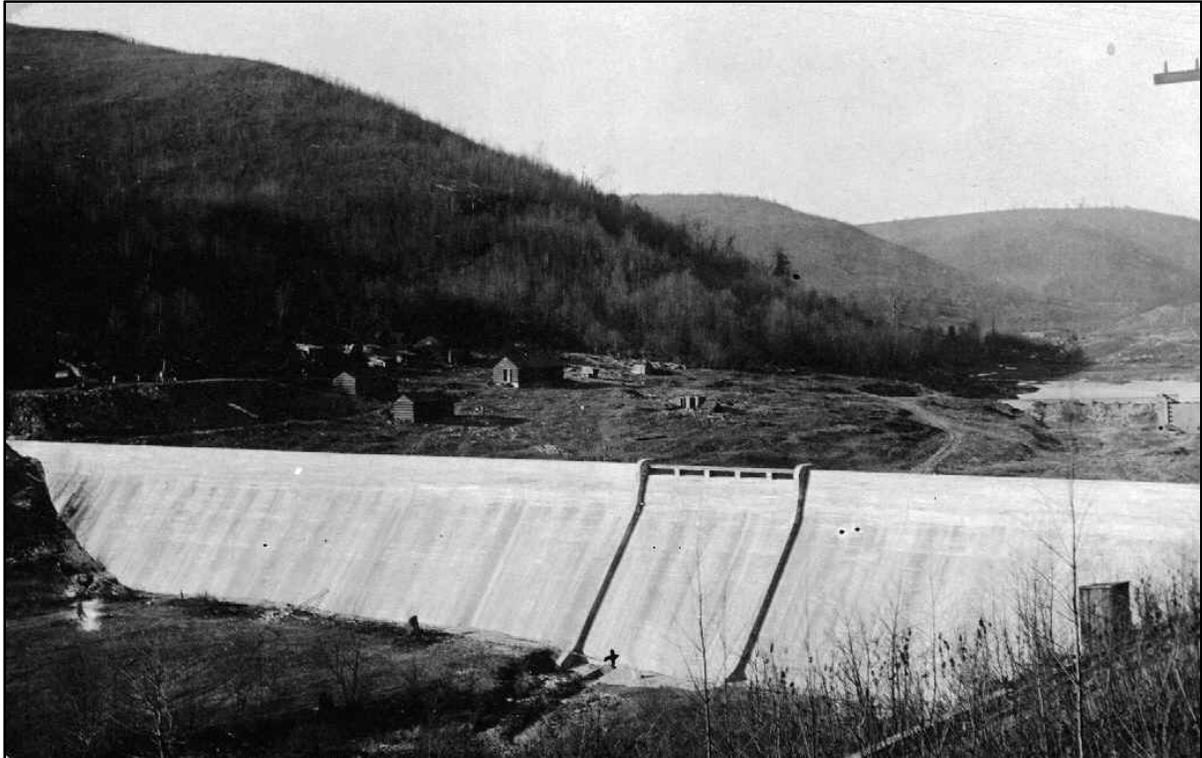
**Figure 2 – Bayless Dam – December 1909**

The dam was ready to be put in service on December 1, 1909. Before water was impounded behind the dam, two transverse vertical cracks developed at locations left and right of the spillway section. Each crack had about a 1/16-inch opening width. Hatton attributed these cracks to thermal contraction since there was no evidence of structural settlement.

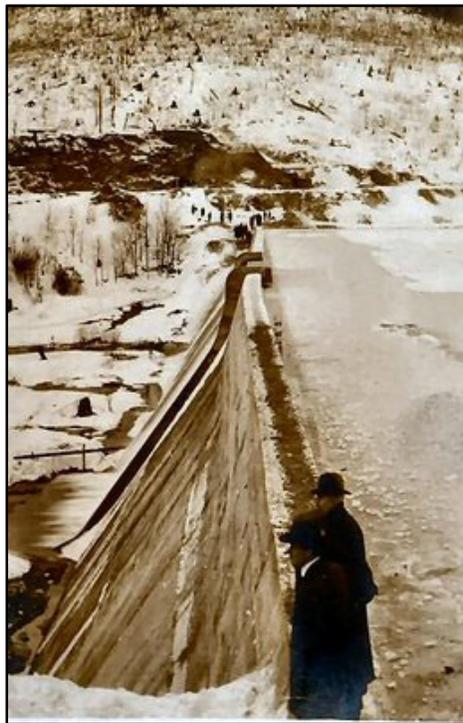
In mid-January 1910, an unseasonably warm period combined with some rain caused rapid snowmelt runoff within the watershed. Within a period of three days the reservoir was filled and the spillway was activated for the first time. On Sunday afternoon, January 22<sup>nd</sup>, the first signs of trouble involved a large landslide at the left abutment on

the downstream side of the dam. Seepage flow, estimated to total about 600 gallons per minute, was present within the slide as well at various locations along the toe of the dam. On Monday, the dam slid downstream with a maximum deflection of 18 inches at the toe and 31 inches at the crest. As a result of the movement, the dam fractured into six or seven distinct sections each bounded by large cracks that were pinched closed at the upstream face. This movement reportedly occurred over a period of eight hours.

In an Engineering News article published on March 17, 1910, Hatton attributed two main causes to the failure as given in the following excerpt: "...the failure of the dam to withstand the flood of Jan. 21 is probably due to two causes. One of these is that the great bulk of concrete which had been hurriedly built, some during freezing weather, and which had been completed but six weeks before the maximum pressure came upon it, had not set up so as to attain its ultimate tensile strength. The most important cause, however, was due to the water getting under the dam. This condition was not anticipated when building the dam, and all precautions which seemed to be necessary at the time were taken to guard against it".<sup>[1]</sup> He also offered further detail with "From the evidence thus far obtained the outward movement of the center of the dam was due to water getting under the foundation, softening up a stratum of clay or shale lying between two layers of rock, and permitting one layer of rock to slip forward about 18 inches upon the lower layer....The water getting under the dam at a depth of 6 ft. below the concrete base exerted a much greater upward pressure than was anticipated when the cross-section was designed and reduced the factor of safety against sliding to an unsafe limit".<sup>[1]</sup>

**Figure 3 – Partial Sliding Failure – January 23, 1910**  
(Source: Potter County Historical Society)

Immediately following the partial failure incident in late January, Hatton consulted with Edward Wegmann about possible repair options and presented them to Bayless. During this same period, Bayless consulted with another engineer for a second opinion about repair options as well as an alternative interim measure which involved building a new timber-crib dam located near the upstream reservoir limits for the concrete dam. The original intent for the smaller and consequently less expensive timber-crib dam was to provide water for the mill while the concrete dam was out of service for repairs.

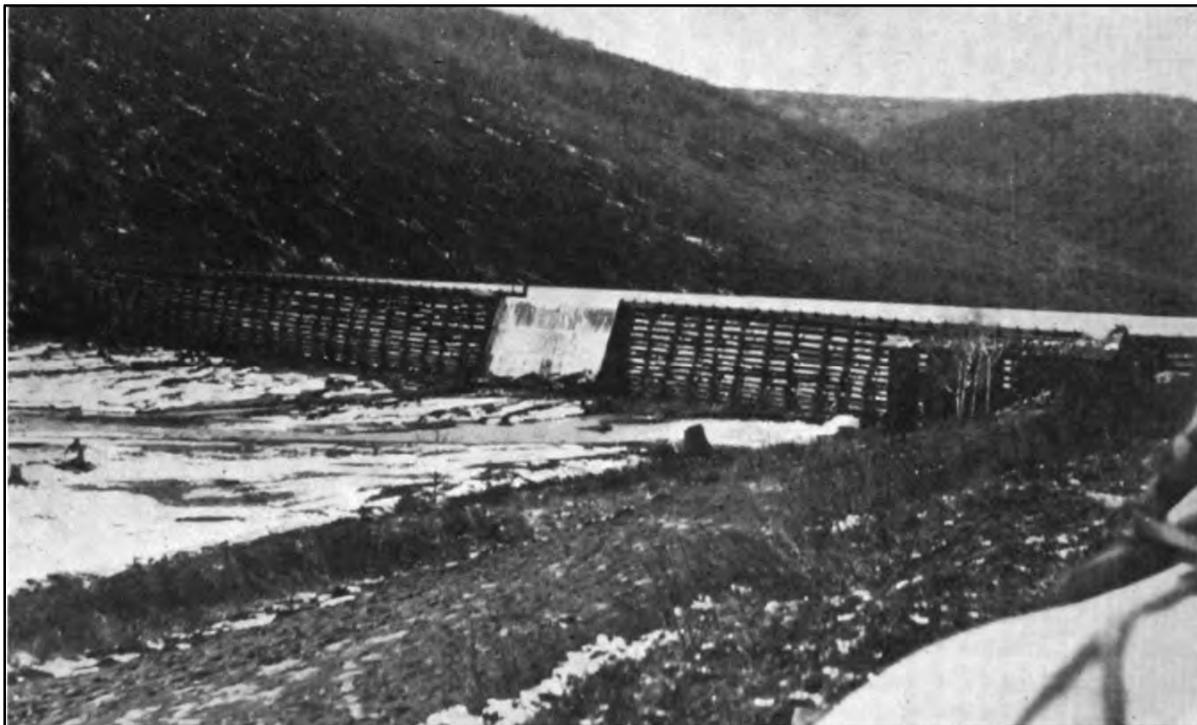
**Figure 4** – Timber-Crib Dam – Completed June 1910 <sup>[10]</sup>

In the first five months of operation, the timber-crib dam experienced seepage at the base along its entire length as well as up the right abutment. By December 1910, ten inches of settlement was observed along the entire length of the dam crest. Upon this news, Bayless directed the mill superintendent to empty the reservoir behind the timber-crib dam to investigate its condition and implement repairs. Later accounts indicate that strengthening this dam with timber, earth and rock required a constant effort.

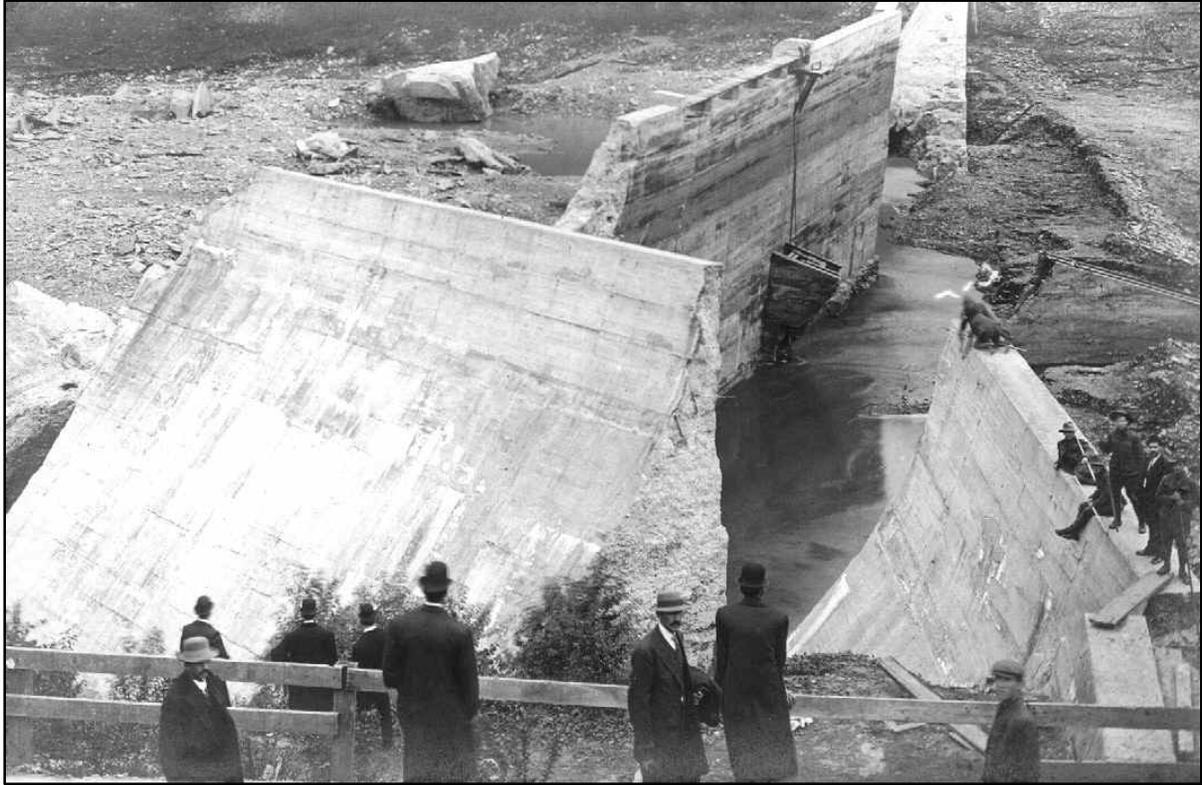
Due to heavy rains during September 15-17<sup>th</sup>, the reservoir completely refilled to within inches of the spillway crest for the first time since the partial failure occurred in January 1910. By Saturday morning, September 30<sup>th</sup>, according to several eye witness accounts, the reservoir level was within a half inch of the spillway crest and leakage both through and under the dam began to increase at an alarming rate. Against the pleas of two mill employees that witnessed the leakage, the mill superintendent refused to allow them to open the outlet works to lower the reservoir nor did he bother to visit the site to observe conditions firsthand. The superintendent's argument was that the reservoir must be kept as full as possible to help meet production demands at the paper mill. Sometime between 2:00 and 2:15 pm in the afternoon, the dam suffered a catastrophic collapse as shown in Figure 5. At the time of failure, no one from the mill was present at the damsite. The developing failure was first observed by two people passing by the dam in a car and by several residents living near the dam.

The resulting flood wave that was released essentially destroyed the towns of Austin and Costello and took the lives of 78 people. In reaction, the county district attorney hired the Director of Engineering at Lehigh University, Prof. Frank P. McKibben, to investigate the cause of failure to determine what further legal action may be warranted. McKibben publicly released his findings in a little over two months in December 1911. His primary conclusion was "The failure of this dam is due to sliding as a result of faulty foundation, faulty design, faulty construction and faulty operation".<sup>[5]</sup> McKibben's detailed discussion of these factors along with his recommendations for future dams appears reasonably valid in light of the profession's knowledge base at that time. Concurrently, the Chief Engineer of the Pennsylvania Water Supply Commission, Farley Gannett, was tasked with conducting a similar investigation for the state's interests. Available documents suggest that Gannett adopted the same findings as McKibben.

**Figure 5 – Catastrophic Collapse – September 30, 1911**  
(Source: Potter County Historical Society)

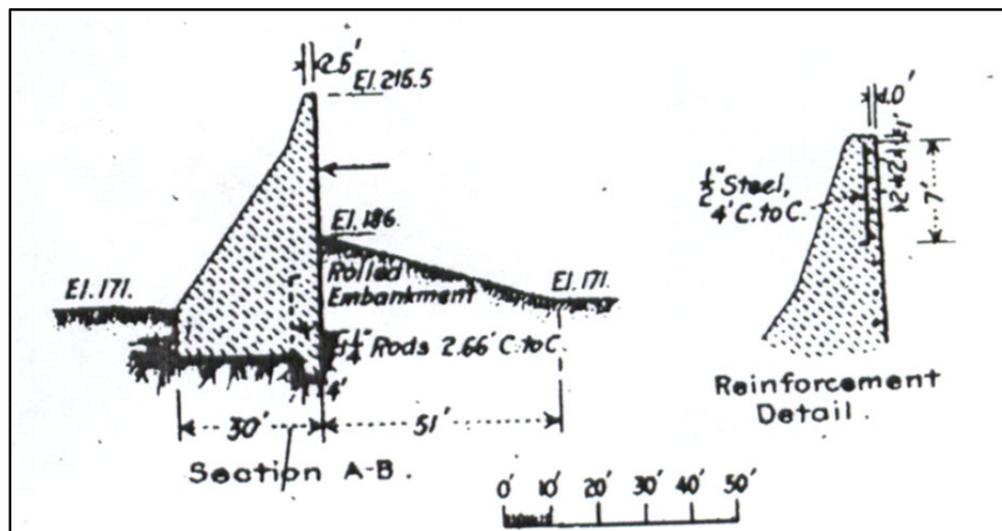
Figure 6 – Non-Overflow Section <sup>[1]</sup>

1. **Unconventional Design Features:** Hatton devised some unique unconventional design features to mitigate the reduction in structure mass that was necessary to meet budget requirements. These features consisted of installing 25-foot-long and 1-1/4-inch diameter twisted steel rods on 2.66-foot-centers (see Figure 6) approximately 6 to 8 feet into the foundation rock “to increase the factor of safety against overturning”.<sup>[6]</sup> Again, to further reduce mass, the dam’s chimney section had a top width of only 2.5 feet with a very steep downstream slope. To prevent

horizontal cracking due to tensile stress in this top portion of the dam, Hatton used ½-inch-diameter steel reinforcement spaced 4-feet-vertically and 2-feet-horizontally.

- 3. Uplift Forces Neglected:** Hatton recognized that uplift forces can develop beneath a gravity dam but incorrectly assumed that a rolled embankment (see Figure 6) at the upstream face could provide an impermeable water barrier and essentially eliminate this force. He also incorrectly assumed this embankment would reduce the hydrostatic pressure against the dam. Hatton cannot necessarily be entirely faulted for this approach since many other gravity dams constructed during this era also have this feature presumably for the same reason.

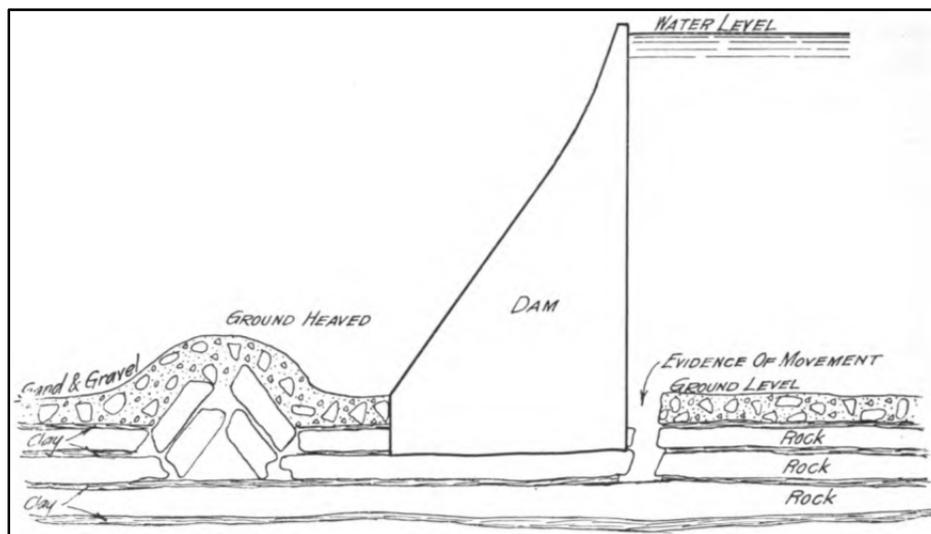
Careful examination of the damsite following the 1911 collapse revealed that the weak plane that precipitated failure of the dam was within the rock foundation at clay-filled bedding joints between sandstone and shale units (see Figure 7). This failure mode was first evidenced during Hatton's inspection of the dam on January 25, 1910 by an 18-inch-wide vertical cleavage in the foundation rock located 12-feet upstream of the upstream face and running parallel to it. Hatton's further details on the failure mode are: "Since January 25, 1910, water has been constantly impounded by this broken concrete wall. The depth of this water has varied from 25 to 52 ft. During this period water has continued to leak through the underlying strata, and this leakage, going on at great pressure, must certainly have washed much of the shale and gravel away, leaving the heavy concrete walls with less and less foundation until the final collapse came on September 30, 1911".<sup>[6]</sup>

**Figure 7** – Schematic of Failure Mode – Slip Between Rock Layers<sup>[3]</sup>
