Failure of Sella Zerbino Secondary Dam in Molare, Italy

Irfan A. Alvi, PE, President & Chief Engineer, Alvi Associates, Inc.

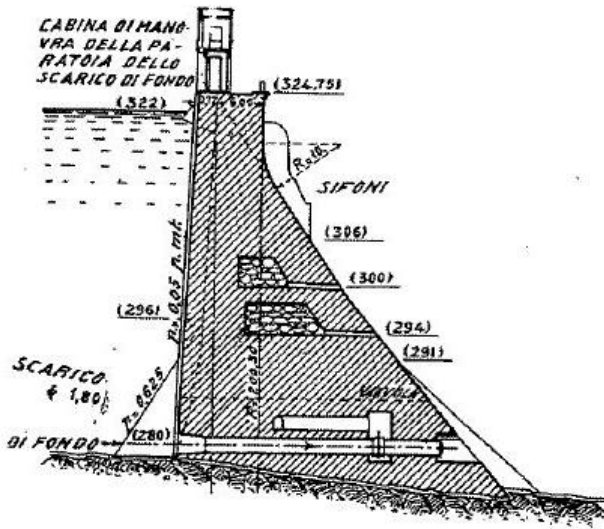
Figure 5. Bottom Outlet of Main Dam

- By 10:00 am, the reservoir level had risen about 25’ and the dam caretaker started an emergency procedure, apparently opening the valves for the bottom outlet and mid-level outlet of the main dam, but the valves became clogged with a large amount of mud and debris within a few minutes [4]. The siphon spillways had a discharge capacity of about 23,000 cfs (less than one third of the peak inflow), and they may also have become partially clogged [3]. There is also indication that a gate for the chute spillway was at least partly inoperable due to rust [3].

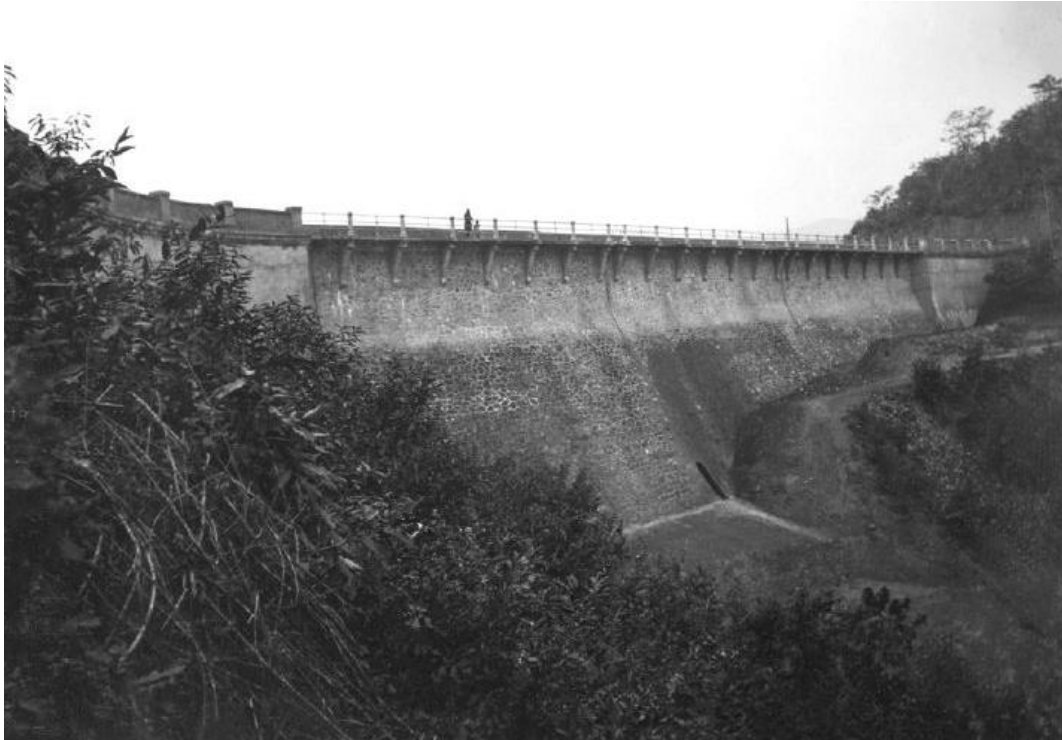
Figure 7. Downstream Face of Secondary Dam

The Sella Zerbino secondary dam augmented the main dam by closing a saddle-shaped gap in the rim of the reservoir, about 1000' northwest of the main dam (Figure 3) [4]. The secondary dam was a straight concrete gravity dam with a height of 46', a crest length of about 360', and no spillway or outlet (Figure 7).

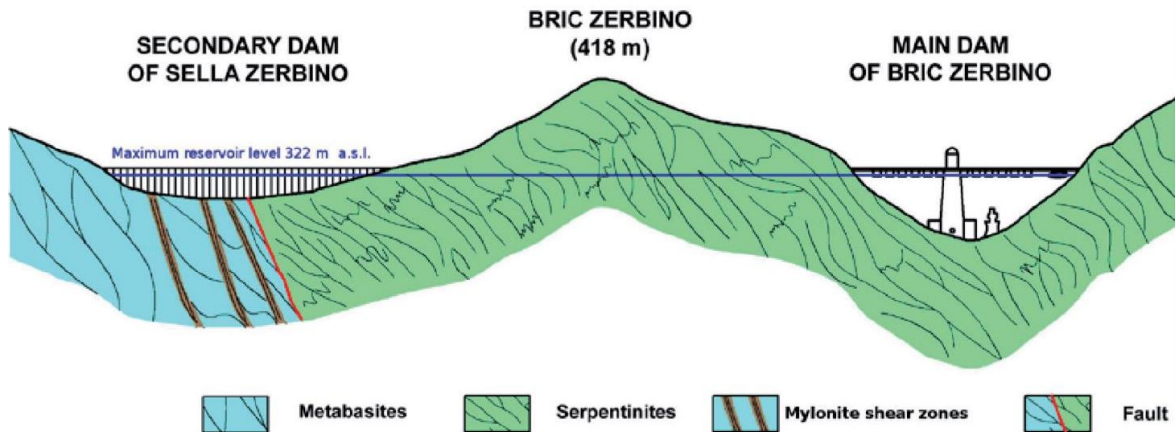
Figure 8. Geologic Section Developed After the Dam Failure [2]

Planning of the Orteglieto Reservoir began circa 1895. This included a short geologic report prepared in 1898, which was not based on detailed geologic surveys, borings, or analysis of rock masses [2]. The report noted that the rock in the valley, belonging to the Voltri Group, was highly variable (Figure 8), yet the report seemingly ignored this variability by concluding that "... in any part of this area it is possible to build a dam in full safety conditions." Moreover, there is evidence that fluvial erosion had exposed joints and shear zones in the rock, but this was not reflected in the report [2]. There was essentially no further geologic investigation after this initial report until the secondary dam failed four decades later.

Finally, the secondary dam failed on August 13, 1935. The apparent mode of failure was overtopping of the dam, resulting in erosion of the rock at the toe of the dam, in turn causing sliding and overturning failure. As further evidence of the low quality of the geologic formation, little remained of the secondary dam and its foundation after the failure, and geologic investigations after the failure indicated that while the main dam was founded on compact serpentinites, the secondary dam was founded on highly-jointed schistose rock with intense foliation and slaty cleavage (Figure 8), which many experts concluded was inadequate for a dam foundation [2].

- The secondary dam had no spillway or erosion protection, and was therefore subjected to undirected and uncontrolled overtopping.
- The foundation rock at the secondary dam was inadequate due to extensive joints, faults, shear zones, and slaty cleavage, which resulted in high erodibility and instability. Before the failure, evidence of these features was provided by exposures from fluvial erosion, seepage through the foundation, and erosion of the rock in a nearby tunnel. After the failure, a large volume of the foundation rock was found to have been washed out.

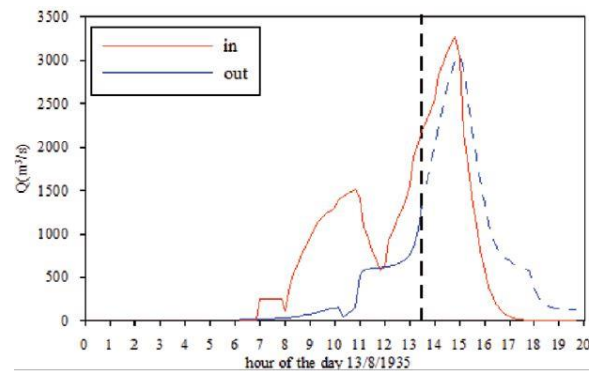
Figure 10. Reservoir Inflow and Outflow on Day of Failure [5]

- Overtopping began around 12:30 pm (Figure 10). Around 1:20 pm, less than an hour after overtopping began, the maximum depth of overtopping reached an estimated at 6’ to 16’ [2]-[6], and the secondary dam failed, leading to rapid release of the reservoir (Figure 10). The failure mode was overturning and sliding, after the overtopping eroded the rock at the toe of the dam. Inflow to the reservoir was still increasing at the time of the failure, and peaked at more than 100,000 cfs less than two hours after the failure (Figure 10) [5]. It may be noted that the duration of the storm and the time until failure are relatively similar to the 5.5-hour time of concentration of the reservoir, which indicates that the storm duration was close to a worst-case scenario for the reservoir.
