REEXAMINATION OF THE 2004 FAILURE OF BIG BAY DAM, MISSISSIPPI¹

Keith A. Ferguson, P.E., National Dam and Hydraulic Structures Practice Leader²
Scott Anderson, P.E., National Technology Leader for Numerical Modeling³
Elena Sossenkina, P.E., National Technology Leader for Risk⁴

ABSTRACT

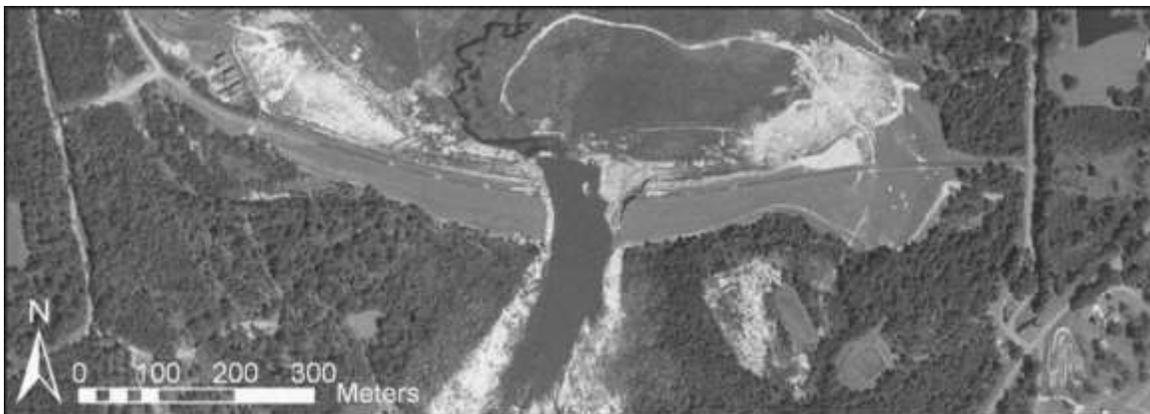
Figure 2. Aerial View of Breach Immediately Following Failure of the Dam

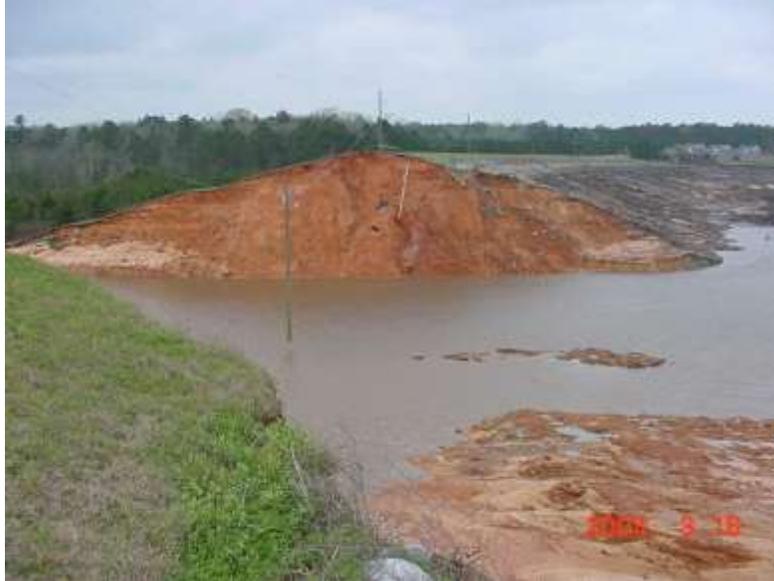
Figure 3. Photo of Dam Breach from Upstream Slope.

The breach that formed in the dam was in the general vicinity of the outlet conduit and resulted in total failure of the outlet intake structure, conduit through the embankment at the foundation contact, and the outlet discharge structure. As described in a subsequent section of this paper, the root cause of the failure was never conclusively established during the subsequent investigation and litigation phases of the project. While several theories were postulated by different parties, the author's examination of the information from the investigations and trial activities along with their general experience with seepage failure modes suggests that the failure mode development process was complex. Contributing factors may have included defects in the outlet conduit, lack of effective seepage control in the central core of the dam, poorly designed and constructed seepage filter and collection systems in the downstream portion of the dam and foundation, and lack of proper instrumentation and monitoring of the dam. The very poor design, remedial construction, and inspection/monitoring records at the dam will not permit conclusive establishment of the root cause of failure. However, a potential failure modes (PFM) framework to reexamine the available information has been highly informative.

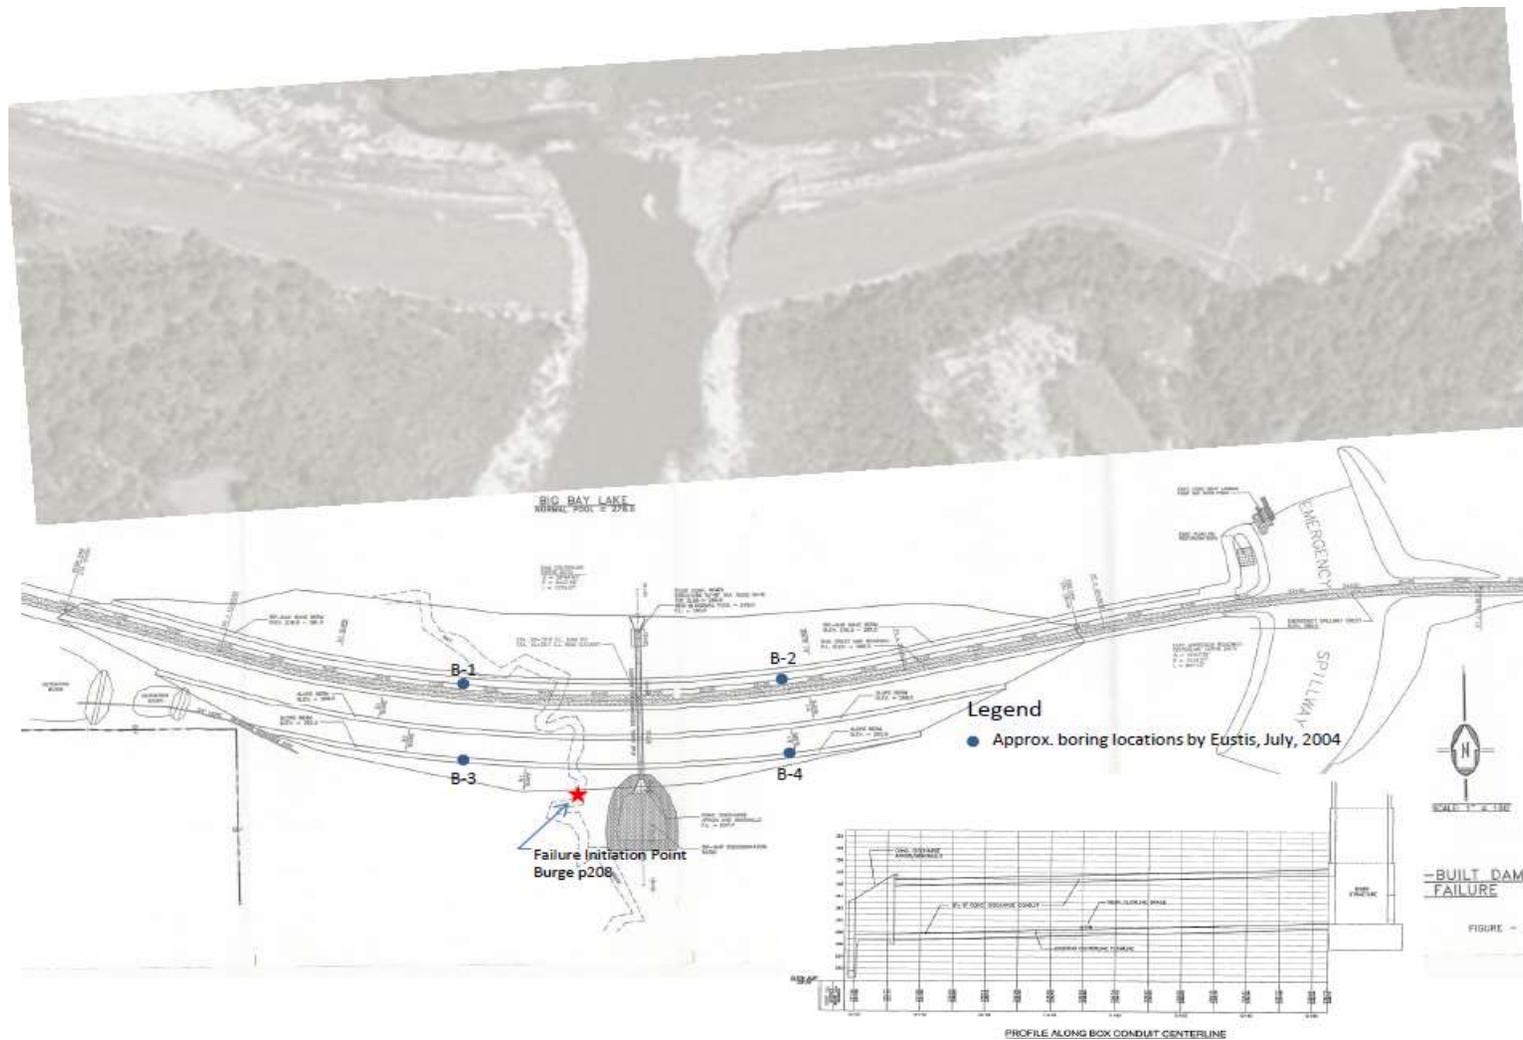
The approximate location where the failure mode breakout occurred, based on deposition by both the Maintenance Man (Daughdrill deposition, p 69, October 3, 2006) and the Engineer (Burge deposition, p 208, December 17, 2007) along with the location where several important initial borings were completed (Eustis, 2004) in the remnant embankment adjacent to the breach location are illustrated on Figure 4. You will note that the original outlet works conduit is shown on the original plan view along the bottom of this figure at a location that is approximately near the center of the final breach configuration. The outlet works intake structure, conduit, and discharge structure were completely destroyed during the breach formation process leaving no remnant structure or embankment/foundation materials available for forensic evaluation.

Figure 4. Plan View of Failure Showing Approximate Location Where Failure Mode Breakout Occurred and Original Borings Were Performed

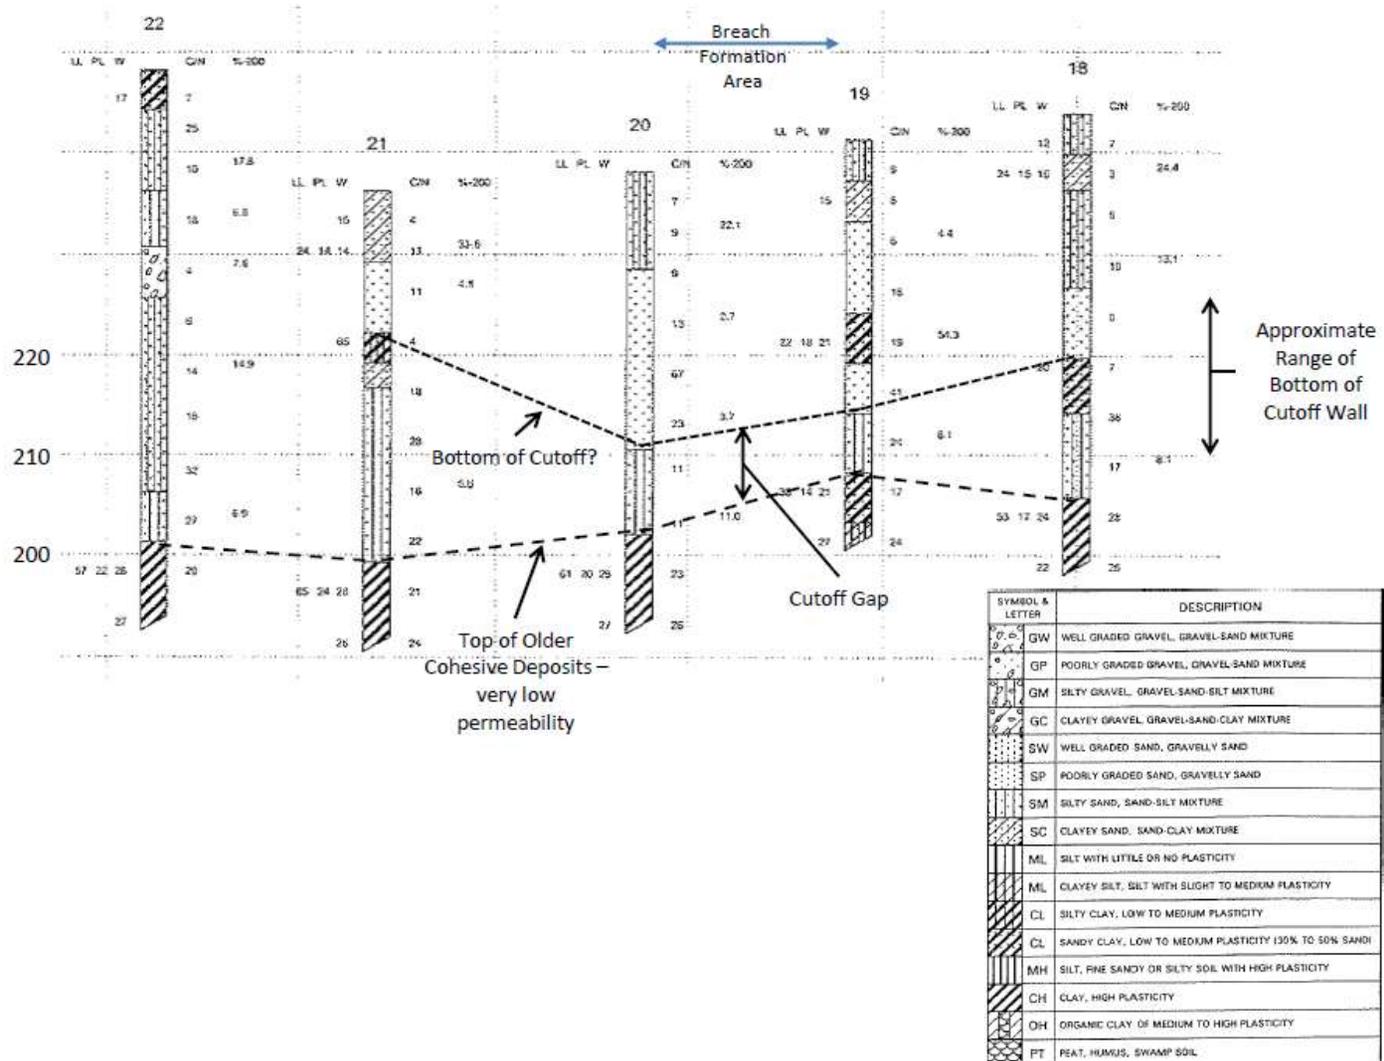
In summary, data gathered following the dam failure indicates that the cutoff that was constructed did not fully penetrate the moderate to highly permeable shallow foundation soils. Older cohesive foundation soils with very low permeability are located at reasonable depth beneath the site. A complete cutoff system could have been achieved if the cutoff had been installed into this layer of “impermeable” foundation materials. In addition to this deficiency in the design and construction, the subsequent investigations of the cutoff wall summarized in Table 1 indicate that the permeability of the “cutoff” materials was variable by up to three orders of magnitude with the higher values providing “windows” that would allow for the development of preferential seepage pathways.

Figure 8. Estimated Bottom of Cutoff in Breach Formation Area

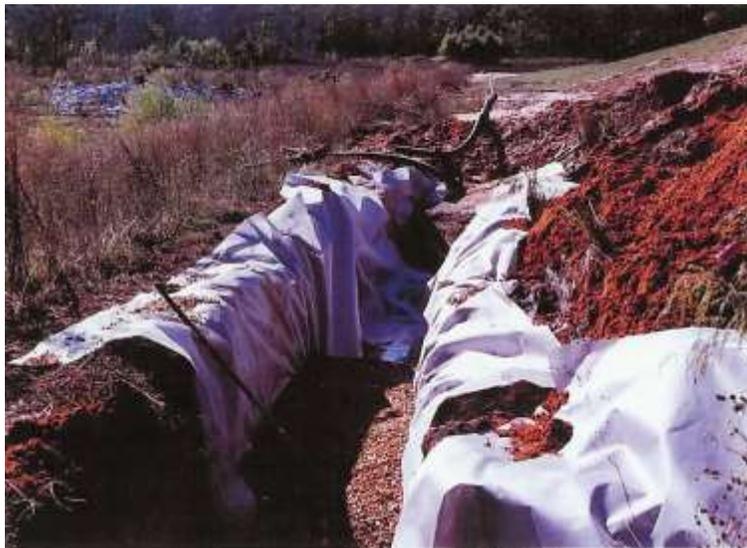
Two important seepage design and subsequent seepage repairs may have significantly contributed to the failure mode development process. First, the small toe drain system installed as part of the original construction and as part of several remedial actions were constructed with a method that would likely contribute to clogging of the drain over time. This is illustrated by the typical drain detail shown on Figure 9. A photograph of the typical installation of a toe drain is also shown on this Figure. You can see in the construction photo that the filter fabric was draped over the vertical sides of the excavation and there are numerous bubbles and very poor installation techniques that were used. This method of installation would not result in intimate contact between the filter fabric lining the trench and the adjacent foundation soils. This would allow soil particles from the soil face to move as seepage water exits from the foundation soils and flows into the drain. Over time, instead of acting as an effective filter/drain protecting the foundation and embankment materials from erosion by collecting and safely discharging foundation and embankment seepage, the filter fabric around the exterior of the drain would have clogged. A clogged drain could result in the localized increase of water pressures in the downstream toe area and a breakout of seepage at an unfiltered and/or uncontrolled location. It is also interesting to note the apparent tear/opening in the filter fabric in the lower right hand area of the photo. Such defects, combined with the possibility of clogging in other areas could result in the initiation of piping into the drain during later stages of the failure mode development process as described in items 1 and 2 of the failure mode description above.

Figure 9. Typical Trench Drain Design Detail and Construction

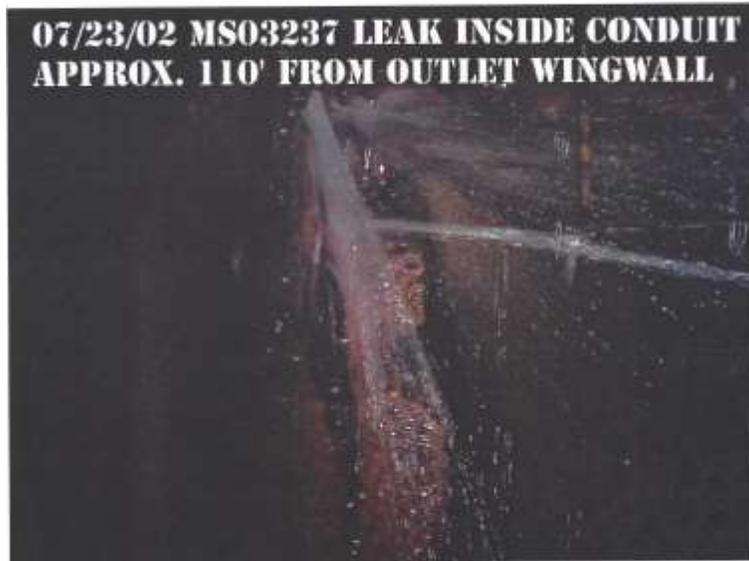
Information in the project record indicates that there were many locations where leakage was occurring into the outlet conduit once the reservoir filled. The characteristics of these leakage locations apparently changed over time. However, the two primary seepage locations indicated as distress locations 1 and 2 appeared to develop and flow for an extended period of time including the time of the July, 2002 inspection by the State Engineer. A photo of the downstream leak approximately 110 feet into the conduit from the discharge wing wall is shown on Figure 10. The discharge from the leak located near the upstream end of the conduit (254 feet from the discharge wing wall) was described as three discharges beginning about 10 inches above the box floor along the west wall.

The seepage ranged from a trickle to $\frac{1}{4}$ to $\frac{3}{8}$ -inch stream with total flow of about 5 to 6 gallons per minute. The seepage described at both locations would be sufficient to carry the substantial majority if not all of the material sizes of embankment and foundation materials indicated on the gradation curves provided on Figure 6.

Figure 10. Photo of Leak Discharging into Conduit Approximately 110 Feet from the Outlet Wingwall. See Figure 7 for Approximate Location on Cross Section.

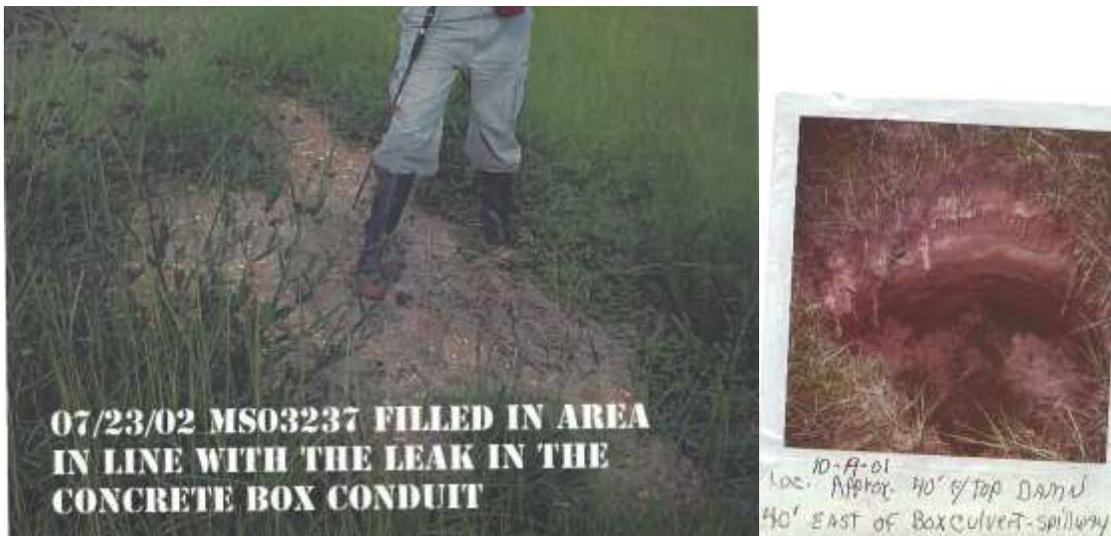
A sinkhole was discovered on a lower bench along the downstream slope of the dam. This sinkhole had been backfilled by the time of the State Engineer inspection in July 2002. Maintenance personnel indicated that the sink hole was over the top of the outlet conduit while the Engineer noted during deposition that it was located 30 to 50 feet east of the conduit. A photo of the backfilled sinkhole is shown on Figure 11. The possible locations of the sinkhole are illustrated on Figure 7. A circle with the number 3 is shown at the two possible bench locations described in the depositions.

Figure 11. Photo of Sinkhole Before and After Backfilling on the Lower Downstream Slope Bench. See Figure 7 for Approximate Location on Cross Section.

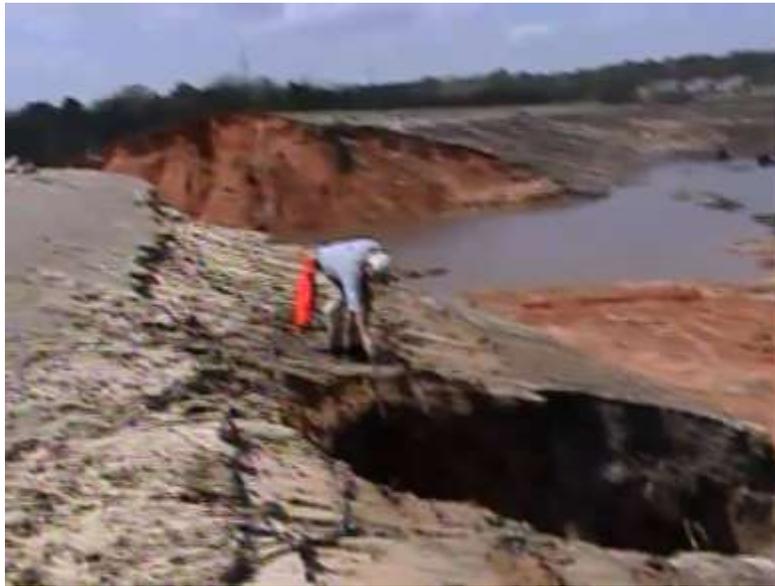
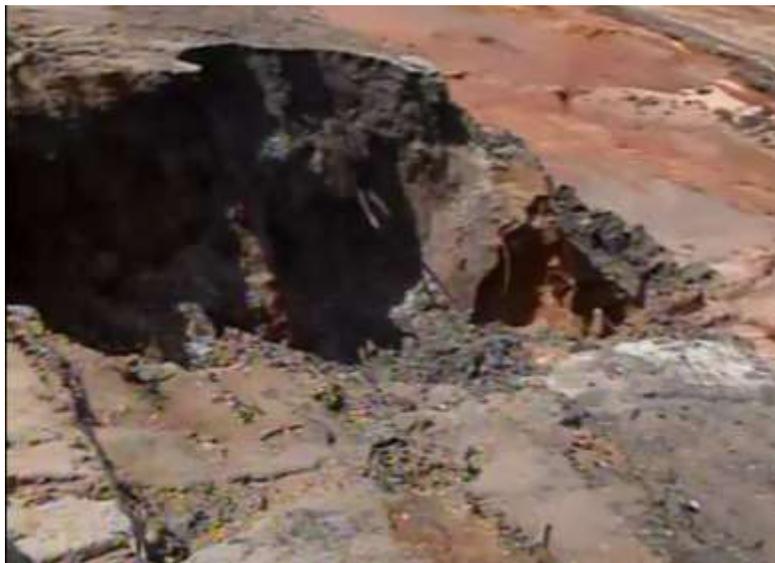
While inspecting various documents and photographs as part of this project review, a picture of a sinkhole on the upstream slope of the dam below the high water line and just outside the breach limits was discovered. A picture of this sinkhole is shown on Figure 12. While a bit unusual to be this far from the outlet conduit, there are no other identifiable conditions that could have led to its formation other than the potential failure mode associated with the outlet conduit. It is possible that several of these sink holes could have formed over the life of the structure with a different one being the primary failure mode pathway.

Figure 12. Photos of Sinkhole on Upstream Slope of Dam Following Breach Development. See Figure 7 for Approximate Location on Cross Section.

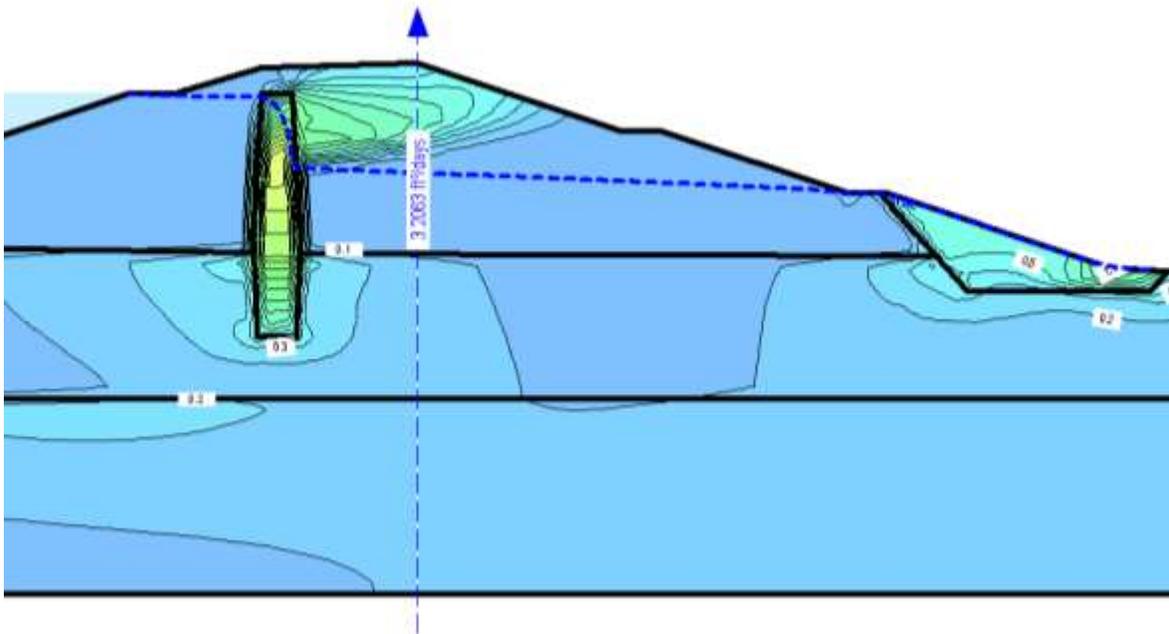
As previously noted, the design details and construction of seepage control features including the minimal toe drain and the 1999 seepage remediation around the outlet conduit likely incorporated filter fabric and construction techniques that had a very high potential for clogging. Testimony further supports this hypothesis indicating that the 1999 remediation around the outlet conduit ceased to discharge after only a short period of operation, even with the indication of foundation seepage encountered during excavation for the remediation work. To gain some insight into the potential impact of clogging of the 1999 seepage remediation work at the end of Step 8, the Step 1, Base Case 1 model of the embankment adjacent to the outlet conduit cross section was modified to include a “clogged” remediation treatment. “Clogging” was simulated by decreasing the permeability of the treatment wedge at the downstream toe by two orders of magnitude. An overview of the phreatic surface and seepage gradients in the embankment and foundation is shown on Figure 21. A close up of the seepage gradients at and below the downstream toe of the dam is shown on Figure 22. Comparing the phreatic surface shown on Figure 21 with the surface shown on Figure 15 suggests that one of the results of clogging would have been to raise the phreatic surface and create the potential for breakout of embankment seepage on the lower bench of the embankment. Whether or not this actually occurred is not clear in the available information. In addition, the likelihood of this happening would have been reduced due to 3-dimensional seepage effects as the width of this treatment was limited (actual lateral limits of treatment are not known from the available information).

Figure 21. Effect of Clogging of 1999 Seepage Remediation Discharge End of Outlet Conduit on Phreatic Surface and Seepage Exit Gradients

However, the effect of this treatment on seepage flow patterns, and discharge gradients at the downstream toe could have been much more significant as indicated by the results shown on Figure 21. While we fully appreciate the limitations of the 2-dimensional seepage model to adequately represent the effect of clogging, the results shown on this figure would certainly suggest that the effect of the clogging of this remediation feature ,
