INVESTIGATION AND EVALUATION OF SEEPAGE CONDITIONS AND POTENTIAL FAILURE MODES AROUND OUTLET CONDUITS

Keith A. Ferguson, P.E.¹

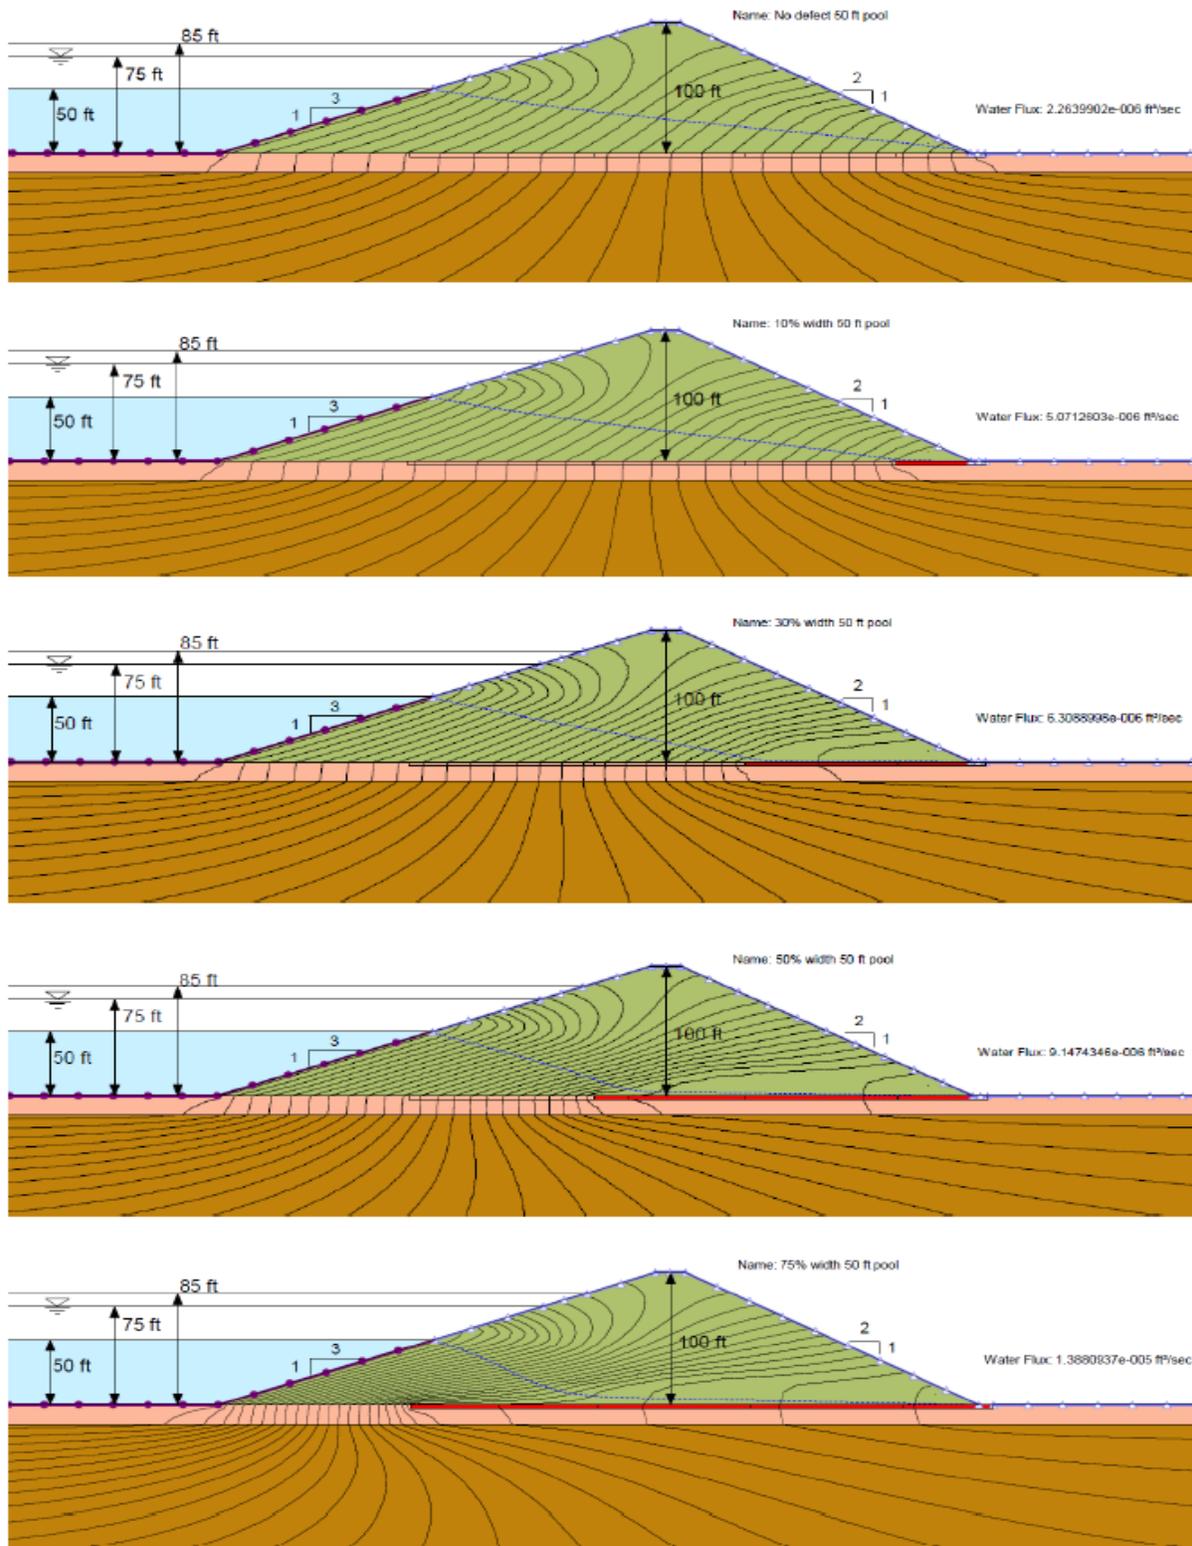
Figure 3. Equipotential Line Plots for Zero, 10, 30, 50, and 75 Percent Defect Extension under the Dam.

The results of the analyses showing the estimated seepage gradients in the embankment and foundation materials for different extents of defect development are illustrated on Figure 3. The extent of the defects is shown on each cross-section in red. A summary of the estimated seepage gradients at the active face of the defect along with the estimated seepage quantity flowing into the upstream end of the defect are summarized in Table 2.

3. The seepage gradients at the active front of the pipe are increasing as the defect advances upstream. As shown in Table 2, the gradients increase from about 0.4 to 1.0 as the defect moves from about 10% to 75% of the distance along the base of the dam. Consequently, the reservoir level required to reactivate the erosion and pipe development process decreases over time. For example, a gradient of 0.5 or higher develops at the active front of the pipe when the feature has advanced to 30% of the distance toward the upstream toe with the reservoir at 85% of the embankment height. A similar gradient exists at a reservoir level of about 75% when the defect has advanced from 40 to 50% of the distance to the upstream toe and a reservoir elevation of only 50% is required to cause a 0.5 or higher gradient once the active front of the defect when it has advanced to about 75% of the distance toward the upstream toe. Consequently, the rate of development/advancement would generally increase over time.

5. Another important observation has to do with the nature of the equipotential lines downstream of the active front of the defect. The model shows that the overall seepage gradient would be very flat relative to the gradient in the vicinity of the active front of the defect. Downstream of the active front, the gradients do not change substantially for significant changes in the reservoir level. This observation suggests that a sufficient number of instruments at appropriate locations are required to properly characterize seepage conditions and evaluate the initiation and extent of potential failure mode development. In other words, a couple of instruments at the downstream toe and perhaps a couple of instruments installed through the dam at the crest will not be sufficient to detect if a failure mode has developed and is active.

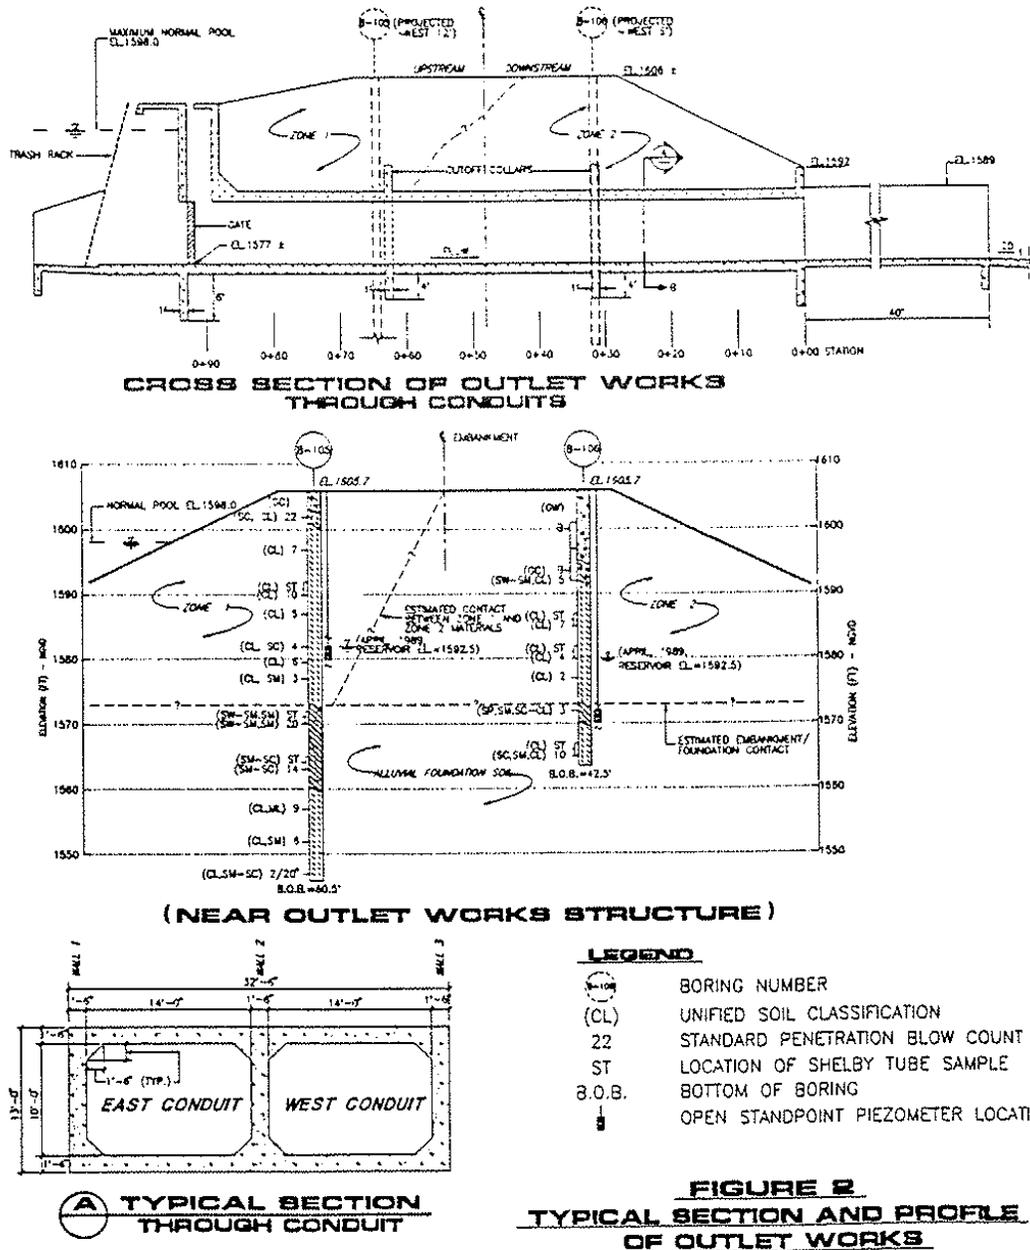
Figure 5. Lake Darling Dam Primary Outlet Works at the time of the 1988 Investigations and Dam Safety Evaluation Studies

The Figure 5 below, taken from Figure 2 in that publication shows some of the details of the outlet conduit. Examination of the information in this figure indicates that the conduit is relatively large compared to the height of the embankment. There was a significant possibility of differential settlement caused by differential loading of slightly compressible foundation (C_c , Compression Index approx. 0.05 to 0.1). The differential load between the base of the conduit and the adjacent base of the embankment was about 1200 psf. This likely resulted in a total differential settlement along the profile of the dam under the crest in the area adjacent to the conduit of perhaps about 4 to 5 inches. From a cross-sectional perspective, the total maximum differential settlement of the conduit was about 4 inches (the difference in settlement under the crest and at the ends of the structure near the upstream or downstream toes of the dam).

Minimal precautions were taken in the design and during construction to minimize the adverse foundation conditions below the conduit. Specifically, camber or flexible construction joints with water stops were not included to address potential settlement of the structure. Likewise, the embankment did not include any chimney filter/drain system that would address hydraulic fracture or cracking potential that may occur as a result of differential settlement in the vicinity of the conduit. During installation of an isolated tip piezometer in Boring B-106 drilled from the crest of the dam and adjacent to the outlet conduit, a significant loss of backfill grout occurred. The loss of grout appeared to occur at or below about the midpoint of the conduit (about elevation 1580). The stratigraphy encountered in the borings indicated that the embankment material was a low plastic clay (CL) and the foundation material immediately below the dam was a variety of uniform fine sand (SP), well graded sand (SW) silty sand (SM, SW-SM) to sandy silt (ML), to clayey sand (SC) and sandy clay (CL). Some of the foundation material would classify as highly erodible.

The characteristics of the grout loss and the actions required to complete installation of the instrument suggested that the loss was associated with a pre-existing void that had formed adjacent to the conduit. The discussion of hydraulic fracturing presented above indicates that hydraulic fracturing that had previously occurred or was caused by the column of backfill grout in the borehole may have also been a contributing factor.

encountered voids below the conduit and along the lower conduit wall (one location). The overall conclusion would be that the cracking of the conduit floor and lower walls provided the critical mechanism for the development of concentrated leaks at a location of highly erodible foundation soils and that initiation of a seepage failure mode had occurred. The pattern of interconnected grout discharge from open grout holes indicated that the failure mode was in the continuation phase and may have advanced to a location under the crest of the dam.

A remediation program was subsequently designed and constructed that included a comprehensive program of low pressure grouting around the conduit. The program was carefully observed and the work progressed from downstream to upstream along the floor and walls of the conduit to maximize the potential to intersect voids and completely fill the voids with what would classify today as a moderately stable and mobile grout material. Additional details of the grouting and overall remediation program that included relief wells and installation of a new floor with proper filters for the cracks that had formed is provide in the reference publication above.

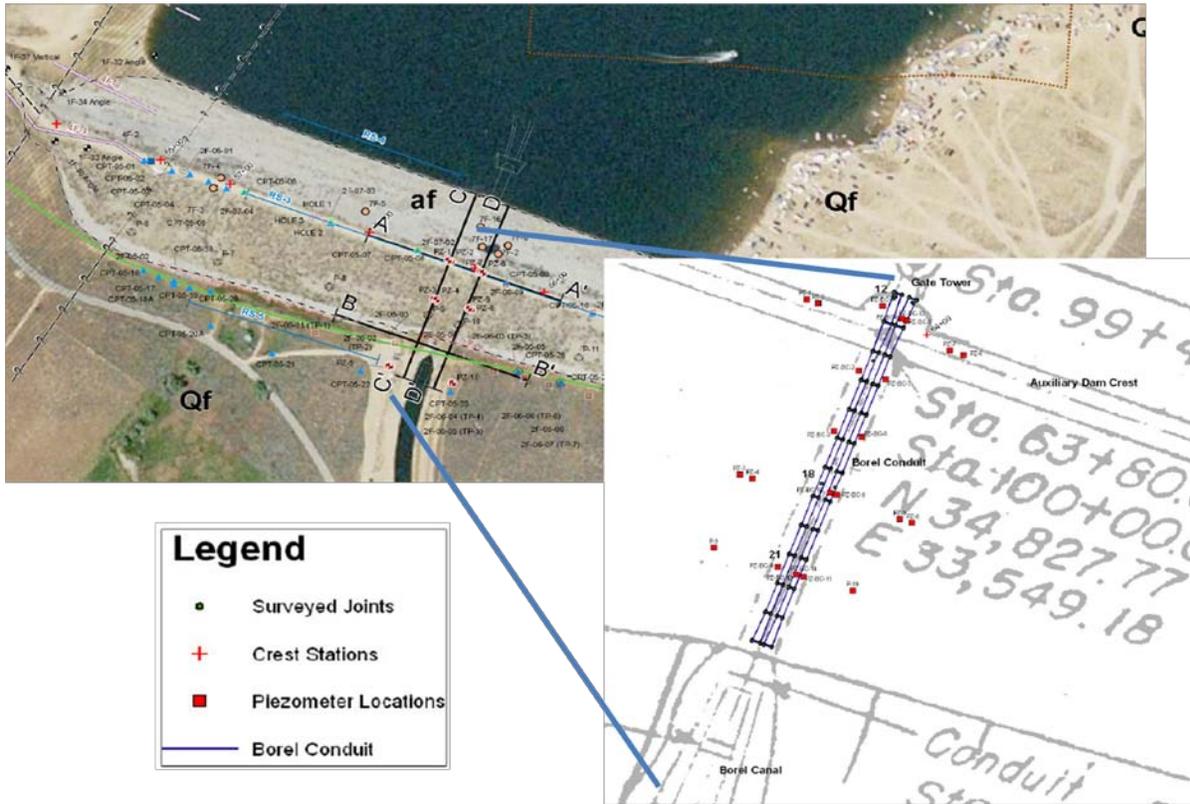
Figure 9. Layout of Investigation and Instruments for assessment of the Borel Canal Conduit

The layout of the exploration program is generally shown on Figure 9. As part of the investigation two significant locations were identified where concentrated seepage were discharging and creating the potential for initiation of a seepage failure mode.

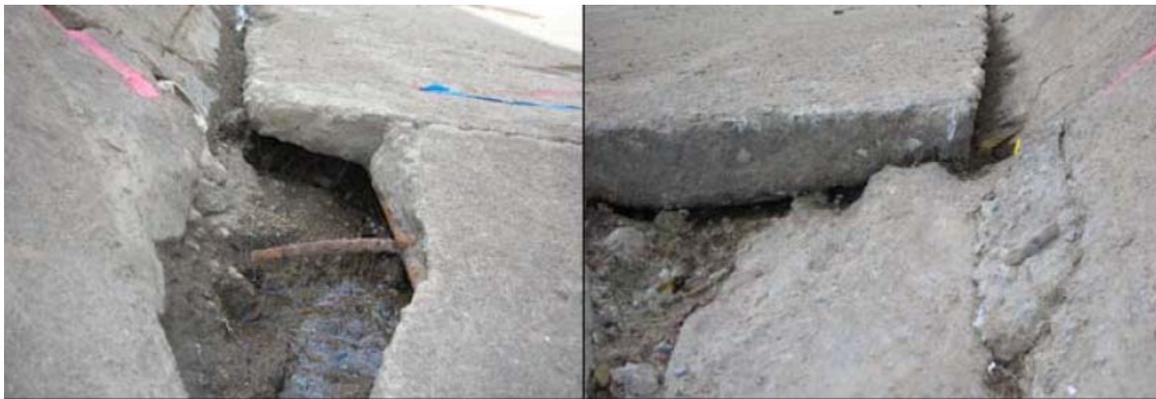
Figure 10. Unfiltered Openings in Canal Lining Immediately Downstream of Conduit Discharge Structure

Location #2: Defects in the Canal lining immediately downstream of the conduit discharge structure. A number of pin boils were observed in the bottom of the canal lining when it was dewatered for the inspection program. Examination of these locations suggested there was unfiltered discharge occurring through the openings. A later investigation of the lining where a more complete dewatering and cleanup was performed indicated a number of distress locations including the damaged lining at the location immediately downstream of the conduit discharge structure shown on Figure 10. In fact,

cloudy water was observed discharging from this location during the time the water in the canal and conduit was being drawn down for the investigation.

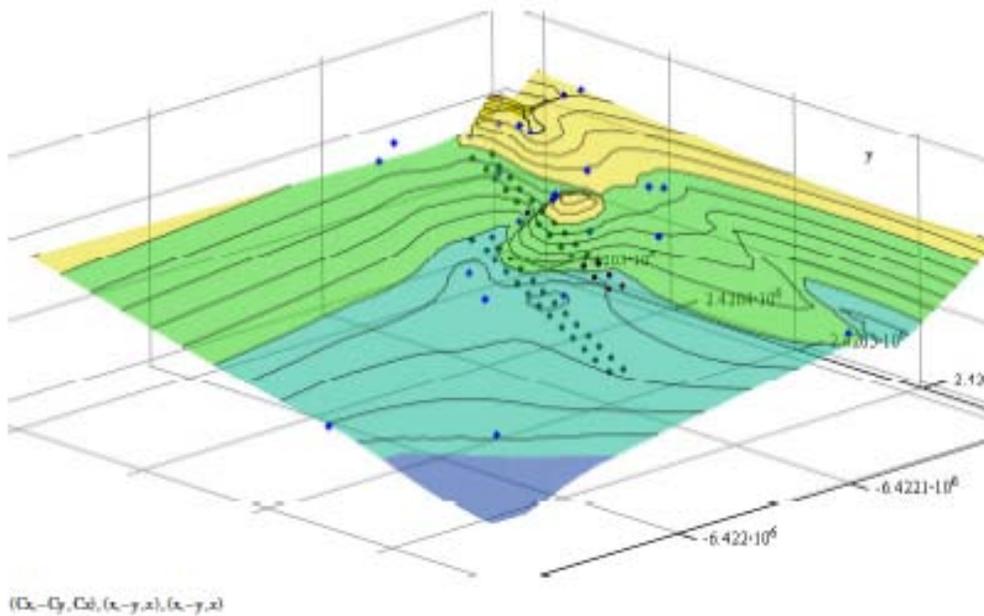
Figure 11. Plot of Water Pressure Contours in the Upper Silty Sand and Sandy Silt Foundation Layer Adjacent to the Borel Canal Conduit

The series of black dots shown on the 3-dimensional plot of water pressure contours on Figure 11 represent the survey point installed along the upper and lower portions of the conduit at each end of each monolith extending from the downstream toe of the dam (the black dots in the lower right of the plot) to the outlet control tower (the dots in the upper central portion of the figure). The blue dots on this figure represent the locations of the various vibrating wire piezometers used for the contouring exercise. The perspective of this plot is looking from the lower toward the upper end of the conduit from an oblique “birds eye” view.
