**Observed Performance of
Dams During Earthquakes**

Volume III

February 2014

Prepared by the USSD Committee on Earthquakes

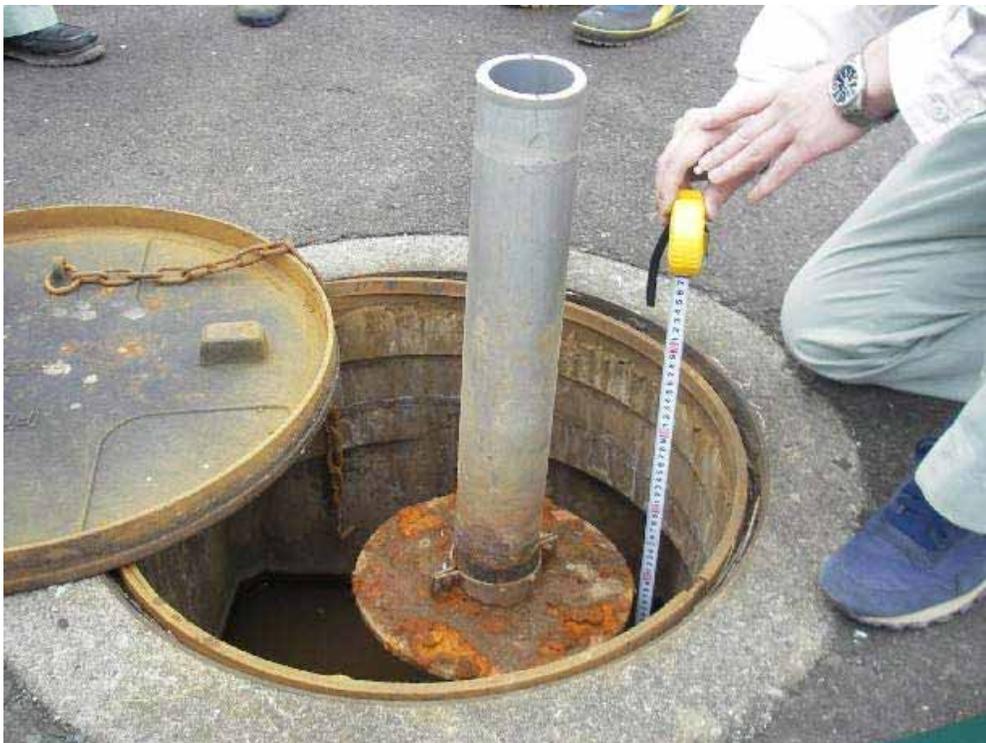
Figure 5. 10 cm of embankment settlement at the spillway (from Tani, et al., 2008).

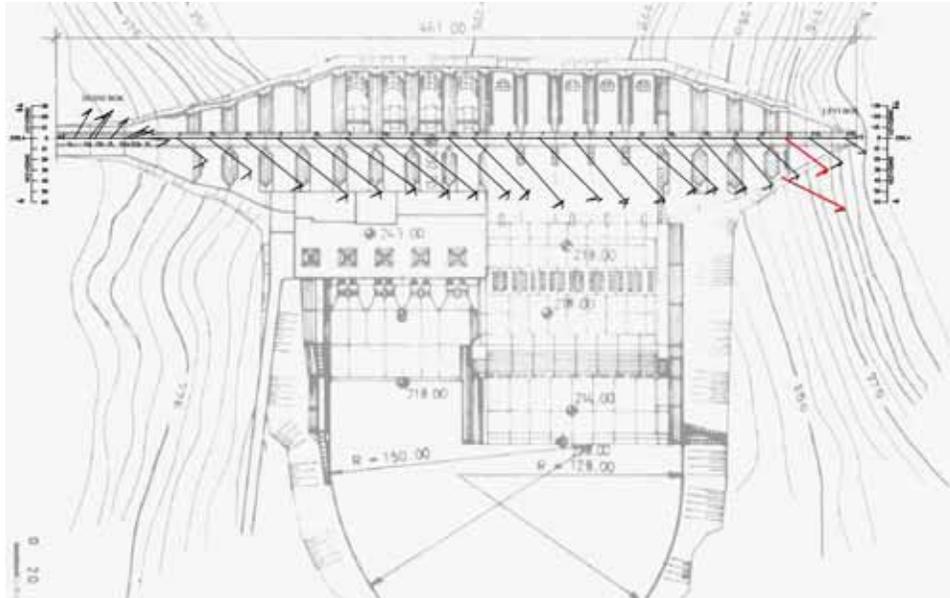
In the case of Bajina Basta Dam, the situation was understood as a combination of expected normal dam movements under design loads and neotectonic influence, producing the observed unexpected total movements, which gradually approached the final position of crest target vectors as shown in Figure 2.

Figure 2. Movement along the dam crest observed in 2009 (from ICOLD 1998).

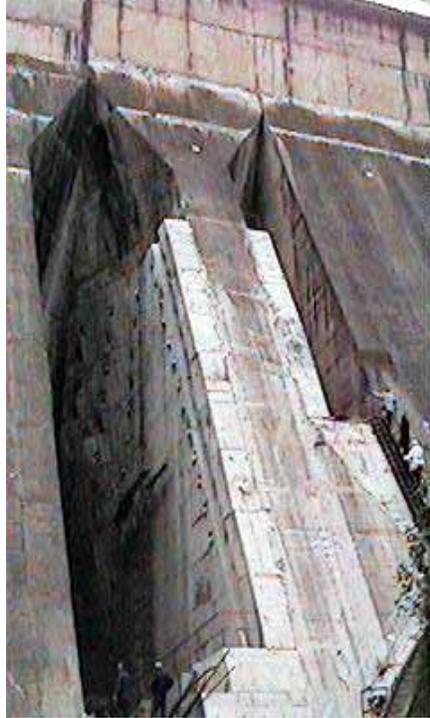
A large vertical crack had formed through the whole thickness along the central part of Block No. 21. It was rehabilitated by placing heavily reinforced concrete plates, which were connected by pre-stressed anchors along each side of the cracked web of the block as shown in Figure 3. In the following 19 years (1992-2011), no further damage has occurred at the rehabilitated Block No. 21.

Figure 3. Rehabilitation of Block 21 (from ICOLD 1998).

The explanation for development of the crack in Bajina Basta Dam was the existence of persistent neotectonic movements. This statement was introduced in ICOLD Bulletin No. 112 (ICOLD 1998).

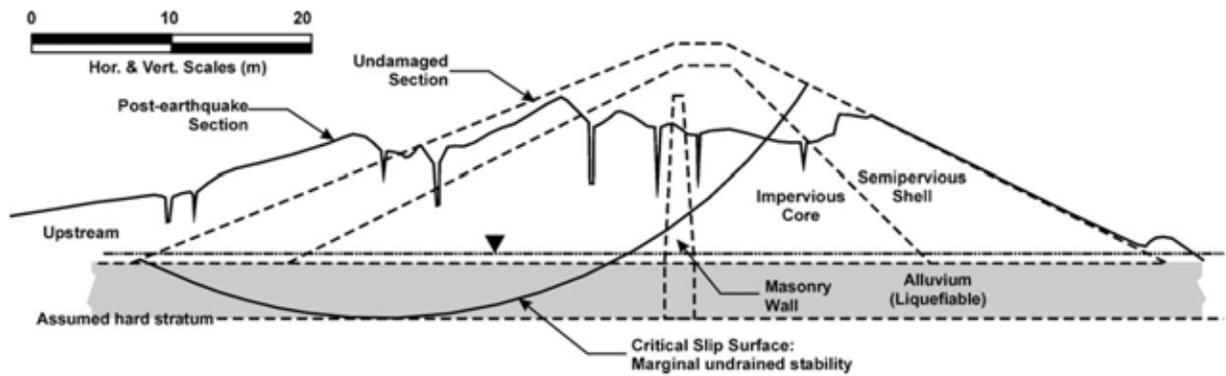
Figure 2. Cross-section of Chang Dam showing undamaged and damaged Embankment. The critical slip surface was calculated based on a post-earthquake stability analysis performed by the original author (from Singh et al., 2005).

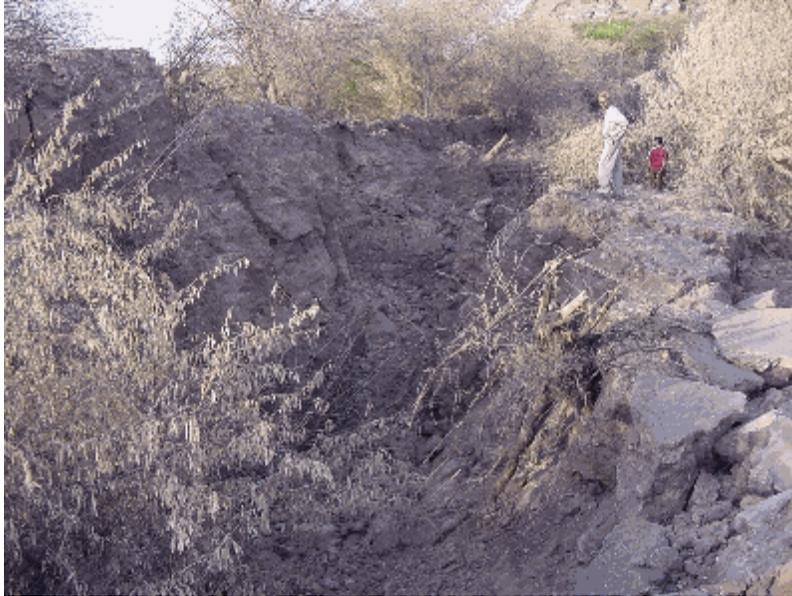
Figure 3. A large longitudinal crack, approximately 10 meters deep, was observed near crest of Chang Dam (from GEER 2001).

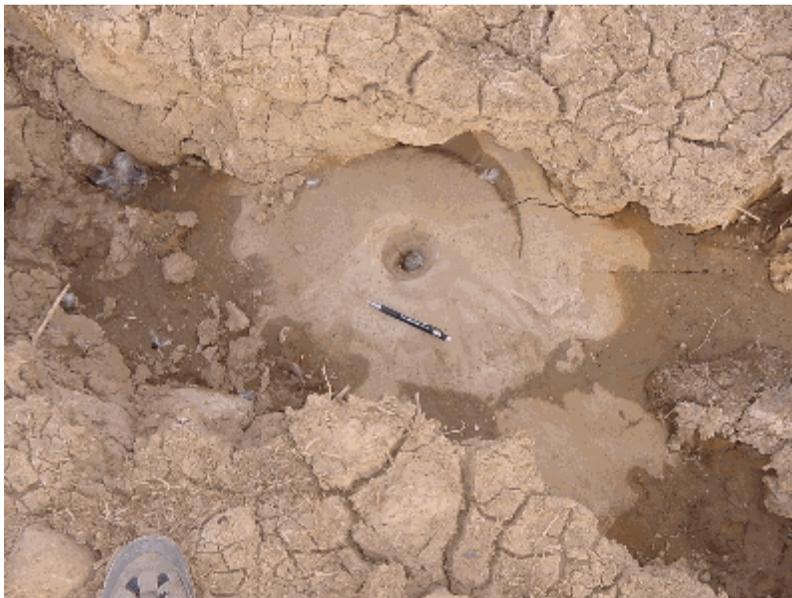
Figure 4. Sand boil observed in the reservoir near the upstream toe of Chang Dam (from GEER, 2001)

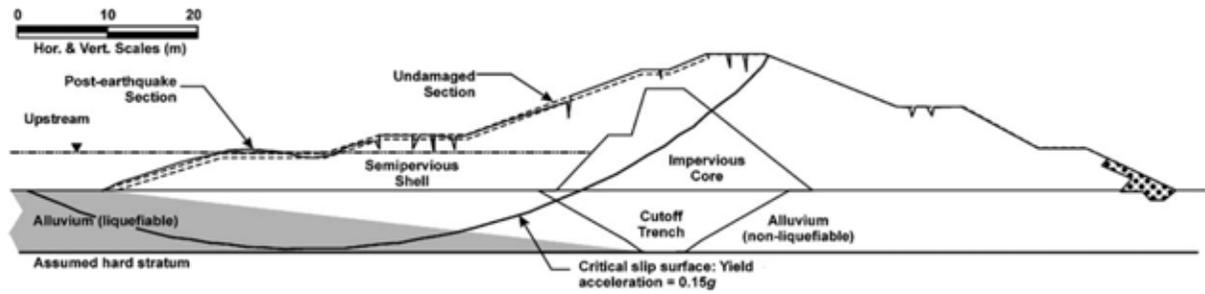
Figure 5. Cross-section of Tapar Dam showing undamaged and damaged embankment. The critical slipsurface was calculated based on a post-earthquake stability analysis performed by the original author (from Singh et al., 2005).

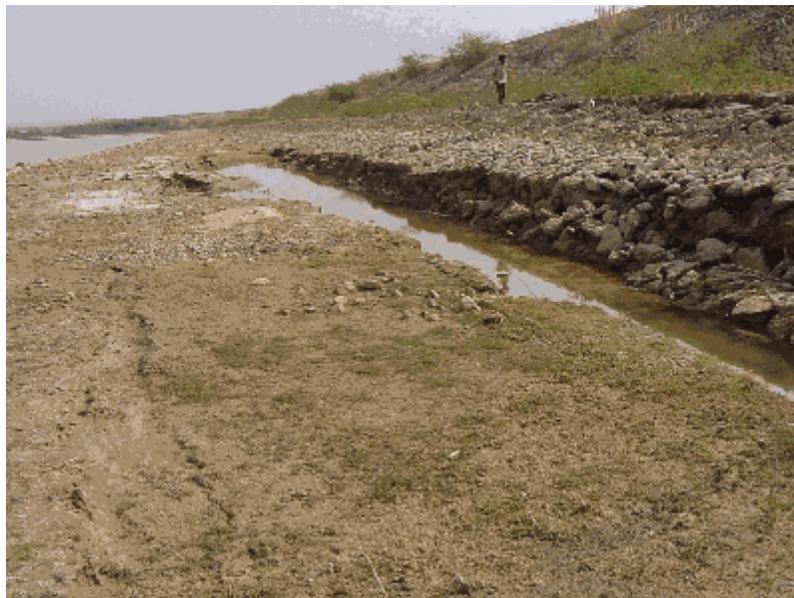
Figure 6. Lateral spreading occurred near the upstream Toe of Tapar Dam (from GEER, 2001).

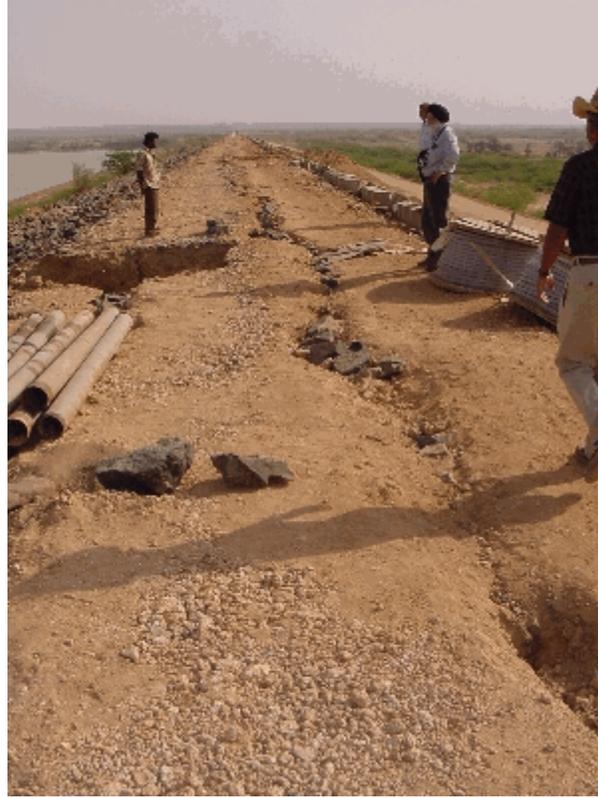
Figure 7. Longitudinal cracks occurred along crest of Tapar Dam. Excavation showed the cracks extended to a depth of 3 meters (from GEER, 2001).

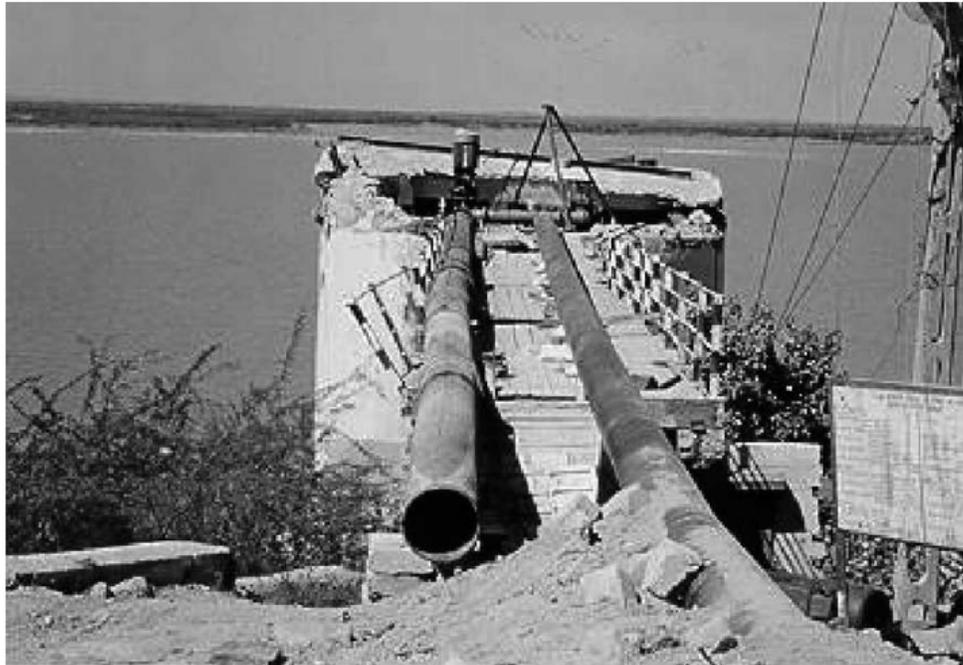
Figure 8. Damaged intake tower at Tapar Dam (from Krinitzsky and Hynes 2002).

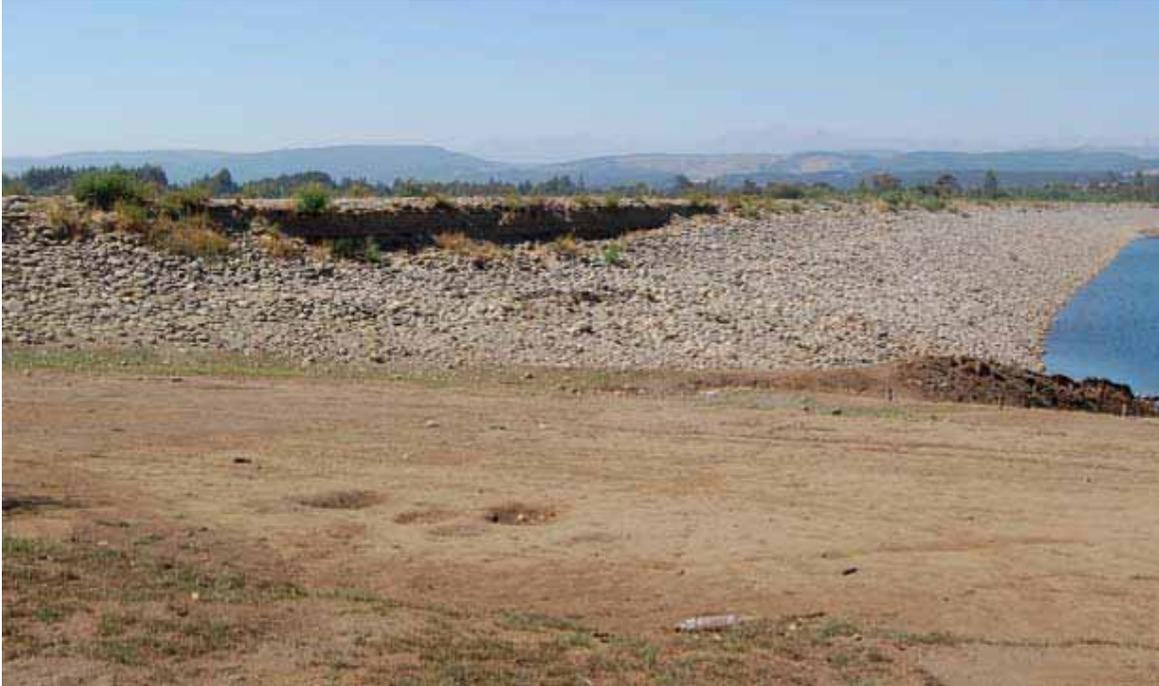
Figure 3. Slough A — near left abutment scarp at dam crest and bulge in lower right of photo (from Bray et al., 2010).

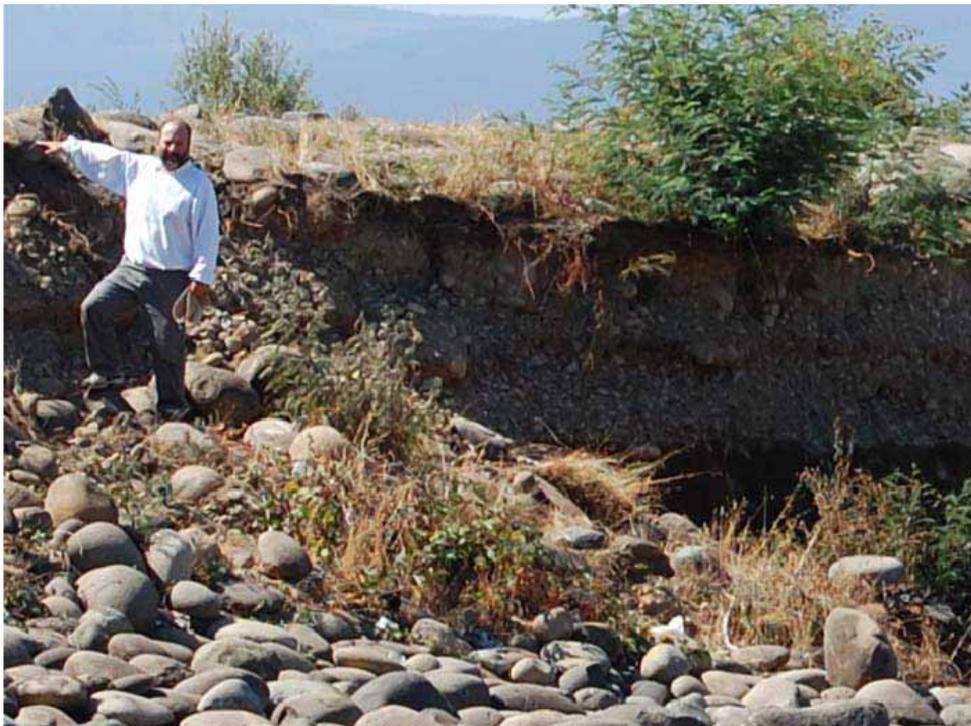
Figure 4. Close up of scarp (from Bray et al., 2010).

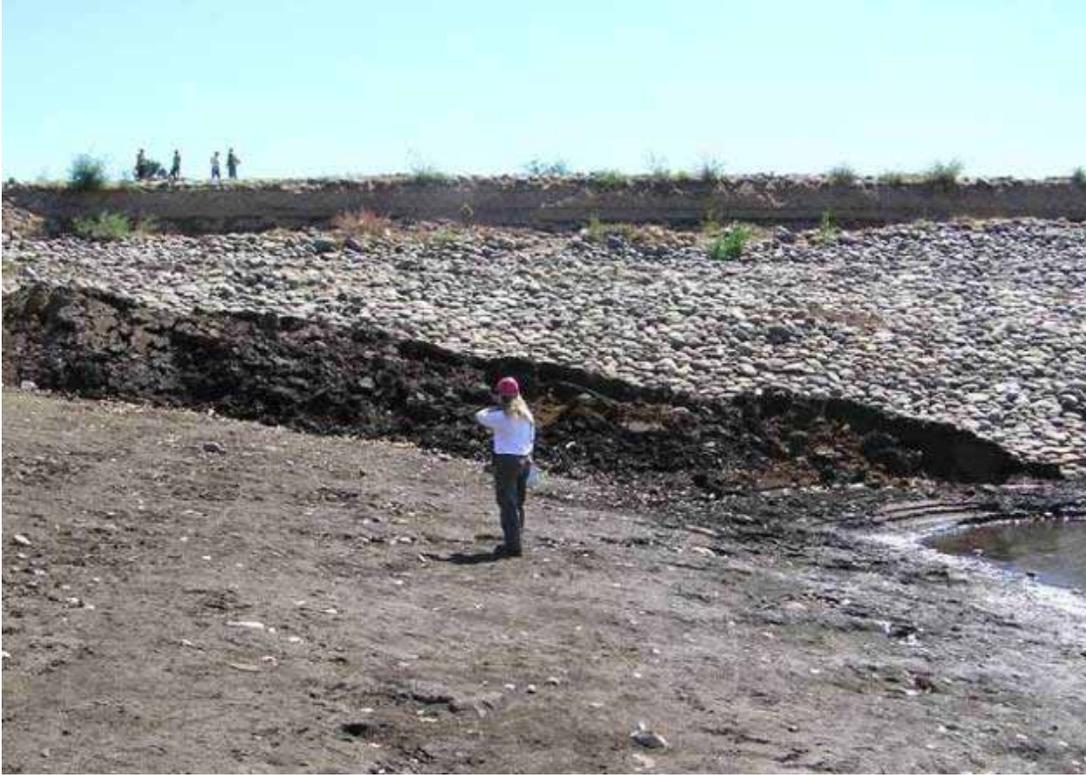
Figure 5. Slough A – bulge (from Bray et al., 2010).

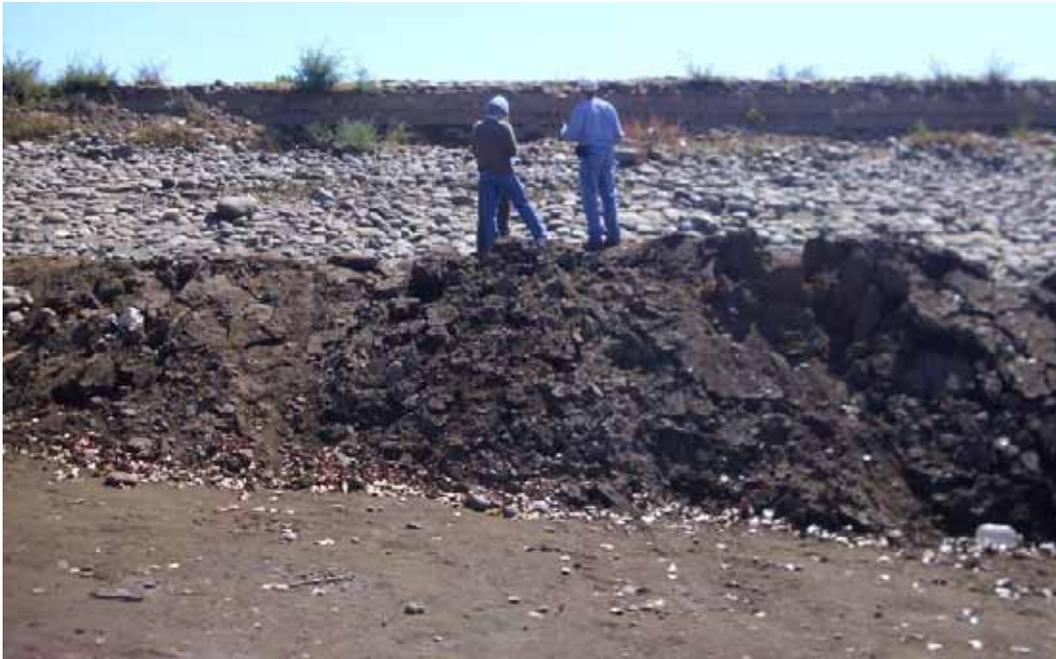
Figure 6. Scarp and bulge (from Bray et al., 2010).

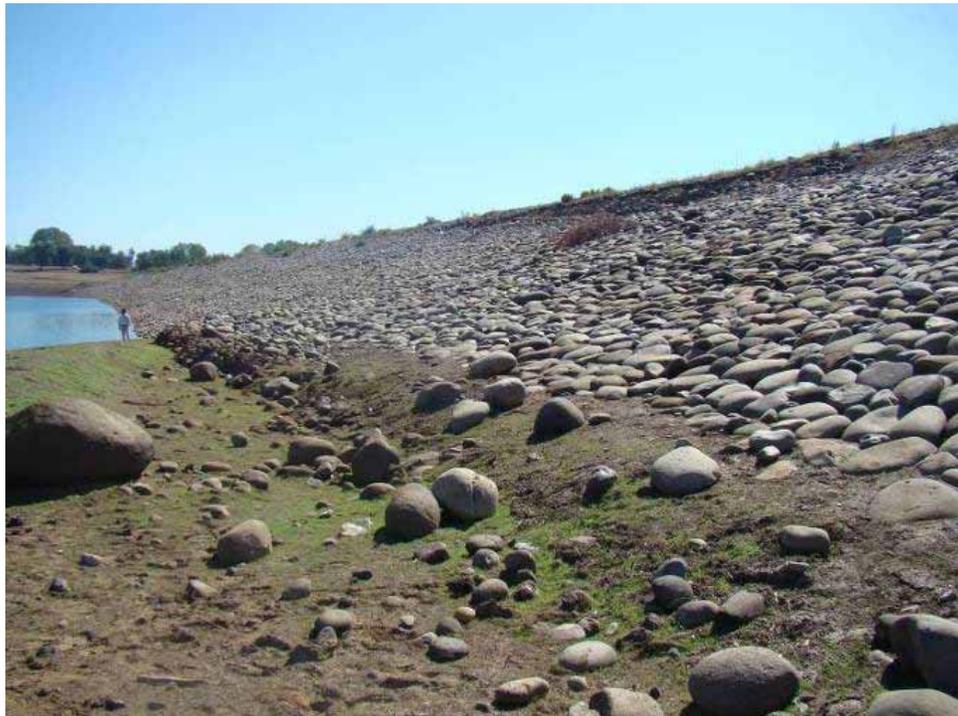
Figure 8. Slough B located right of the highest part of the embankment (from Bray et al., 2010).

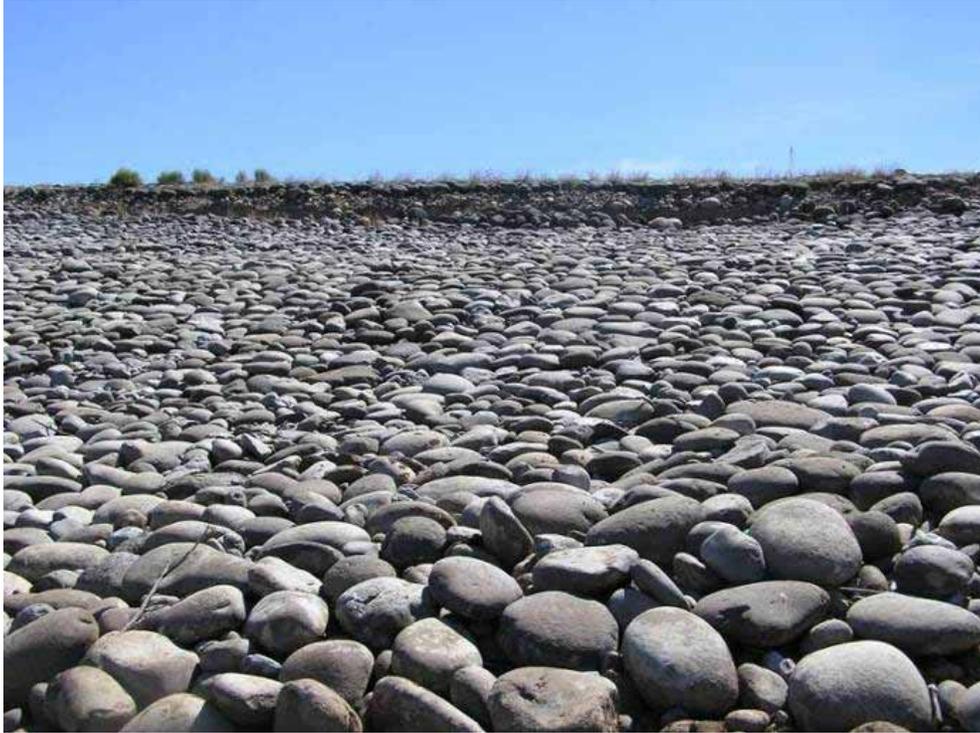
Figure 9. Slough B from its toe (from Bray et al., 2010).

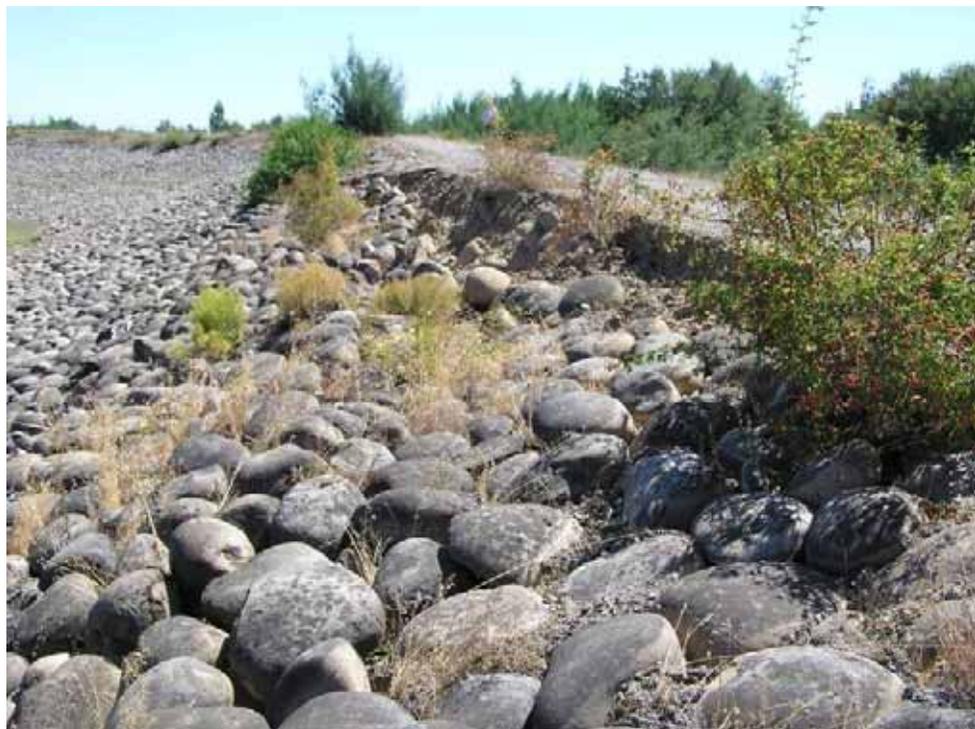
Figure 10. Slough C on right side of embankment (from Bray et al., 2010).

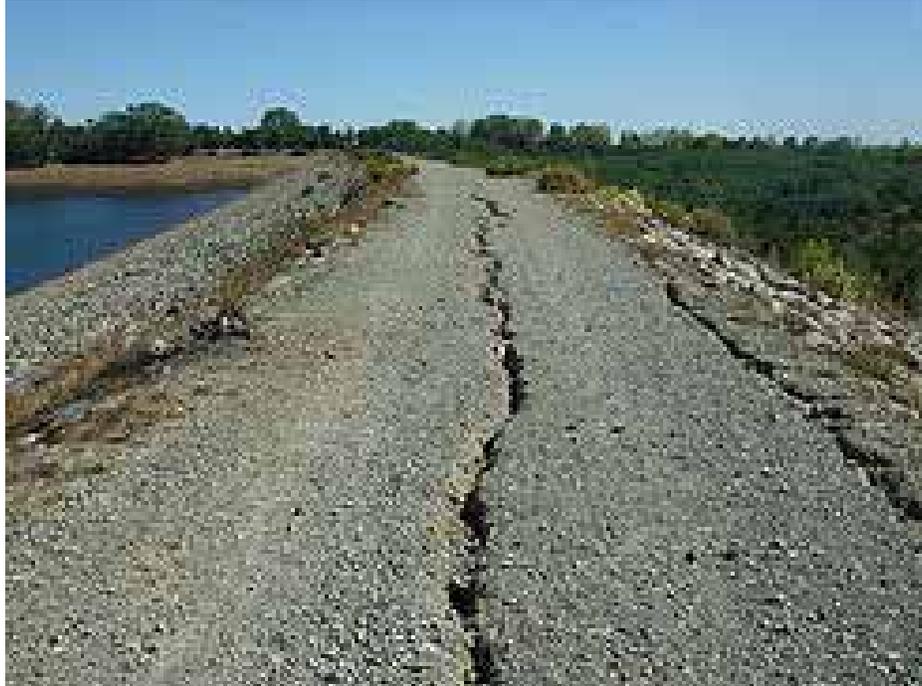
Figure 11. Crest cracking (from Bray et al., 2010).

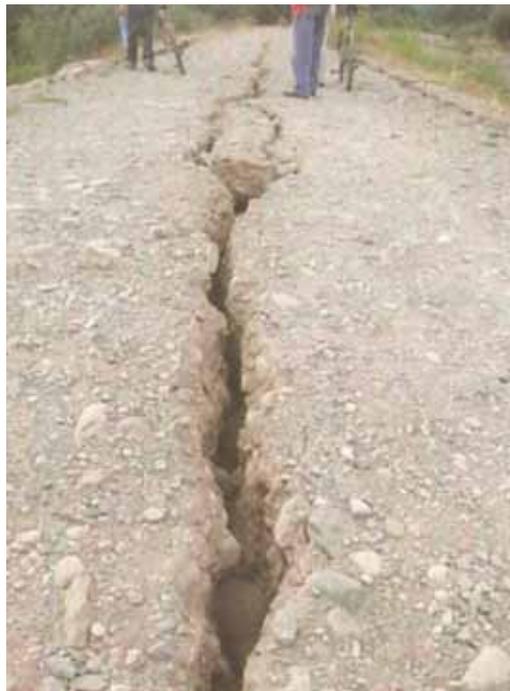
Figure 12. Crest cracking near right end of embankment (from Bray et al., 2010).

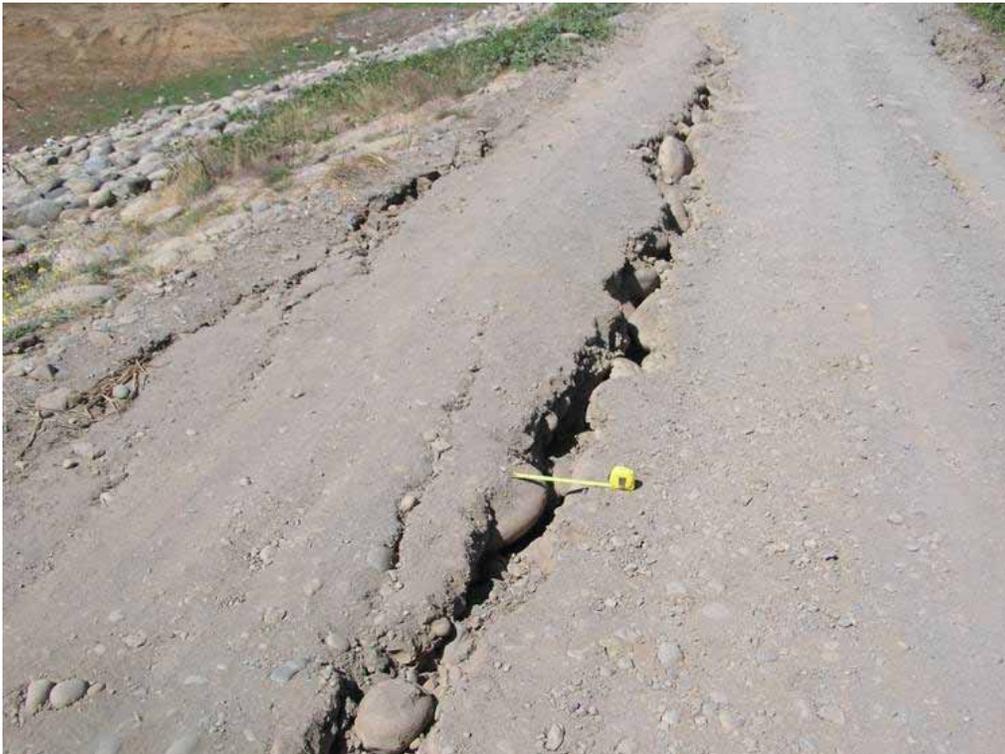
Figure 14. Cracking in crest of Saddle Dam (from Bray et al., 2010).

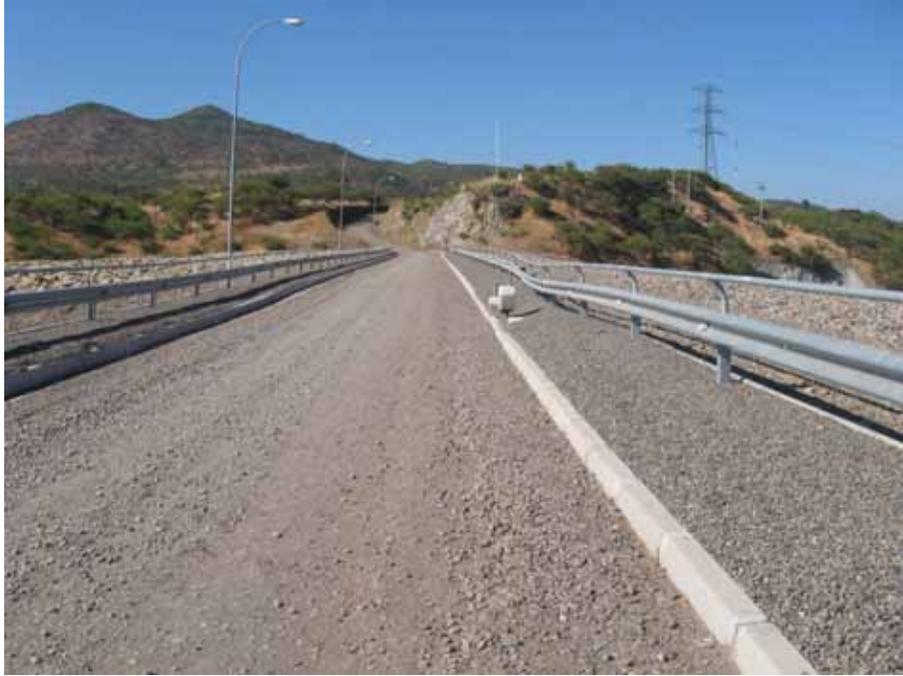
Figure 5. Depression in crest (from Noguera, 2010).

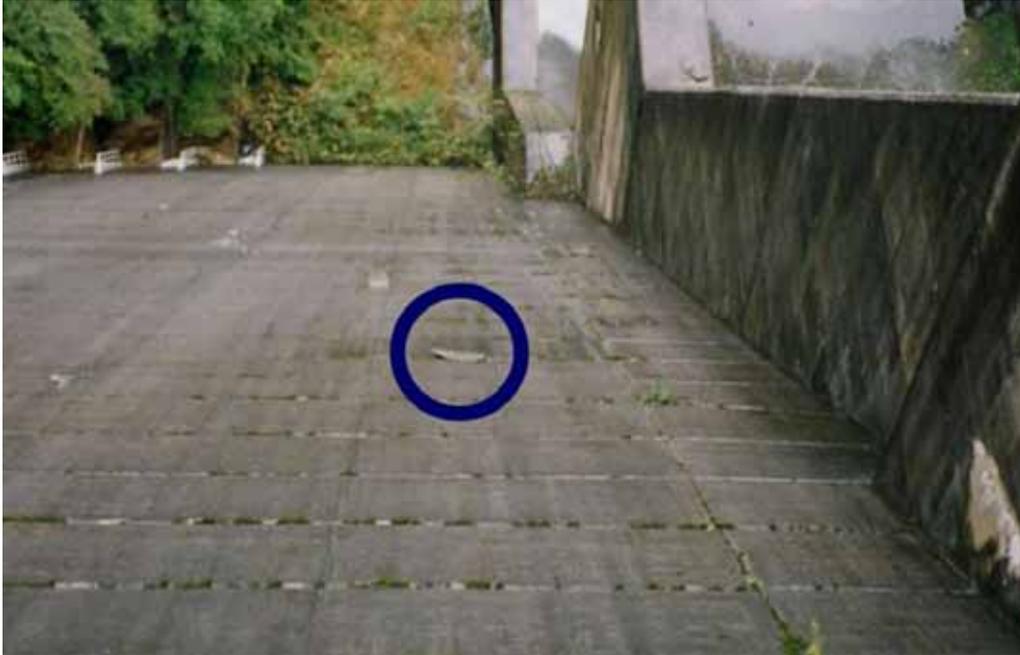
Figure 11. Concrete spall on the downstream face of Sugesawa Dam (from Yamaguchi et al., 2002).

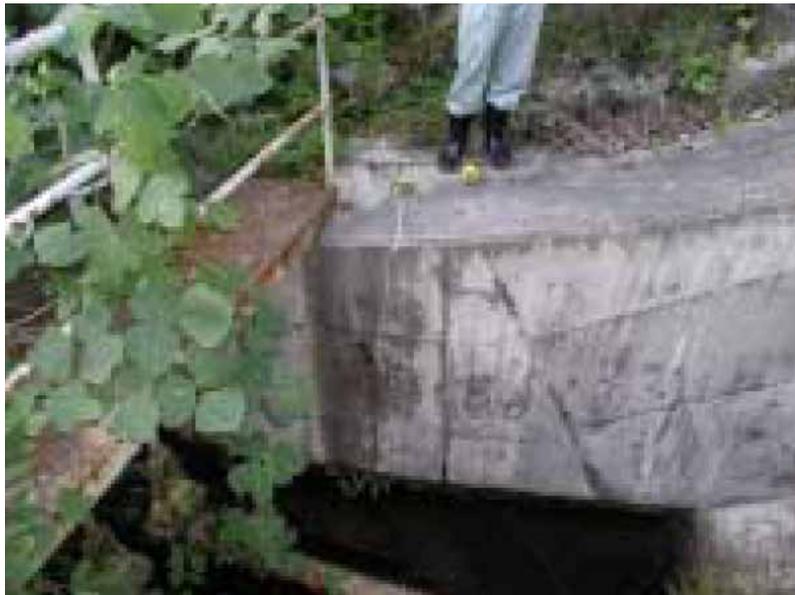
Figure 14. Cracking of the spillway channel wall of Uh Dam (from Takasu et al., 2000).

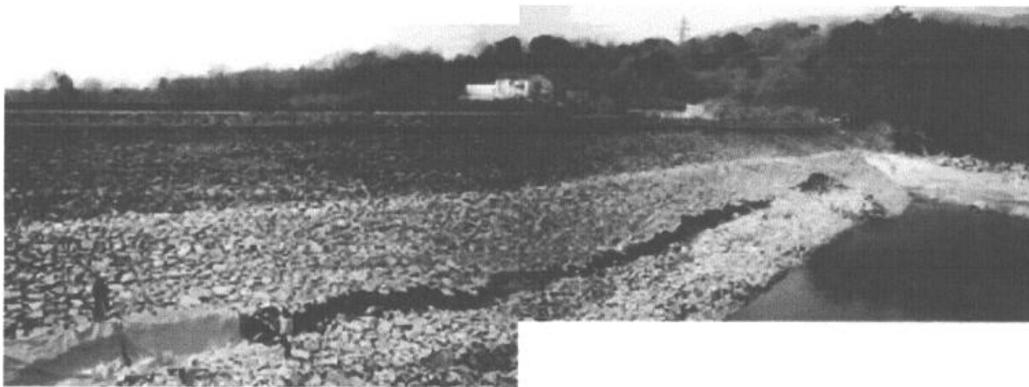
Fig.2 Over view of damage to the Kitayama Dam due to the Kobe Earthquake

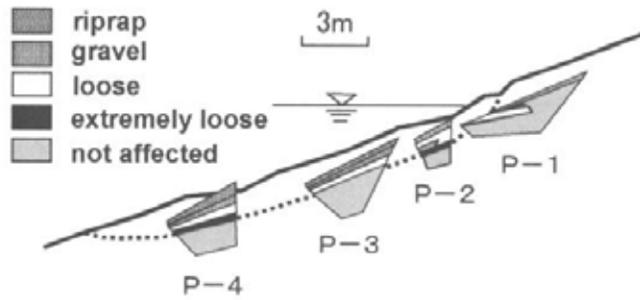
Fig.4 Cross section of the sliding failure by pit excavation investigation

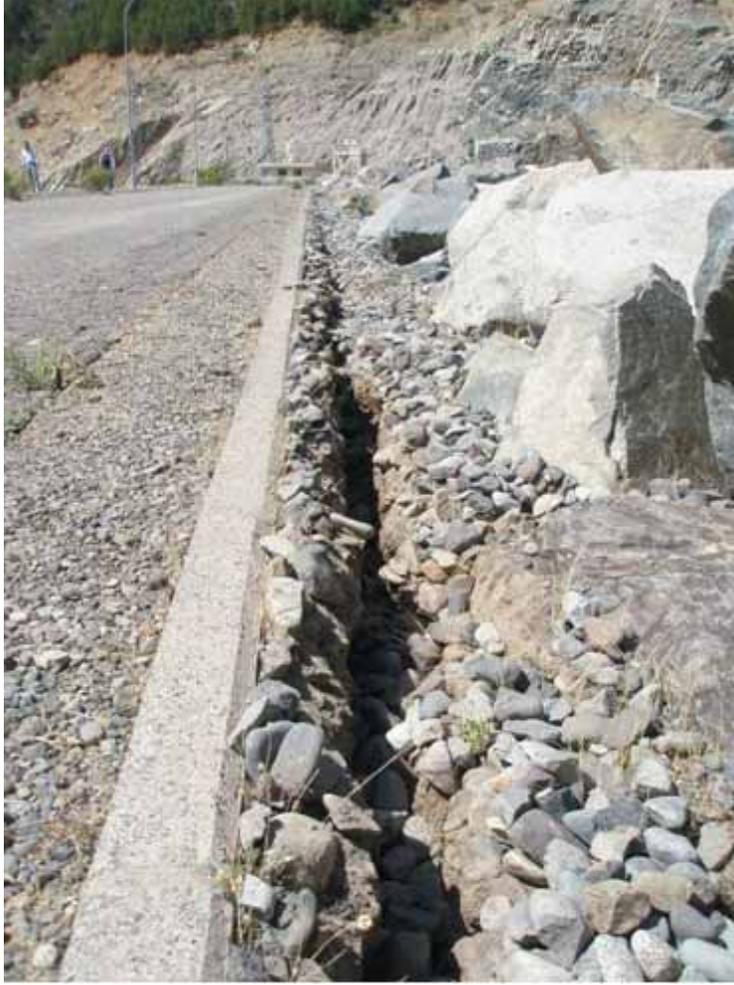
Figure 3. Longitudinal cracking on upstream side of crest (from Noguera, 2010)

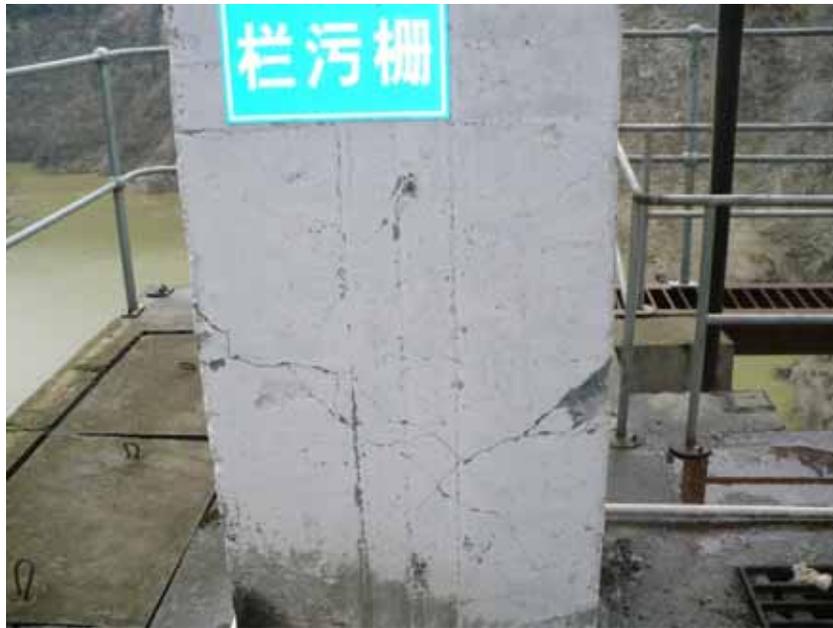
Figure 4. Cracking on gate hoist structure (Babbitt).

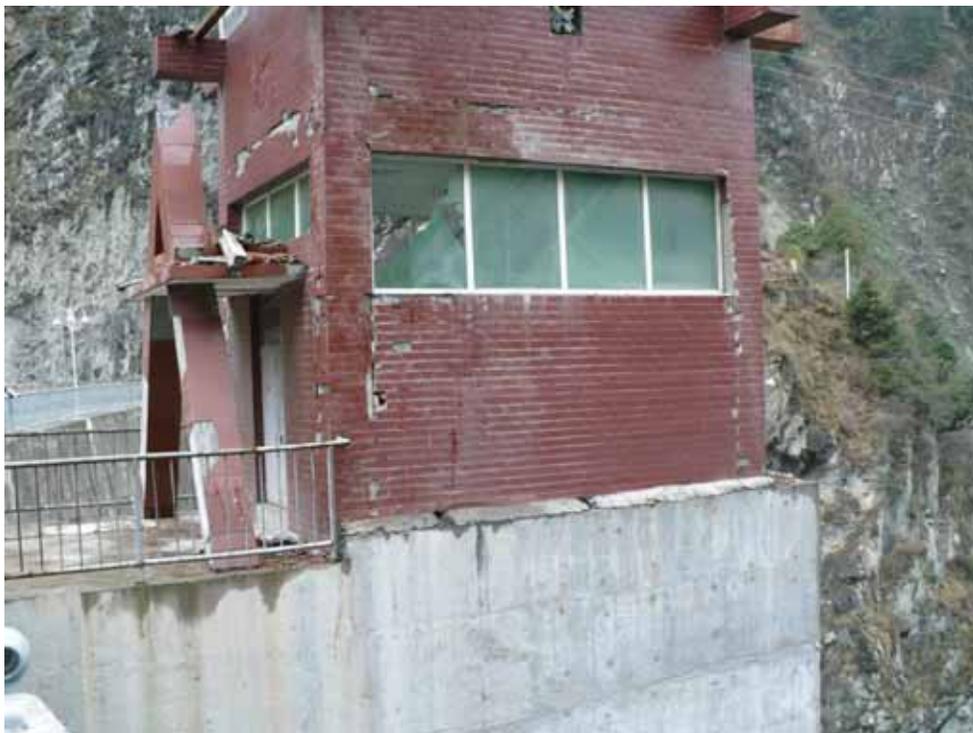
Figure 5. Damaged elevator shaft building (Babbitt).

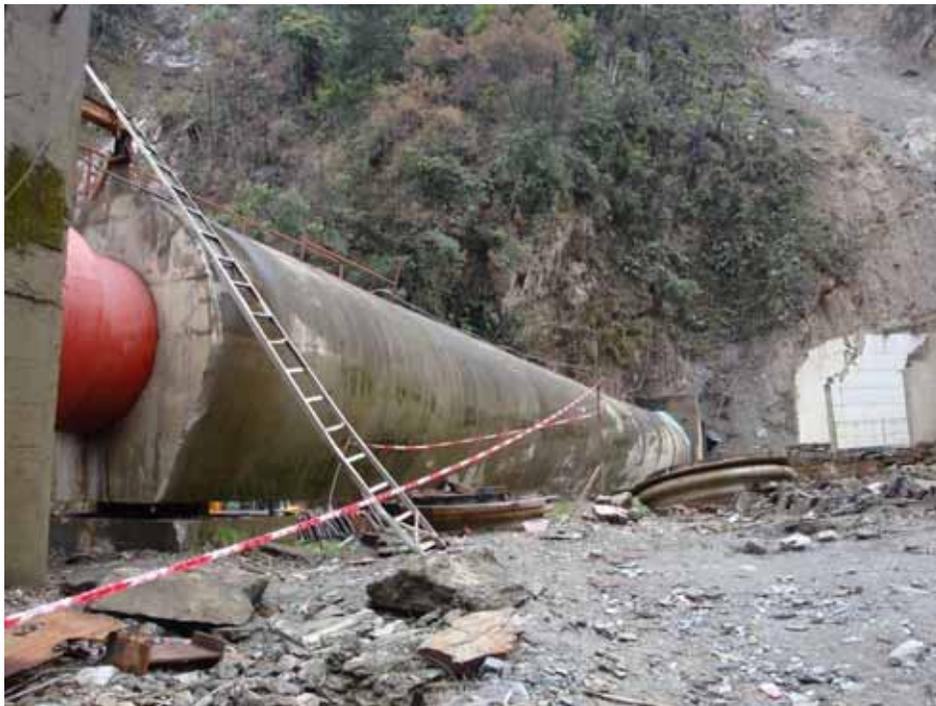
Figure 7. Repaired penstock (Babbitt).

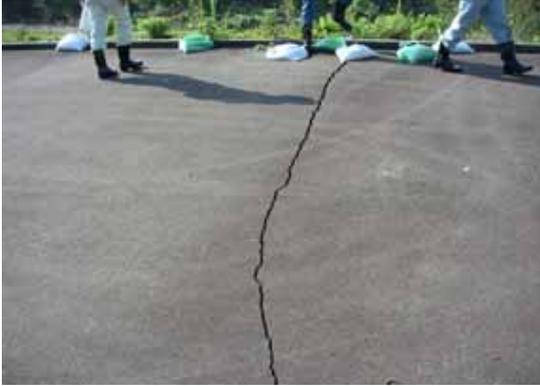
approximately 2.8 feet, which is nearly 2% of the dam height. The cause of the settlement has been attributed to the central clay core having been held up by the arching stresses from the shoulders and the seismic shaking releasing these stresses.

Crack in the asphalt pavement
(from Omachi)

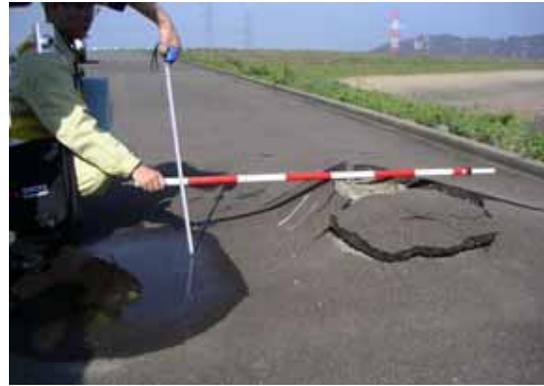
H-beam's top exposed showing settlement
(from Omachi)

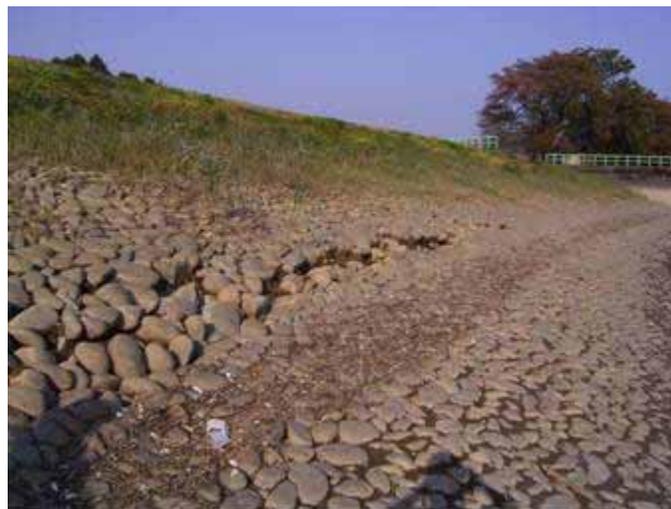
The post earthquake investigation trenching showed that the sand boil source was shallow at a maximum depth of 3.3 feet. The slip deformation was found to be shallow and was approximately 1.6 feet at maximum. The sand boiling and the shallow slip deformation were found to be at the same elevation as the reservoir water level at the time of the earthquake.

Slip of reservoir side slope (from Yasuda et al.).

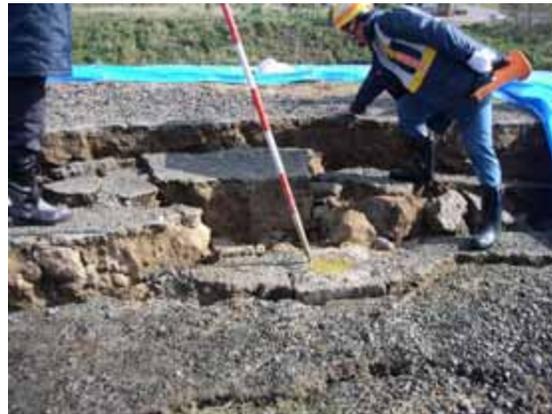
Based on the post earthquake investigation, the cracks and steps along the dam crest extended deeper in the upstream direction and were found to be no deeper than 10.8 feet. The crest deformation has been attributed to the insufficient compaction of the upper 3 meters of the dam body.

Cracks on the crest of dam
(from Omachi)

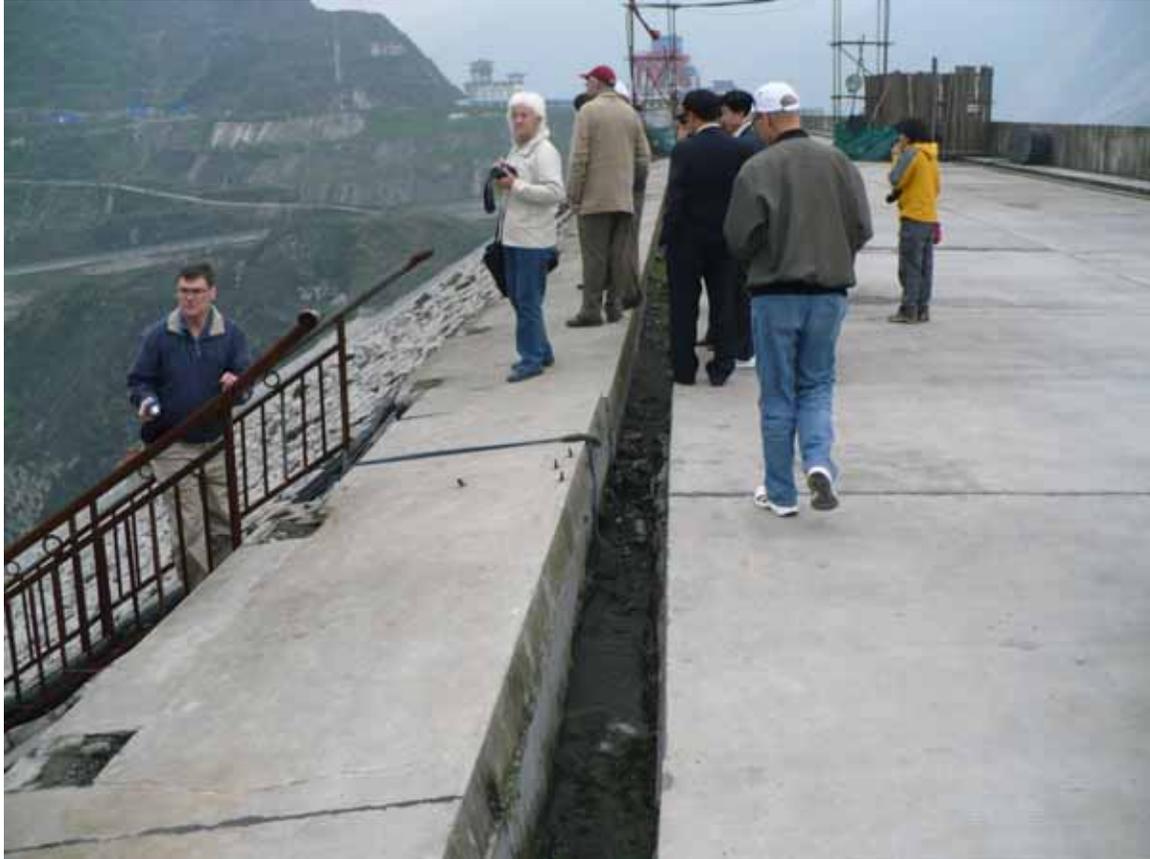
Figure 5. Gap at downstream edge of crest (Babbitt).
