LAKE DELHI DAM BREACH – TWO PERSPECTIVES

Lori McDaniel, Iowa Department of Natural Resources, Des Moines IA; Jonathan Garton, Iowa Department of Natural Resources, Des Moines IA; William Fiedler, Bureau of Reclamation, Denver CO; Wayne King, Federal Energy Regulatory Commission, Atlanta GA; Neil Schwanz, U.S. Army Corps of Engineers, St. Paul District, St. Paul MN

Abstract

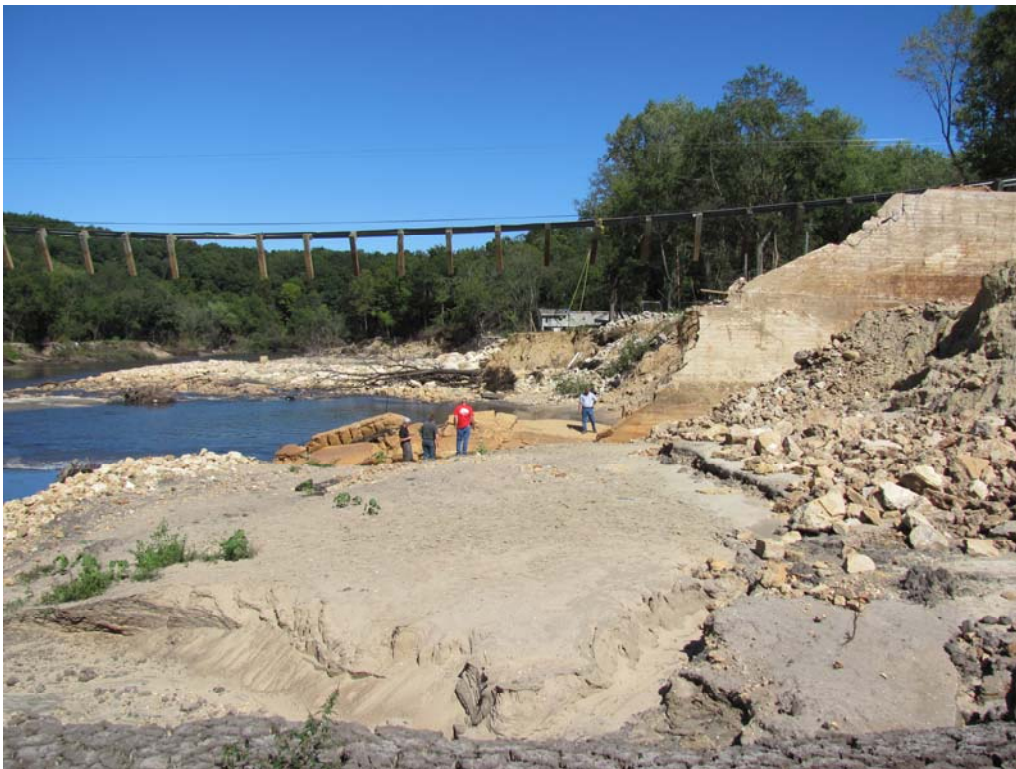
Figure 7. IPE investigation of former embankment foundation. Remnants of core wall on the right side of photo. Source: Iowa DNR

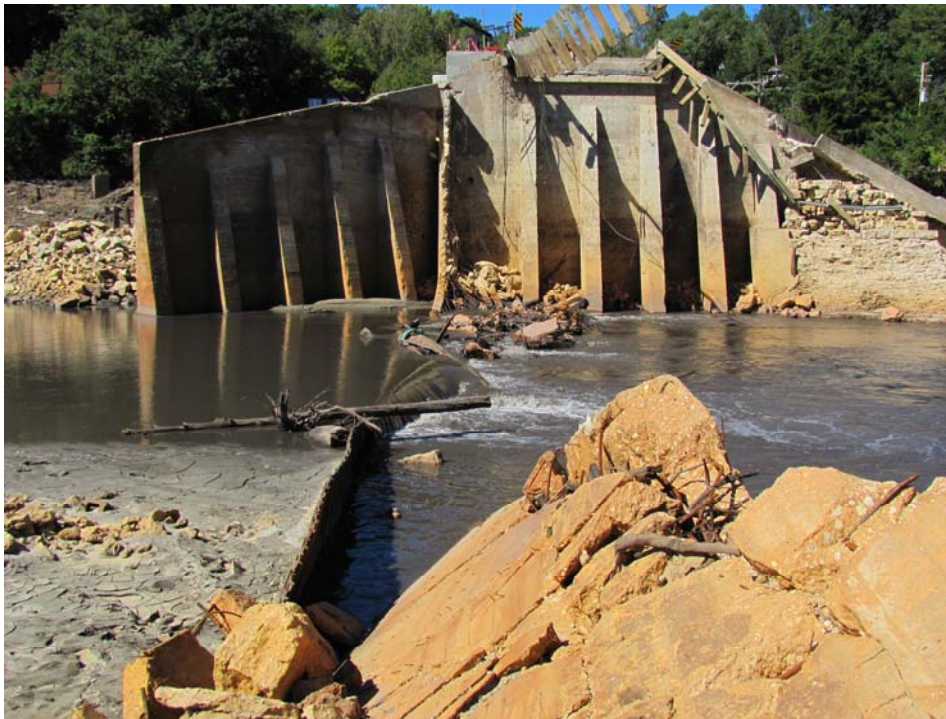
The concrete core wall (see Figure 8) was placed on top of steel sheet piling that extended to rock for some distance near the right abutment wall of the gated spillway. The core wall was founded directly on bedrock from the spillway wall to a distance of about 20 ft from the wall. South of that point the sheet piling is shown extending to bedrock for a short distance where the depth to bedrock was known. The top of the cutoff wall extended to within about 6 ft of the crest of the dam.

Figure 8. Remnants of sheet pile, core wall and spillway wingwalls. Source: Iowa DNR

The concrete cutoff wall on top of a sheet pile wall created a vertically rigid element in the dam that would not settle over time, as compared to the embankment on either side of the cutoff wall which could settle. This situation likely created differential settlement in the area of the cutoff wall that caused low stress that could have lead to cracks in the embankment fill emanating from the top of the cutoff wall. The potential seepage path created by the cracks from the cutoff wall and the low plasticity embankment material created a situation where internal erosion of the embankment could initiate and progress quickly.

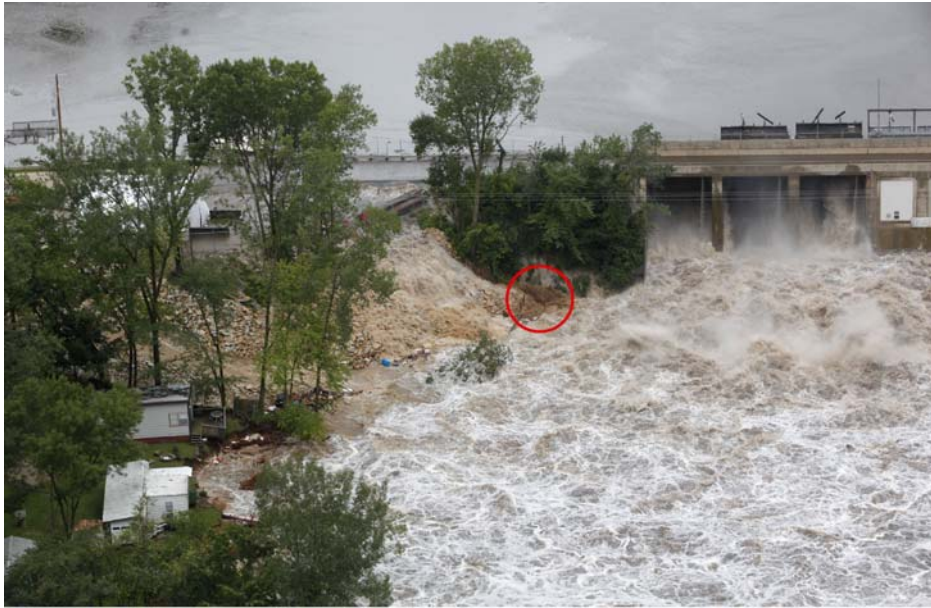
Seepage from the downstream slope was first observed around 6:00 am July 24, 40 to 50 ft south of the spillway training wall. At 6:00 am, settlement of the dam crest was observed in the areas where the vortices and sinkholes were first observed. All of this evidence is consistent with internal erosion occurring in the portion of the embankment above the top of and downstream of the concrete core wall.

Figure 9. Discolored water (circled) exiting the dam, indicating piping. Source: SourceMedia Group News

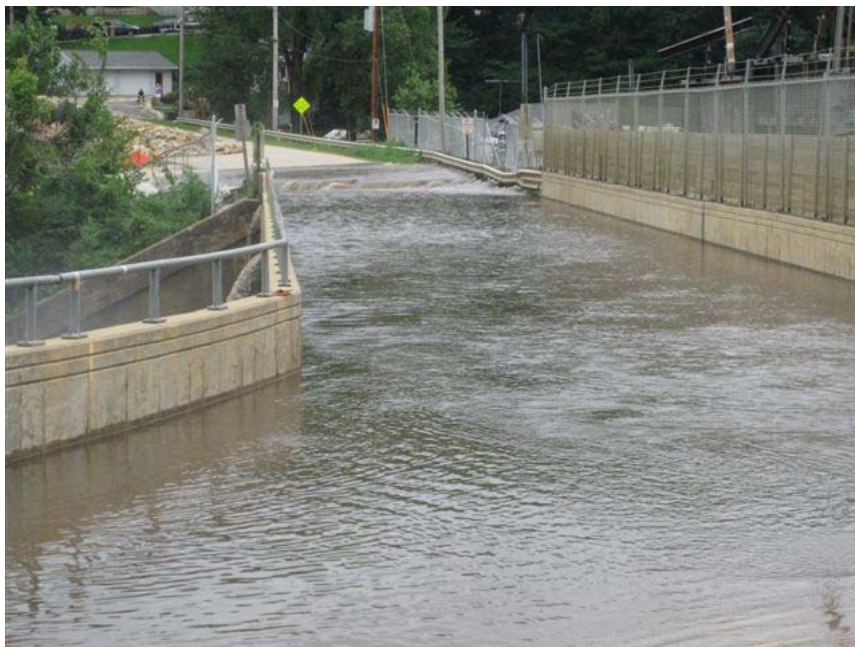
The dam breach began to accelerate around 12:30 pm on Saturday, July 24th. The dam breach was caused by internal erosion of the embankment, flows over the embankment and structural failure of the thin concrete core wall. A full breach of the embankment dam occurred at about 1:00 pm on July 24th. The concrete core wall appeared to have failed due to differential loading caused by the flood and erosion of downstream embankment soils. As erosion of embankment soils continued, sections of the core wall also toppled, eventually ceasing at a maximum breach width of 235 ft. It is likely that the concrete core wall slowed down the rate at which the embankment dam breached.

Figure 10. Breach in progress, headcut completely through roadway. Source: Iowa DNR.

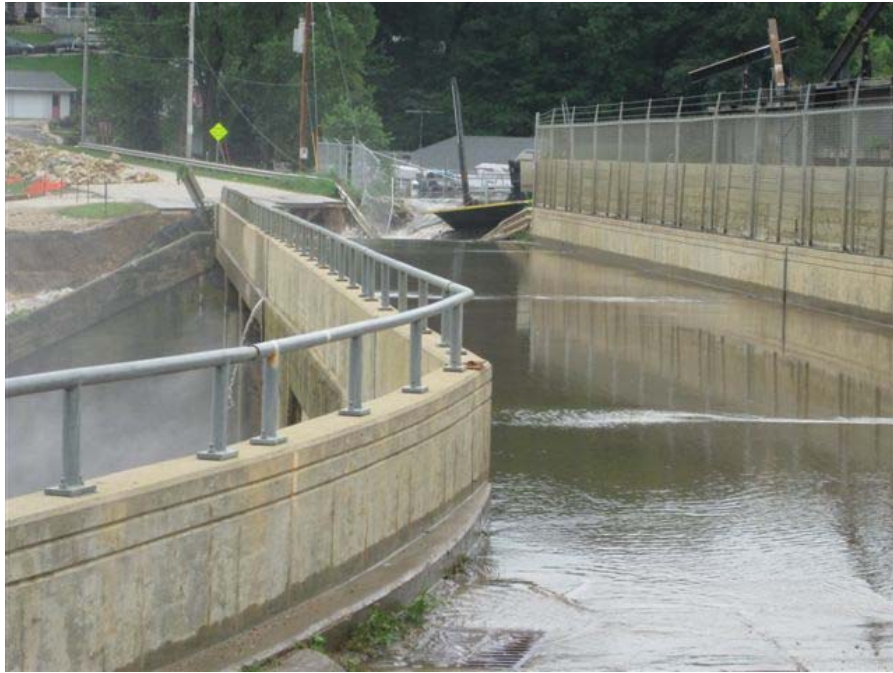
Figure 11. Breach in progress, headcut deepening through roadway. Source: Iowa DNR.

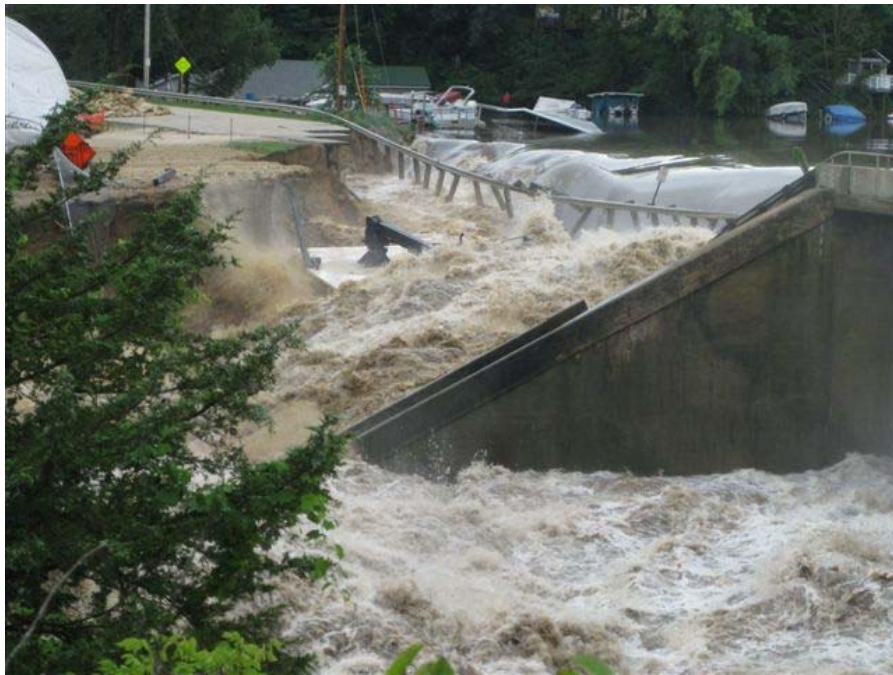
Figure 12. Breach in progress, core wall still in place. Source: Iowa DNR.

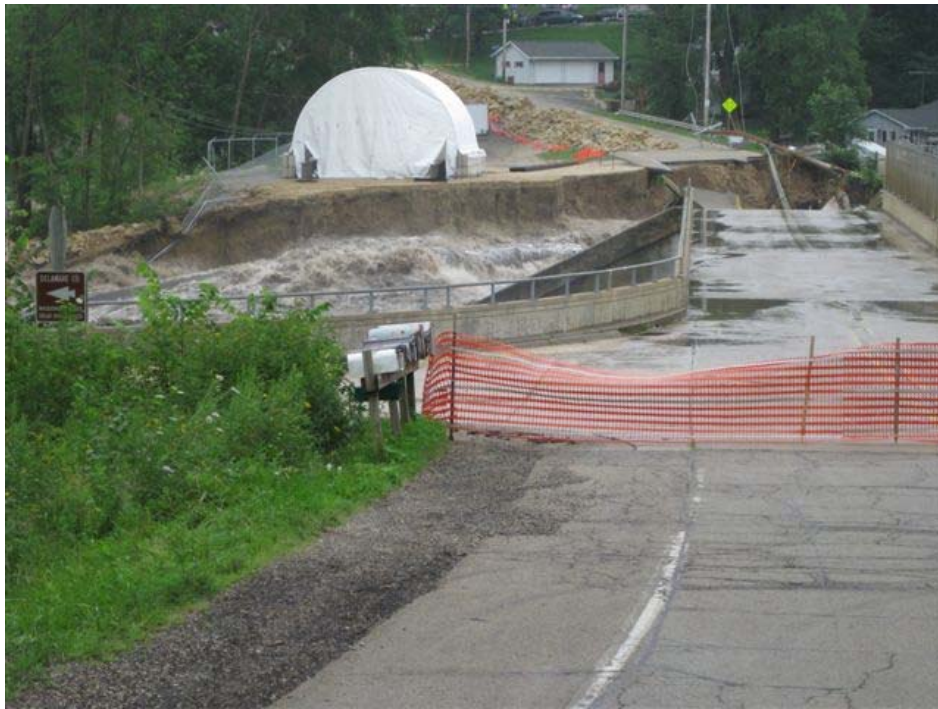
Figure 13. Full breach and uncontrolled release of water. Source: Iowa DNR.

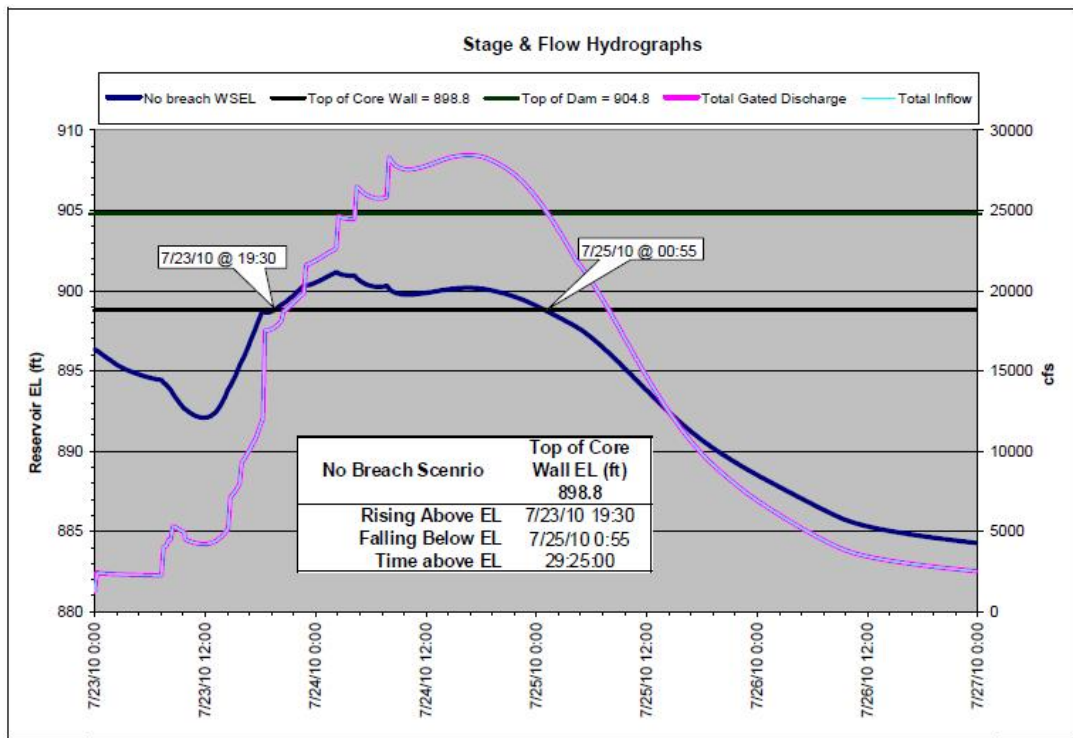
One of the items explored was the effect of the partially closed spillway gate. A routing was performed in which all three gates were opened to 18 ft, which was the maximum opening achieved by Gate 1 during the July 22- 24, 2010 flood. The flood routing results indicated that Delhi Dam would not have overtopped if all three gates had been fully opened. However, the reservoir would have exceeded the top of the core wall by up to 2.4 ft for about a day, and it is likely that internal erosion would have initiated in the embankment. Figure 14 shows the results of this analysis. Based on the duration of seepage that likely would have occurred through the embankment, it is judged that the dam would have suffered damage and possibly a total breach, even with all three gates fully open.

Figure 14. Hypothetical Scenario using Logbook Controlled Gates with all 3 Gates Fully Operational to 18 feet Maximum Opening. Source: Lake Delhi IPE Report.

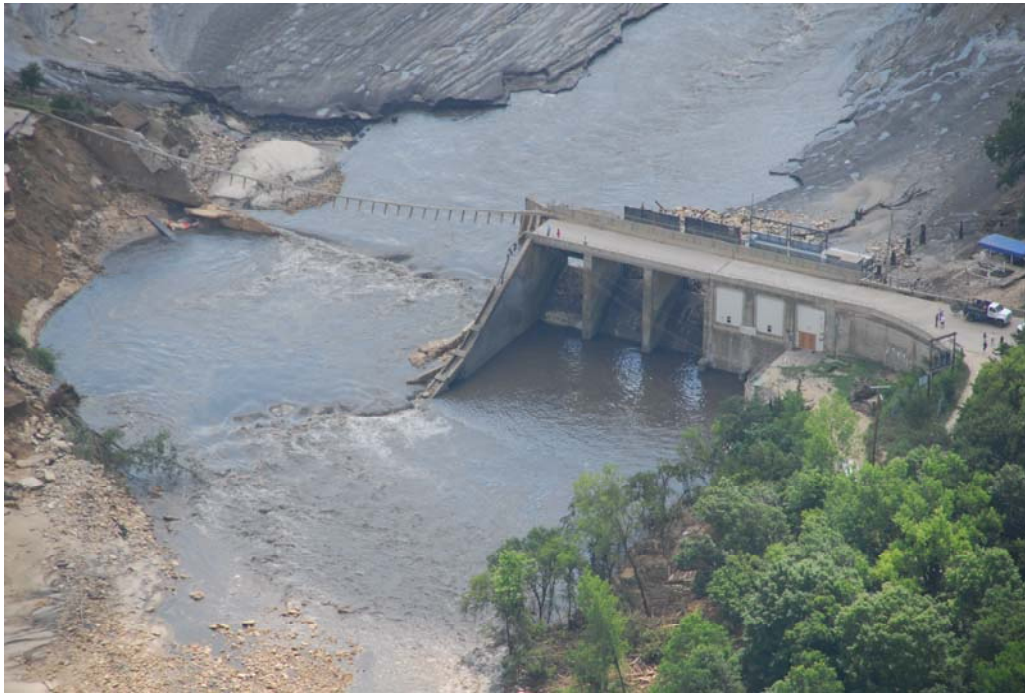
From the eyewitness descriptions, photographic and video evidence and limited excavation investigation, the cause of the dam breach was internal erosion in the embankment coupled with overtopping flow. The internal erosion was most likely caused by a seepage path initiated along differential settlement of the embankment material adjacent to the core wall. The failure mode was triggered by reservoir levels that exceeded the top elevation of the concrete core wall, which was exacerbated by the inability to open the third gate beyond the 4.25 ft measured in the post breach investigation.

Figure 15. Aerial view of breach. Source: Iowa Wing Civil Air Patrol.

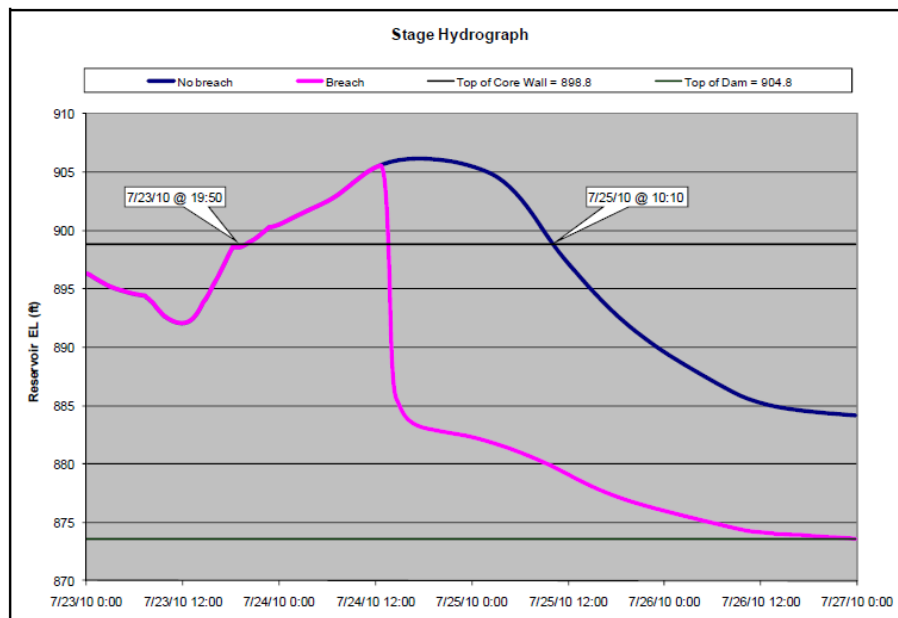
If internal erosion did not occur, the duration of 16 hours and maximum depth of 1.4 ft of overtopping predicted by the flood model (with one gate malfunctioning) would have likely caused a breach via overtopping and headcutting erosion. The results of this analysis are shown in Figure 16. Overtopping erosion to the point of breach was predicted with WINDAM, a NRCS erosion program. A summary of the WINDAM analysis is included in the full IPE Report referenced at the end of this article. Several other factors that would add to the likelihood of overtopping erosion are the downstream slope of 1V:2H, erosion features located at the toe as described in recent inspection reports, the rock toe and inclusion of the 1920's roadbed, unknown (but likely low) insitu soil densities and the trees and vegetation on the downstream slope. Conversely, if the dam had not experienced overtopping flows above the original dam crest elevation (this would have required that Gate 3 was fully functional July 22-24, 2010 flood event), it is possible that the internal erosion mechanism by itself would have lead to the breach of the dam.

Figure 16. Estimated time of reservoir levels higher than the top of core wall (shown at EL 898.8ft NGVD) Source: Lake Delhi IPE Report.
