PIPING, SEEPAGE, CONDUITS, and DAM FAILURES

Harald W. Van Aller, P.E.
Maryland Dam Safety Division

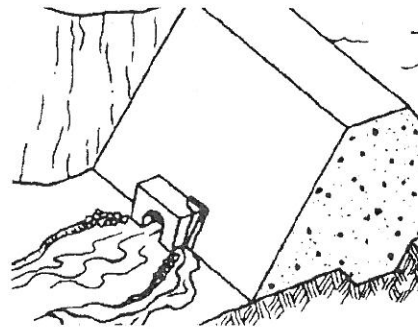
Seepage around conduit (from Colorado Dam Safety Manual)

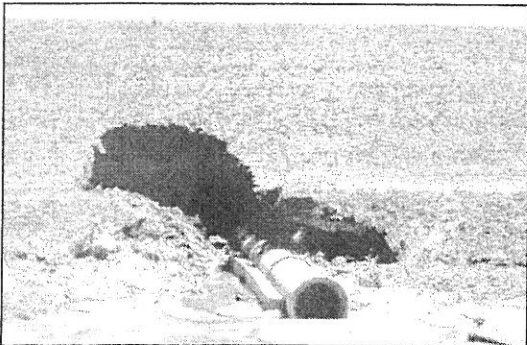
The failure of the “Owl Creek Site 7” dam shown at left occurred during first filling in 1957 (photo by provided by Danny McCook, NRCS). The failure was investigated by James Sherard and published in 1972 (Sherard, 1972). In another 1972 report, Sherard, Decker and Ryker (1972) note that although the seepage followed the conduit in the downstream portion of the dam, the seepage did not initiate near the conduit at

the upstream end. Instead, it was determined that seepage initiated in a crack near the left abutment, where it followed the dam/foundation interface along the upstream side of the cutoff trench until it reached the conduit. Seepage was then apparently able to make its way to the downstream end of the dam, eroding away the surrounding embankment soils.

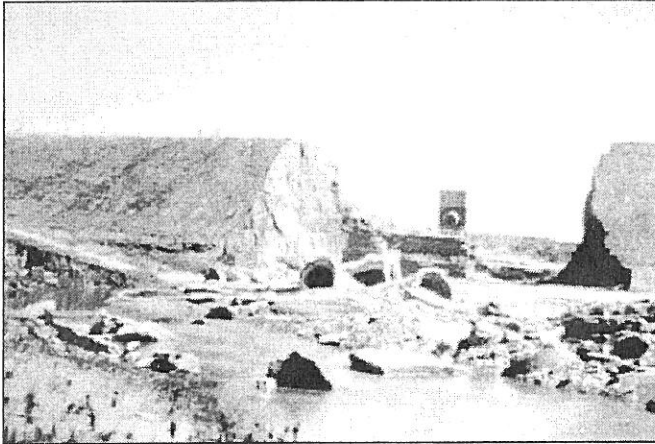
The embankment failure at left was caused by internal erosion of fill near the conduit. The initial failure was tunnel shaped, but the collapse of the roof of the tunnel resulted in the observed shape of breach. Hydraulic fracture in highly dispersive clay embankment soils caused the failure. The embankment design included anti-seep collars but no filter diaphragm (USBR, 2004).

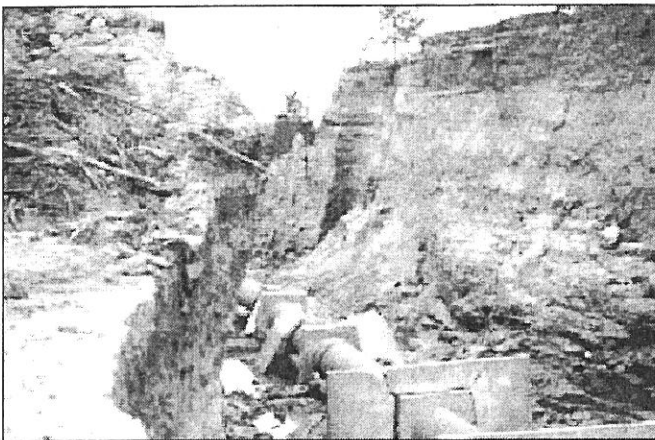
Failure of a dam following first filling due to internal erosion along the conduit. (USBR, 2004). Clearly, the anti-seep collars did not prevent a seepage failure.

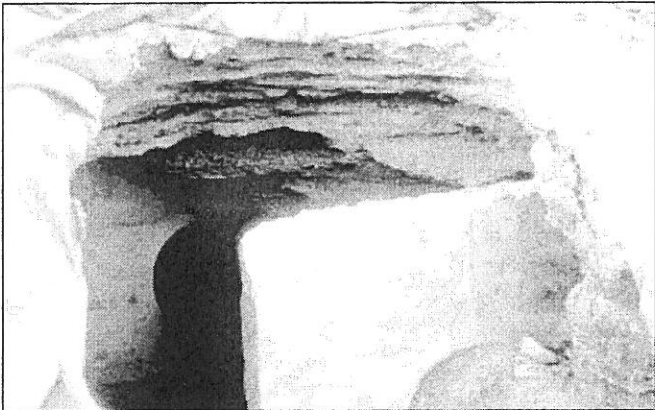
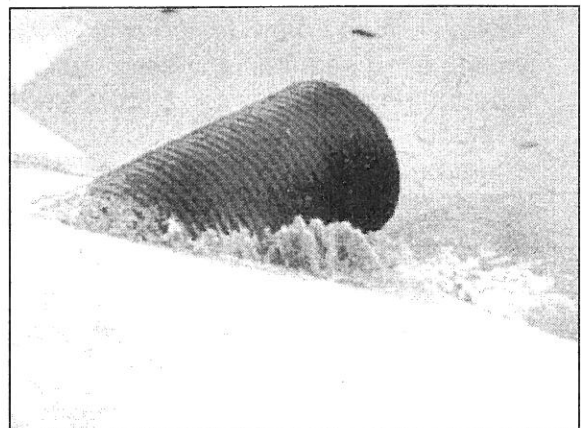
At right, seepage is exiting the downstream slope of a dam along the outside of a spillway conduit. (Photo from USBR, 2004, provided by

Ohio Dam Safety Division.) This seepage flow is carrying soil fines and failure of the dam is imminent.

Anti-seep collars are unable to prevent this type of flow and subsequent dam failure.

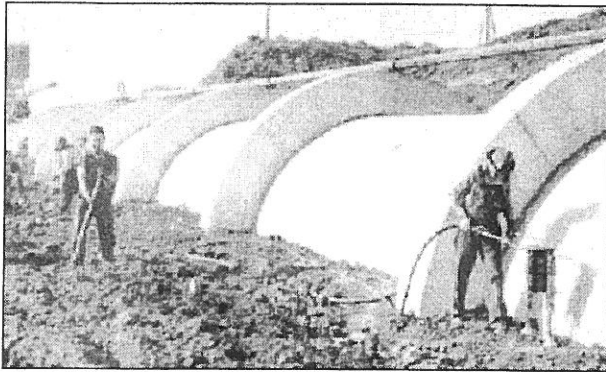
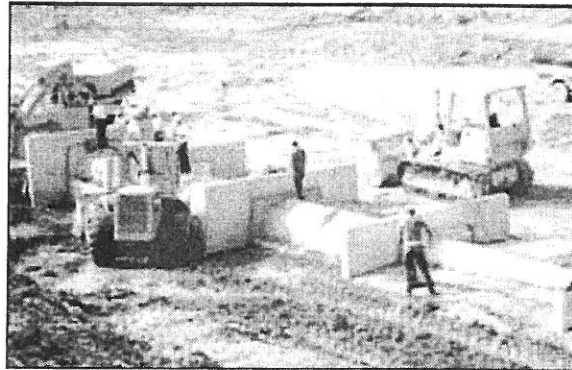
Part of the problem with anti-seep collars is that good compaction in the critical zone around the conduit is difficult to achieve. Also, the backfill is likely to have different density, strength, and compressibility than the rest of the dam embankment, leading to the possibility of differential settlement and cracking of the fill. (above photos from USBR, 2004).

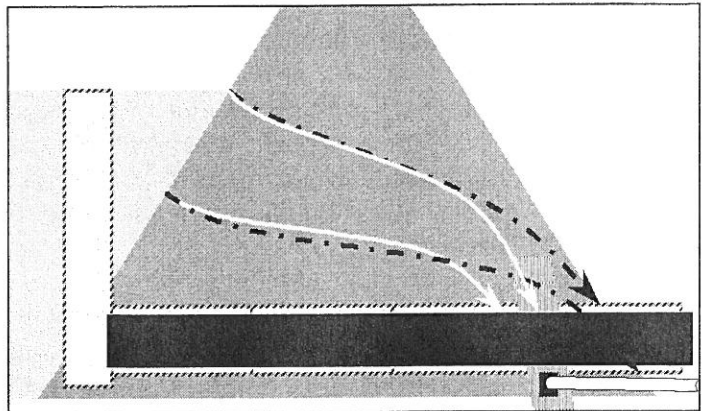
It is important to consider the effect of the conduit repair on existing seepage in the embankment. Defects (leaks) in the existing conduit may have allowed seepage to enter the conduit undetected for many years. After installation of the slipliner and the annular space is grouted, the leaks are plugged and the seepage pattern may change. This can allow seepage to follow along the outside of the conduit until it reaches the downstream face of the dam. Without a properly designed filter the seepage may initiate internal erosion, which then can lead to dam failure. It is recommended that all sliplining repair projects include installation of a filter diaphragm around the conduit near the downstream end to control seepage and minimize the potential for internal erosion.

In the figure at right, the existing seepage pattern (white lines) entered the CMP conduit through defects in the pipe. After the CMP is sliplined and grouted, seepage into the pipe can no longer occur, and the seepage could find its way along the pipe to the downstream toe (black dashed lines.) A properly designed filter diaphragm around the conduit near the downstream end (light gray box) will intercept potential seepage and prevent internal erosion.

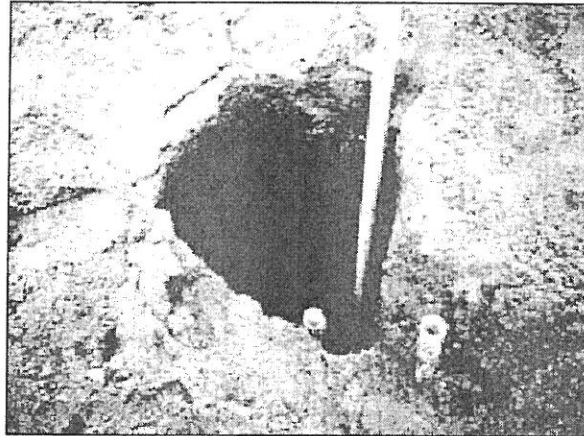
In testing of microtunneling and HDD for installation of pipes under levees, the US Army Corps of Engineers found that the process can severely damage the embankment (Bennett and Staheli, 1997). The pressures associated with pumping of the drilling slurry can cause hydraulic fracturing of the embankment and foundation soils.

In the photo at right, a very large surface void appeared directly above a test microtunneling installation when the operator stopped advancement of the machine but briefly allowed the slurry pump to continue to circulate the drilling mud. The void appeared in backfill surrounding some test instruments, some of which appeared to support the adjacent soils. (photo from Bennett and Staheli in CPAR GL-97-1).
