OVERVIEW OF THE TAUM SAUK PUMPED STORAGE POWER PLANT UPPER RESERVOIR FAILURE, REYNOLDS COUNTY, MO

Conor M. Watkins

J. David Rogers

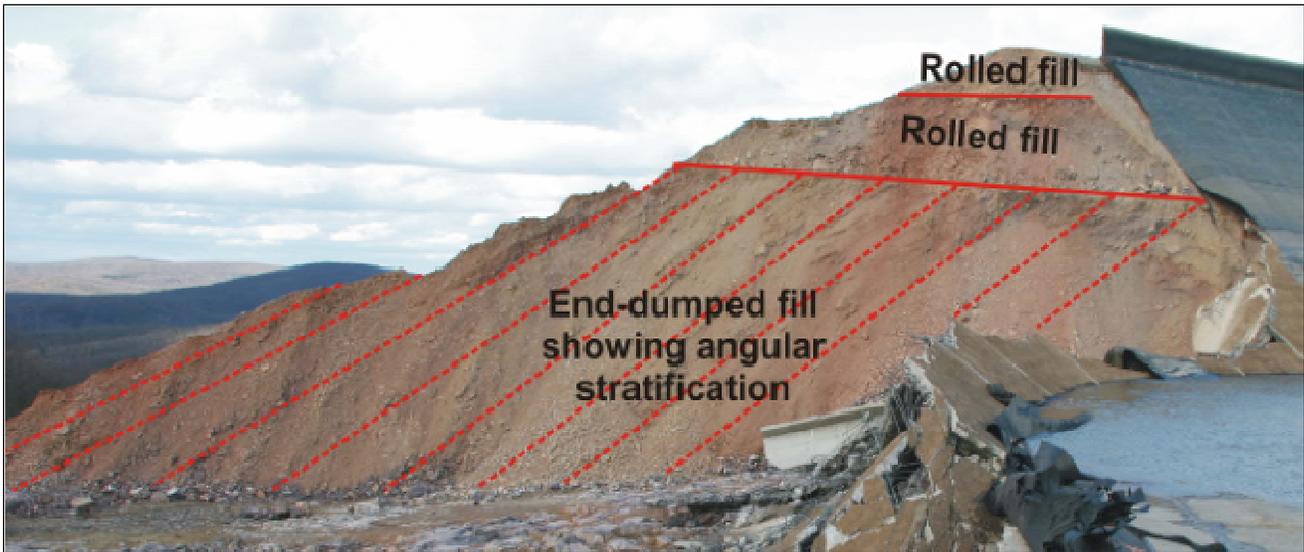
The majority of the upper reservoir's rockfill embankment appears to have been constructed through simple end dumping of the excavated material. The fill was allowed to tumble down the side of the embankment, lying near its natural angle of repose. The embankment materials were not mechanically compacted until the upper 16 feet of fill, which was compacted in four separate 4-foot thick lifts. According to FERC (2006), this was the last uncompacted concrete faced rockfill dam constructed in the United States. The boundaries between the different methods of fill placement were easily observed in the breached section of the embankment after the failure (see Fig. 2).

Fig. 2. – North side of the breached embankment shows the lower three quarters was end-dumped while the upper quarter was placed into two sequences of rolled filling. There does not appear to have been any significant effort made to mechanically compact the embankment because it was assumed to be a clean rockfill.

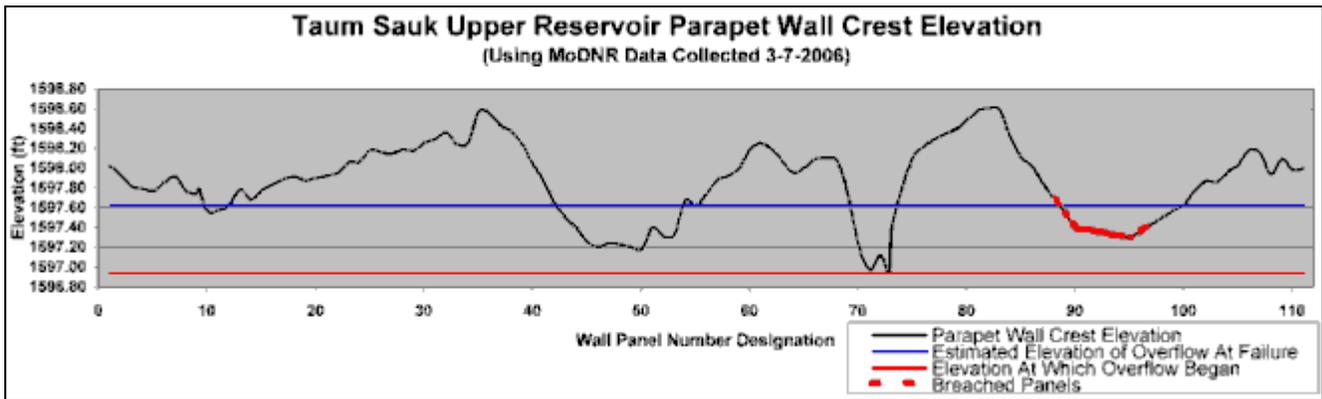
Settlement continued up to the time of failure in December 2005, with differential settlements approaching two feet along the crest of the reservoir’s parapet wall (see Fig 3). This differential settlement also led to a cracking of the concrete lining and continual problems with leakage. Leakage became so severe in 1963, only months after operations began, it necessitated shutdown of the facility and additional grouting of the reservoir floor in the northwest portion near where the reservoir failed in 2005 (FERC Independent Panel, 2006).

Fig. 3. – This figure illustrates the differential settlement along the crest of the upper reservoir parapet wall. Four segments of the parapet wall were almost two feet lower than their original elevation. The elevations of the breached panels (shown here in red) were estimated by AmerenUE after the failure and may not be accurate. (Data: MoDNR (2006))

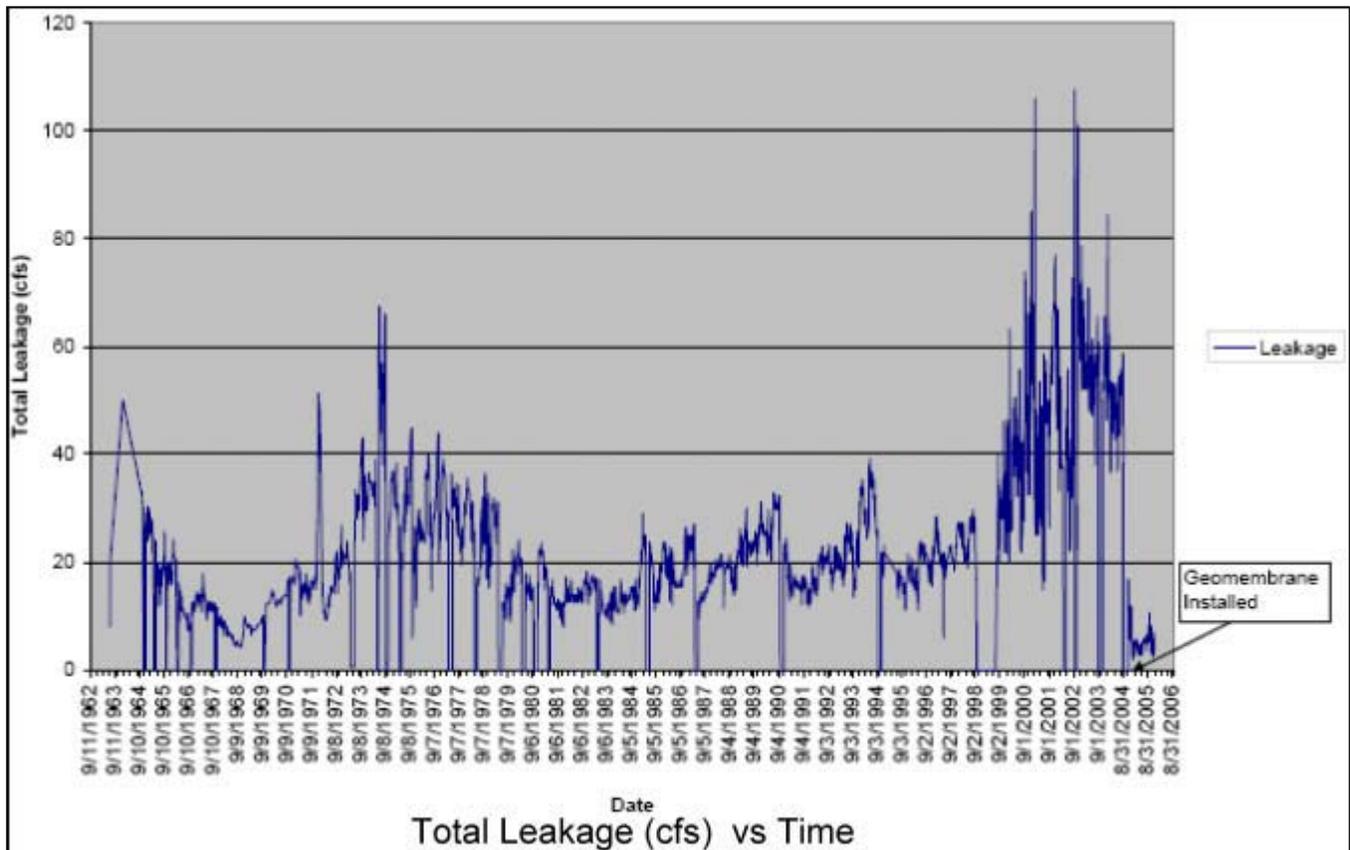
Fig. 4. – This figure from FERC’s Independent Panel of Consultants Report (2006) shows a gradual upward trend in leakage rates until it was lined in 2004, dramatically reducing seepage.

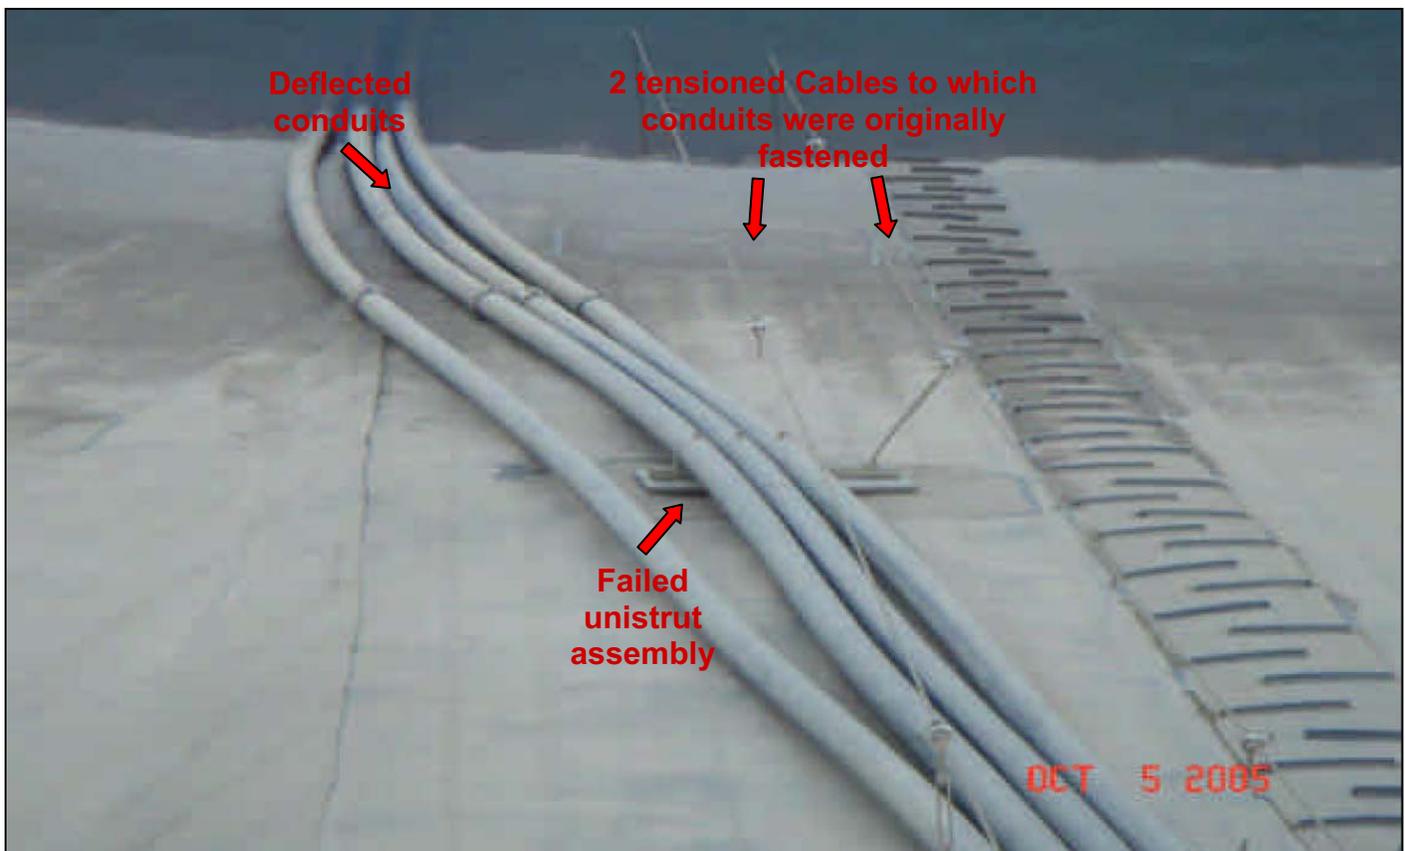
Divers were summoned and they ascertained that the new sensor conduits had become detached from their mountings along the sloping concrete face of the reservoir. Maximum water levels in the reservoir were re-programmed to reduce the operating level by two feet to provide a temporary “margin of error.” Unfortunately, permanent repairs were postponed until regularly-maintenance the following spring (FERC Taum Sauk Investigation Team, 2006) to avoid an additional shutdown of the facility. Fig. 5 shows a Photo taken by AmerenUE on Oct 5th, 2005 when the reservoir pool was drawn down. This shows the sensor conduits have detached from their anchorages.

Fig. 5. – This photo taken on October 5, 2006 by AmerenUE shows the gross deflection of the reservoir’s instrumentation array (photo from Rizzo Associates, 2006).

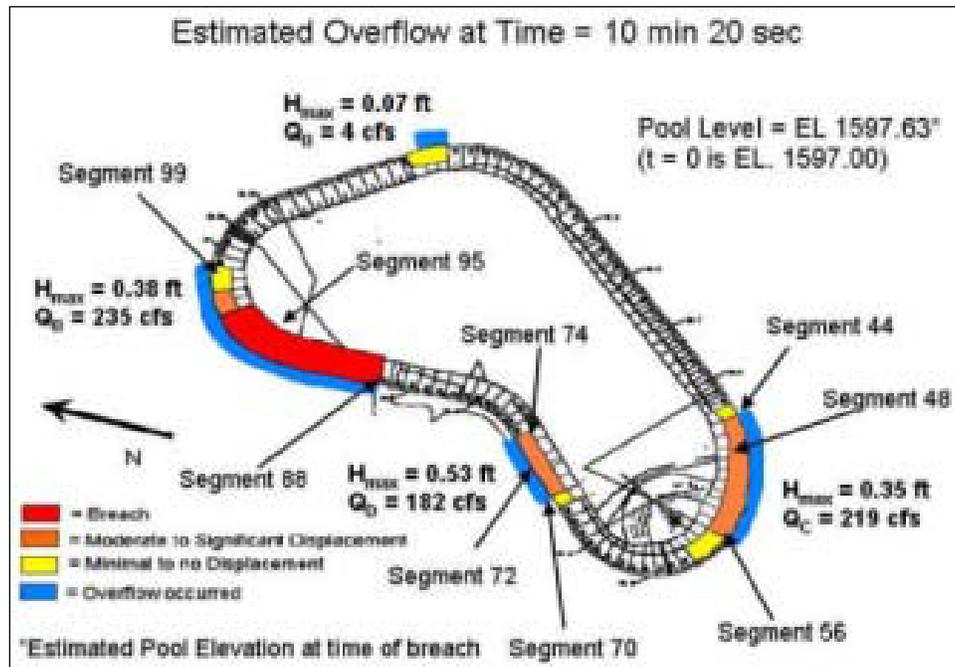
The 6,562 ft long parapet wall was comprised of 111 panels, each about 60 feet long. Each wall panel was designated by a number, between 1 and 111. These numbers are referred to in the description that follows. See Fig. 6 for locations of overflow (shown in orange) and the eventual breach (shown in red).

Fig. 6. – This graphic from Rizzo Associates, Inc. (2006) shows panel locations where overflow and failure occurred.

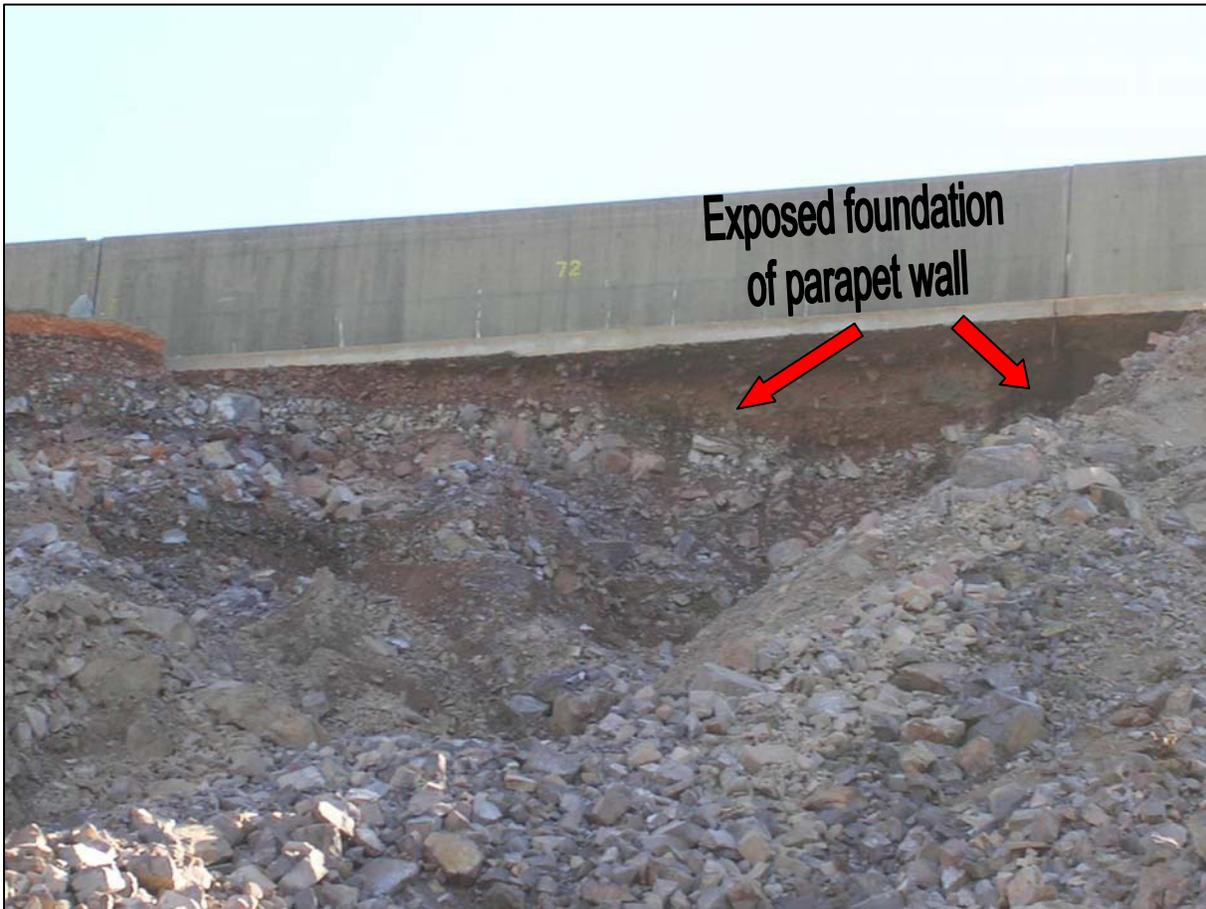
Fig. 7. – This photo taken below panels 71-72 show the deep plunge pool that developed and subsequent undercutting of the parapet wall. (Photo courtesy of David Hoffman).

At 5:15 AM, only six minutes after overtopping is believed to have initiated, the 60-foot long segment near wall panel 95 toppled, unleashing 15 feet of flowing water over the remaining embankment and concrete liner (Figure 7).

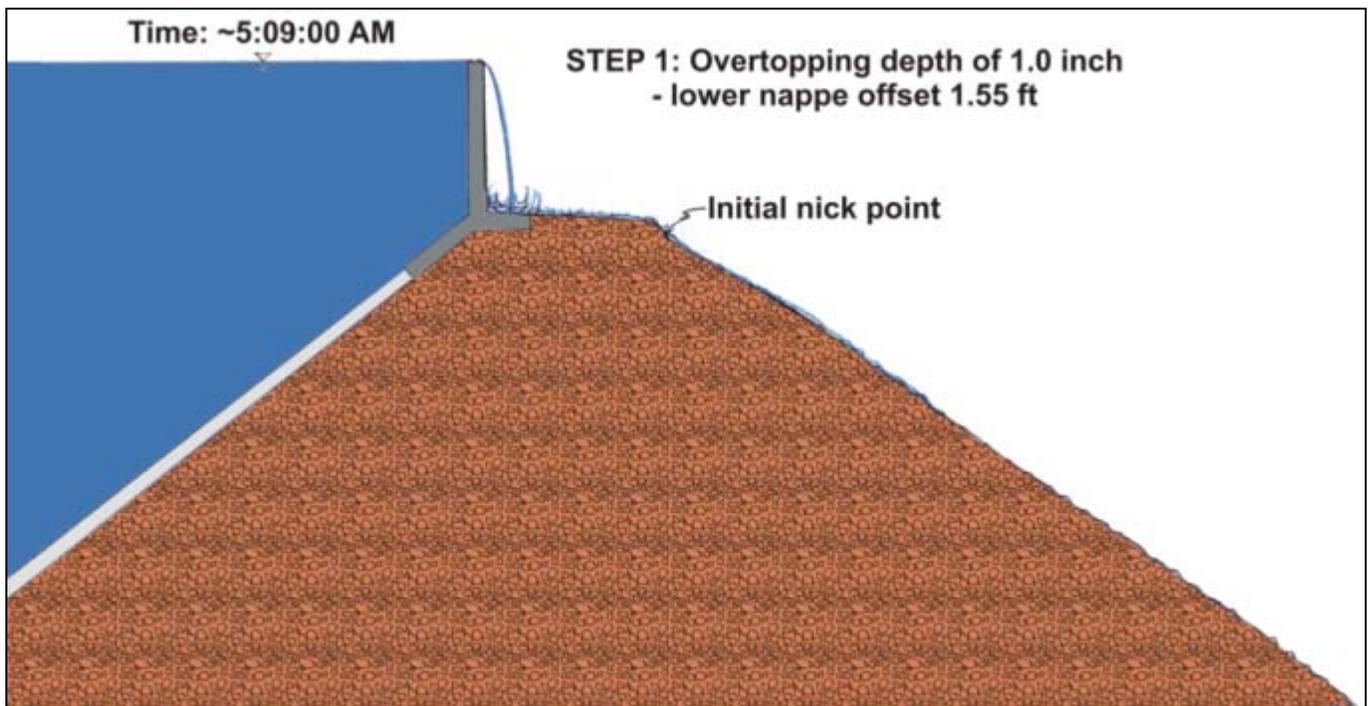
Fig 8. – The first figure from the reconstructed failure sequence shows the initiation of overtopping around 6 minutes prior to failure. Water is spilling onto the 3 foot wide parapet wall footing and just beginning to erode crest of the embankment.

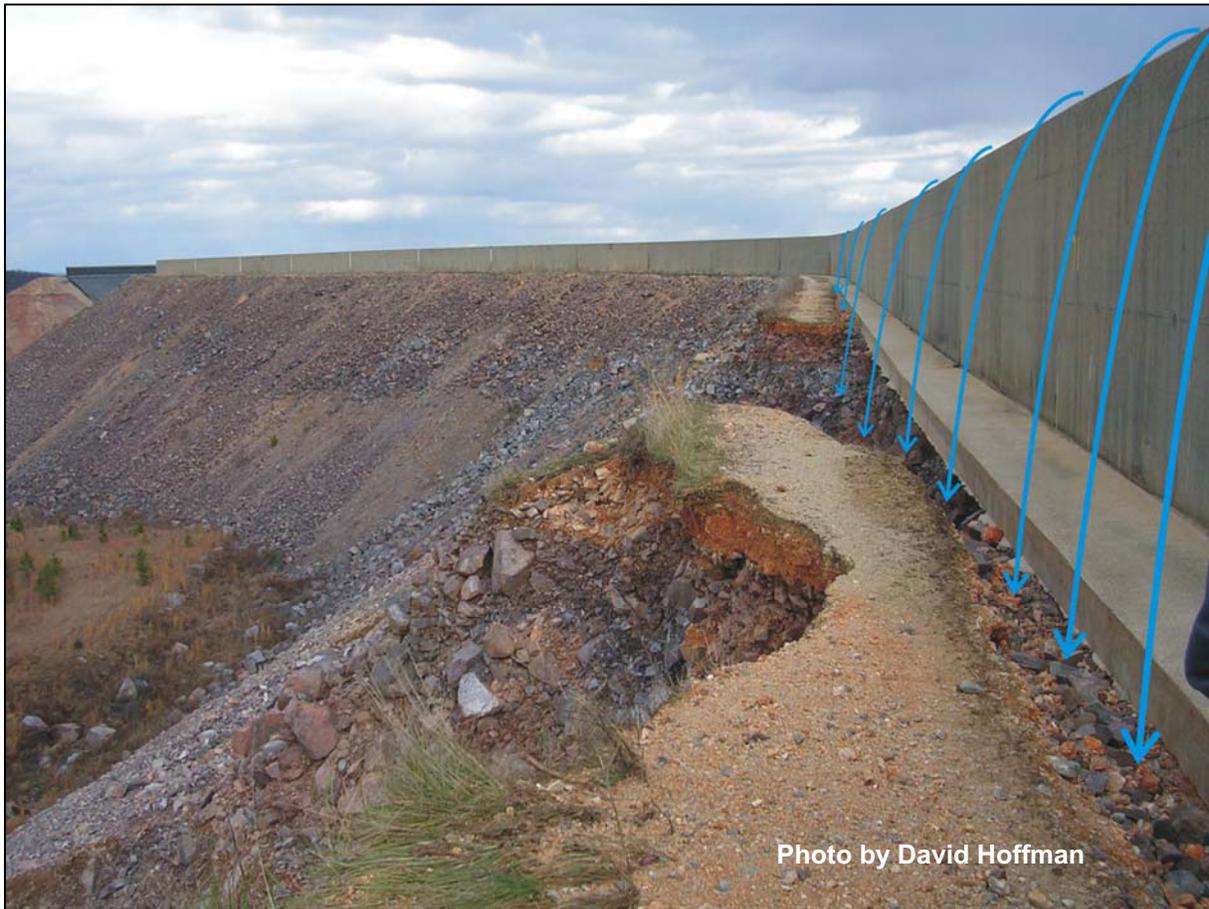
Fig 9. – This photograph shows arrows representing the overflow nappe once it extended beyond the 3 foot wide wall footing and directly onto the underlying rockfill. The rate of scour and erosion increased dramatically once this occurred.

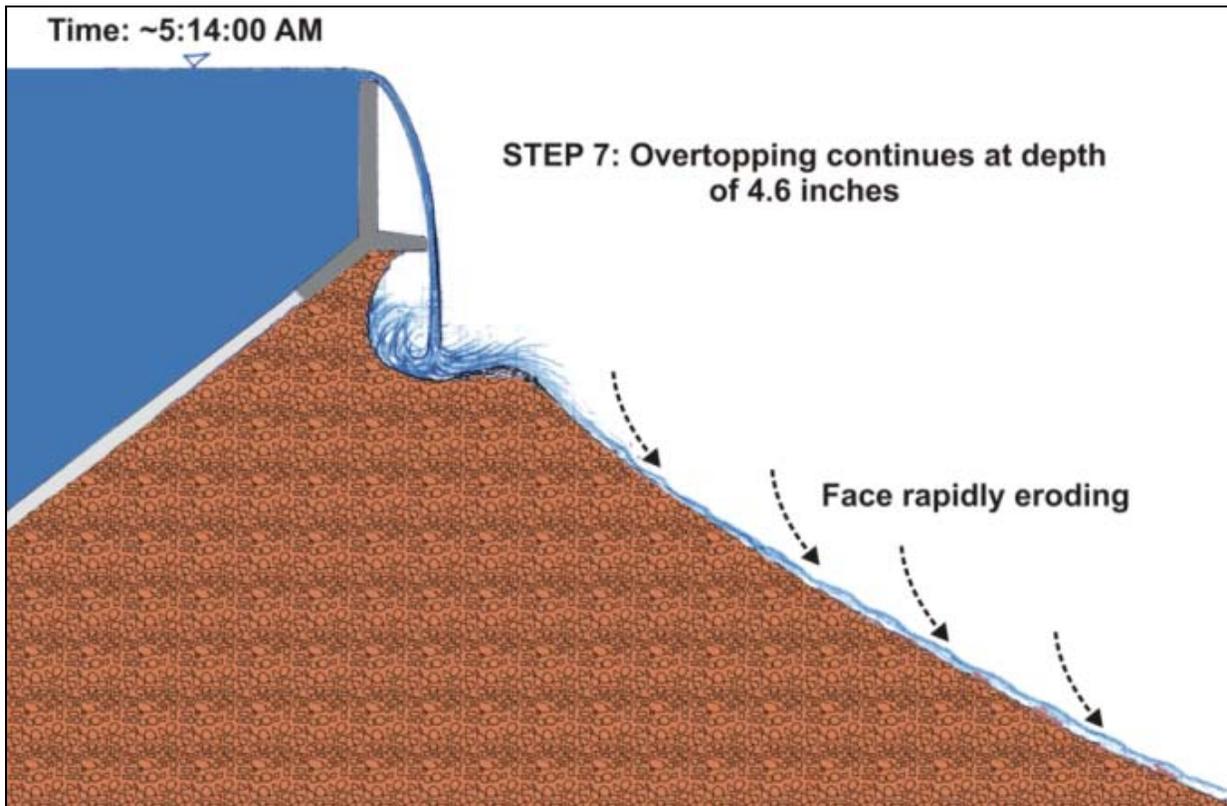
Fig 10. – This step of the reconstructed failure sequence illustrates the undermining of the parapet wall and rapid erosion of the embankment. The wall remained standing at this point due to the hydrostatic load on the inclined portion of the wall footing and 3-dimensional effects from surrounding wall panels.

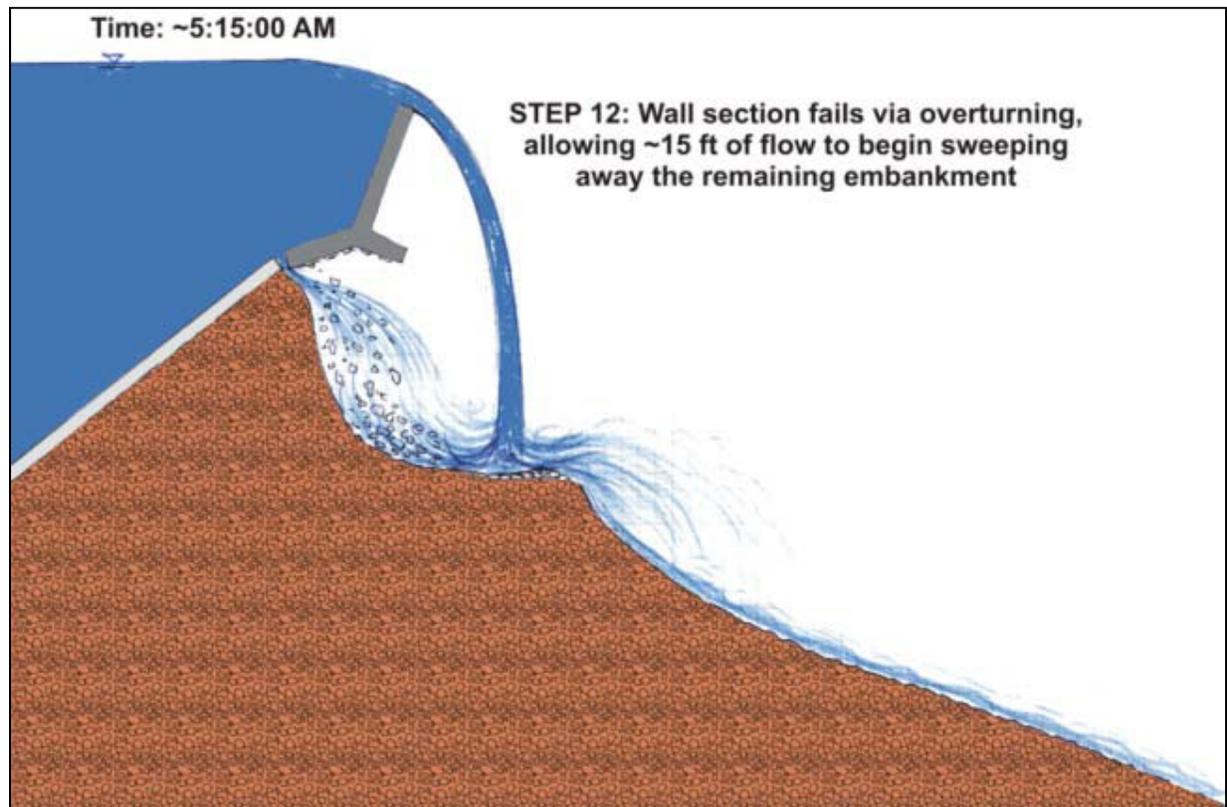
Fig. 11. – This step portrays how the parapet wall toppled in vicinity of panel 95, initiating the catastrophic failure of the reservoir by unleashing around 15 feet of flow over the remaining embankment.

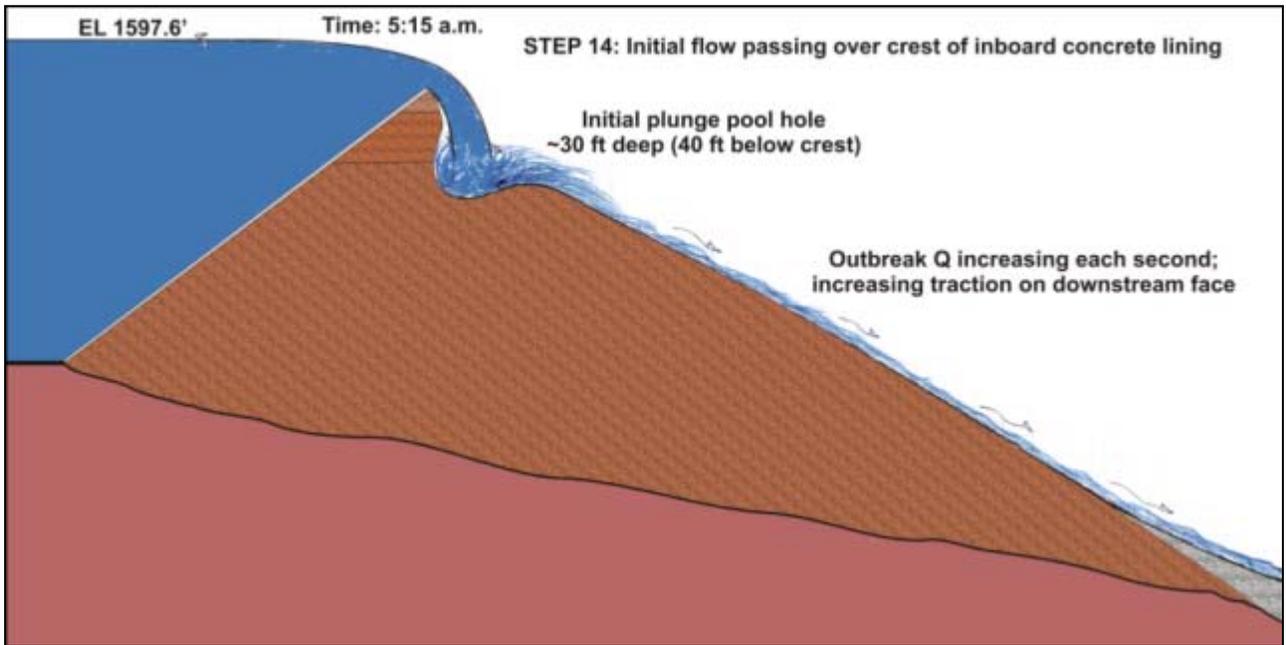
Fig. 12. – This figure illustrates ~15 feet of water overflowing the embankment immediately after the failure of the parapet. The reinforced concrete liner behaved as a thin-crested weir and allowed for the formation of a deep plunge pool.

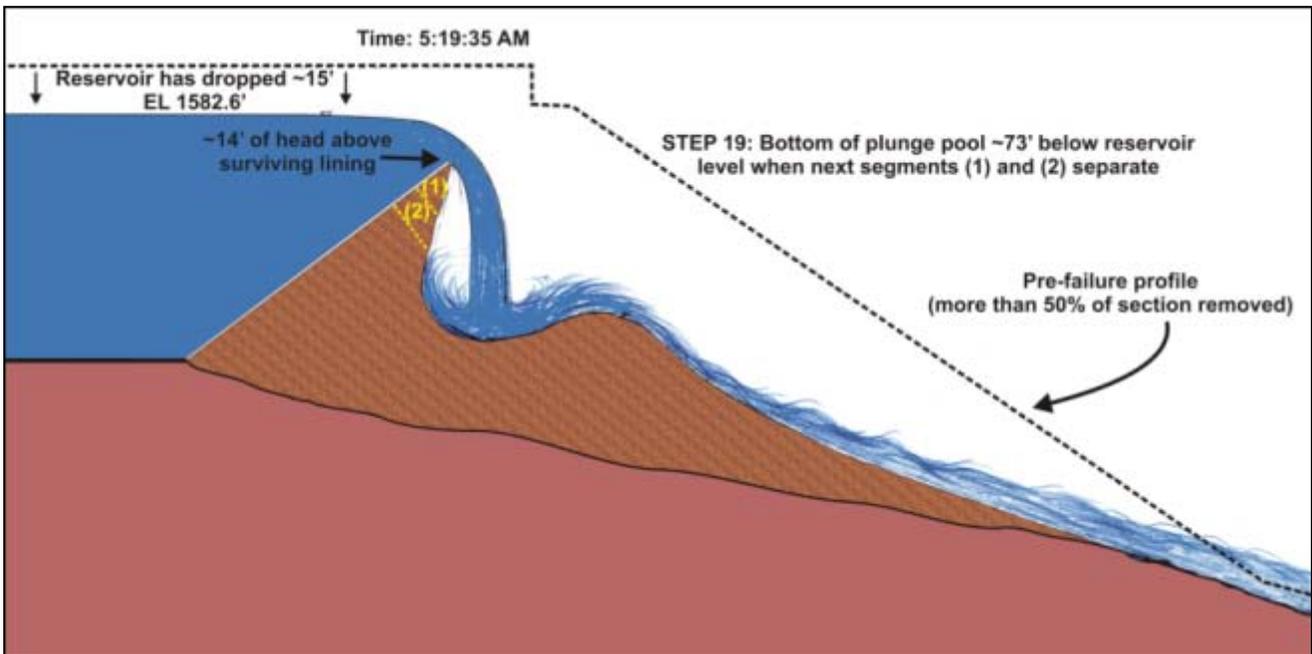
Fig. 13. – The embankment and concrete liner are progressively removed by the outflow. About one half the embankment remains at this stage.

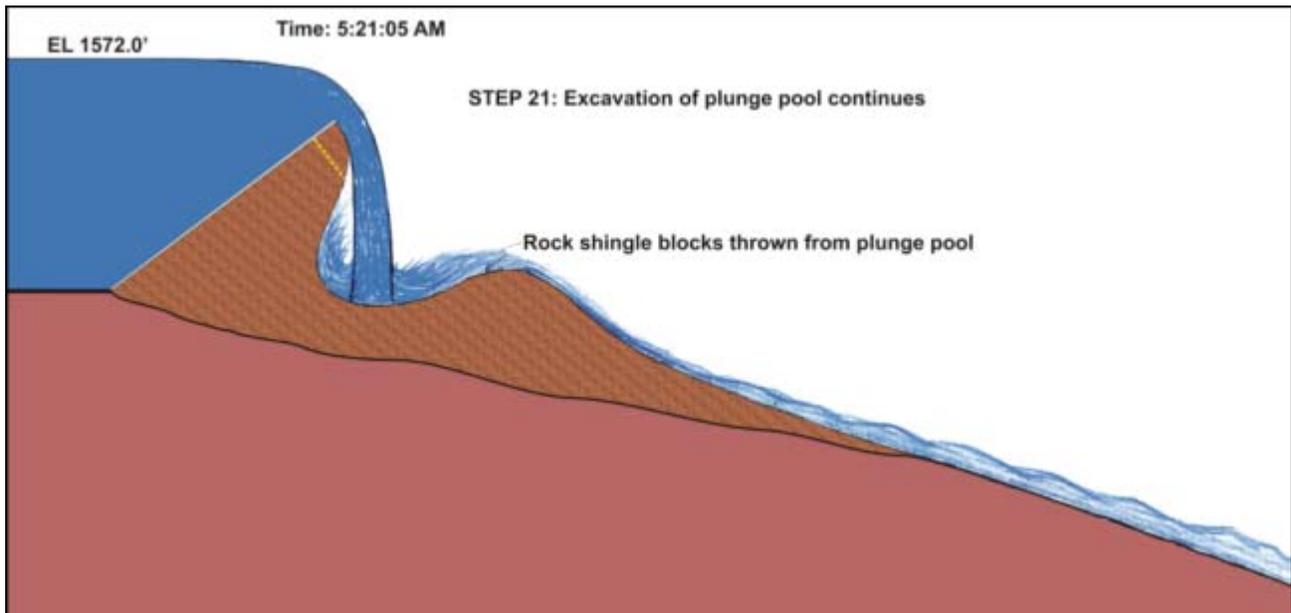
Fig. 14. – A continuation of the sequence show deepening of the plunge pool and ejection of large shingle blocks/boulders.

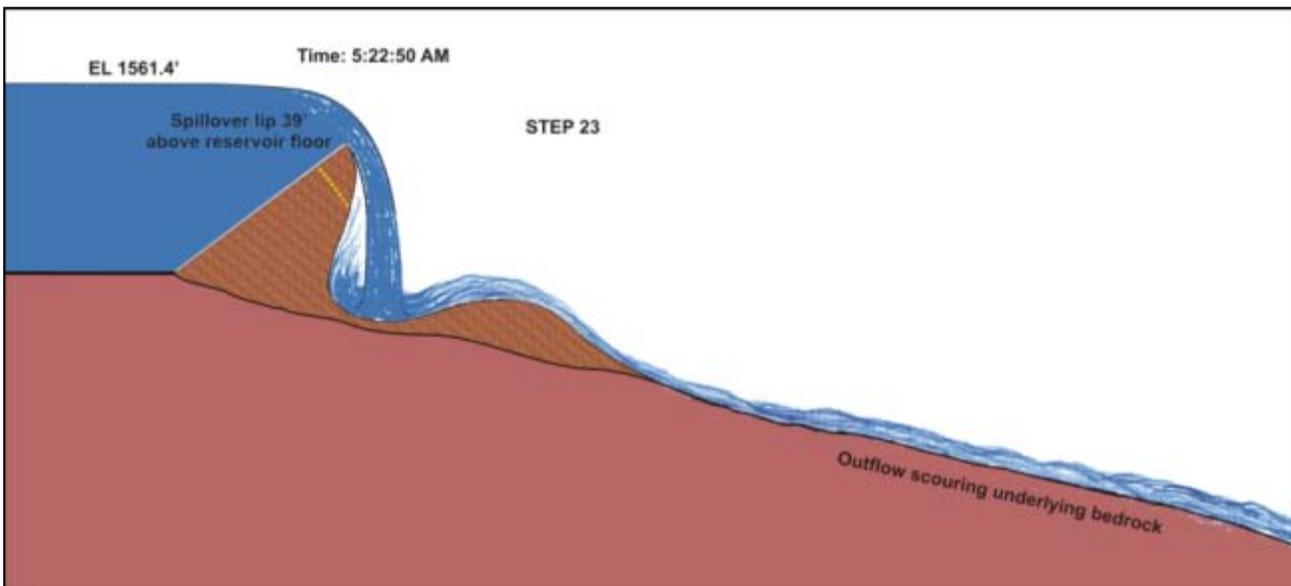
Fig. 15. – The plunge pool deepens towards the foundation interface and outflow has exposed much of the underlying bedrock, which is then scoured.

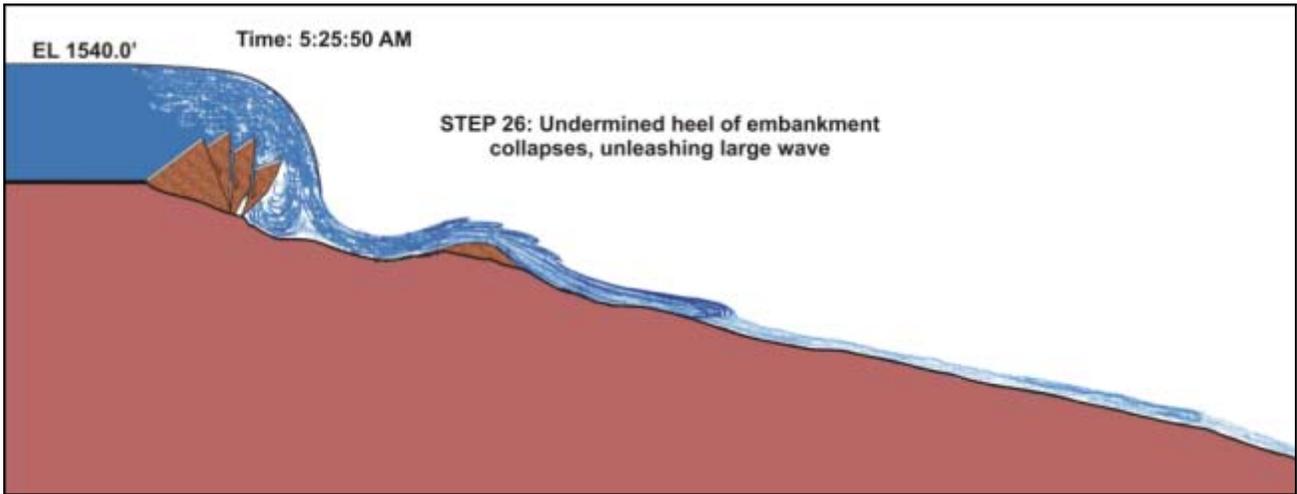
Fig. 16. – The embankment undergoes one final large collapse involving the concrete liner, sending one final surge down the slope.

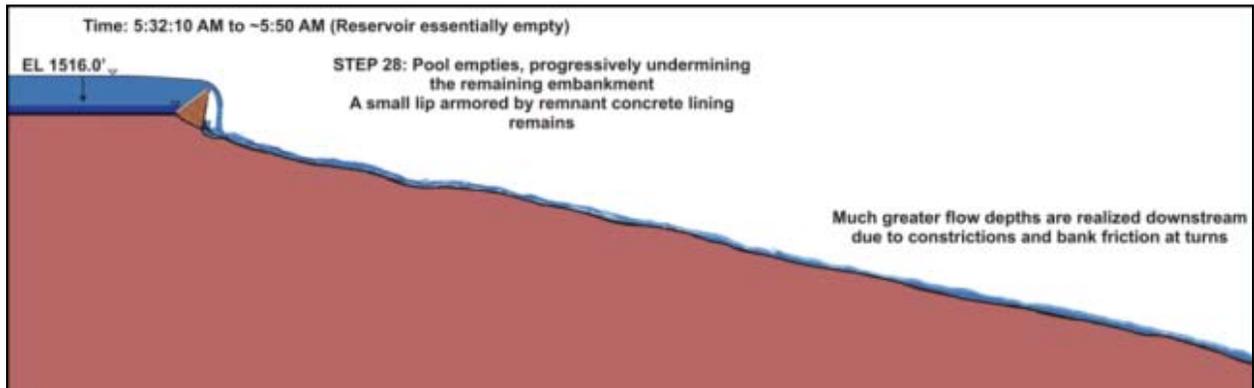
Fig. 17. – A small lip formed by the concrete liner armored the final last remnants of the embankment. Only a small amount of water remained in the reservoir.

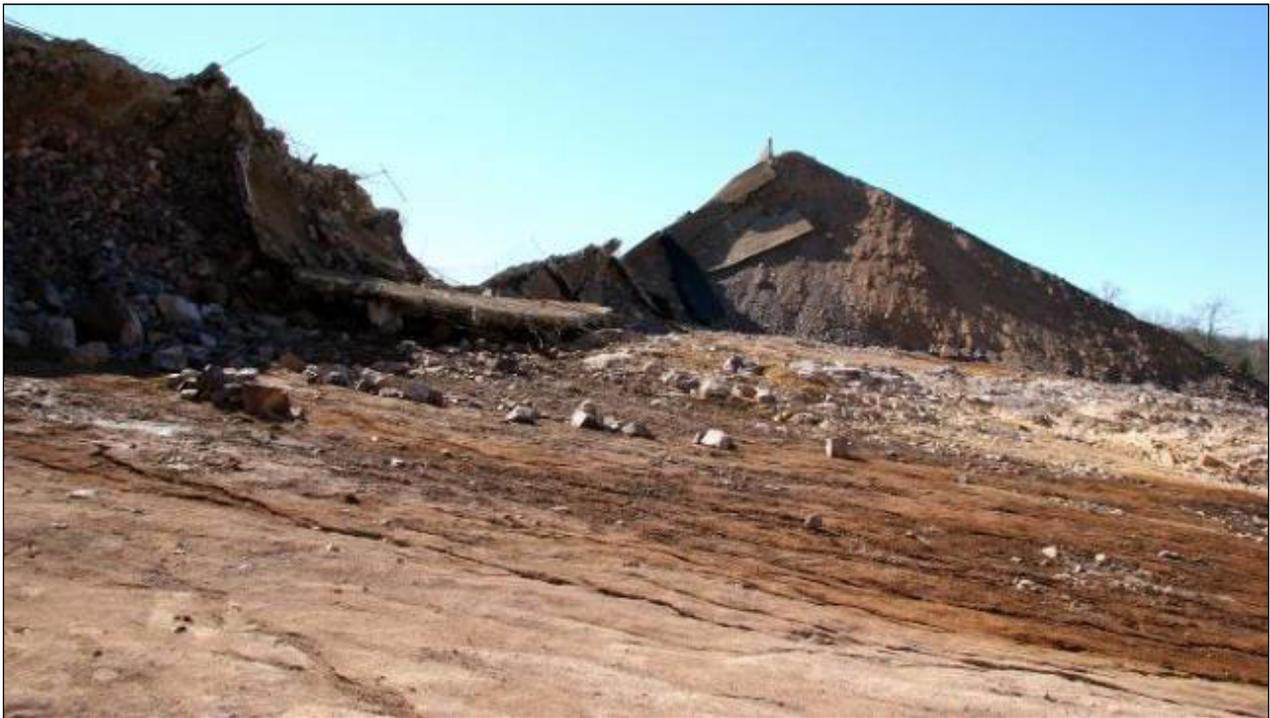
Fig. 18. – The remnant lip as seen at the failure site.

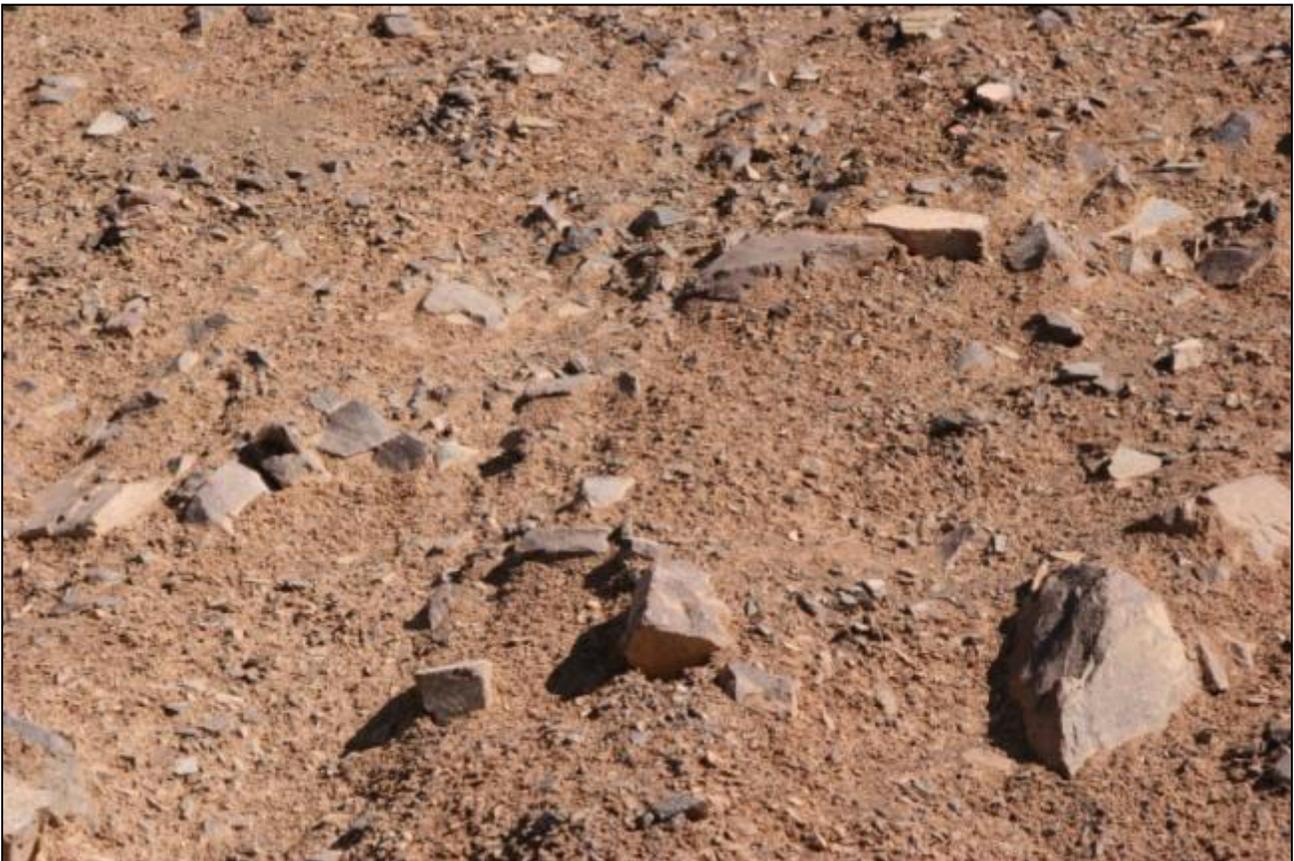
After the reservoir failure, The Federal Energy Regulatory Commission (FERC) and the Missouri Department of Natural Resources, Dam and Reservoir Safety Division (MoDNR-GSRAD) conducted investigations into the failure. Although the embankment was intended to be clean rockfill (less than 5% passing the No. 200 sieve) an excessive amount of fine-grained material was visually recognized in the exposed dike one day after the failure (Leonard, 2005). Forensic analyses by FERC's Taum Sauk Investigation Team (2006), FERC's Independent Panel (2006), and by Rizzo Associates, Inc. (2006) confirmed a fines content of between zero and 20% in the exposed embankment bordering the breach (shown in Figs. 2 and 19). In addition, the percentage of sand sized material within the embankment was as great as 45% in certain locations, creating a far more erodible mixture than normally expected of clean rockfill (FERC Independent Panel, 2006). This problem was manifest by the unusual level of surficial erosion during the project's 42 year life, from rainfall-induced runoff (FERC Independent Panel, 2006). Cooke (1967) surmised that the dike could not have been clean rockfill because the observed settlement was almost an order of magnitude greater than those recorded on other concrete-faced rockfill dams (prior to 1967).

Fig. 19. - Close up of "dirty" rockfill exposed on lateral margins of the breach. The large clasts are 10-12 inches diameter.

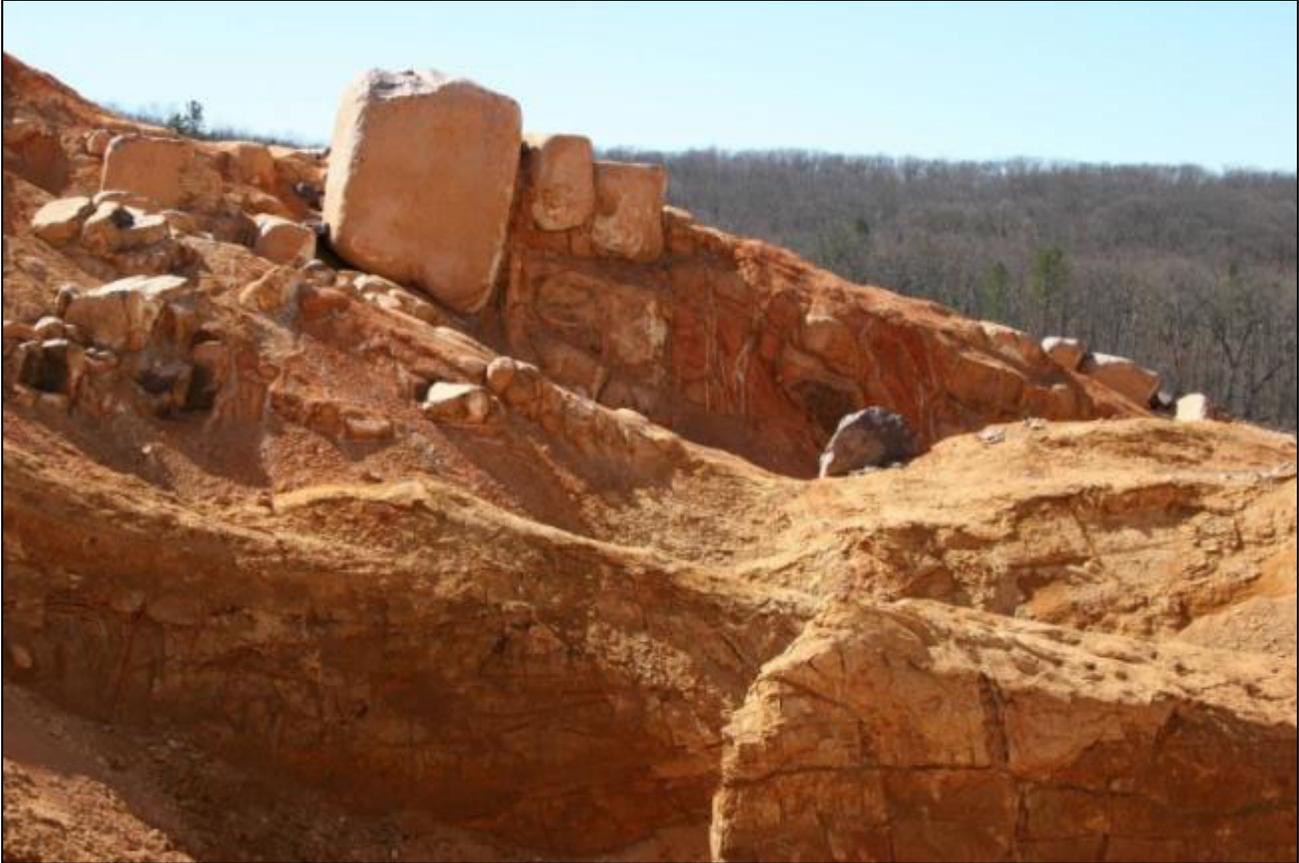
High rates of settlement were experienced at the upper reservoir during the first four and a half years of operation. Between 0.5 and 0.8 feet of settlement were experienced during this time, which correlates to 0.53% to 0.73% of the total embankment height, respectively. J. Barry Cooke (1915-2005), a member of the National Academy of Engineering, served as a consultant to Union Electric for the project, from the time of its design and many years thereafter. In 1967 Cooke summarized his observations about the reservoir’s performance in a letter to Union Electric (Cooke, 1967). Cooke felt that the average settlement rate of over 0.1 ft/year was unprecedented when compared to other rockfill dams, but was acceptable for this project. He concluded that “*The Taum Sauk Rhyolite Porphyry is an excellent high compressive strength rock that should have stabilized in its settlement. However, the formation contained frequent zones of soft weathered rock, all of which could not have been selectively wasted*” and that “*I believe that a fill of 100% competent rock would have stabilized and that the percentage of weathered rock in the Taum Sauk is the cause.*” An example of such a weathered zone is shown in Fig. 20.

The December 2005 outbreak flood exposed deeply weathered zones in the bedrock slopes of Proffit Mountain. A seam of weathered rhyolite was observed beneath the breached section of the embankment. The upper slopes of Proffit Mountain also contain a zone of deeply weathered diabase saprolite, which appears to be the remnant of a disintegrated dike or sill (see Fig. 20). Adjacent granites and rhyolites also exhibited a high degree of weathering, likely from hydrothermal alteration associated with intrusion of the diabase. The weathered diabase exhibits a soil-like texture, though retaining the rock's original fabric and fracture patterns. Core stones and remnant spheroidal weathering rinds are also visible.

Fig. 20. – A zone of deeply weathered bedrock (saprolite) on the upper slopes of Proffit Mountain appears to have formed due to the disintegration of a diabase dike or sill and nearby hydrothermally altered granites.

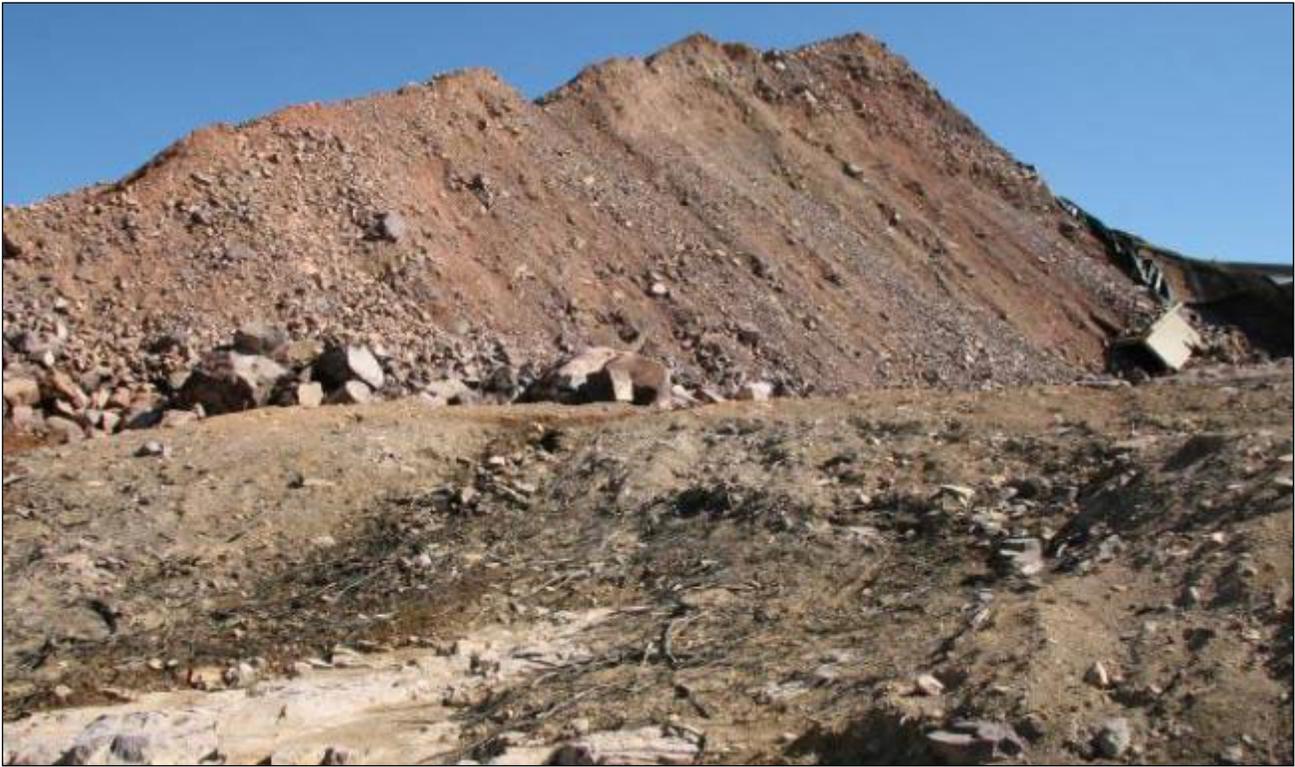
Post-failure investigations included exploratory drilling through the embankment-foundation interface to ascertain the character of the contact. These borings revealed that up to 18 inches of residual soil were not stripped off prior to placement of the rock fill. Soils containing tree roots and other organic matter were also observed beneath the breached section of the embankment (see Fig. 21). This may have contributed to the increased settlement and shifting of the embankment in this area, due to the high fines content, poor drainage, and higher compressibility of the un-stripped residual soil cap, as well as the 'dirty' rockfill.

Fig. 21. – Residual soils, including tree roots and other organic matter, were observed left in place beneath the failed portion of the upper reservoir embankment.

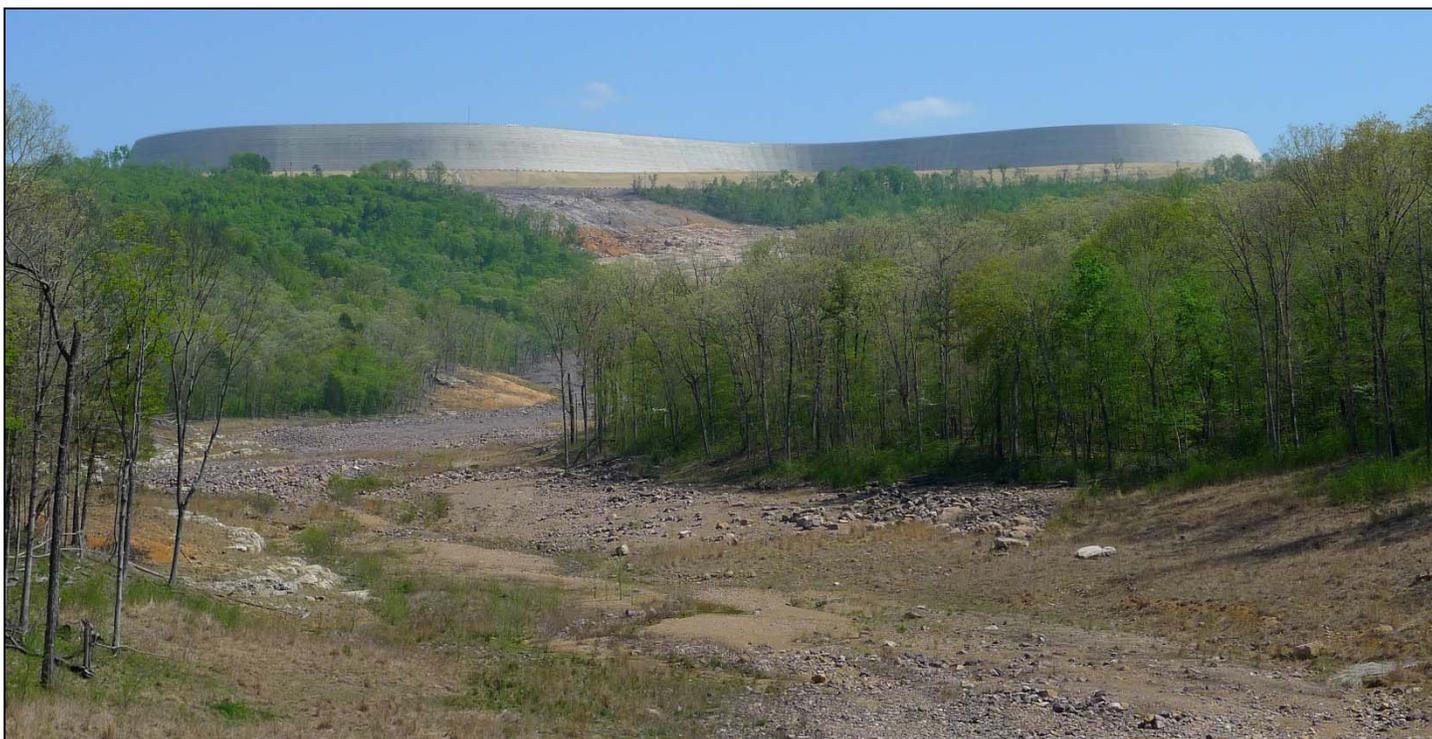
Fig. 21. – Overlooks within Johnson’s Shut-ins State Park provide excellent views of the scour path formed during the failure and rebuilt structure. This photograph shows the rebuilt RCC upper reservoir during the spring of 2010, just prior to the resumption of operations at the facility.

AmerenUE is paying for 100% of the clean-up and repair at Johnson's Shut-ins State Park. FERC approved AmerenUE's plan to rebuild the upper reservoir and the utility recently completed the rebuild, successfully renewed its FERC permit, and resumed operations in the spring of 2010. The utility is involved in a lawsuit and investigation by the Missouri Attorney General's office. In November 2007 another suit was filed against AmerenUE by the Great Rivers Environmental Law Center alleging that FERC has failed to properly monitor the reconstruction project. Both of these suits have slowed the approval process. AmerenUE reconstructed the upper reservoir from scratch using a roller compacted concrete (RCC) embankment with a similar footprint, height and capacity to the original structure, creating the largest RCC dam in North America (see Fig. 22 for view of the rebuilt structure). Much of the aggregate material from the failed structure was washed, crushed, and resorted to make it suitable for reuse in the RCC mix. Sections of the foundation containing deeply weathered zones were over excavated and replaced with concrete and the footprint of the structure was altered slightly to avoid other such zones. The rebuilt structure includes a spillway discharging over the eastern side of Proffit Mountain in case of another overtopping. This location discharges onto uninhabited lands that the utility owns and controls and in a direction away from Johnson's Shut-in State Park. Additional measures will also be undertaken to reduce the risk of overtopping.
