A DAM INCIDENT AT SUGAR CREEK L44

*D. Wade Anderson, P.E. U.S. Army Corps of Engineers, Tulsa District. (918) 669-7654
(formerly with USDA-NRCS, Fort Worth, Texas)*

*Arvil Bass, P.E. USDA-NRCS, Stillwater, Oklahoma. (405)742-1270,
Arvil.Bass@ok.usda.gov.*

Abstract

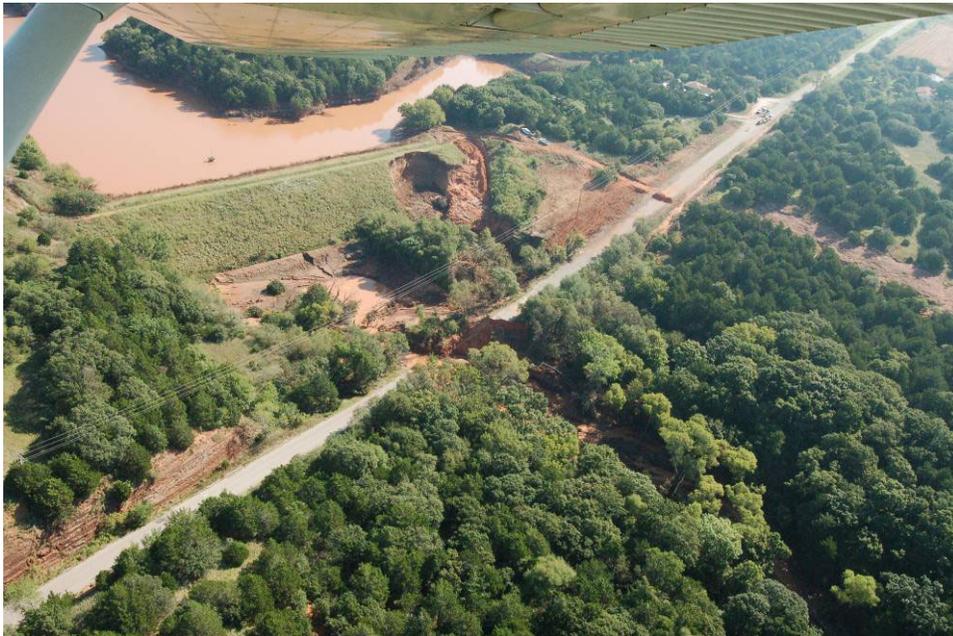
Figure 2 Downstream Road Breach

August 19, 2007, 8:15 am – Resident observed the entire road fill had failed. He did not observe any failure in the dam from his view on the right abutment. The breached roadway embankment is shown in Figure 2.

- Coordinate repair of the downstream roadway and channel improvements to insure adequate drainage capacity downstream of the dam is constructed and maintained.

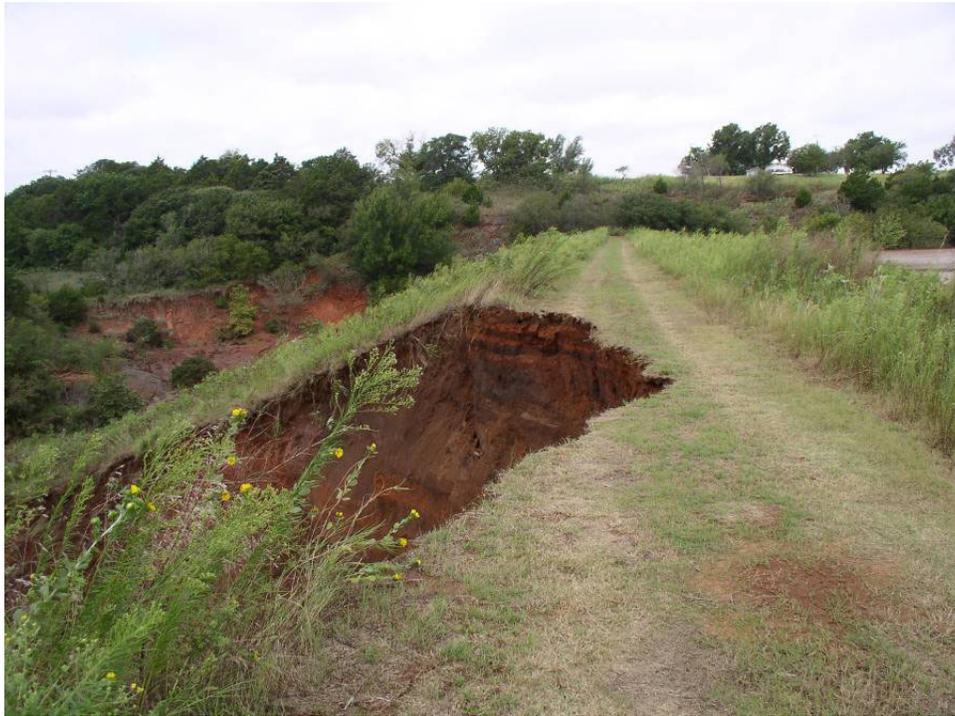
August 20, 2007, 8:00 am – The ASW flow had ended and the erosion in the dam was up to the top of the dam and widened, as shown in Figures 3 and 4.

Figure 3 Crest of Dam

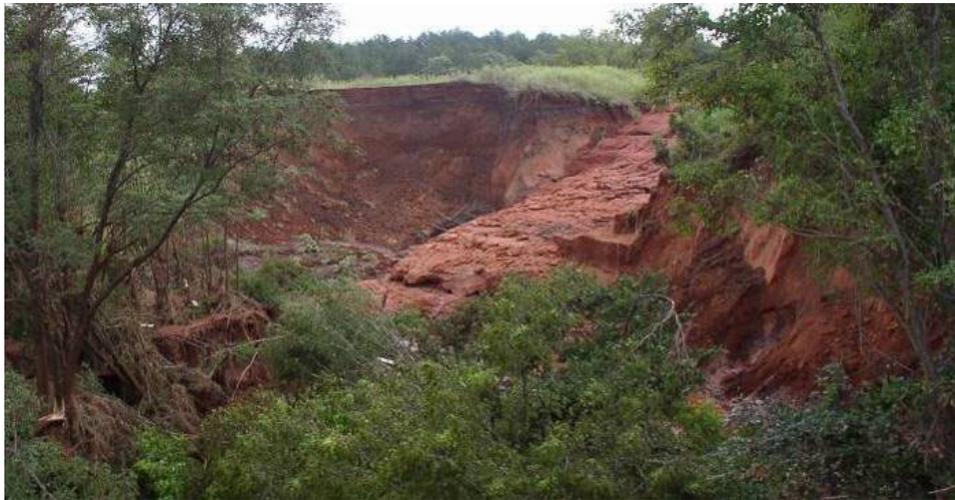
Figure 4 Eroded Auxiliary Spillway taken from Road

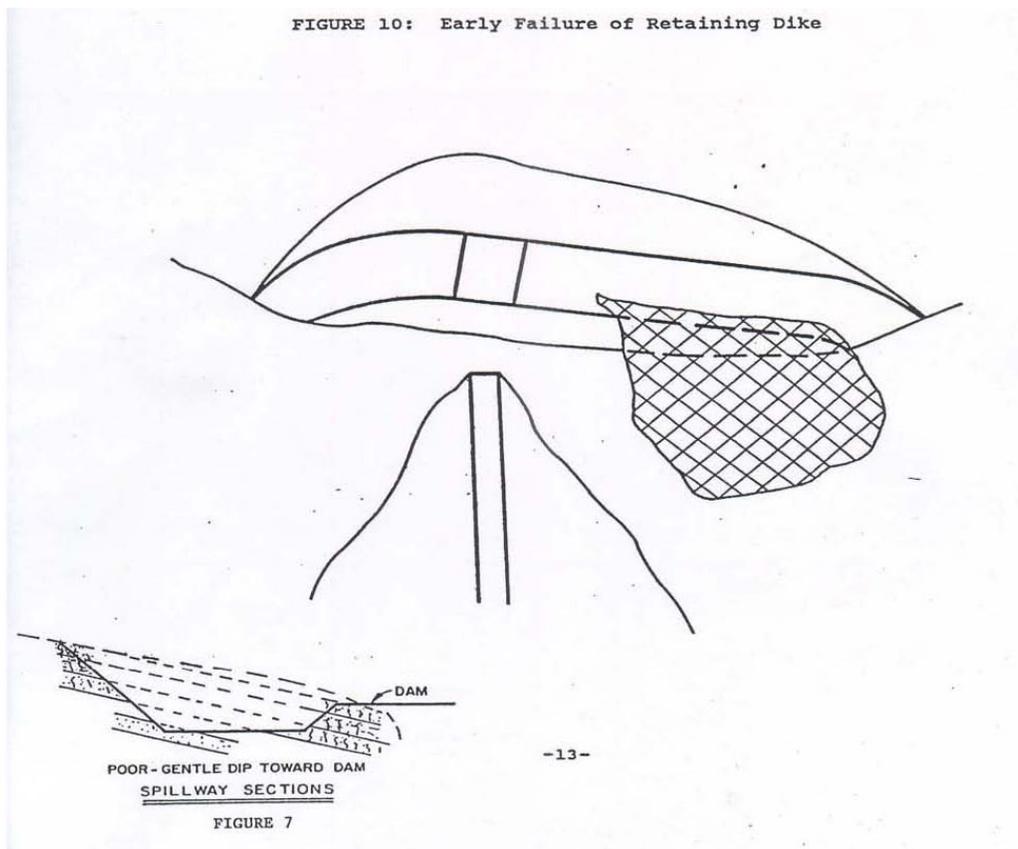
Figure 5 of this paper shows figures 7 and 10 from the technical note. The early failure of the retaining dike led to uncontrolled flow damaging the abutment and nearly breaching the embankment. This scenario exists for the bedrock under the as-built ASW, as shown in Figure 6.

Figure 5 Geology Technical Note Figures

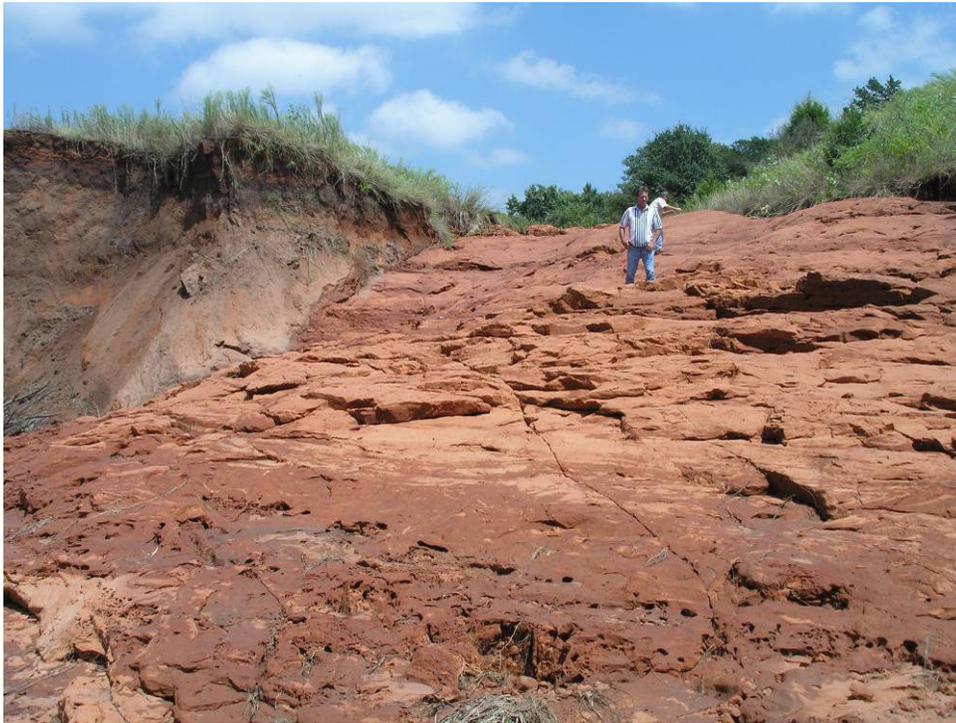
Figure 6 Exposed bedrock in ASW sloping toward dam

- If a vegetated or earth/rock spillway is incorporated as part of the rehabilitation, excavation of the ASW in the right abutment rock should be considered.

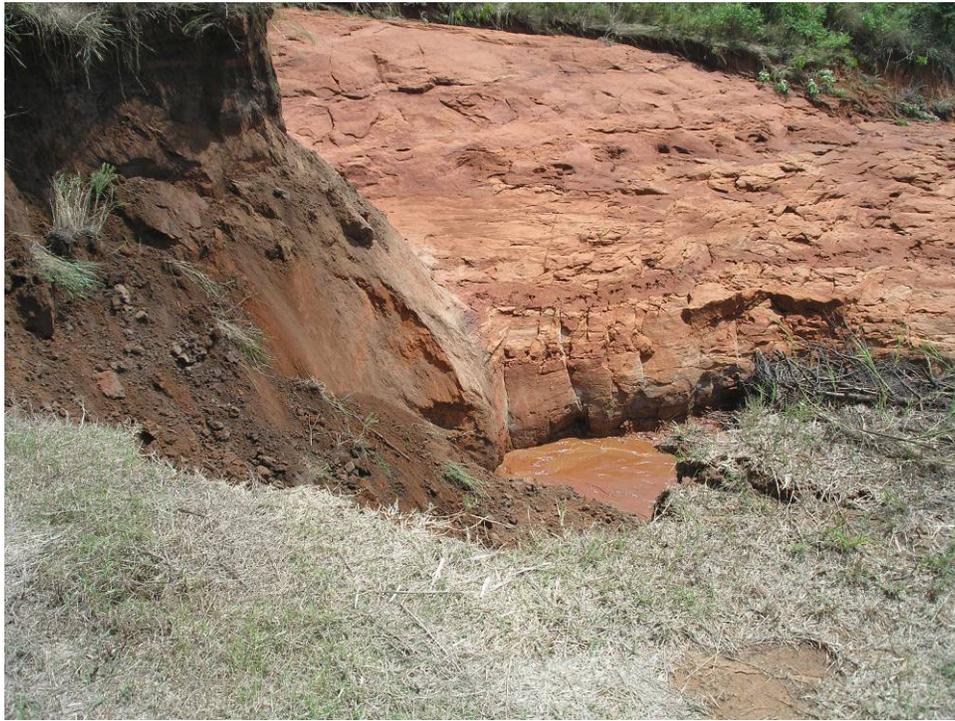
Relocation of the ASW from the original layout along with increasing the slope of the exit channel to 9.75 degrees occurred prior to construction. Unfortunately, and unknowingly, the ASW relocation placed the training dike directly over a near vertical outcrop of the sandstone that the spillway flow had eroded down to and exposed. This outcrop provided a 10+ foot near vertical outfall that added to the hydraulic energy when the training dike eroded, as shown in Figure 7 and 8. A plan view of the ASW superimposed on the exposed rock in the ASW is illustrated in Figure 9. This exposed rock surface was surveyed immediately after the 2007 event. This sketch displays the highest tail-water of 1295, which indicates that the lower 27± feet of the top of the dike were submerged to that elevation.

Figure 7 Near vertical outfall of over 10 feet at groin of dam and abutment

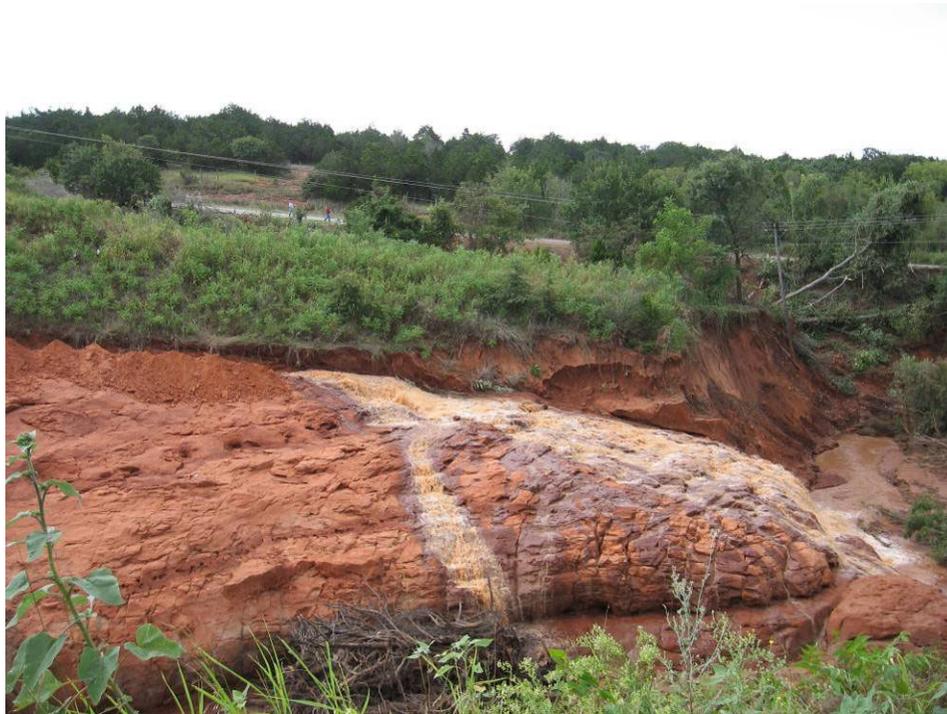
Figure 8 Near vertical outfall running entire length of ASW outlet channel
Note: Uncontrolled pumped discharge attempting to flow towards the dam

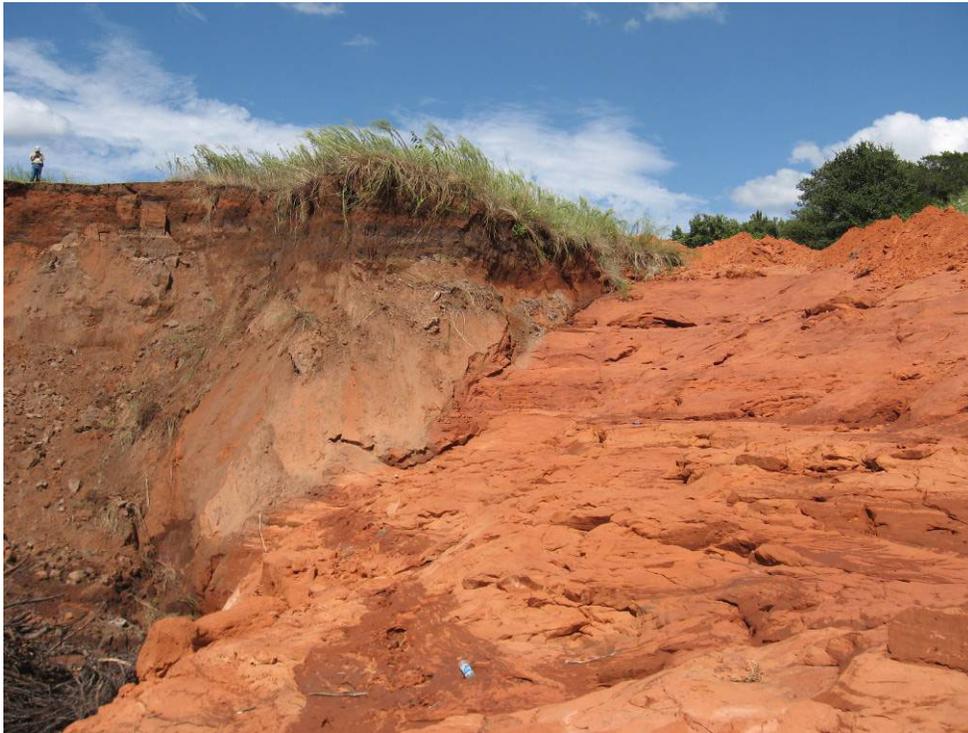
Once the top of the dike eroded through, the process continued down cutting through the dike, especially when the road breached and the tailwater began to subside. The near vertical outfall of 10+ feet added additional energy to the erosive forces, and the head cut advanced up the groin of the structure close to the position outlined in Attachment 10a. Attachment 10a also illustrates the flow direction of the ASW. It should be noted that the flow concentrated directly toward the inside edge and into the near vertical outfall. The headcut advance allowed the dike to be eroded away and the abutment groin headcut to advanced to approximately Station 1+80, as shown in Figure 10 (photo looking upstream on ASW).

Figure 10 Headcut advance into abutment and embankment groin
