A LOOK AT EARTH SPILLWAY DESIGN AND EVALUATION AFTER MORE THAN 50 YEARS OF EXPERIENCE

*Paul G. Schweiger, P.E.¹, Darrell M. Temple, P.E.²
Danny McCook³, P.E., & Amanda J. Hess, P.E.⁴*

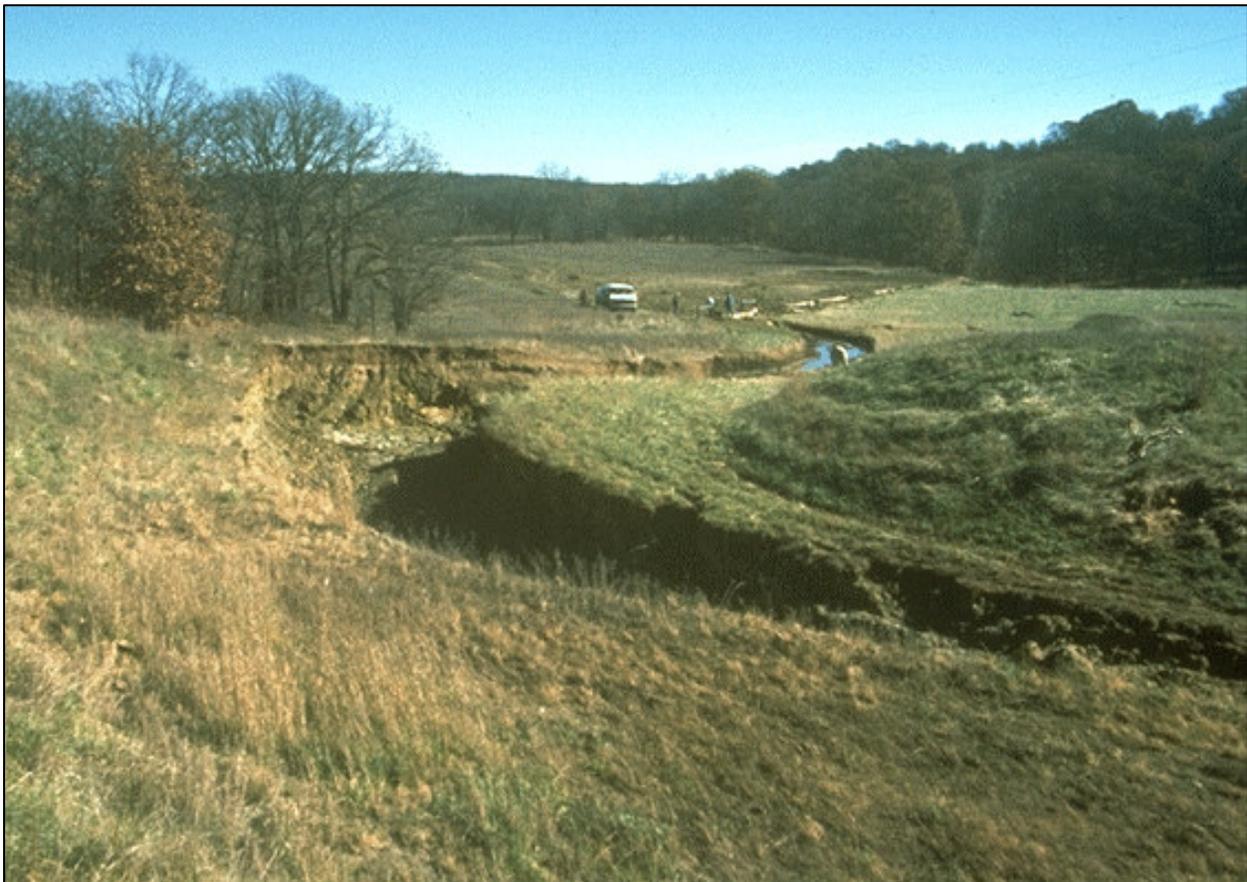
Figure 3. Twin Caney Site 17-3 Kansan in October 1986 provides an extreme case of headcutting when breaching of the spillway was initiated by a roadway paralleling the flow. The flow and stress concentrated in the unvegetated roadway tire tracks on the 10 percent exit channel slope resulting in the development of an overfall. Once formed this overfall moved both upstream and downstream along the lines of flow concentration formed by the tire tracks. Vegetated areas outside of the area of the roadway were undamaged.

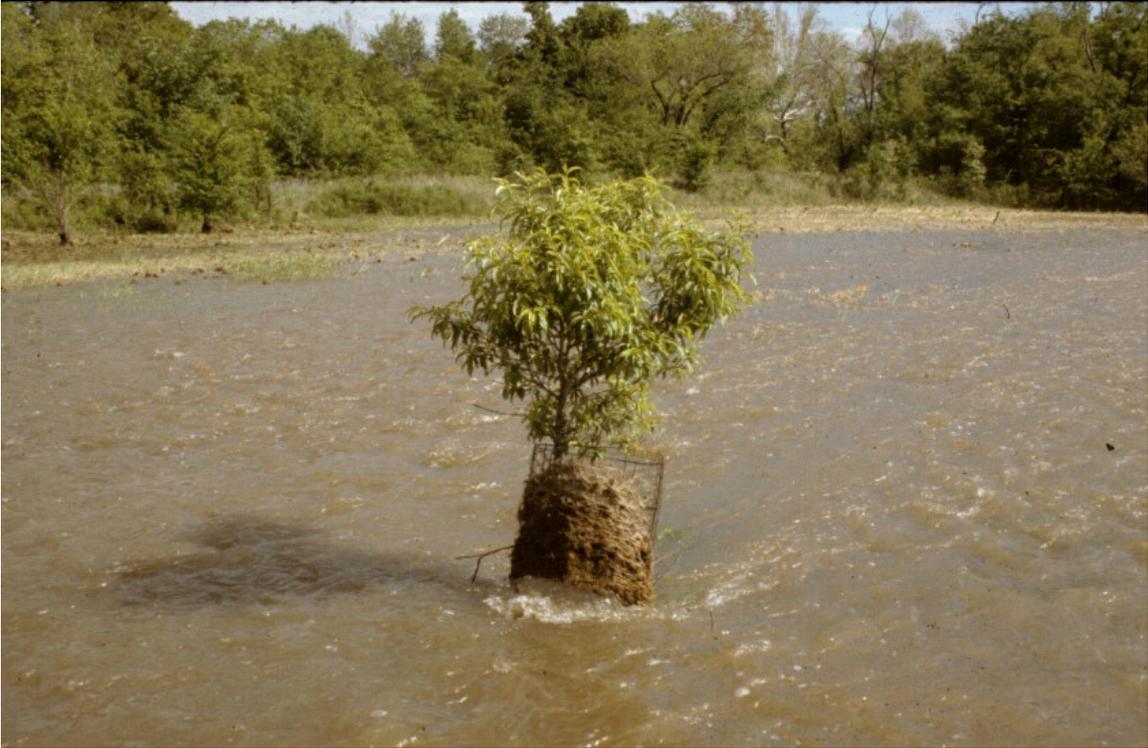
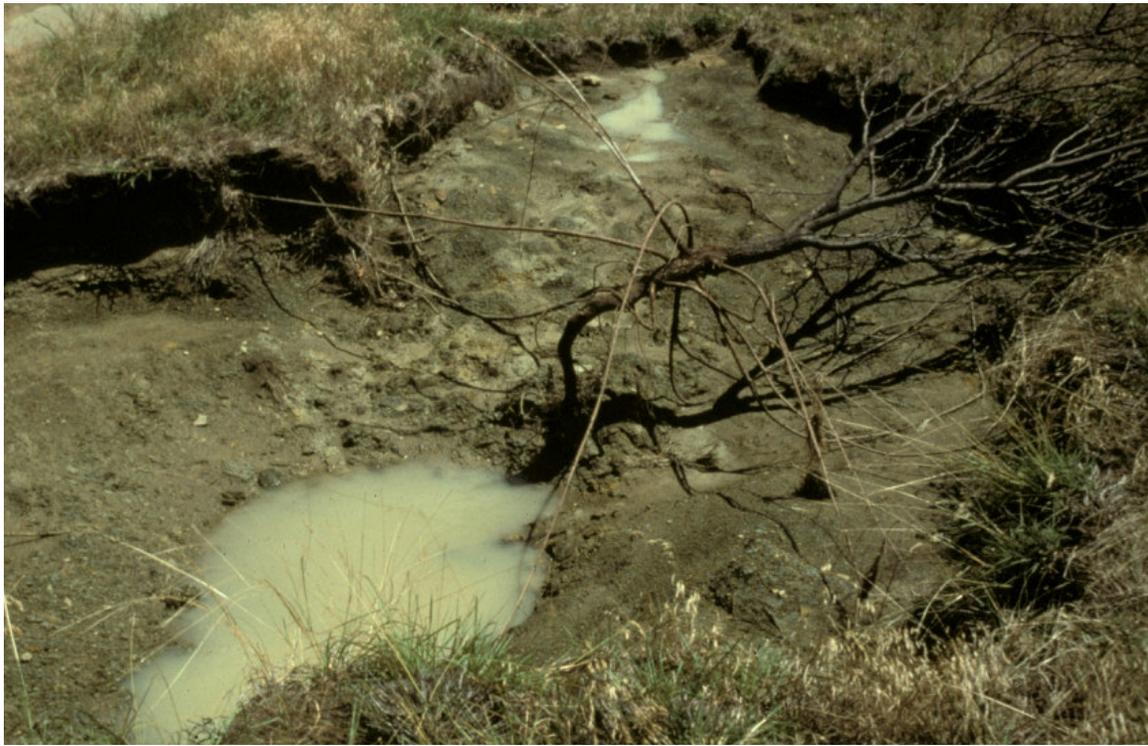
Figure 4. Example of a discontinuity (small tree) in an auxiliary spillway. Flow concentrates around the discontinuity causing higher stresses and local erosion of the grass cover.

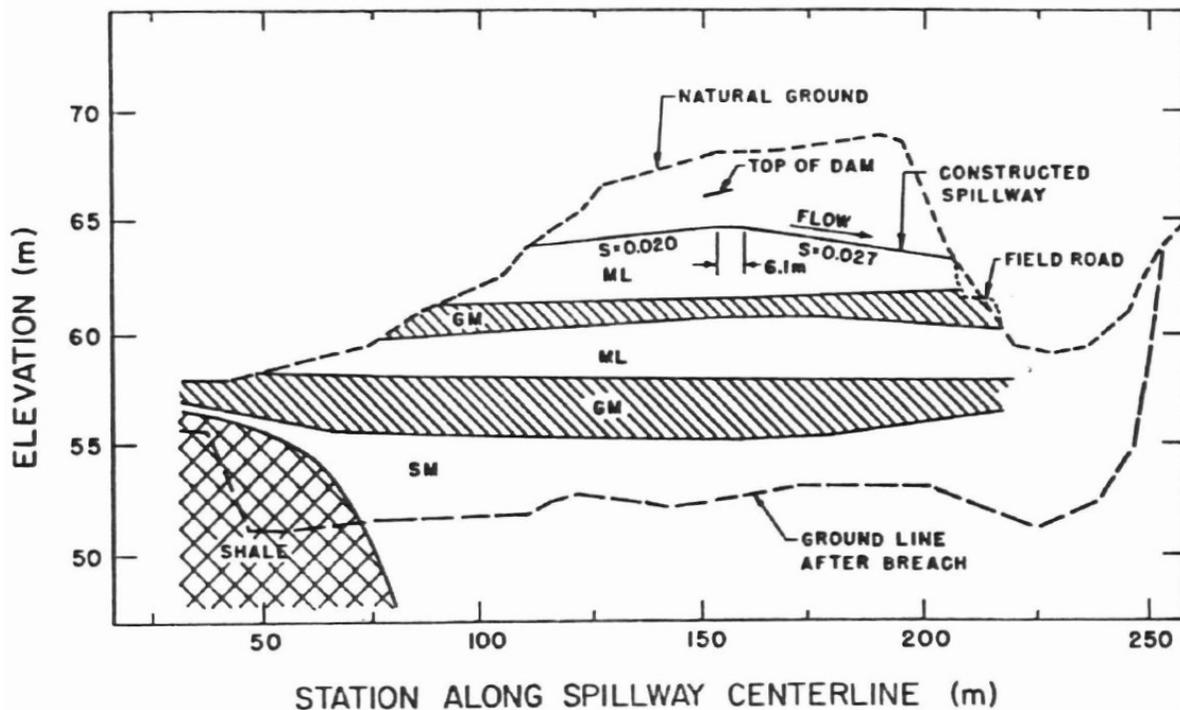
Black Creek Site 53 consisted of a 50-foot high flood control earth embankment on a 19 square mile watershed. The auxiliary spillway was 100-feet wide with 3H:1V side slopes. The spillway was vegetated with grass that was in good condition at the time of the failure. No major discontinuities existed within the spillway. A road crossed the spillway exit channel perpendicular to the flow, forming two sharp drops shown in Figure 5. These drops were determined to be the points of primary attack and initial headcut formation. The spillway materials consisted of GM, ML and SM materials in lenses as shown in Figure 5.

Figure 5. Black Creek Site 53 auxiliary spillway profile and geology (Temple, 1989).

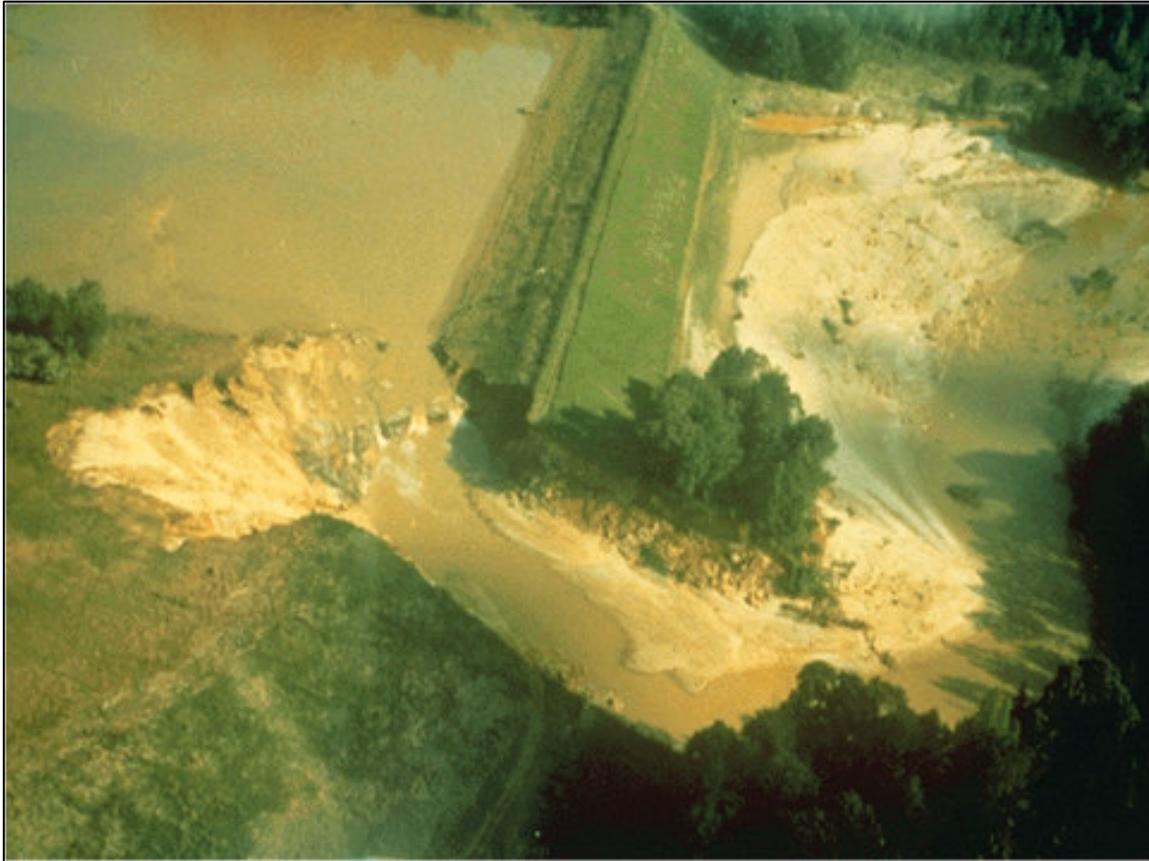
On May 20, 1983, two storms released 5 and 9 inches of rain, respectively, in less than a week. The first storm raised the reservoir water surface and decreased the flood storage available to contain runoff from the second storm. The second storm generated enough runoff to activate the auxiliary spillway and caused it to discharge flow for over 60 hours. The maximum head on the spillway was 5.1 feet and the peak unit discharge was 84.7 cfs per foot. The final breach through the spillway was approximately 40 feet deep, 160 feet wide, and over 500 feet long. The breach effectively drained the flood control pool. It was estimated that 187,000 cubic yards of spillway material was eroded. A photo of Black Creek 53 following complete breaching of the auxiliary spillway is presented in Figure 6.

Figure 6. Black Creek Site 53 following breach of auxiliary spillway (Temple, 1989).

This auxiliary spillway example illustrates the importance of inspection, maintenance, and owner education. The roadway located at the downstream end of the spillway was credited with initiating and accelerating the headcut formation. This feature was not on the original plans for the site. It is likely that the roadway was constructed by non-technical parties unaware of its possible impact on spillway operation. The Black Creek Site 53 spillway failure also showed the importance of understanding material variations in the observed failure process and the need for thorough geologic investigation and evaluation in spillway siting.

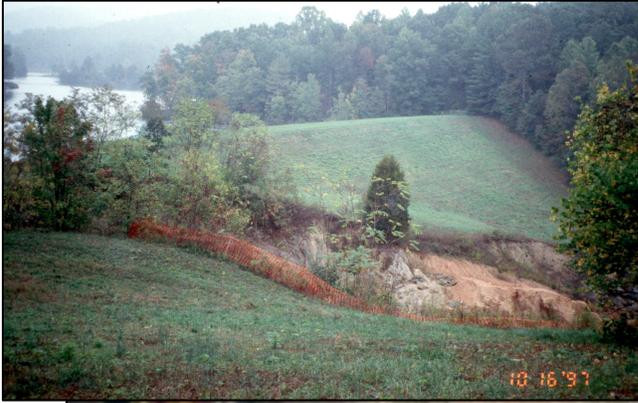
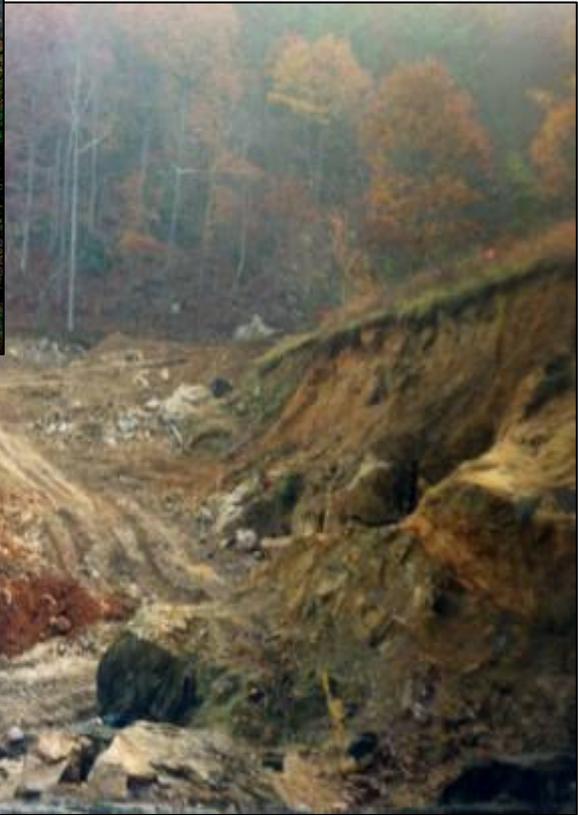
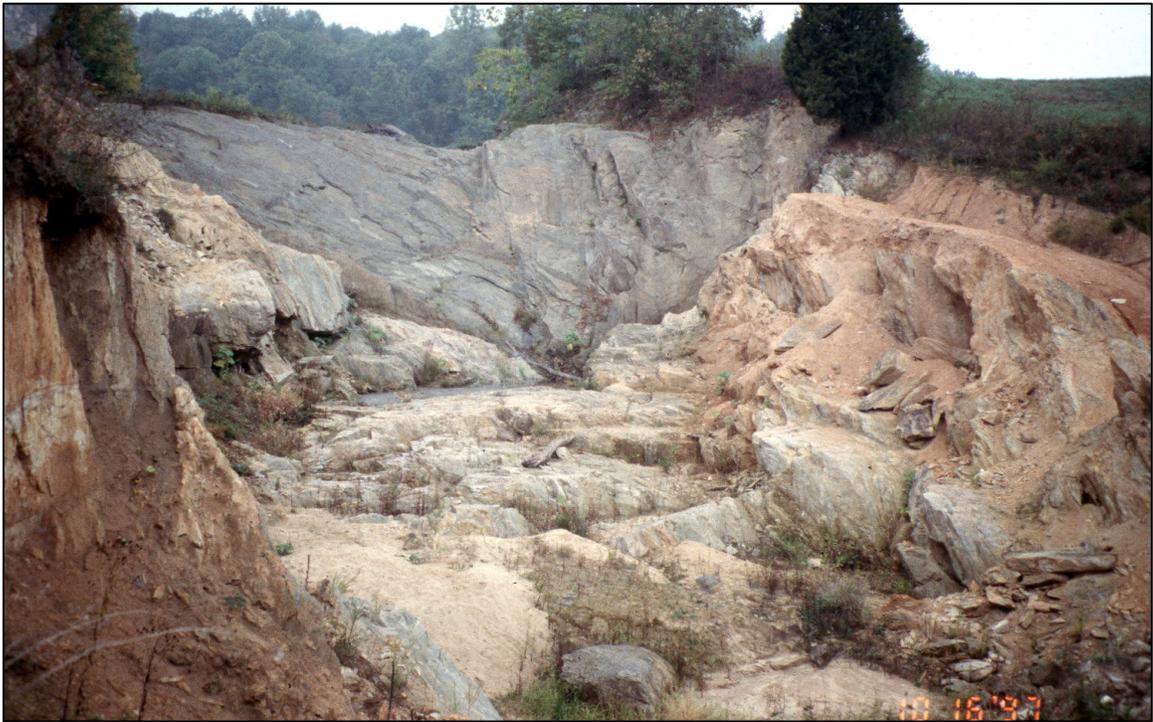
White Oaks Dam is a 63-foot high earthen embankment with a 63-foot wide auxiliary spillway constructed in 1964 for flood control and water supply. The dam is located in Madison County, Virginia. The contributing drainage area is 5 square miles in rural mountain terrain. On June 27, 1995, over 21 inches of rain fell within an 18-hour period, activating the auxiliary spillway and creating a maximum head on the spillway of 10 feet, and a peak unit discharge of 138 cfs per foot.

This extreme flow eroded approximately 300 feet of the spillway to a maximum depth of 50 feet and width of 130 feet downstream of the control section. It was estimated that 10,500 cubic yards of spillway material was eroded. Boulders as large as 6 feet by 12 feet were observed immediately downstream of the spillway [Clements, 1998]. The control section was originally constructed by blasting a 75-foot wide channel in an unweathered granite formation which fortunately prevented breaching of the spillway and failure of the dam. Photographs of the White Oak Dam auxiliary spillway showing the erosion caused by the June 1995 flood event are presented in Figure 7.

Figure 7. Photos of White Oak Dam auxiliary spillway looking downstream (top) & upstream (bottom) after June 27, 1995 flood when 21 inches of rain fell in less than 18 hours.

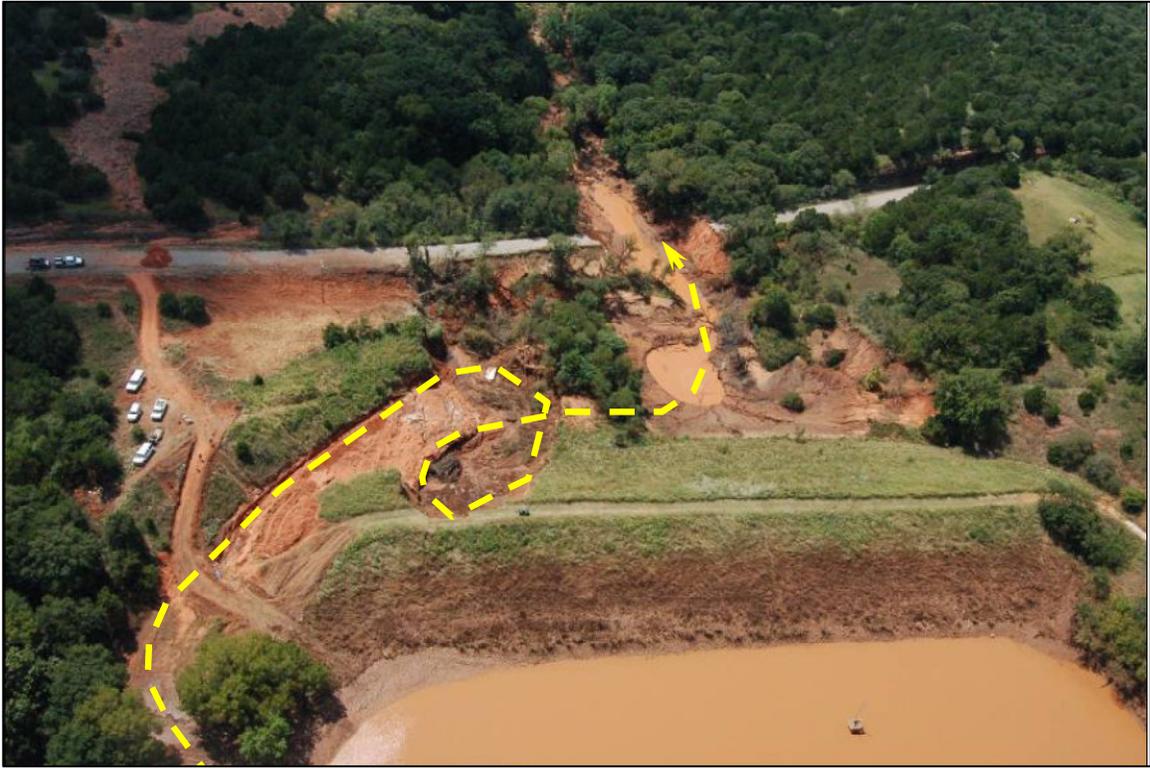
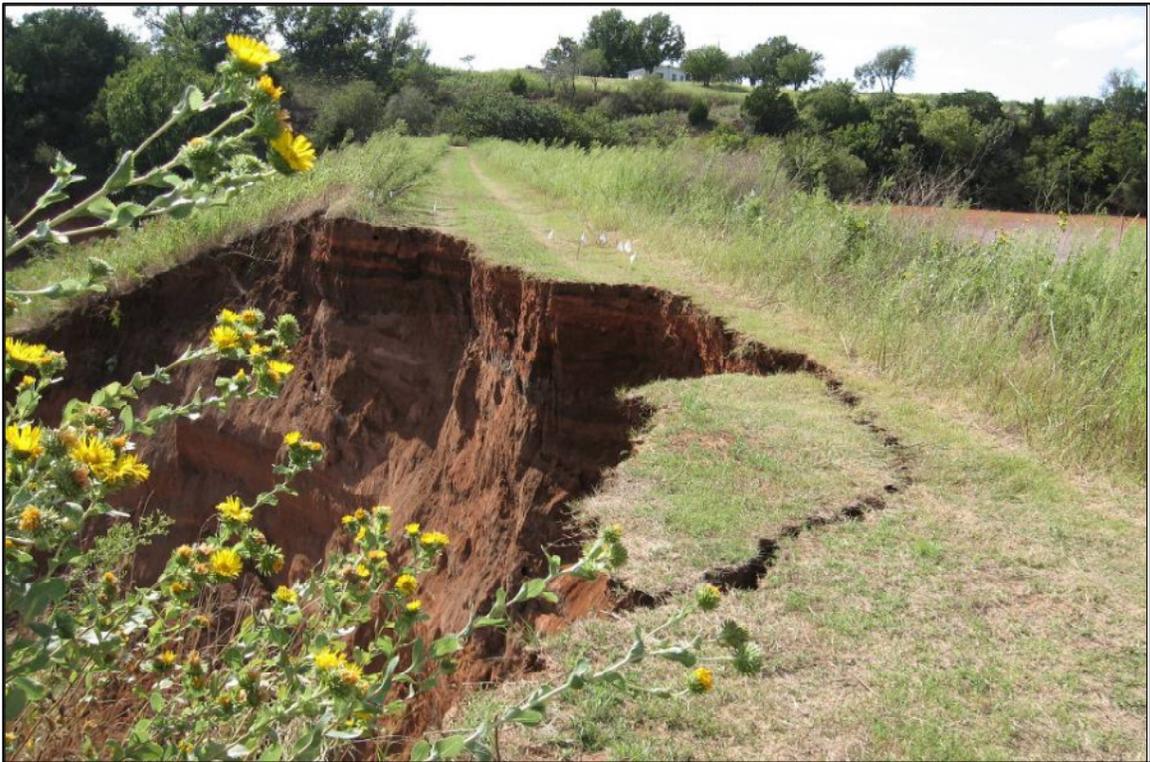
On the weekend of August 18-19, 2007, tropical depression Erin swept across Oklahoma. Rainfall amounts fell in parts of Caddo County that greatly exceeded that of a 100-year frequency storm. Preliminary measurements of the rainfall in the drainage area above Sugar Creek Dam L-44 indicate that over eight inches of rain fell in less than 12 hours and activated the auxiliary spillway. Flows from the auxiliary spillway were discharged beyond the toe of the earth embankment, but returned after encountering the Highway 81 road embankment to erode the downstream slope of the dam and nearly breach the dam. Backwater from debris plugging the culvert under Highway 81 may have contributed to unusual flow condition. Photographs of Sugar Creek Dam L-44 showing the erosion caused by the auxiliary spillway flows are presented in Figure 8.

Figure 8. Photographs showing the flow path and erosion in the downstream slope of Sugar Creek Dam L-44 located in Caddo County, Oklahoma following Tropical Depression Erin on August 19, 2007.

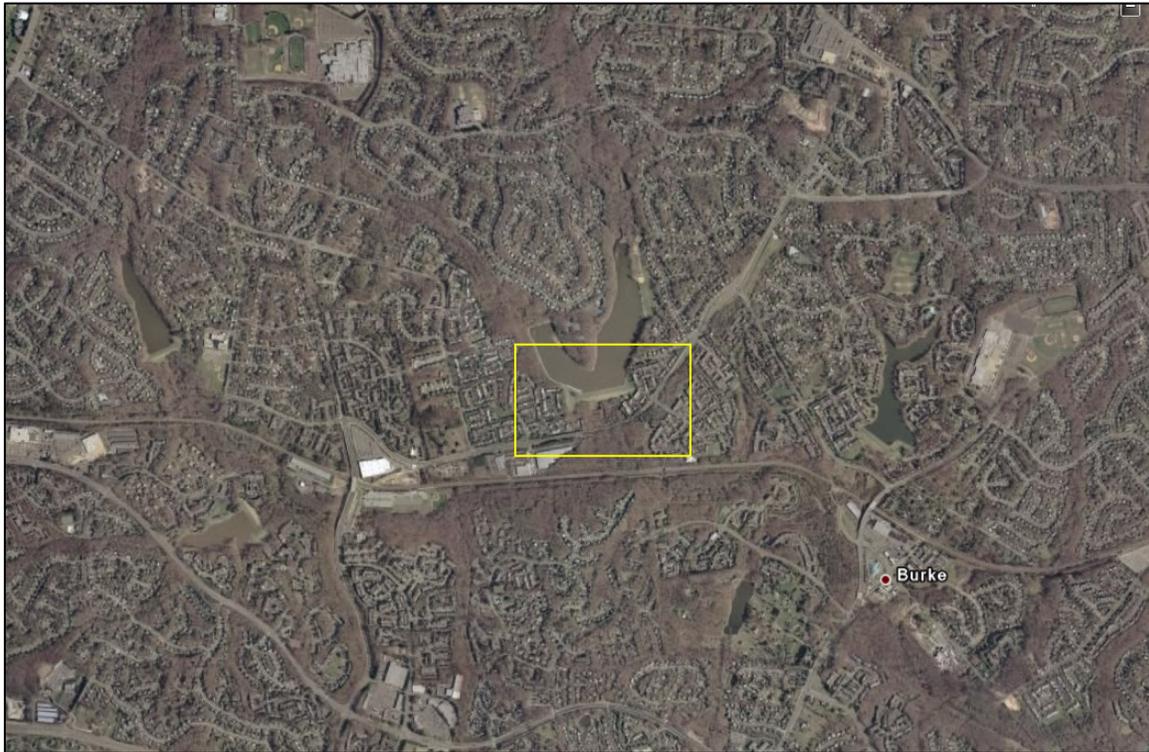
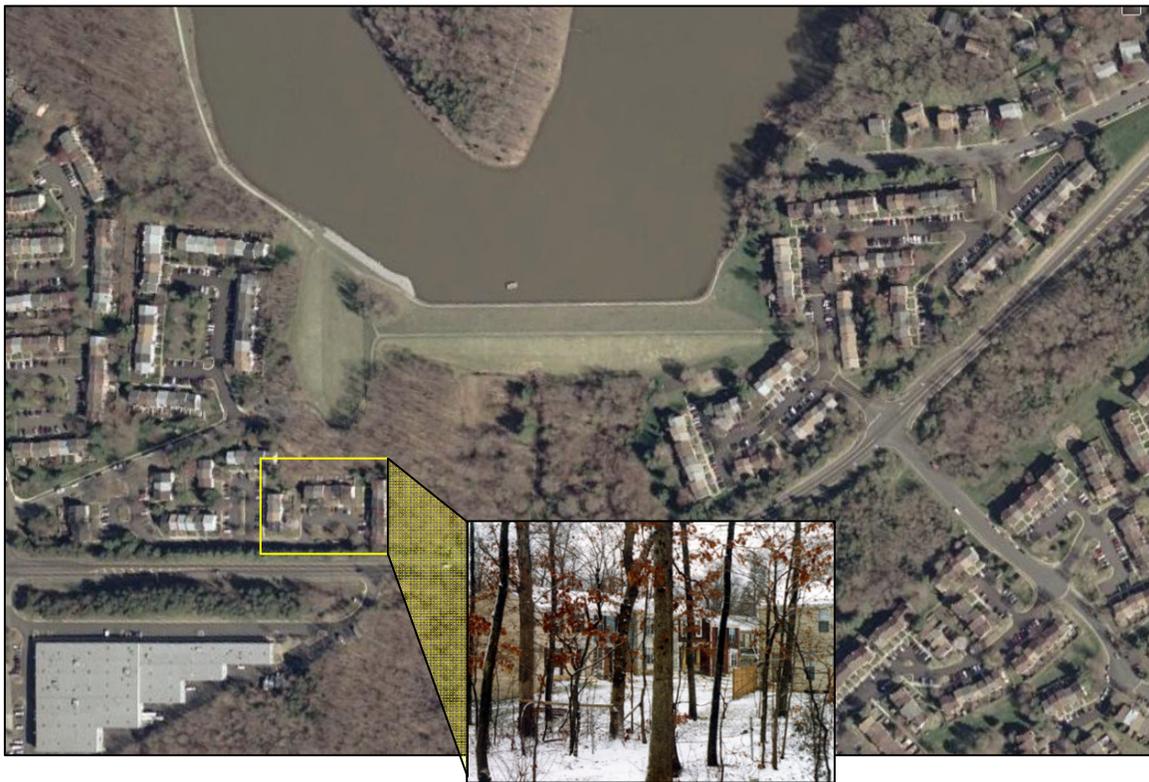
Pohick Creek Dam No. 4 is a flood retarding dam constructed by the Soil Conservation Service in 1976. The lake created by the dam is used for recreation and has a normal pool which is 13 feet below the crest of the emergency spillway, and 24 feet below the top of the dam. The dam is a zoned earth embankment 1,010 feet long and 42 feet high. The auxiliary spillway consists of a 100-foot wide grass-lined trapezoidal channel excavated at the right dam abutment. The crest or control section of the emergency spillway is also grass-lined and consists of a 30-foot long level section. The side slopes of the spillway channel are 3(H):1(V). Approximately 200 feet downstream from its crest section, the grass-lined spillway channel abruptly transitions into a densely wooded area with a 10 percent bed slope. Intense urban development has occurred within the watershed and in the immediate vicinity of the dam. Townhouses were constructed in 1978 and 1979 within 300 feet of the crest of the emergency spillway and are within the path of flows exiting the emergency spillway channel. Aerial photos of Pohick Dam No. 4 showing the intense urban development within the watershed and immediately downstream of the dam and auxiliary spillway are presented in Figure 9.

Figure 9. Aerial photos of Pohick Dam No. 4 showing intense urban development within watershed and immediately downstream of the dam and auxiliary spillway.
