PUBLIC SAFETY AT LOW-HEAD DAMS

*By Kenneth R. Wright, P.E.,¹ T. Andrew Earles, Ph.D., P.E.,²
and Jonathan M. Kelly, P.E.³*

Abstract

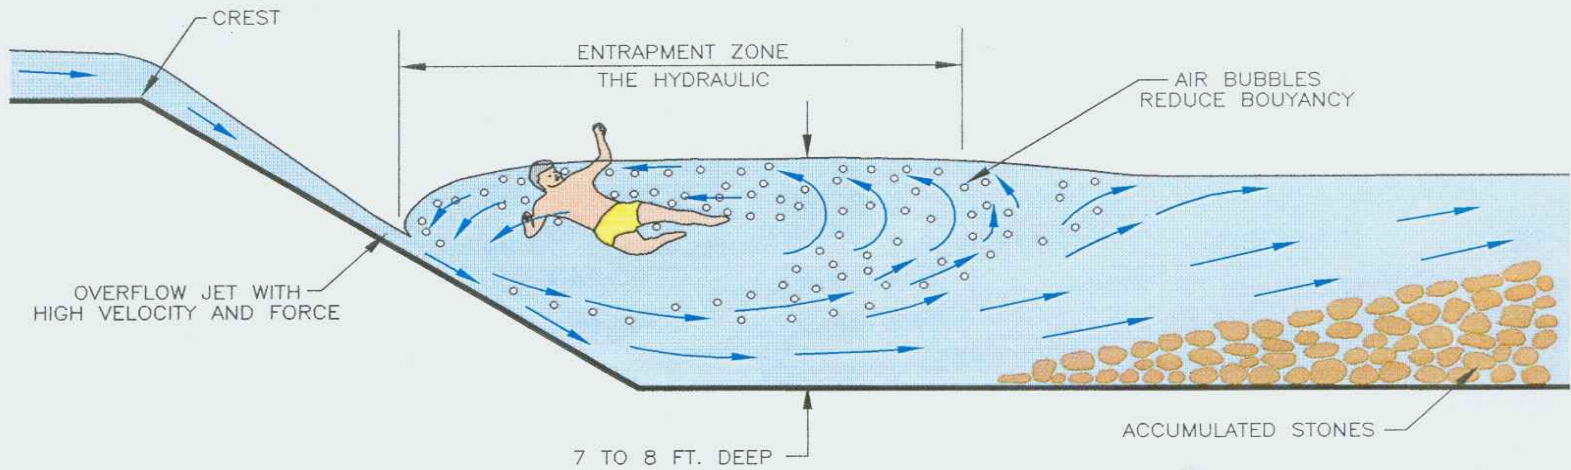
Figure 1 – GCS at Salt River Tempe, Arizona

As a result of a highway project and improvements to the channel of the Salt River through Tempe, Arizona, GCSs in a series were under construction in the 1991–1993 period to control bed erosion. One GCS, No. 5, immediately downstream of the McClintock Bridge, was built of compacted soil cement 378 feet with a height of 5 feet, with a stilling pool 64 feet long and 4 feet deep, as illustrated in Figure 1.

At the likely location where the two canoes passed over the GCS, the vertical hydraulic drop on March 25, 1993 was only 4 feet. The velocity of flow at the crest was about 9 fps, with a depth of 1.4 feet. Where the overflow jet met the downstream water surface, it had an estimated velocity of 17 fps, plunging into the stilling basin to create a submerged hydraulic jump. Kinetic energy in the submerged jet was maintained until the jet rose to the surface downstream of the crest where a boil was formed. Some of the jet flowed downstream and some flowed upstream, back towards the GCS face and the plunging jet. Based on photographs and video records, the water flow character downstream of the GCS appeared somewhat smooth and tranquil, but bubbles rising to the surface and some debris bobbing in the water at the downstream face of the GCS told another story; this was a drowning machine.

- (1) Overflow jet produces large submerging force on victim.
- (2) Air bubbles reduce buoyancy of victim.
- (3) Reverse flow in upstream direction carries debris and victims back into overflow jet.
- (4) Water too deep for standing.

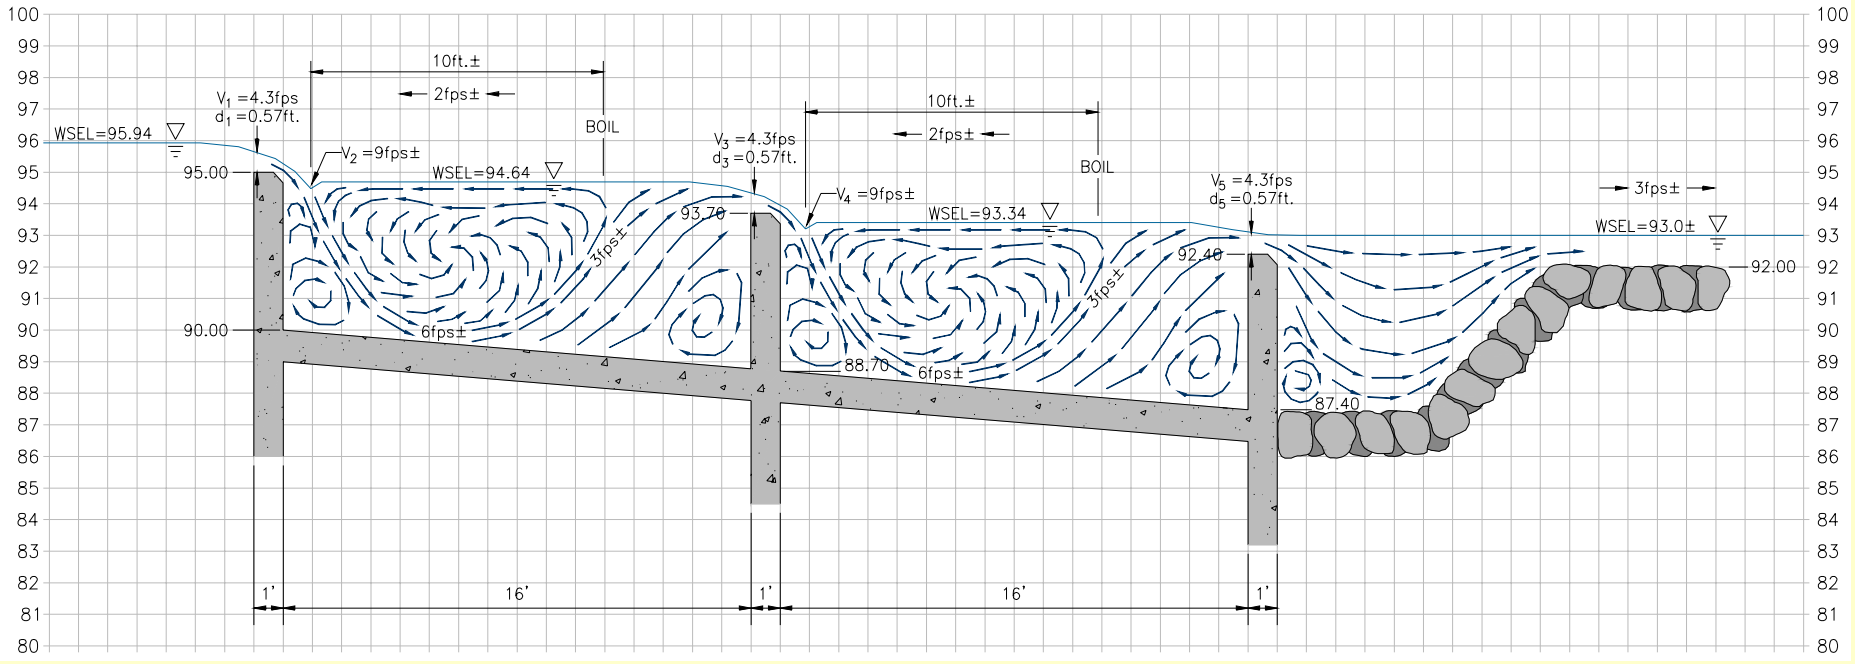
Figure 2 – Swackhammer Dam on Catherine Creek Near Union, Oregon

The tragic drowning of a mother and daughter near Union, Oregon on June 30, 1996 was caused by one or more reverse rollers, where the hydraulic drop from one set of weirs to another was only 1.3 feet. It was here on Catherine Creek that the old Swackhammer Dam was replaced with a modern drop structure to facilitate fish passage, as shown in Figure 2. The U.S. Bureau of Fisheries and the State of Oregon designed the structure; both neglected to consider hazards created by submerged hydraulic jump reverse rollers to the general public.

The total hydraulic drop across the new structure was only 2.9 feet at 160 cfs, the vertical drop being distributed over three concrete weirs in series. The flow velocity at each weir crest was 4.3 fps, while the jet velocity impinging on the lower water surface was 9 fps. Water depth in the pools was 5.6 feet, and the reverse roller was about 10 feet long. A relatively slow reverse current of 2.0 fps provided the hydraulic trap for the two victims.

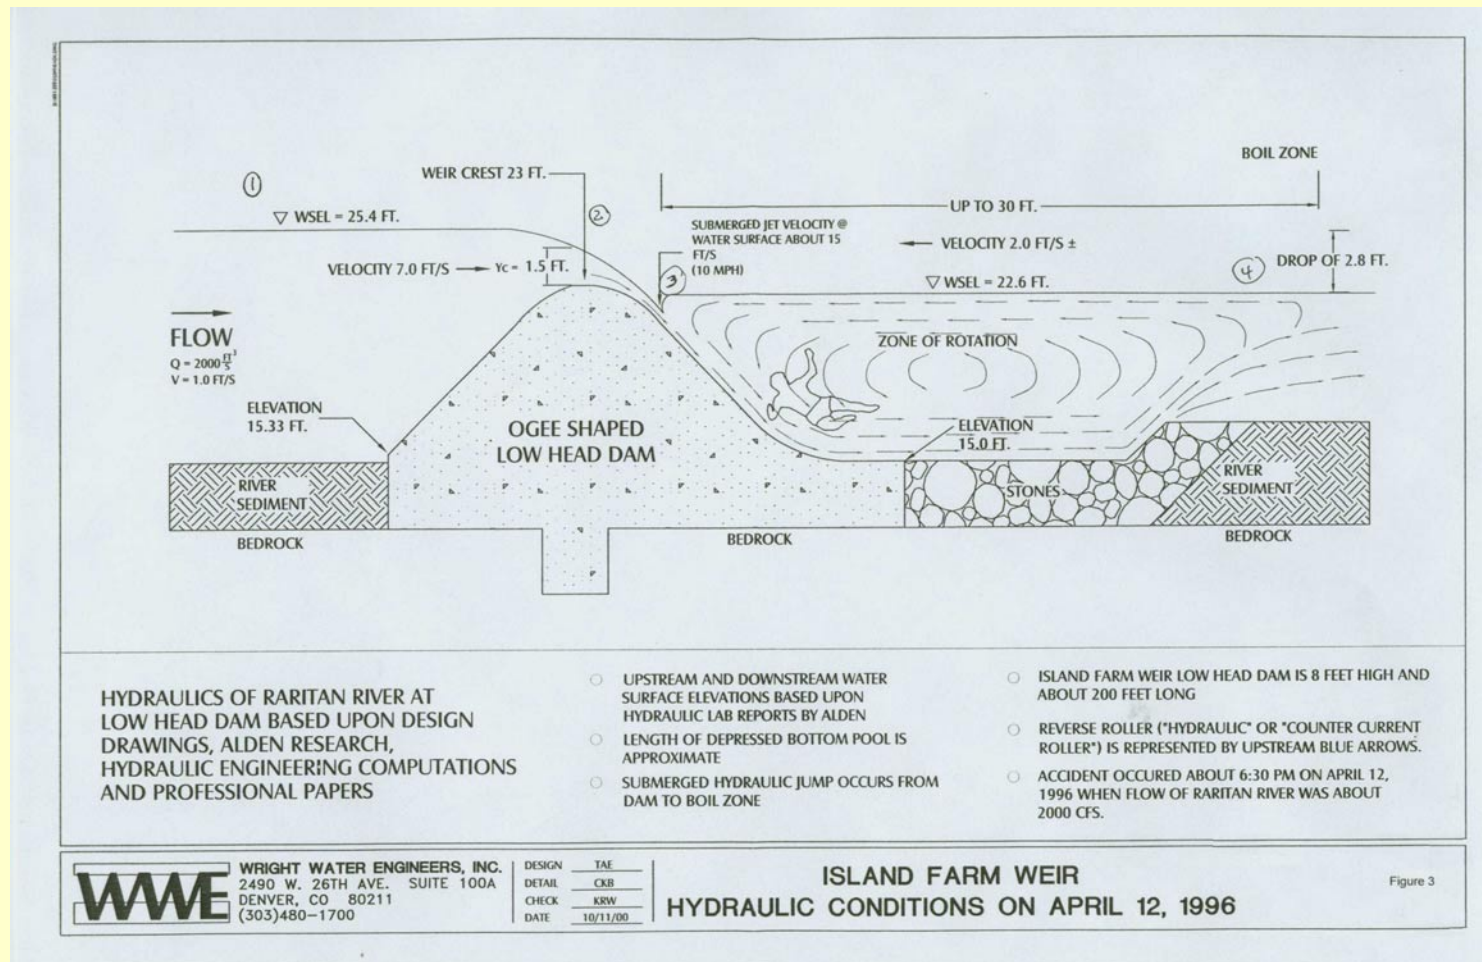
Figure 3 – Island Farm Weir Hydraulic Conditions on April 12, 1996

Even though the dam was 8 feet high, the hydraulic drop across the dam, from upstream to downstream, was only 2.8 feet, due to the stilling basin depth and the high tailwater conditions. At the crest of the dam, the velocity was 7 fps, with a depth of 1.55 feet. Meanwhile, where the overflow jet met the downstream pool, the velocity had increased to over 13 fps, with a Froude number of 2.8.

Figure 3 illustrates the dam and hydraulic characteristics at the time of the drowning and shows the length of the reverse roller at 30 feet, with an upstream velocity toward the dam of only a modest 2.0 fps; yet the current was able to trap the victim causing his expiration and the injury of two companions.

The Island Farm Weir was finally retrofitted in 1998 after four drownings in only three years following its construction. The successful retrofit consisted of merely flattening the downstream face of the dam by providing a series of steps to dissipate energy and to eliminate the opportunity for a reverse roller to form below the dam structure.

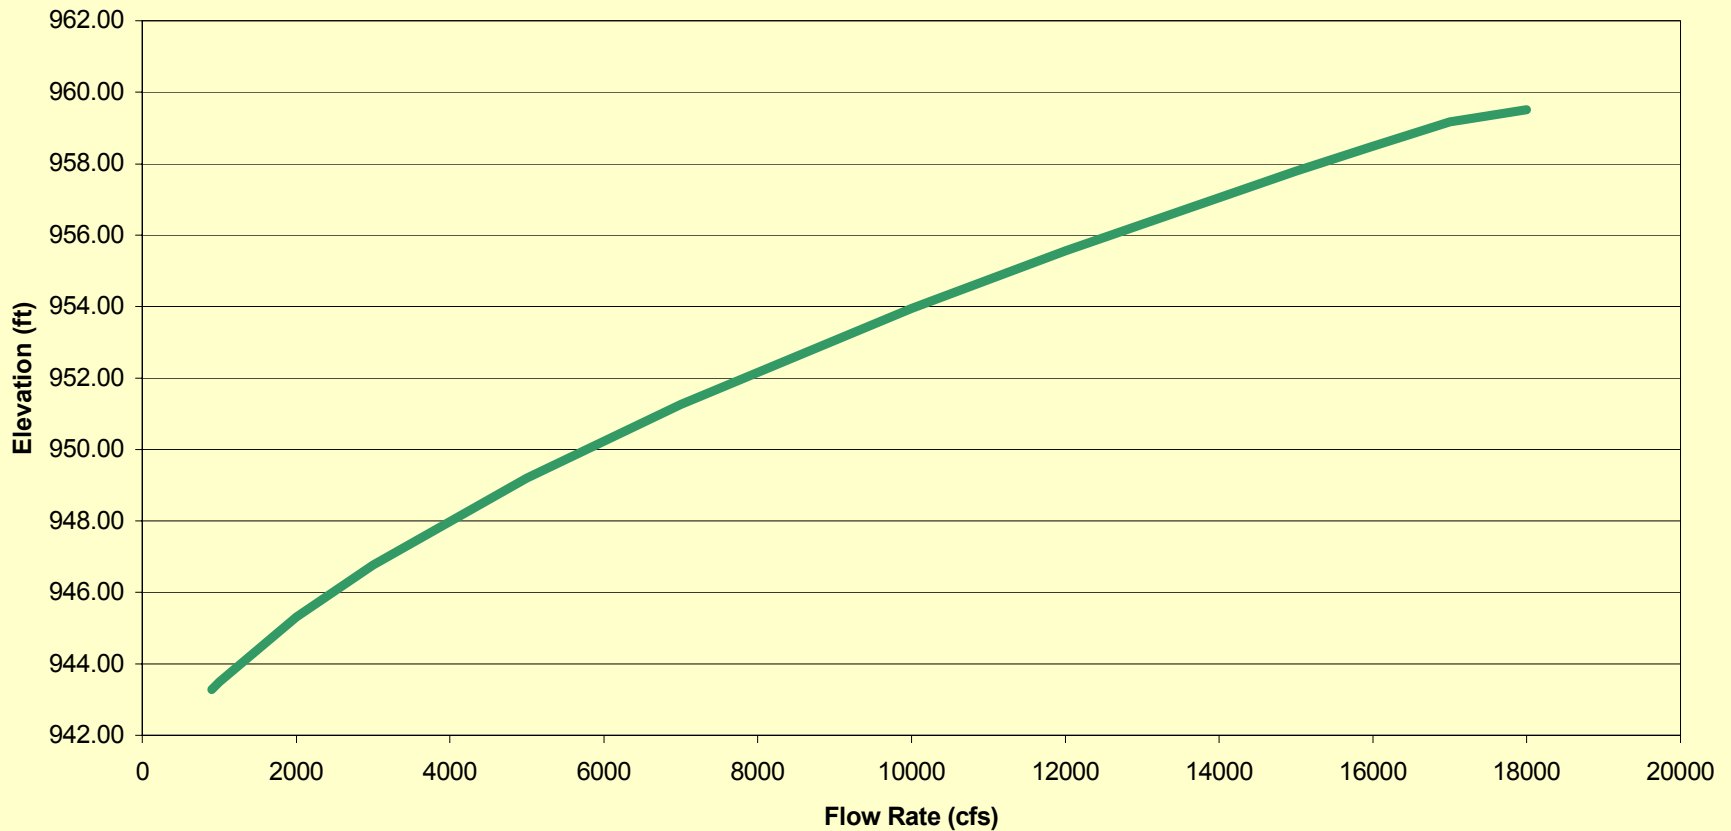
Figure 4 – Tailwater Elevation Rating Curve for Highland Dam

At the time of the incident, the depth of the flow over the crest was 0.97 feet at a velocity of 4.0 fps. The tailwater elevation was 7.9 feet below the dam crest with a vertical upstream-downstream water surface drop of 8.9 feet and a jet velocity of 24.2 fps where the jet plunged into the downstream pool (Froude number of 9.0). The jet surfaced approximately 40 feet

downstream of the dam at a boil, where the remaining kinetic energy in the jet caused a small water surface rise with bubbles, with a portion of the jet flowing upstream at a relatively high velocity of 6.5 fps. The tailwater rating curve and the submerged hydraulic jump characteristics are presented in Figures 4 and 5.

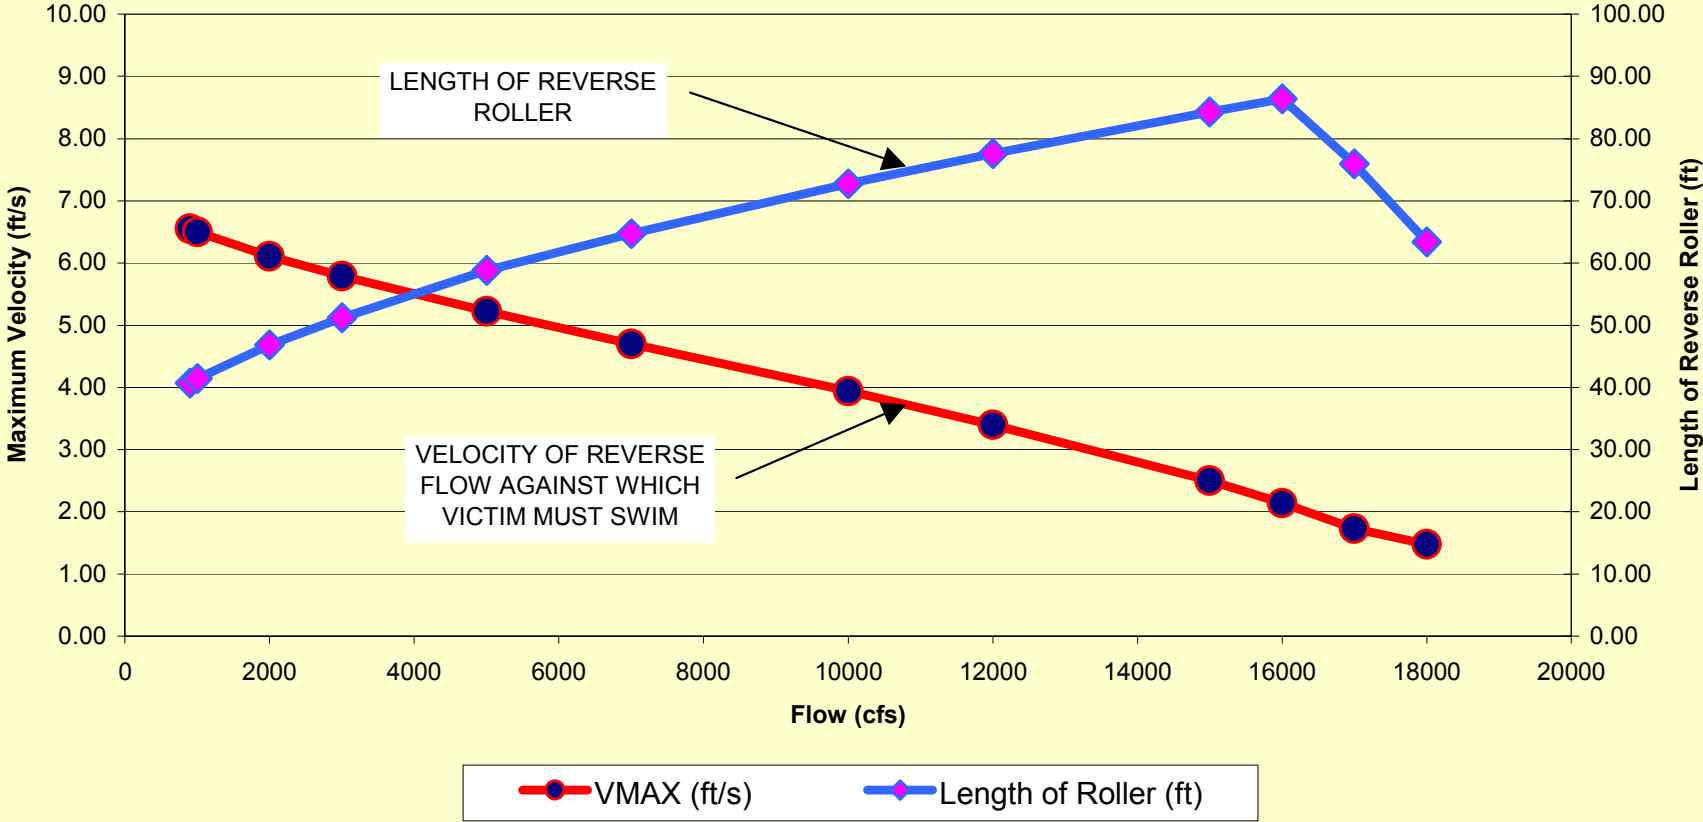
Figure 5 – Highland Dam, West Fork River Submerged Hydraulic Jump Characteristics

When the 15-foot canoe overturned upstream of the boil, the three occupants were carried to the base of the dam by the reverse current, where they encountered the force of the spillway jet, causing them to be submerged along with the plunging jet, only to be carried downstream, rising to the surface near the boil and then being carried back to the face of the dam in a continuing cycle. All three of the canoeists drowned at the base of the Highland Dam on the West Fork River that was classified by the State of West Virginia for recreation, including boating. There were not warning signs above or below the dam to warn recreationists.

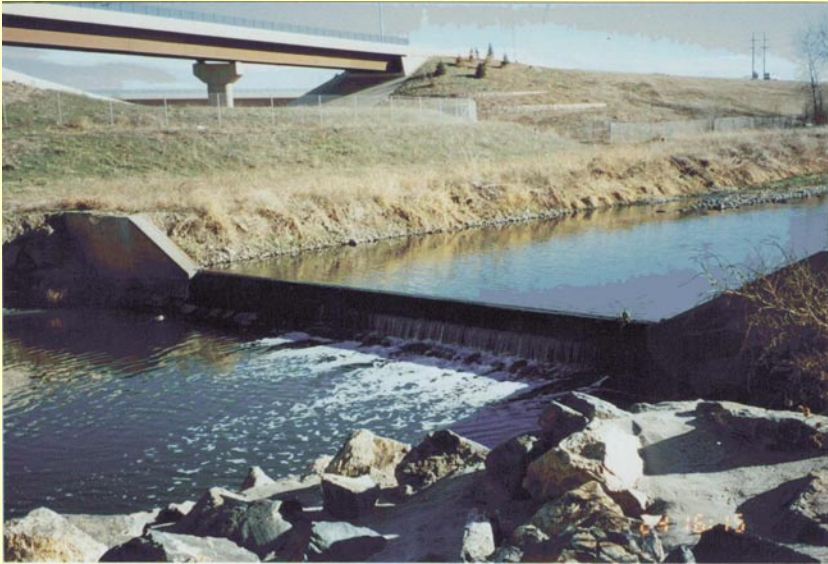
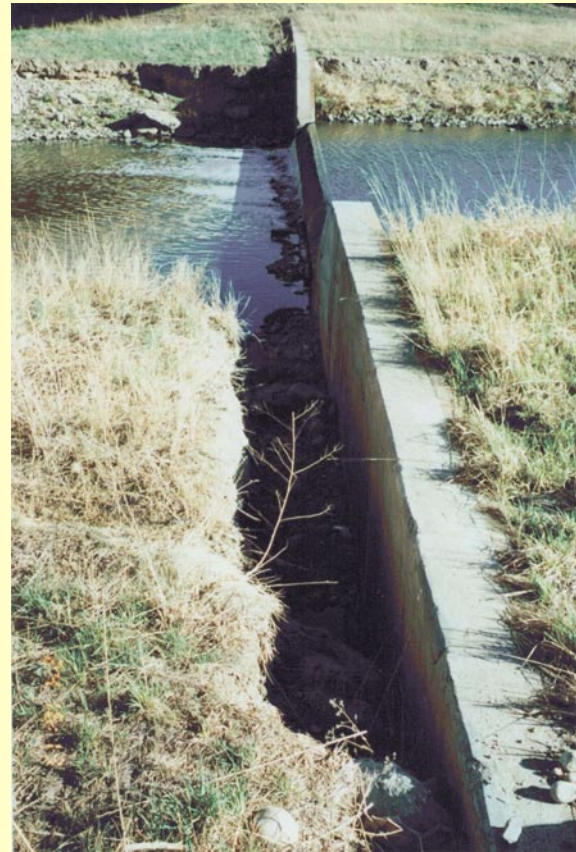
Figure 6 - Photos of GCS Structure in Adams County, Colorado

The Colorado Department of Transportation (CDOT) constructed three low-head GCS structures in series in Clear Creek under Interstate 25 during 1991 and 1992. On June 30, 1996, a man and wife floated down Clear Creek in Adams County, along with another couple; upon encountering the first GCS, their raft capsized, and the first couple was tragically drowned. The second couple survived. The stream flow was about 700 cfs at the time of the incident. The GCS structure is shown in Figure 6.

In May 1992 prior to the accident, the director of the local county Parks and Recreation Department wrote to CDOT informing them of the hazardous nature of the GCS design and construction. By June 1998, the three GCS structures were retrofitted by creating a 1:10 sloping, grouted, riprap surface downstream of each crest. This created enough of a horizontal flow vector, hydraulic roughness, and shallow enough flow depth immediately below each structure so that reverse rollers no longer form.

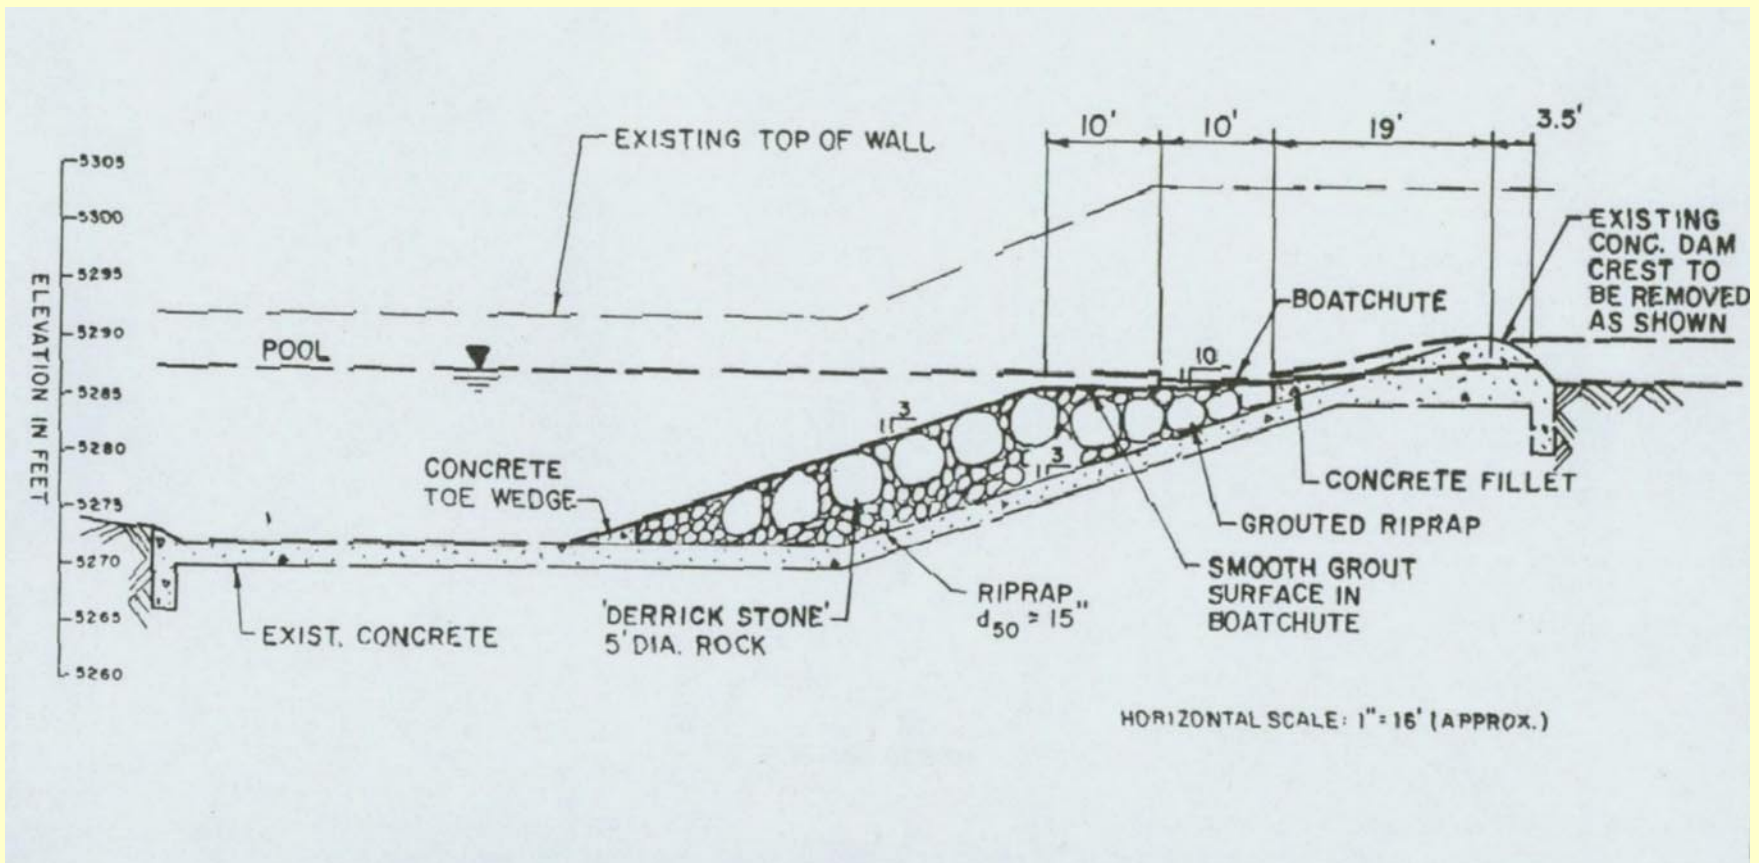
Figure 7 – Boating Improvements to Union Avenue Dam (Section Thru Existing Dam)

When the USACE replaced the historic St. Petersburg Ditch diversion dam in 1985 on the South Platte River with a new structure, they did not give adequate consideration to the pre-design period recommendations of local recreational boaters. The new structure was called the Union Avenue Dam. Its profile is shown in Figure 7.

The new dam was an 18.5 feet high, concrete gravity dam with an over-the-dam spillway that sloped at 33 percent into a stilling basin, the hydraulic drop being 15 feet. Typical spring river flows over the dam of 700 cfs, and even up to higher flows such as 1,300 cfs, gave the sound and appearance of a good whitewater rafting experience, and the stilling basin provided an attractive urban setting for recreationists to practice hazard maneuvers. The South Platte River classification by the State of Colorado included recreational uses.

During the three years (1985-1988) following the new dam completion, three boaters drowned. At this point, it was obvious that a public water hazard had been created. The USACE and the state wanted to cure this hazardous public works problem.

The solution was to build a boat chute near the right abutment and to flood the downstream face of the dam with a series of four downstream stair-stepped embankments so that each hydraulic drop would be only 3 to 4 feet high, and each embankment would include a designed boat chute that would safely convey recreational boaters without a reverse roller being formed.

Fortunately, the state agency was willing to have the design tested using a 1:18 hydraulic model built by the U.S. Bureau of Reclamation's hydraulic laboratory at the Denver Federal Center. The extensive model testing effort also included the placement of rock fill on the downstream face of the dam to eliminate dangerous currents, even during higher flow periods when discharges exceeded the boat chute flow. Their thorough and comprehensive model study and report by Klumpp, Pugh, and Fitzwater (1989) was highly successful; the resulting retrofit of the Union Avenue Dam converted a serious public hazard into a popular water recreational park.
